Stonewall Structural Engineering, PLLC  
Raleigh Office  
9203 Baileywick Rd. #200  
Raleigh, NC 27615  
(919) 407-8663

Re: Structural Observation — 1215 Anne Street, Henderson, NC 27536

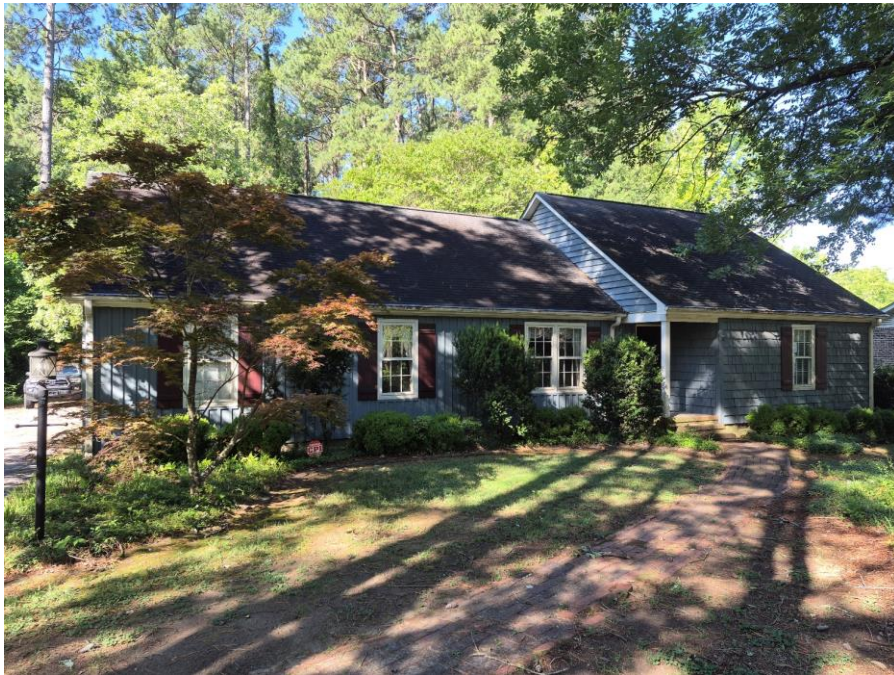
*Picture 1 – 1215 Anne Street, Henderson, NC 27536*

At your request, on June 24, 2026 we performed a visual structural observation of reported damaged floor framing at the Henderson residence noted above. The structure is a conventionally framed, detached, single family residence with raised first-floor framing over a pier/girder foundation system with a partial foundation wall and partial pier/curtain wall foundation (*see picture 1*).

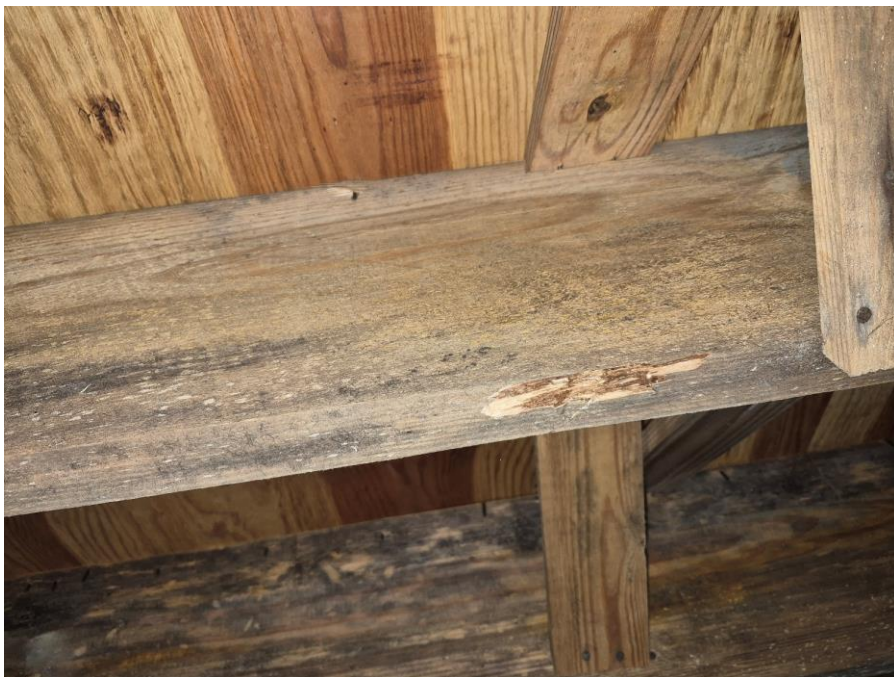
- The following floor framing members were noted during our site visit to be deteriorated or damaged enough to warrant structural reinforcement or replacement (*see pictures 2-5 for examples*).

- In the front joist bay of the left portion of the home, the 12<sup>th</sup>-21<sup>st</sup> joists from the left as well as the 23<sup>rd</sup> joist from the left.

- In the back joist bay of the left portion of the home, the 14<sup>th</sup>-16<sup>th</sup>, 18<sup>th</sup>, 22<sup>nd</sup>, and 27<sup>th</sup> joists from the left.

- The deteriorated floor framing has likely been the result of prolonged exposure to moisture in the crawlspace.

*Picture 2 – Deteriorated joist*

- 1) Reinforce each of the deteriorated joists noted above with an additional full depth ply of 2x #2 Southern Yellow Pine (SYP), fastened to the side of the deteriorated joists using (3)10d common nails at each end and at 12" on center staggered top and bottom along the lengths of the joists. Sistered material should span continuously between end supports.

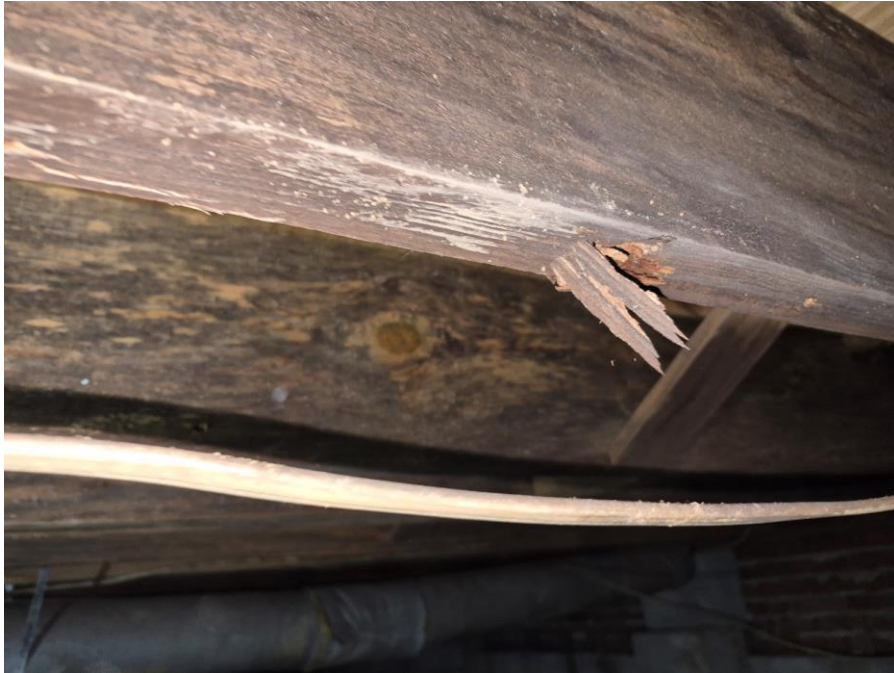
*Picture 3 –Deteriorated joist*

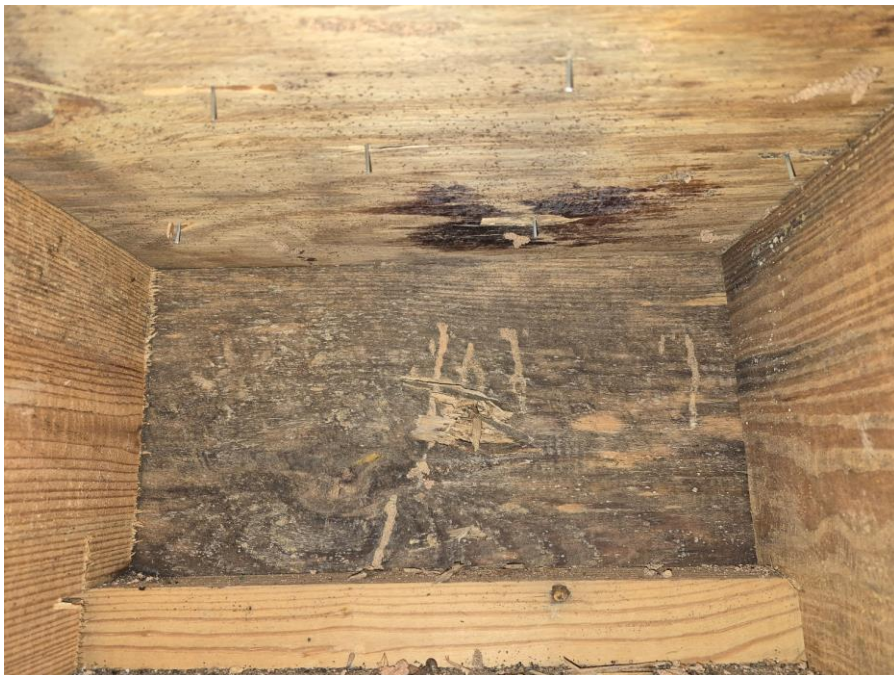
- Along the front of the home, the 4<sup>th</sup> and 5<sup>th</sup> rim beam spans from the left.
  - Ledgers along the central girder in the left portion of the home.

*Picture 4 – Deteriorated rim beam*

- 2) Remove the above-noted deteriorated sections of perimeter rim beams and replace them with full depth built-up (4)2x10 treated #2 SYP material. Reattach joists to the face of the new members using Simpson face hangers. Replacement rim beams should only be spliced over the centers of pilasters.
- 3) Remove any deteriorated ledger strips and fasten joists directly to the sides of the girders using Simpson face hangers.

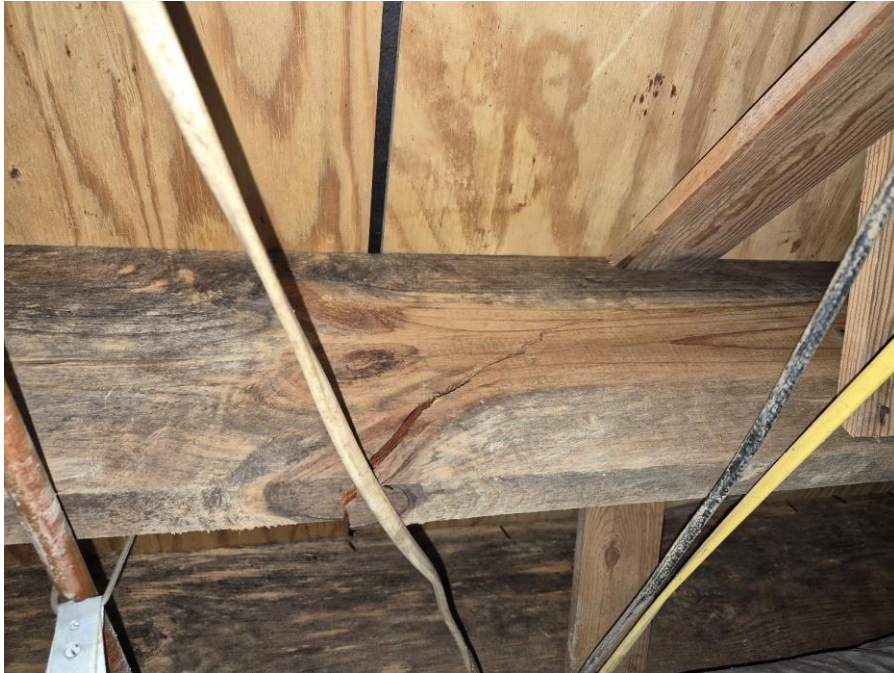
*Picture 5 – Cracked joist*

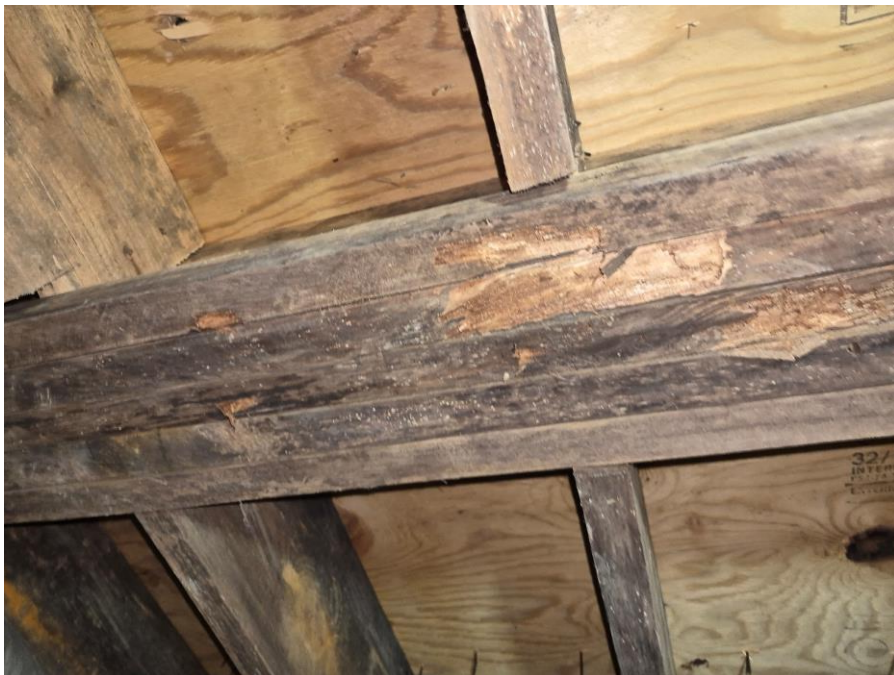
- The bottom of the 4<sup>th</sup> and 5<sup>th</sup> girder spans from the left of the home were noted to be minorly deteriorated (*see picture 6 for example*).

- Measurement by laser level indicated the girders were sagging within code allowable limits.

*Picture 6 – Minor deteriorated girder*
