GILES FLYTHE  
ENGINEERS

Re: Limited Structural Inspection  
2053 Stillwood Drive  
Youngsville, NC

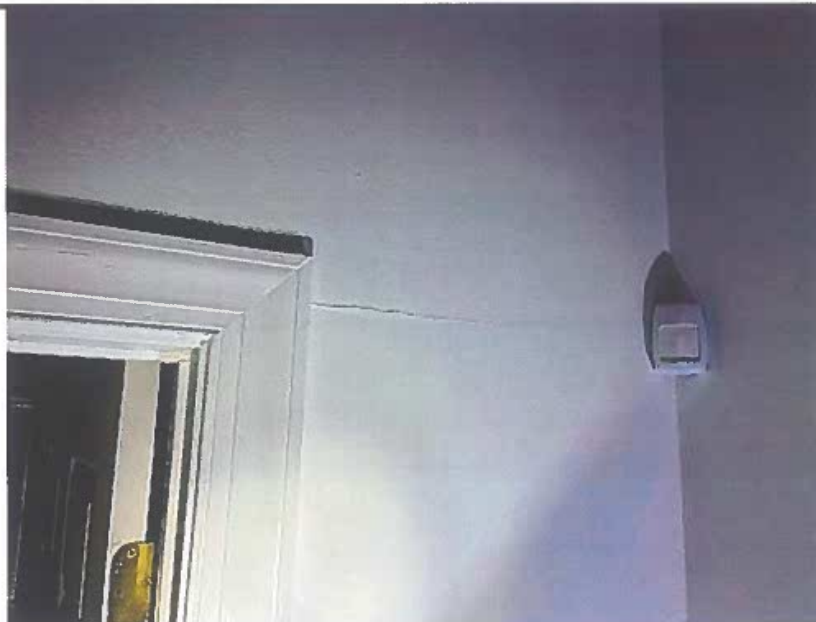
Photo No.  
2

1. Multiple minor cracks/separations (less than 1/16" wide) were observed in the wall/ceiling finish materials throughout the home.

The minor interior wall/ceiling finish material cracks/separations noted above (Observation #1) are likely the result of the supporting members contracting/deflecting. Minor drywall cracking and finish carpentry separations are typically associated with changes in weather, temperature and humidity causing wood to shrink and swell with the seasons. Repeated seasonal cycles can also cause drywall tape to lose its adhesive properties. When moisture is taken away from wood it has a tendency to contract thus resulting in deflection (or sagging). Any walls, windows or doors bearing on the deflected members will also move. We do not consider the interior wall/ceiling finish material cracks/separations to be a structural concern.

Typical view of a minor  
interior finish material  
crack.
