# ATLANTIC COAST SEPTIC SOLUTIONS

## SEPTIC REPORT

10 Alease Dr  
Zebulon, NC 27597

12/03/2025

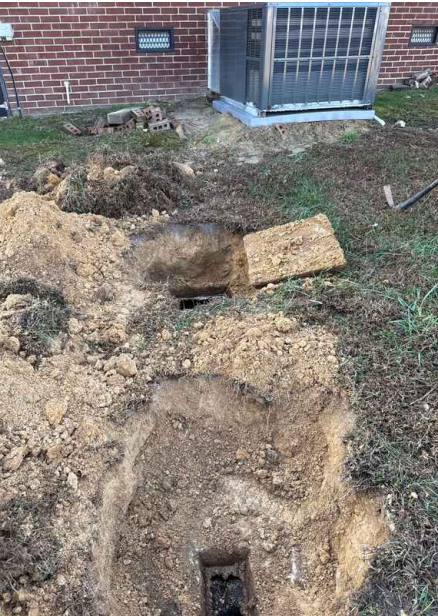
**Tank Assessment: Distance from primary structure (approximate in feet)**  
Approx 8 feet

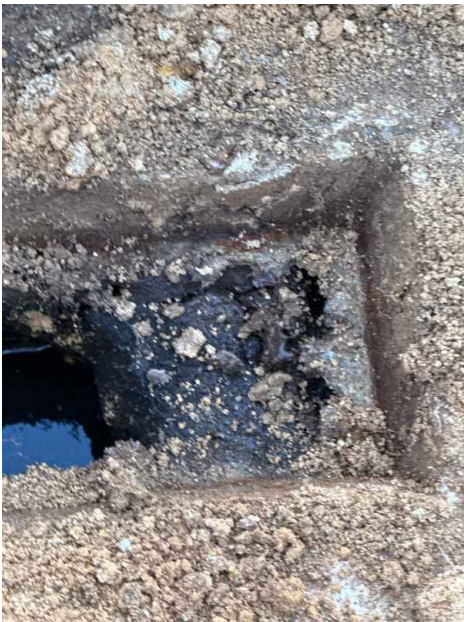
**Tank Assessment: Baffle wall present and in good condition?**  
Visible portions in good condition

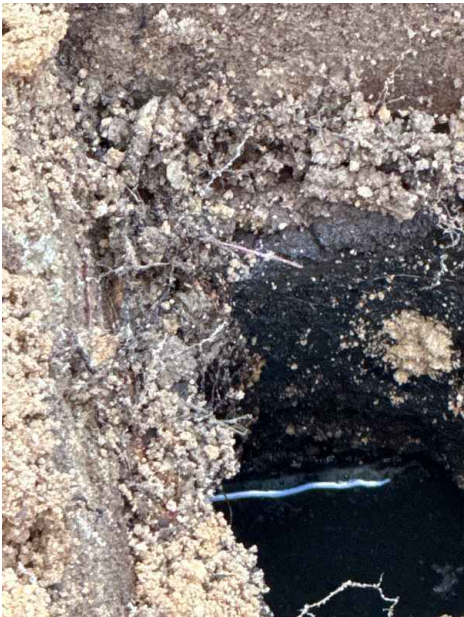
| <b>Tank Assessment: Evidence of possible infiltration or non permitted connections such as from downspouts or sump pumps?</b><br>No | <b>Tank Assessment: Evidence of tank leakage?</b><br>No | <b>Tank Assessment: Root intrusion visible?</b><br>Yes |

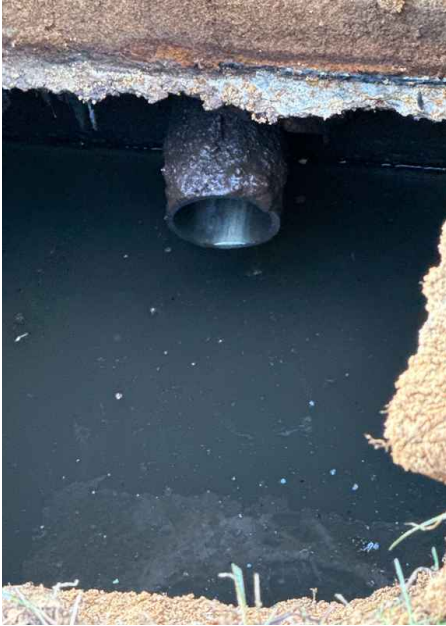
**Tank Assessment: Connection present from house to tank?**

Yes

The buried lines from the structure to the home are not normally visible during the inspection. This limits the inspector's correct assumption of this area in some scenarios.

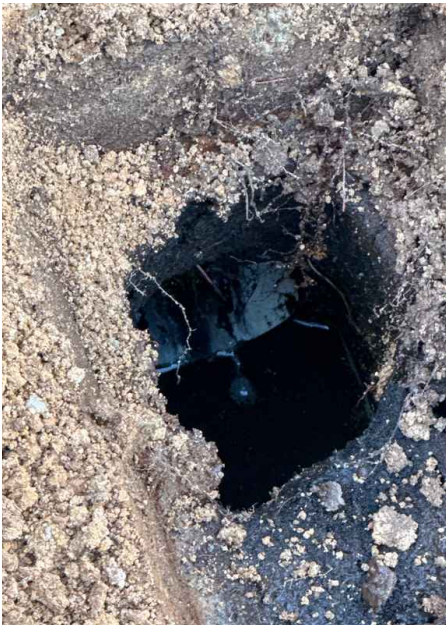
**Tank Assessment: Connection present from tank to next component?**

Yes

The buried lines from the tank to the next component are not normally visible during the inspection. This limits the inspector's correct assumption of this area in some scenarios.

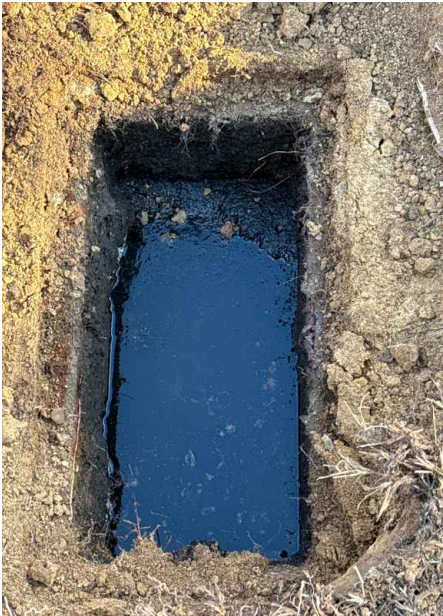
5.1.1 Distribution Box

**Distribution Box: Device appears to provide equal distribution or performing as designed?**

No

**MISSING SPEED LEVELERS**[Summary](#)

Speed levelers are not installed. This can prevent even distribution of effluent to the lines. We recommend a licensed septic contractor further evaluate and repair as needed.

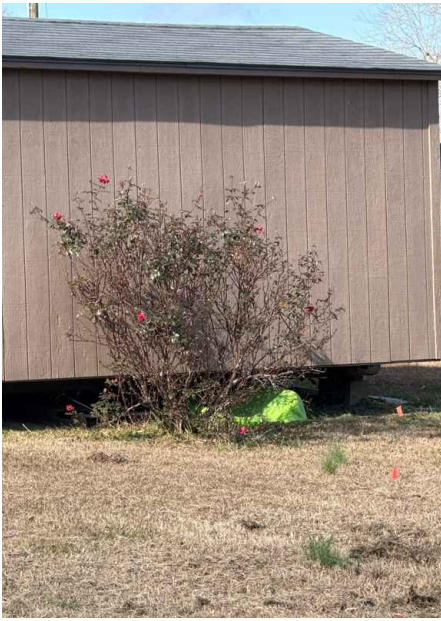
#### 5.2.1 Drainage Field

**Drainage Field: Possible vegetation impact?**

Yes

### **VEGETATION**

Vegetation is present that can impact the drainage field. This can prevent proper operation and increase probability of the system failing. We recommend a licensed wastewater contractor further evaluate and recommend a path to repair if needed.

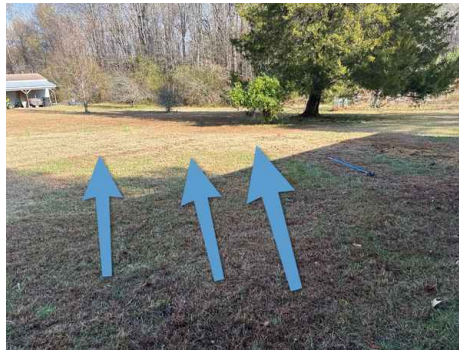
**Drainage Field: Grading or drainage that may impact the system?**

Possibly
