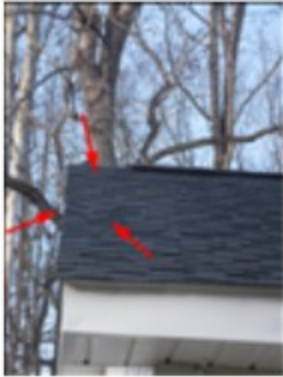
### **(C1 - 1.1 ) Main House**

From the exterior of the home, the roof surface has visible sags located between the rafters. The low areas have displaced the roof covering materials and this condition could increase the probability of leaking. A licensed general contractor should be consulted for further evaluation and repair to ensure the weathertightness and stability of the structure.

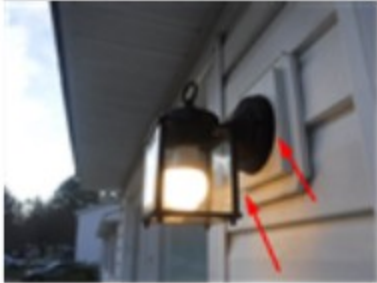
### **(E5 - 1.1 ) Exterior Front**

The light fixture is not secure. Loose installations could result in improper operation and electrical hazards. A licensed electrical contractor should be consulted for a complete evaluation to determine the significance of this concern and make necessary repairs to correct defects and prevent safety hazards. A licensed electrical contractor should be consulted for further evaluation and repair.

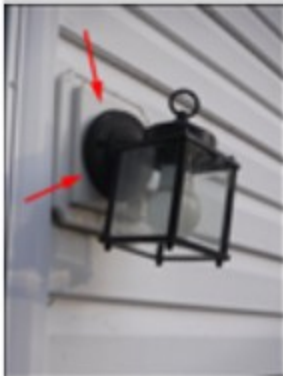
### **(E5 - 2.1 ) Exterior Left**

The light fixture is not secure. Loose installations could result in improper operation and electrical hazards. A licensed electrical contractor should be consulted for a complete evaluation to determine the significance of this concern and make necessary repairs to correct defects and prevent safety hazards. A licensed electrical contractor should be consulted for further evaluation and repair.

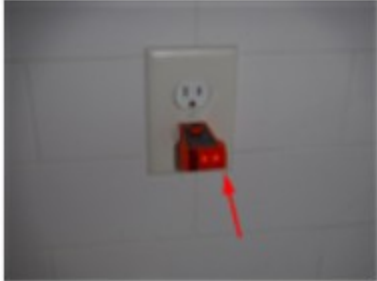
## (H2 - 1.4 ) Kitchen

The GFCI receptacle(s) did not test/reset correctly to ensure that it was ground fault protected. GFCI protection is needed to reduce shock in hazardous locations.
