## Norwood Plumbing - NC: Septic System Inspection

May 20, 2026

4107 Maynard Circle , Franklinton,  
NC

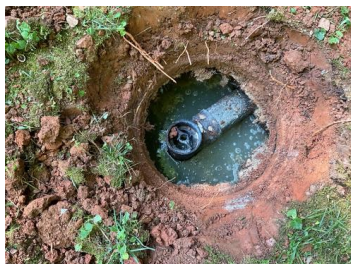
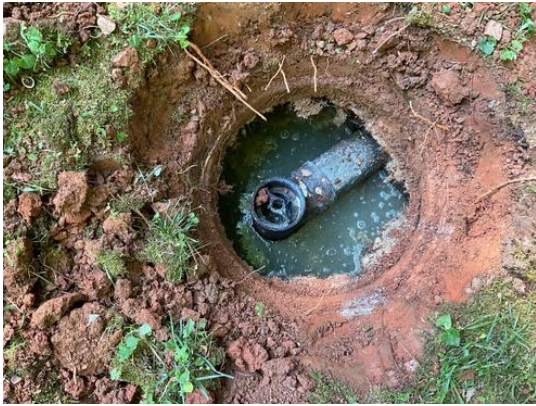
Photo 7

Condition of septic tank inlet access lid

Good

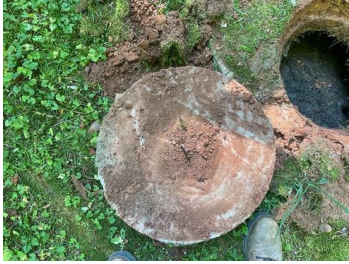
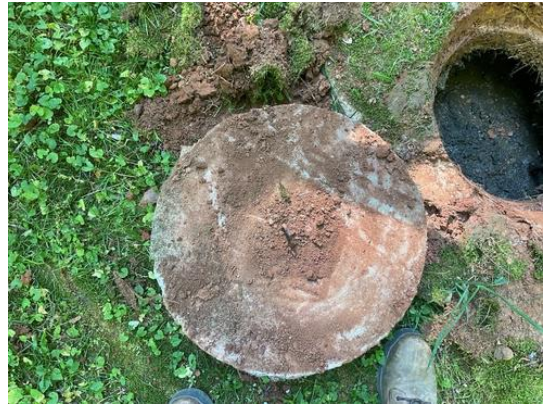
Photo 8

**Condition of septic tank outlet access lid**

Good

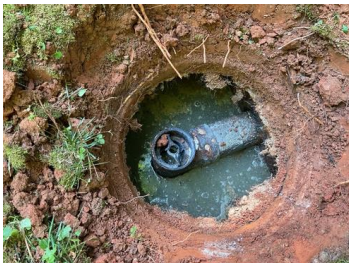
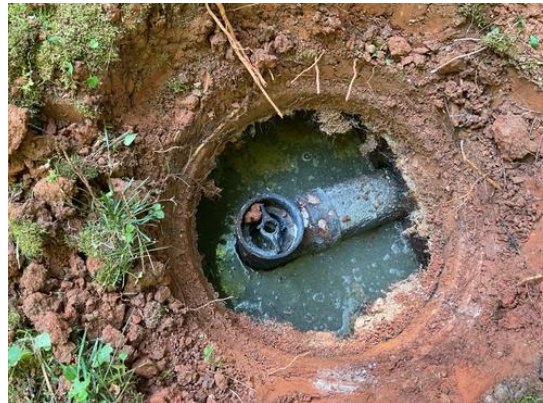
Photo 10

**Condition of outlet tee**

Good

**Outlet tee is at appropriate elevation**

Yes

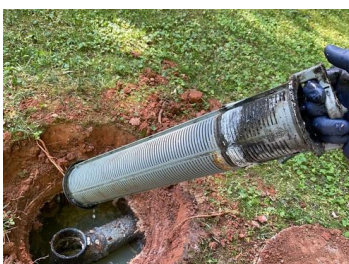
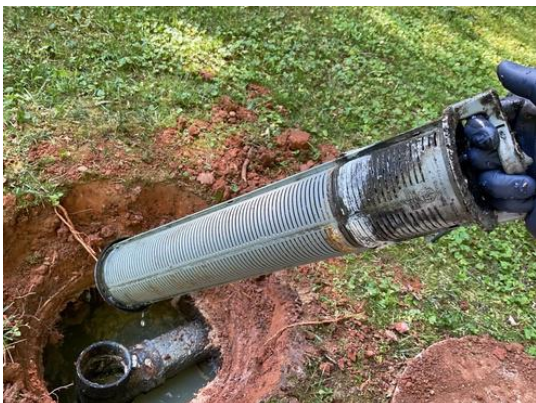
Photo 11

**Condition of effluent filter.**

Good

\* Clean the effluent filter every one to two years.

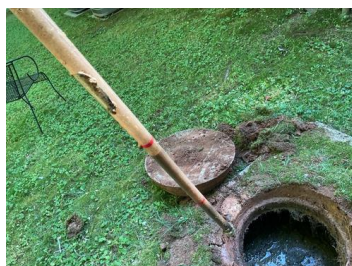
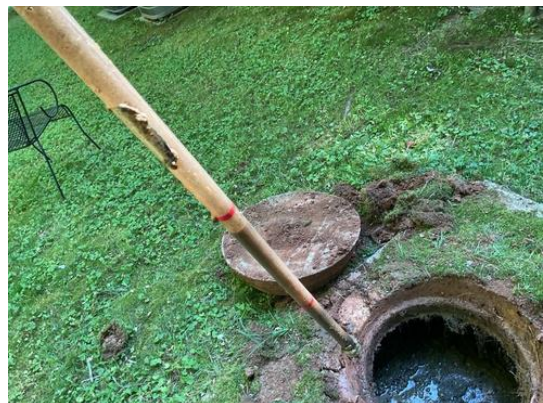
Photo 12

**Percentage of solids (sludge and scum) in tank**

23 %

\* Accumulated solids inside of the septic were measured as being higher than state recommended acceptable operating levels. Solids should be removed from both the inlet and outlet side of the septic tank.

\* FOGs were present at the upper layer crust level inside the septic tank. Fats, oils and/or grease should not be in the septic system as the decomposition of these types of solids produces hydrogen sulfide gas which will deteriorate the cement components used in the system component construction.

Tank is recommended to be pumped

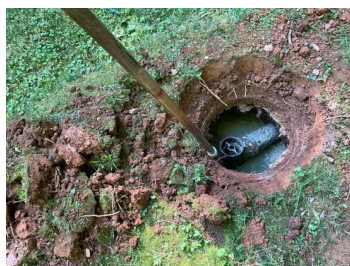
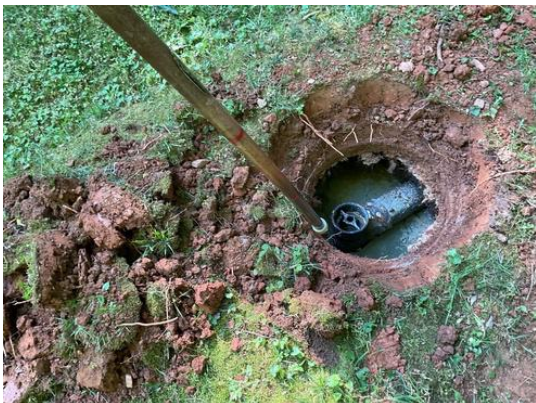
Photo 13

**Root intrusion in tank**

Yes

**Root growth is entering the tank at:**

Inlet Lid

Outlet Lid

\* It is suggested that a preventative maintenance treatment of a root killer be added in the septic system to kill off any root mass intruding into the drain lines. Any products (specified for septic system use) that consist mostly of copper sulfate will kill off existing roots and prevent further root growth from growing in and around the drain lines.

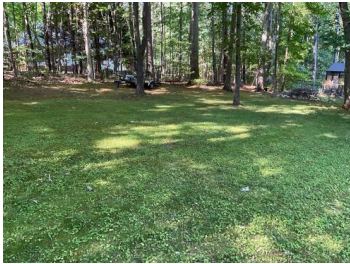
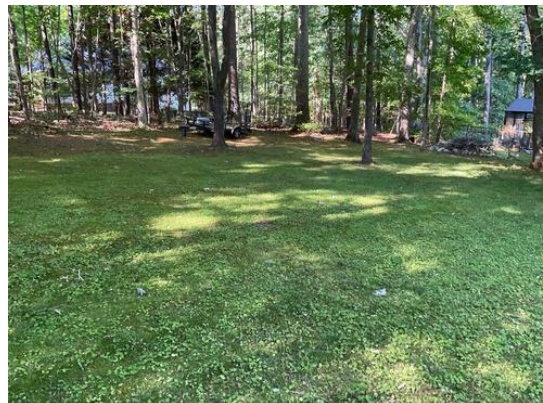
| Photo 14 | |

| Type of drain field | Conventional (Rock and Pipe) |
| Evidence of surfacing effluent | No |
| Confirmation that effluent is reaching the leach field (visibility limited) | Yes |
