Property Inspection Report

Report Number: 2025058

213 Nine Mile Road
Newport, North Carolina 28570

Date of Inspection: Monday, June 30, 2025

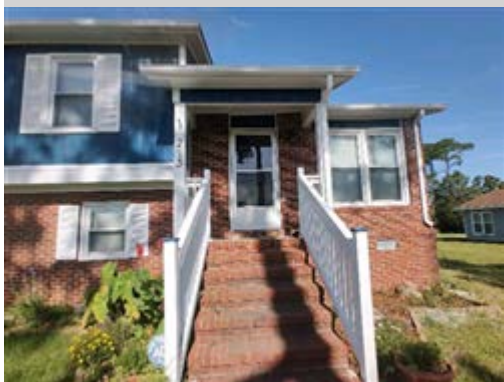
(A2 - 1.1) Porch

The columns appear to be solid. Repairs have been made to the column base.

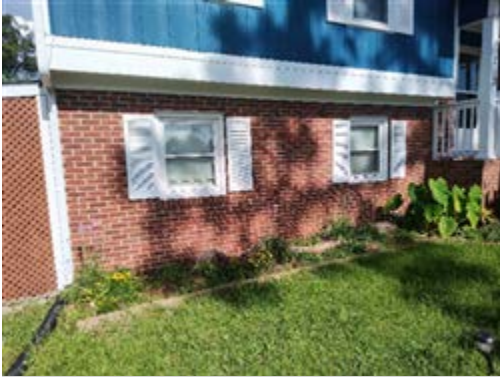
(B1 - 1.1) Main House

Bric veneer at ground floor

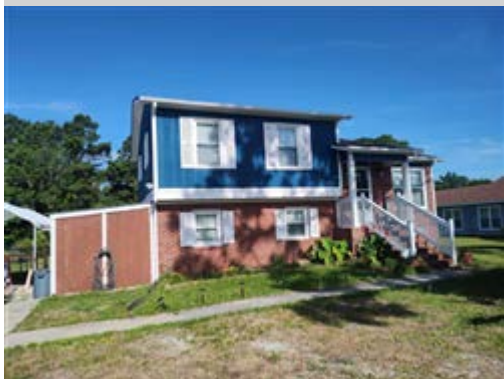
(B2 - 1.1) All Windows

All windows functioned easily.

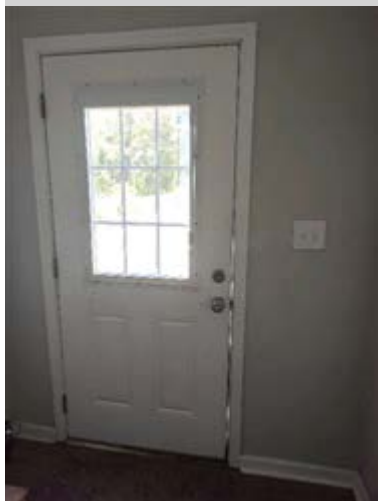
(B2 - 2.1) Exterior Doors

Downstairs. Rear door. You can light shining around the door on the strike side. The door and frame are not in alignment and the weatherstripping may need to be replaced

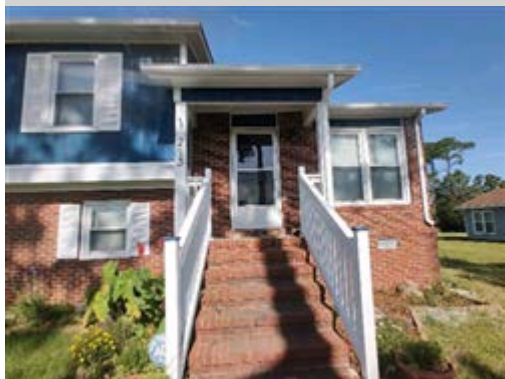
(B3 - 1.1) Porch

Columns and handrails show evidence of wear and tear but it appears any rot and decay has been addressed.

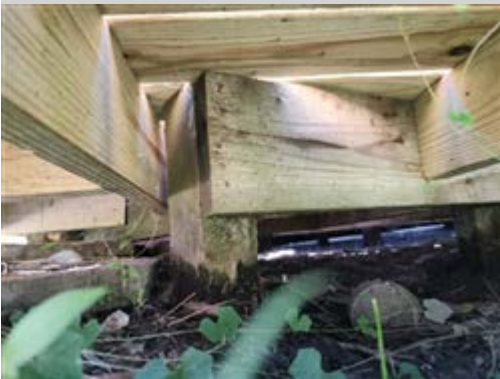
(B3 - 2.3) Deck

A glimpse of the framing below the decking. It appears the bands/girders are attached to the side of the post/4x4 and are not bearing supported. This method of construction (nonbearing supported) requires each connection to be through bolted with 5/8" galvanized bolt nut and washer. (or equal). The joist are also not bearing supported (no ledger or joist hanger). The joist are supported by nails driven through the band into the end of the joist. Joist should be bearing supported. A repairman/carpenter can repair.

The bands and girders are not bearing supported so they should be through bolted with 5/8" galvanized bolts, nuts and washers, or equal.

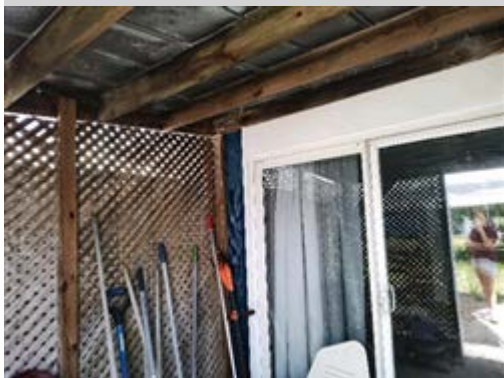
(B3 - 3.1) Patio Cover

This covers the patio. It is not constructed to code and was probably not permitted.

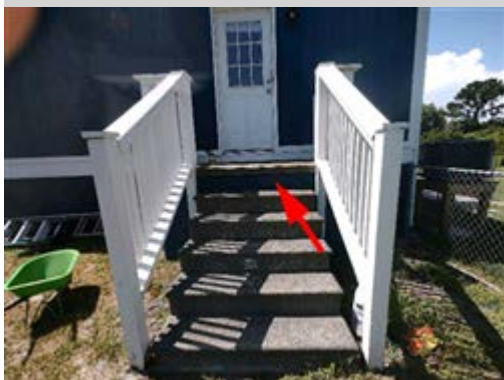
(B3 - 4.1) Stoop

The last riser going up is significantly higher than the rest. this is somewhat of a tripping hazard. The steps appear to be precast. A repairman could reset the precast steps so that all risers (except the 1st at the ground) are the same height.

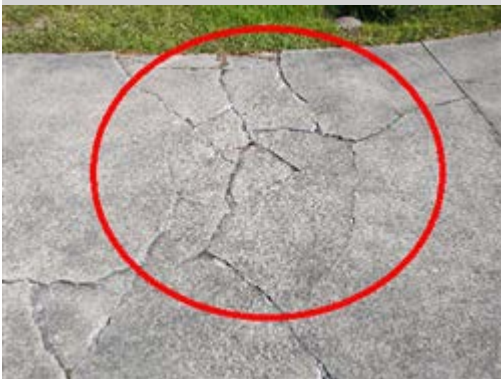
(B4 - 1.2) Driveway

Lots of cracks and evidence of settlement of the driveway over the concrete pipe. The repair is to cut out and replace.

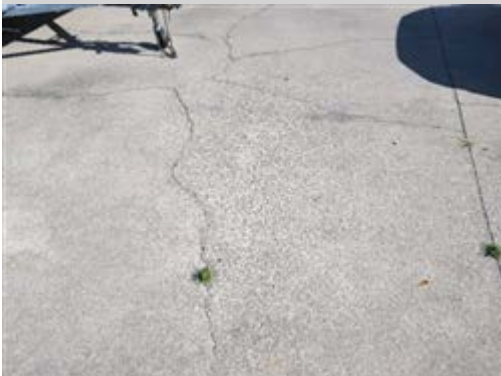
(B4 - 1.3) Driveway

Typical expansion/contraction cracks

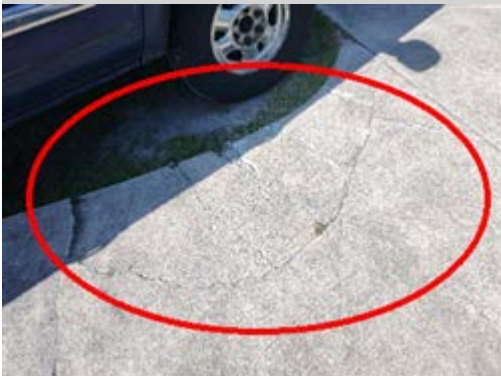
(B4 - 1.4) Driveway

Another area of cracks and settlement .

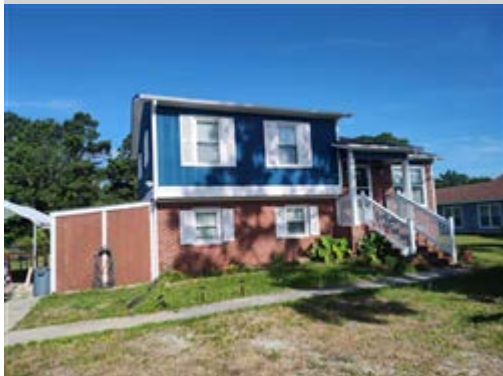
(B5 - 1.1) Vegetation

No vegetation negatively affecting the property and improvements were observed.

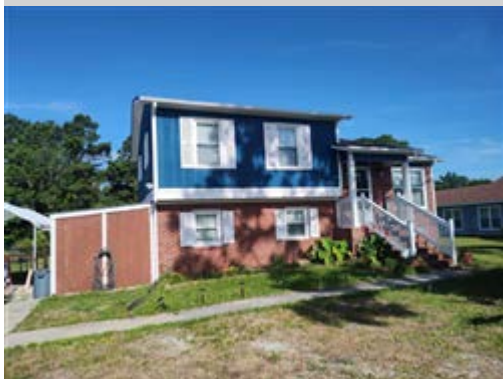
(B5 - 2.1) Grading

No areas of improper grading or lack of draining water away from the improvements were observed

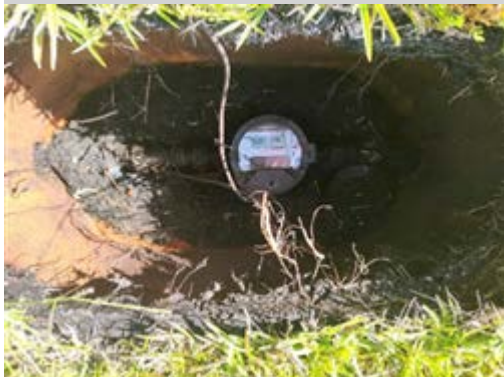
(D1 - 1.1) Main

Water Meter

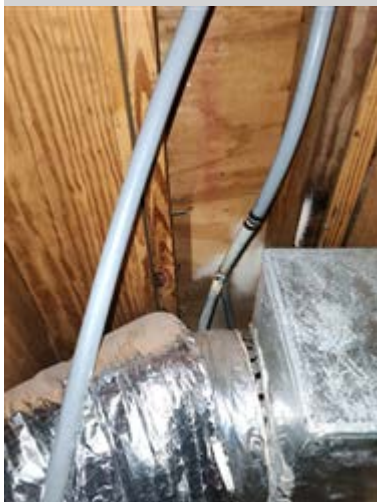
(D1 - 2.1) All Accessible Areas

In the water heater closet. PEX to polybutylene

This home has a plumbing supply system that uses polybutylene plastic distribution lines and compression band fittings. Even though this plumbing system was installed in many homes from 1978 until mid-1990's, it is no longer manufactured in the original formulation as an approved plumbing system due to a history of material failures. The failures were related to improper installation, improper handling, improper storage, and plastic deterioration due to chemical reactions with the water supply. Due to the nature of this latent defect, it was not possible to adequately assess the condition of the plumbing system during the home inspection. A licensed plumbing contractor should be consulted for a complete evaluation of the plumbing system to determine the significance of this concern.

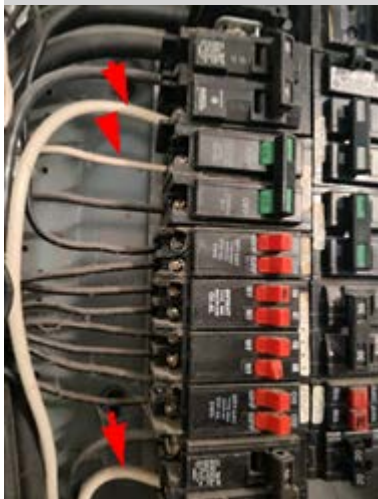
(E2 - 1.4) Main Panel 1

When black is used for hot it should be indicated so with black or red tape or black marking. A repairman/electrician can repair. In the panel, a 220 volt breaker is supplied by a white and black wire. In this configuration, the white wire is used for power and not as a neutral and should be correctly labeled with black markings. This configuration could result in personal injury to service and repair people. A licensed electrician should consulted to check the general condition of the panel and the conductors at the termination points and provide black markings to ensure that service/repair workers are alerted to the color difference and the presence of hot conductors.

When black is used for hot it should be indicated so with black or red tape or black marking. A repairman/electrician can repair. In the panel, a 220 volt breaker is supplied by a white and black wire. In this configuration, the white wire is used for power and not as a neutral and should be correctly labeled with black markings. This configuration could result in personal injury to service and repair people. A licensed electrician should be consulted to check the general condition of the panel and the conductors at the termination points and provide black markings to ensure that service/repair workers are alerted to the color difference and the presence of hot conductors.

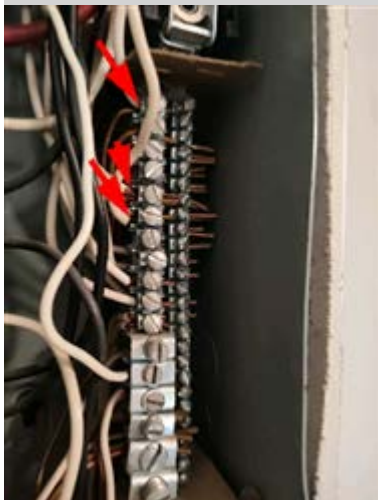
(E2 - 1.6) Main Panel 1

There are some neutrals and grounds under the same lug and then there are two neutrals under the same lug. An electrician can evaluate and repair. Neutrals and grounds should not be under the same lug, especially when on the same circuit.

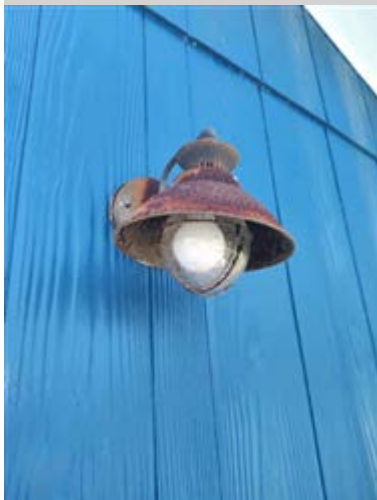
(E5 - 1.1) Exterior

Did not function. Replace bulb and verify function to ensure there are not underlying problems.

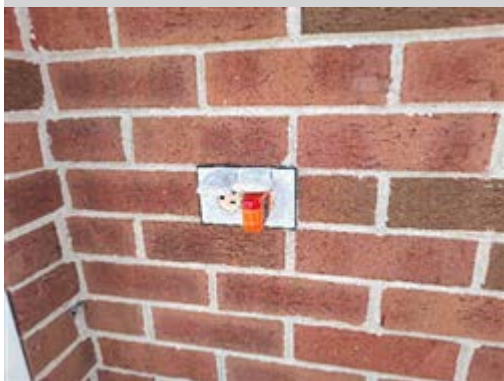
(E5 - 1.2) Exterior

Front porch receptacle not GFI protected. Required since 1973. An electrician can evaluate and repair.

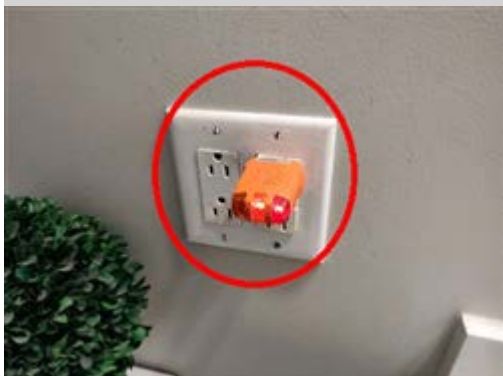
(E5 - 2.1) Interior

Main bathroom. The GFI is not tripping with my tester. An electrician can evaluate and repair.

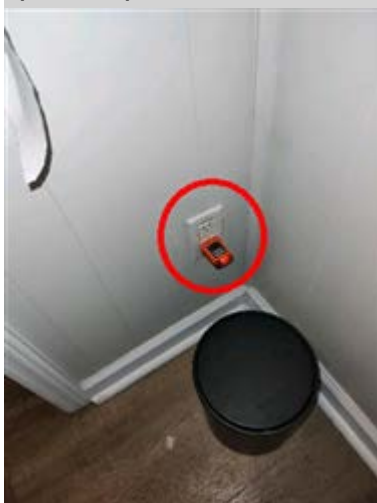
(E5 - 2.2) Interior

Downstairs half bath. Incorrect wiring. The GFI will not function. An electrician can evaluate and repair.

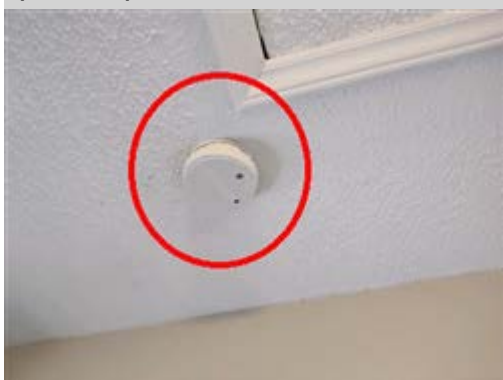
(E5 - 2.3) Interior

This smoke detective did not test as working. A repairman can replace

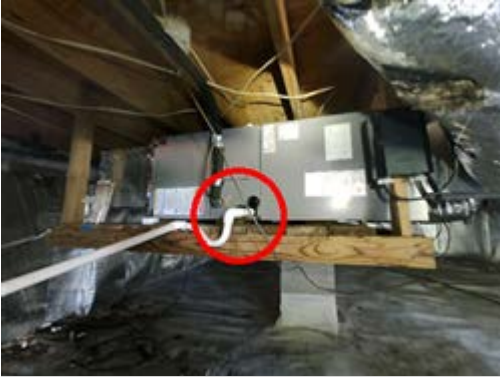
(F1 - 2.1) Heating Unit 2

1 condensate drain line to exterior. If this line fails, condensate can build up and the water will fall to the vapor barrier. I suggest a safety cut-off switch be installed, because you don't want condensate draining into the crawlspace.

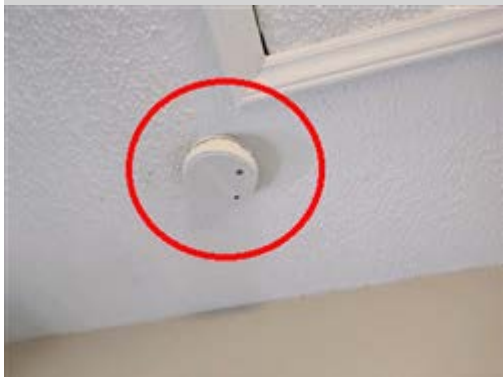
(H1 - 1.2) Hall

This smoke detective did not test as working. A repairman can replace

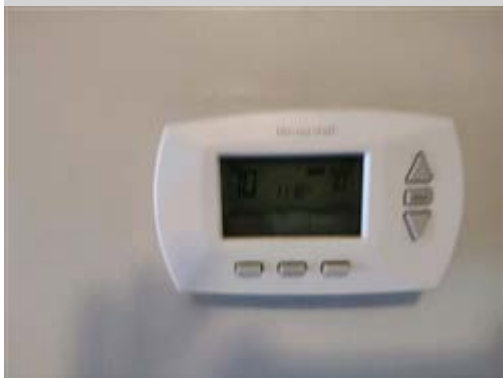
(H1 - 1.3) Hall

Unit 1 thermostat

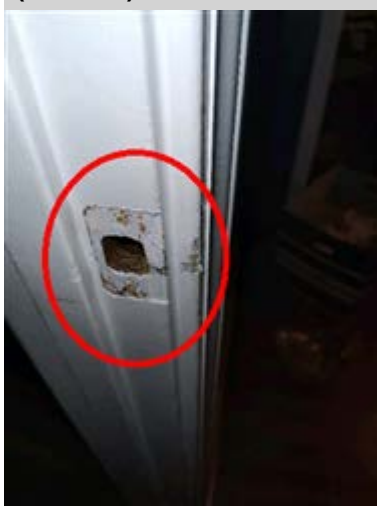
(H1 - 5.2) Bedroom 2

The latch plate is missing.

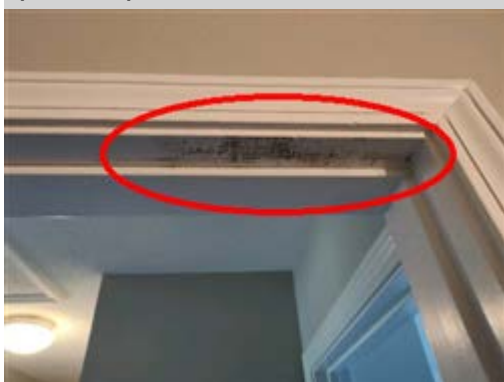
(H1 - 5.3) Bedroom 2

The bedroom door is rubbing the top jamb. A repairman/carpenter can repair.

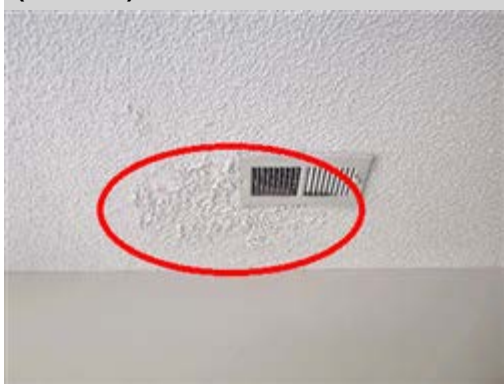
(H1 - 6.2) Bedroom 3

Area of ceiling repair. Request seller disclosure.

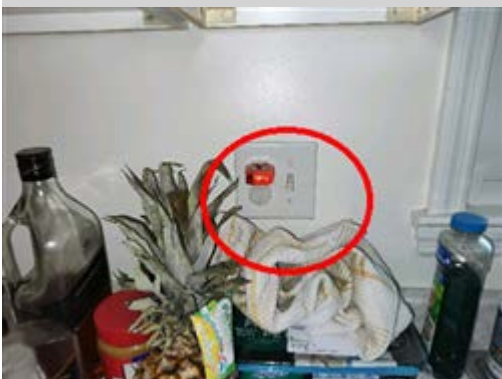
(H2 - 1.1) Kitchen

Not ground fault protected. Required since 1987. An electrician can evaluate and make repairs.

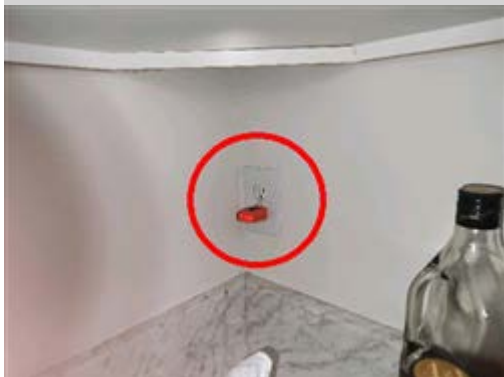
(H2 - 1.2) Kitchen

Not ground fault protected. Required since 1987. An electrician can evaluate and make repairs.

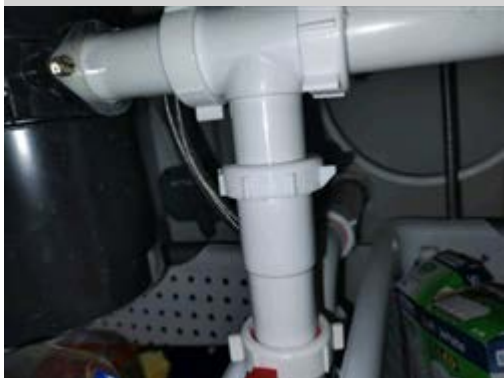
(H2 - 1.3) Kitchen

Appears to be polybutylene piping.

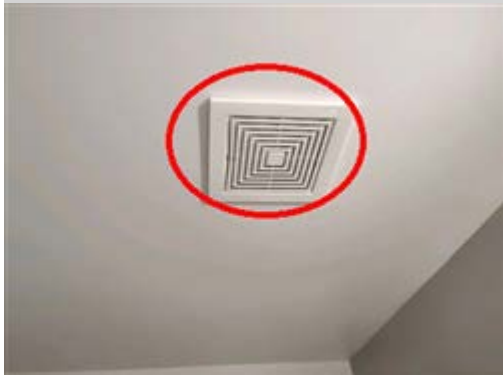
(H3 - 1.2) Bathroom 1

The bearings in the exhaust fan are about gone. the unit is loud and probably inefficient. A repairman can replace

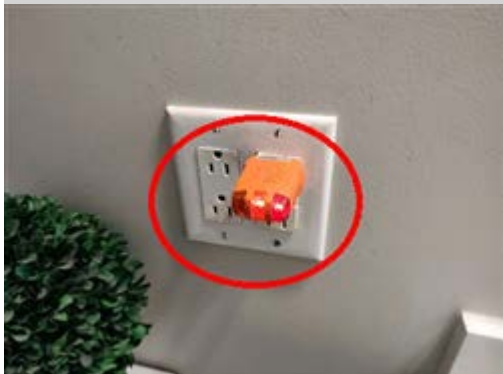
(H3 - 1.3) Bathroom 1

This is a GFI receptacle but it does not appear to be functioning properly. It does not trip with my tester.. A repairman/ electrician can evaluate and repair.

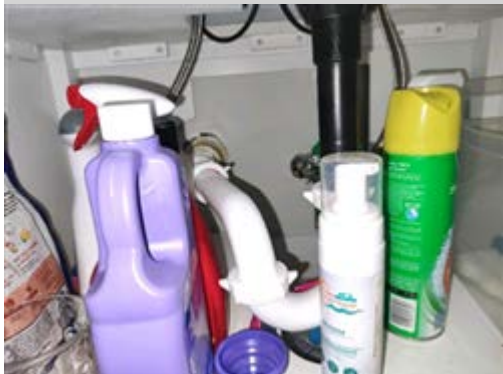
(H3 - 1.4) Bathroom 1

PEX piping

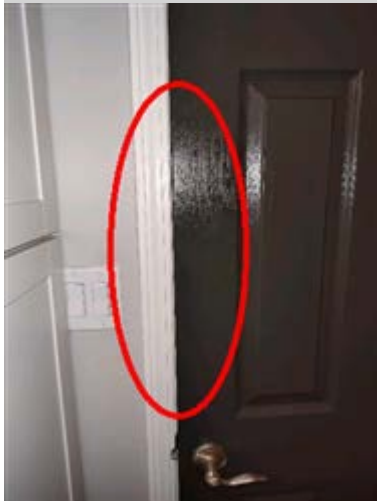
(H3 - 1.5) Bathroom 1

The door is hitting the frame on the strike side and repairman Carpenter can repair

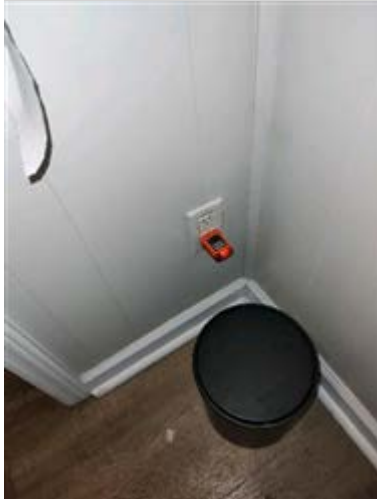
(H3 - 2.2) Half Bathroom 1

Incorrect wiring, therefore the GFI receptacle does not function as intended. A repairman/electrician can repair.

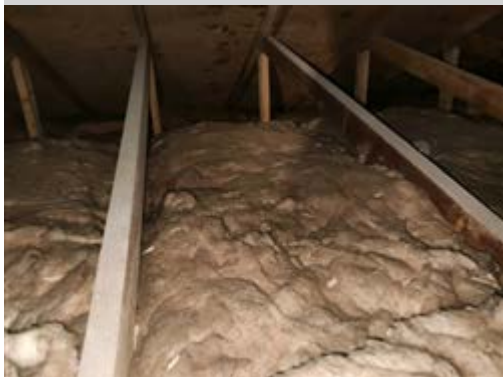
(I1 - 1.1) Attic: All Accessible

R-30
