(B3 - 2) Deck
Exterior: Decks, Porches, Stoops, and Balconies (Defects, Comments, and Concerns):

**C - Roofing Section
 (General Limitations, Implications, and Directions):**

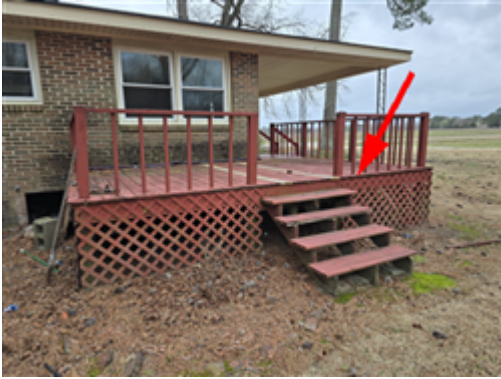
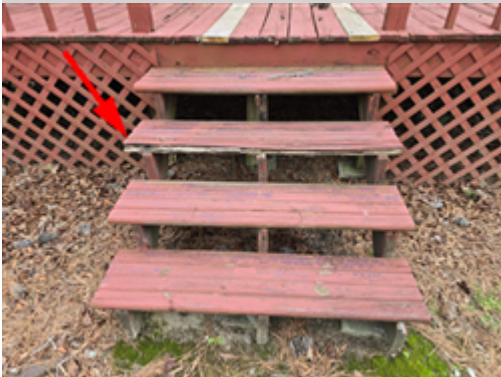
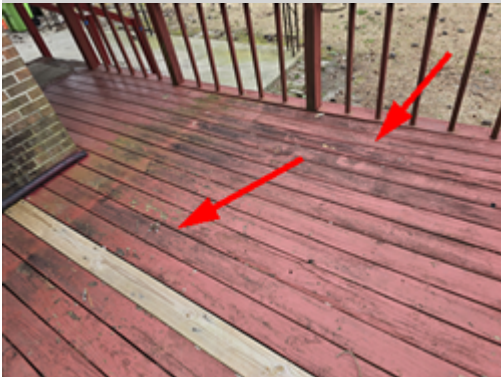
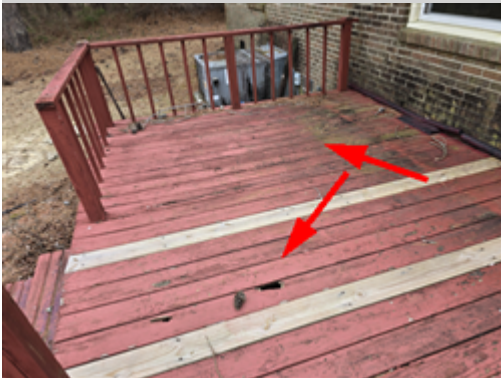
(B3 - 2.1) Deck

The deck is in need of further evaluation and repair as it was noted to be in poor condition, the following items were noted at the time of the inspection. A complete evaluation is needed as a repair plan is developed to determine the extent of the damage. Improper deck construction can result in unsafe conditions and possible deck failure. A licensed general contractor should be consulted for a complete evaluation of the deck and to make necessary repairs.

1. Damaged steps with missing handrails were noted on the rear side of the steps.
2. Moisture damaged handrails.
3. The decking surface is poor condition; Several moisture damaged decking boards were noted throughout.

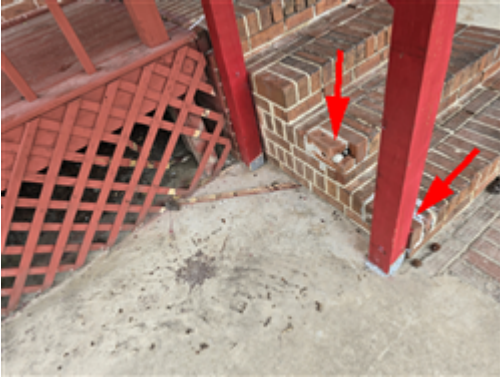
(B3 - 3.1) Stoop

Damaged and missing bricks noted on the left side entrance door stoop steps.

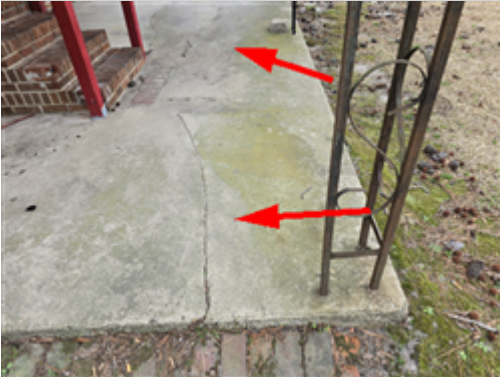
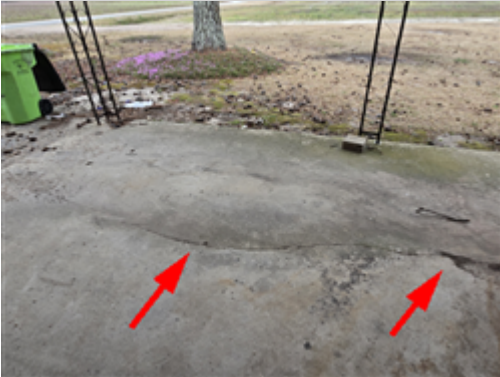
(B4 - 1.1) Carport

The left side of the carport concrete floor is cracked and slightly displaced. The raised section of the carport has created a path for possible water penetration under the slab and a trip or fall hazard. A licensed general contractor should be consulted for further evaluation and repair.

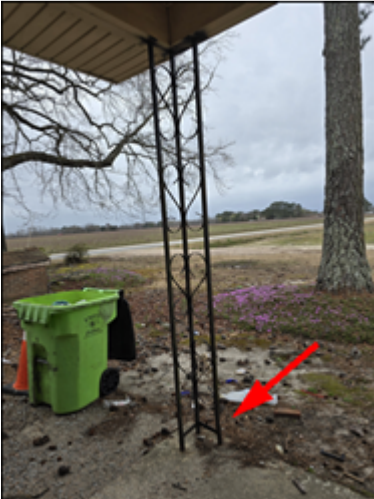
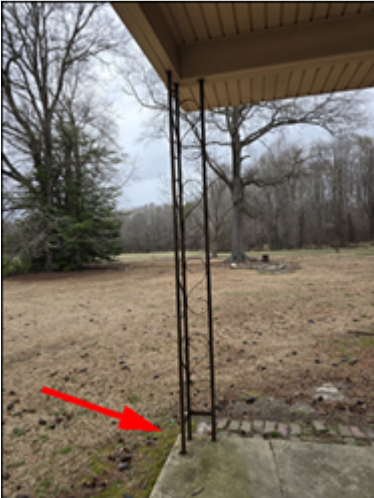
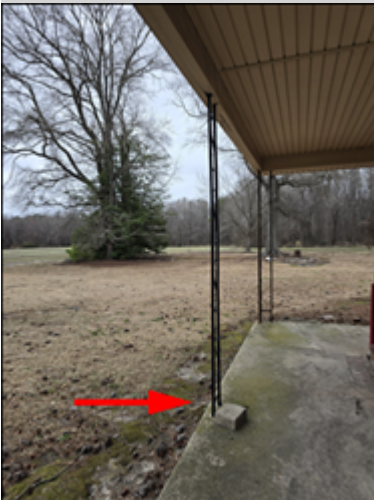
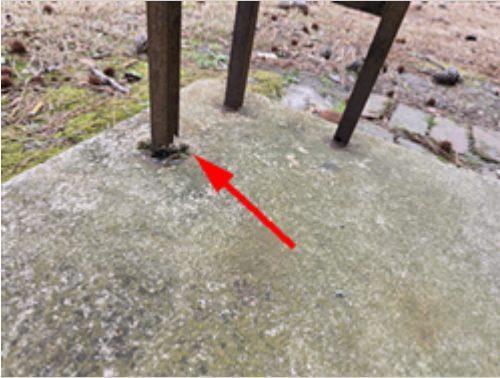
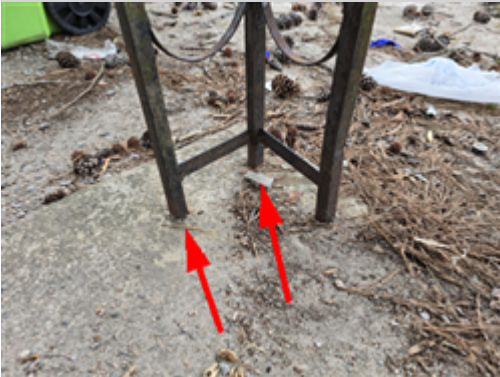
(B4 - 1.3) Carport

The metal support columns along the left side of the carport have visible areas of rust and deterioration at the base. The rust indicates a history of elevated moisture and or direct water penetration in or around the column area. The damage has likely jeopardize the strength of the columns. A licensed general contractor should be consulted for further evaluation, to make necessary repairs, and determine the cause of the deterioration.

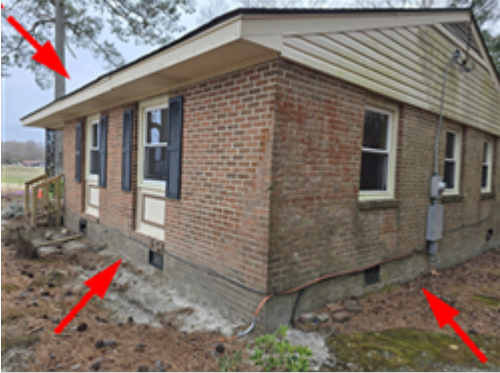
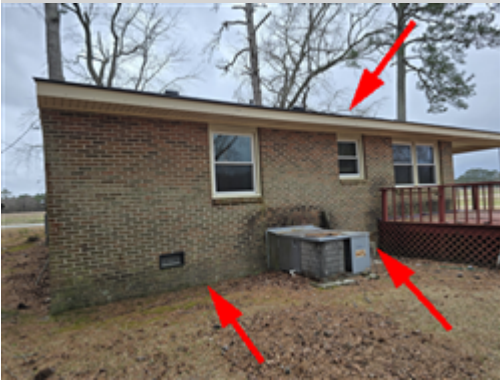
(C2 - 1.1) All Accessible Areas

This home does not have a system such as gutters to control roof drainage. Direct drainage to the foundation and cladding from the roof system can result in water penetration into the foundation area and foundation deterioration. It is recommended that a gutter system with extended downspouts be installed to protect the wall cladding and foundation areas of the home. A licensed general contractor should be consulted for evaluation and installation.

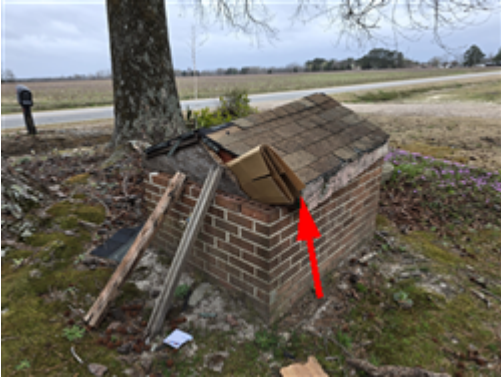
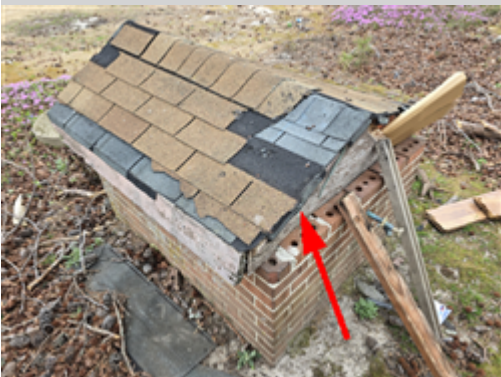
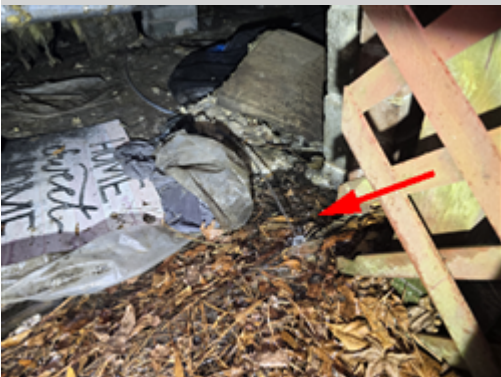
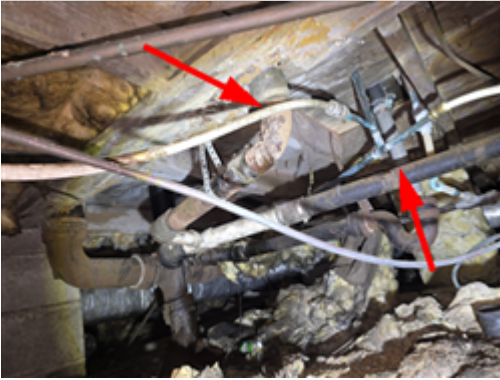
(D1 - 1.1) All Accessible Areas

The plumbing system is in need of further evaluation and repair as the water supply line system is in poor condition; the following concerns were noted at the time of the inspection: Plumbing issues should be corrected prior to purchasing the home to prevent leaking or future problems and ensure sanitary conditions. A plumbing contractor should be consulted for a complete evaluation of the system and to make necessary repairs.

1. Well house is in poor condition with severalty damaged roof.
2. Poor water is noted in kitchen.
3. Numerous water supply line leaks noted under the bathrooms.
4. Amateur plumbing repairs noted throughout the crawl space; Inadequate water supply line transition were noted under both bathrooms.
5. Icemaker maker line leaks when main water supply line is turned on; leaks into the crawl space.

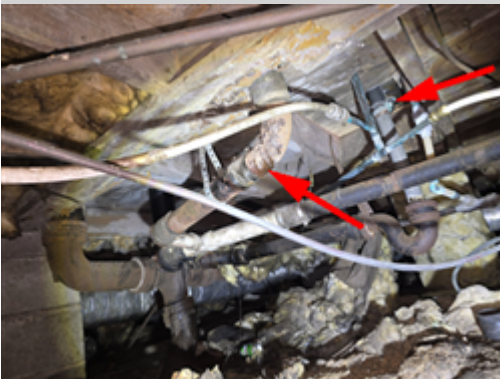
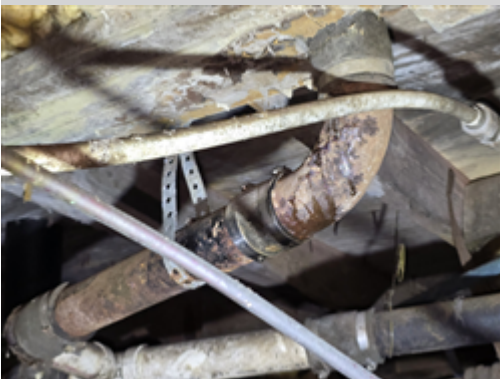
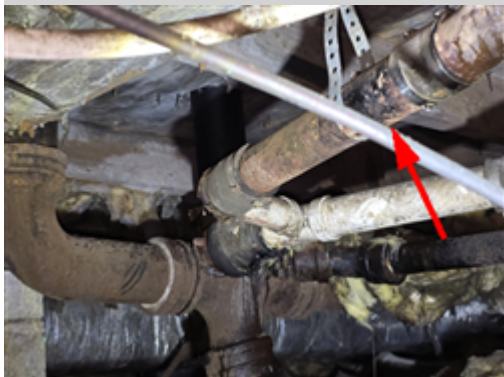
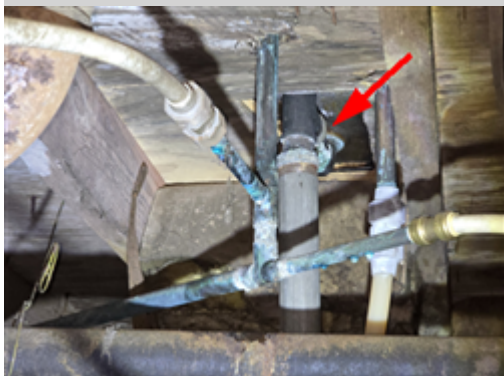
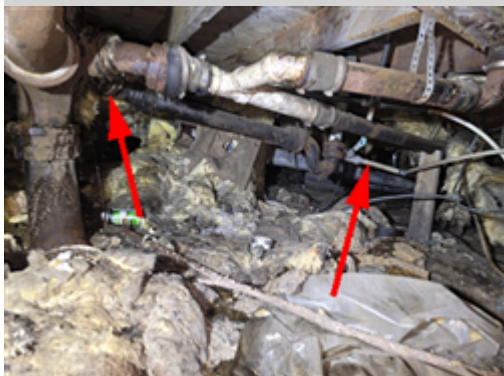
(D2 - 1.1) All Accessible Areas

The plumbing system is in need of further evaluation and repair as the water drain line system is in poor condition; the following concerns were noted at the time of the inspection: Plumbing issues should be corrected prior to purchasing the home to prevent leaking or future problems and ensure sanitary conditions. A plumbing contractor should be consulted for a complete evaluation of the system and to make necessary repairs.

1. Numerous damaged, heavily corroded, and leaking water drain line leaks were noted under the bathrooms.
2. Amateur plumbing repairs were noted throughout the crawl space; inadequate drain line transitions were noted.
3. Poor drain flow, or backflow was noted in both bathroom plumbing fixtures.

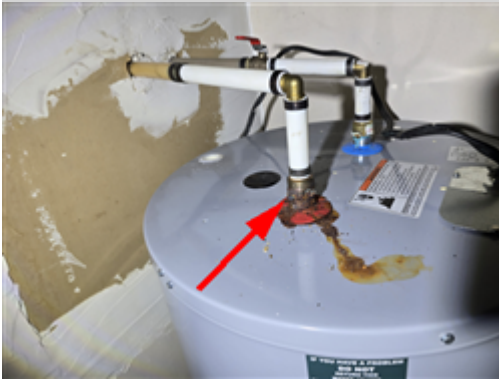
(D3 - 1.2) Unit #1

The water heating unit for this home has heavy corrosion at the hot side supply line connections to the tank. A licensed plumbing contractor should be consulted to evaluate the system and repair/replace as needed to ensure safe and reliable hot water supply.

Also note: Subfloor is weak, indication possible moisture damage from previous plumbing leaks.

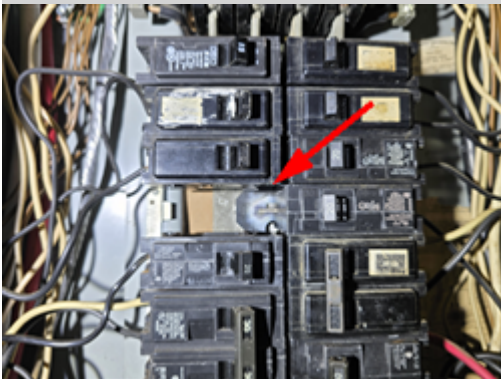
(E2 - 1.3) Main Panel #1

Knockout plug on the interior electrical panel cover is exposing a main bus bar that feeds a branch circuit is damaged. This condition indicates a history of arcing and or overheating. This condition presents a safety hazard that could result in interrupted service, property damage, and serious personal injury. A licensed electrical contractor should be consulted for repair and a complete evaluation of the electrical system.

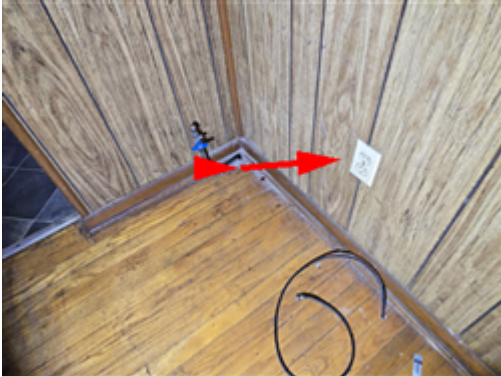
(E5 - 1.1) Interior

The receptacle next to the Livingroom closet has a cracked face. A cracked receptacle could result in increased shock and fire hazards. A licensed electrical contractor should be consulted to make necessary repairs to ensure safe and proper operation and installation.

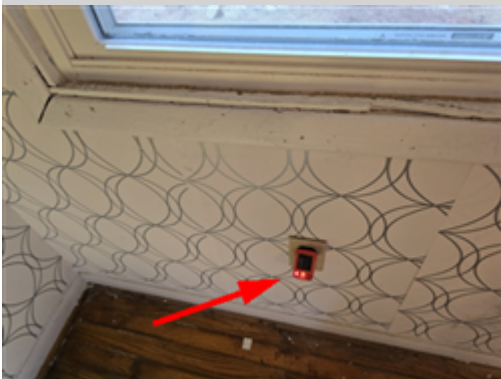
(E5 - 1.2) Interior

The receptacle under the rear master bedroom window tested as reversed polarity. Polarization provides an extra safety feature to prevent electrical shock hazards and property damage. A licensed electrical contractor should be consulted for a complete evaluation to determine the significance of this concern and make necessary repairs to correct defects and prevent safety hazards.

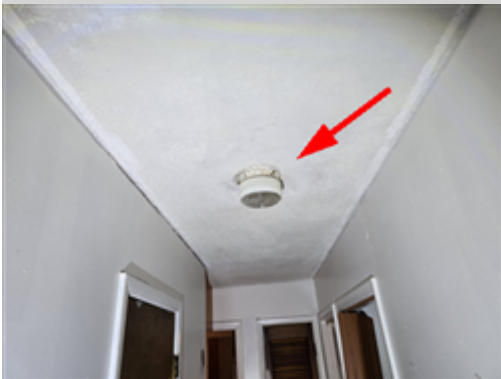
(E5 - 1.3) Interior

The main hallway ceiling light fixture was not functional when tested. This could indicate a defective bulb or other more serious problem such as faulty wiring or a defective fixture. A licensed electrical contractor should be consulted for further evaluation and repair.

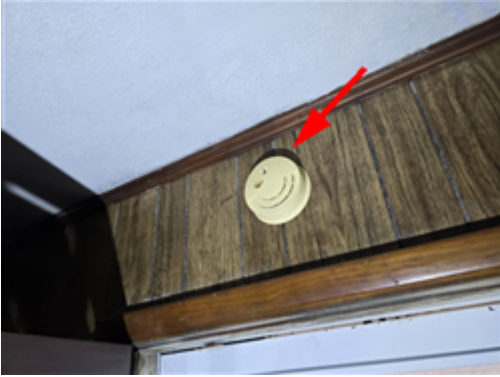
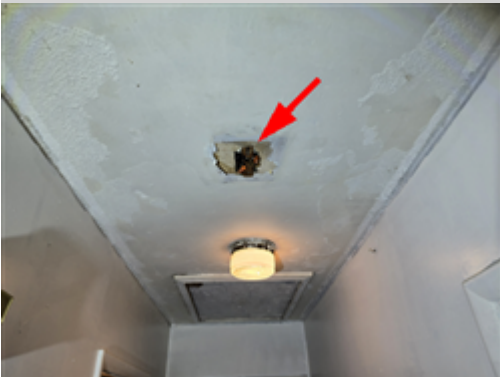
(E5 - 1.4) Interior

Most detectors did not respond to the test button; most are only battery operated. A properly functioning smoke detector is vital to the safety of a home. Smoke detector should be replaced or updated every 5 to 7 years and batteries changed annually. The unit should be repaired or replaced to ensure a safe environment. This home has a limited number of smoke detectors as compared to current standards. Currently it is recommended that a smoke detector be installed at each floor level in the home and in each sleeping room. Correction is recommended. Installation is recommended.

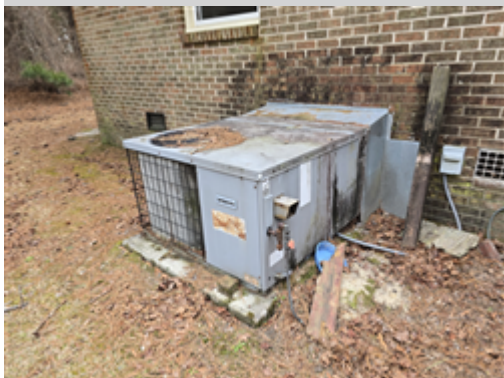
(F1 - 1.1) Heating Unit #1

Information label if faded; age of hvac unit not determined.

Although operational at the time of inspection, Due to the age of the hvac system it is highly recommended that it be serviced and further evaluated by a licensed hvac company.

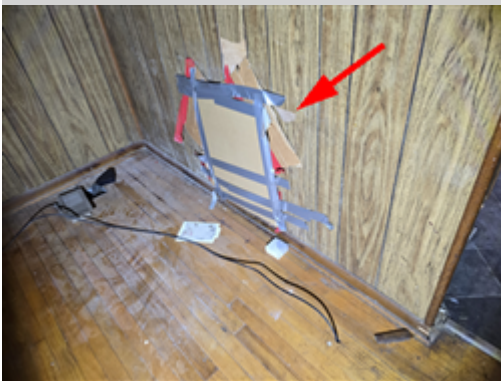
(H1 - 1.1) All Rooms

Damaged left rear Living room wall, adjacent to the kitchen.

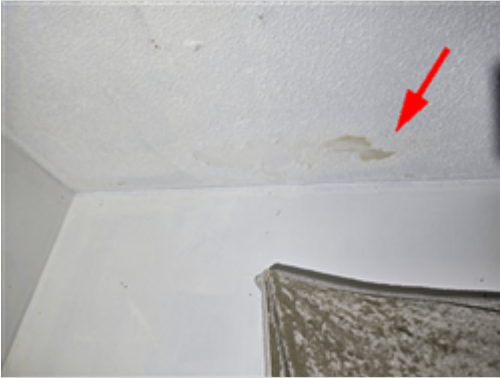
(H1 - 1.2) All Rooms

Stain on the ceiling over the left front bedroom window likely indicates history of a roof leak. At the time of the inspection it was not possible to determine if the condition was due to an active or past occurrence. Further investigation by a repair specialist and owner disclosure is recommended. Refer to the Attic section of the report.

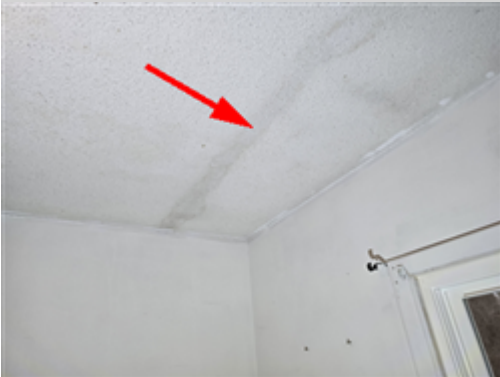
(H1 - 1.3) All Rooms

Stains also noted on the right rear section of right side middle bedroom.

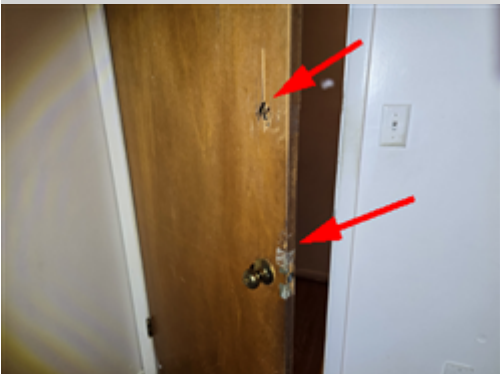
(H1 - 1.4) All Rooms

Doors are missing from the front bedrooms. Door is damaged at the right side center bedroom.

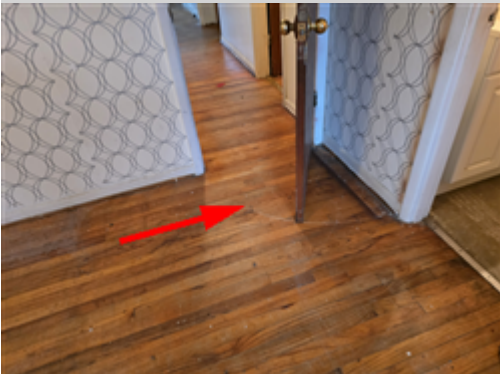
(H1 - 1.5) All Rooms

The master bathroom door drags the floor and is difficult to open or close. Area of unlevel floor such as this were noted at several areas throughout the interior of home. This condition could indicate improper installation or framing movement. The door needs repair/replacement to ensure that the door closes securely and operates properly. A general repair specialist or licensed general contractor should be consulted for evaluation and repair.

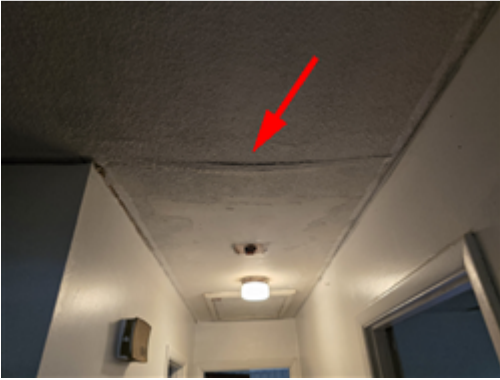
(H1 - 1.6) All Rooms

Cracked and bowed ceiling was noted on the right front hallway. A general repair specialist or licensed general contractor should be consulted for evaluation and repair.

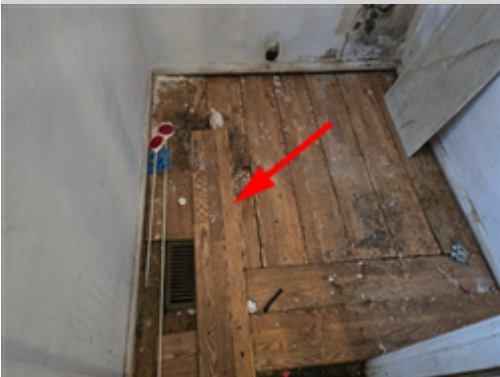
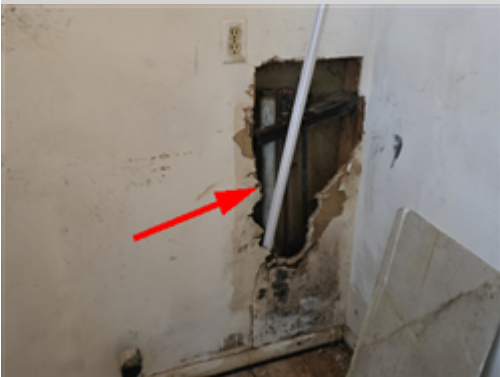
(H1 - 2.1) Laundry

Weak subfloor noted throughout the laundry room likely indicating moisture damaged from previous plumbing leaks or leaking washing machine. Damaged wall was also noted at the washing machine connection to water supply lines. Along with the noted damaged wall and floor, peeling paint was noted from the laundry room, likely indicating poor ventilation. A licensed general contractor should be consulted for a complete evaluation to determine the significance of this concern and make necessary repairs.

Also note: Laundry room door is also missing.

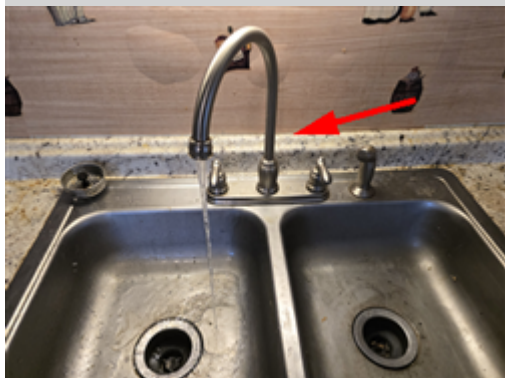
(H2 - 1.1) Kitchen

Poor water pressure was noted on the hot and cold sides of the kitchen sink faucet.

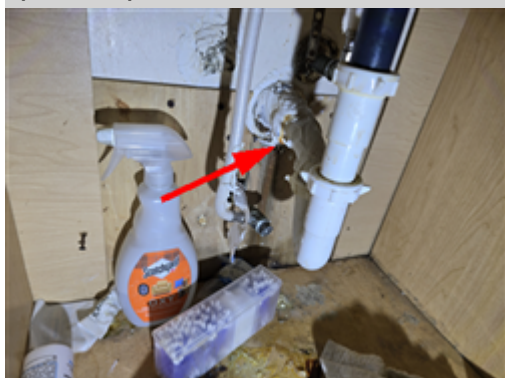
(H3 - 1.1) Bathroom: Master

Damaged drain line noted under the hallway bathroom sink.

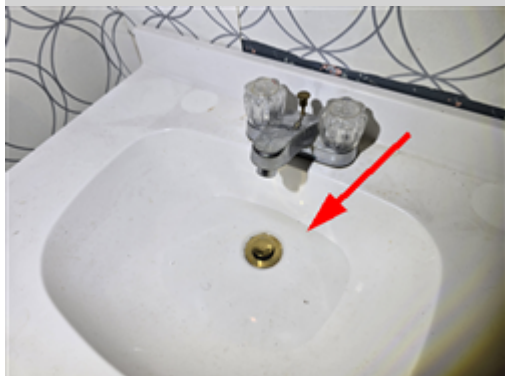
(H3 - 1.2) Bathroom: Master

The master bathroom sink drain slowly and the sink top is loose.

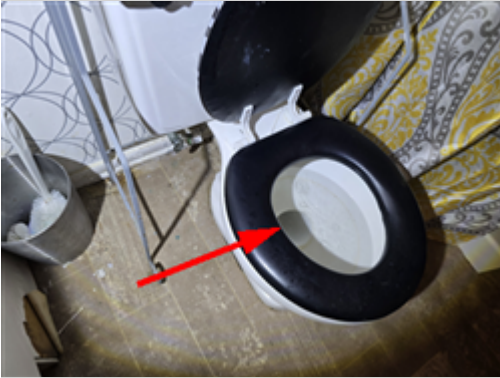
(H3 - 1.3) Bathroom: Master

The master bathroom toilet did not flush as it seems to be clogged. A licensed plumbing contractor should be consulted for evaluation and repair.

Also note: The master bathroom toilet floor slopes towards the the hallway bathroom.

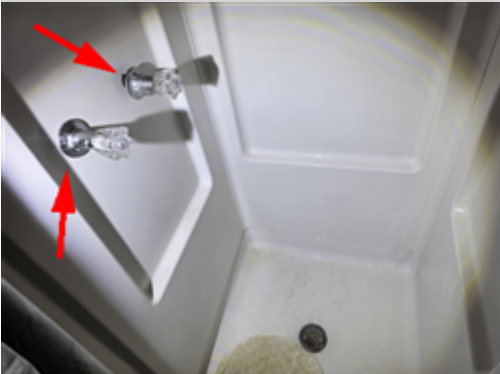
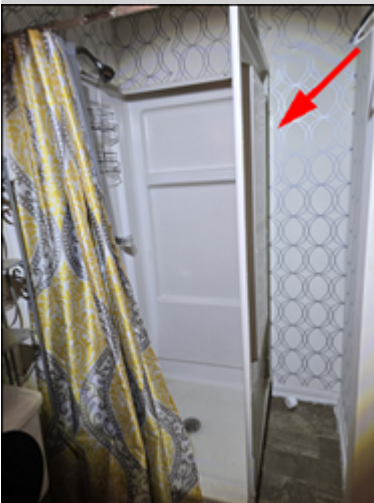
(H3 - 1.4) Bathroom: Master

The master bathroom shower water control knobs are loose, poor drain flow was also noted at the master bathroom shower. Right side master bathroom shower wall is not supported with a solid/stable wall. A licensed plumbing contractor should be consulted for a complete evaluation to determine the significance of this concern and make necessary repairs to prevent leaks and ensure sanitary conditions.

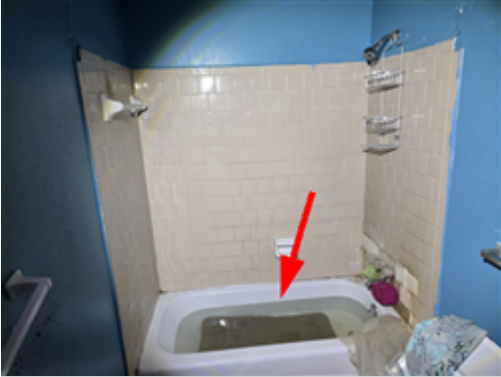
(H3 - 2.1) Hallway bathroom

The hallway bathroom tub is currently full of water, not operational.

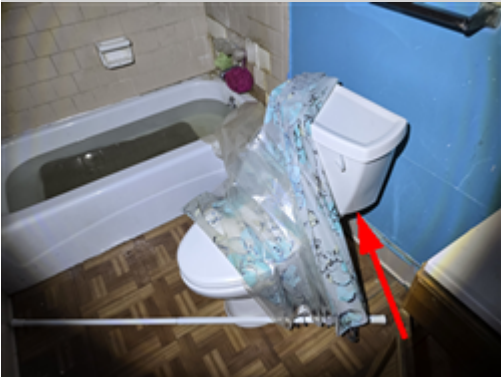
(H3 - 2.2) Hallway bathroom

The hallway bathroom toilet is also not operational. A strong bad odor was noted in the hallway bathroom at the time of inspection. Bubbling and gurgling was noted at the hallway bathroom toilet and sink while running water throughout this bathroom sink. A licensed plumbing contractor should be consulted for a complete evaluation to determine the significance of this concern and make necessary repairs to prevent leaks and ensure sanitary conditions.

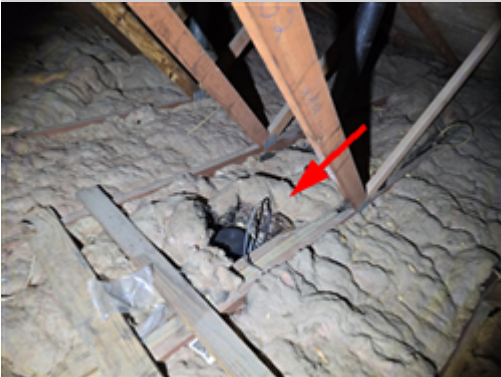
(H5 - 1.1) Attic: Unfinished

The bathroom ventilation fan exhaust duct does not exit to the exterior of the home. The fan exits to the attic space which will add undesirable moisture to the area. A licensed general contractor should be consulted for repair/replacement.

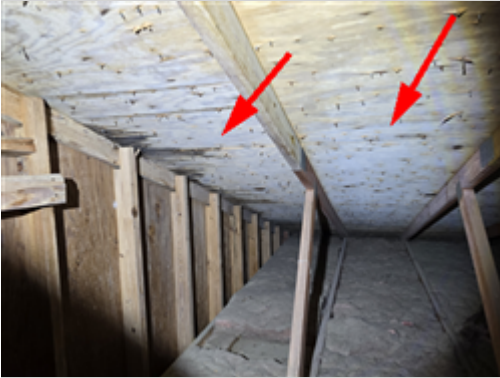
(H5 - 1.2) Attic: Unfinished

Discolored roof sheathing was noted at several areas of the attic space, indicating previous or ongoing poor ventilation.

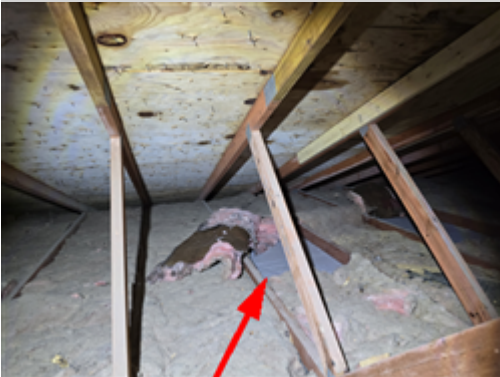
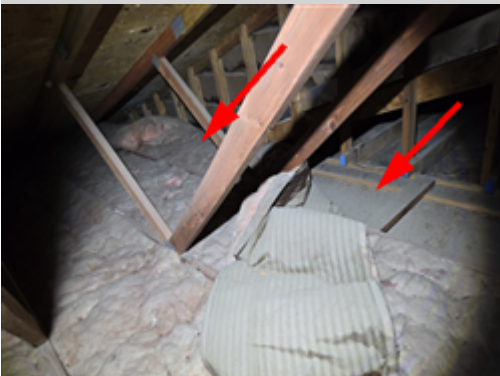
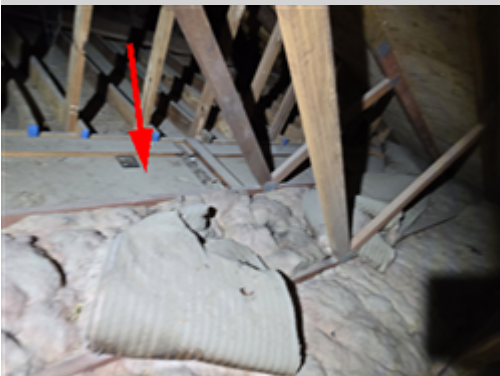
(H5 - 1.3) Attic: Unfinished

Disturbed fiberglass insulation noted at the right front section of attic space and along the left side attic transition between the main home and carport. Improper insulation installation could result in condensation and inadequate conditioning of the living areas. A licensed general contractor should be consulted for repair/ replacement.

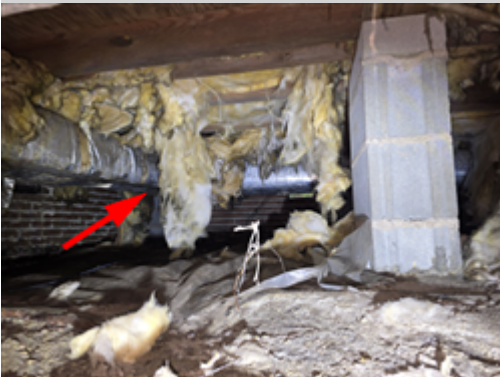
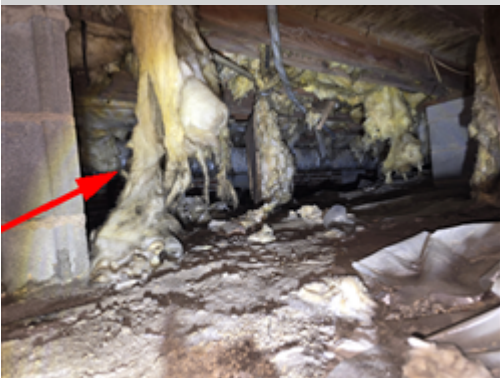
(I1 - 1.1) All Accessible

Substantial amount of loose, fallen, damaged, and/or missing fiberglass insulation was noted at several areas throughout the crawl space; large areas of exposed crawl space subfloor were noted throughout the crawl space. Evidence suggest this could have been caused by entry of animals into the crawl space, poor installation method, disturbance by previous crawl space repairs, and/or frequent high levels of crawl space moisture content. All damaged, fallen, and/or missing crawl space insulation should be properly replaced and secured between the crawl space floor joists for proper crawl space ventilation and home energy efficiency.
