# SOUNDVIEW HOME INSPECTION LLC

## SOUNDVIEW HOME INSPECTION REPORT

104 Elm Ct  
Pine Knoll Shores, NC 28512

01/30/2026

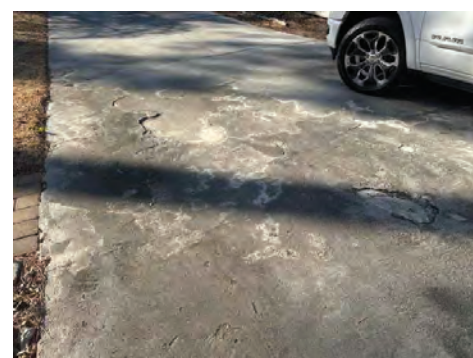
Driveway

### DRIVEWAY CRACKING - MAJOR

Major cracking was found in the driveway. This could lead to further damage and is a tripping hazard. Recommend repairs.

Contact a qualified driveway contractor.

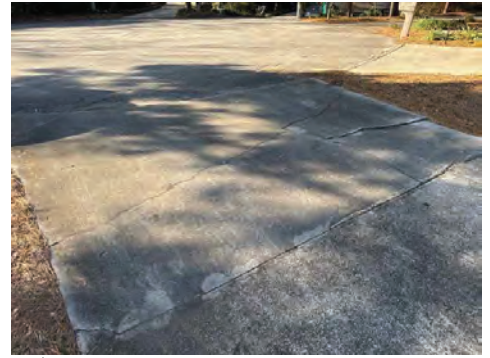
Driveway

**DRIVEWAY CRACKING - MINOR**

Minor cracking was found throughout the driveway. This could lead to further damage. Recommend repairs.

Contact a qualified driveway contractor.

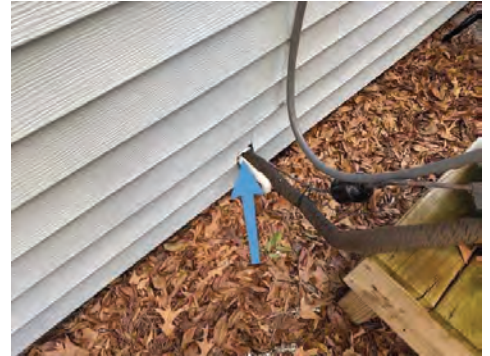
Left Behind Condenser

**CLADDING-SEALANT MISSING**

Sealant was missing from around a penetration into the cladding. This could result in moisture intrusion behind the cladding. Recommend repairs

Contact a qualified siding specialist.

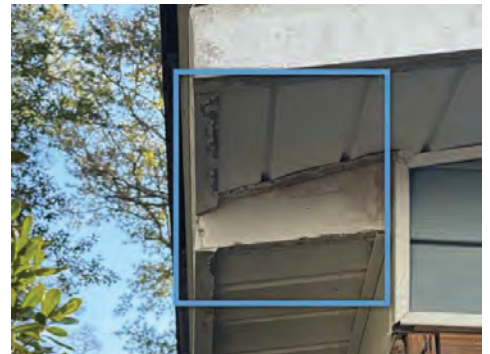
1st Floor Rear Right Porch

**PAINT DETERIORATION**

The paint is deteriorated on one or more portions of the soffit/eaves/fascia. This could result in the component being directly exposed to the sun and moisture. Recommend repainting.

Contact a qualified painting contractor.

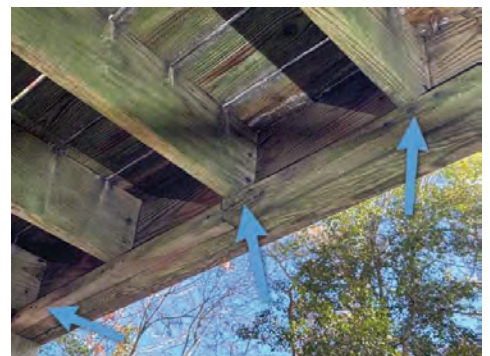
2nd Floor Rear Deck

**LEDGER STRIP DETERIORATED**

The ledger strip(s) on a deck are deteriorating. This could result in failure of the joists and deck system. Recommend repair or replacement.

Contact a qualified deck contractor.

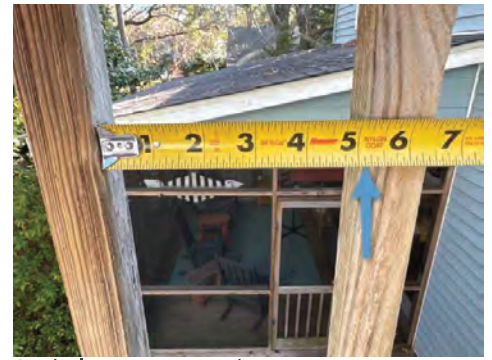
2nd Floor Rear Deck

The baluster space is not up to modern safety standards. The space between balusters should not allow passage of a 4 3/8-inch sphere for child safety. Recommend repairs or mitigation.

Contact a qualified deck contractor.

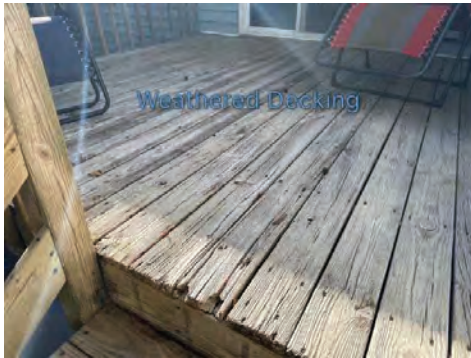
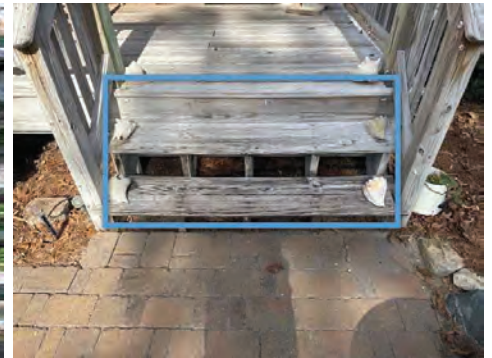
There are one or more areas of weathered wood. The wood is approaching the end of its lifespan. Recommend budgeting for replacement.

Recommend monitoring.

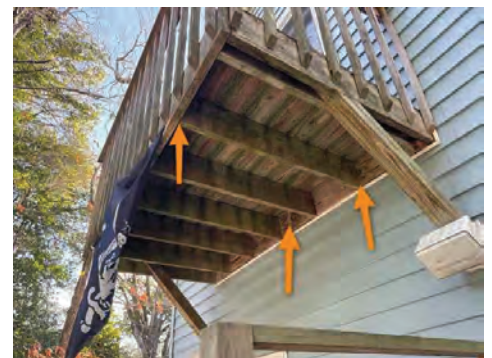
2nd Floor Rear Balcony

**IMPROPER CONSTRUCTION PRACTICES**

Improper construction practices/methods were observed on the balcony. The deck band was attached with nails only and no ledger strip/joist hangers were present on the floor joists. Recommend repairs

Contact a qualified deck contractor.

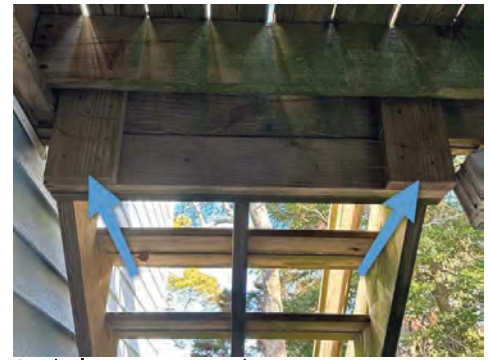
2nd Floor Rear Deck

The suspended header on a set of stairs is attached to the deck incorrectly. This method could prematurely wear/fail. Recommend repairs.

Contact a qualified deck contractor.

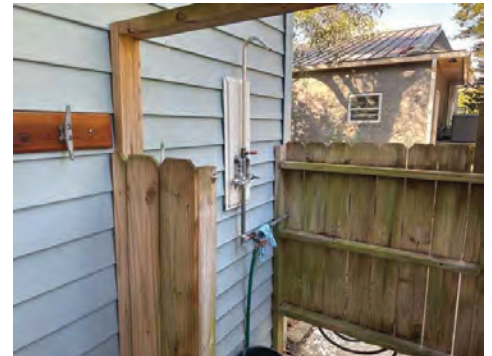
Outdoor Shower

An outdoor shower did not function as designed. It is not usable in the its present condition. Recommend repairs.

Contact a qualified plumbing contractor.

**\*\*Per Seller this has been addressed. The outdoor shower has been winterized.**

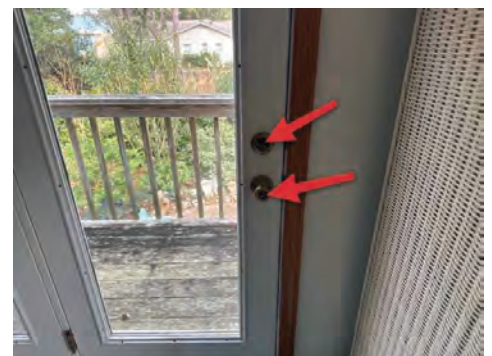
2nd Floor Rear Balcony

A door would not lock. This is a safety and security hazard. It is not functioning as designed. Recommend repairs

Contact a qualified door repair/installation contractor.

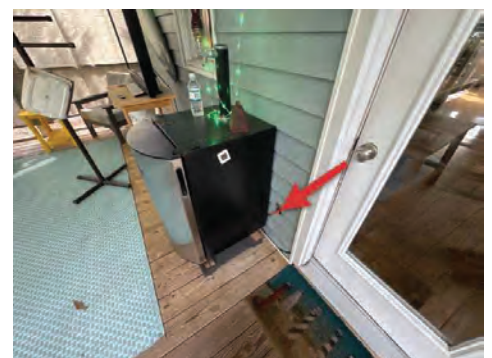
1st Floor Rear Right Porch

There was no GFCI protection installed/functioning on the indicated receptacles. This is a safety hazard. Recommend installation.

Contact a qualified licensed electrician

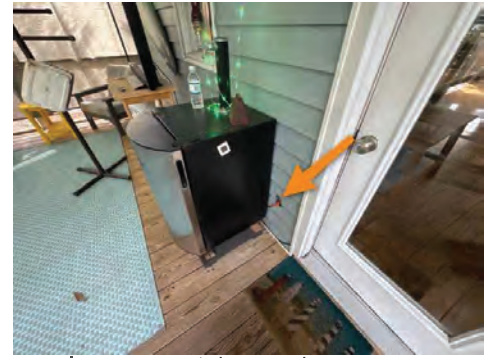
1st Floor Rear Right Porch

**COVER PLATE MISSING**

A receptacle was missing a cover plate. This leaves the component unprotected. Recommend installation.

Recommended DIY Project

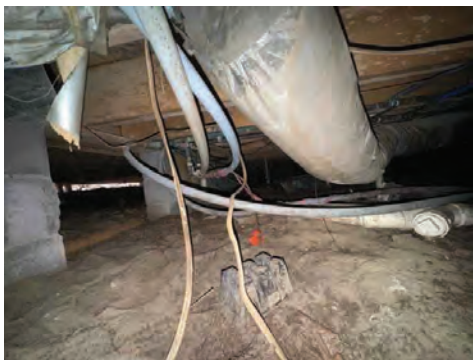
Access Point

Low/Monitor
**DISTRIBUTION LINE IMPROPERLY SUPPORTED**

A water distribution line is improperly supported. This could result in leaks and/or malfunction of the line. Recommend installation of proper support.

Contact a qualified plumbing contractor.

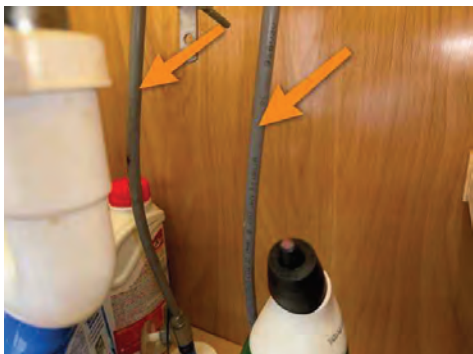
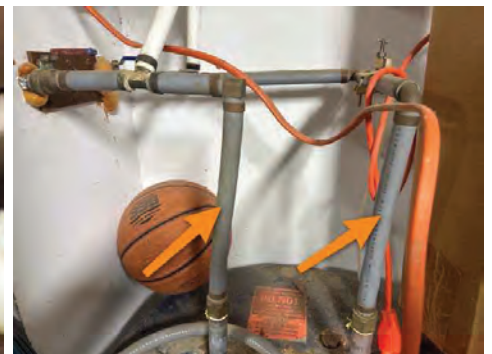
Polybutylene piping was present. This type of water distribution piping is known for failures due to brittleness and susceptibility to deterioration when exposed to chlorine. Additionally, many polybutylene pipes have been recalled. Recommend evaluation and, if compromised, replacement.

Note: Polybutylene piping was observed under all sinks

Contact a qualified plumbing contractor.

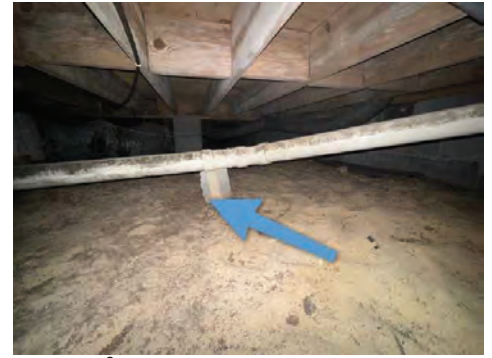
Rear Left

**IMPROPER SUPPORT**

A DWV line was improperly supported. This could result in leaks. Recommend repairs.

Contact a qualified plumbing contractor.

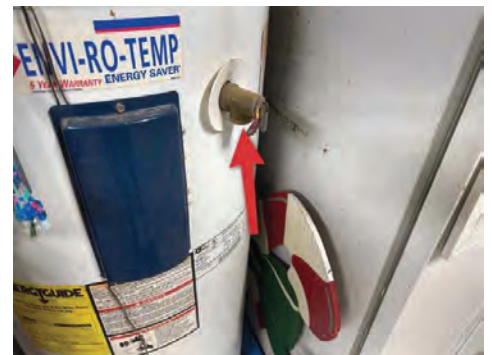
Water Heater

**TPR EXTENSION MISSING**

The temperature/pressure relief (TPR) valve had no discharge pipe installed. If the valve were to activate while a person was nearby, that person could be badly burned. Additionally, surrounding components could be damaged. Recommend installation

Contact a qualified plumbing contractor.

**\*\*Per Seller this has been addressed.**

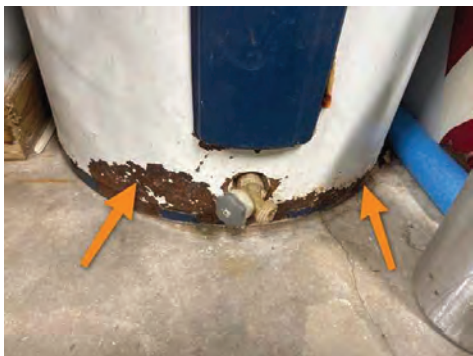
Water Heater

**EXTERIOR RUST**

There was rust on the body of the water heater. This may result in leaks. Recommend maintenance or replacement.

Contact a qualified plumbing contractor.

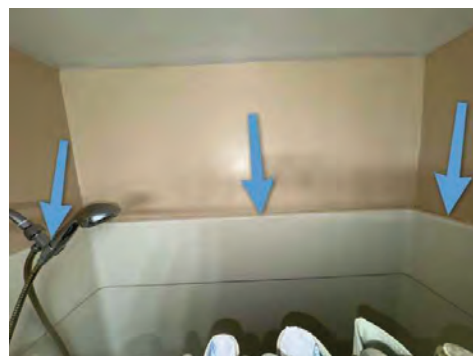
1st Floor Left Bathroom

**SEALANT DETERIORATED/MISSING**

Sealant in and/or around the shower was deteriorated/missing. This could result in moisture intrusion to the surrounding areas. Recommend repairs.

Contact a qualified professional.

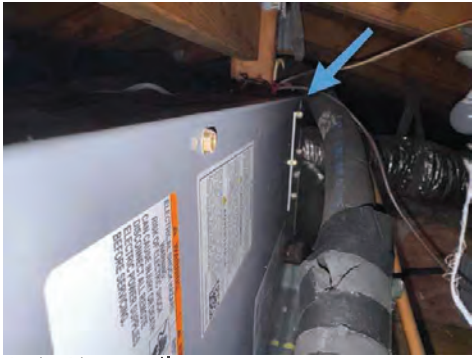
Attic Air Handler

The access panel to the air handler was not readily accessible. The system is not functioning as designed. There may be concealed defects. Recommend mitigation.

Contact a qualified licensed hvac technician

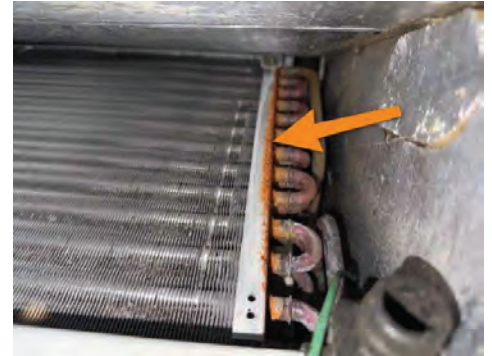
Front Right Eaves Air Handler

**COIL RUSTED**

The coil of the air handler was rusted. This may result in system inefficiency and/or refrigerant leak. Recommend evaluation and repair

Contact a qualified licensed hvac technician

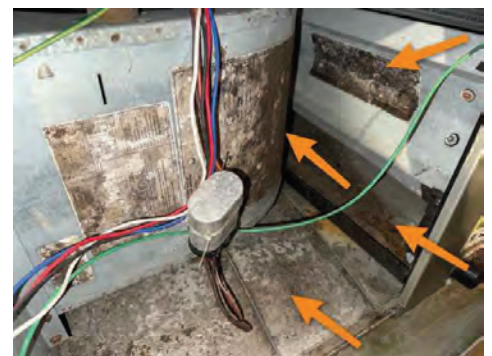
An apparent microbial growth was present. This could lead to reduced efficiency of the system, increased moisture levels, and breathing difficulties. Recommend maintenance.

Contact a qualified licensed hvac technician

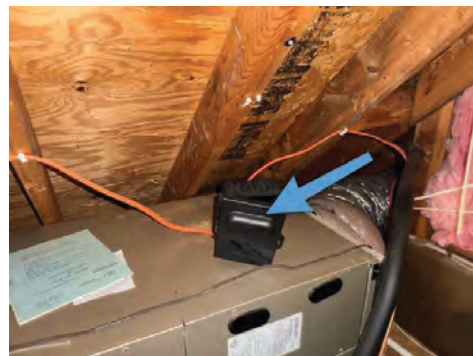
Front Right Eaves Air Handler

**ELECTRIC DISCONNECT IMPROPERLY INSTALLED**

The electric disconnect was improperly installed. As installed, this could lead to damage to the system. Recommend repairs.

Contact a qualified licensed electrician

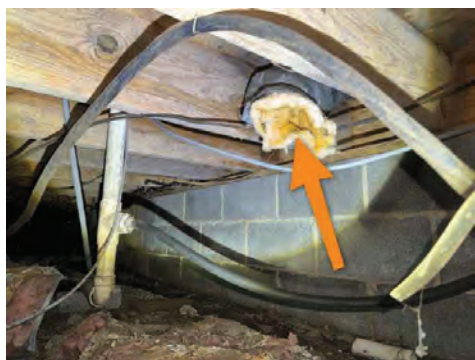
Rear Middle

There were disconnected joints in the ductwork. This could result in significant energy loss. Recommend repairs

Contact a qualified licensed hvac technician

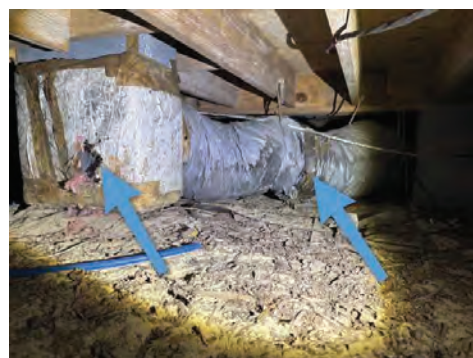
Rear Left

**DUCTWORK DAMAGED**

Ductwork was damaged. This could result in loss of efficiency. The associated photo is representative of most of the insulation. Recommend repairs.

Contact a qualified licensed hvac technician

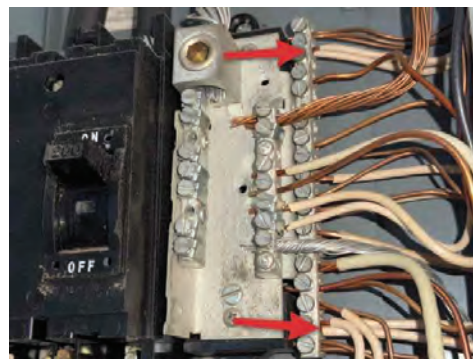
Hallway Main Panel

There are multiple neutral wires under one screw post on a bus bar. This is a safety hazard. Recommend repairs

Contact a qualified licensed electrician

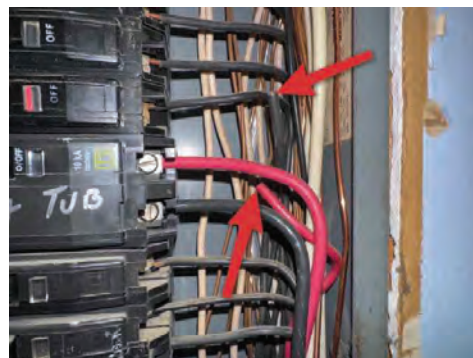
Hallway Main Panel

A wire was disconnected and exposed. This is a safety hazard. Recommend repairs.

Contact a qualified licensed electrician

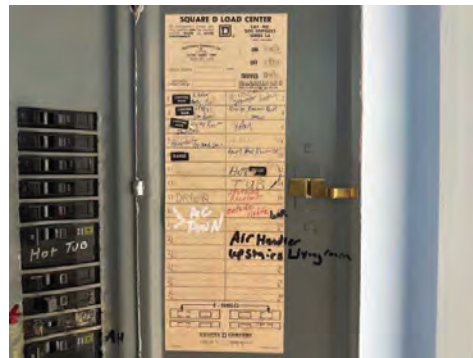
Hallway Main Panel

The index for the panel appeared to be inaccurate. This could lead to confusion when shutting down appliances during maintenance or emergencies. Recommend correction.

Recommended DIY Project

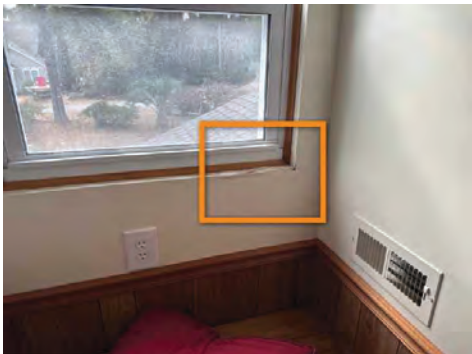
2nd Floor Landing

### EVIDENCE OF MOISTURE INTRUSION

There was evidence of moisture intrusion. There may be additional concealed damage. Recommend evaluation and repairs.

Contact a qualified general contractor.

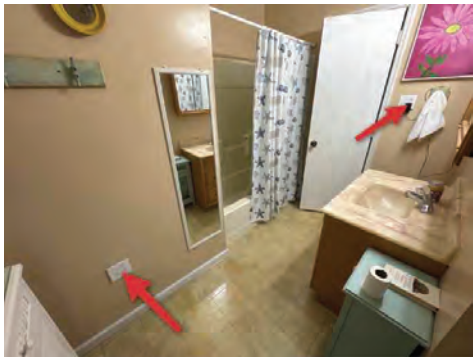
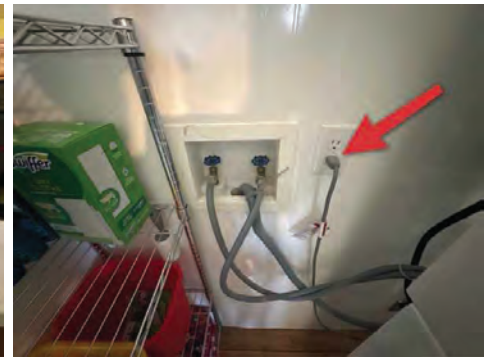
There was no GFCI protection installed/functioning on the indicated receptacles. This is a safety hazard. Recommend installation.

Contact a qualified licensed electrician

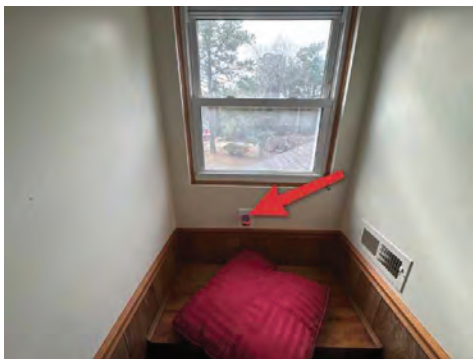
2nd Floor Landing

A receptacle had an open ground. This is a safety issue and could result in electrical shock and/or fire. Recommend repairs

Contact a qualified licensed electrician

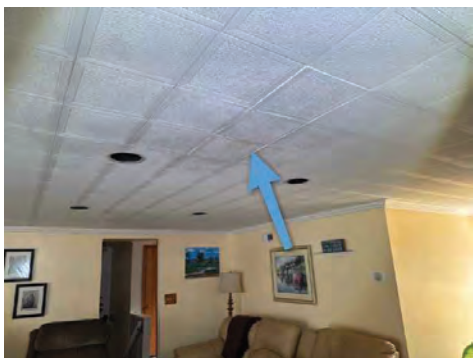
2nd Floor Living Room

**MOISTURE STAIN(S)**

There was an area of staining on the ceiling. This could result in damage to the area. Recommend repairs and monitoring.

Contact a qualified drywall contractor.

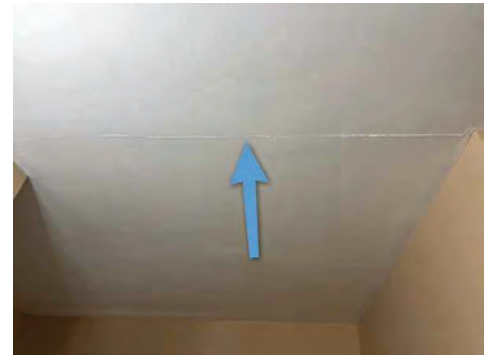
1st Floor Left Bathroom

Low/Monitor
**CRACK-MINOR**

There is what appears to be a typical crack in the ceiling. This crack could worsen and cause further damage. Recommend repairing and monitoring.

Contact a qualified drywall contractor.

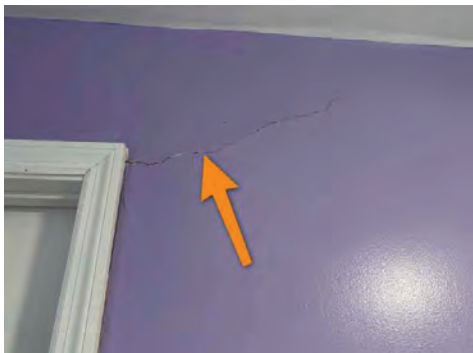
1st Floor Rear Left Bedroom

Medium
**CRACK-MAJOR**

There was a crack in the wall. This may be a symptom of structural movement or failure of a surrounding component. Recommend evaluation and repairs.

Note: These cracks were adjacent each other in separate rooms

Contact a qualified general contractor.

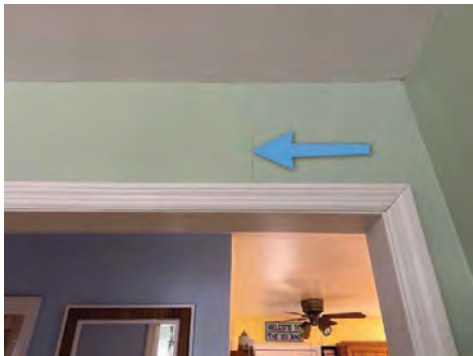
1st Floor Dining Room

Low/Monitor
**CRACK-MINOR**

There is what appears to be a typical crack in the wall. This crack could worsen and cause further damage. Recommend repairing and monitoring.

Contact a qualified drywall contractor.

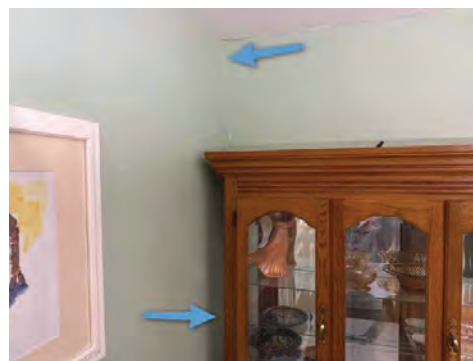
1st Floor Dining Room

There is a detached drywall seam tape on the wall. Further damage may occur if left in this condition. Recommend repairs.

Contact a qualified drywall contractor.

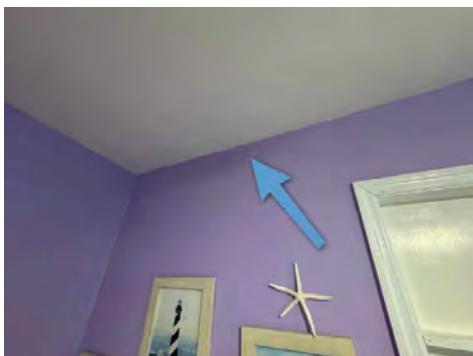
1st Floor Rear Left Bedroom

**DAMAGE**

An area of the wall was damaged. This could result in further damage and/or detachment of materials. Recommend repairs

Contact a qualified drywall contractor.

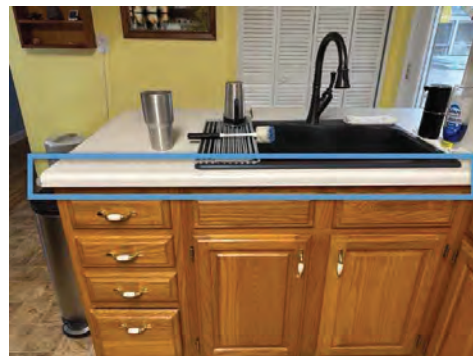
1st Floor Kitchen

There is a counter top detached. This could result in damage to the component. Recommend adhering the countertop to the cabinets

Contact a qualified cabinet contractor.

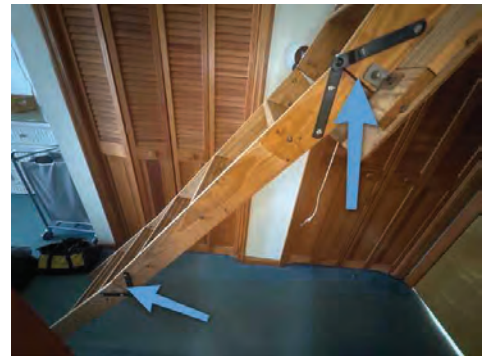
Attic

The access stairs for the attic were too long. This is placing undue stress on the joints. Recommend repairs

Contact a qualified carpenter.

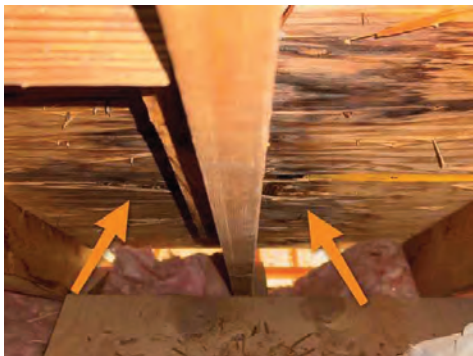
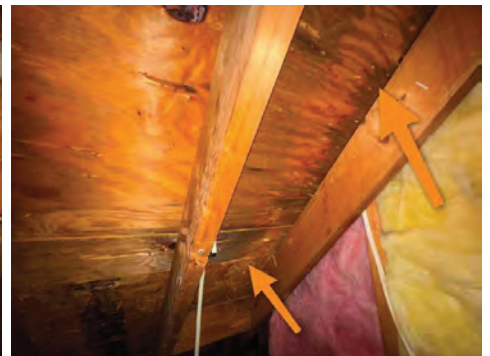
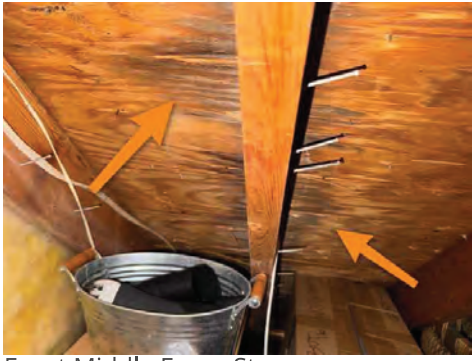
#### EVIDENCE OF MOISTURE INTRUSION

There was evidence of moisture intrusion. This may lead to further damage and deterioration of materials. Recommend repair.

Contact a qualified roofing professional.

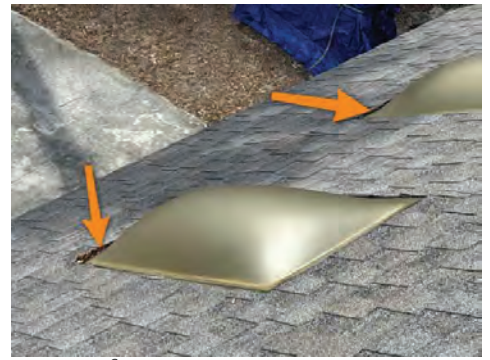
Front Left

### IMPROPERLY INSTALLED FLASHING

There was improperly installed flashing on the roof. Moisture intrusion may occur or be occurring already as debris is collecting in the bottom of this area. Recommend repairs.

Contact a qualified roofing professional.

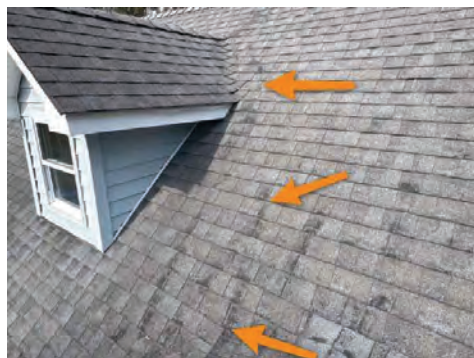
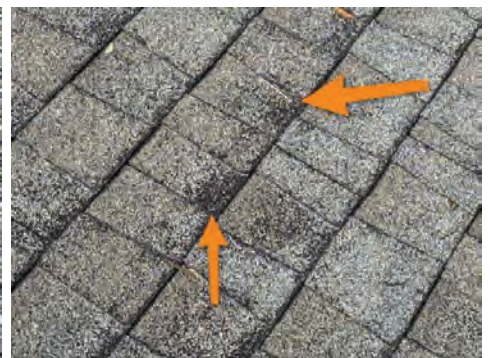
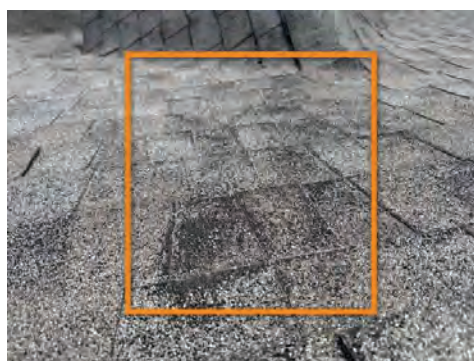
The coverings for the roof were weathered. The fiberglass underlayment is showing through, major granule loss has occurred, and the coverings are brittle. Moisture intrusion may occur. Symptoms of moisture intrusion are already present. Recommend replacement.

Contact a qualified roofing professional.

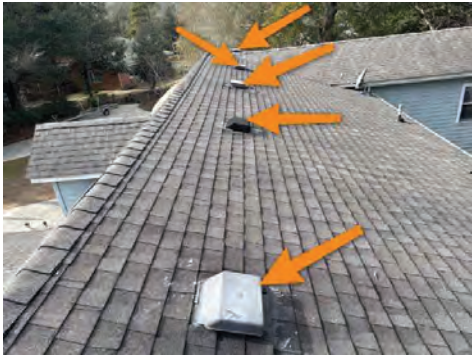
Rear

## VENT CAULK DETERIORATED

The caulking around a vent penetration was deteriorated. This could result in moisture intrusion. Recommend repairs

Contact a qualified roofing professional.
