## Property Inspection Report

**Report Number: 34-25**

908 Vance St. E  
Wilson, North Carolina 27893

Date of Inspection: Monday, March 3, 2025

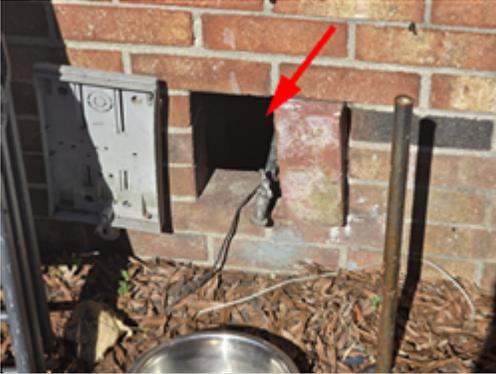
**(A1 - 1.1) All Accessible Areas**

Large hole noted on the foundation wall and damaged crawl space access door along with a loose exterior water faucet line was noted on the rear center of home.

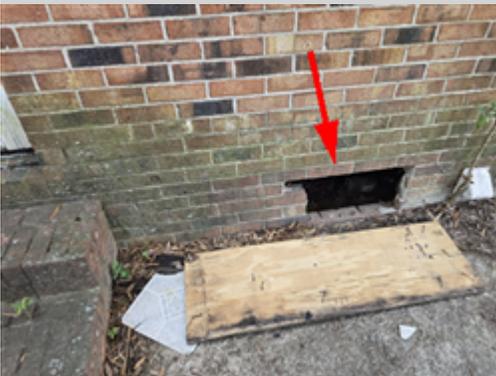
**(A1 - 1.2) All Accessible Areas**

Damaged partial crawl space access holes were noted on the left rear side of home. All damaged crawl space access doors should be secured to prevent large animals from entering the crawl space area that could cause potential damage to plumbing, electrical, or hvac system components.

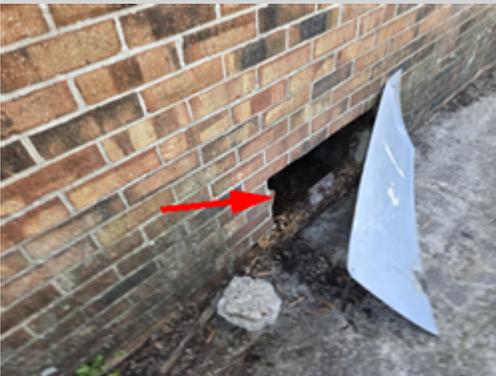
**(A1 - 1.3) All Accessible Areas**

Additional Photograph: This is a photograph of above noted item 1-2

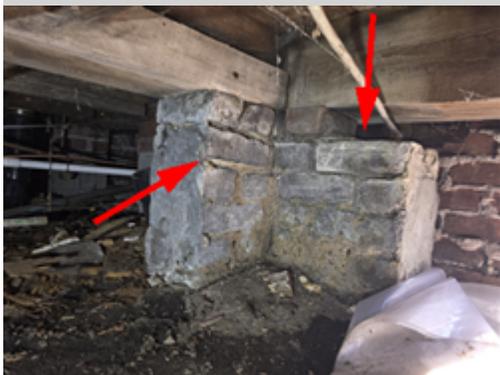
**(A2 - 1.1 ) All Accessible Areas**

The piers throughout the crawl space of this historical home were was soft and easily probed. The condition of the piers presents a serious concern that needs further evaluation. A masonry specialist and/or a structural engineer should be consulted to determine the significance /cause of the soft bricks and outline any necessary repairs.

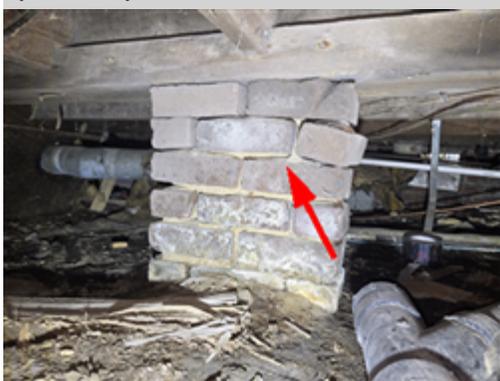
**(A2 - 1.2 ) All Accessible Areas**

Additional Photograph: This is a photograph of above noted item 1-1

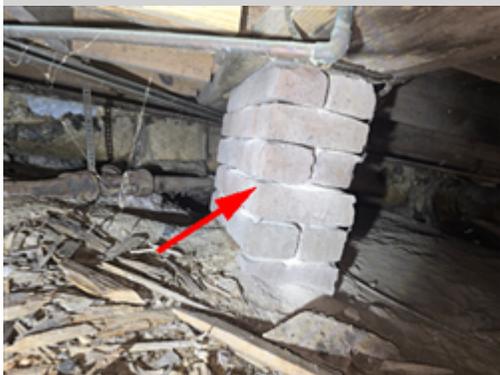
**(A2 - 1.3 ) All Accessible Areas**

Additional Photograph: This is a photograph of above noted item 1-1

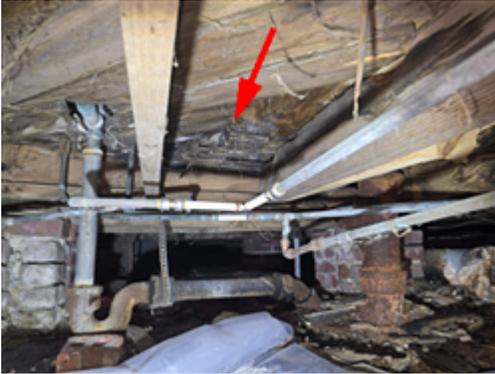
**(A3 - 1.1 ) All Accessible Areas**

The visible significant moisture damaged wood framing components in the crawl space under the main hallway bathroom have been repaired or supplemented. The repairs do not conform to typical construction methods and are in need of review by a licensed general contractor or an engineer to ensure the stability of the home and prevent further damage. This damage has created a large area of unlevel and unstable interior floor throughout the hallway bathroom.

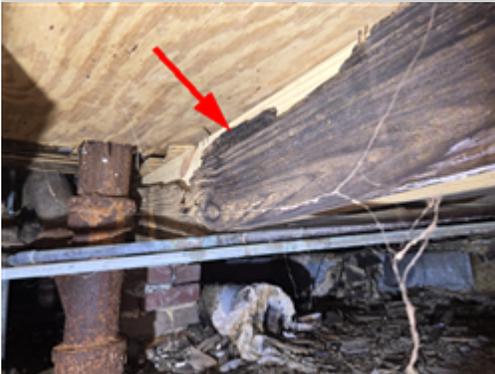
**(A3 - 1.2 ) All Accessible Areas**

Additional Photograph: This is a photograph of above noted item 1-1

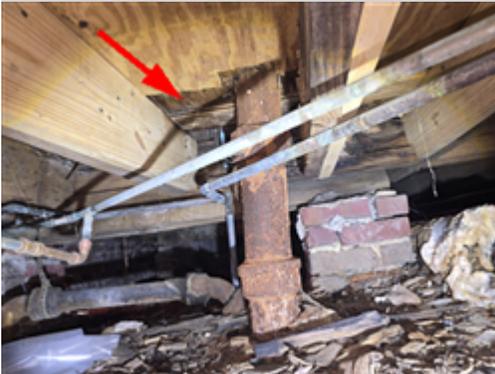
**(A3 - 1.3 ) All Accessible Areas**

Additional Photograph: This is a photograph of above noted item 1-1

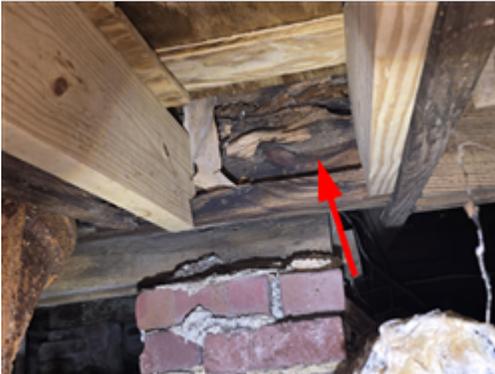
**(A3 - 1.4 ) All Accessible Areas**

Additional Photograph: This is a photograph of above noted item 1-1

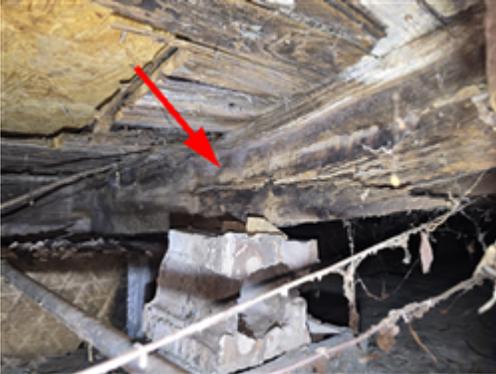
**(A3 - 1.5 ) All Accessible Areas**

The visible severe moisture damaged wood framing components in the crawl space under the kitchen/water heater area have been repaired or supplemented. The repairs do not conform to typical construction methods and are in need of review by a licensed general contractor or an engineer to ensure the stability of the home and prevent further damage. This damage has created a large area of unlevel and unstable interior floor extending along the left side of the kitchen and onto the left front bedroom.

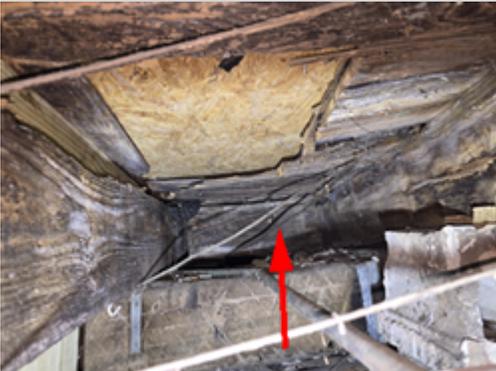
**(A3 - 1.6 ) All Accessible Areas**

Additional Photograph: This is a photograph of above noted item 1-5

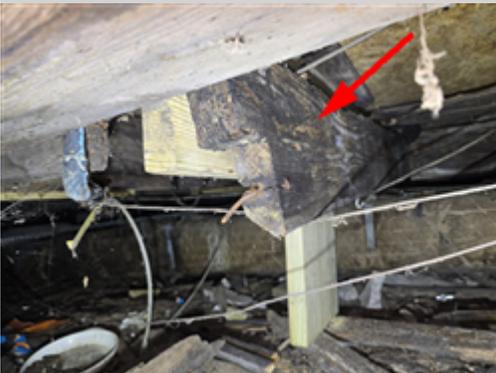
**(A3 - 1.7 ) All Accessible Areas**

Additional Photograph: This is a photograph of above noted item 1-5

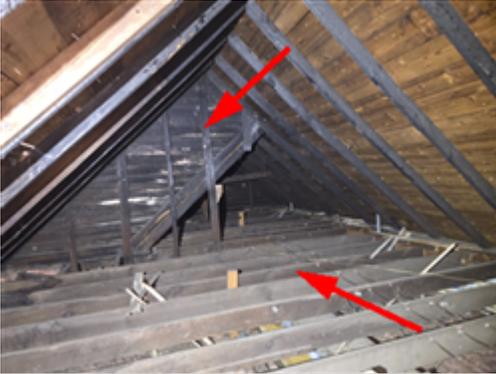
**(A6 - 1.1 ) All Accessible Areas**

Evidence suggests that this home has been subjected to a fire. In the attic area, the framing was noted to be black/charred. Construction restoration after a fire must include all systems. In most cases all electrical, plumbing and insulation components are replaced. Any charred wood members that are not replaced require sealants to prevent reoccurring odors and engineering review and letters of structural integrity to remain with the home. The home owners should be asked for disclosure related to the extent of the fire and details for the renovation. An engineer should be consulted for a complete evaluation of the home and all the systems.

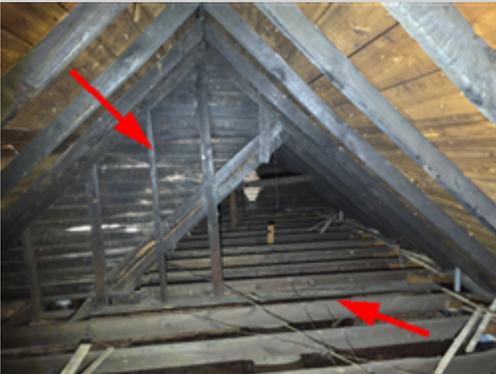
**(A6 - 1.2 ) All Accessible Areas**

Additional Photograph: This is a photograph of above noted item 1-1

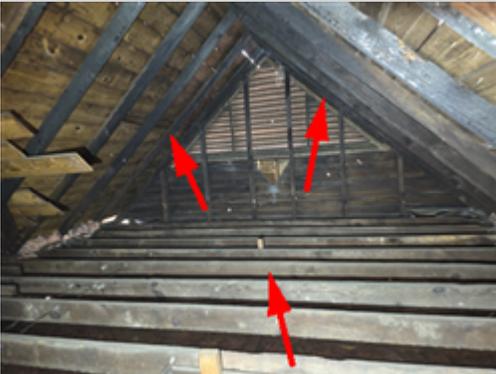
**(A6 - 1.3 ) All Accessible Areas**

Additional Photograph: This is a photograph of above noted item 1-1

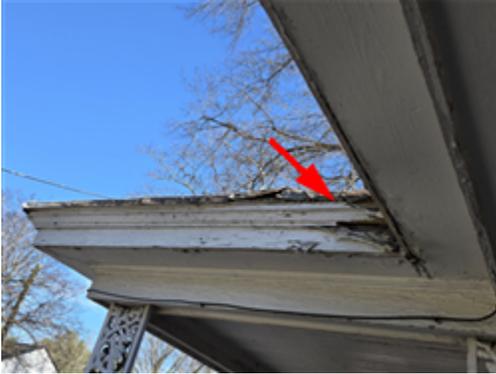
**(B1 - 1.1) All Accessible Areas**

The exterior wooden trim, siding, and boxing of the home need repairs and painting to prevent further damage and water penetration. The following items were noted during the inspection, all areas should be evaluated as a repair plan is prepared: Siding was found to have areas of decay, loose boards, peeling paint, swollen edges, swollen nail locations; Boxing and trim areas were found to have damage related to age and roof drainage; Gable trims and shingle rake trims were noted to be decayed and warped. A licensed general contractor should be consulted for a complete evaluation of the exterior siding, trim and boxing to determine the extent of the damage and to make necessary repairs. Some defected area noted:

- 1, Soffit boxing over right side inner corner of front porch.
2. Siding over right side of front porch.
3. Damaged, warped slat on right side gable vent.
4. Soffit boxing over left side of right side porch.
5. Wooden siding and trim on upper rear center of home, adjacent to the chimney at left rear center; Damaged gable vent slat also noted here.
- 6, Soffit boxing at left rear corner.

-Comment # 1

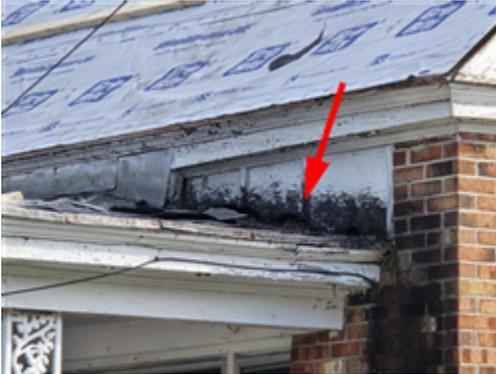
**(B1 - 1.2) All Accessible Areas**

Additional Photograph: This is a photograph of above noted item 1-1

-Comment # 2

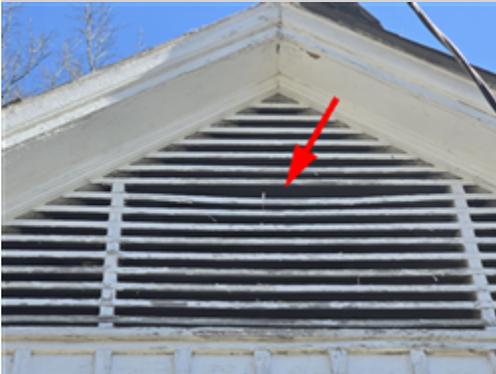
**(B1 - 1.3) All Accessible Areas**

Additional Photograph: This is a photograph of above noted item 1-1

-Comment # 3

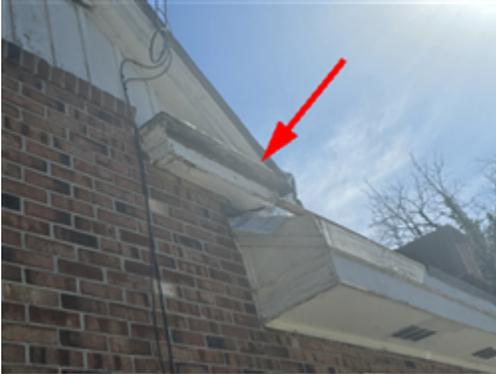
**(B1 - 1.4) All Accessible Areas**

Additional Photograph: This is a photograph of above noted item 1-1

-Comment # 4

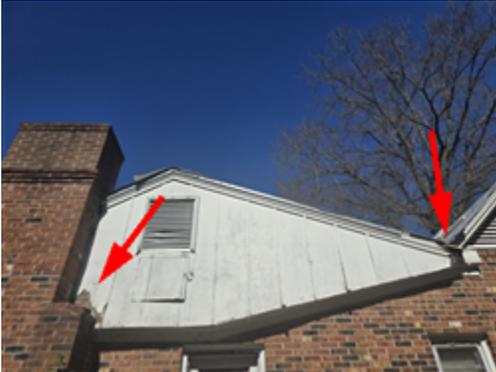
**(B1 - 1.5) All Accessible Areas**

Additional Photograph: This is a photograph of above noted item 1-1

-Comment # 5 Far view

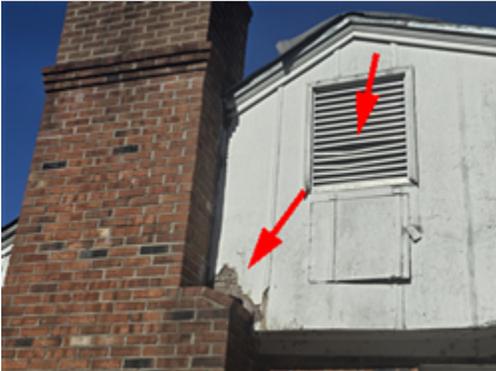
**(B1 - 1.6) All Accessible Areas**

Additional Photograph: This is a photograph of above noted item 1-1

-Comment # 5 -Close view

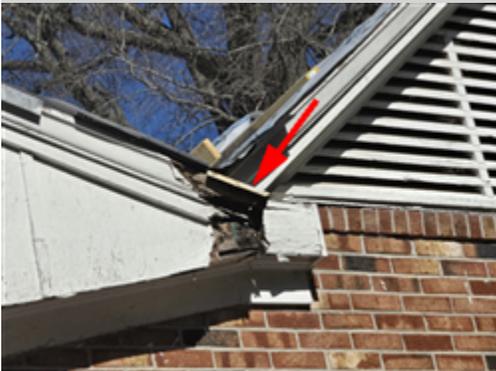
**(B1 - 1.7) All Accessible Areas**

Additional Photograph: This is a photograph of above noted item 1-1

- Comment # 5 Close view
