Cabins to Castles Home Inspection, LLC

Property Inspection Report

135 Mimosa , Pine Knoll Shores, NC

Date of Inspection: 9/11/2025 Time: 12PM

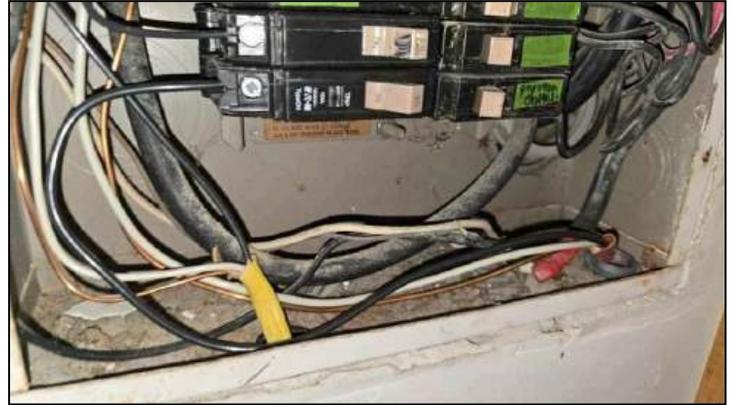
Electrical panel in good overall condition. Is an original electrical panel.

Generator does not have a safety interlock

- The main electrical panel was not completely labeled at all circuits, and final labeling is suggested for clarity and safety. A generator receptacle was observed on the exterior side of the panel with a 10 AWG cable connected to a breaker. There is currently no safety interlock device installed. A safety interlock is designed to prevent the main breaker from being on at the same time as the generator breaker, which helps avoid potential back feeding into utility lines. While the generator can be used safely if the main breaker is manually switched off during operation, a listed safety interlock device provides an added measure to ensure this occurs reliably. Further evaluation and correction by a licensed electrician can be completed to install a proper safety interlock or disconnect the generator receptacle from the breaker if not intended for use.

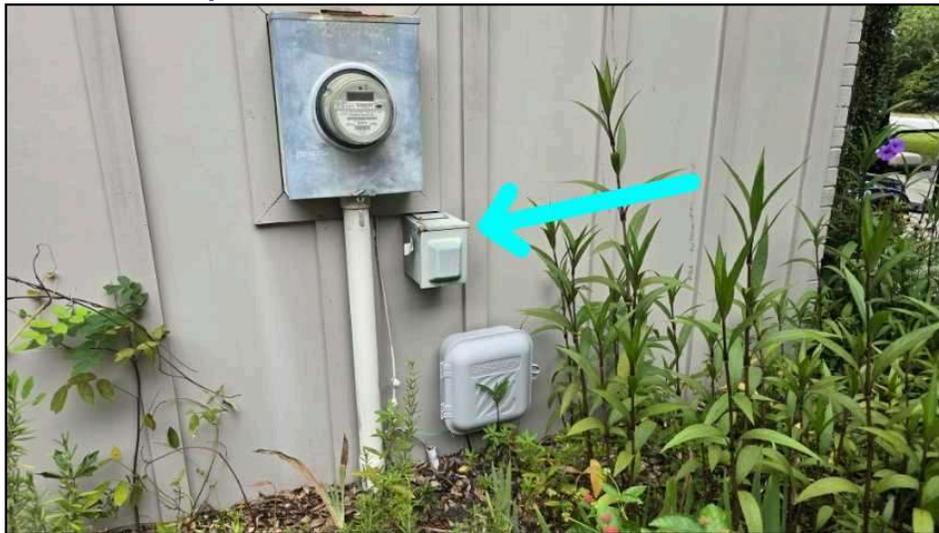
Generator receptacle

This is actually an RV plug

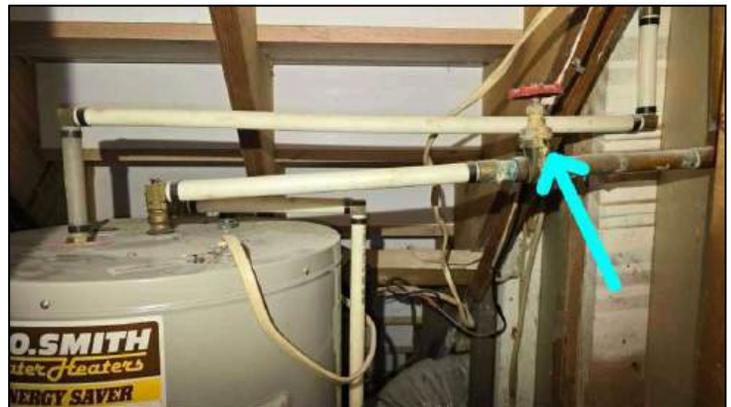
Evidence of previous drip at the packing nut at the water heater shut off valve. Not currently leaking. Adjustment may have been completed in the past to prevent this as this is a common issue when operating older valves.

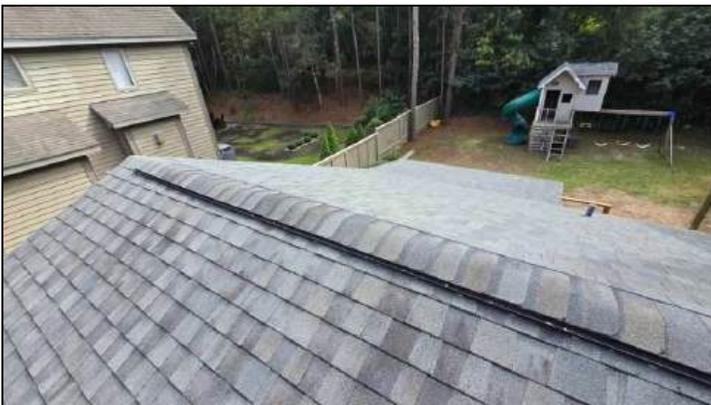
Architectural shingles appear newer. Typical organic growth staining as the front does not receive as much direct sunlight.

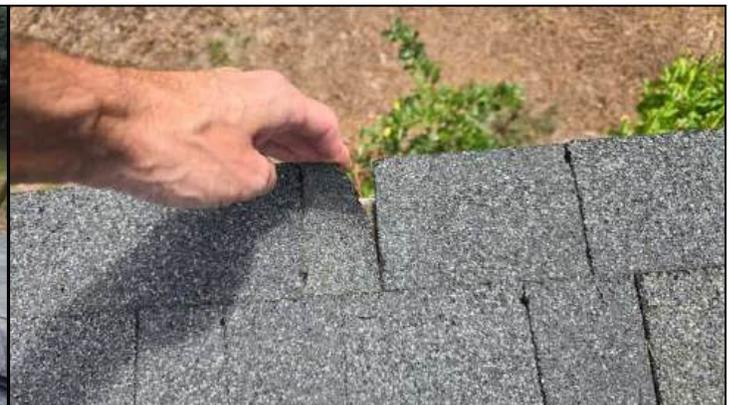
No starter course over the back storage room only. Refer to the storage room ceiling section of the report for more information for repairs needed.

Roof inspection completed and repaired as suggested

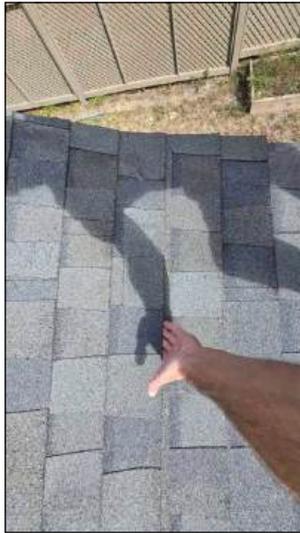
The shingles need to be resealed at the location between the storage room and the main garage / laundry room roof area.

These are the shingles that need to be sealed with roofing sealant to avoid uplift during a major storm.

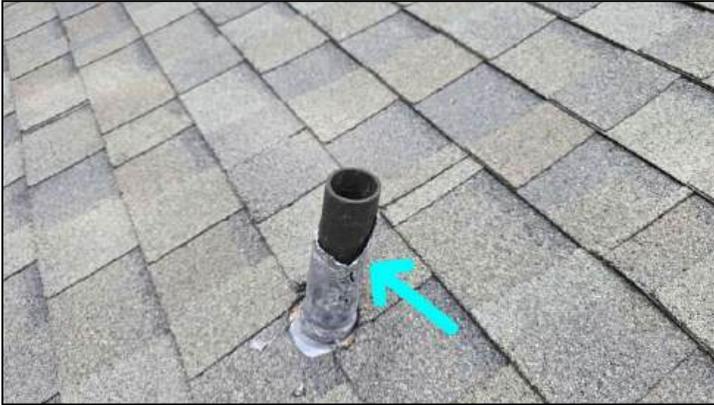
There is also a small area of damage/abrasion from a previous tree limb at the side of the house, which allowed squirrels to access the roof and chew the sewage vent boot flashings, causing damage that needs repair. Refer to the images, especially at the smaller boot flashing that will need replacement.

Previous squirrels chewed the lead boot flashing

Further evaluation and repairs can be completed by a general contractor.

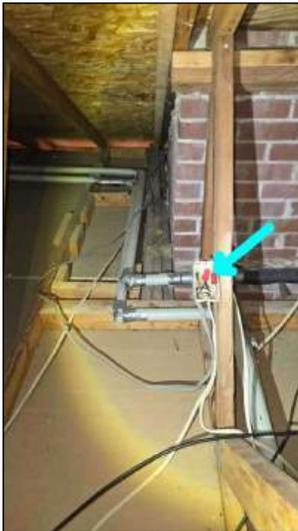
- Electrical splices were observed in the attic spaces that were capped with wire nuts but not contained within electrical junction boxes, which is needed for safety. For splices already located in junction boxes, cover plates are suggested. Some added electrical cables, such as those for light fixtures over the laundry room, were not fully secured and would benefit from the use of appropriate staples to prevent movement that could affect their connections. Further evaluation and minor electrical repairs or adjustments can be completed by a licensed electrician.

Cover plates needed over electrical splices in attic spaces

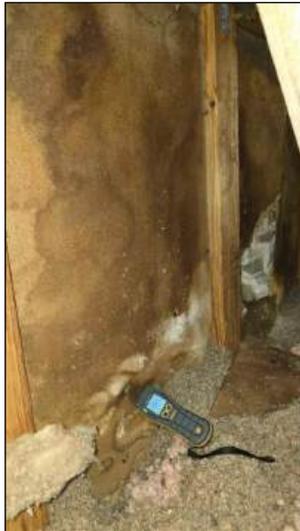
This is the attic space over the main house. Previous moisture intrusion occurred around the chimney - did not identify elevated moisture at this time.

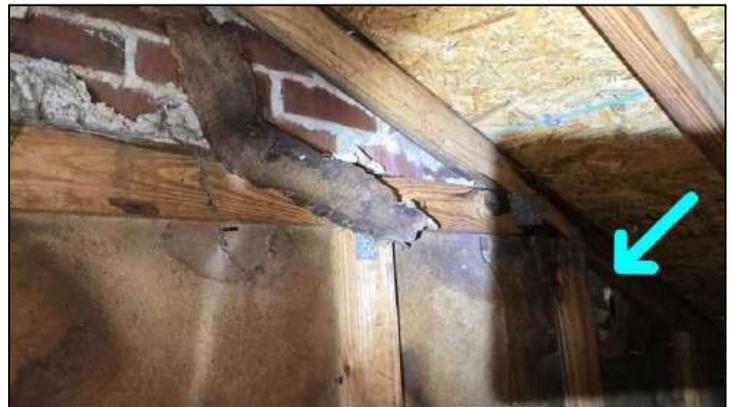
Small daylight can be seen at the vinyl overhang feature. It does appear to have been sealed with a clear sealant, causing light to shine through.

This is an old stain prior to siding being fully replaced in 2017

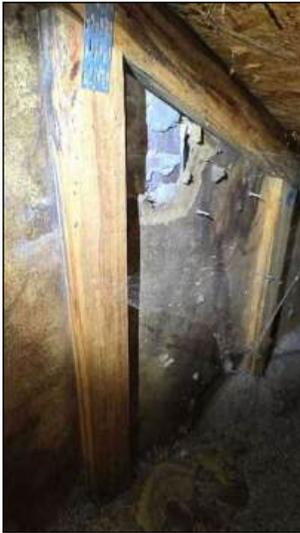
Another view. This wall sheathing is not necessarily needed at the chimney chase location and its previous damage does not appear to pose an immediate concern

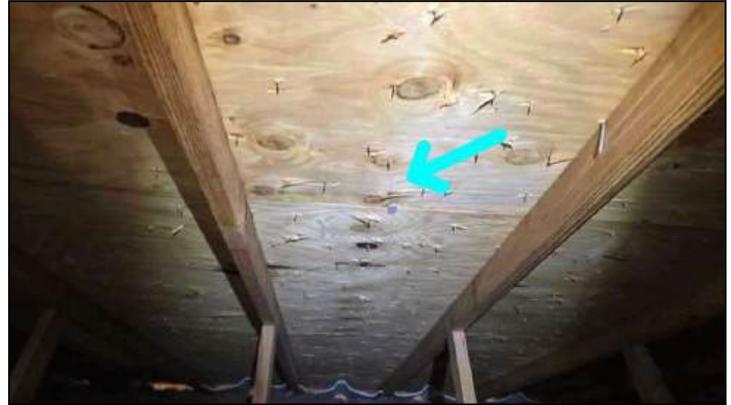
Someone stepped at a plywood roof decking seam, which can cause minor cracking of roof decking. Common condition.

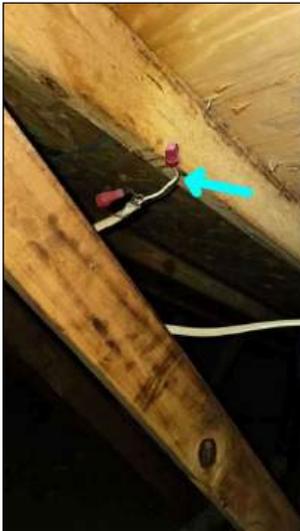
Secure electrical cable within a junction box at previous location of roof mounted exhaust fan or possible previous light.

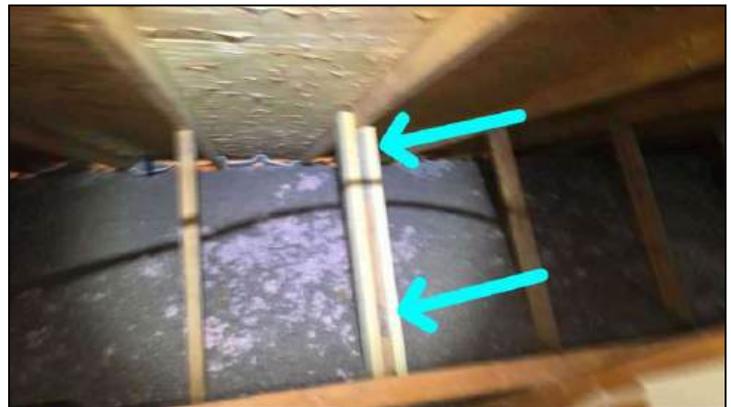
Two previous truss repair areas. Appears functional. Has been cistered on both sides with 2x6's, which is larger than the original component.

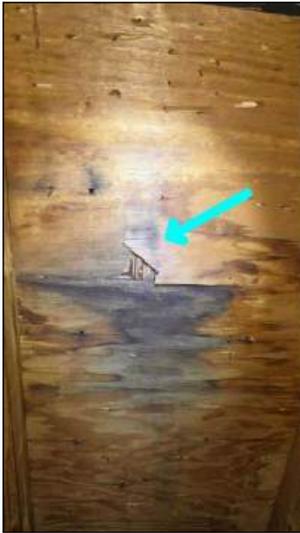
Close-up view of a damaged area of roof decking that would benefit from reinforcement, such as with wood purlins.

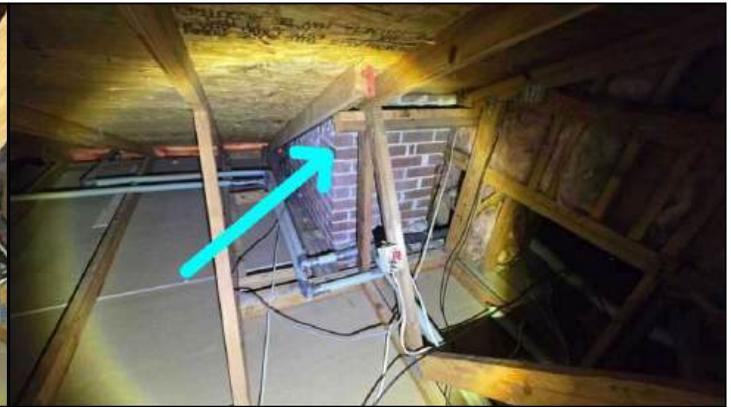
During the construction process, engineered roof trusses were altered to accommodate the chimney. Although reinforcement has been completed, whenever this is observed standards always suggest further evaluation of an engineered system that was altered. Although visibly it doesn't appear to have caused a support issue.

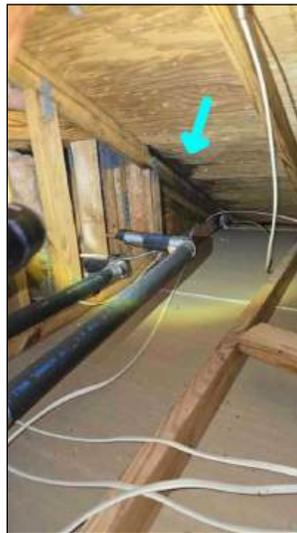
Previous moisture staining. Usually only severely damaged areas are cut out and replaced when shingles are installed. Therefore, old moisture stains will exist.

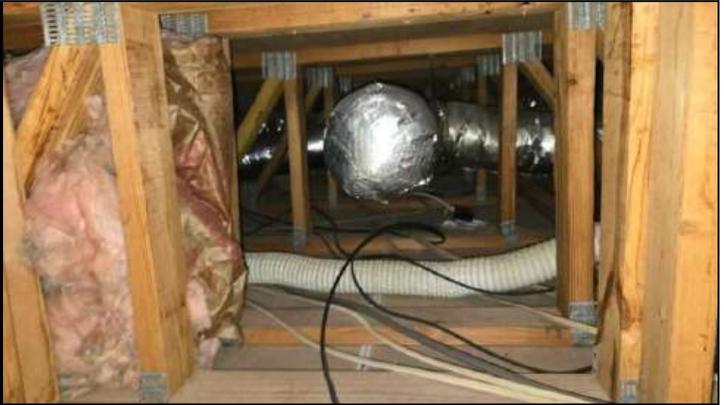
- In the attic space over the garage, the engineered floor trusses of the house were open to view, and the area was not properly insulated. This condition allows heat transfer from the attic into the subfloor system between the first and second levels, which can reduce comfort and efficiency. Over time, it may also contribute to condensation within the floor system.

Not insulated properly at the side of the engineered floor trusses as seen within the attic over the garage

This allows heat movement through the subfloor system.

Repairs are needed by a general contractor, insulation contractor, or experienced individual to ensure proper insulation is installed at the sides of the trusses so unconditioned attic air does not enter this assembly.

The insulation repair will be completed by 10/4/25

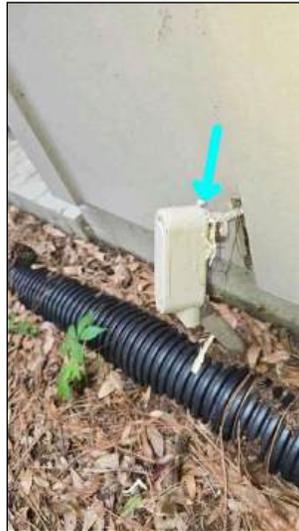
Secure electrical cable and junction at the side of the home.

Repair to be completed by 10/4/25

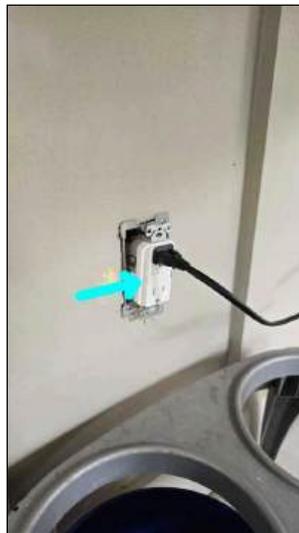
Need securing at exterior beside TV

Completed

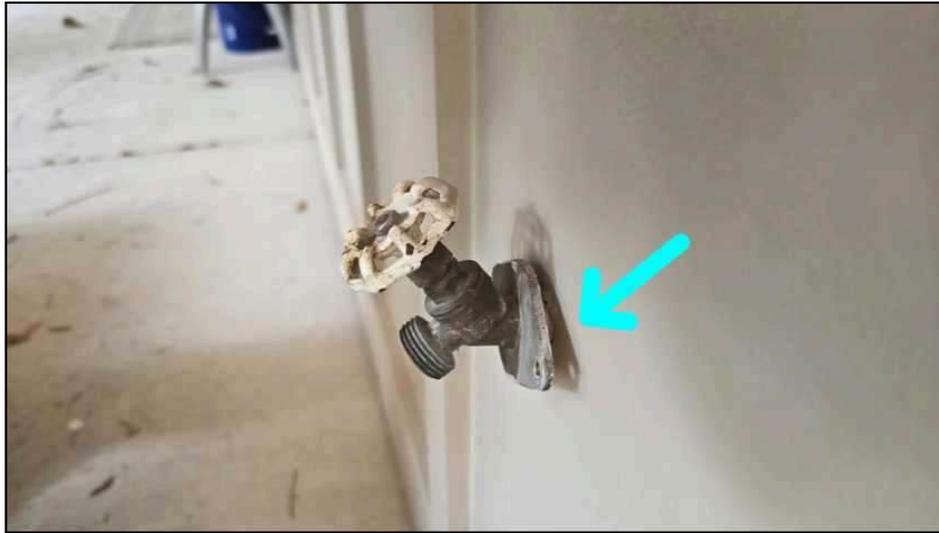
- The hose bib / spigot at the back of the house needs to be secured using screws, as noted in the image. This minor repair can be completed by a handyman or plumber.

Need screws

Will be completed by 10/4/25

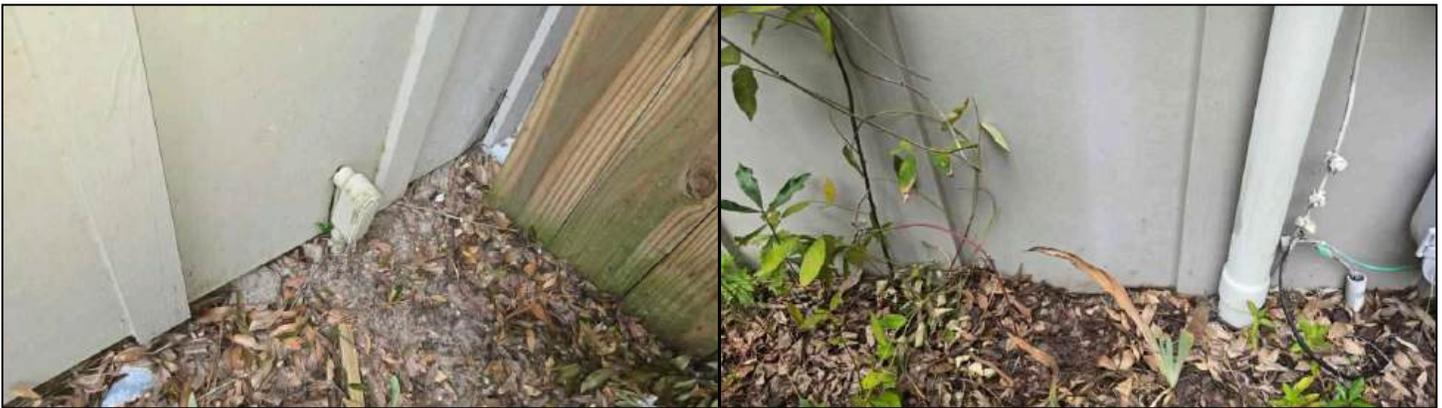
Slightly pull away dirt or landscaping to avoid moisture saturation at fiber cement panels.

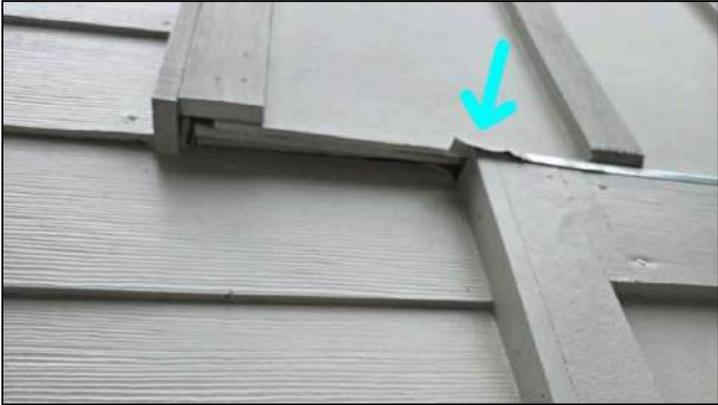
Minor adjustment suggested at the Z flashing at the back of the home

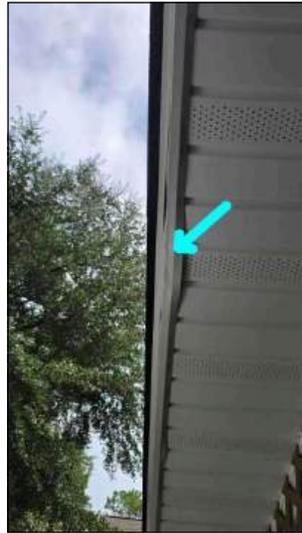
Bent aluminum does not pose an immediate concern at the front of the garage

Completed repair

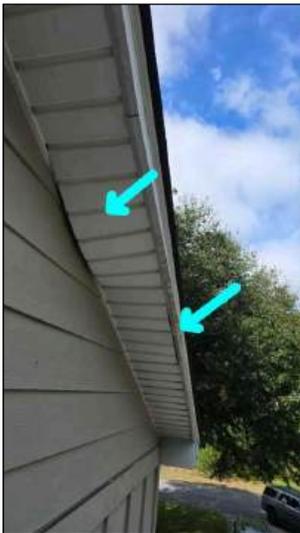
Loose vinyl soffit at roof overhangover garage area needs adjustment.

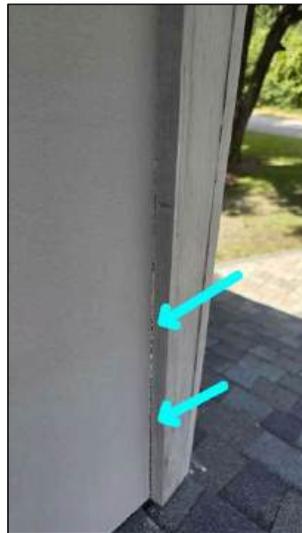
Slight movements from expansion and contraction and natural movements of wood trim material cause the need for caulk repairs over time.

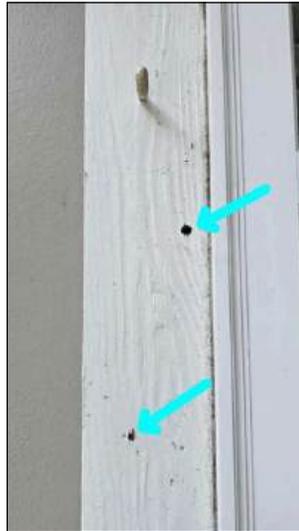
Seal previous storm panel holes.

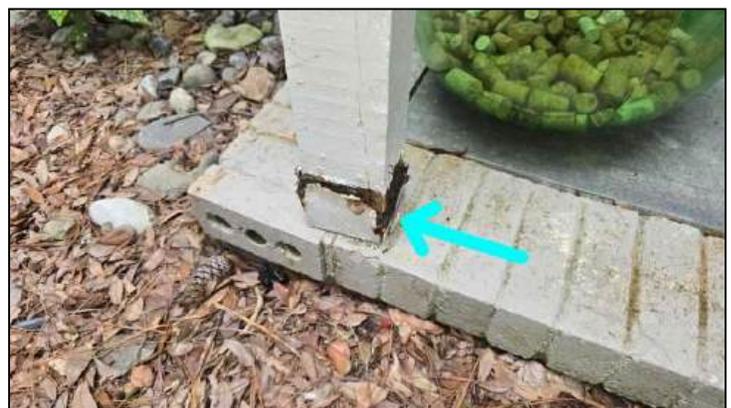
Corrosion at front porch post galvanized bracket. Not an immediate concern at this time, but future repair is suggested.

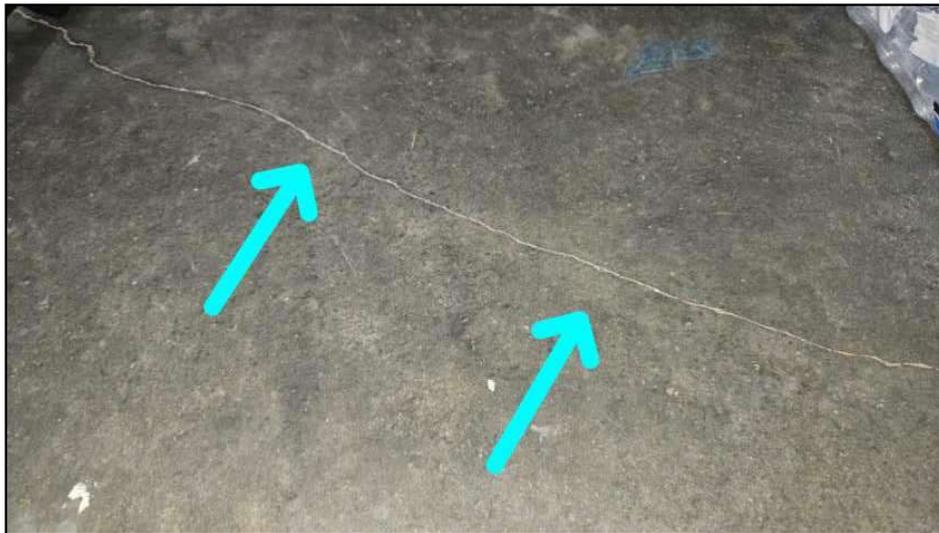
No major differential movement observed at the concrete slab crack

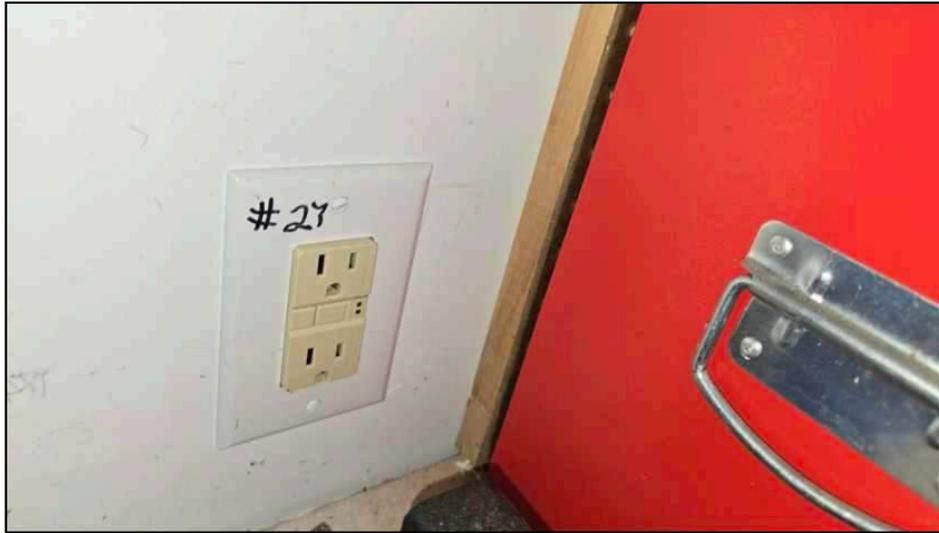
GFCI protected receptacle. However, not all receptacles are protected. Therefore, use those for refrigerator or freezers.

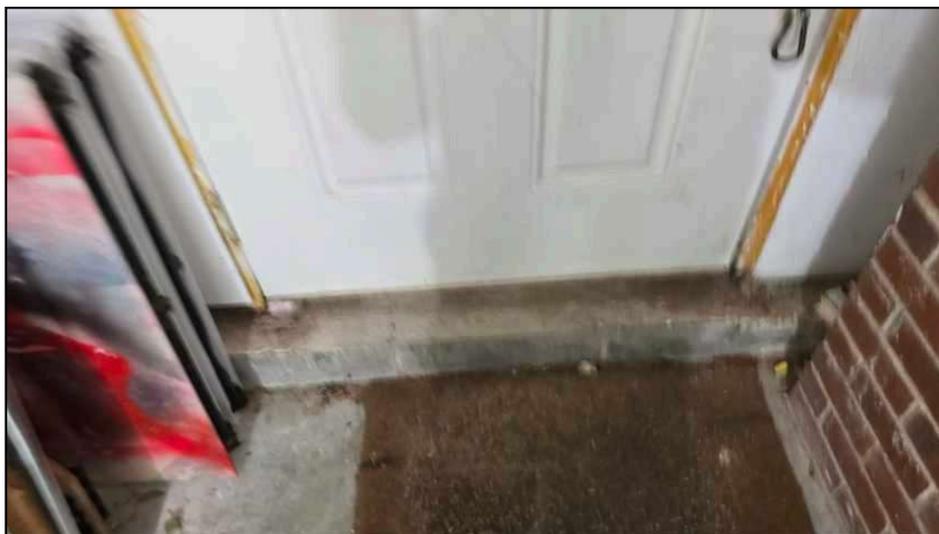
Observations:
 • The back exterior garage door needs repair at the jamb and threshold. Further evaluation for typical maintenance repair can be completed by a general contractor or handyman.

Door jamb and threshold needs repair

Work to be completed by 10/4/25

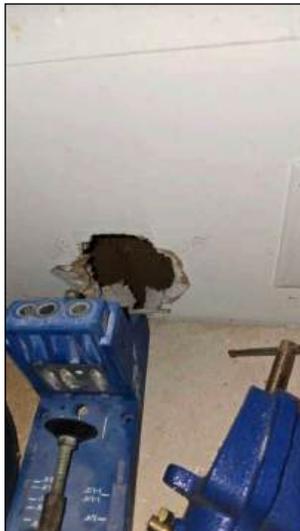
Repair drywall for a more fire rated garage at openings from previous access locations that were created.

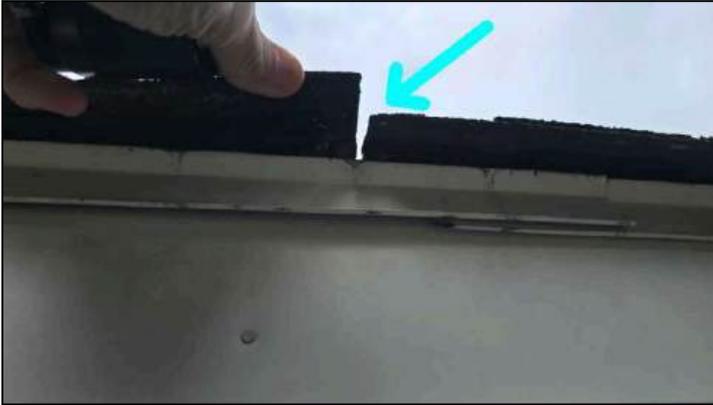
No starter course at the storage room only.

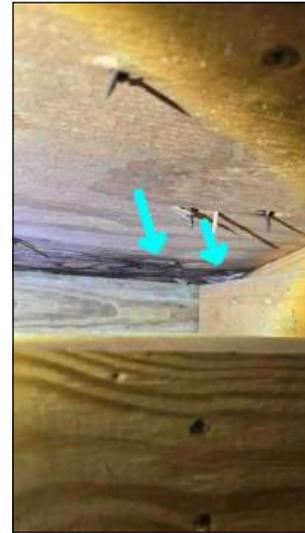
- There are visible moisture stains at the plywood storage room roof decking. Further evaluation found that starter course was not installed at the first course shingle installation over the storage room only. This caused moisture to drain at the first course butt joints. Further evaluation for the installation of a starter course is needed to prevent damage to the plywood in the future. This can be completed by a general contractor or handyman.

Moisture staining at the plywood roof decking of the storage room as a result of no starter course.

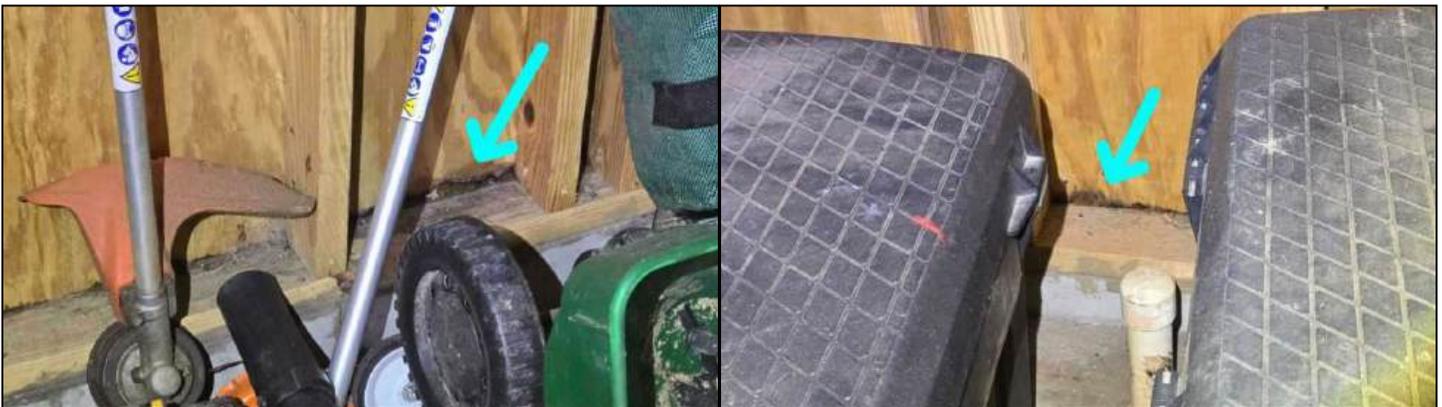
Moisture is starting to splash and/or wick up at the plywood wall sheathing of the storage room. This is a common condition near the ground. Try to keep water away as much as possible on the exterior side.

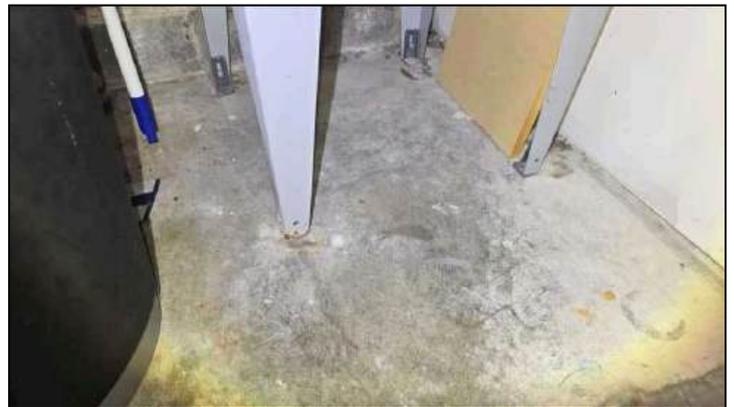
No active leak. Slip joint nut was slightly loose and I tightened it. **Secure legs for additional rigidity if desired.**

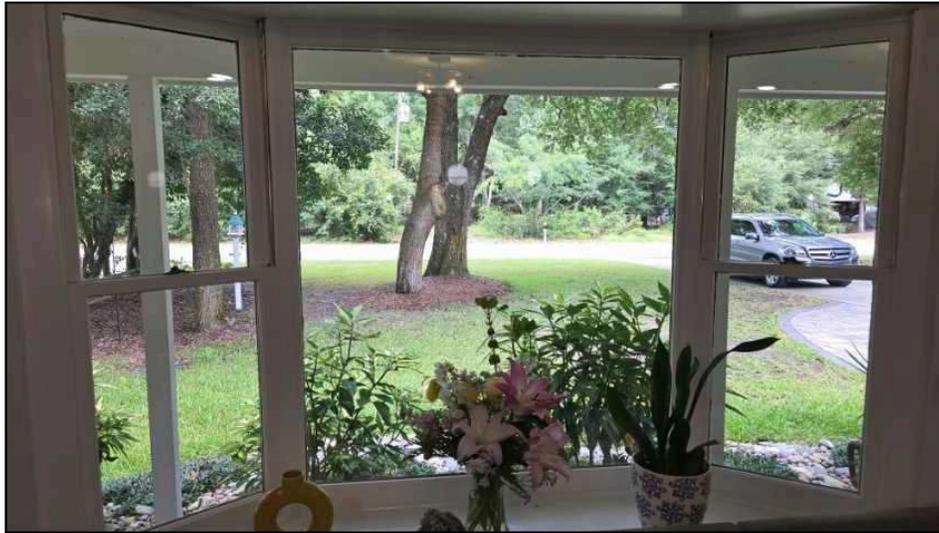
Older wood framed windows painted shut.

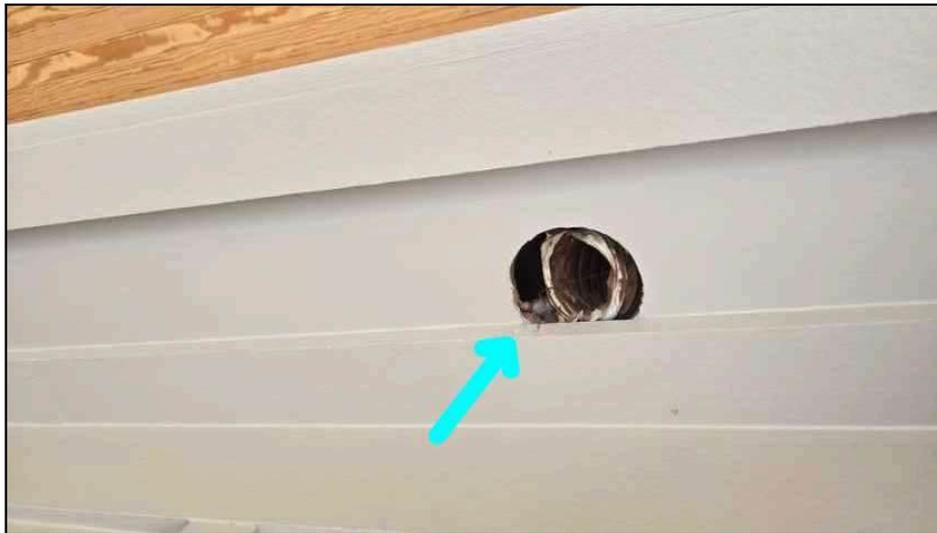
Half bath exhaust needs a cover

To be completed by 10/4/25

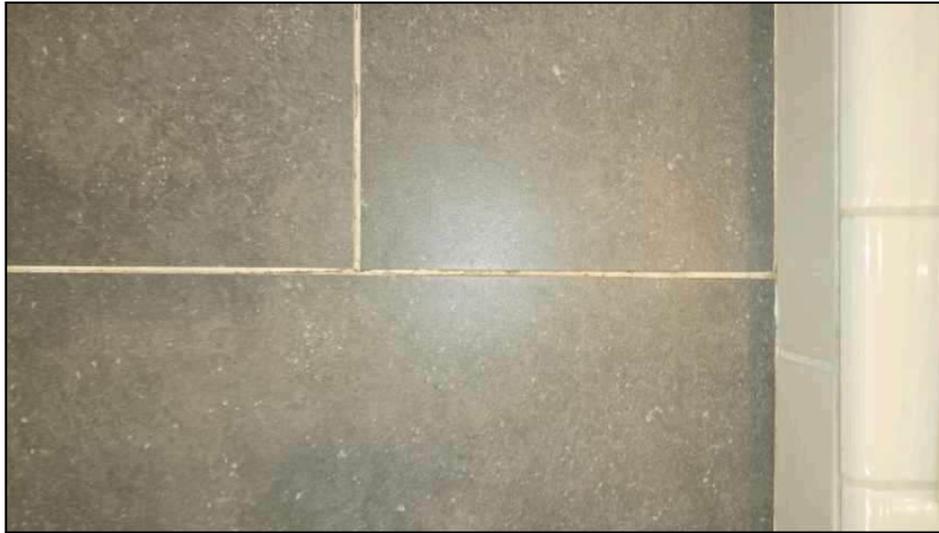
Cracks have developed at the grout line at the tile floor in the master bathroom. Floor coverings are generally considered cosmetic conditions. Repair if desired. This can be completed by a general contractor or handyman.

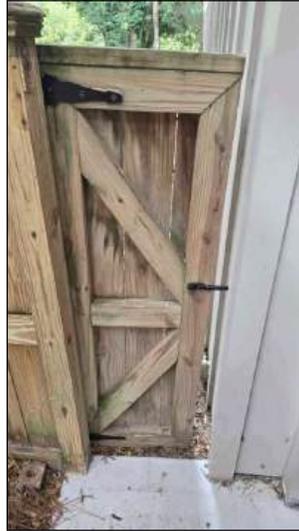
Repair needed for the gate on the west side to operate. This can be completed by a handyman.
