SUMMARY

266 E Red Head Cir, Sneads Ferry, NC
28460
aimee.jarrels@amerispec.net
06/19/2026

Dawson Sears
NC# 5891
AmeriSpec Inspection Services
910-392-3132
vick-office@amerispec.net

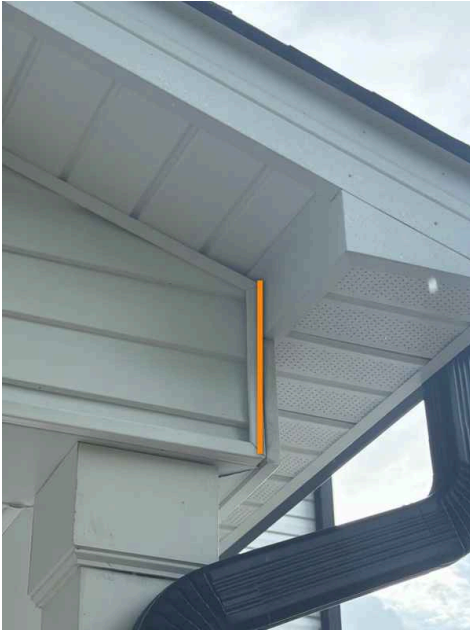
Left Front

UNSEALED EXTERIOR AREAS - Rectified.

Unsealed areas were observed on the exterior of the house. This is a water penetration and damage concern. Moisture can cause adverse conditions like moisture damage and organic growth.

Contact a qualified general contractor.

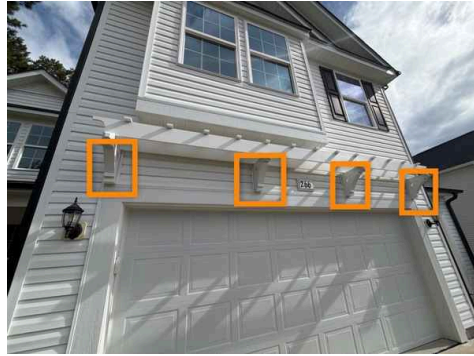
Front J channel to wood transition - gaps in sealant

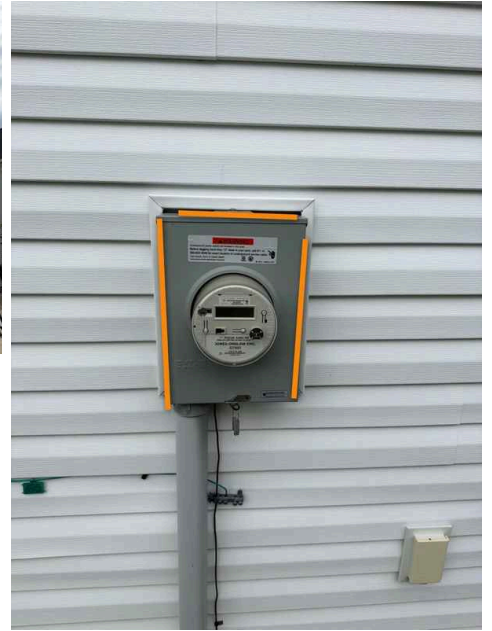
Right - J channel to meter transition

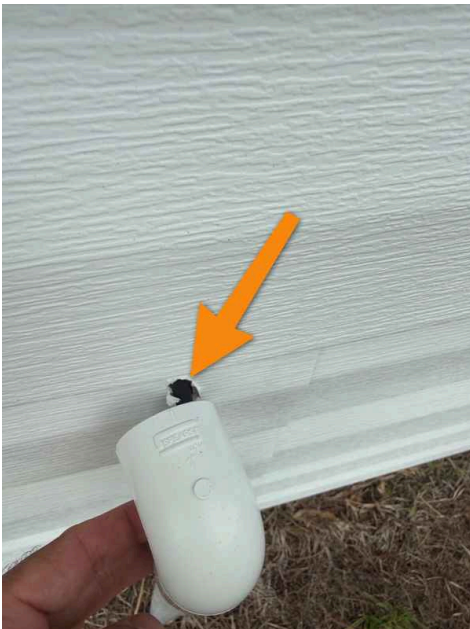
Right - wire penetration

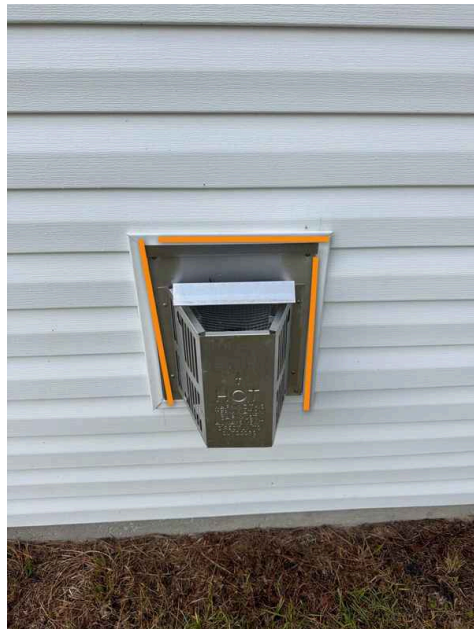
Rear - vent to J channel transition

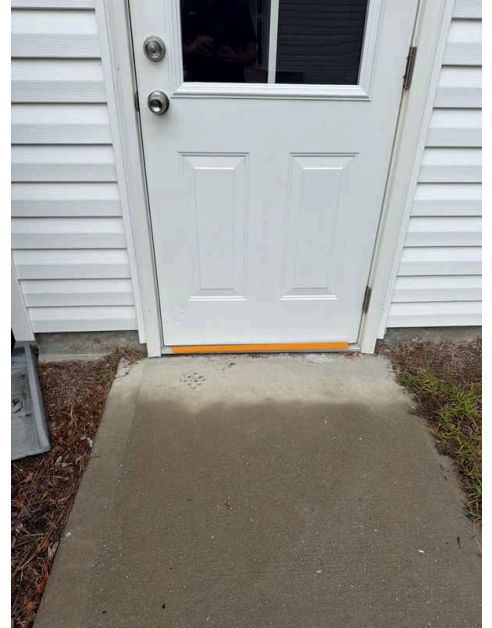
Right - garage side door

DOOR THRESHOLD NOT SUPPORTED - Rectified.

The entry door threshold at the noted location was not fully supported at the lower areas which allowed for movement when pressure is applied. Proper support helps ensure the stability of the lower door threshold and to prevent damage. Repairs are recommended.

Contact a qualified professional.

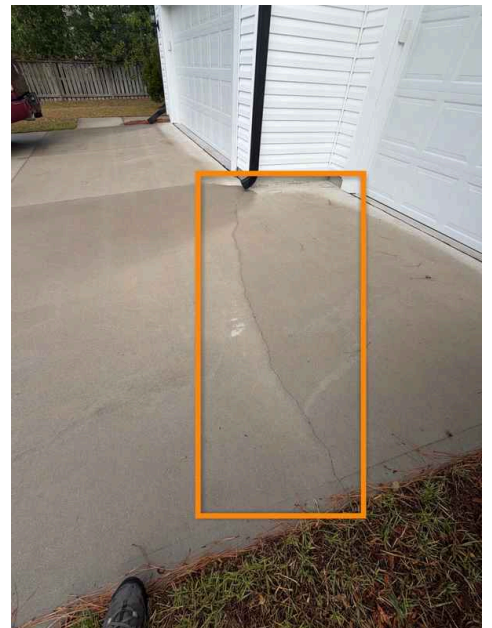
FRONT - CRACKING

UNEVEN AND DAMAGED AREAS - As Built.

Uneven and damaged areas have been observed on the surfaces at the noted locations. These present a risk of damage, toe stubbing, and tripping. Further review of the conditions is recommended for any necessary repairs.

Contact a qualified general contractor.

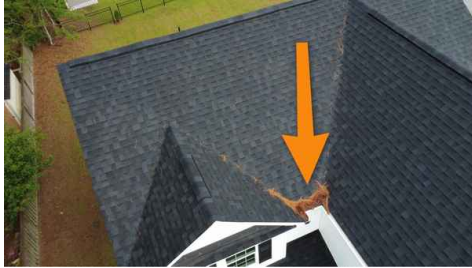
Front

DEBRIS ON ROOF - Rectified.

Vegetative debris has accumulated in the specified areas of the roof. Debris can impede proper water flow and may lead to water backing up beneath the shingles. The buildup of debris can reduce the lifespan of the roofing material. The areas beneath the debris are obscured, making it difficult to assess their condition. It is recommended that the debris be removed and to check the conditions of the areas that are currently concealed for any repairs needed.

Contact a qualified roofing professional.

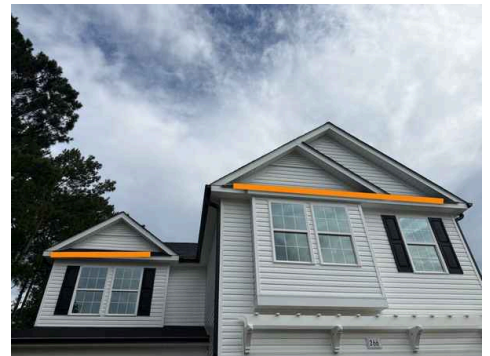
Front

ATYPICAL SHINGLE OVERHANG - As Built.

Areas of the shingles observed that did not have the proper overhang at the edges. The recommended overhang for asphalt composition shingles typically ranges from 1/4 inch to 3/4 inch at both the rakes and eaves. This is an installation and damage concern. We recommend further review for any repairs needed.

Contact a qualified roofing professional.

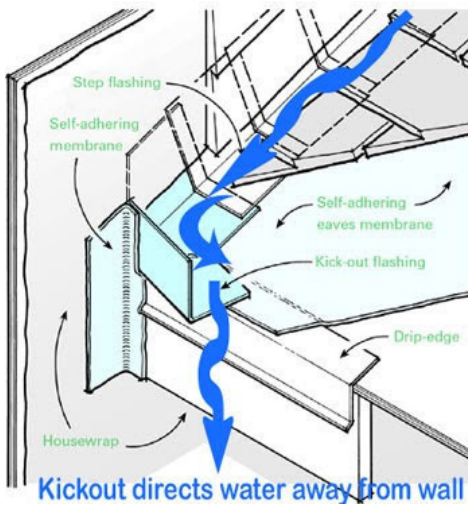
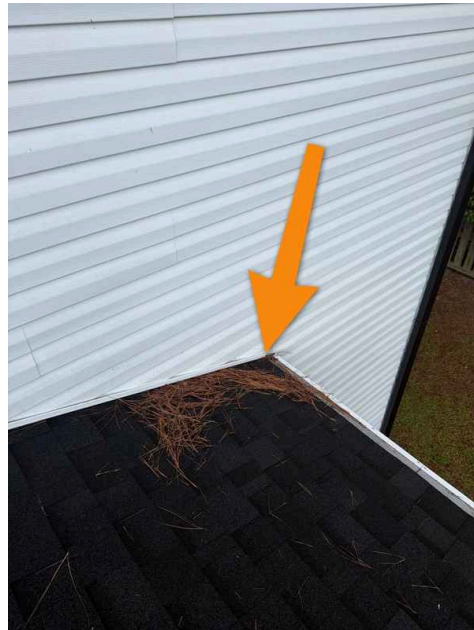
REAR LEFT

KICKOUT FLASHING MISSING - Rectified.

Kickout flashing was not present in area(s) where the fascia abutted a sidewall. The installation of kickout flashing is recommended to be performed by a roofing contractor at any areas where fascia meet a sidewall, preventing rainwater from infiltrating between the end of the fascia and the wall. Hidden damage behind the exterior wall clad or drywall may exist in areas where kickout flashing is missing. The home inspector probed if the area is safely accessible.

Contact a qualified general contractor.

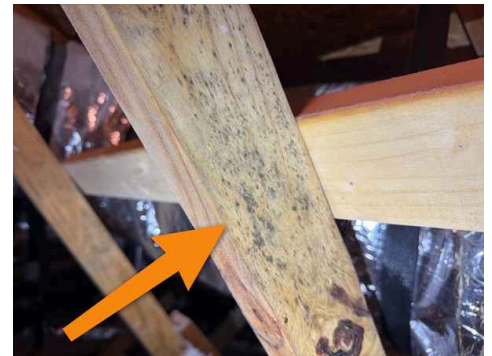
SCATTERED AREAS - ON TRUSSES

ORGANIC GROWTH OBSERVED - Rectified.

Stains, discoloration, growth and/or evidence of moisture observed in the attic at the noted area(s). These conditions may indicate mold and/or fungus growth, and were discovered during the home inspection. Because certain types of mold may be toxic and result in adverse health effects, it is recommended that a mold inspection be performed by a qualified professional to determine the presence and types of mold in the house and that corrective measures be taken to limit moisture inside the home.

Contact a qualified mold inspection professional.

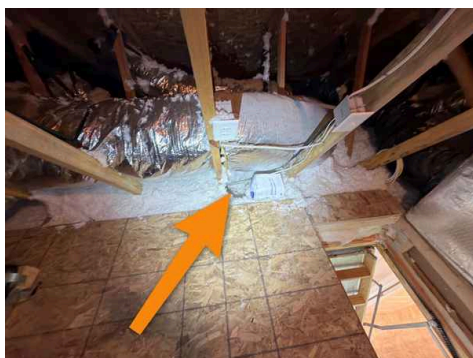
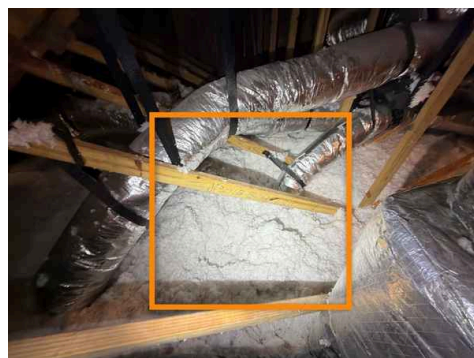
LOW/ MISSING INSULATION - Rectified.

SCATTERED AREAS - DISPLACED INSULATION FROM FOOTSTEPS

Low &/or missing insulation was noted in the attic at the noted area(s). This is an energy efficiency and moisture concern. Recommend having repaired as required.

Contact a qualified general contractor.

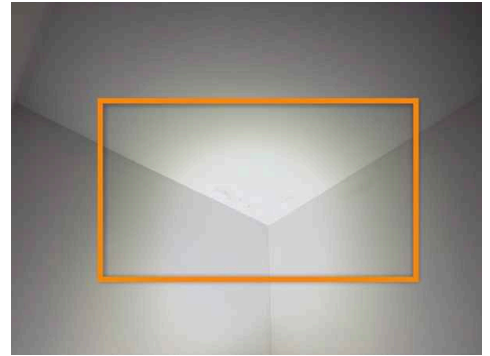
Right Rear Bedroom Closet

ORGANIC GROWTH OBSERVED - Rectified.

Stains, discoloration, growth and/or evidence of moisture observed in the mentioned area(s). These conditions may indicate mold and/or fungus growth and were discovered during the home inspection. Because certain types of mold may be toxic and result in adverse health effects, it is recommended that a mold inspection be performed by a qualified professional to determine the presence of, and types of, mold in the house and that corrective measures be taken to limit moisture inside the home.

Contact a qualified mold inspection professional.

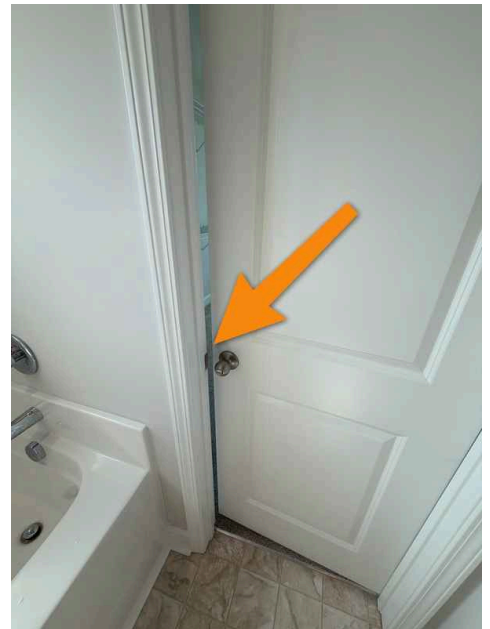
Primary Bedroom Closet

DOOR(S) NOT LATCHING - Rectified.

The door latch bolt did not align with the hole in the strike plate, and did not hold the door closed. This is an adjustment concern.

Contact a qualified professional.

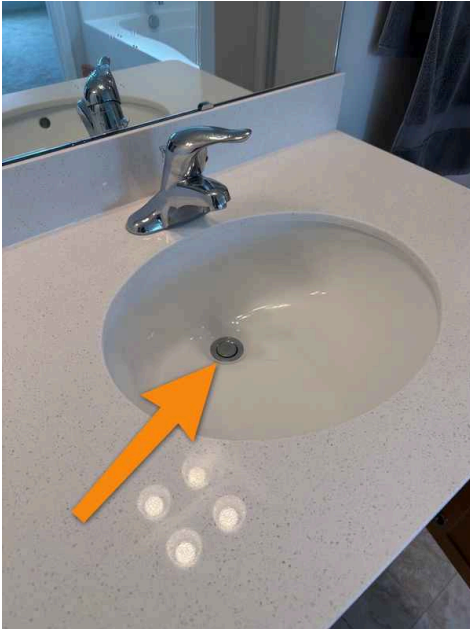
DRAIN STOPPER INOPERABLE - Rectified.

PRIMARY BATHROOM RIGHT SINK - STOPPER DOES NOT SEAL

The drain stopper was inoperable. This is a function concern and does not allow for filling of the fixture. Recommend review for repair.

Contact a qualified professional.

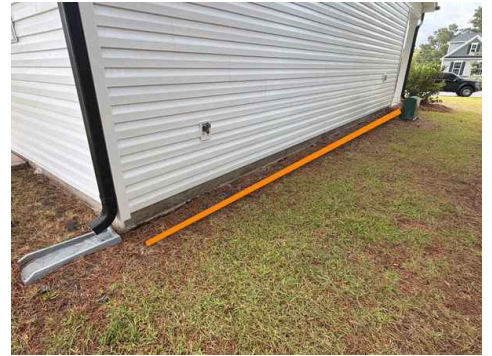
WASHOUT OBSERVED - Rectified.

LEFT - BOTTOM AREAS OF SLAB EXPOSED

Washout was observed at areas of the structure. Unable to determine the extent or if damage is present to the slab as a result. Recommend further evaluation by a licensed professional to determine if damage is present and for appropriate repairs to restore to proper conditions.

Contact a qualified general contractor.

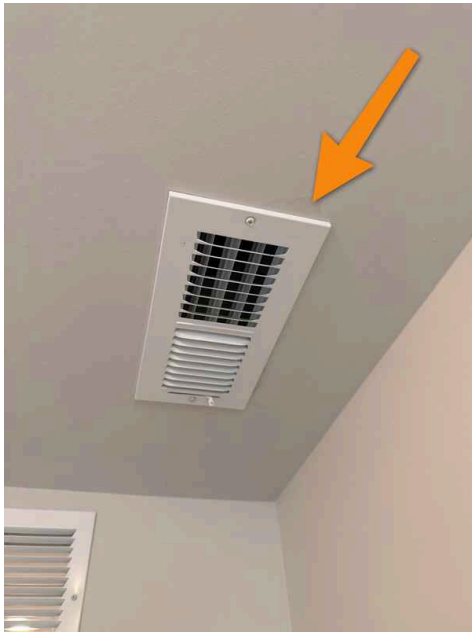
Laundry room

MOISTURE STAINS AT AIR REGISTERS - Rectified.

Staining was observed around the air registers indicating a possible loose connection at the duct boot. This is a damage and energy efficiency concern. Recommend review by a licensed HVAC contractor to ensure ducts are properly sealed to ensure proper operation and prevent further damage.

Contact a qualified heating and cooling contractor

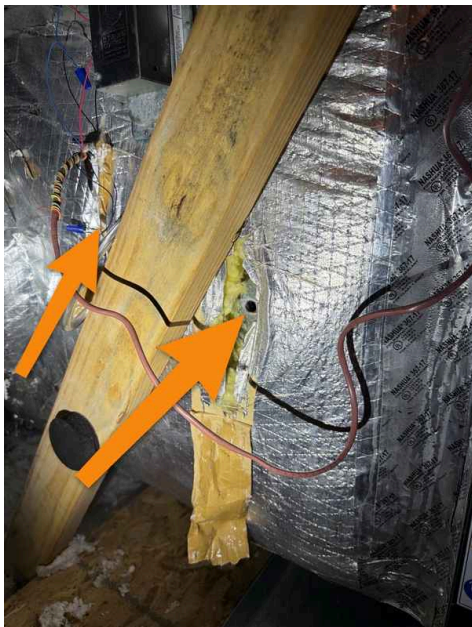
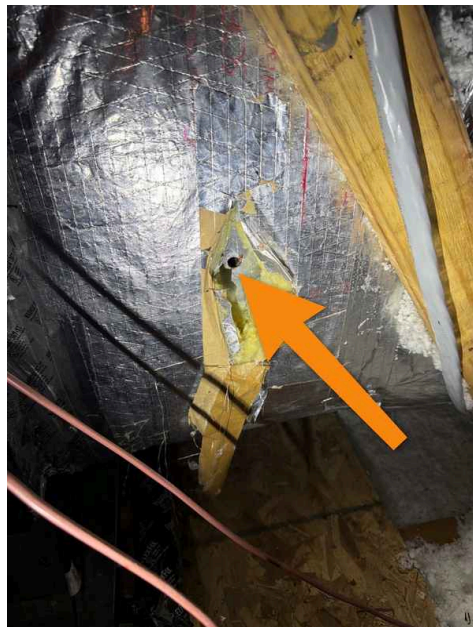
ATTIC CENTER - LEFT/RIGHT SIDES AT AIR HANDLER

LEAKING DUCTWORK - Rectified.

Leaking observed at the HVAC ductwork. This is a conditioned air loss concern. Recommend having repaired and verifying proper operation.

Contact a qualified heating and cooling contractor
