3/2/2026

I was recently asked to examine the trees on a lot just south of 176 Flamingo Ln, Sneads Ferry, NC 28460 (between 176 and the small cemetery). On 2/27/2026 I visited the site and found the following nine trees:

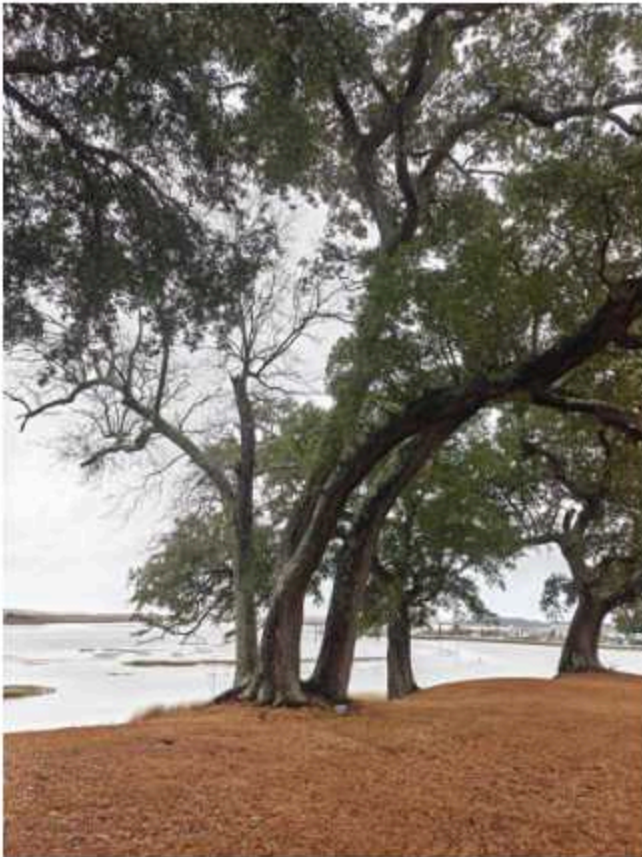
Tree #1: pignut hickory (*Carya glabra*) 22" DBH ("Diameter at Breast Height"), directly behind Trees #2 & #3.

The hickory appears to have sustained significant storm damage in the past, but by taking the brunt of the storm, it probably protected the adjacent live oaks from taking the damage. I would not recommend removing the hickory unless necessary, as it is still providing some protection to Trees #2 & #3.

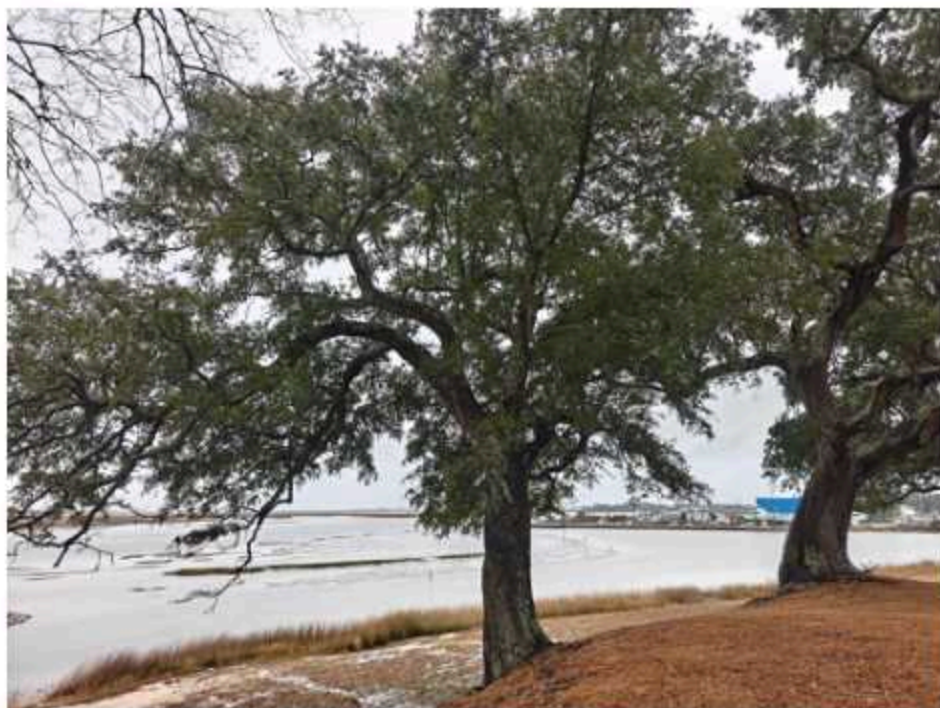
Tree #4: southern live oak (*Quercus virginiana*) 45" DBH.

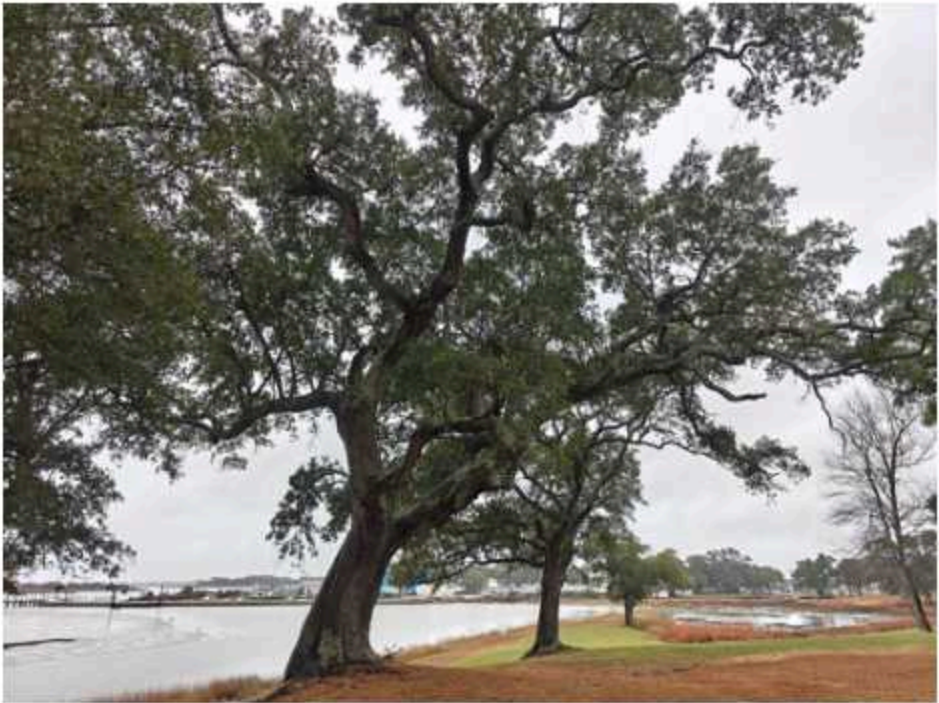
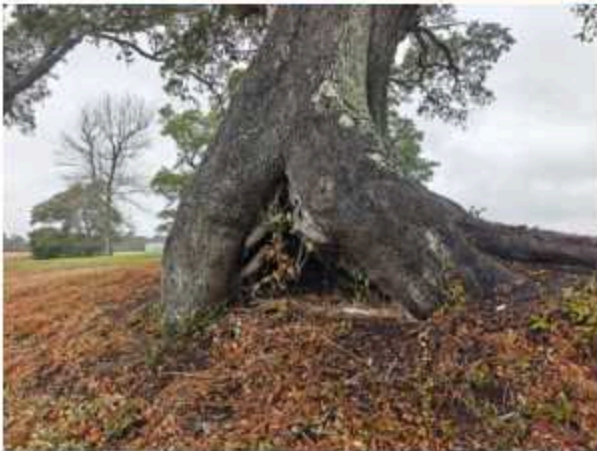
Tree #5: southern live oak (*Quercus virginiana*) 66" DBH.

The largest and oldest tree on this site, it has a significant cavity near ground level. Some of this is due to erosion, and it has been exacerbated by fires. The tree is stable at this time.

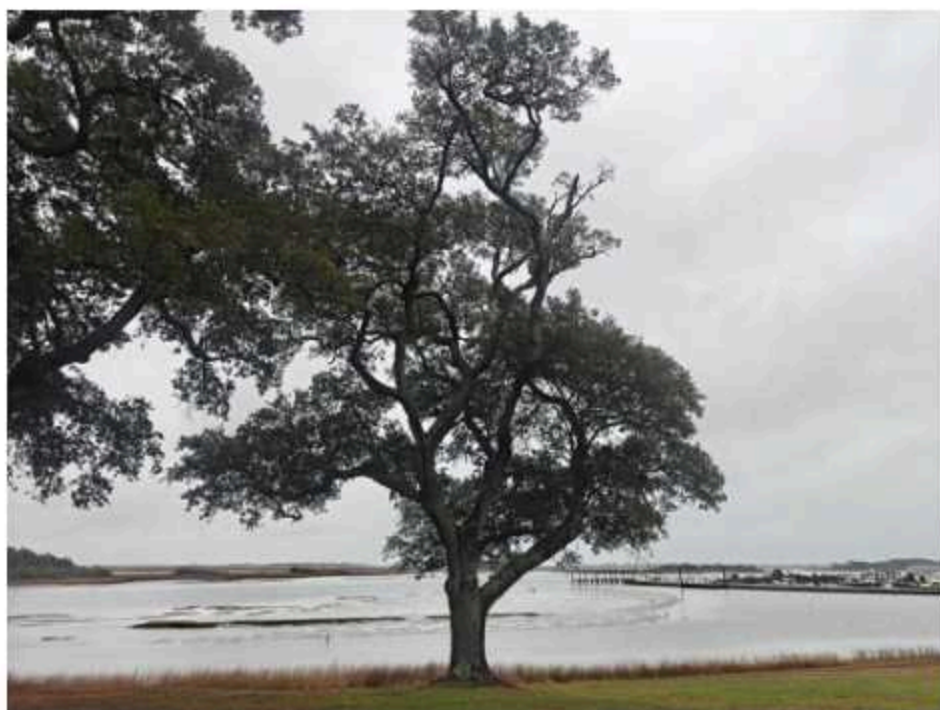
Tree #6: southern live oak (*Quercus virginiana*) 40" DBH.

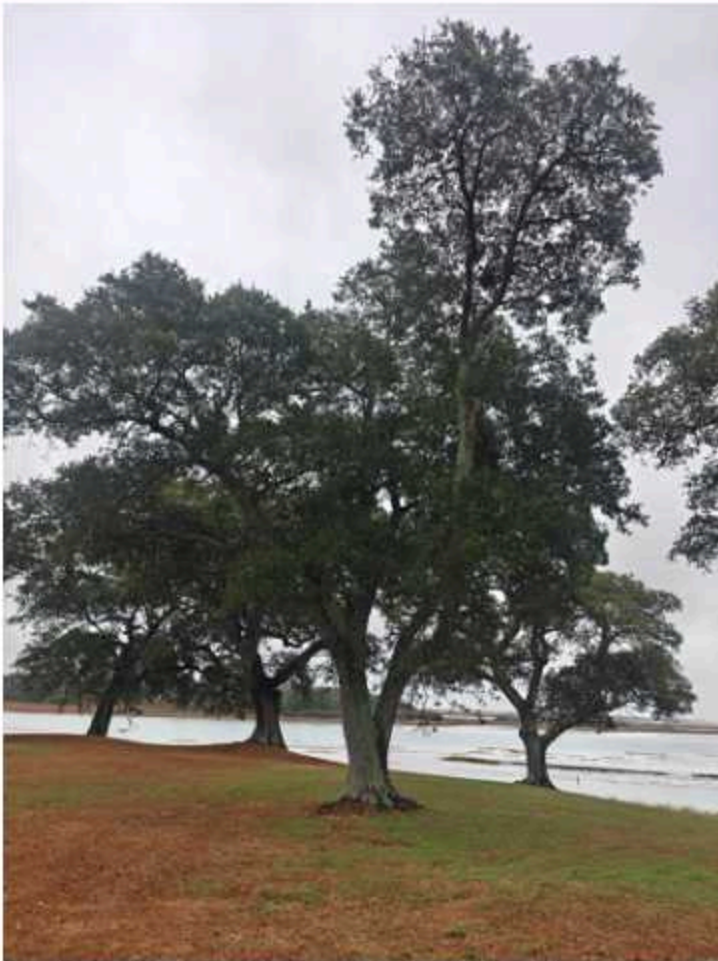
Tree #7: southern live oak (*Quercus virginiana*) 34" DBH.
This tree has a co-dominant structure, two trunks that diverge at approximately 6 feet above grade.

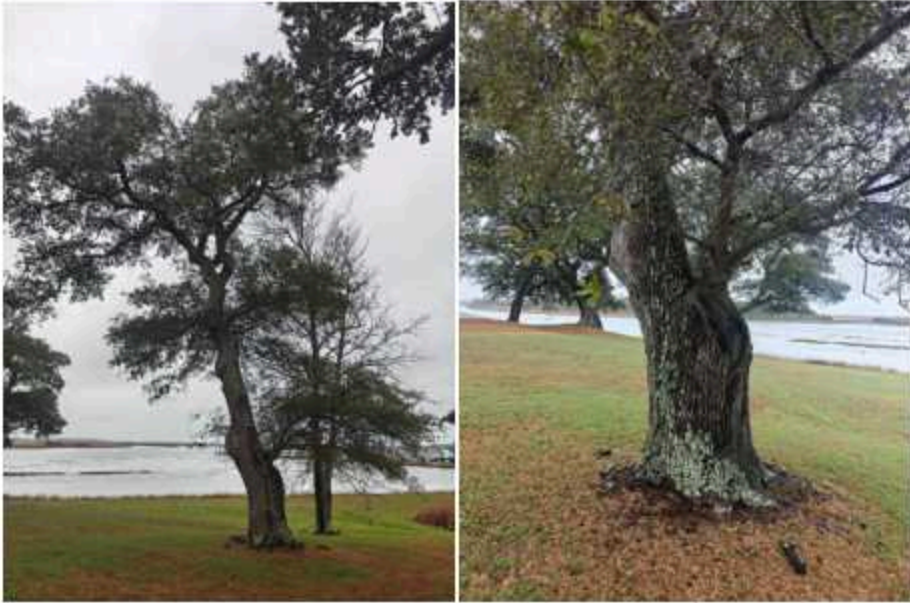
Tree #8: southern live oak (*Quercus virginiana*) 40" DBH.

This tree used to have a co-dominant structure, with two trunks diverging at approximately 6 feet above grade. One trunk was lost long ago, and an appropriate pruning cut was made, leaving this tree with the best possible chance of survival.

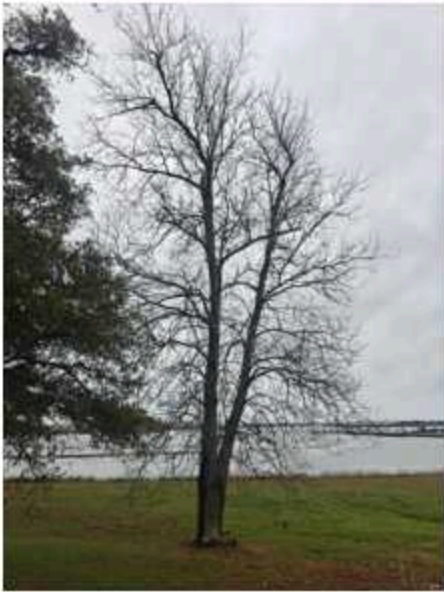
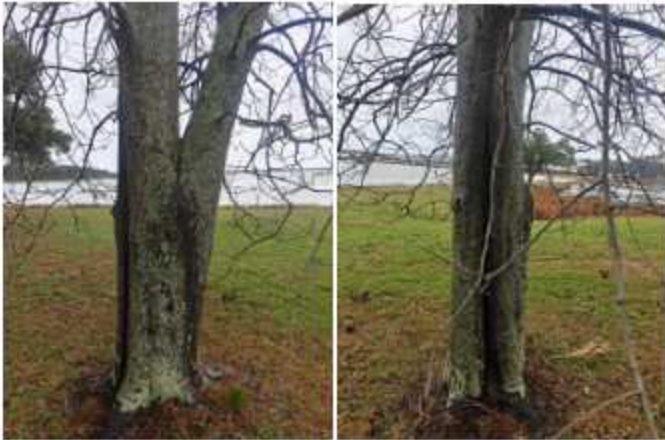
Tree #9: pignut hickory (*Carya glabra*) 26" DBH.

This hickory has a co-dominant structure, with two trunks diverging at approximately 6 feet above grade. The trunks are very close together, with included bark indicating a weak connection between them. There is also a deep cavity running at least 6 feet up the northern trunk. This tree is vulnerable to splitting, or breaking and falling, in a storm of even moderate magnitude. However, since there are no nearby targets of concern, it does not qualify as hazardous at this time.
