Property Inspection Report

Report Number: 2967

106 Dukes Lake Circle
Richlands, North Carolina 28574

Date of Inspection: Thursday, March 6, 2025

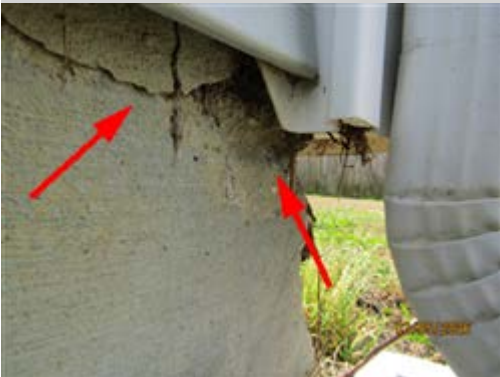
(A1 - 1.2) All Accessible Areas

The concrete slab foundation is damaged on the back left corner of the home. Further evaluation and repair by a masonry contractor is recommended to ensure no other concerns are present.

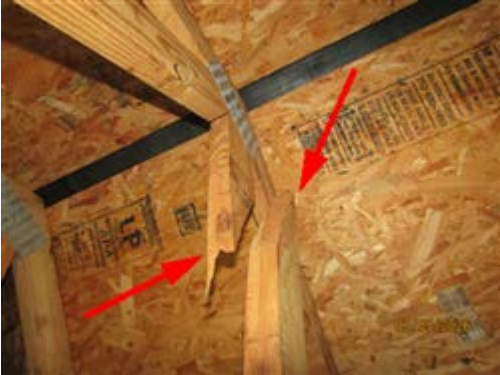
(A6 - 1.1) All Accessible Areas
--

From the attic, where visible, one truss was noted to be damaged/cracked and in need of repair. Since trusses are considered engineered systems, any modification or repair must be outlined by an engineer or licensed general contractor. An engineer or licensed general contractor should be consulted for further evaluation to determine the significance of the concern, outline necessary repairs to prevent any further damage.

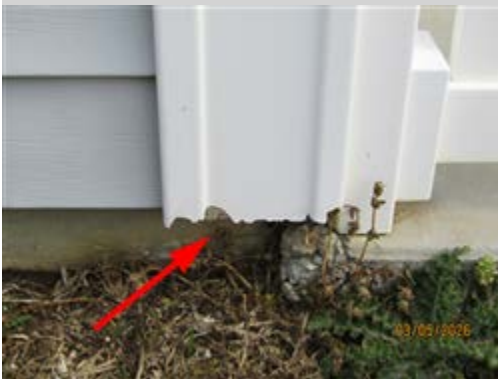
(B1 - 1.2) Main House: All Accessible Areas

The vinyl corner trim was noted to be damaged in several locations around the home. A siding installation company or general contractor should be consulted to evaluate and repair the siding to ensure the integrity of the cladding system.

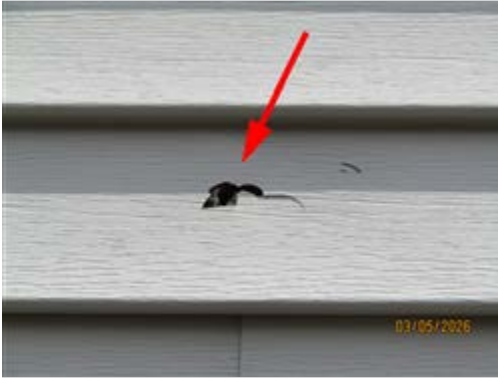
On the left side of the home, several damaged or cracked pieces of siding are in need of repair or replacement. A siding installation company or general contractor should be consulted to evaluate and repair the siding to ensure the integrity of the cladding system.

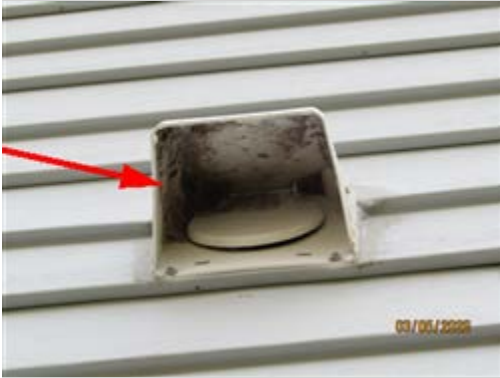
The rear exit for the dryer exhaust has lint build up present. This can result in improper operation of the dryer, overheating of the dryer, and a fire hazard. A qualified contractor should be consulted for a complete evaluation of the duct system and to make necessary repairs to ensure reliable and safe operation.

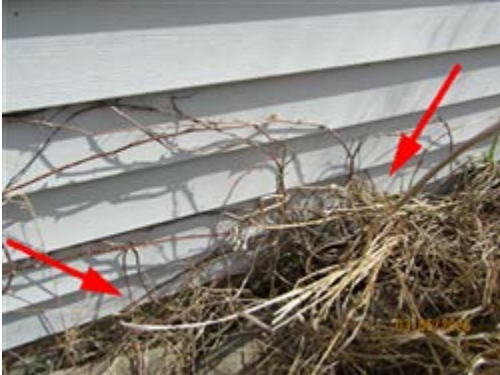
The exterior siding of the home is too close to the grade and needs repair to prevent insect and water penetration. A general contractor should be consulted for a complete evaluation of the siding and to make necessary repairs. At the time of the repair, all adjacent building components should be inspected for possible evidence of water penetration and hidden damage.

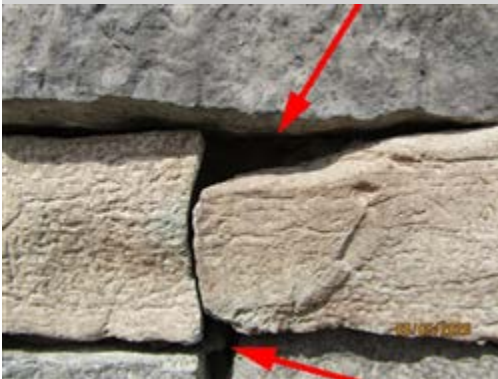
Adhered manufactured stone veneer cladding has been installed on this home. Several areas were noted to be missing mortar. The installation of the stone cladding should be evaluated by a general contractor and repaired as needed to verify that the stone cladding is installed to the specific installation requirements of the North Carolina State Building Code: Residential Code and/or the Masonry Veneer Manufacturer's Association (MVMA). <http://www.masonryveneer.org> -Please note that because the water resistive barrier, metal lath, and base coat(s) of cement stucco are completely concealed behind the adhered masonry stone veneer cladding, they cannot be evaluated by a visual inspection.

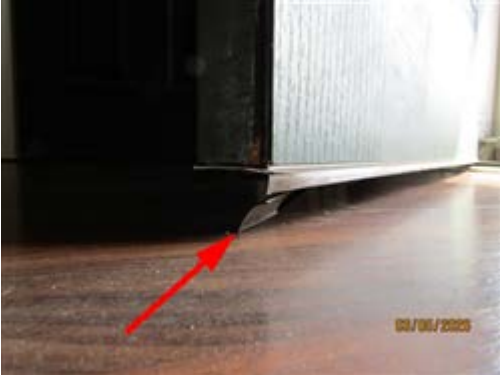
The front door weather-stripping and bottom seal are damaged and not affective in areas. The weather-stripping and bottom seal need repair to ensure that the door closes securely and is weather tight. A qualified contractor should be consulted for evaluation and repair.

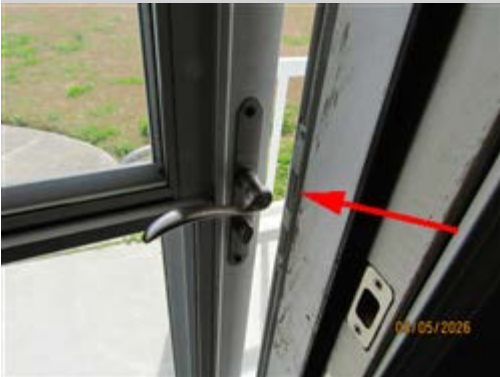
The front storm door does not close or secure as intended. Further evaluation and repair by a qualified contractor is advised to ensure proper function.

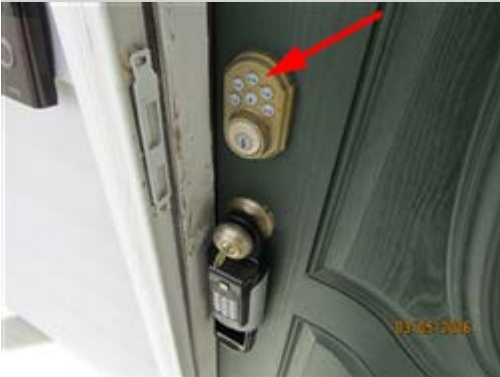
The front door electronic lock assembly does not function properly. Further evaluation and repair by a qualified contractor is advised to ensure proper function.

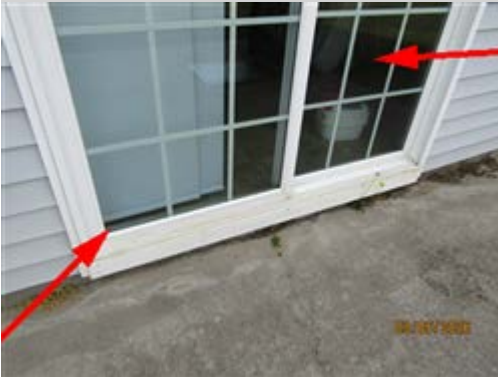
The back door does not have a sliding screen panel present. The sliding glass door was also noted to be scratched and/or scuffed up in multiple locations. Further evaluation and repair by a qualified contractor is recommended.

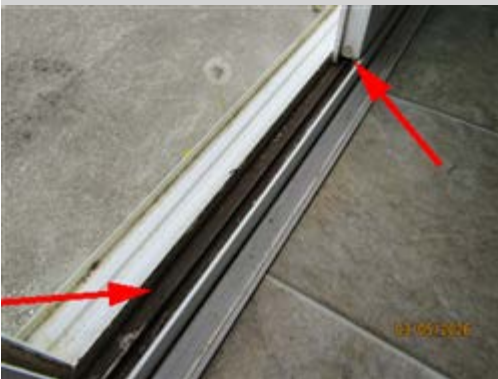
The rear sliding glass door was more difficult to operate than would be expected. The track is rusted and the panel roller ball assembly needs adjustment/repair. A general contractor should be consulted for further evaluation and repair to ensure proper operation and safe egress.

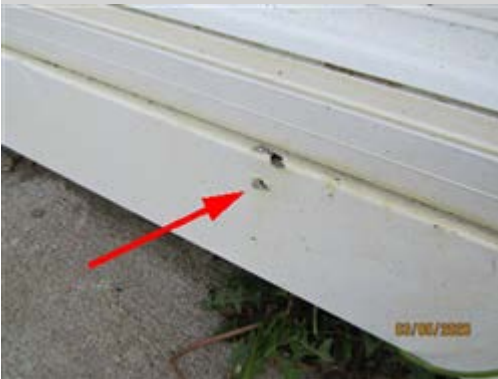
The nails for the aluminum cladding covering the back door wood trim were noted to be loose or backed out. If the cladding is not properly installed it will not shed water away from the underlying wood trim resulting in water penetration and decay. A siding installation company or general contractor should be consulted to evaluate and repair the trim to ensure the integrity of the cladding system.

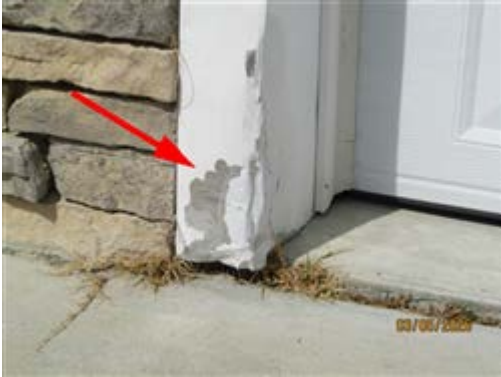
The aluminum cladding covering the garage door wood trim was damaged in several locations. If the cladding is damaged it will not shed water away from the underlying wood trim resulting in water penetration and decay. A siding installation company or general contractor should be consulted to evaluate and repair the trim to ensure the integrity of the cladding system.

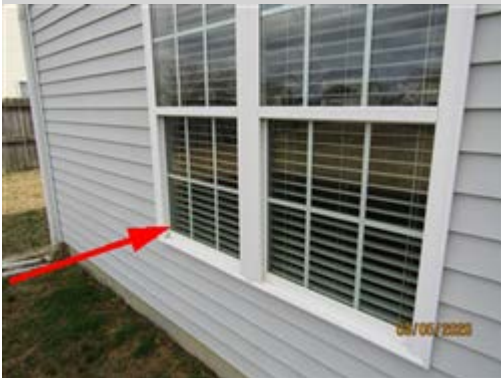
The window screens were noted to be damaged and/or missing in several locations around the home. Further evaluation and repair by a qualified contractor is recommended.

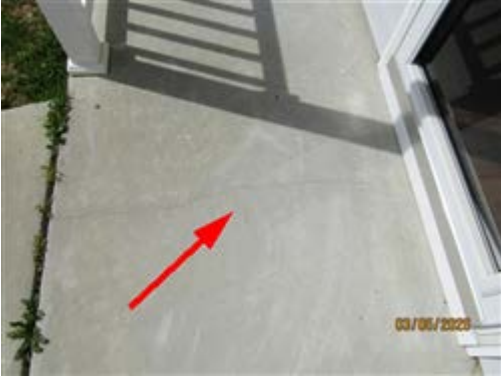
The front porch floor pad is cracked due to the natural shrinkage that occurs when concrete cools after it heats up and expands as it cures. The pad surface was even and no evidence of differential movement was noted. A general repair person should be consulted to seal the cracks to prevent water penetration.

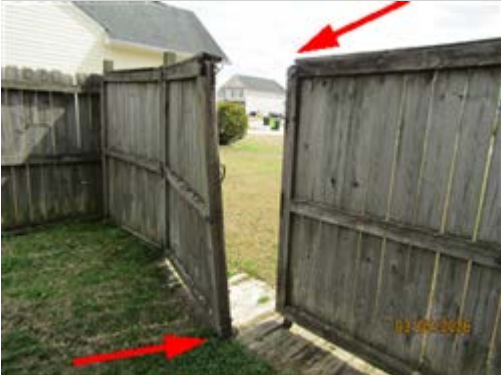
The right side backyard wood fence gate assembly is damaged and does not open and close as intended. Further evaluation and repair by a qualified contractor is advised to ensure proper function.

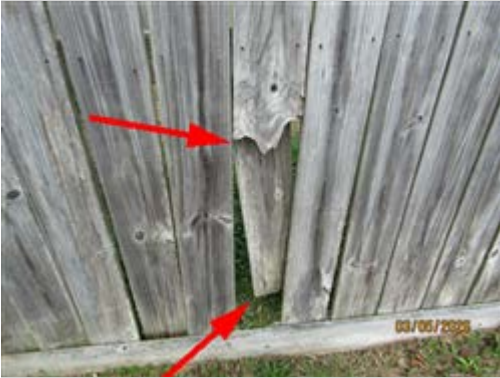
The backyard wood fence panels and pickets were noted to be damaged and/or leaning in numerous locations. Overall the wood fence is in poor condition. Further evaluation and repair/replacement by a qualified contractor is recommended.

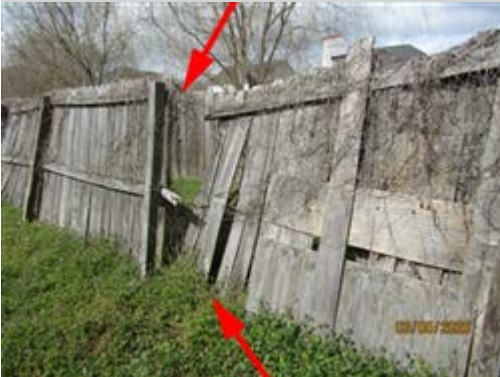
The backyard wood fence panels and pickets were noted to be damaged and/or leaning in numerous locations. Overall the wood fence is in poor condition. Further evaluation and repair/replacement by a qualified contractor is recommended.

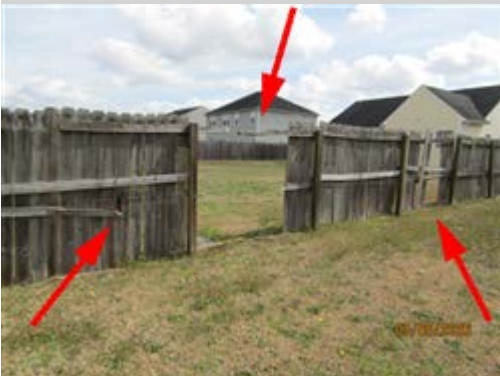
The backyard wood fence panels and pickets were noted to be damaged and/or missing in multiple locations. Overall the wood fence is in poor condition. Further evaluation and repair/replacement by a qualified contractor is recommended.

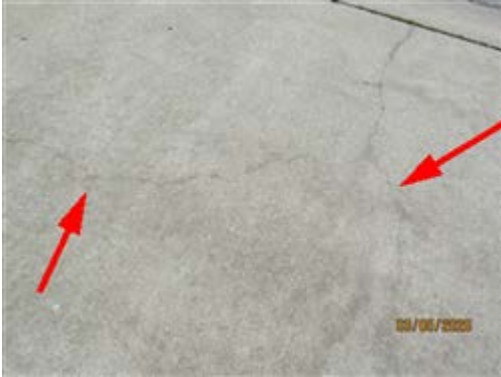
The driveway is cracked in several locations. The cracked sections of the driveway has created a path for water penetration under the driveway slab and could pose a trip or fall hazard. A masonry or general contractor should be consulted for further evaluation and repair.

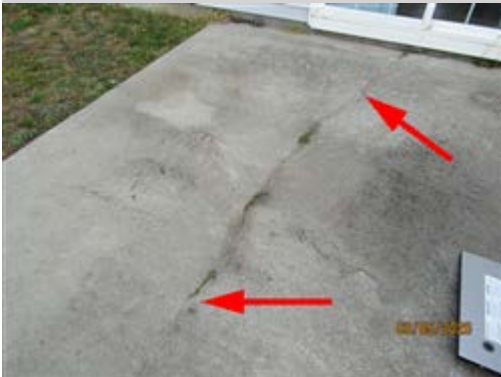
The back patio concrete pad is cracked in several locations. The cracked sections of the driveway has created a path for water penetration under the patio slab and could pose a trip or fall hazard. A masonry or general contractor should be consulted for further evaluation and repair.

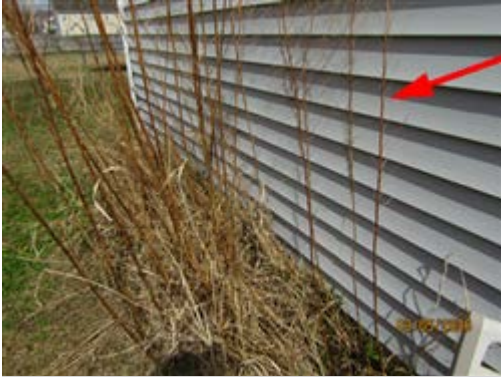
The vegetation around the perimeter of the home is over grown and touching the exterior. The growth also limited the inspection access in areas. A landscaping company should be consulted to correct the over growth and the inspection should be completed prior to purchase.

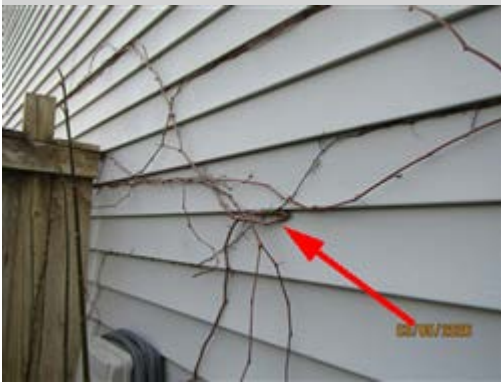
The exterior of the home is covered with ivy or other type of vine in areas. The presence of the vines limits the inspection. Vine roots can penetrate and damage siding materials. The condition of the wall cladding behind the siding needs further evaluation. A general contractor should be consulted for further evaluation to determine the extent of the concern.

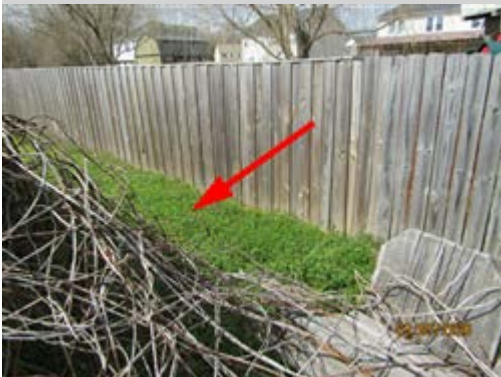
A drainage area was noted on the back side of the property. It is recommended that the buyer request disclosure related to the frequency and volume of water that has been noted to drain to or from this area, the liability for maintenance of the drain area, and survey placement of the lot related to flood zones.

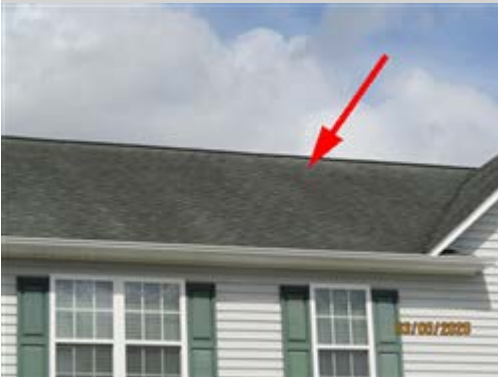
The roof surface is streaked with gray/black blotches typical of algae. Algae typically do not damage the roof covering but can indicate elevated moisture and or limited ventilation. A roofing contractor should be consulted for a complete evaluation of the roof covering to determine the source of the discoloration and if repairs/cleaning is needed.

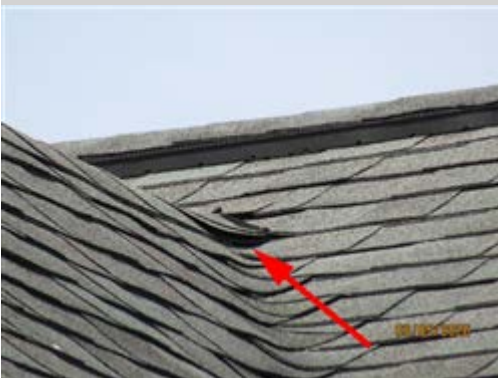
A slightly raised shingle on the front-right ridge area of the roof surface is in need of repair. Raised shingles are more susceptible to storms and high wind events. A roofing contractor should be consulted for a complete evaluation and repair to ensure the weathertightness of the roof covering system.

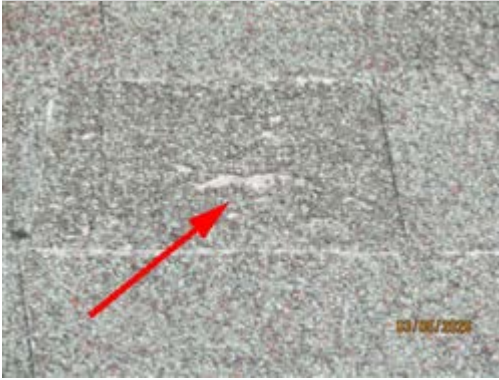
The shingles have visible signs of aging such as low ballast, and exposed base matt. A roofing contractor should be consulted for a complete evaluation of the roof covering and flashings system to make necessary repairs to ensure the weathertightness of the roof covering system. At the time of the repair, the roofer may be able to answer questions related to the life expectancy of the roof covering system.

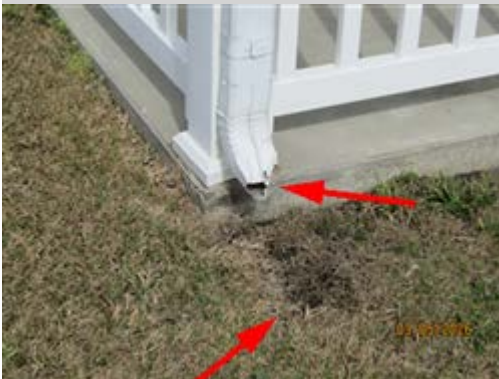
Some of the gutter downspouts are damaged and not extended or piped to direct roof drainage away from the foundation. Direct drainage to the foundation from the gutter system can result in water penetration into the foundation area and foundation deterioration. A general contractor should be consulted for a complete evaluation and to make necessary repairs.

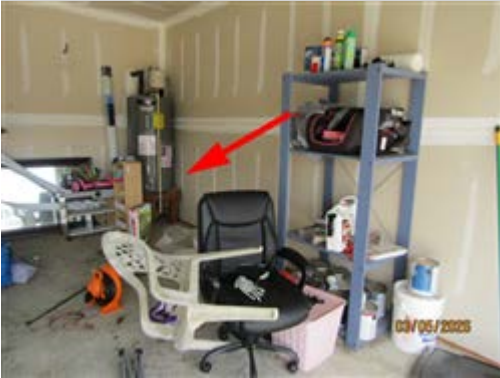
The water heater is located in the garage. Appliances that are pressurized should be protected from impact when installed in a garage. It is recommended that a qualified contractor be consulted to install a bollard to protect the unit from a potential automobile impact.

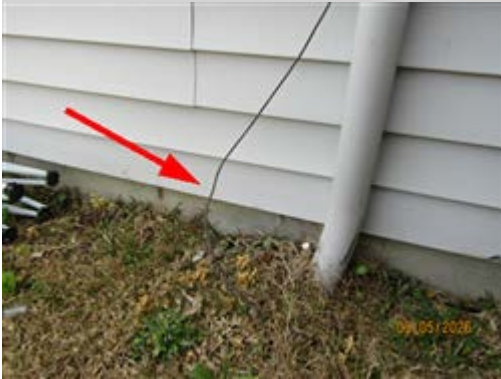
The electrical system ground connection is not secured to the side of the home properly. An electrical contractor should be consulted for repair of the ground system to ensure safe, proper service.

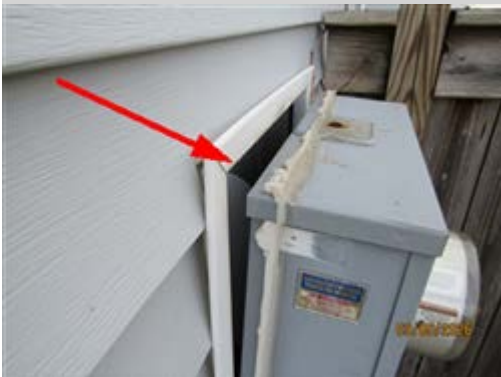
The electrical service panel and meter is not secure where it is attached to the wall of the home. This condition presents a safety hazard that could result in serious personal injury and or property damage. A licensed electrical contractor and/or the utilities provider should be consulted for repair and a complete evaluation of the panel to ensure that it is safe and functioning properly.

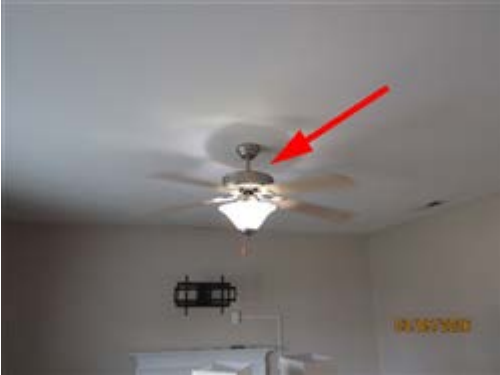
The family room area ceiling fan is off balance, fans need to be balanced and secure to operate safely. The light receptacle box needs to be verified to be rated for fan installation. An electrical contractor should be consulted for a complete evaluation to determine the significance of this concern, make necessary repairs to correct defects and prevent safety hazards.

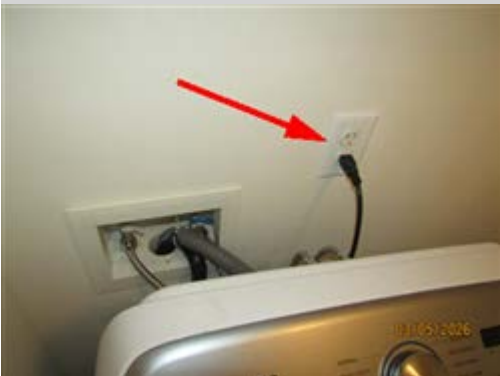
The laundry area receptacle is not GFCI protected. Receptacles located in potentially wet locations should be GFCI protected to reduce shock risks. An electrical contractor should be consulted for further evaluation and repair.

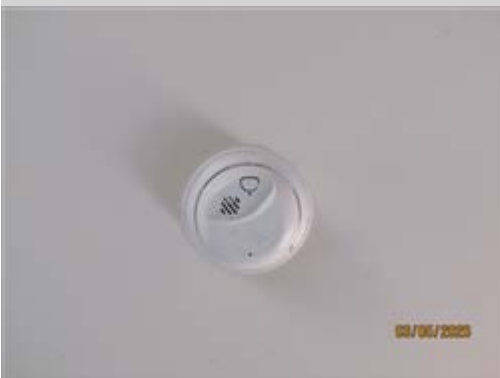
As part of our standard of practice, the inspector must report the absence or presence of a permanently installed carbon monoxide detector in all homes with garages or fueled appliances. Please note that your report reflects the absence of a carbon monoxide detector. All homes with gas appliances, garages, or fireplace should have a carbon monoxide detector as protection to prevent possible carbon monoxide poisoning. It is advised that a qualified contractor install new smoke alarms and carbon monoxide detectors prior to moving into the home to ensure a safe environment.

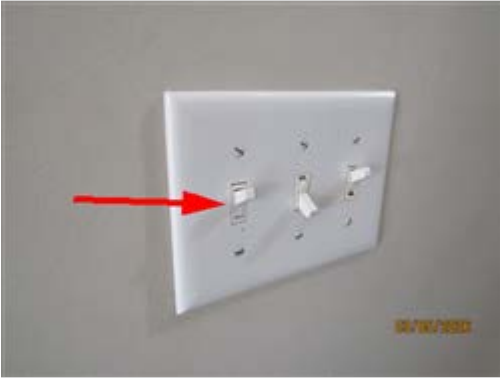
The noted light switch used to control the family room area ceiling fan was broken and did not operate correctly. An electrical contractor should be consulted for a complete evaluation to determine the significance of this concern, make necessary repairs to correct defects and prevent safety hazards.

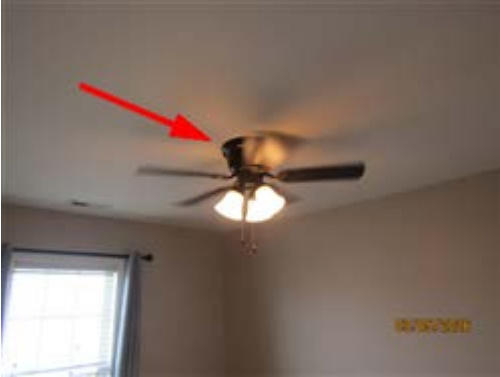
The rear bedroom area ceiling fan is off balance, fans need to be balanced and secure to operate safely. The light receptacle box needs to be verified to be rated for fan installation. An electrical contractor should be consulted for a complete evaluation to determine the significance of this concern, make necessary repairs to correct defects and prevent safety hazards.

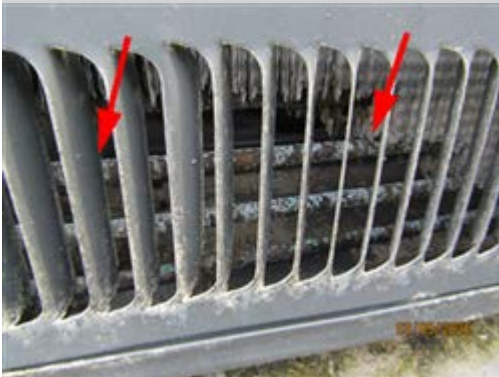
The outside compressor/coil unit for the heat pump system has visible damage to the coil fins. The fins are deteriorated and missing in multiple areas. A damaged coil can result in leaking refrigerant and poor system performance. A licensed HVAC contractor should be consulted for a complete evaluation and repair of the system to ensure reliable and proper operation of the HVAC system.

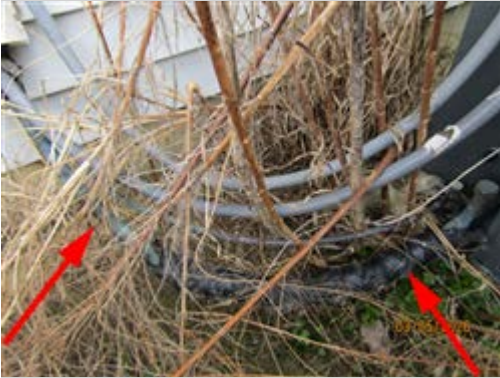
The large line of the AC refrigerant line set that connects the outside compressor unit to the interior air handler is required to be insulated to reduce condensation and associated water damage. The AC line insulation is missing/damaged in areas. A HVAC contractor should be consulted for a complete evaluation and repair of the system to ensure reliable and proper operation of the HVAC system.

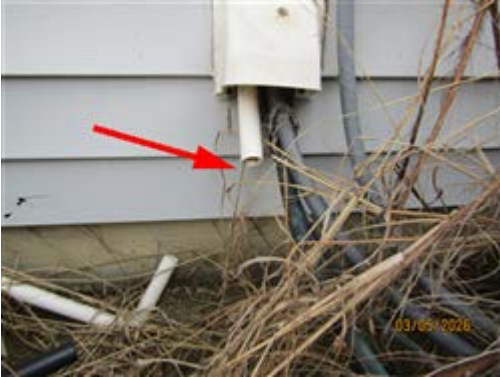
The drain for the AC condensate water should exit away from the foundation area of the home. A HVAC contractor should be consulted for a complete evaluation of the condensation drainage system and to make necessary repairs to ensure that the condensate water exits away from the home and foundation.

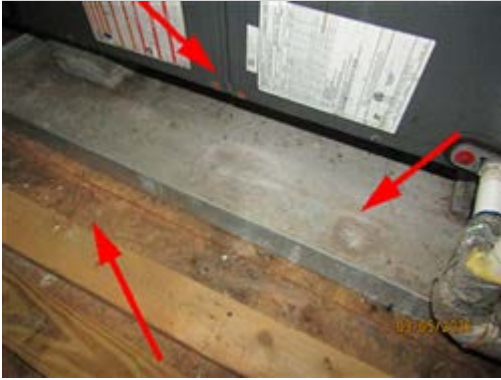
The duct system, pan and service floor around the air handler cabinet shows evidence of a history of condensation. Condensation occurs when the duct surfaces reach the dew point of the surrounding air; this can be related to duct air leaks, excessive demand on the HVAC system, and/or improper HVAC system operation. A licensed HVAC contractor should be consulted for a complete evaluation of the HVAC system to ensure reliable and proper operation of the HVAC system.

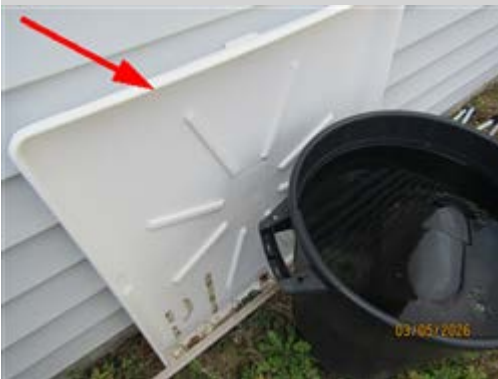
The laundry area for this home is on the second floor. Although not required in all municipalities, a washing machine pan should be in place in case of leaks and/or improper function. The pan noted was on the right side of the home at the time of inspection. Further evaluation and installation of the washing machine pan by a qualified contractor is advised.

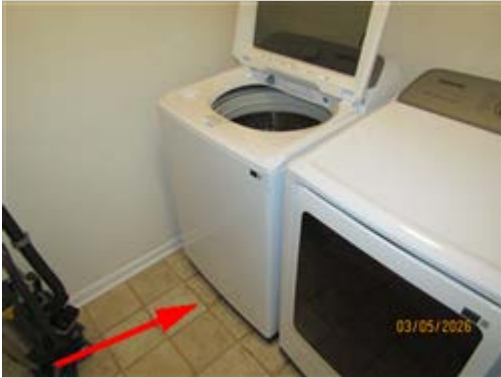
The laundry area for this home is on the second floor. Although not required in all municipalities, a washing machine pan should be in place in case of leaks and/or improper function. The pan noted was on the right side of the home at the time of inspection. Further evaluation and installation of the washing machine pan by a qualified contractor is advised.

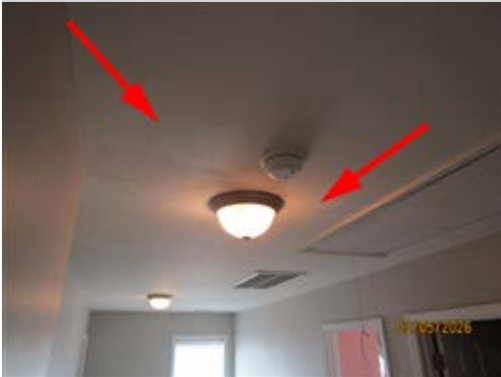
Evidence suggests that the upstairs ceiling has been attempted to be repaired/painted in areas. The seller should be asked for disclosure related to the extent of any related repairs, leaks or problems and the reason the ceiling was painted. New paint can limit the inspection as all history of defects or concerns are not visible.

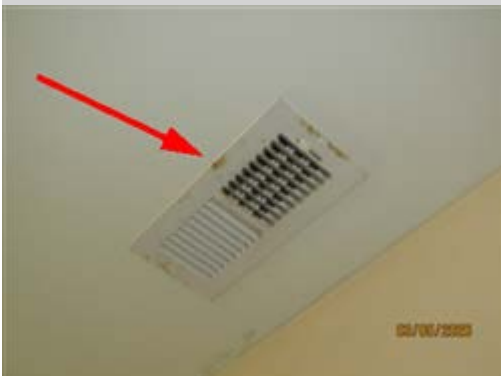
Some of the HVAC registers were rusted and stains suggests a history of condensation. This could indicate improper HVAC system operation, restricted air flow, air leaks and or poor insulation. A HVAC contractor should be consulted for a complete evaluation to determine the cause of the condensation and if related damage is present.

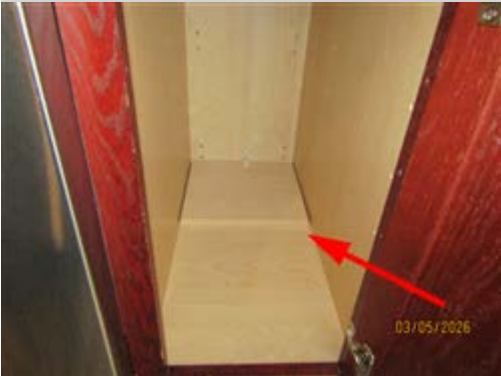
The shelves for the kitchen cabinets were noted in stalled in areas. Further evaluation and repair by a qualified contractor is recommended.

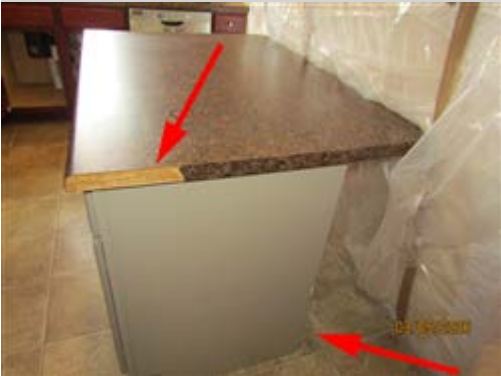
The kitchen island counter top is damaged in several locations. The island cabinet base is also not secured to the floor properly. Further evaluation and repair by a qualified contractor is recommended.
