Home Inspection Report

117 Noyes Ave, Morehead City , NC 28512

Wednesday July 16, 2025

288

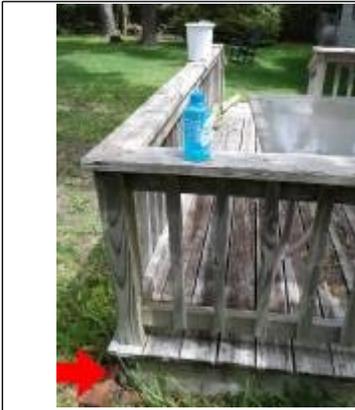
Support lumber is ground contact I recommend monitoring this for further decay in the future.

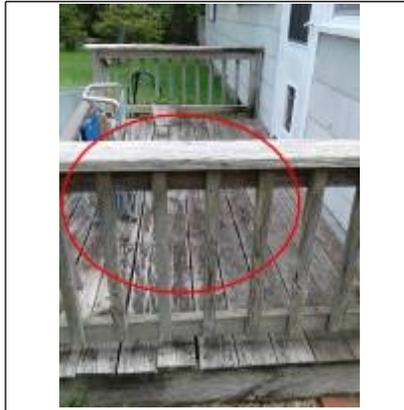
Flooring boards have a degree of decay. I recommend a handyman add a few nails or screws in places to make sure they are stable. I recommend monitoring this for further decay.

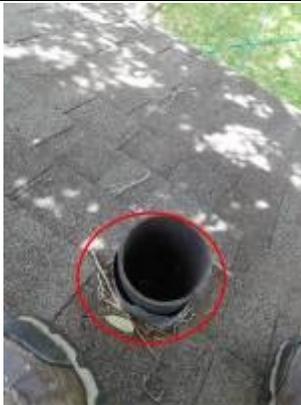
This is the second decayed wit a lead boot decayed. I recommend installing a new rubber boot or seal with flashing cement.

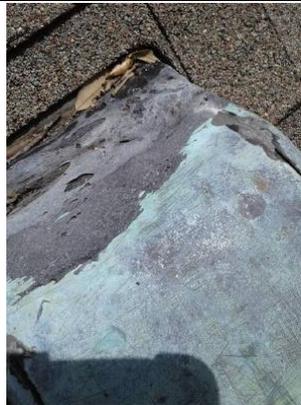
Check this exhaust vent also.

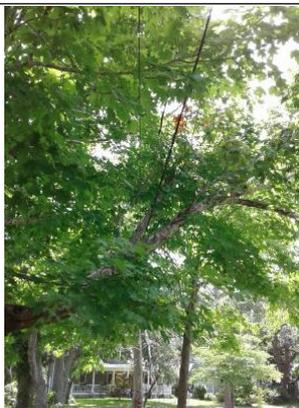
Electric service wiring is through these trees. I recommend a qualified tree expert trim to prevent outages in storms.

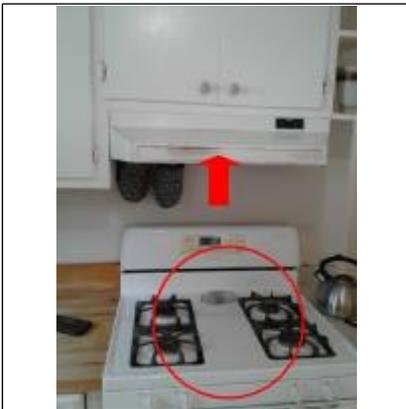
Circle shows burners that don't always ignite from automatic ignition. There is a grill lighter present. I recommend a qualified gas/ plumber stove appliance man. Evaluate and make repairs as needed. Arrow shows the light doesn't work. I recommend a handyman check the bulb first.

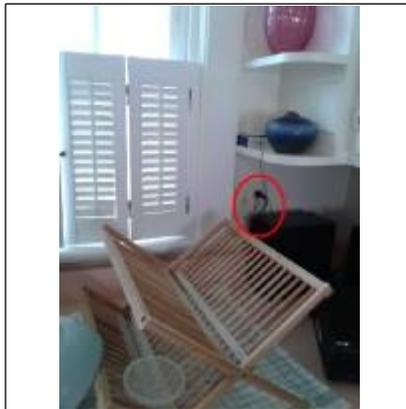
Receptacles within 6 feet of the sink are not GFCI protected. I recommend they be upgraded to meet current safety standards.

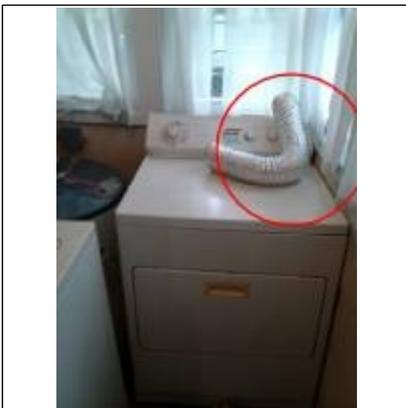
Vent hose doesn't go outside. I recommend a handyman create a opening of the exterior.

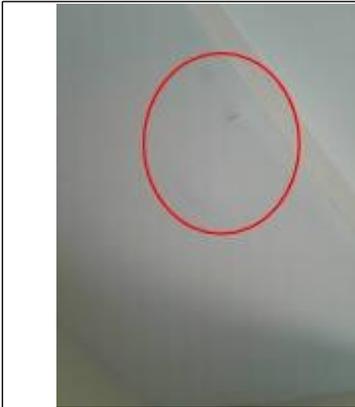
This is a small blemish of peeling paint. I recommend a handyman a handyman touch up as needed.

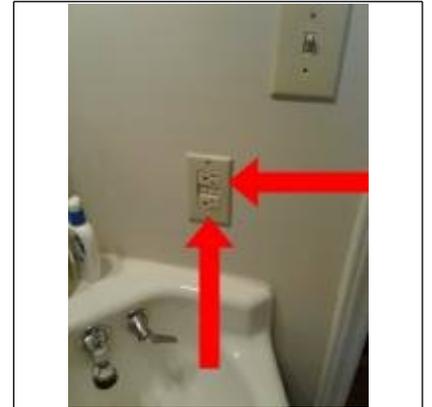
This left arrow receptacle trips the GFCI working properly. THE up arrow bottom half does not trip the circuit. I recommend a handyman evaluate and repair as for current safety standards.

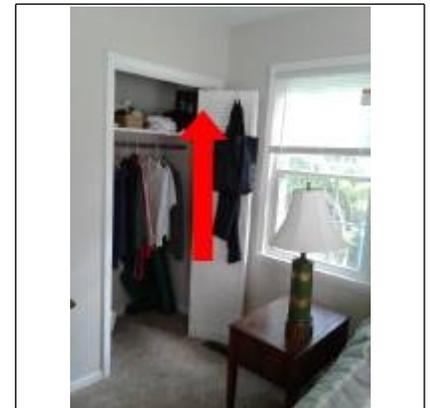
This door needs to be adjusted to run in the track properly. I recommend a handyman evaluate and repair as needed for proper function.

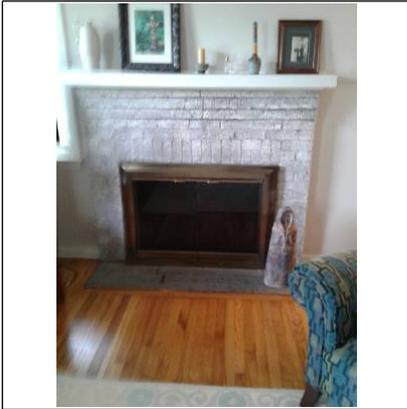
Comments Damper is missing. I recommend a mason evaluate and repair as needed.

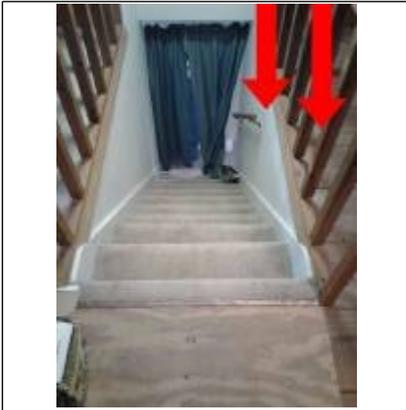
I recommend evaluation of this handrail. I recommend it reaches from top of the staircase to the bottom with returns to meet current safety standards.

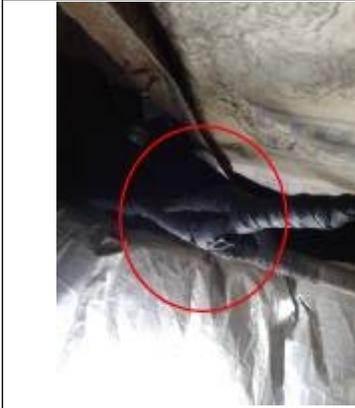
This is a wiring junction. I recommend a qualified electrician evaluate and repair as needed for proper use and safety reasons. It should be inside a mounted electrical box.

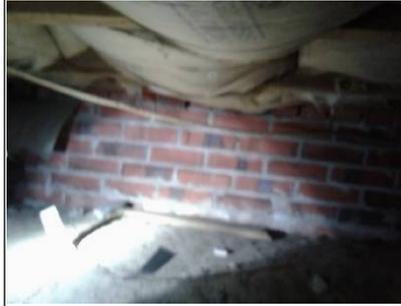
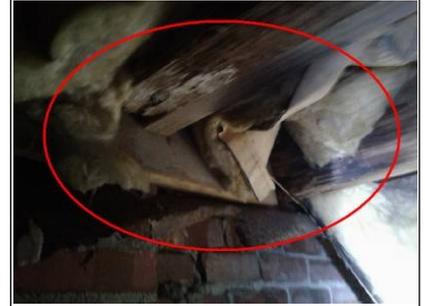
Example of decay at the chimney. I believe this area is directly below the crack i pointed out on the roof section at chimney and house juncture.

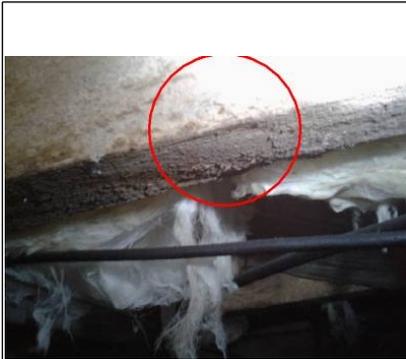
Example of moisture decay. Floor joists had at least 30 percent humidity and in places over 60 percent.

No HVAC on second floor.
Humidity in the CRAWLSPACE. I saw some joists and girders repaired or replaced from moisture damage.
I highly recommend closing all vents to keep humidity out and install a vapor barrier and DEHUMIDIFIER at least. Vapor barrier may be difficult to install.

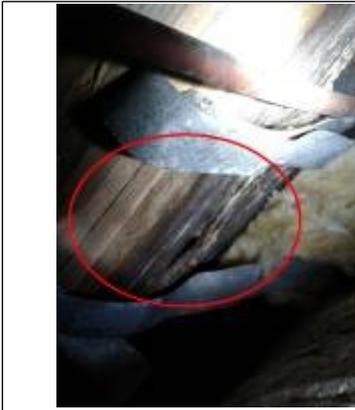
Darker right hand side is the result of moisture decay. Anytime moisture content is over 20 percent in lumber the potential for microbial decay can occur. This was probably repaired years ago.

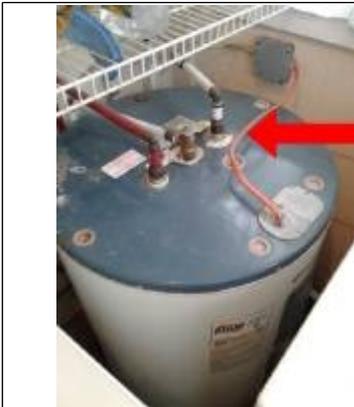
I recommend this 220 volt wire be covered by conduit. To meet safety standards in a actively used area.

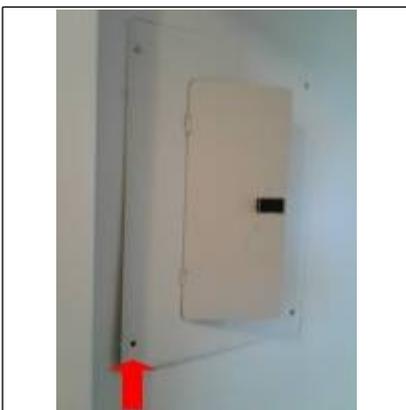
There is one screw missing here. I recommend adding it from hardware store?

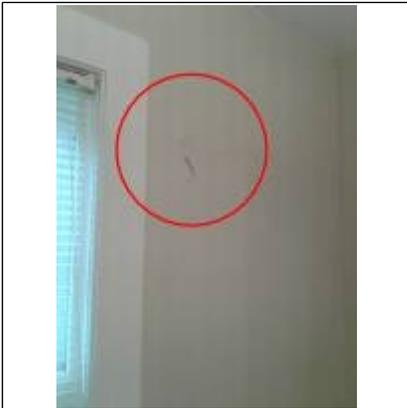
Paint is peeling here. I recommend a handyman evaluate and repair as needed for proper function.

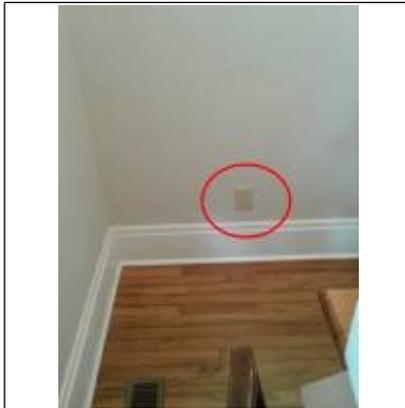
This is showing open neutral. I recommend a qualified handyman or electrician evaluate and repair as needed for proper function. Not working.
