Ambassador Inspections
Robert Smith
Ambassadorinspections1@outlook.com
919.339.5633
PO Box 337
Bunn, NC 27508

03-04-2025 13:29:54	
Street:	235 Poor Rd.
City:	Scotland Neck
State:	NC
Zip Code:	27874
Client Name:	New Villiage LLC & Dwelling Place Properties
Date of Inspection:	2025-03-04
Advertised number of bedrooms as stated in MLS or as stated in attached in sworn statement by owner or owner's representative:	3 Bedrooms
Designed system size or number of bedrooms as stated in available local health department information in gallons per day:	unknown because there is no septic permit.
Inspection shall include any part of the system located more than 5 feet from the primary structure that is part of the operations permit:	yes
Copy of Operations permit from County Environmental Health attached:	no
Issuing County:	N/A
Operations Permit Unavailable:	yes
System requires a certified subsurface water pollution control system operator pursuant to G.S. 90A-44:	no
Current Operator's name:	N/A
Most recent performance, operation and maintenance reports available?:	no

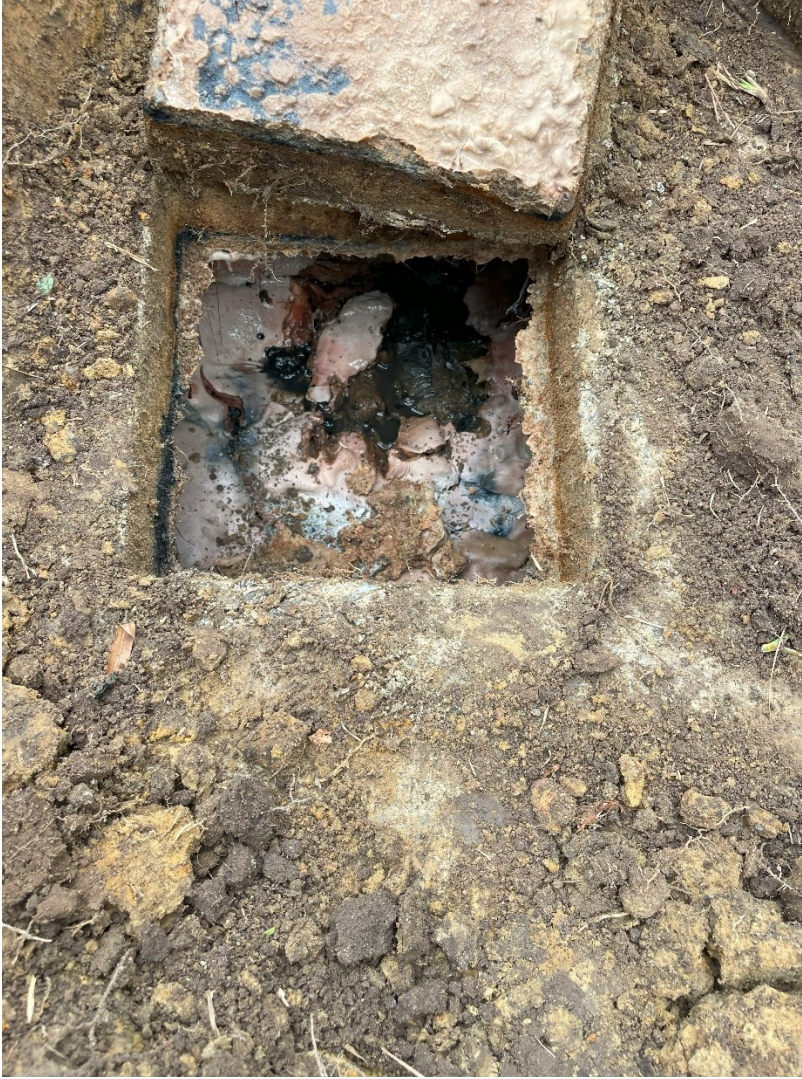
outlet?:	
Water Level Relative to Outlet Description:	Water level is high because the solids are blocking the outlet pipe.
Outlet T present:	yes
Outlet T Description:	Solids are over the outlet pipe, I don't believe the outlet Tee is present.
Outlet filter present:	no
Effluent leaves the outlet:	yes
Effluent Leaves Discription:	Very slow trickle out of the tank because of the solids level would is blocking the outlet pipe.
Roots Present in Tank:	no
Evidence of Tank Leakage:	no
Evidence of Non-permitted Connections:	no
Connection Present From House to Tank:	yes
Connection Present From Tank to Next Component:	yes
Percentage of solids in tank:	45 percent
Unable to locate tank. (System Inspection cannot be completed until tank is located.):	no
Date tank was last pumped:	Unknown.
Pump Tank Present:	no
Distance in feet from house or structure:	n/a
Distance in feet from well or spring (if applicable):	n/a
Distance in feet from water line (if applicable):	n/a

This is the outlet end of the septic tank; It is so full of solids I can't see the inlet pipe or the outlet Tee because they are under the solids in the tank.

*** I do not believe that there is an outlet Tee on this, I was able to stick my probe into the outlet pipe and create a slight opening so water could leave the tank.

Inspector Signature:	
Summary:	<p>1. *** Septic tank needs to be pumped</p>

2. *** The outlet Tee needs to be repaired.
3. *** The distribution box is corroded through and needs to be replaced.
4. *** Two of the three leach lines are not functioning.
5. I did not see any sign of surfacing in the leach field.

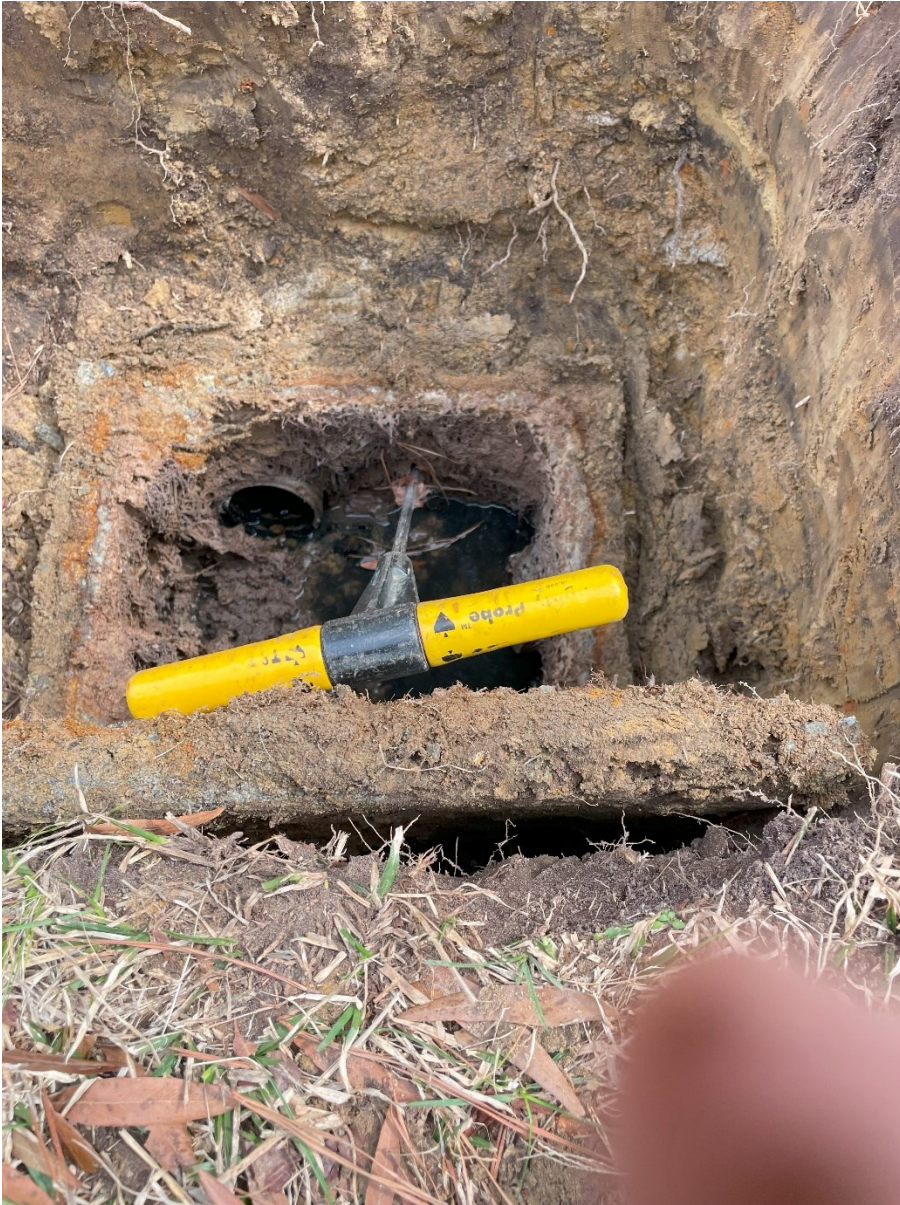
This is a picture of my finger and the distribution box; my finger is good; the distribution box is bad. It needs to be replaced.

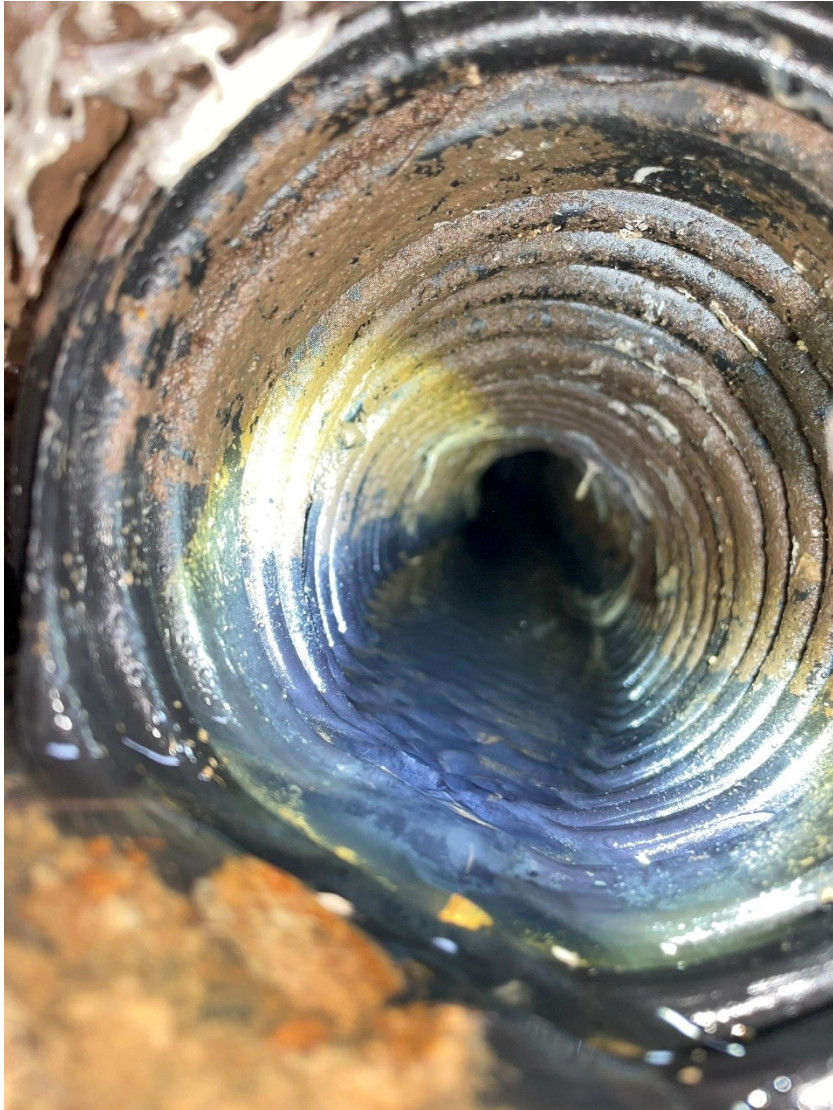
This picture shows water going down the only line that functions.

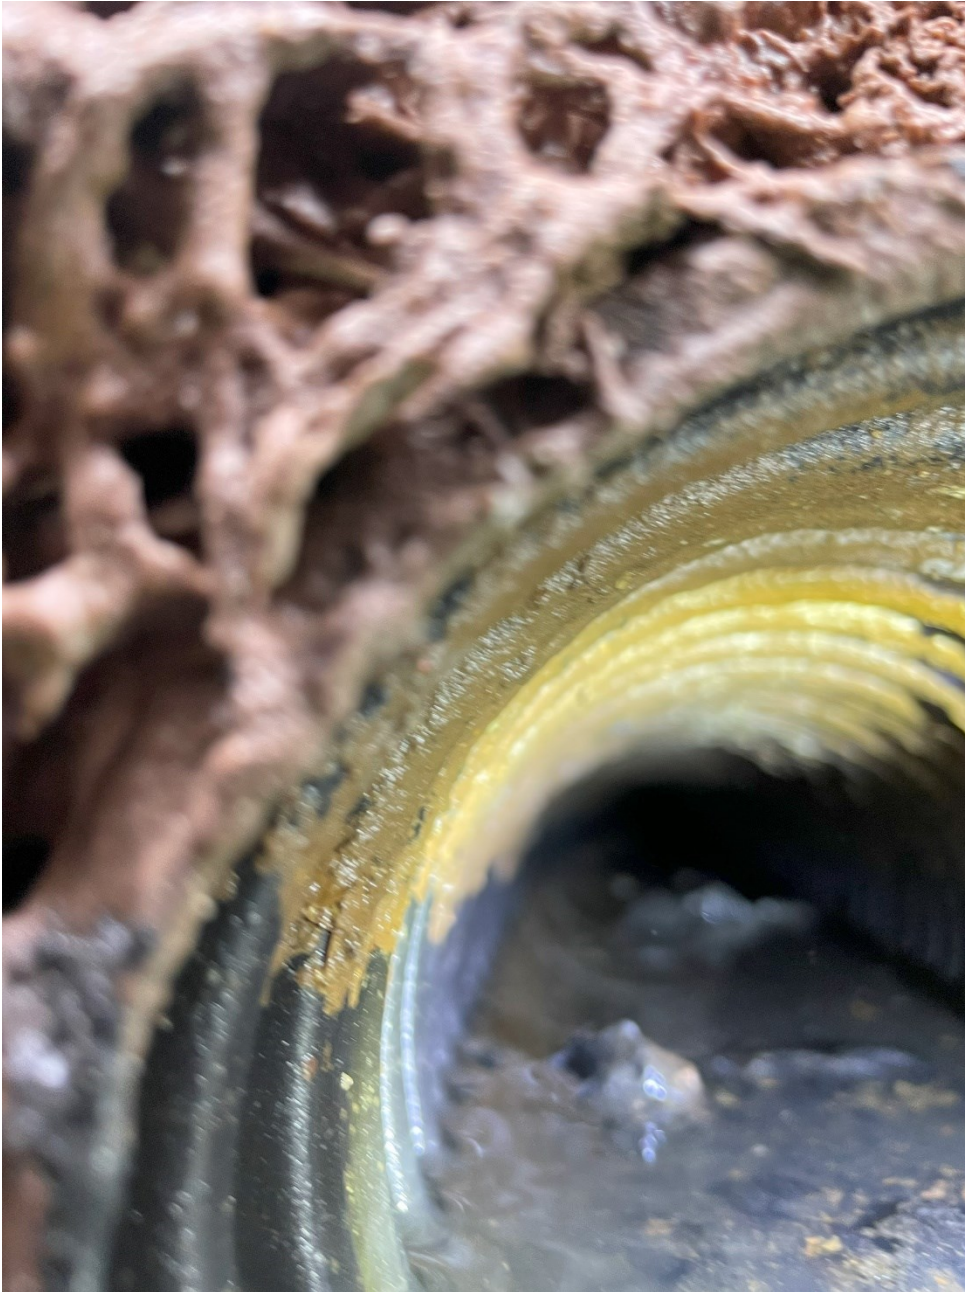
This picture shows that it has a lot of solids in it and the water is not going anywhere, it's just sitting in the pipe. This line does not function.

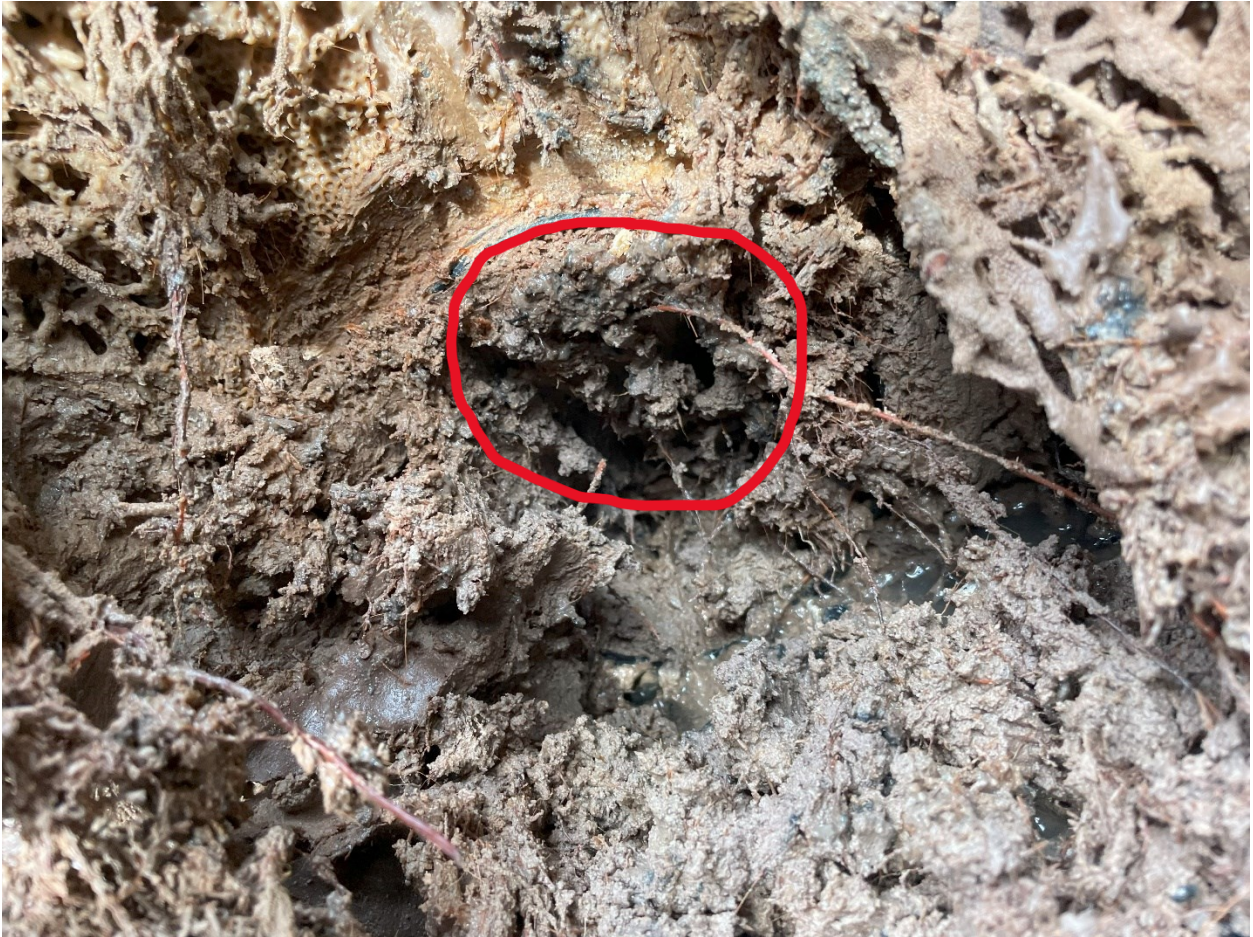
This circle is around the third leach line leaving the distribution box; it is completely full of solids and does not function.

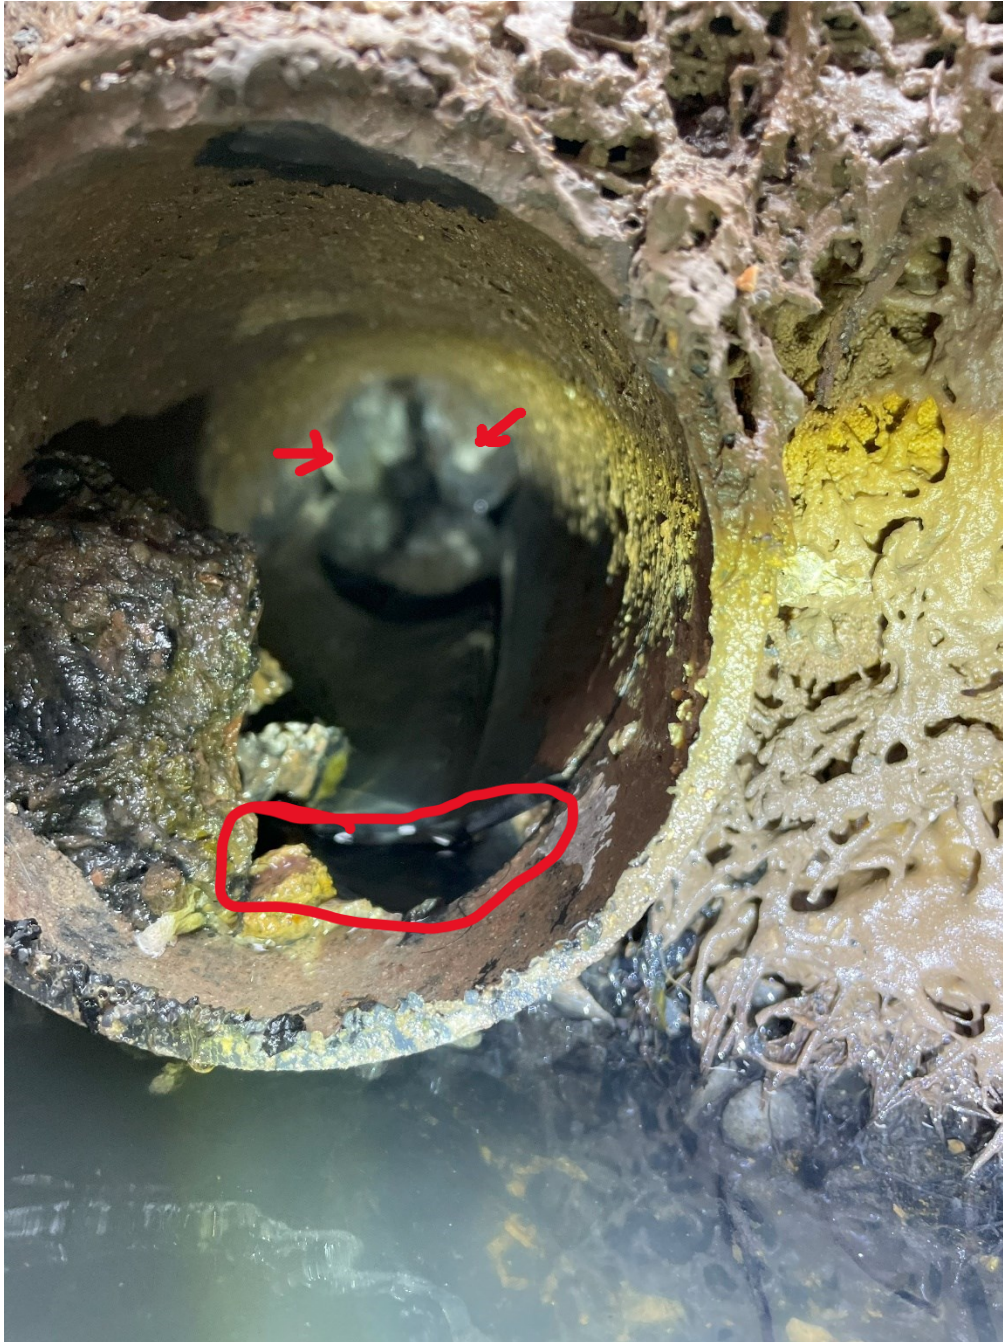
The red is around a hole in the pipe coming into the distribution box from the septic tank.
The red arrows are pointing at the solids inside the septic tank. There is no outlet Tee in place.

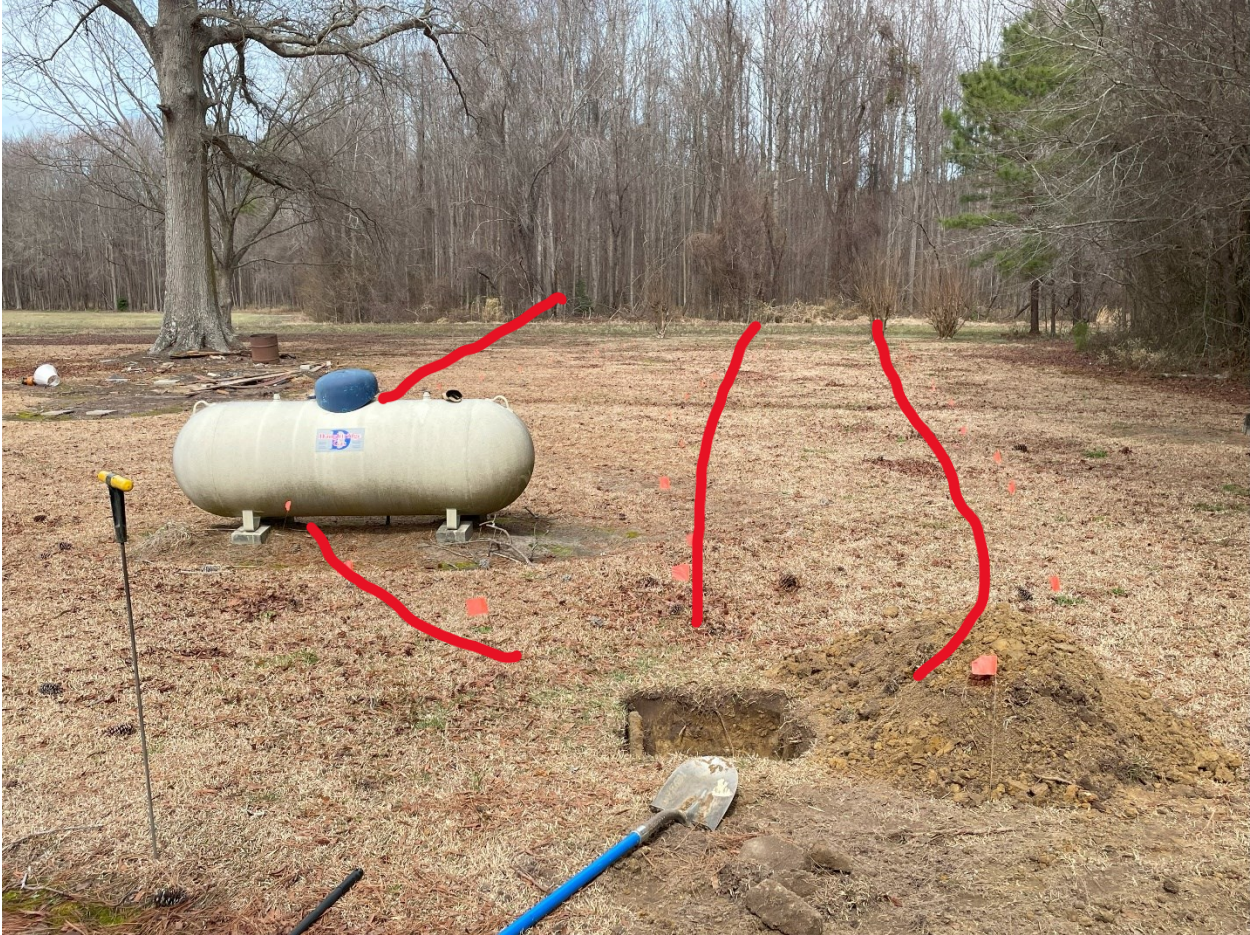
These red lines show where the leach field is. My flags are not showing up very well.
