Property Inspection Report

Report Number: 48-25

235 Poor Rd.
Scotland Neck, North Carolina 27874

Date of Inspection: Sunday, March 16, 2025

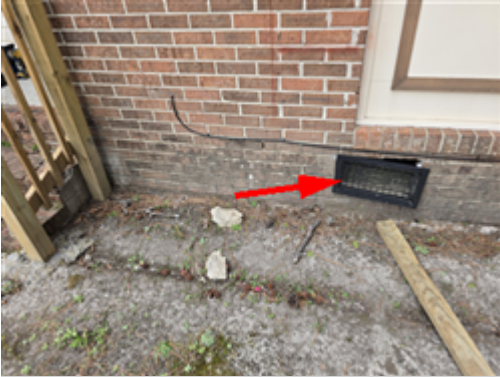
(A1 - 1.1) All Accessible Areas

The foundation vents are loose and damaged and not operating properly all around home. Improper ventilation could result in condensation and elevated moisture levels in building components. A licensed general contractor should be consulted for a complete evaluation of the crawl space to determine the significance of the concern and make necessary repairs. Refer to the foundation section of the report.

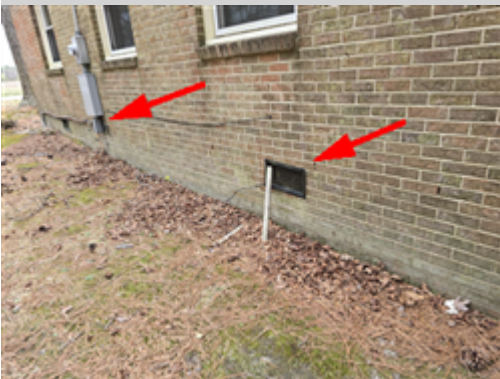
(A1 - 1.2) All Accessible Areas

Additional Photograph: This is a photograph of above noted item 1-1

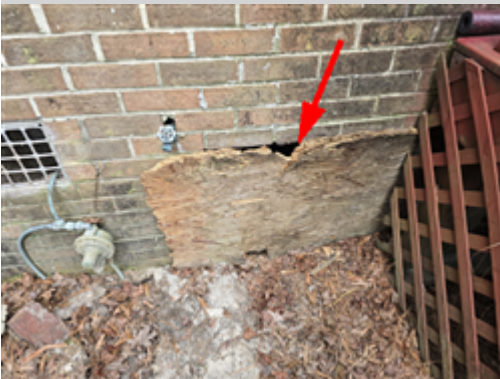
(A1 - 1.3) All Accessible Areas

Moisture damaged rear crawl space access door. The crawl space access door should be repaired to prevent large animals and rain from entering the crawl space area that could cause potential damage to plumbing, electrical, or hvac system components.

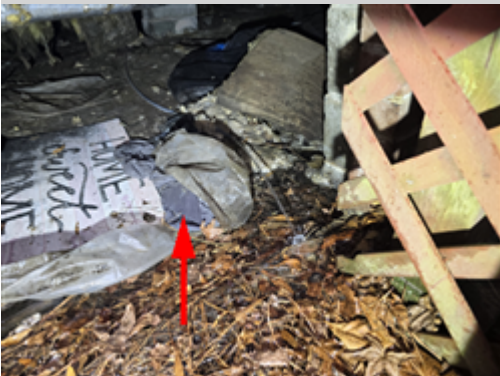
(A1 - 1.4) All Accessible Areas

Along with heavy debris, several areas of exposed damp ground were noted throughout the crawl space due to damaged and wrinkled plastic vapor barrier; The vapor barrier was noted to be "Dry rotted" at several areas of the crawl space. The crawl space vapor barrier should be replaced with a high mil-rated plastic vapor barrier to prevent possible high moisture levels from reaching the under side home's wooden structure as well as other plumbing, electrical, and hvac systems components.

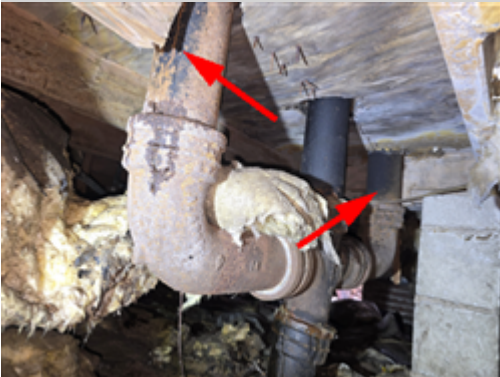
(A3 - 1.1) All Accessible Areas

Floor structural framing under both bathrooms have jeopardized by installation of large drain lines. Notched or completely cut through framing members including floor joists and girders were noted. A licensed general contractor should be consulted for complete evaluation and to make necessary repairs.

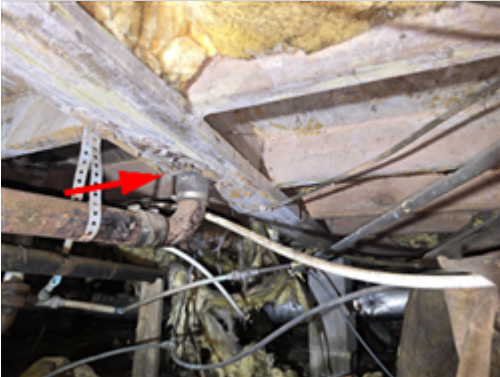
(A3 - 1.2) All Accessible Areas

Additional Photograph: This is a photograph of above noted item 1-1

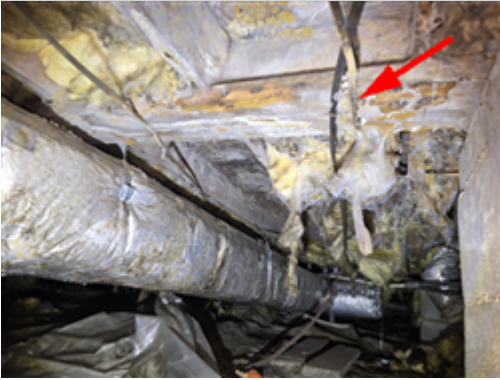
(A3 - 1.3) All Accessible Areas

The wood framing components across the center of crawl space are heavily discolored and with heavy fungi build up typical of wood destroying fungus; most significantly noted under the bathroom, kitchen, and laundry areas. The level of decay indicates long term excessive moisture that could involve a leak and hidden areas of damage. Note: several areas across the center of crawl space were noted completely visible or accessible due low clearance, substantial amount of present hvac ductwork, fallen insulation, electrical, and plumbing lines. A licensed general contractor should be consulted for further evaluation and repair to determine the source of the water penetration and extent of the damage to ensure the stability of the home and prevent additional damage.

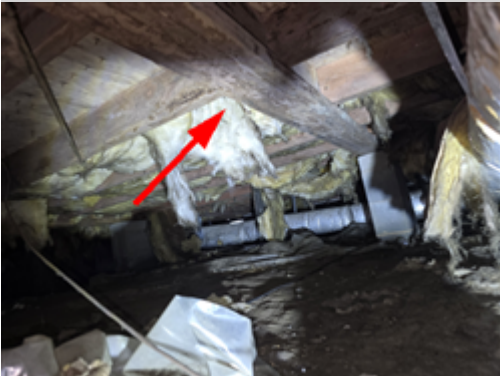
(A3 - 1.4) All Accessible Areas

Additional Photograph: This is a photograph of above noted item 1-3

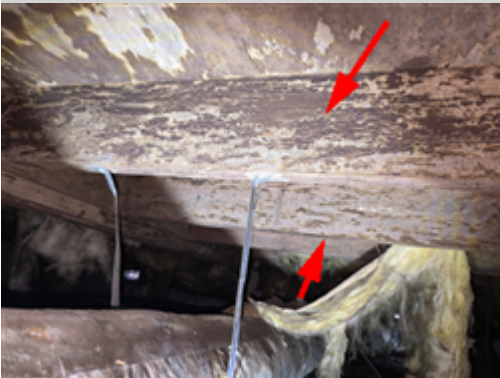
(A3 - 1.5) All Accessible Areas

Additional Photograph: This is a photograph of above noted item 1-3

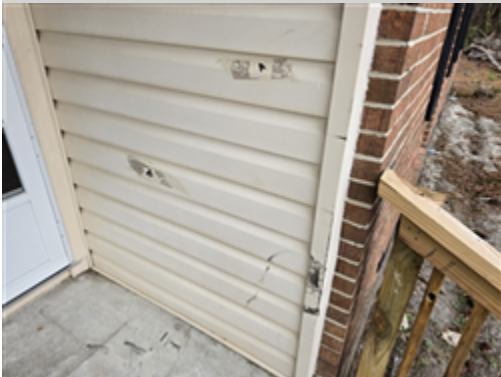
(B1 - 1.1) All Accessible Areas

Damaged pieces of siding are in need of replacement right of the front entrance door. A siding installation company or general contractor should be consulted to evaluate and repair the siding to ensure the integrity of the cladding system.

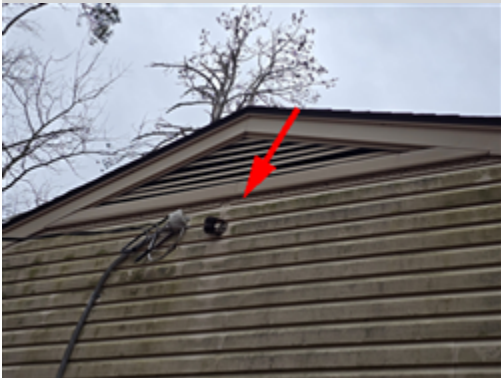
(B1 - 1.2) All Accessible Areas

Missing piece of vinyl siding noted under the right side gable vent.

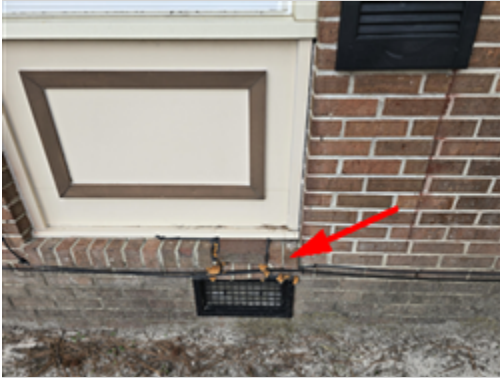
(B1 - 1.3) All Accessible Areas

Loose siding brick noted under the right front bedroom window. This has caused for a loose crawl space vent. Evidence suggest this is likley the cause of an overgrown tree root.

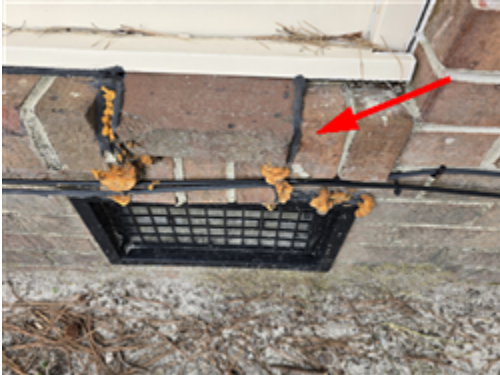
(B1 - 1.4) All Accessible Areas

Additional Photograph: This is a photograph of above noted item 1-1

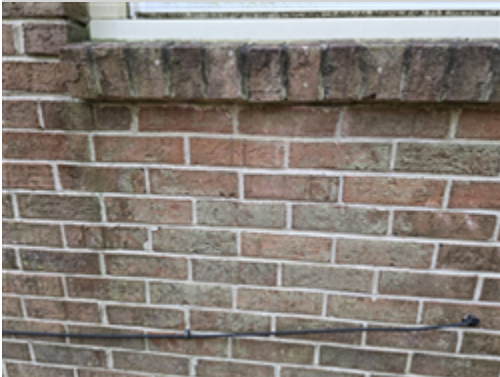
(B1 - 1.5) All Accessible Areas

Cracks were noted above/below the windows/doors in the brick veneer. Cracks in brick veneer indicate a deficiency that can change or progress over the life of the home. The cracks on this home were closed at the time of the inspection and presented no visible evidence of progression to the foundation areas, however, the cracks could open or change seasonally. The owners should be asked for disclosure related to the progression, history of repairs, or seasonal changes of the cracks. Even closed or minor cracks can cause consumer or buyer concerns at the time of resell. The buyers should observe the cracks and assess their concerns related to the presence of the cracks, the number of cracks, and possibility of the condition worsening over the life of the home. The cracks should be noted, repaired by a general contractor, and monitored to establish a history of stability. If additional information is needed an engineer should be consulted.

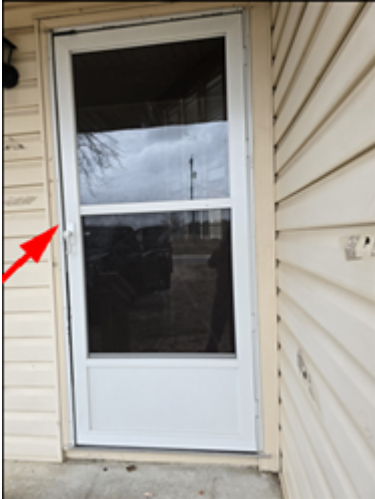
(B2 - 1.1) All Doors

Front storm door damaged and drags the latch side door frame, making difficult to open and to close.

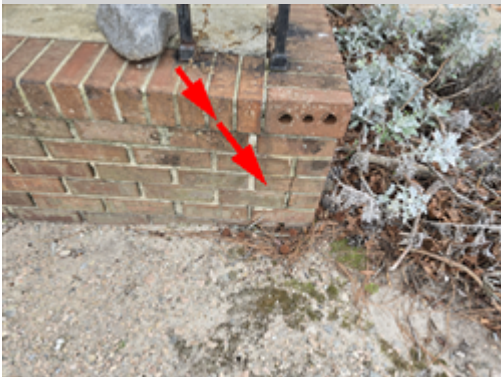
(B3 - 1.1) Porch

Foundation crack was noted on left side of the front porch. A licensed general contractor should be consulted for further evaluation, to determine the extent of the damage, and to make necessary repairs.
