Jan 20th, 2026

208 White Street, Williamston, NC, 27892

Home Inspection Report

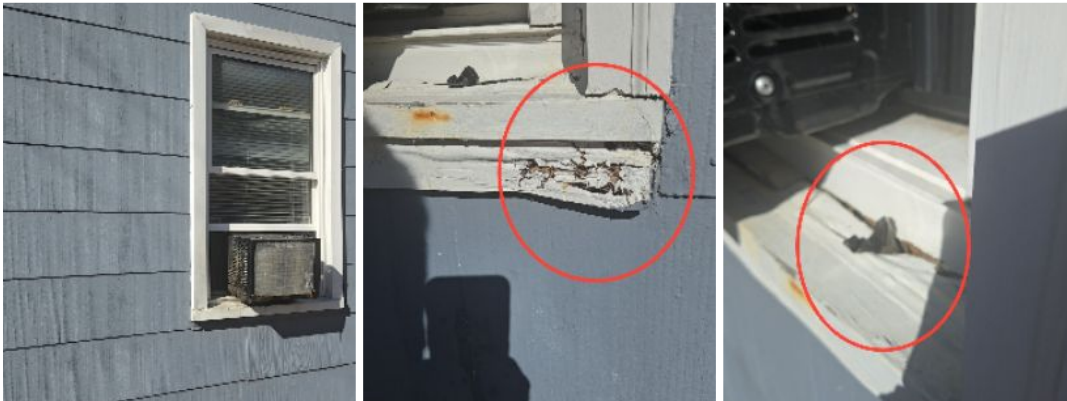
Window and Trim

The trim on the exterior windows is deteriorating. This is a functional issue. Recommend further evaluation, repair and or replacement as necessary of this and all windows and trim by a qualified or licensed window installer or licensed general contractor for proper function and safety.

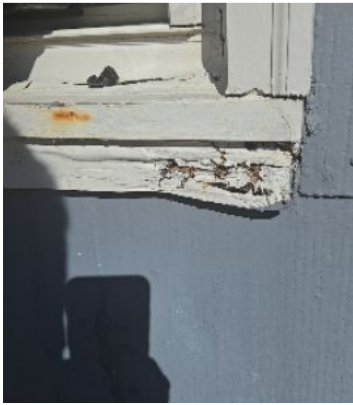
Rot noted

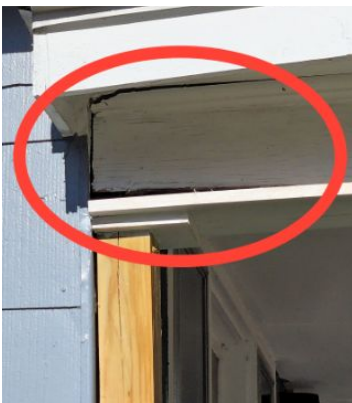
Porch

The porch appears to be pulling away from the house where the porch attaches to the house on the left rear corner. This is a functional as well as a safety concern. Recommend further evaluation by a licensed general contractor of this and all other areas of the structural parts of the structure, for proper function and safety.

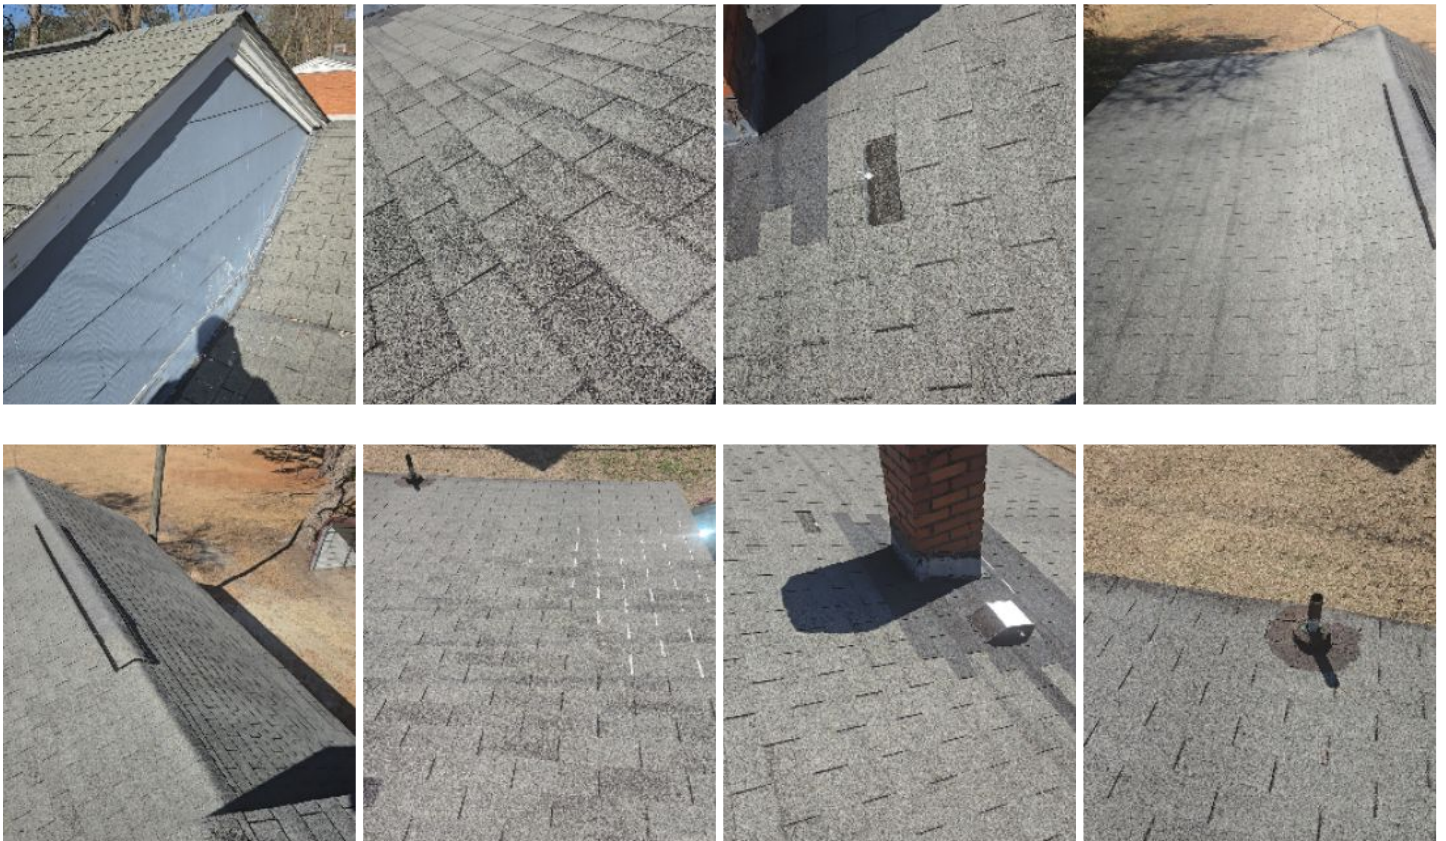
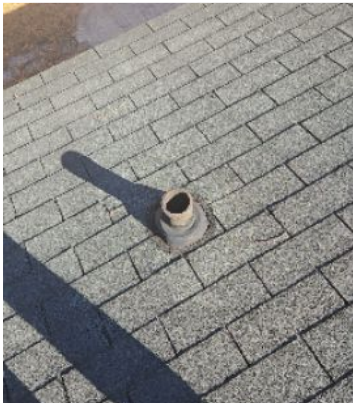
Roof

Roof at/near end of useful life. There are multiple shingles missing and others damaged. This is a functional concern. Recommend further evaluation, repair and or replacement as necessary by a qualified or licensed roofer or licensed general contractor of all matters pertaining to the roof for proper function.

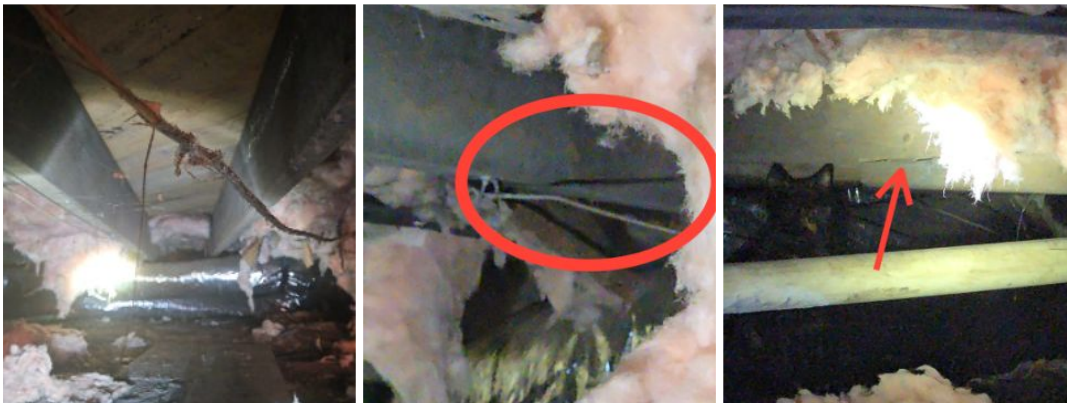
broken floor joist

Floor Joist

A broken floor joist was found during the inspection of the crawlspace and it was also noted that the floors of the structure are very uneven and not level during the interior inspection. The broken floor joist is a functional as well as a safety concern. Recommend further evaluation, repair and or replacement of the damaged floor joist and all other flooring be completed by a licensed general contractor for proper function and safety.

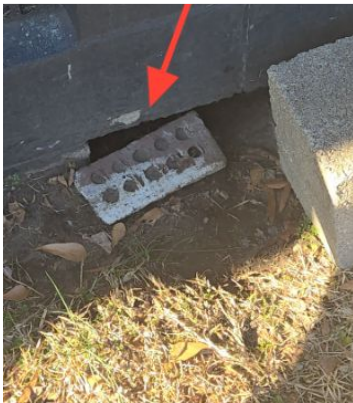
Hole in foundation wall.-
This is allowing animals to enter the crawlspace.-
This is a functional issue. It is recommend that further evaluation, repair, and or replacement of this and all other foundation and foundation wall be completed by a foundation contractor.

Recommend further evaluation of the foundation and the foundation wall. This is to be completed by a qualified or licensed foundation contractor or a licensed general contractor for proper function and safety.

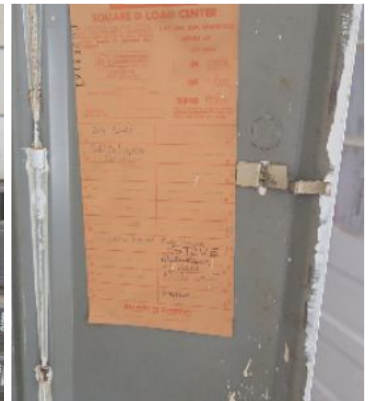
open knock out

Open knockout hole. Insert blank to cover opening.

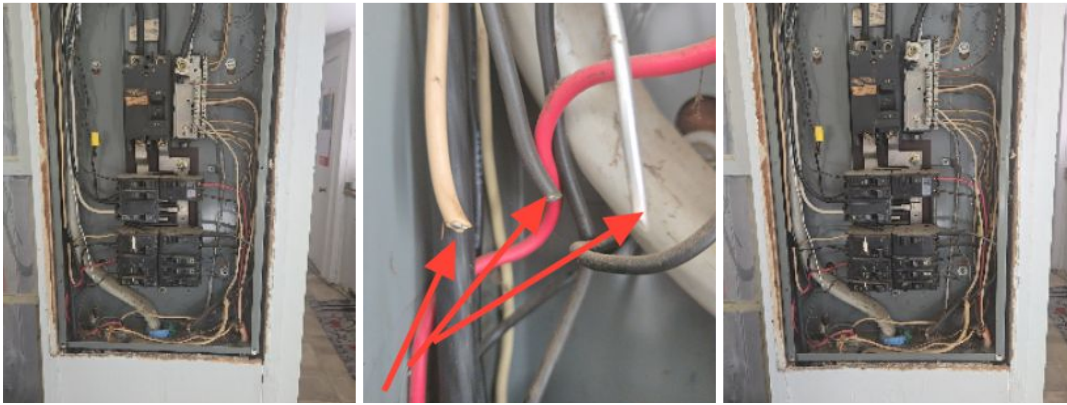
arrows are pointing at 3 wires that have been cut and are not capped with a wire nut inside the panel box. The wire with 2 arrows, 1 at the bottom and 1 midway, is a solid aluminum wire. Recommend all electrical be evaluated by a licensed electrician.

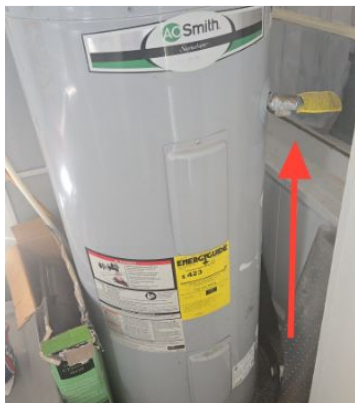
no TPR pipe

TPR Overflow Pipe

The water heater is missing the TPR Overflow pipe. This is a safety concern. Recommend further evaluation, repair, or replacement as necessary of this and all plumbing be completed by a licensed plumber for proper function and safety.

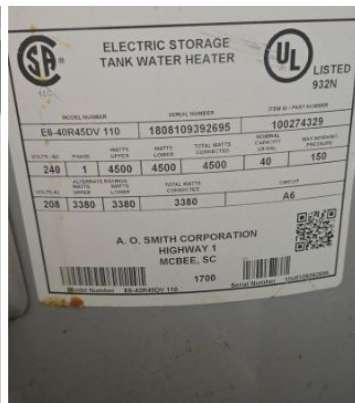
The serial number format suggests this unit was likely manufactured in August 2018

Water heater is nearing the end of its design life

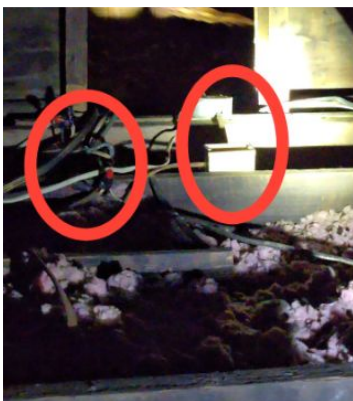
Wire splices not in junction box and open junction box

Improper Electrical Splice

Multiple improper electrical splices and open junction boxes were identified in the attic. This is a safety / fire / electrical shock hazard. Recommend further evaluation, repair and or replacement as necessary of this and all electrical by a licensed electrical contractor for proper function and safety.

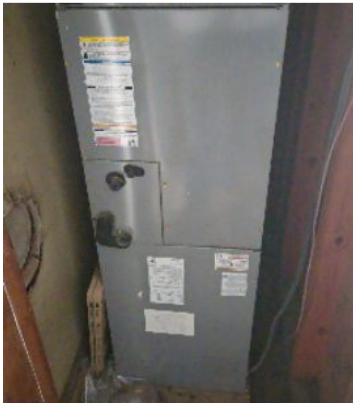
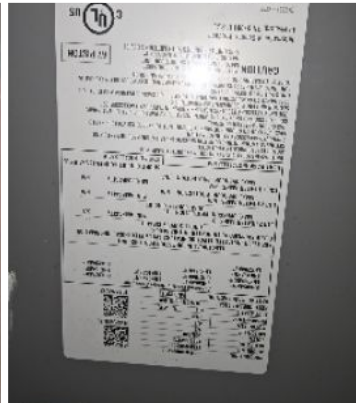
Date of Manufacture is
2018

Service recommended

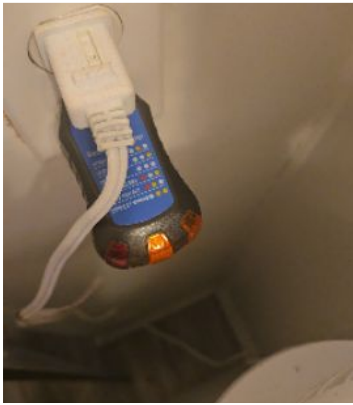
Non-GFCI circuit

Open Ground

Open or missing ground. This is a safety concern. An open ground is an electrical shock hazard. Further evaluation, repair and or replacement of this and all electrical by a licensed electrician is recommend for proper function and safety.

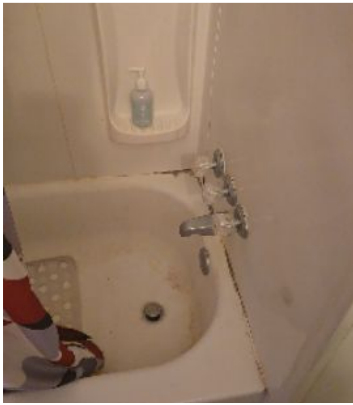
Bath tub surround

Caulk edge(s) of tub/surround. Missing caulking allows for the infiltration of water which allows for fungal growth and deterioration of the wood structure. This is a functional and a safety issue. Recommend further evaluation of this and all plumbing by a qualified or licensed plumber for proper function and safety.

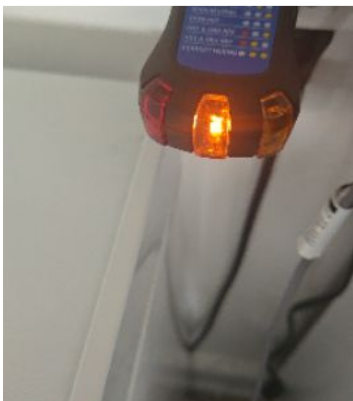
Open Ground

Non-GFCI circuit. Recommend GFCI circuit be installed. This circuit also has an open ground. This is an electrical shock hazard. Recommend further evaluation, repair and or replacement of this and all electrical of the property by a licensed electrician for proper function and safety.

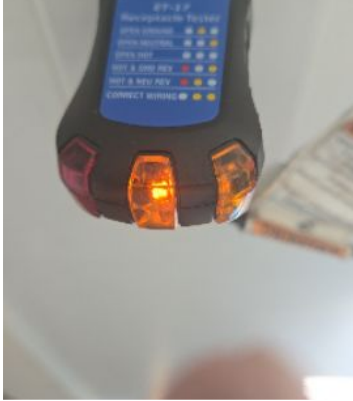
Open or missing ground

Open Ground

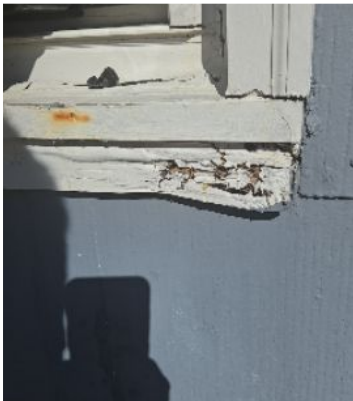
Rot noted

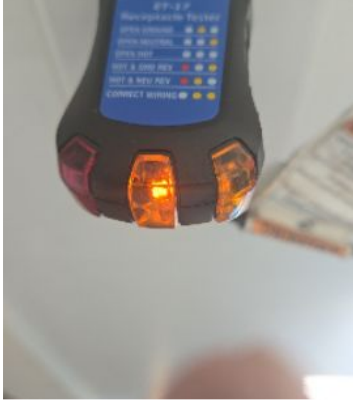
Open or missing ground

Open Ground
