Building Inspection Report

See Report Overview for Exclusive Use

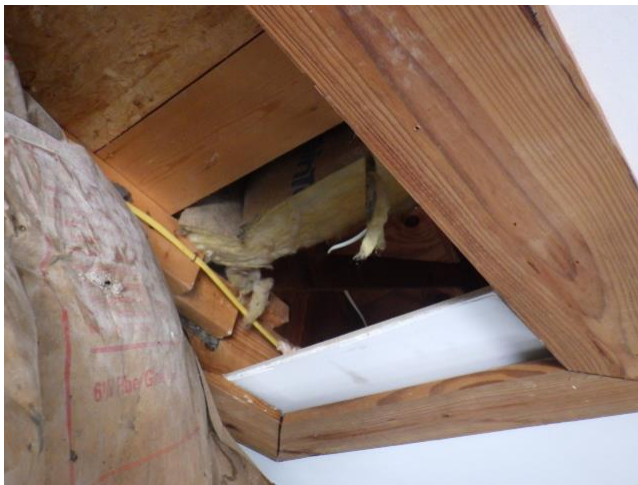
There is an access hatch on the garage ceiling near the front wall intended to provide observations for the small attic space in front of the FROG. This hatch is mostly positioned under the finished flooring for the FROG, leaving a small gap that cannot be accessed with reasonable effort. Observations in this part of the attic are restricted due to this condition. Consider engaging a qualified contractor to modify this access hatch.

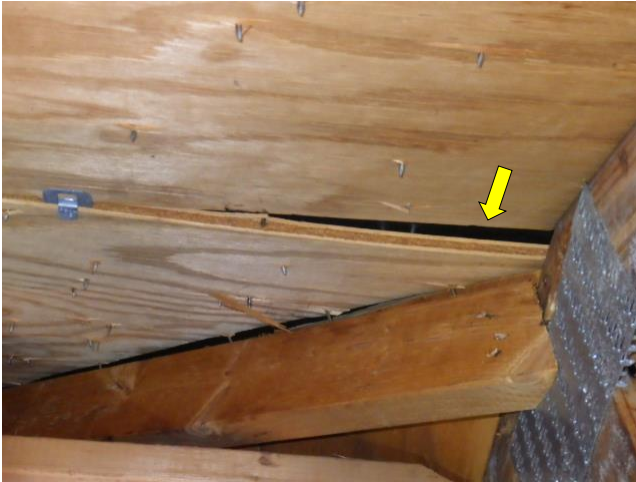
A section of the roof sheathing is not properly supported and offset where the rear roof slope meets the hip roof ridge line above the floored space in the high attic (above the air handler). Recommend investigating this further through a qualified contractor and take action to reinforce the sheathing at this area, as additional damage may result during shingle replacement.

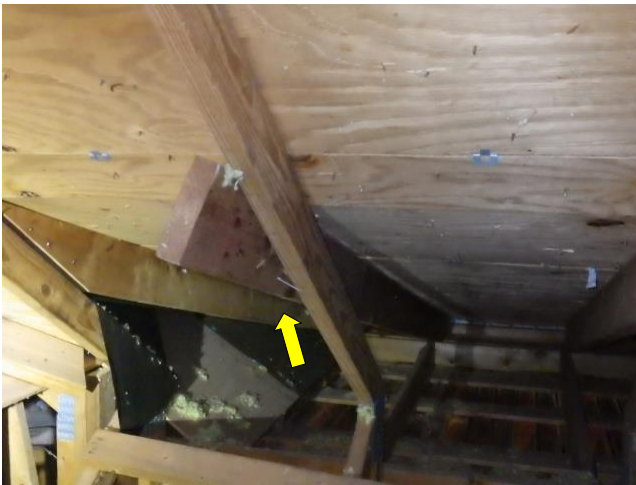
Approximately seven rafters are spliced onto the sides of trusses, forming the front roof slope above the porch. These rafters are bowing and pulling away from the trusses, which is pulling much of the nailing out. Recommend investigating this further through a qualified contractor and take any corrective action warranted to fully secure the framing connections.

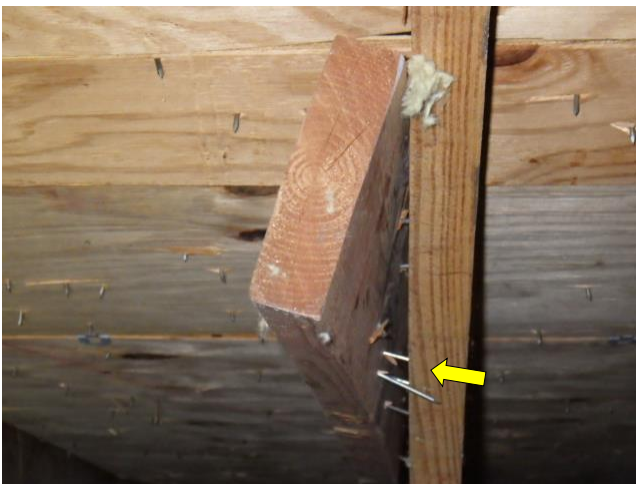
Close-up view showing one of the rafters that has bowed and pulling away from the truss it is connected to.

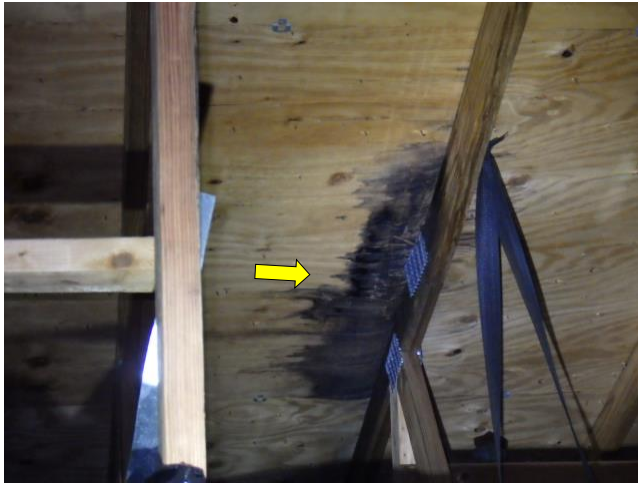
There are two large, dark stains on the roof sheathing at the rear slope over the living room. These areas are not directly accessible from inside the attic to determine if any damage exists. Some patching as well as a nail is visibly raised and cut through the shingles on the rear roof slope as seen from the exterior (see the photos in the roofing section of this report). Further evaluation is recommended through a qualified roofer during shingle replacement to determine the integrity of the sheathing and possibly replace these sections if needed.

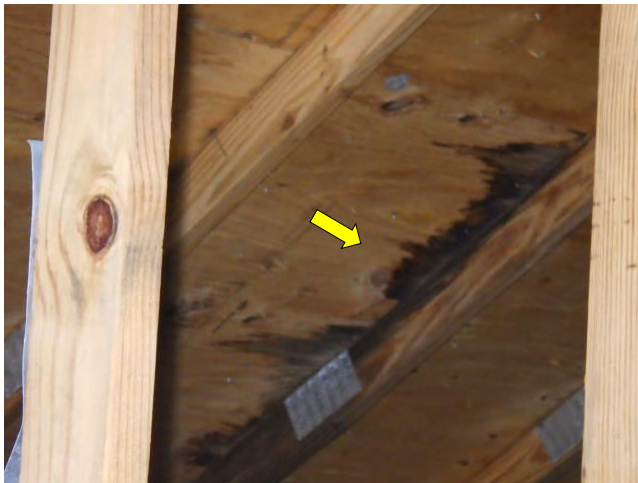
View showing the second large, dark stain on the rear roof slope sheathing as seen from inside the attic.

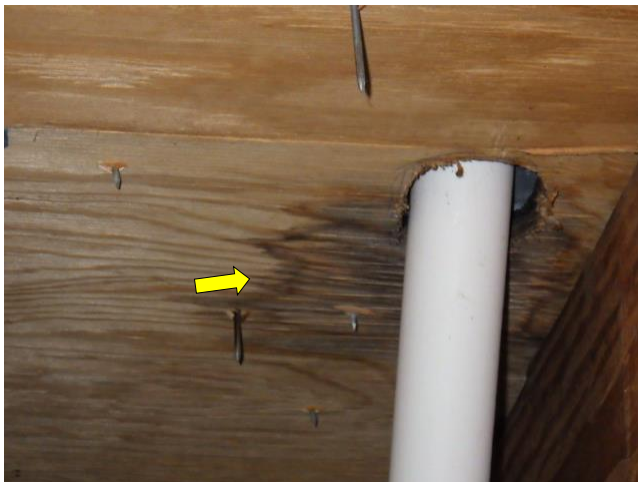
Staining is visible on the roof sheathing around a plumbing vent pipe on the right roof slope behind the FROG air handler. Flashing for the vent pipes is significantly damaged, which can allow for rainwater penetration (see the photos in the roofing section of this report).

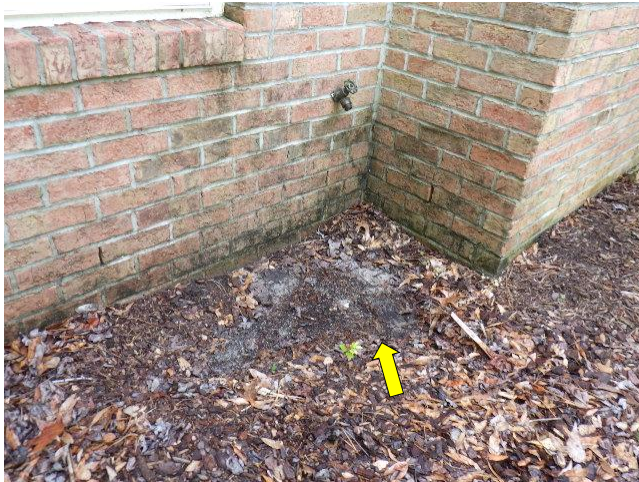
There is a low area at the front exterior against the building's foundation at an inside corner below the hose bib fixture. No guttering is present, which allows rainwater to flow off the roof slope at this area. There are additional ruts and low areas at the left, rear, and right exterior of the building caused by rainwater where guttering is also missing. Action is warranted to regrade and create positive slope away from the building with erosion control material. Consider adding guttering to better capture and move rainwater away from the building's foundations.

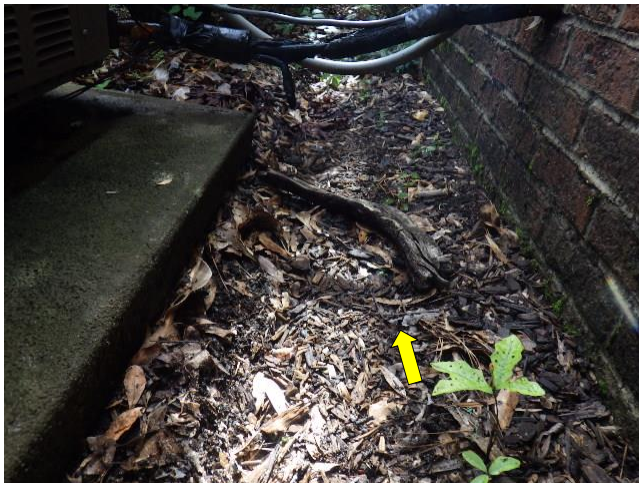
Close-up view showing an eroded area along the left side of the building where rainwater flows from the roof slopes above.

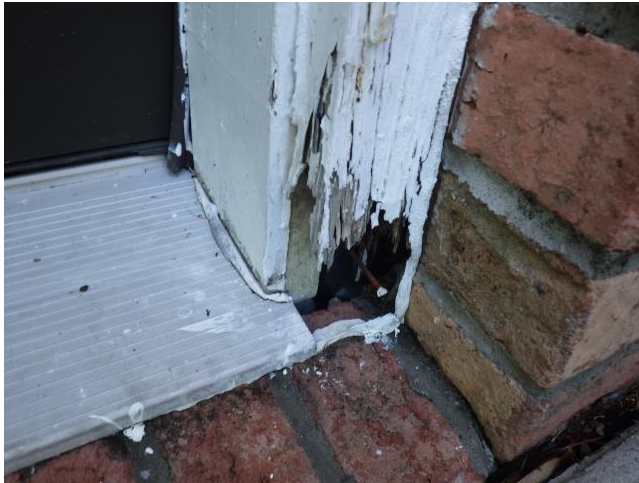
There is severe water damage in the trim near the threshold at the bottom corners of the garage personnel entry door. Additional water damage is present on the casing and the door itself at the bottom hinge side (visible only with the door open). Recommend investigating repairs through a qualified contractor to eliminate this water damage. The store binds with the frame and needs minor adjustment to eliminate the conflict. Weatherstripping is also damaged along the bottoms and latch sides of this door, and needs replacement.

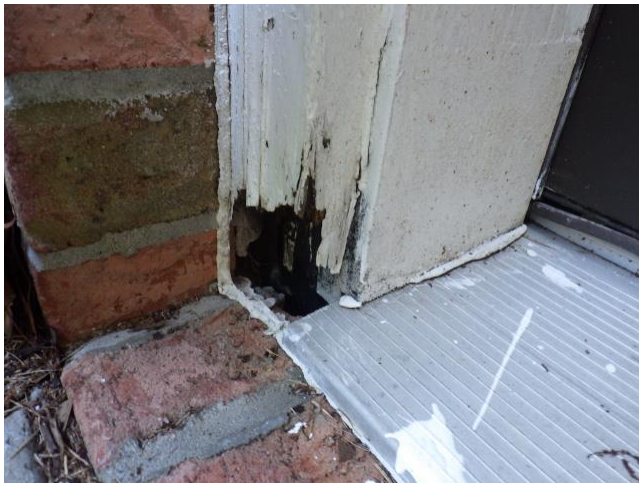
Second view showing water damage in the trim near the threshold.

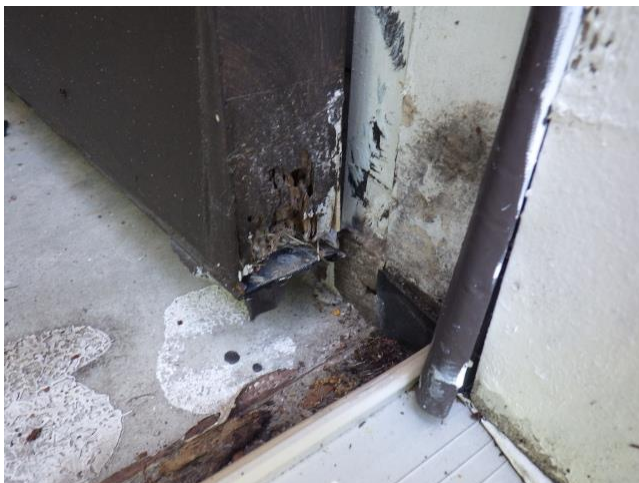
View showing water damage at the bottom hinge side of the door.

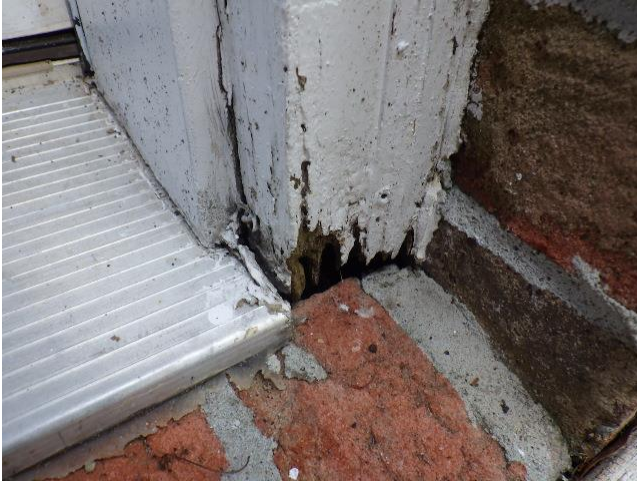
There is water damage in the trim near the threshold at the rear exterior double door unit for the living room. Damage is also present at the bottom latch and hinge sides of the main door (visible only with the door open). The bottom latch bolt for the secondary door will not release with reasonable effort and this door cannot be operated. Additional water damage may exist that is not identified due to this condition. Recommend investigating repairs through a qualified contractor.

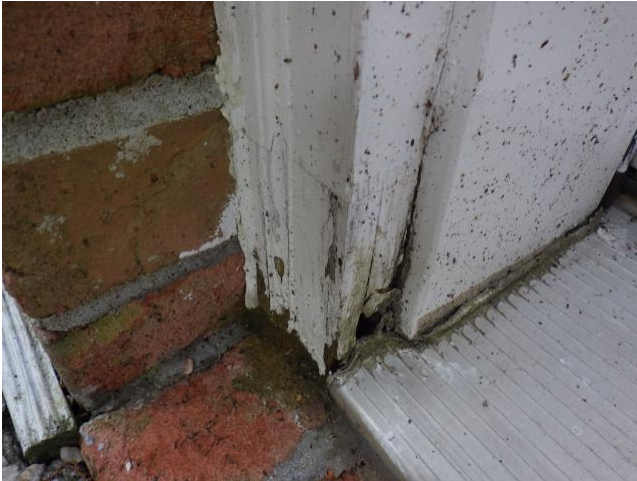
Second view showing water damage in the trim at the rear exterior living room door.

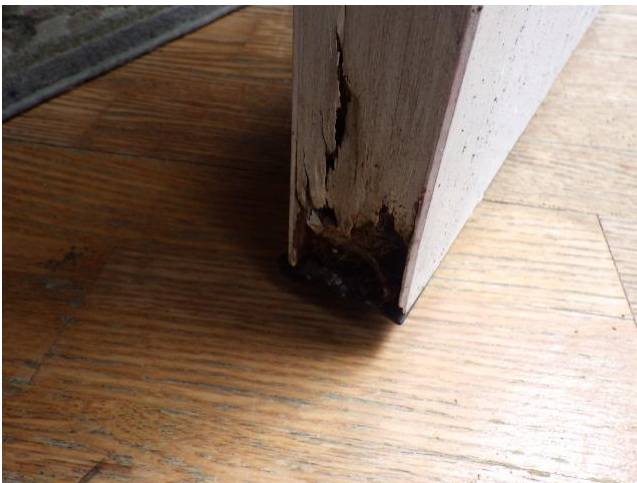
View showing water damage at the bottom latch side of the main door.

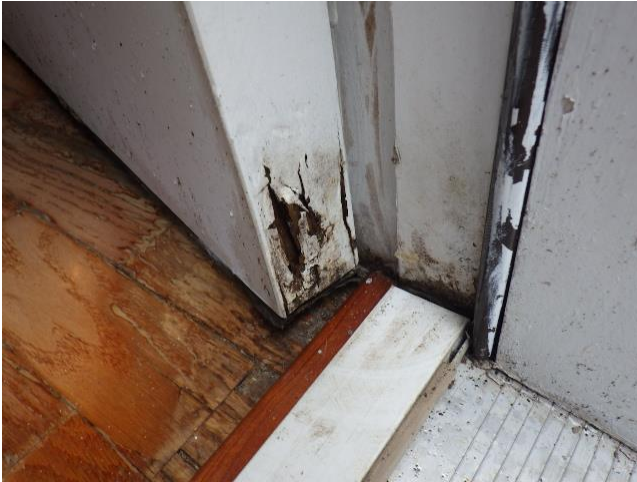
View showing water damage at the bottom hinge side of the main door.

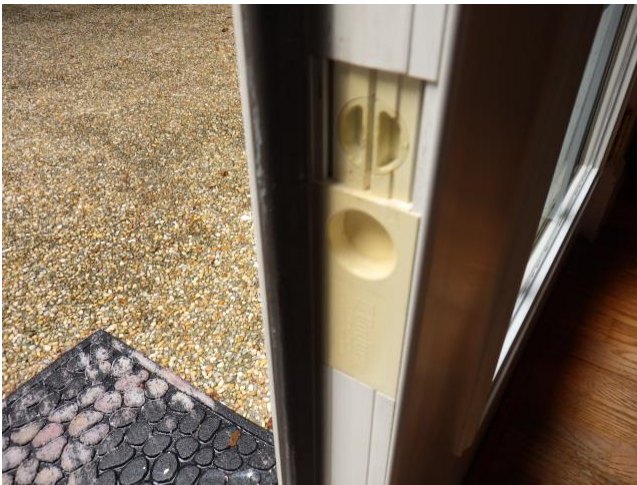
View showing the bottom latch bolt mechanism for the secondary door for the living room exterior door unit that will not release with reasonable effort. This door cannot be operated due to this condition and additional damage may exist that is not identified in this report.

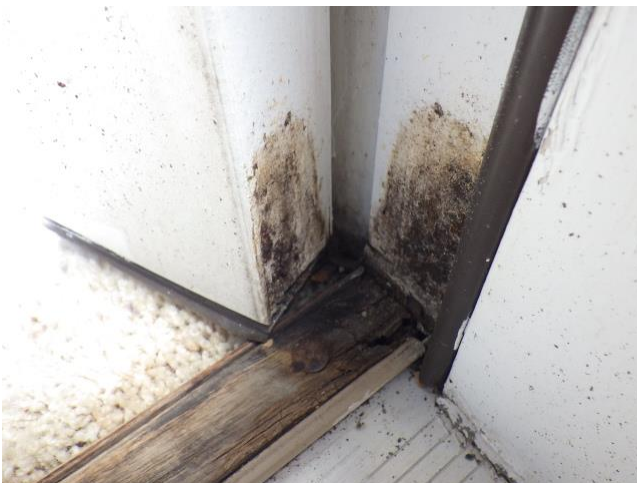
There is water damage in the trim and casing at the bottom corners near the threshold for the rear exterior double door unit at the primary bedroom. Additional water damage is visible at the bottom latch and hinge sides of this door unit (visible only with the doors open). Water damage is also present along the wooden threshold strip. Recommend investigating these conditions further through a qualified contractor and repair/replace these components as needed.

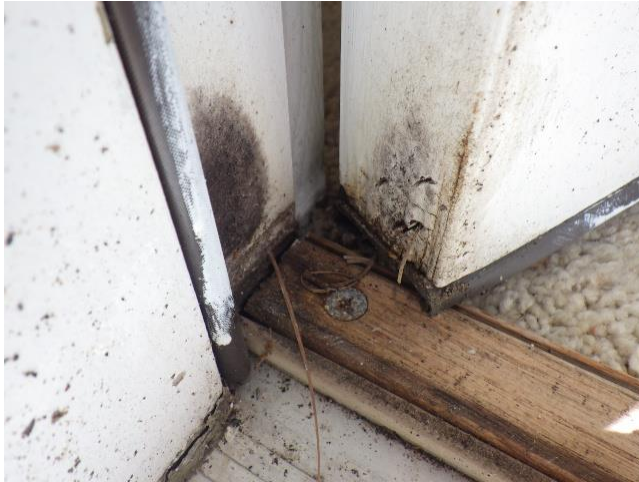
View showing minor water damage at the bottom hinge side of the secondary door for the double door unit at the primary bedroom.

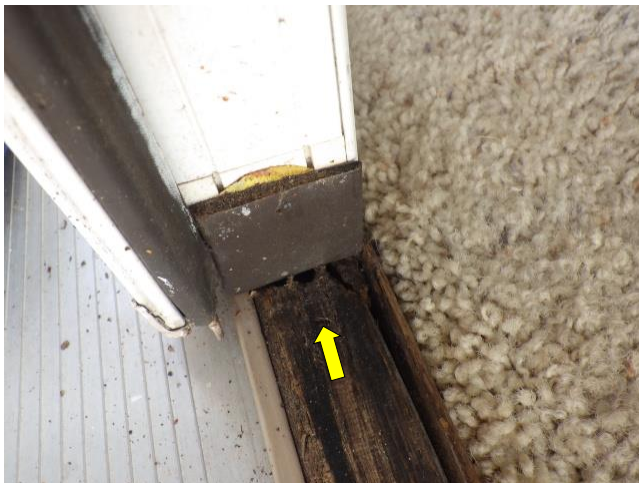
View showing water damage in the wooden component of the threshold where the secondary door latch bolt engages.

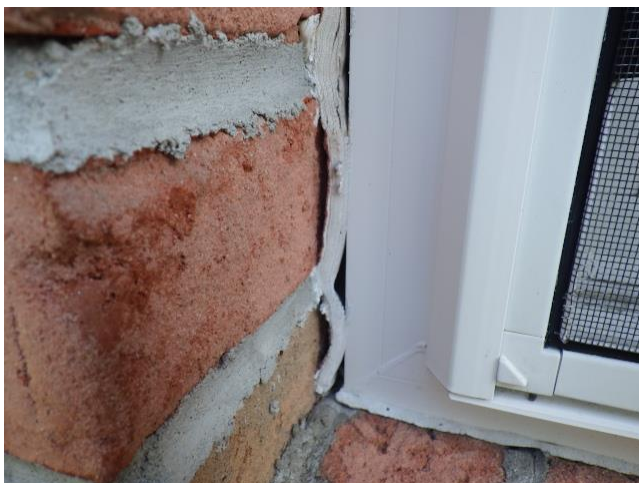
Caulking has opened at many of the windows around the building's exterior where the frames meet the brick veneer. Action is warranted to clean away the old caulking, then re-caulk to seal the frames with the brick veneer.

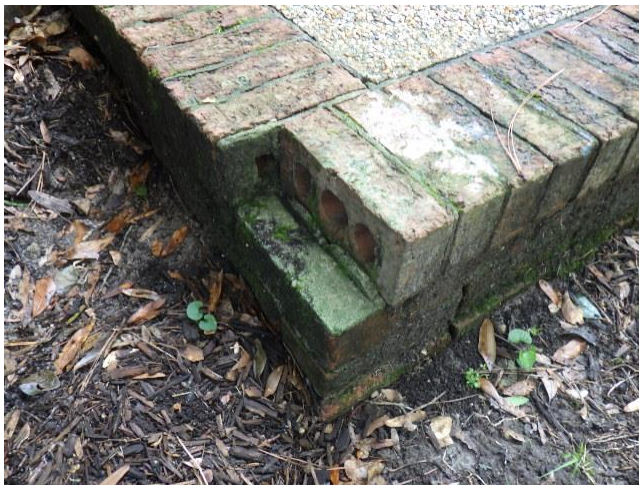
One brick is missing at the outer corner of the rear concrete patio. Installation is warranted through a qualified contractor.

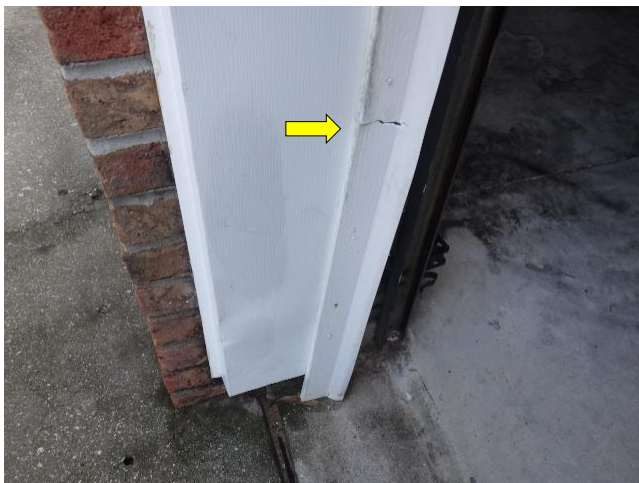
Weather stripping is damaged along the left side of the rear garage door and has been re-nailed into place. Replacement of this weatherstripping section is warranted to properly mate with the garage door when closed.

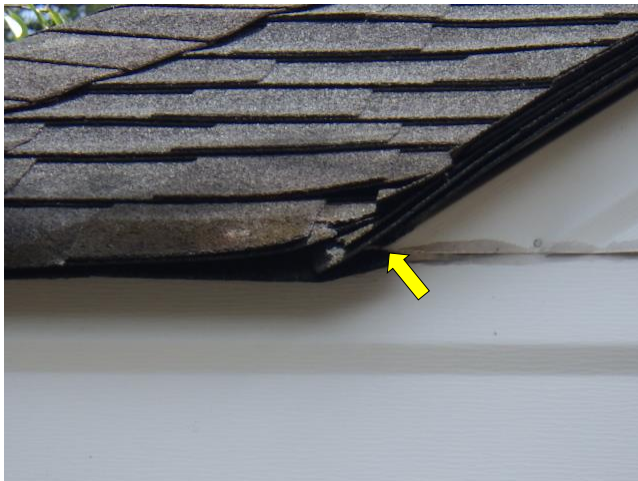
The roof covering is original to the building, making it approximately 24 years old at the time of the inspection. There are many defects with the shingles and flashing observed that are not individually catalog during the inspection. These conditions indicate the shingles are at end of their functional life expectancy. Recommend a comprehensive evaluation through a qualified roofer as replacement of the shingles and flashing appears warranted.

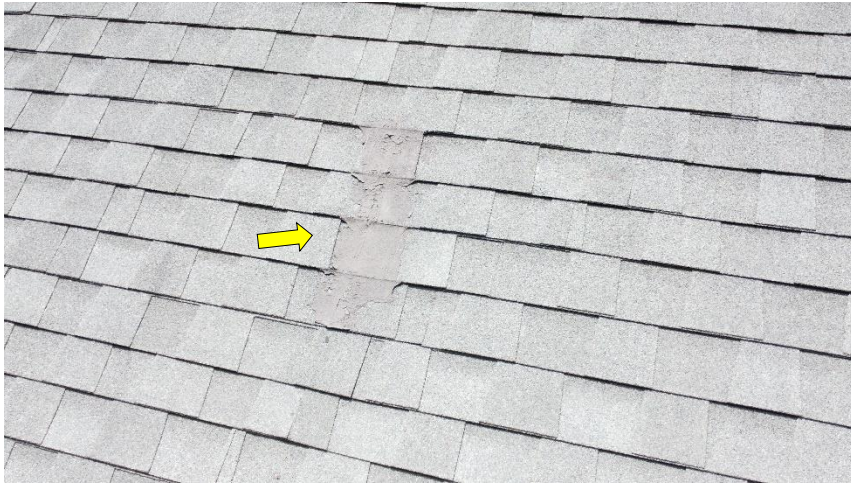
View showing roofing sealant applied to shingles on the rear roof slope. This is at an area where one of the dark stains observed from inside the attic.

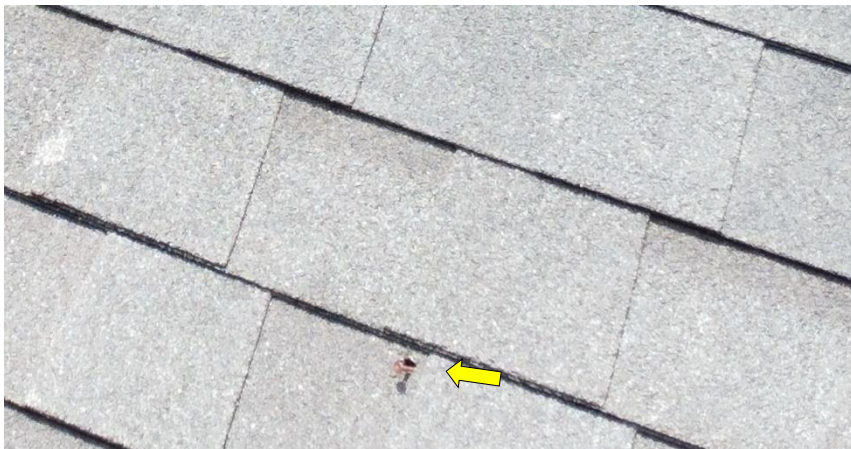
View showing a nail that has cut through the shingles on the rear roof slope. This is at an area where one of the dark stains is observed from inside the attic.

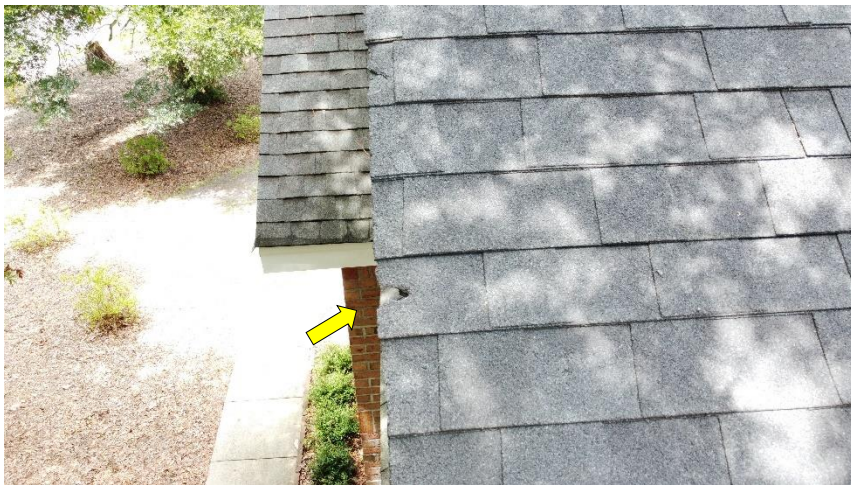
View showing damage shingles along the rake for the front facing gable above the FROG.

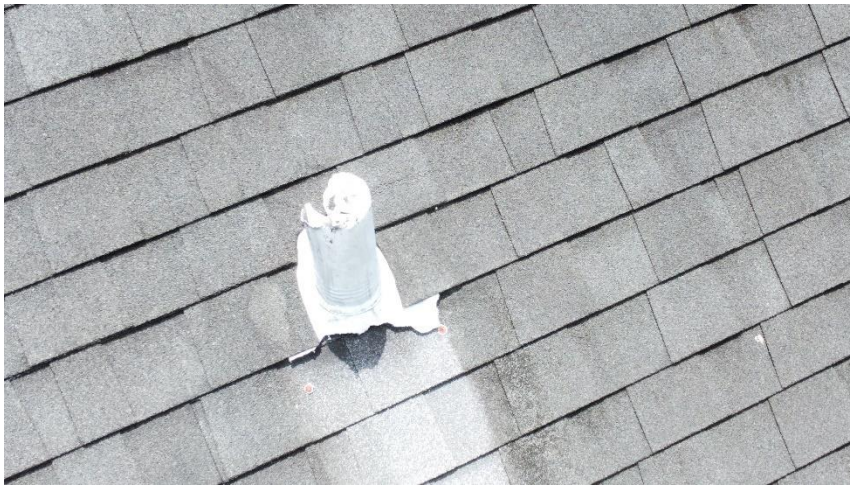
View showing damage to flashing for the plumbing vent pipe on the left roof slope. The vent pipe itself is also damaged from possible squirrel activity. Replacement of this vent pipe section appears warranted during shingle and flashing replacement. This may involve cutting the pipe from inside the attic and splicing in a new section.

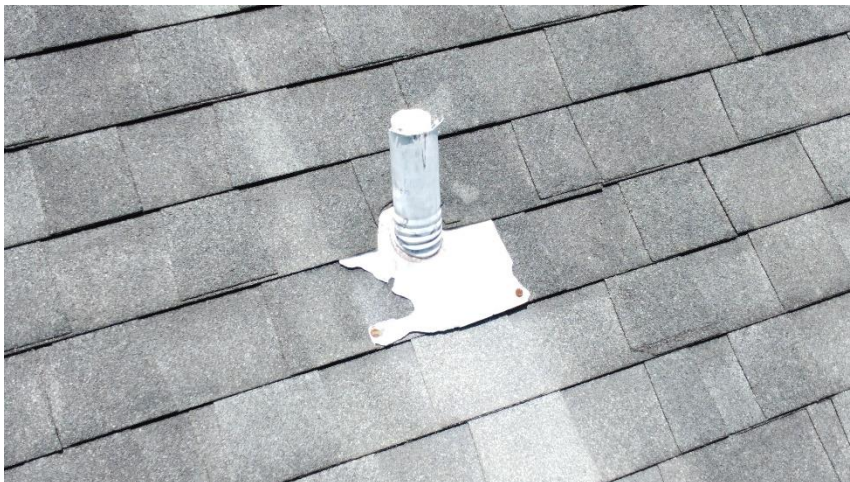
View showing damaged flashing for one of the plumbing vent pipes on the right roof slope.

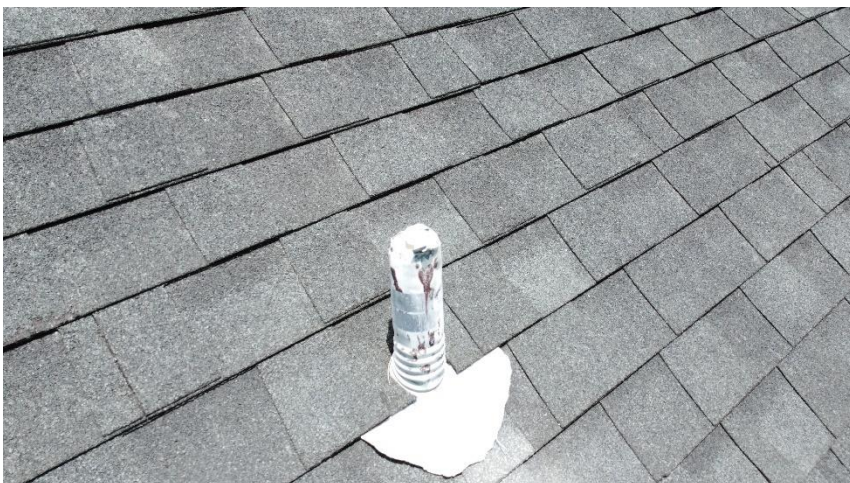
View showing damaged flashing for the second plumbing vent pipe on the right roof slope.

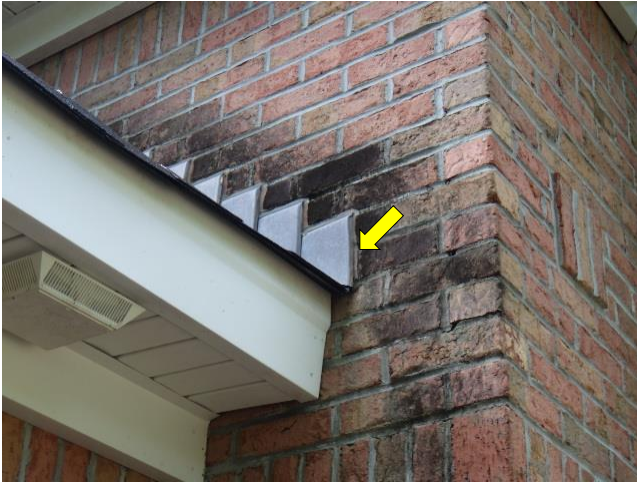
The left end of the front main roof slope ties into a higher brick veneer wall to the left of the porch entry. This detail is assembled without the use of kick-out flashing. This type of flashing is desired to channel rainwater out and away from the brick veneer, to aid in minimizing moisture penetration. Recommend investigating this further through a qualified contractor or roofer and take action to install the necessary flashing.

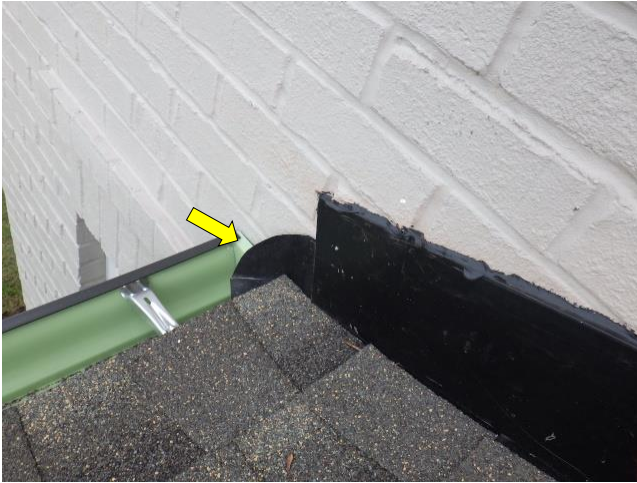
View showing another brick veneer home with kick-out flashing installed at the eave.

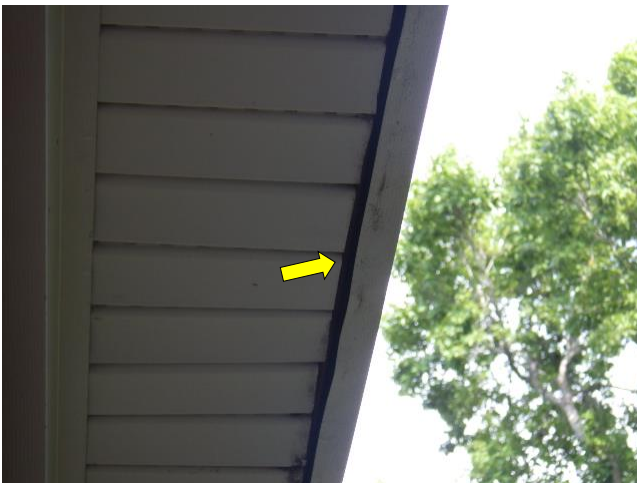
Aluminum cladding is not fully secured in place on the fascia at the left exterior near the rear corner of the building. This leaves a gap at the soffit, which could allow for flying insect entry. Repair is warranted through a qualified contractor.

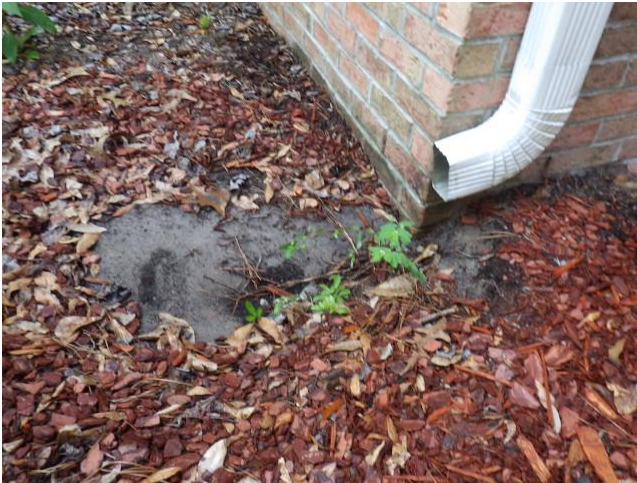
Localized erosion is occurring at the front exterior gutter downspout next to the porch entry. Recommend regrading to create positive slope and installing a splash block or pipe extension to channel rainwater out and away from the building.

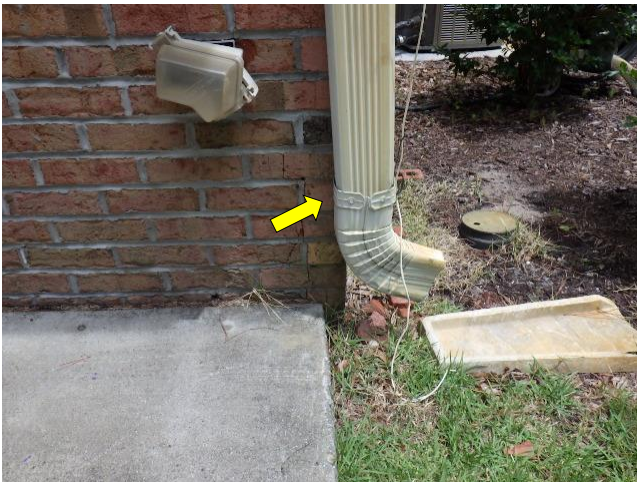
The bottom bracket for the gutter downspout is not secured in place at the right exterior near the garage personnel entry door. Repair is warranted to reconnect this bracket.

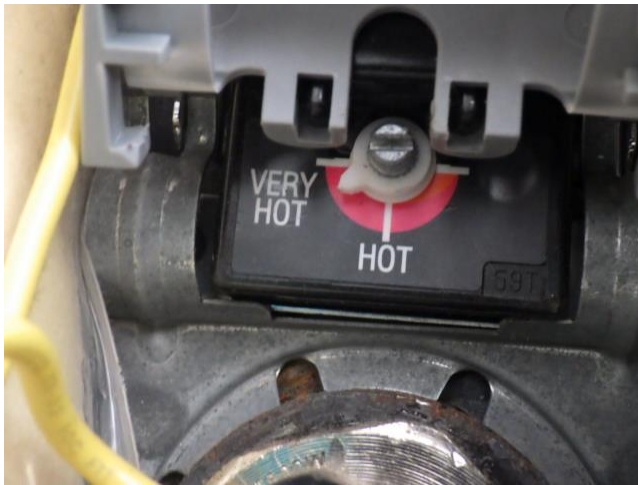
Temperature settings for the thermostats in the water heater are close to the maximum settings. Manufacturer’s recommendations state the temperature should not exceed 125 degrees for scalding safety. The Bradford White website states the “hot” setting on the thermostat is close to 125 degrees. Recommend lowering these setting for improved safety.

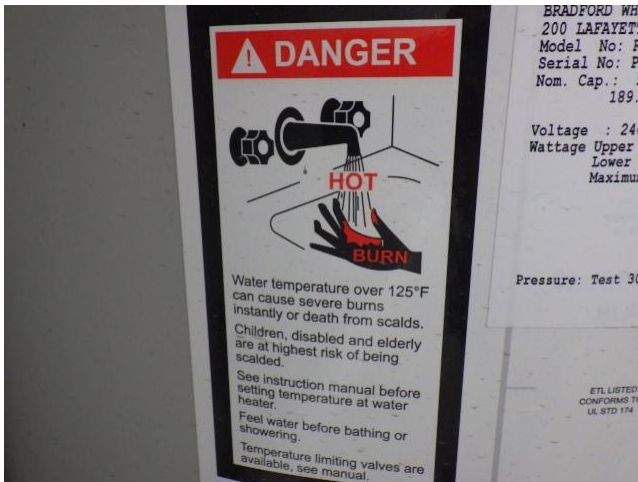
View showing the warning label on the appliance stating to not exceed 125 degrees.

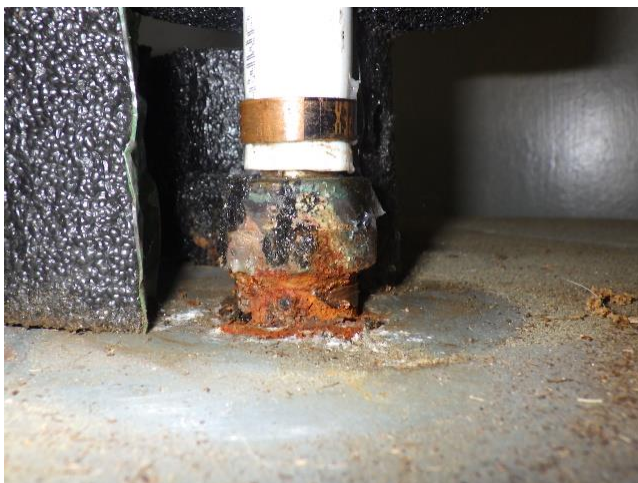
There is a concerning amount of corrosion/rusting formed at the hot water piping connection on top of the water heater. This is often caused by a cross-threaded connection or possible electrolysis reaction with the appliance. Recommend investigating this further through a qualified plumber and take any corrective action warranted to ensure integrity of the connection. Flushing the water heater and replacement of the anode may also be warranted.

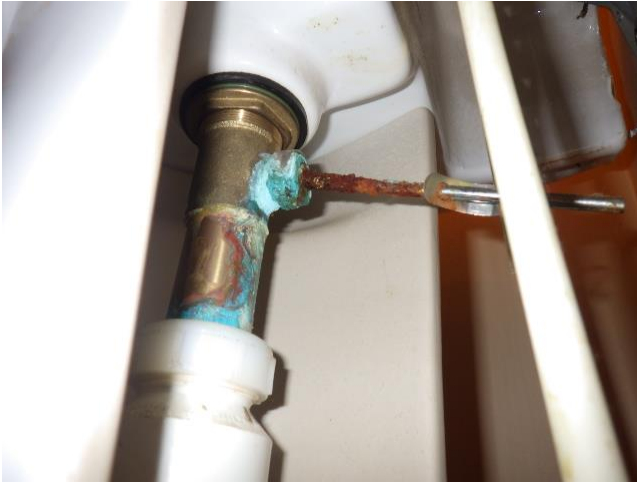
There is significant rusting and corrosion where the sink stopper rod connects to the drain piping behind the bathroom pedestal sink and active leaking is occurring at this area. Additionally, the pedestal sink and base are not properly secured in place as they exhibit some movement when pressure is applied. Recommend investigating repairs through a qualified plumber.

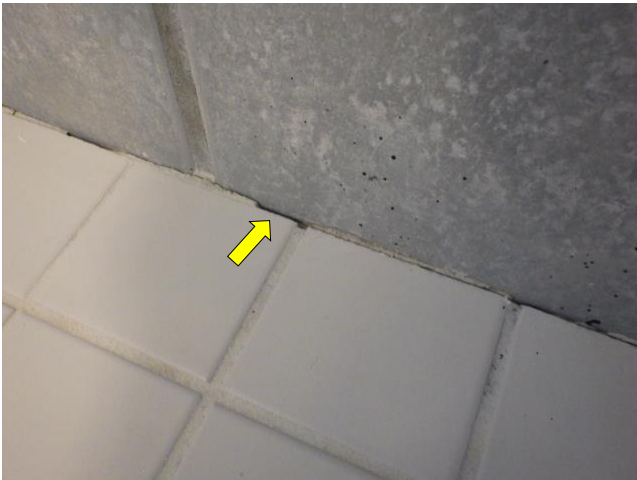
There is cracking and grout loss around the floor perimeter of the front full bathroom tile shower. Additional cracking is occurring in grout joints between wall tile at the corners. Action is warranted to re-grout and eliminate all cracks.

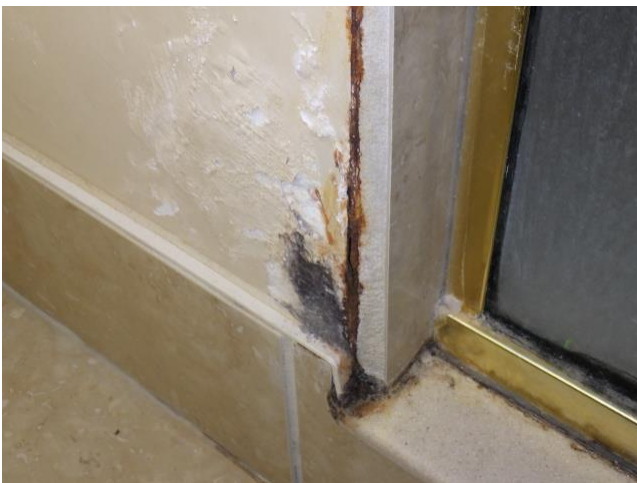
There is evidence of moisture escaping the shower enclosure at the outside wall near the floor in the primary bathroom. The extent of the damage could not be determined during the inspection. Recommend further investigation contractor and take any corrective action warranted to resolve.

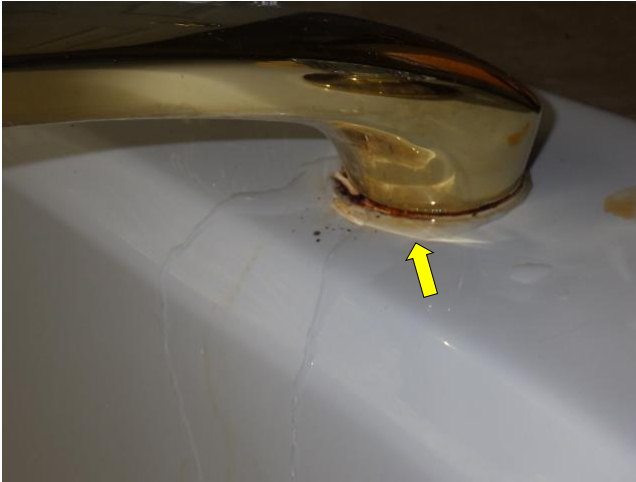
The primary bathroom whirlpool tub faucet is significantly rusted and water leaks from the base while filling the tub. No leaking into the tub cavity underneath is observed however the connecting components are severely rusted. Recommend investigating this further through a qualified plumber and take action to replace this fixture.

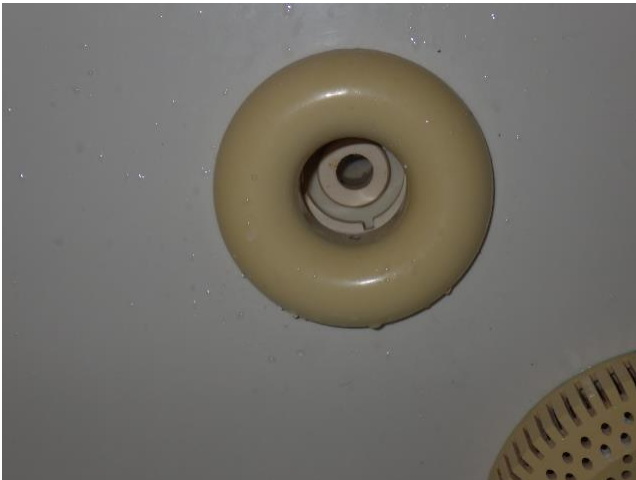
One of the primary bathroom whirlpool tub jets is missing. Replacement of this component is warranted.

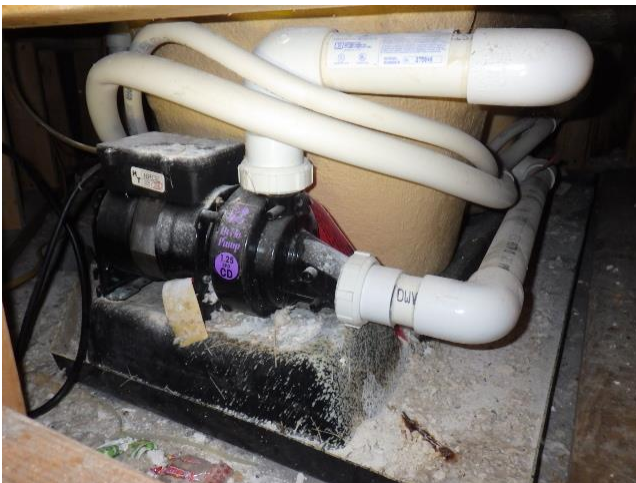
View showing the primary bathroom whirlpool tub pump motor. There is an access hatch in the adjacent closet. The circuit is ground fault protected by a GFCI breaker in the left main electrical panel.

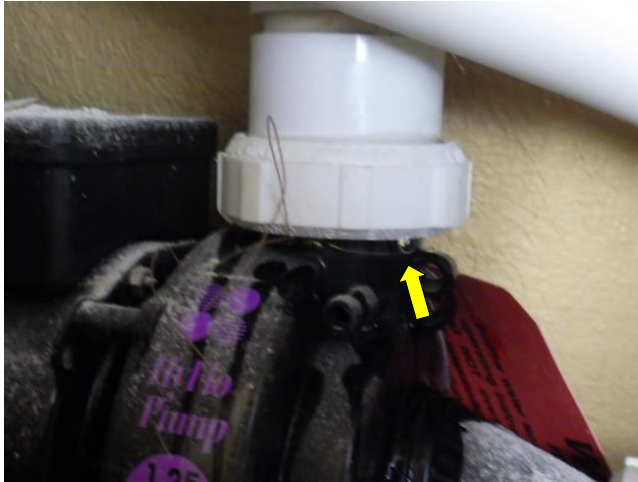
There is an active leak occurring at a piping connection on top of the pump motor at the primary bathroom whirlpool tub. Recommend investigating repair through a qualified plumber.

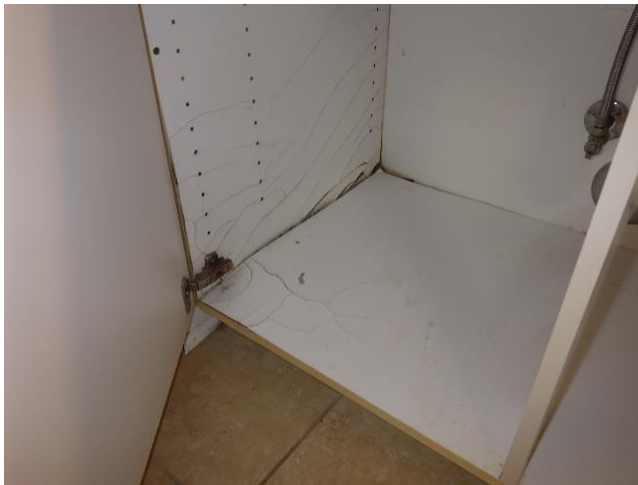
There is water damage at the side and bottom panels of the base cabinet for the right vanity sink in the primary bathroom. Recommend investigating repair or possible replacement of the base cabinet through a qualified contractor.

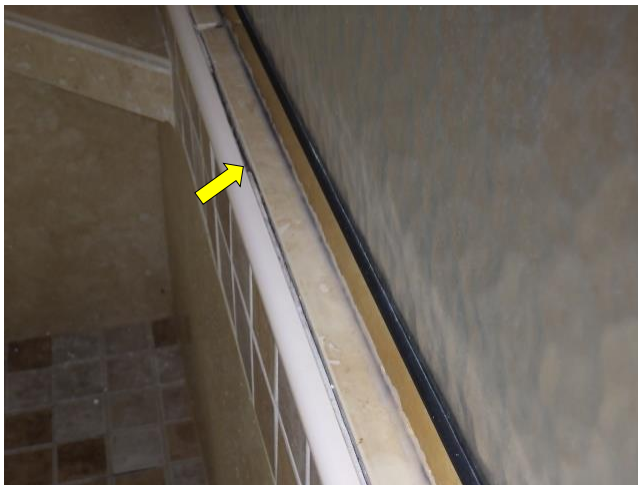
There is grout loss along the top edge of the wall tile inside the primary bathroom tile shower where the partition divides it from the whirlpool tub. These gaps introduced potential for water penetration behind the tile. Recommend investigating action through a qualified contractor to re-grout and eliminate any gaps or openings.

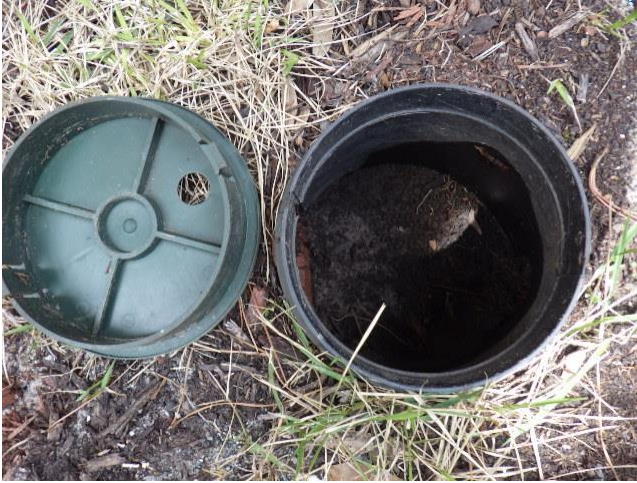
There is a valve box in the right side yard in front of the heat pump unit. This is filled in with dirt but may contain a main water shut off, which could not be verified during the inspection. Excavation is recommended through a qualified plumber to verify a properly functioning main water shut-off valve for the property.

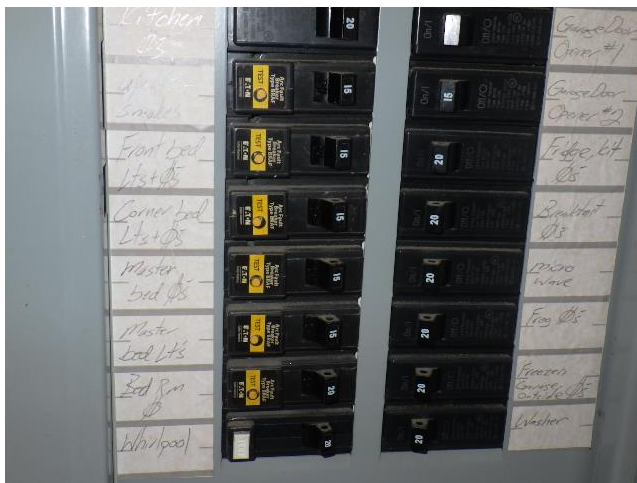
There are six arc fault breakers and one GFCI breaker present in the left main electrical panel. These are older style Eaton brand breakers which are known to malfunction over time with age. The breakers do trip and reset during the inspection when pressing the integrated test buttons.

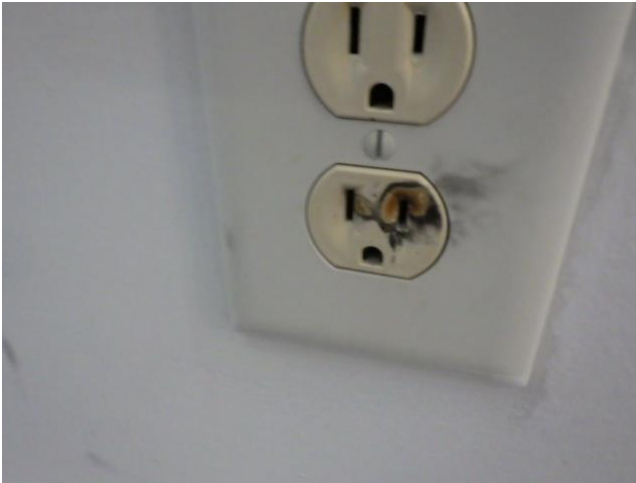
Scorching is visible on the face of a receptacle at the left wall inside the FROG. A cause, for this could not be determined during the inspection. Even though the receptacle tests to be functioning, replacement is recommended through a qualified electrician to ensure safety.

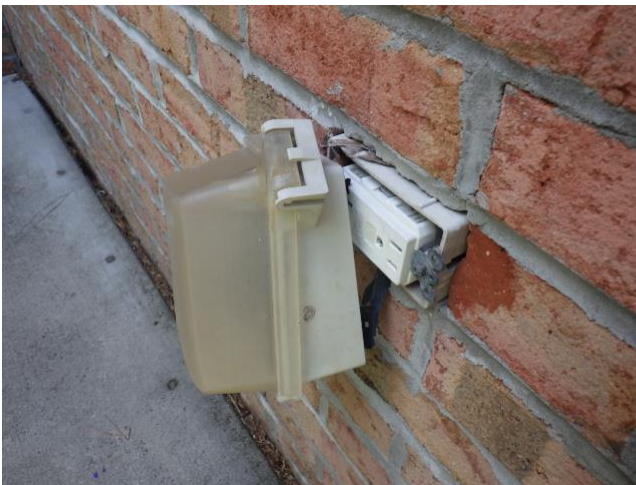
The GFCI receptacle and associated weatherproof cover are not secured in place at the right exterior wall near the entry door to the garage. Recommend investigating repair through a qualified electrician.

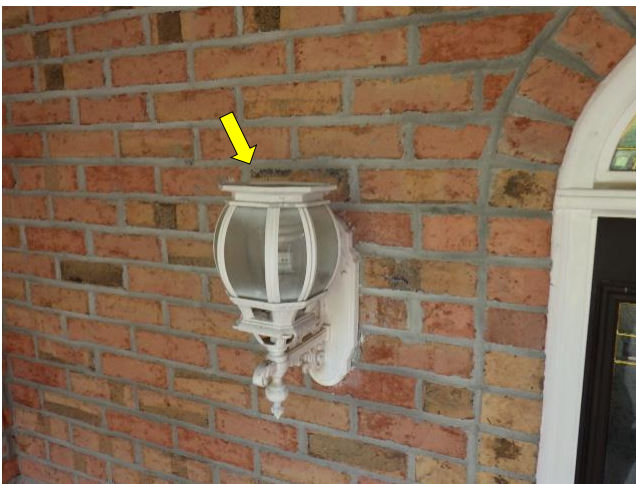
The top cap is missing for the left light fixture at the front exterior entry door. Installation is warranted to seal off this opening.

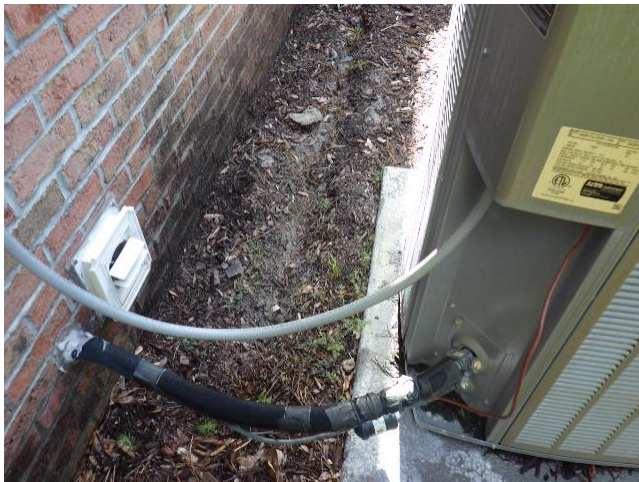
The dryer exhaust discharges at the right exterior directly behind the heat pump unit. This is not a desired condition as it could contribute to lint accumulation on the coil. Routine cleaning of this heat pump unit should occur due to this condition. Consider investigating possible relocation of the dryer exhaust hood through a qualified contractor.

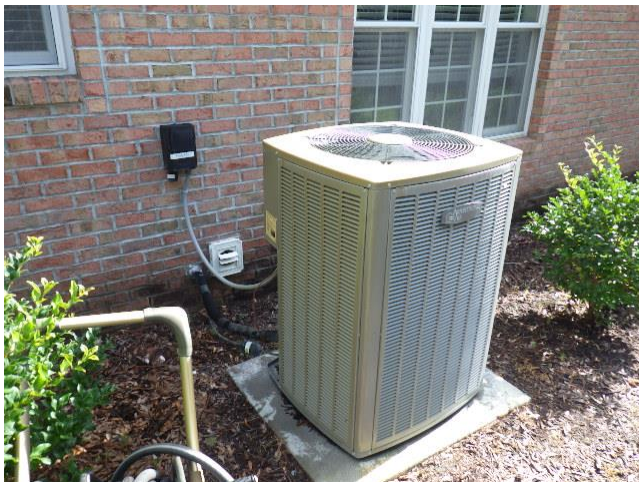
The right exterior heat pump unit exhibits a significant amount of movement on its pad when pressure is applied (rocks back-and-forth). Recommend investigating action through a qualified HVAC technician to install shims or other modification to fully stabilize the unit.

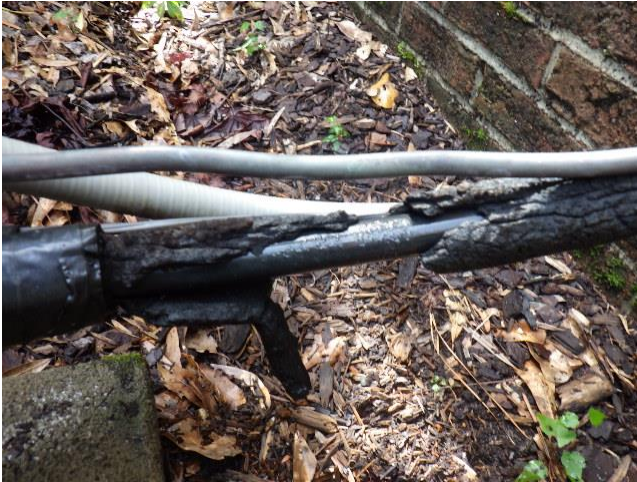
Insulation is deteriorated on the refrigerant line at the left exterior heat pump unit. Recommend investigating repair through a qualified HVAC technician.

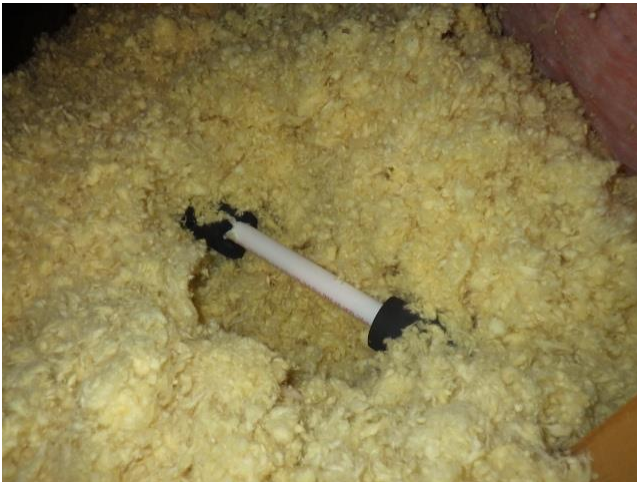
A section of the primary condensate drain line is not insulated in the high attic near the air handler. This can allow condensation to form on the exterior surfaces of this piping seasonally and drip into the insulation below. Recommend action through a qualified HVAC technician to fully insulate the drain line, to prevent condensation from forming.

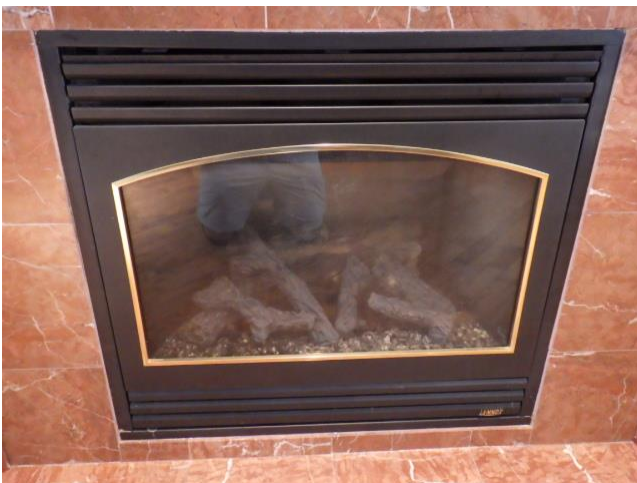
The gas log unit cannot be operated as a propane tank is not present. A remote connection is located in the rear yard. The log unit appears to be older and possibly original. Recommend investigating this further through a gas log specialist to ensure proper functionality and also ensure integrity of the gas line.

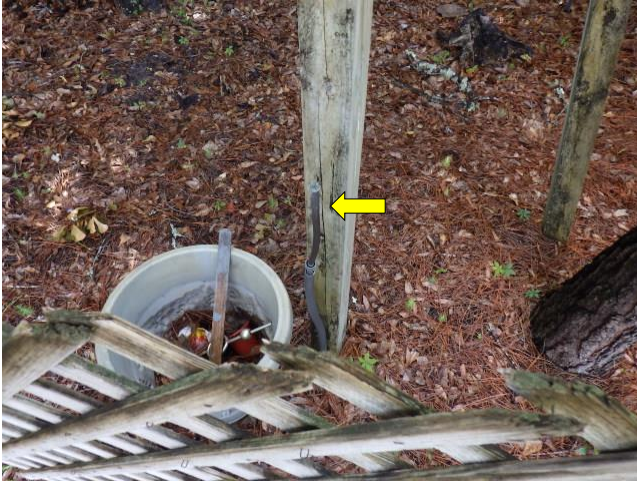
View showing the gas piping at the rear exterior. This has not been properly capped off and a regulator is not present.

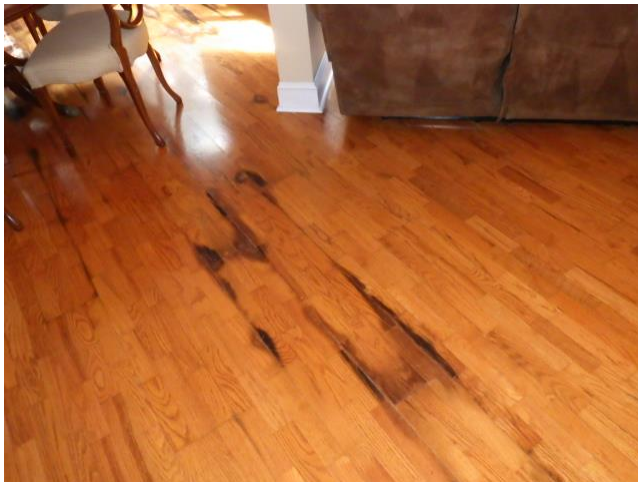
Flooring through the dining and living room areas as possible pet stains, and other discoloration. Flooring in the living room near the rear entry door is generally worn and weathered. Recommend investigating these conditions further through a flooring specialist and take any corrective action warranted to resolve.
