Building Inspection Report

See Report Overview for Exclusive Use

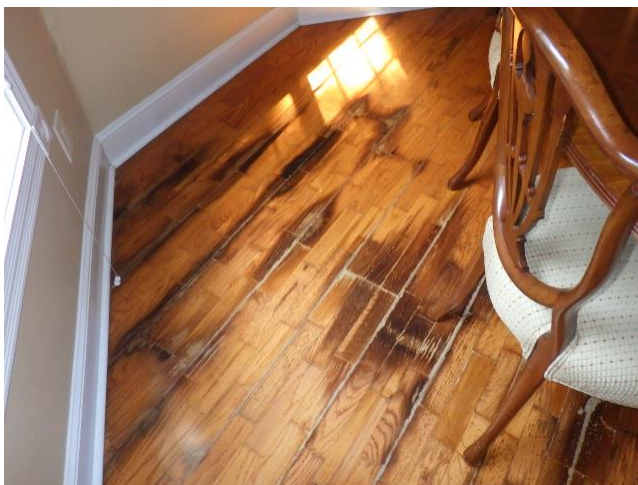
Second view showing stained flooring in the dining area.

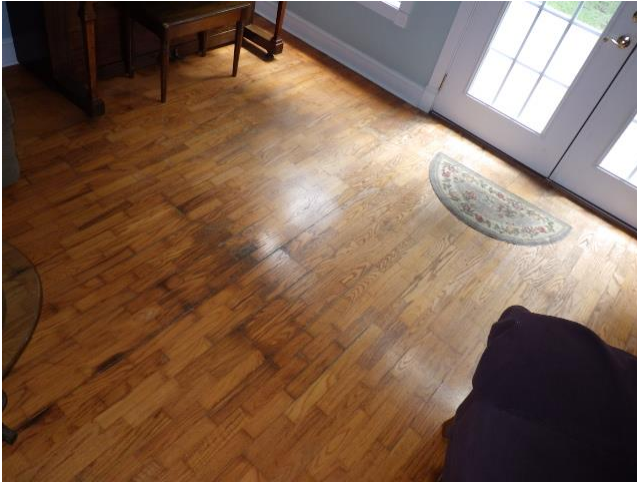
View showing flooring in the living room that is weathered and stained.

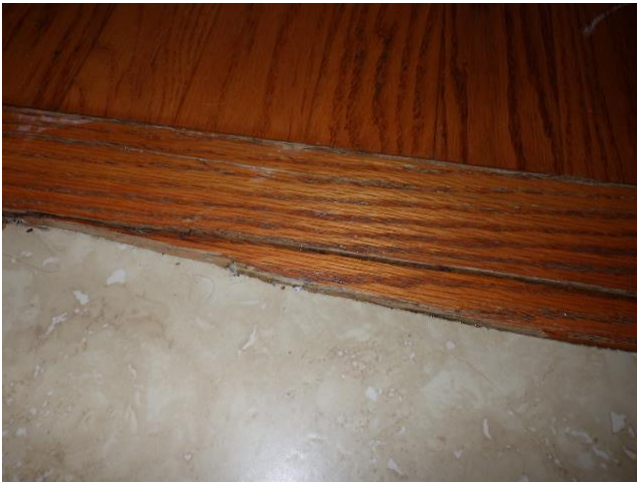
The transition strip between the foyer tile floor and wood flooring is partially cracked and missing. Replacement of this component is warranted.

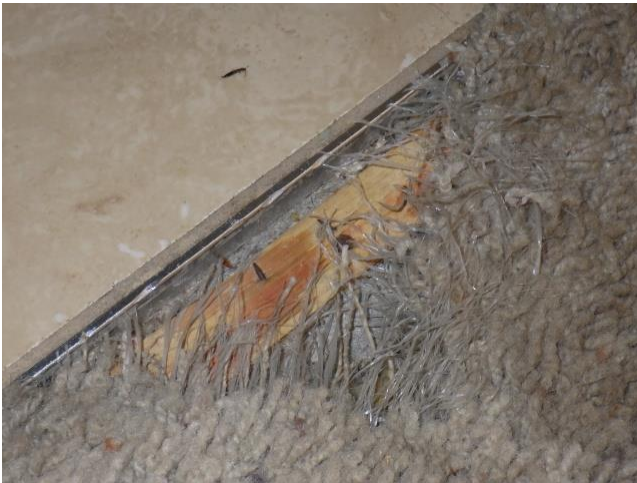
There is a small area of damaged carpet at the entry leading into the primary bathroom. Placement of this carpet section is warranted.

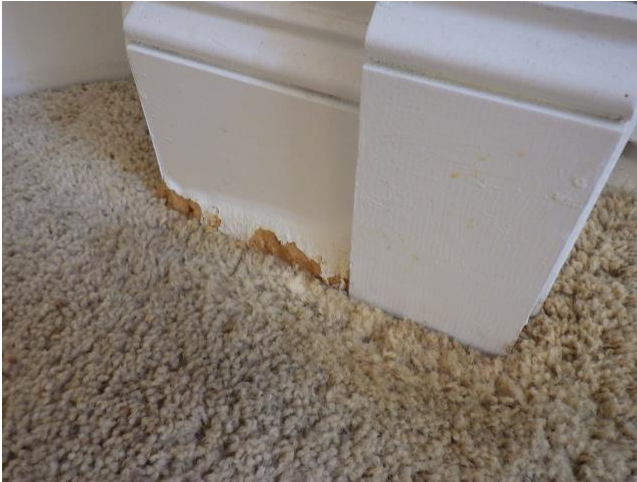
There is pet urine damage on baseboard trim in the primary bedroom to the left of the entry door leading into the bathroom. Replacement of this trim is warranted.

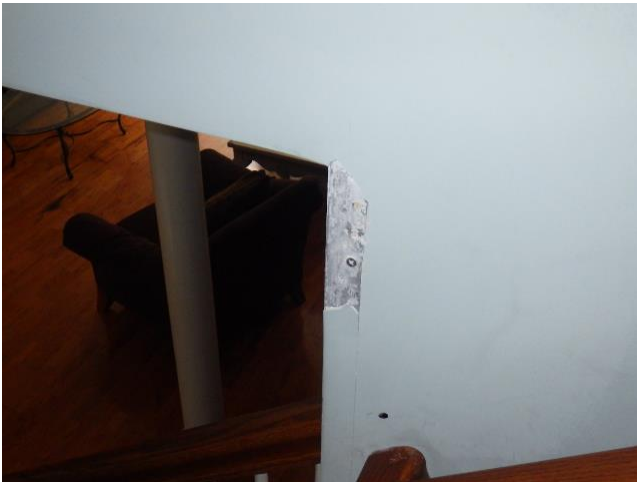
There is cosmetic damage on the drywall at a corner for the wall at the stairway leading to the FROG. Cosmetic restoration is warranted.

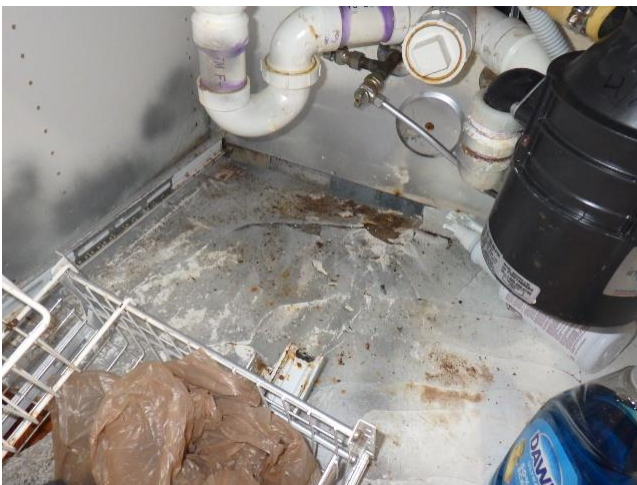
The bottom panel is severely water damaged for the kitchen base cabinet underneath the sink. Recommend investigating replacement of this panel through a qualified contractor.

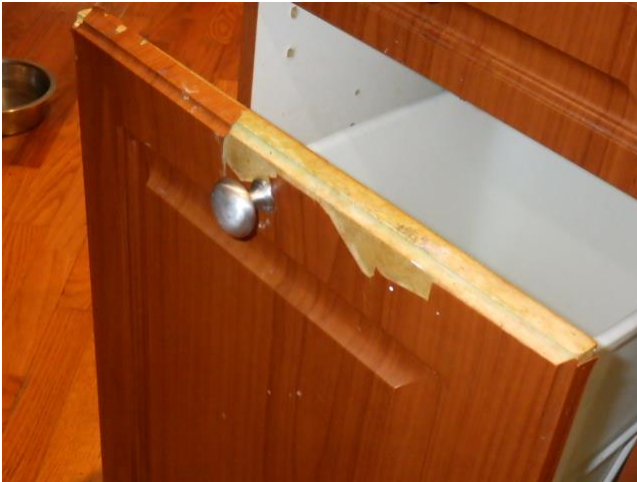
The cabinet panel for the kitchen garbage can is delaminating and difficult to operate. Recommend investigating repairs through a cabinet specialist.

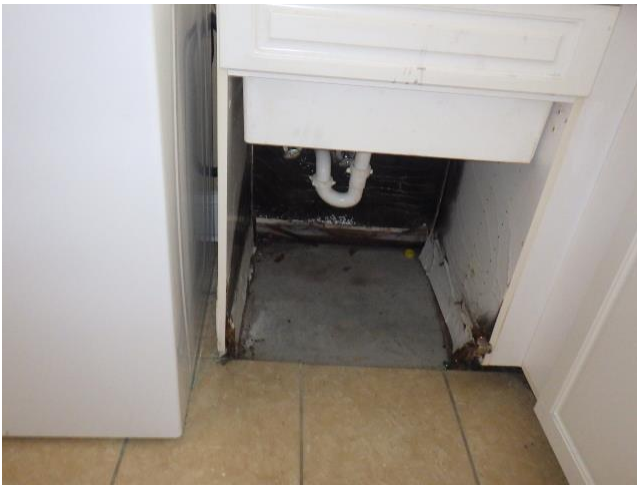
There is severe water damage at the base cabinet in the laundry room underneath the sink. The bottom panel and the cabinet door are both missing. Additionally, the plastic laminate is not secured on the countertop at the left end of this base cabinet. Recommend investigating replacement of this cabinet through a qualified contractor.

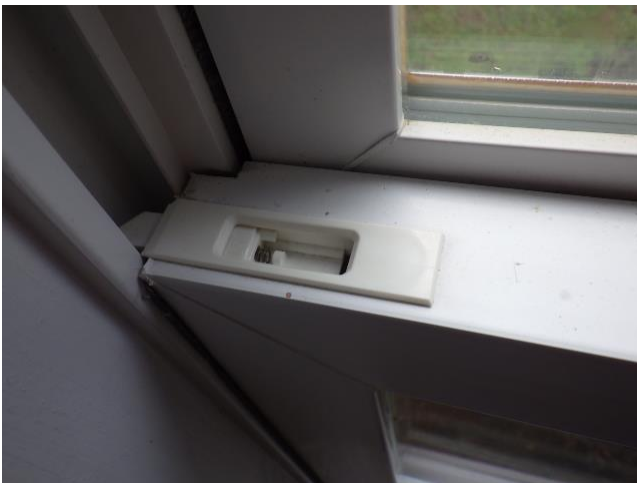
One of the tilt release latches is broken for the right window in the rear dining area. Replacement of this component is warranted.

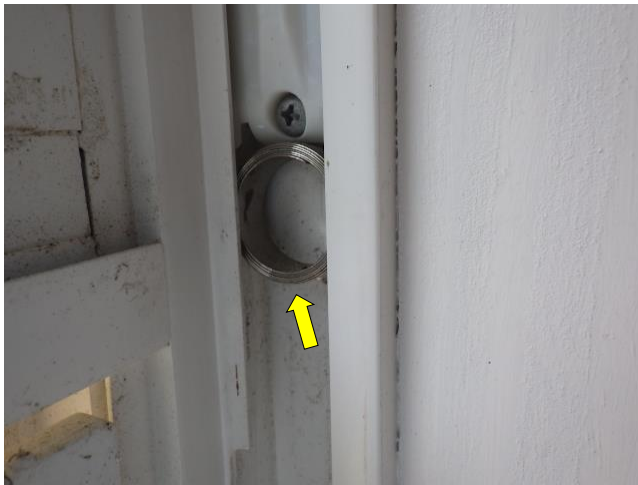
The lower sash for the front window on the left wall in the FROG has a broken jamb mechanism and does not properly operate (oriented when facing the front of the building). Recommend investigating repair through a window specialist.

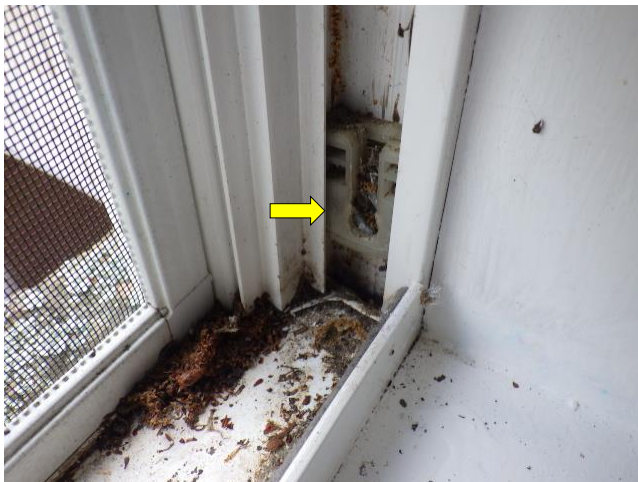
The lower sash for the rear window on the left wall in the FROG has disconnected/damaged jamb mechanisms and does not properly operate (oriented when facing the front of the building). Recommend investigating repair through a window specialist.

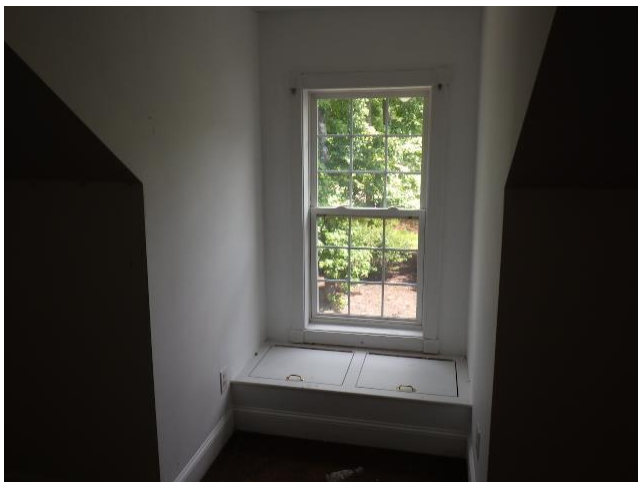
Storage has been added underneath all four windows in the room above the garage. These details are considered potentially unsafe as it introduces falling potential for small children should they be left unattended with a window open. Recommend adding child safety locks to the windows to prevent them from being fully opened.

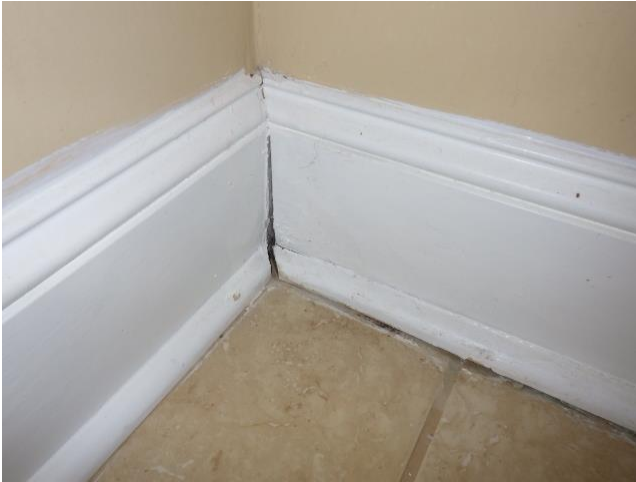
There are large gaps in the corners where baseboard sections come together behind the toilet in the primary bathroom. An exact cause for this could not be determined during the inspection however appearances suggest past possible moisture exposure. Recommend investigating cosmetic repair through a qualified contractor.

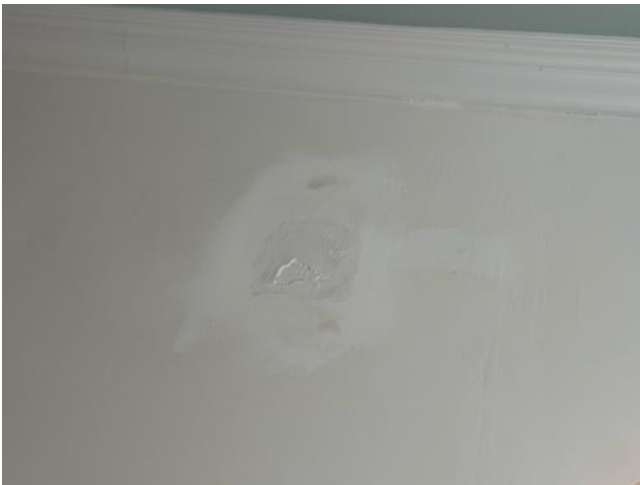
There is a blemish in the living room ceiling where some attempted patching has been performed. This is at an area where one of the dark stains is identified in the attic. Additional cosmetic restoration is warranted to restore the drywall once shingle replacement has occurred.

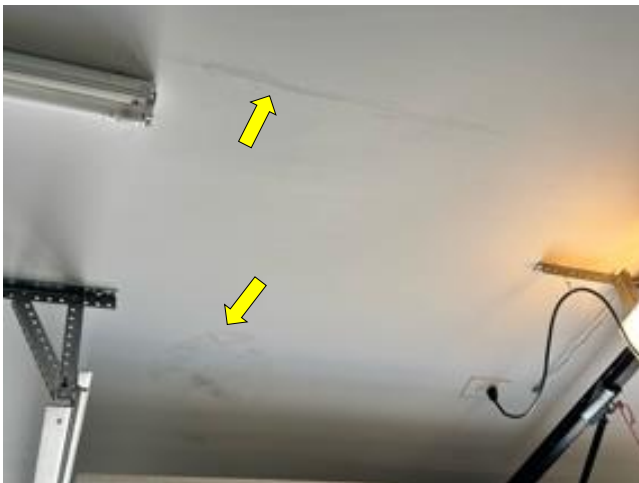
There is faint staining on the garage ceiling above the rear bay. A cause for this could not be determined during the inspection as there is no plumbing in the FROG above. Recommend investigating this further through a qualified contractor to determine the source. Cosmetic restoration is warranted for the garage ceiling.

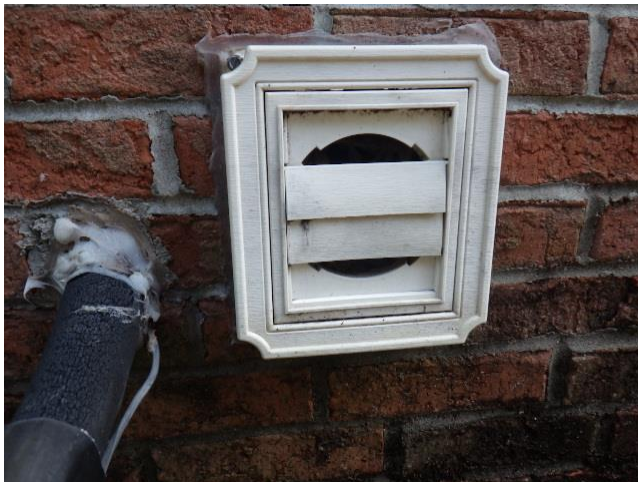
Two of the four louvers are missing for the dryer exhaust hood at the right exterior. Installation is warranted to properly seal off the opening when the appliance is not in use.

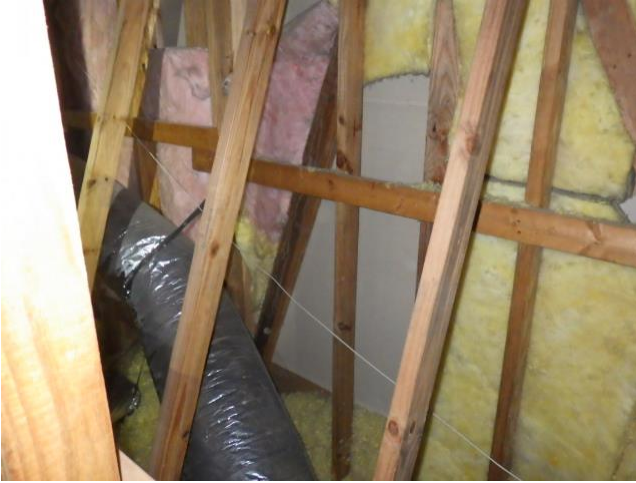
Three insulation batts are missing from the rear wall of the FROG as seen from inside the main attic. Replacement of this installation is warranted to fully insulate the wall.

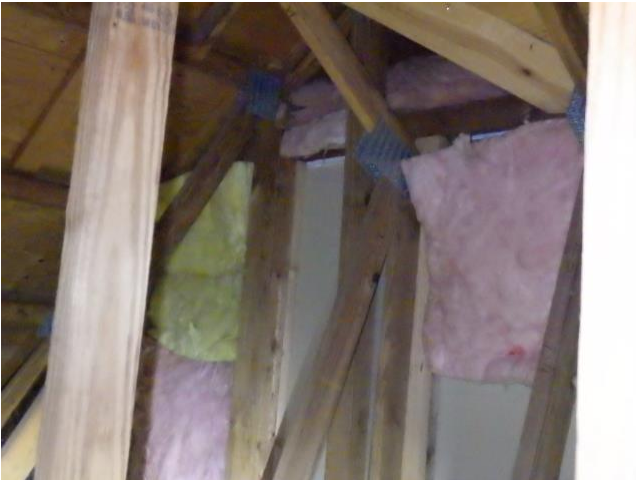
Second view showing missing insulation from the rear wall of the FROG.

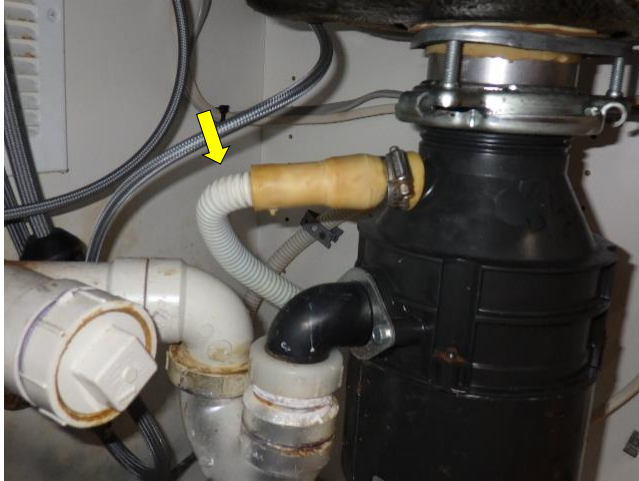
The dishwasher drain tubing does not have a visible high loop configuration where it connects under the kitchen sink. The high loop is needed to prevent dirty water from potentially back-flowing into the dishwasher and contaminating dishes or utensils. Recommend modification of this drain tubing for improved safety.
