Property Inspection Report

Report Number: 2402

2402 Carey Rd.
Kinston, North Carolina 28504

Date of Inspection: Thursday, May 29, 2025

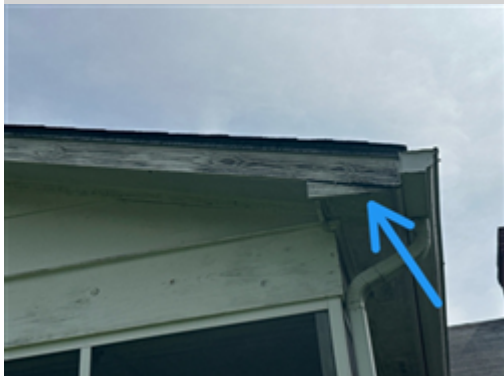
The fascia boards are suspected to be decayed on the rear of the rear of the screen porch. While pressing up trim that covers the fascia on the side of the home, a soft and crunchy feeling was discovered. Because of the siding and trim it is not possible to directly examine the beam. A licensed general contractor should be consulted for an inspection of the area and to make any necessary repairs.

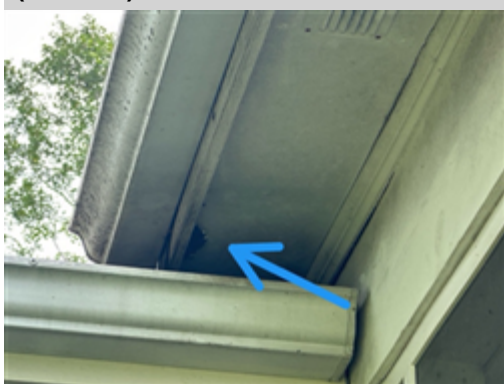
The soffit is decayed on the rear of the home where the screened porch roof ties into the main roof on both the left and right sides as well in the area above the screen door. No other surrounding areas showed any evidence of damage. A licensed roofing contractor and/or licensed general contractor should be consulted to perform an invasive inspection to determine the source of the water that has caused the decay and of the surrounding areas and to make any necessary repairs.

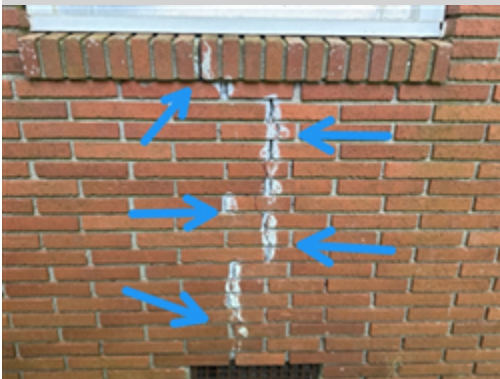
There is an open crack in the brick veneer as seen on the right of the home. The open crack can allow water to penetrate behind the brick veneer system to the framing of the home. The crack did not progress to the foundation area. The seller can be asked for disclosure in regards to progression of any cracks on the home. The buyer should monitor the home for new cracks and the existing cracks for any progression. A masonry contractor or general repair specialist can be consulted to seal any open cracks to prevent water from accessing the framing of the home.

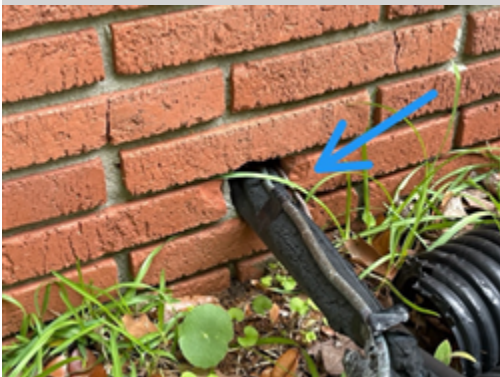
The AC line exits the siding system on the right side of the home. The seal around this exit is missing. This can allow water to penetrate behind the siding system to the framing of the home. A general repair specialist or licensed general contractor can be consulted for review.

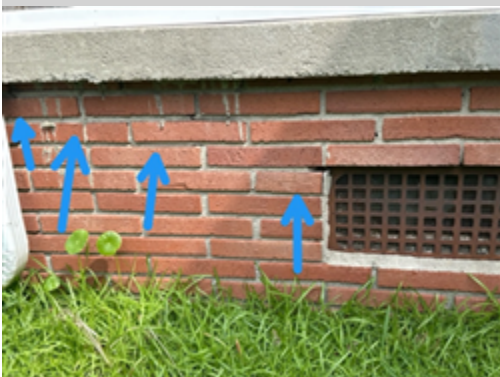
Cracks were noted in the brick veneer on the rear and right of the home. The cracks on this home were closed at the time of the inspection and presented no visible evidence of progression to the foundation areas, however, the cracks could open or change seasonally. The sellers should be asked for disclosure related to progression, history of repairs, or seasonal changes of the cracks. The buyer should observe the cracks to see if they get larger. The buyer should monitor the brick veneer system for any new cracks. If concerned further, a masonry contractor or licensed general contractor should be consulted for further evaluation of the brick veneer system.

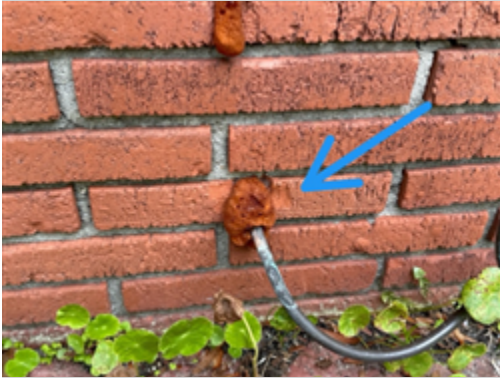
Spray foam was observed around gas piping penetrations at both the rear and right sides of the home. This type of foam is not intended to be used as a permanent or proper sealant around gas lines, as it may degrade over time and does not provide an adequate barrier against moisture or pests. A licensed contractor should be consulted to remove the foam and properly seal the penetrations with code-compliant materials.

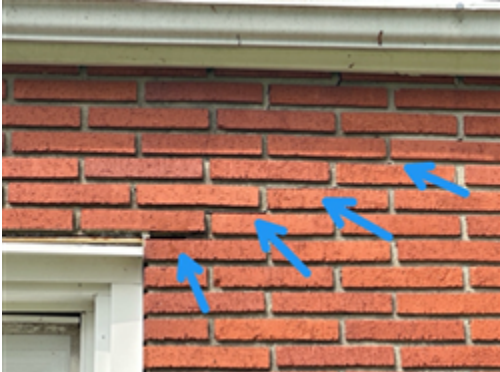
There is a crack in the mortar between the brick veneer above the lintel that spans the garage and the trim. The lintel is designed to support the weight of the siding above the garage door. The crack in the mortar can allow water to penetrate to the lintel and flashing area, which can cause decay. A masonry contractor should be consulted to review the brick veneer and make any necessary repairs to prevent water from penetrating to the lintel area. If concerned, a licensed general contractor can be consulted to review the lintel to determine the extent of the water penetration.

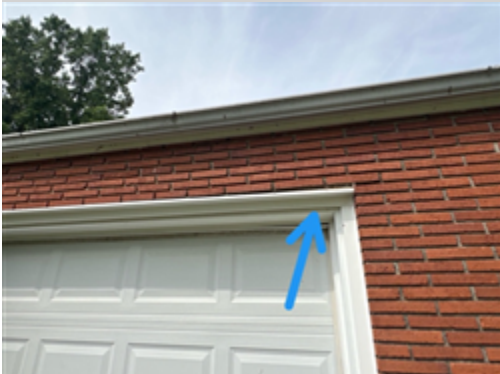
The trim that covers the lintel over the opening of the garage is loose. The lintel is the metal piece that spans the top of the opening and supports the bricks above it. When the trim is loose, it can allow moisture to get to the lintel. When wet, the lintel can rust and expand, potentially causing cracking in the brick veneer. A general repair specialist, masonry contractor, or licensed general contractor can be consulted for review.

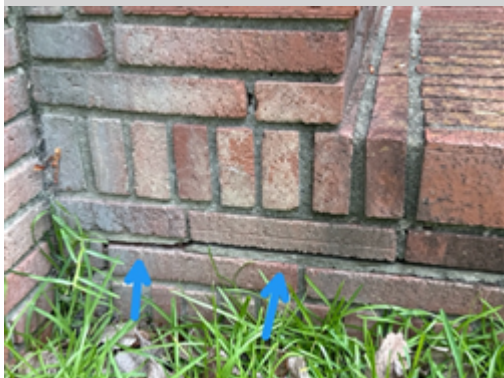
There is a crack in the masonry steps on the rear of the home. The crack shows evidence of movement. The buyer should monitor the crack to see if it changes over time and if concerned should consult an engineer to review and recommend repairs.

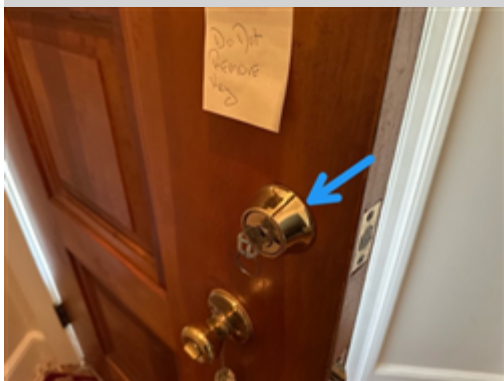
The front and rear door to the home have a double key deadbolt lock. This type of lock cannot be unlocked from the interior of the home without the key and is not recommended for main egress doors. In the event of an emergency, the key may not be available resulting in a person not being able to exit the home. Replacement is recommended by a general repair specialist.

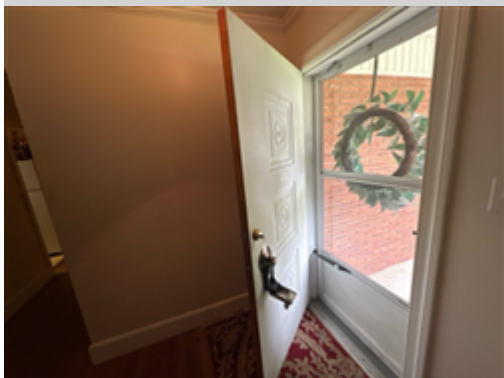
The front door is not plumb. The door does not stay in a set position. This can indicate an issue with installation or the hinges. A general repair specialist should be consulted for review.

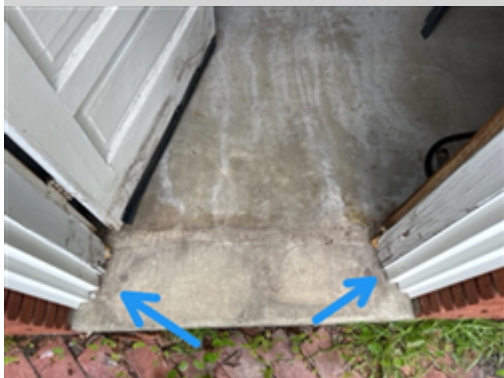
The garage man door frame is starting to get soft. This indicates that water has accessed this area of the door. A general repair specialist or licensed general contractor can be consulted to review the area to prevent water from causing decay.

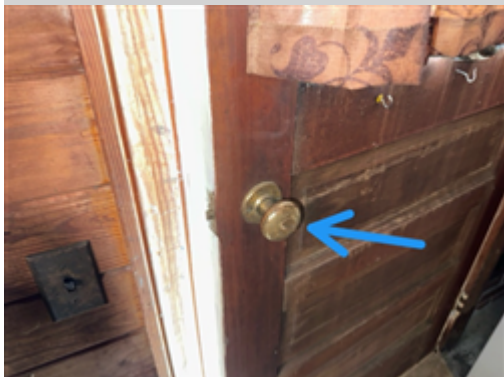
The garage man door lock assembly is not functional. The lock could not be engaged to secure the door. A general repair specialist or licensed general contractor should review the lock and make necessary repairs to ensure that the door closes securely.

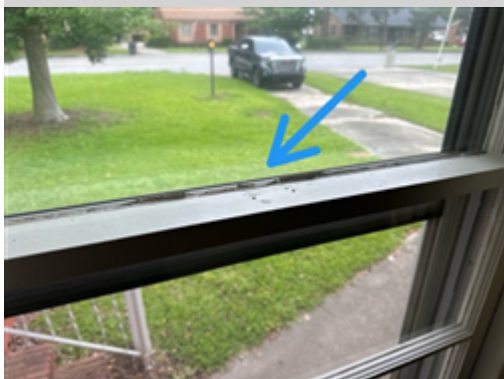
The locking mechanism on all the windows are damaged or missing. A damaged or missing locking mechanism can effect the safety of the home. A general repair specialist should review and make necessary repairs.

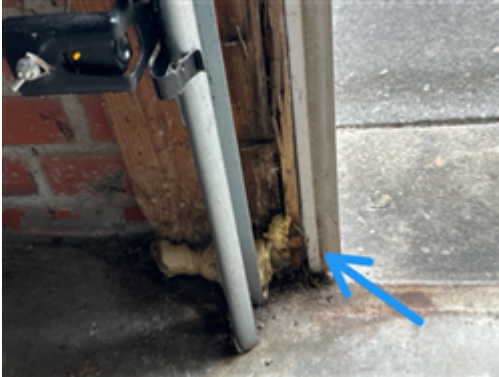
The trim around the garage door was noted to have areas of decay near the left and right side on the bottom. A continuous moisture presence is necessary for decay to take place. A general repair specialist or licensed general contractor can be consulted for review.

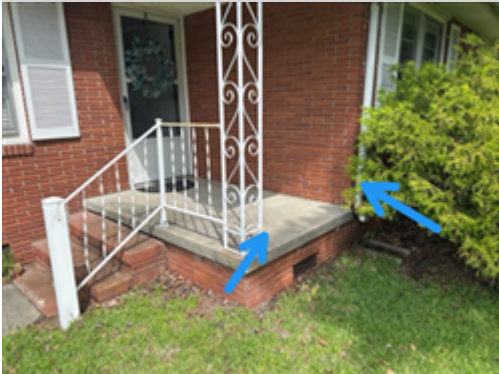
The porch does not have handrails to prevent accidentally falling or stepping off the floor surface. It is recommended that handrails be installed to ensure safe and functional use of the porch. If desired, a general repair specialist or licensed general contractor should be consulted for a complete evaluation and to make necessary repairs.

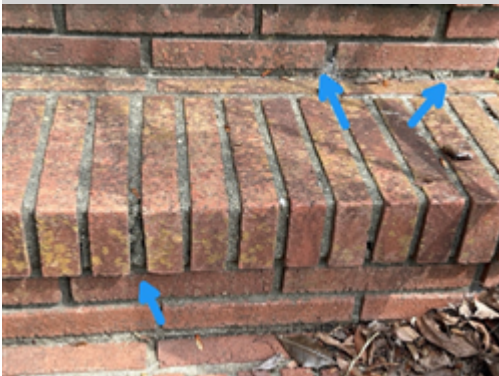
The masonry system of the front porch steps have low and missing mortar in between some of the masonry units. This can allow water to penetrate to undesirable locations and cause masonry units to become dislodged and create a trip/fall hazard. A masonry contractor or licensed general contractor should be consulted to review all of the masonry units on the porch and make necessary repairs.

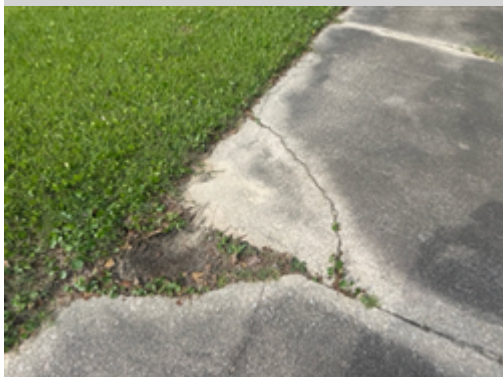
The driveway is cracked. The buyer should monitor the driveway for any new cracks and to see if the existing cracks get larger or show signs of displacement. If ever concerned, a licensed general contractor should be consulted.

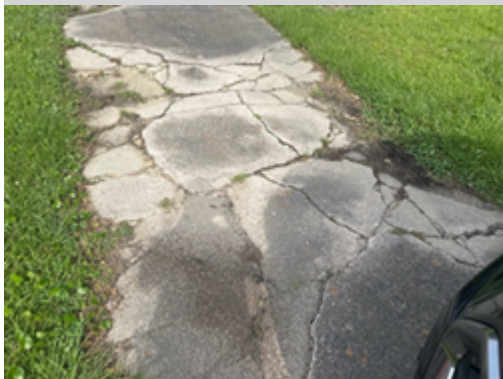
There are a higher number of cracks and displacement in the driveway than is normally seen. A licensed general contractor should be consulted to review the driveway and provide guidance to the buyers.

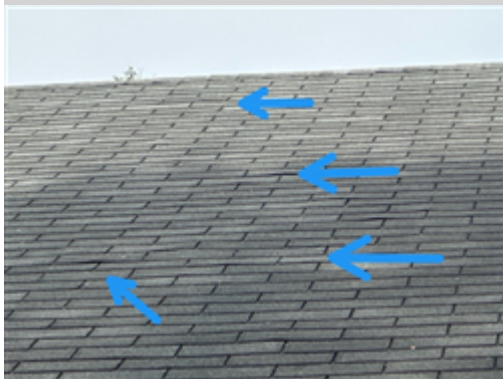
Raised shingles were noted on the front and rear of the roof surface. Displaced shingles can indicate an underlying problem with the shingle's installation or attic conditions. A licensed roofing contractor should be consulted for a complete evaluation and repair to ensure the weathertightness of the roof covering system.

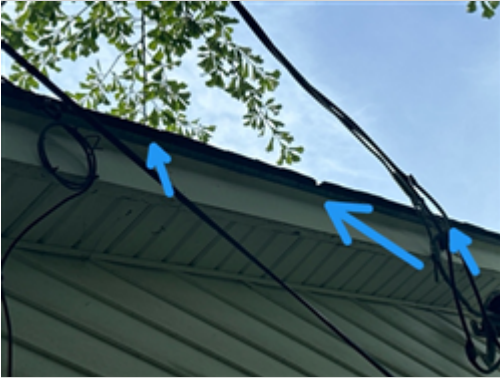
The shingles were noted to be damaged on the right side of home from the overhanging tree. Damaged shingles can allow water to penetrate to the roof sheathing. A professional roofing company should be consulted to review the entire roofing system and make any necessary repairs.

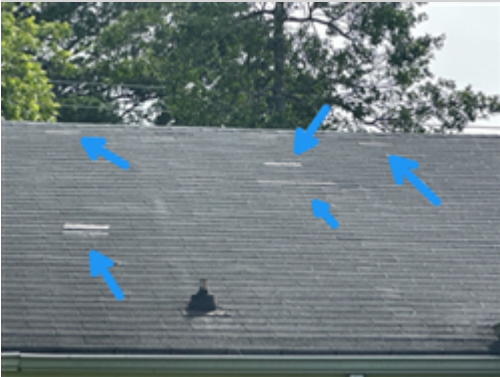
Several shingles are missing or damaged over the front and rear areas of the roof surface. The missing shingles could indicate an underlying problem with the shingle installation or the sheathing. A licensed general contractor should be consulted for a complete evaluation of the roofing system to verify that shingles are installed correctly and to make necessary repairs to ensure the weathertightness of the roof covering system.

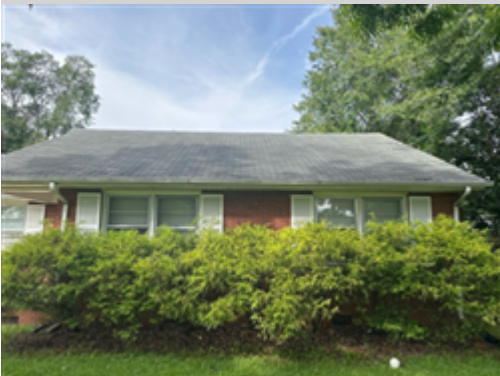
The shingles have visible signs of deterioration such as tab shrinkage, low ballast, and exposed base matt that indicate that they are approaching the end of their service life. Damaged shingles are in need of replacement. A licensed roofing contractor should be consulted for a complete evaluation of the roof covering and flashing systems to make necessary repairs to ensure the weathertightness of the roof covering system.

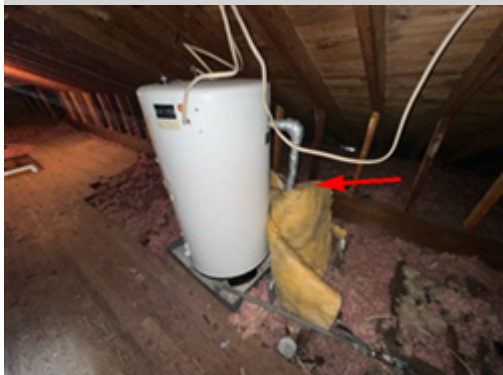
The supply lines are only partially insulated, and the existing insulation is deteriorated or poorly installed. This can reduce energy efficiency and may lead to condensation or freezing issues in unconditioned attic spaces. A plumber should be consulted to evaluate the system and repair / replace as needed to ensure safe and reliable hot water supply.

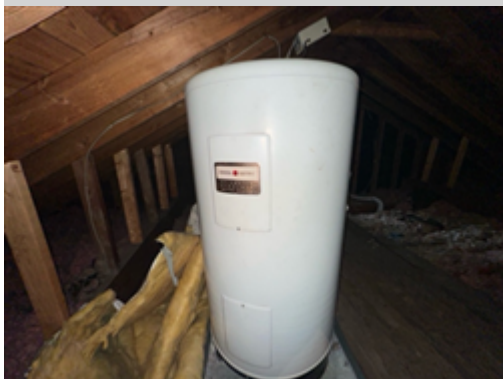
The water heater appears to be older based on visual inspection. If concerned with the remaining service life, a licensed plumber should verify the age and evaluate whether replacement is recommended.

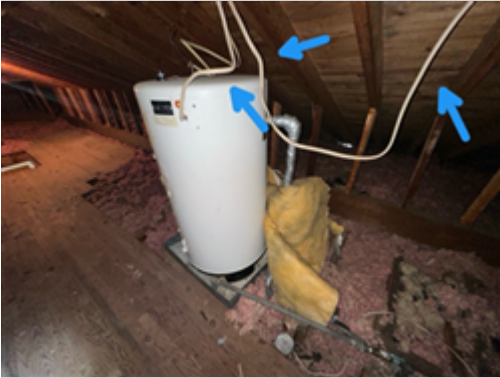
The electrical wiring is loosely routed and not enclosed in protective conduit. This is not appropriate for an attic environment, where physical damage is more likely, and poses a safety hazard. A Licensed electrician should be contacted for further evaluation.

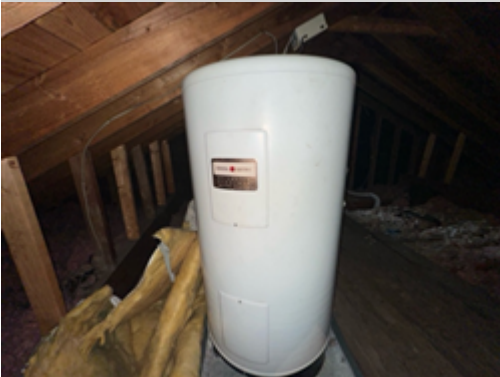
The hot water heater was noted to be in the attic. The water heater should be monitored to ensure it is not leaking, which can cause property damage. If concerned, a plumber should be consulted for review.

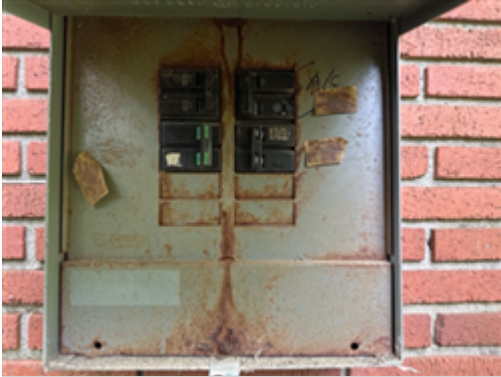
All of the breakers in the panel have been added or replaced. The new breakers are of a different brand from the panel enclosure and are not listed on the label of the panel. Breakers must be UL listed and certified for each panel to ensure proper operation. The compatibility of the breakers to the panel needs further evaluation by an electrician to ensure safe and proper operation of the overcurrent protection systems.

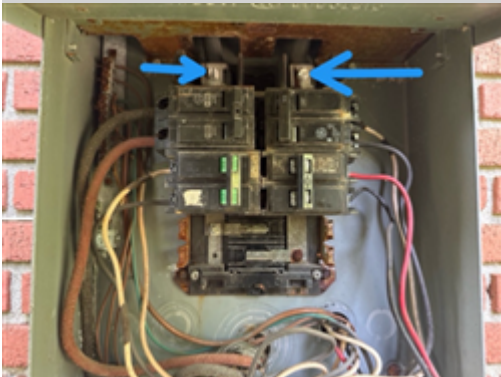
The lugs that secure the main electrical service cable are corroded. Corrosion on the lugs could result in arcing and overheating. This condition presents a safety hazard that could result in interrupted service, property damage, and serious personal injury. An electrician should be consulted for repair and a complete evaluation of the electrical system.

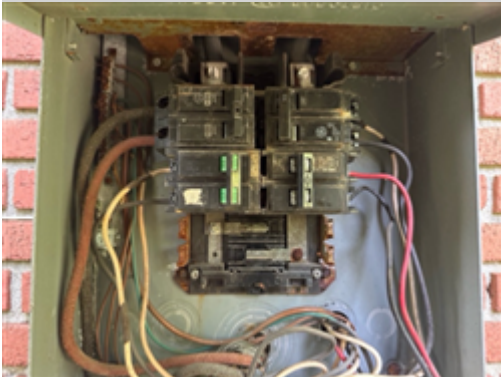
Rust and corrosion are present, particularly near the top and bottom of the panel, which may compromise electrical connections. A licensed electrician should be consulted to evaluate the panel for safety, correct wiring practices, and code compliance.

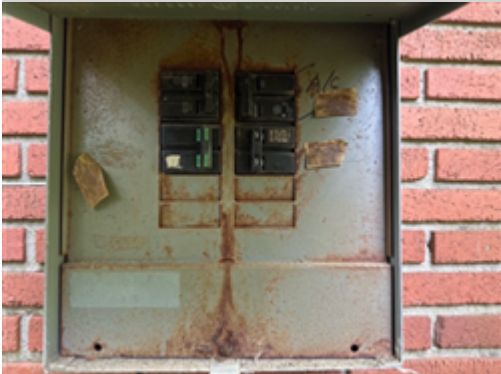
There is rust on the main electrical service panel on the exterior of the home. This indicates that water has been able to penetrate the system. Rust makes metal weak and can allow water to further penetrate into the panel. An electrician should be consulted for review.

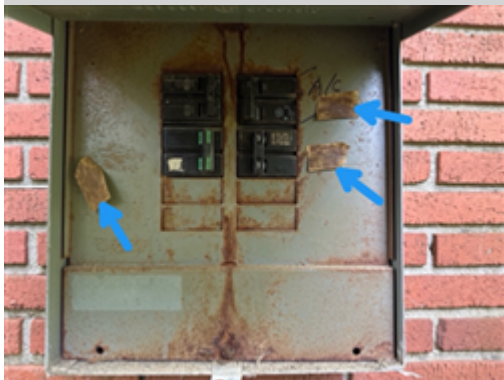
The breakers in the main electrical service panel have faded labels. Easy to read labels for the breakers are vital to the safety of any person who operates or works on the electrical system. An electrician should be consulted to correctly label the breakers.

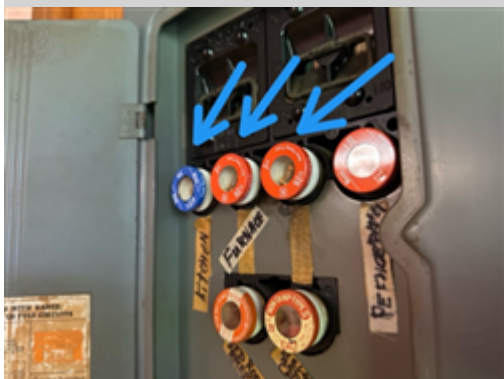
The distribution panel in the kitchen is an older fuse-type panel, and several fuses were observed protruding further than the others. This may be a sign of improper installation or unsafe tampering. Fuses should sit flush when properly installed. A licensed electrician should be consulted to evaluate the panel for safety and code compliance.

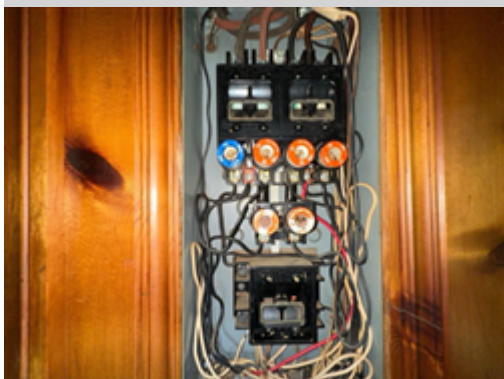
The distribution panel is an older fuse-type system, which is considered outdated by current standards. A licensed electrician should be consulted to evaluate the panel and overall electrical system for safety, capacity, and compliance with modern codes.

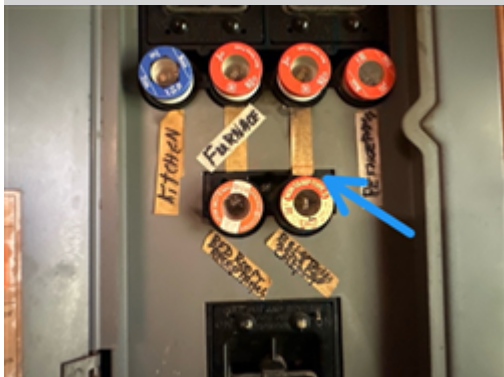
The fuses in the distribution electrical service panel in the kitchen have faded labels. Easy to read labels for the fuses are vital to the safety of any person who operates or works on the electrical system. An electrician should be consulted to correctly label the breakers.

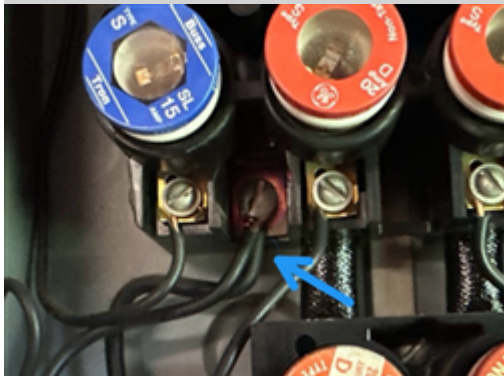
The fuses of the electrical panel have two conductors attached to the power screw. Typically, fuses are not rated for double taps due to possible loose connections and circuit overloads. This condition presents a safety hazard that could result in interrupted service, property damage, and serious personal injury. An electrician should be consulted for further evaluation and repair.

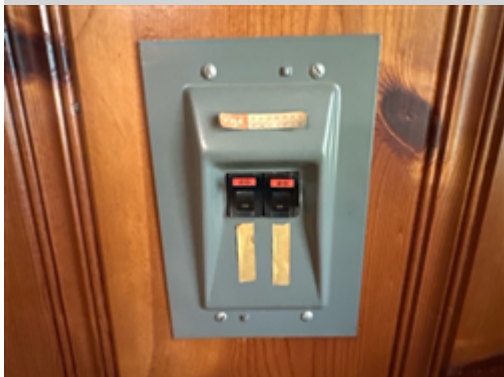
The distribution electrical panel in the kitchen is a Federal Pacific Electric Stab-Lok service panel. There have been multiple reports of problems associated with these electrical panels which could affect the safety and habitability of the home. Determination of specific potential problems for the equipment installed at this home is beyond the scope of a home inspection. Further investigation by an electrician is recommended to determine if the panel should be replaced and the approximate cost of replacement.

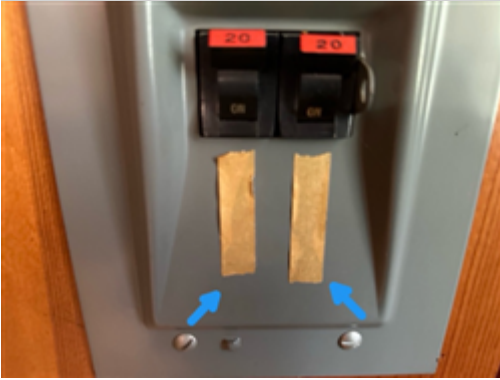
The breakers in the distribution electrical service panel in the kitchen are not labeled. Correctly labeled breakers are vital to the safety of any person who operates or works on the electrical system. An electrician should be consulted to correctly label the breaker.

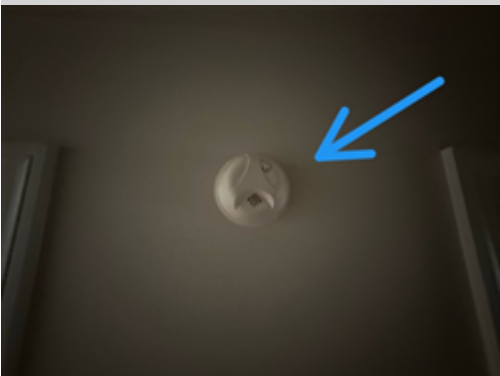
This home has a limited number of smoke detectors as compared to current standards. Currently it is recommended that a smoke detector be installed at each floor level in the home and in each sleeping room. Correction and installation are recommended.

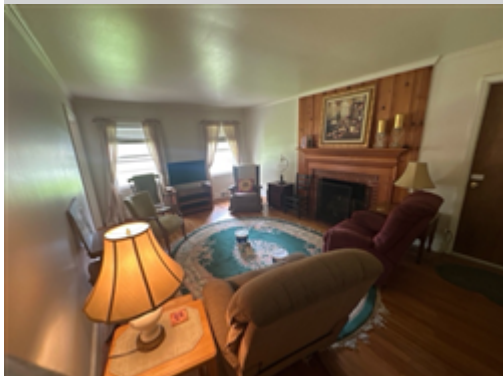
All homes with gas or oil appliances should have a carbon monoxide detector installed to detect improper appliance operation and prevent possible carbon monoxide poisoning. It is recommended that a CO detector be installed for each section of the home.

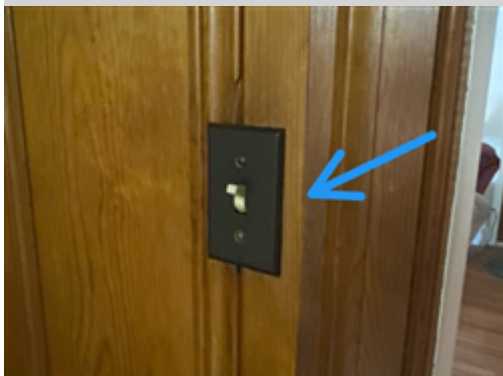
The switchbox located in the dining room is loose. Loose switchboxes could result in electrical shock or property damage. An electrician should be consulted for a complete evaluation to determine the significance of this concern and make necessary repairs to correct defects and prevent safety hazards.

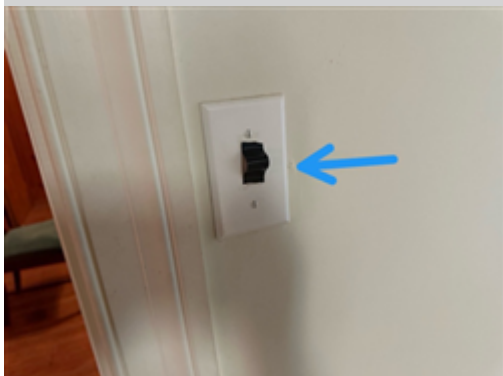
The light switch in the hallway and on the living room front wall is broken, making operation of the switch difficult. A general repair specialist or electrician can be consulted for repair.

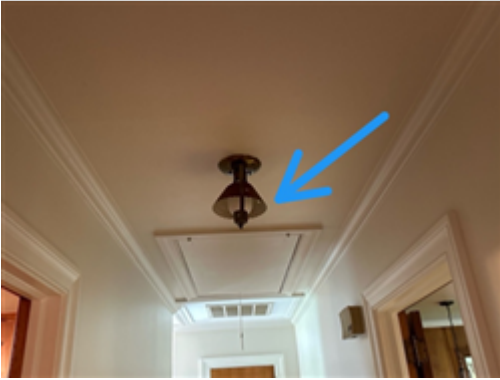
The light fixture in the hallway does not function. A general repair specialist should replace the bulb and if after that the fixture doesn't work an electrician should be consulted for review and repair.

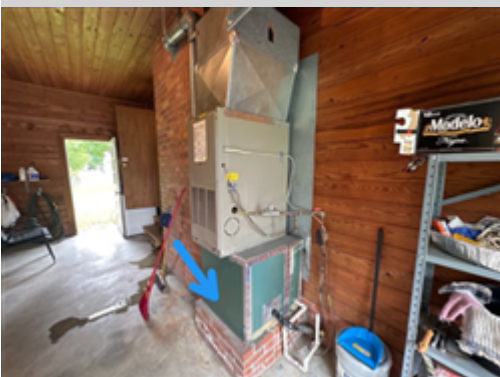
Since the unit is located in a garage, its important that any open flames or ignition sources (such as from the burner) are elevated at least 18 inches above the floor to reduce the risk of igniting flammable vapors. A licensed HVAC technician should be consulted to evaluate the installation for safety and compliance

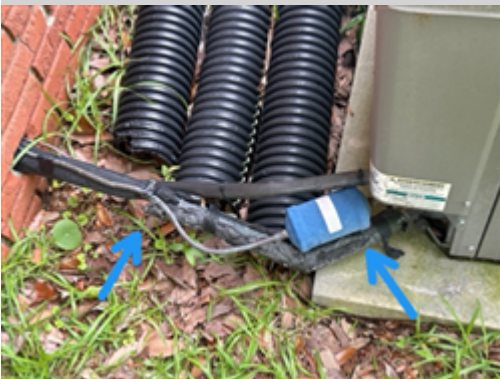
The insulation around the refrigerant line for the air conditioner is damaged/missing. This can cause the condensation to drip down onto the surrounding area. Moisture should be prevented from effecting the interior of the home. A general repair specialist or HVAC contractor should be consulted to review the system to ensure efficient and proper operation.

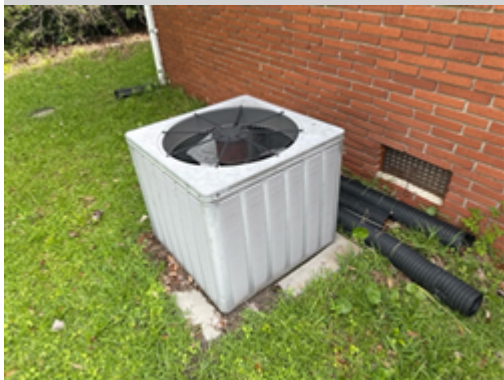
The HVAC system for the home was noted to be older. As HVAC systems age, the probability that they fail increases. An HVAC contractor can be consulted for review.

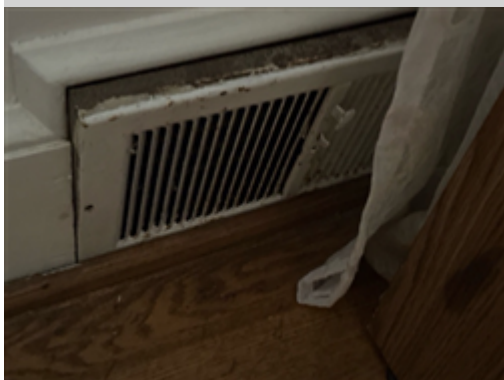
The vents in the following areas appear to be blocked off and are not functional: the rear wall vent in the back left bedroom, front wall of the living room, rear wall of the dining room. These conditions may impact airflow and temperature regulation in the affected rooms. A licensed HVAC contractor should be consulted to evaluate the system configuration for repair.

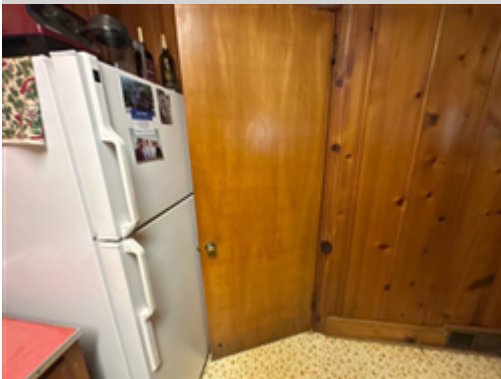
The interior door in the kitchen is obstructed by the refrigerator and cannot fully close. This limits the functionality of the door. A general repair specialist or licensed general contractor should be consulted to review the door and make necessary repairs.

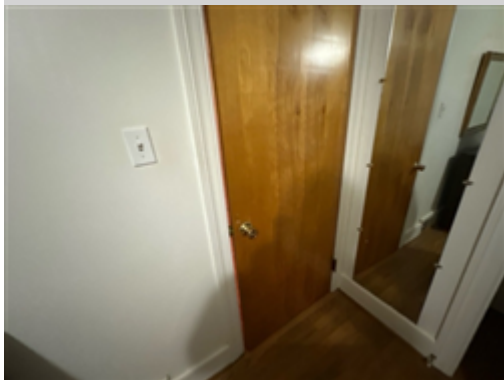
The rear bedroom and bathroom doors do not latch and stay closed. A general repair specialist should be consulted to adjust the door system so the door catches.

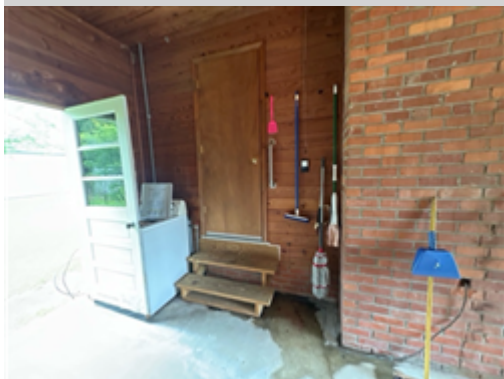
The door from the garage into the home opens over the steps. This is a safety hazard as someone can open the door from the inside and knock another person down the steps. A general repair specialist or licensed general contractor can be consulted for review.

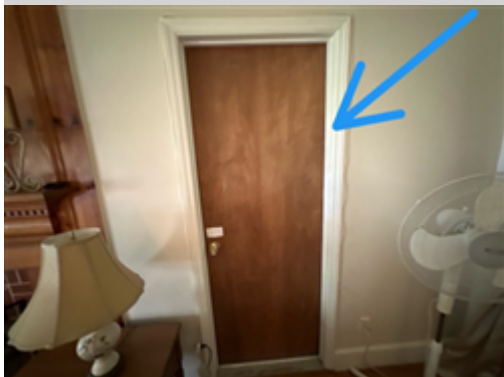
It could not be determined if the door from the garage into the home is a fire rated door. A fire rated door helps in the safety of the home. If concerned further, a licensed general contractor can be consulted for review.

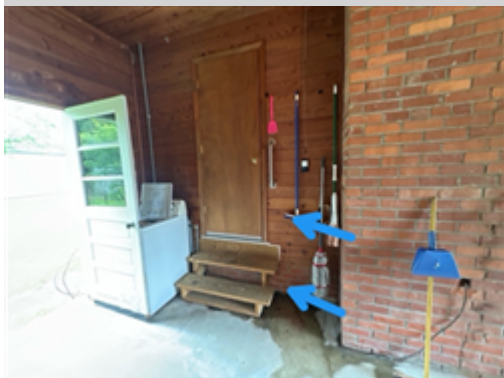
There is not a handrailing on either side of the steps from the garage into the home. This can be a safety/fall hazard. If desired, a general repair specialist or licensed general contractor can be consulted for placement.
