## Property Inspection Report

May 16, 2026 (11:00 AM)

HI57-051626-509Bascom  
509 Walnut St Wilmington, NC

Steel Magnolia Home Inspections

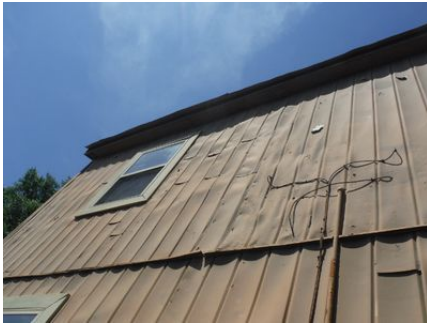
(A1-1.1) Main House

The siding for this home is a vinyl material. The vinyl was noted to be dry and brittle. There are numerous areas of warped panels, the vinyl has been painted (it was not determined if the proper type of paint was used). A licensed general contractor should be consulted for complete evaluation to locate and repair all areas of damage. At the time of the repair, the contractor may be able to predict the remaining service life of the siding system. The exterior of the home has been upgraded with vinyl siding. Wood trim, windows, and exposed hardboard type sidings were noted to be deteriorated. It is suspected that other areas of damage were covered with the vinyl. Deterioration of exterior components can result in water penetration into the living areas and foundation which can result in structural damage and undesirable environmental conditions contributing to fungus/mold/mildew growth. A licensed general contractor should be consulted to repair all visible damage and check the home for possible areas of hidden damage.

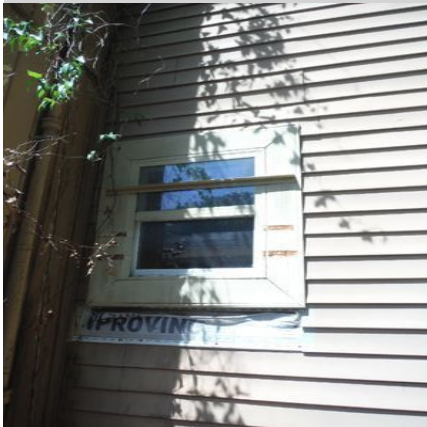
(A1-1.2) Main House

On the right side of the home, several pieces of siding are in need of replacement. A siding installation company or general contractor should be consulted to evaluate and repair the siding to ensure the integrity of the cladding system.

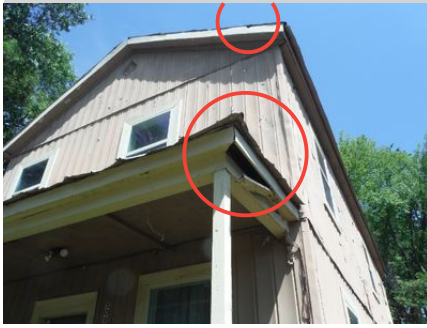
**(A1-1.3) Main House**

The exterior trim and boxing of the home need repairs and painting to prevent further damage and water penetration. The following items were noted during the inspection all areas should be evaluated as a repair plan is prepared: Boxing and trim areas were found to have damage in a few areas related to age, decay. A licensed general contractor should be consulted for a complete evaluation of the exterior siding, trim and boxing to determine the scope of the damage and make necessary repairs.

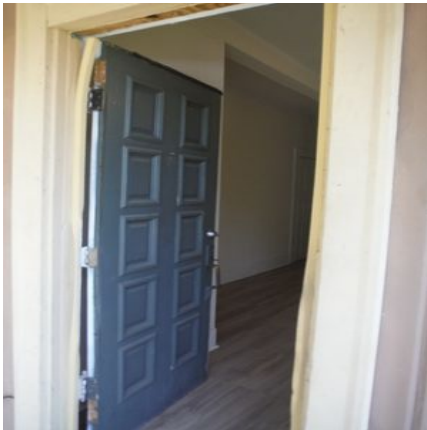
The door weather-stripping is damaged. The weather-stripping needs repair/replacement to ensure that the door closes securely and is weather tight. A general repair specialist or licensed general contractor should be consulted for evaluation and repair.

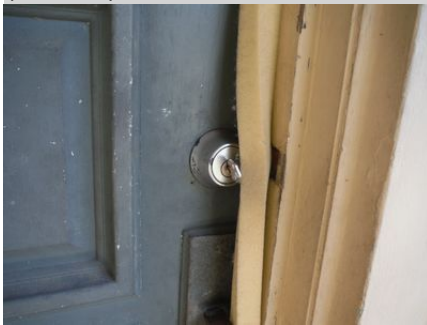
**(A2-1.2) Doors**

The dead bolt key is the same as the apt. 2.

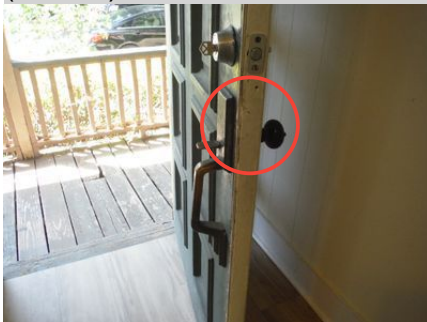
**(A2-1.3) Doors**

The door knob/lock assembly does not operate, the dead bolt has to be engaged to secure the door.

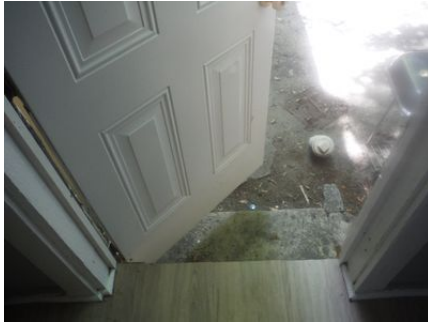
#### (A2-2.1) Doors

The exterior steps were built without a landing which is not typical when the exterior door is installed to swing out over the steps. The door has not been installed in a typical/safe manner. This configuration could result in a trip or fall hazard. A licensed general contractor should be consulted for further evaluation and repair to ensure safe and proper entry and egress to the home.

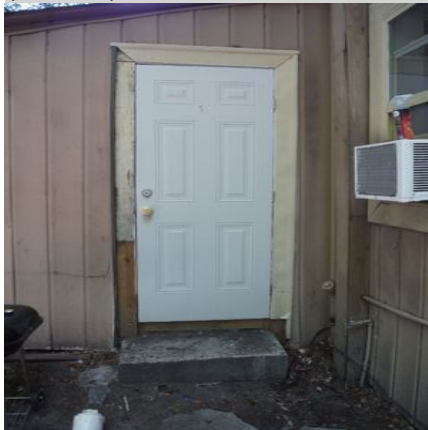
#### (A2-2.2) Doors

The door trim has soft and decayed wood in the frame area. Decay in the door trim can result in leaking and water penetration and should be repaired as soon as possible. A general repair specialist or licensed general contractor should be consulted for evaluation and repair.

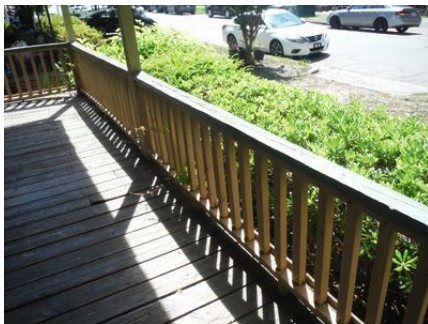
#### (A3-1.1) Porch

The hand railings for the porch are damaged/decayed and in need of repair or replacement to ensure safe and functional use of the porch. A licensed general contractor should be consulted for a complete evaluation and to make necessary repairs.

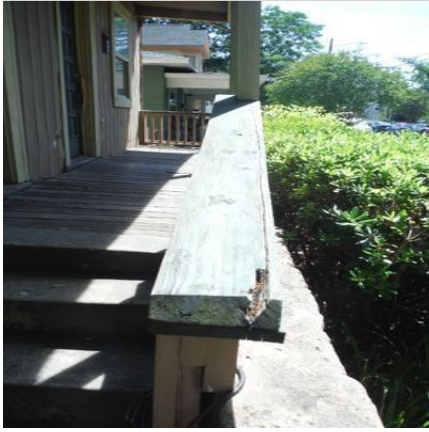
**(A3-1.2) Porch**

The top plate or grip that is installed on the handrails for the porch steps is too wide. The top plate should be within a size and thickness so that it can be easily gripped to prevent a fall. A licensed general contractor should be consulted for a complete evaluation of the porch and to make necessary repairs to ensure safe and functional use of the steps.

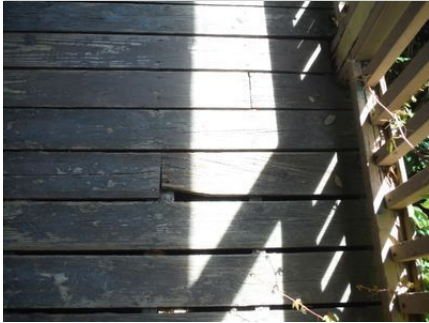
**(A3-1.3) Porch**

The porch surface boards are damaged and splintered. A licensed general contractor should be consulted for a complete evaluation of the porch and to make necessary repairs to ensure the stability and durability of the porch.

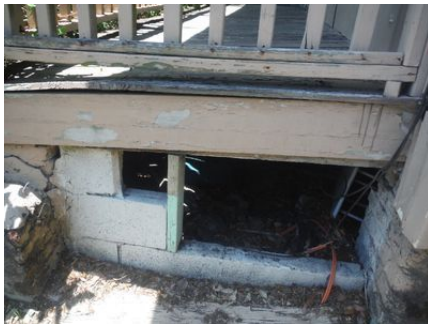
(B1-1.1) Main House

The crawl space area has several openings that are not blocked to prevent rodents/animals from entering. Rodents/animals can cause damage to building components and unsanitary conditions. A licensed general contractor should be consulted for repair.

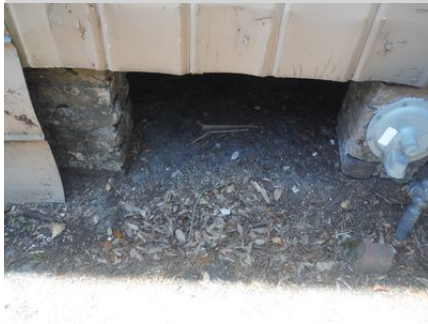
(B1-1.2) Main House

The crawl space area has several openings that are not blocked to prevent rodents/animals from entering. Rodents/animals can cause damage to building components and unsanitary conditions. A licensed general contractor should be consulted for repair.

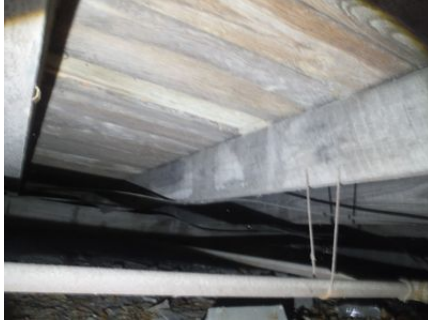
(B3-1.1) Main House

The wood framing components in the foundation areas of the home have been subjected to insect damage typical of wood destroying beetles. The damage is done by the larvae that feed and reduce the wood to a fine powder or mass of small pellets. The larvae can tunnel in the wood for months or years before they emerge as adult beetles. Since the larvae never come to the surface, the damage can be considerable and hidden deep in the center of timber. The damage reduces the overall density and therefore the overall strength of the wood. All framing components under this home have some level of visible damage (beetle exit holes). The inspection of the wood members during a home inspection consists of sounding and direct probing. This method alerts the inspector to possible damage but cannot fully define the extent of the damage. An engineer or a licensed general contractor that specializes in historical homes should be consulted to evaluate the framing to determine the extent of the damage and necessary repairs. A licensed pest inspector should also be consulted to determine activity level for the insects and if treatment is required.

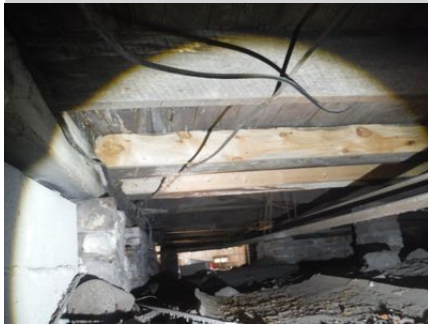
(B3-1.2) Main House

The visible wood framing components in the crawl space of this home have been repaired or supplemented. The repairs do not conform to typical construction methods and are in need of review by a licensed general contractor or an engineer to ensure the stability of the home and prevent further damage. Owner disclosure is recommended related to the extent of the damage and scope of the repairs.

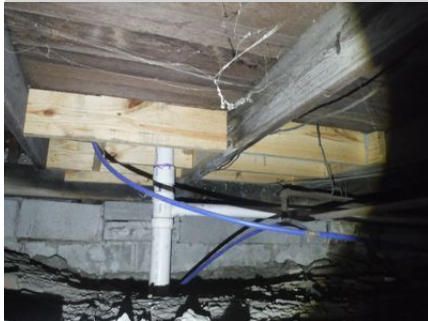
(B3-1.3) Main House

The visible wood framing components in the crawl space of this home have been repaired or supplemented. The repairs do not conform to typical construction methods and are in need of review by a licensed general contractor or an engineer to ensure the stability of the home and prevent further damage. Owner disclosure is recommended related to the extent of the damage and scope of the repairs.

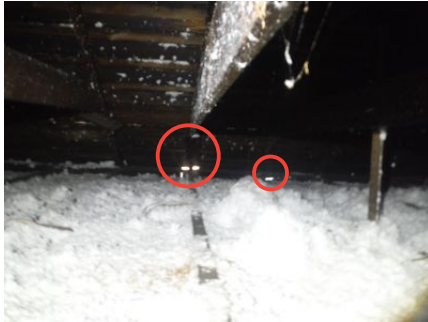
(B6-1.1) Main House

From the attic, the wood framing components in the boxing area are decayed/damaged. A licensed general contractor should be consulted for further evaluation and repair and determine the extent of the damage to ensure the stability of the home and prevent additional damage.

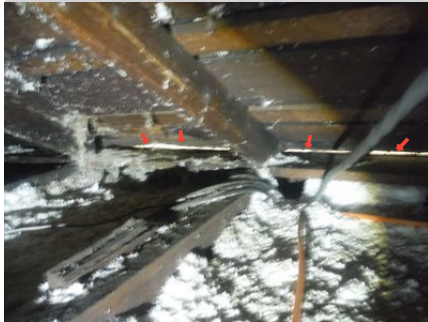
(B6-1.2) Main House

From the attic, the wood framing components in the boxing area are decayed/damaged. A licensed general contractor should be consulted for further evaluation and repair and determine the extent of the damage to ensure the stability of the home and prevent additional damage.

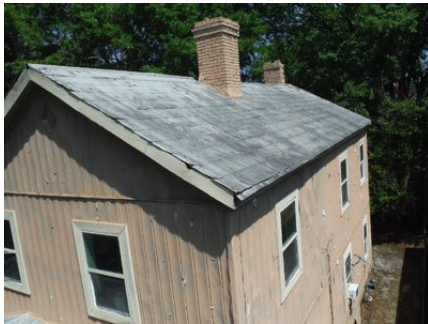
(C1-1.1) Main House & Addition

The roof covering system is in need of further evaluation and repair. The following concerns were noted at the time of the inspection: corrosion, loose fasteners, raised panels, flashing details, and history of leaks around chimney. A licensed roofing contractor should be consulted for a complete evaluation of the roof covering and flashings system to make necessary repairs to ensure the weathertightness of the roof covering system. At the time of the repair, the roofer may be able to answer questions related to the life expectancy of the roof covering system.

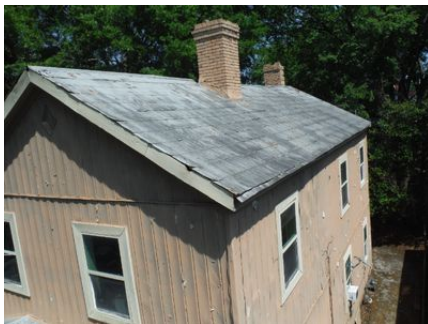
(C4-1.1) Main House

1. Missing bricks
2. Cracks
3. Flashing Details

A licensed general contractor should be consulted for a complete evaluation of the chimneys and to make necessary repairs to ensure that the chimney is safe and ( if client plans to open fireplaces) functional. If any structural issues are located an engineer should be consulted for a complete evaluation, to determine the significance of the concern and outline necessary repairs.

The chimneys need a complete evaluation and repair related to the following concerns were noted at the time of the inspection:

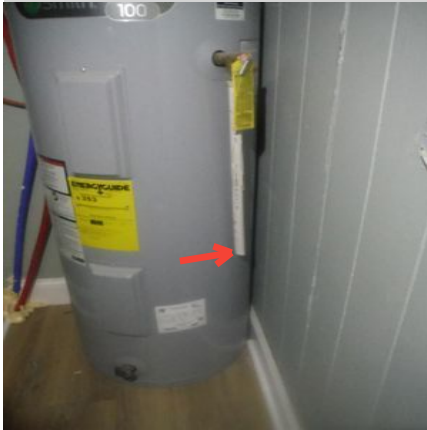
**(D4-1.2) Unit 1**

The Temperature Pressure Relief Valve (TPRV) for the water heater is a safety device to prevent the unit from exploding in case of a malfunction. The TPRV is located at the top of the hot water unit and to prevent burn injury in the event of a discharge, the TRPV requires a piped extension down to the floor area. The TPRV for this unit is not properly extended to ensure proper valve operation or prevent personal injury, this is a safety issue that needs to be corrected to prevent personal injury or property damage. A plumbing contractor should be consulted for further evaluation and repair.

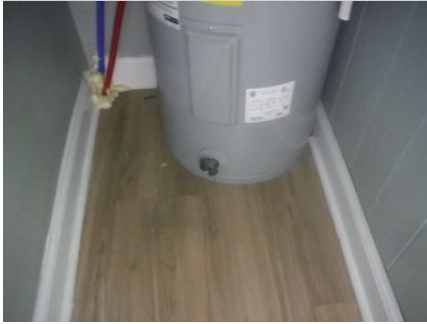
**(D4-1.3) Unit 1**

The water heating unit for this home is located in the living area. The installation of the unit in the living areas requires an emergency drain pan to prevent personal injury and property damage in the event of a malfunction or a leak. The water heater for this home was installed without a drain pan with a piped exit. This is a safety issue that needs to be corrected to prevent personal injury or property damage. A plumbing contractor should be consulted for a complete evaluation and to make necessary repairs to ensure safe, reliable, and proper operation of the system.

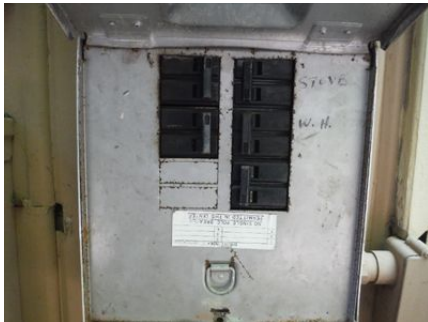
(E2-1.1) Main Panel Apt. 1 (Ground Level)

The service breakers in the panel are not properly identified or labeled. Proper labeling ensures adequate service for appliances and sub-panels and the overall safety of system when emergencies occur or repairs are needed. Without proper labels the inspector's ability to evaluate and inspect the system is greatly reduced. A licensed electrical contractor should be consulted for a complete evaluation to label all electrical panels, subpanels, and service breakers and verify the compatibility of the configuration, and the main service disconnect.

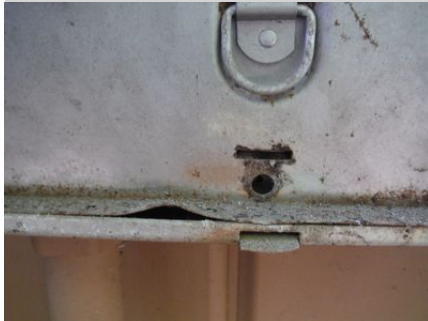
(E2-1.2) Main Panel Apt. 1 (Ground Level)

The main electrical service panel cover is missing fasteners that secure the cover to the enclosure. The door/cover prevents direct contact with hot electrical circuits and contains the electrical energy of the electrical system in the event of a short or electrical explosion; therefore the cover must be secured with the correct type, size and number of fasteners. This condition presents a safety hazard that could result in serious personal injury or death. A licensed electrical contractor should be consulted for a complete inspection of the electrical system and for repair/replacement of the panel to ensure that it is safe and functioning properly.

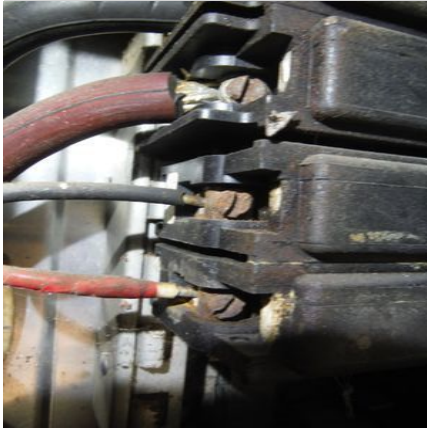
**(E2-1.3) Main Panel Apt. 1 (Ground Level)**

The electrical system of this home has single strand aluminum wiring present on the lighting and receptacle branch circuits. As a result of documented fire hazards, the use of single strand aluminum wiring for lighting and receptacle branch circuits was discontinued in 1974 until material improvement could be made. Due to the concealed nature of the electrical components, the general condition of the system could not be determined during the home inspection. A licensed electrical contractor should be consulted for a complete evaluation of the electrical system to determine if repair, modification, or replacement is needed to ensure safe and reliable service. For more information on aluminum household wiring and recommended repair methods, refer to the C.P.S.C. booklet *Repairing Aluminum Wiring*. The toll-free hotline number for obtaining this booklet is 1-800-638-2772, or you can visit: <https://www.cpsc.gov/s3fs-public/516.pdf>

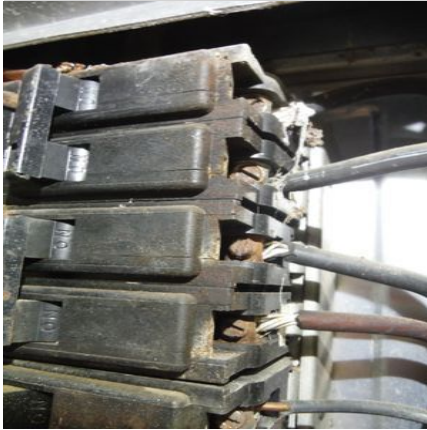
**(E2-1.4) Main Panel Apt. 1 (Ground Level)**

The breakers were noted to have visible water marks and corrosion. Evidence suggests a history of water penetration or moisture into the panel which could result in personal injury or property damage. A licensed electrical contractor should be consulted for repair and a complete evaluation of the electrical system.

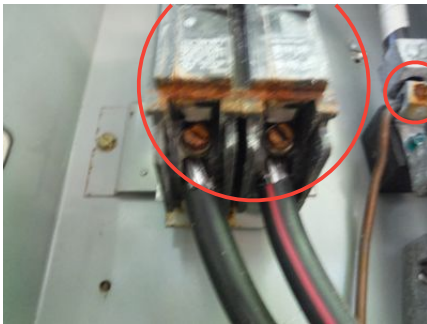
**(E2-2.1) Main Panel Apt.2 (Upper Level)**

The interior components were noted to have visible water marks and corrosion. Evidence suggests a history of water penetration or moisture into the panel which could result in personal injury or property damage. A licensed electrical contractor should be consulted for repair and a complete evaluation of the electrical system.

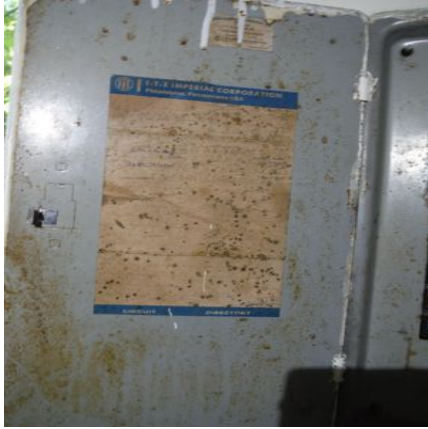
#### (E3-1.1) Distribution Panel Apt. 1

The service breakers in the panel are not properly identified or labeled. Proper labeling ensures adequate service for appliances and sub-panels and the overall safety of system when emergencies occur or repairs are needed. Without proper labels the inspector's ability to evaluate and inspect system is greatly reduced. A licensed electrical contractor should be consulted for a complete evaluation to label all electrical panels, subpanels, and service breakers and verify the compatibility of the configuration, and the main service disconnect.

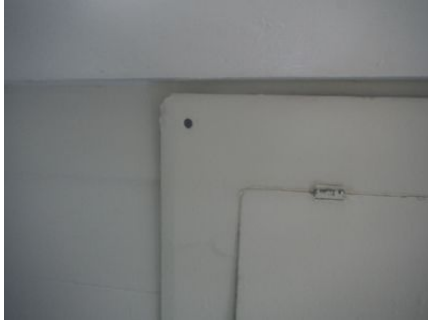
#### (E3-1.2) Distribution Panel Apt. 1

The distribution electrical service panel cover is missing fasteners that secure the cover to the enclosure. The door/cover prevents direct contact with hot electrical circuits and contains the electrical energy of the electrical system in the event of a short or electrical explosion; therefore the cover must be secured with the correct type, size, and number of fasteners. This condition presents a safety hazard that could result in serious personal injury or death. A licensed electrical contractor should be consulted for a complete inspection of the electrical system and for repair/replacement of the panel to ensure that it is safe and functioning properly.

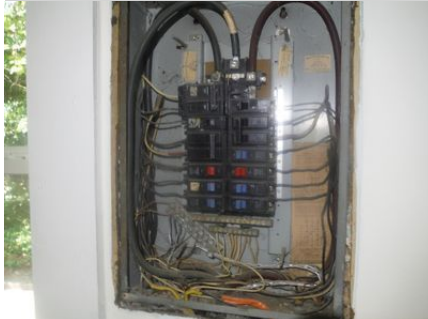
#### (E3-1.3) Distribution Panel Apt. 1

The electrical system of this home has single strand aluminum wiring present on the lighting and receptacle branch circuits. As a result of documented fire hazards, the use of single strand aluminum wiring for lighting and receptacle branch circuits was discontinued in 1974 until material improvement could be made. Due to the concealed nature of the electrical components, the general condition of the system could not be determined during the home inspection. A licensed electrical contractor should be consulted for a complete evaluation of the electrical system to determine if repair, modification, or replacement is needed to ensure safe and reliable service. For more information on aluminum household wiring and recommended repair methods, refer to the C.P.S.C. booklet Repairing Aluminum Wiring. The toll-free hotline number for obtaining this booklet is 1-800-638-2772, or you can visit: <https://www.cpsc.gov/s3fs-public/516.pdf>

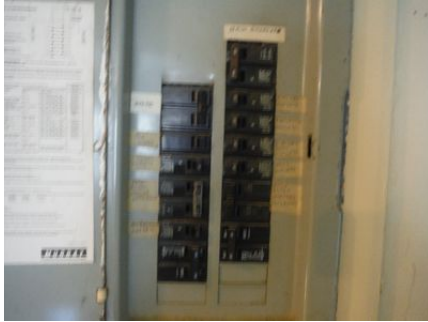
#### (E3-2.1) Distribution Panel Apt. 2

The service breakers in the panel are not properly identified or labeled. Proper labeling ensures adequate service for appliances and sub-panels and the overall safety of system when emergencies occur or repairs are needed. Without proper labels the inspector's ability to evaluate and inspect system is greatly reduced. A licensed electrical contractor should be consulted for a complete evaluation to label all electrical panels, subpanels, and service breakers and verify the compatibility of the configuration, and the main service disconnect.

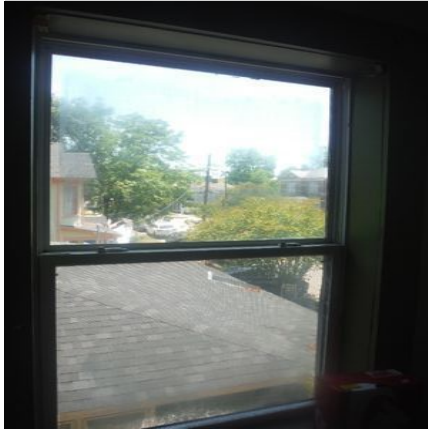
(H1-2.2) Bedroom 1 Apt.2

The window has a cloudy or hazy appearance. The cloudy appearance indicates that the gas seal between the double glass panes has been jeopardized reducing the energy rating of the windows. The severity of the hazing varies with season and time of the day; therefore, all damaged windows may not have been visible at the time of the inspection. All windows should be evaluated as repairs are made. A licensed general contractor should be consulted.

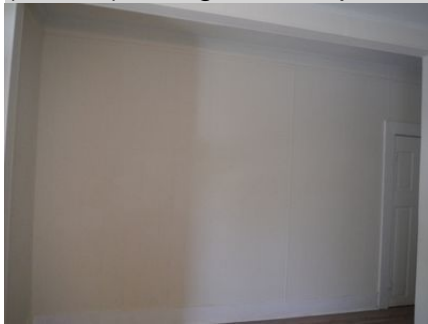
(H1-6.2) Living Room Apt.1

The presence of paneling restricts the inspection of the walls and presence of cracks/damage.

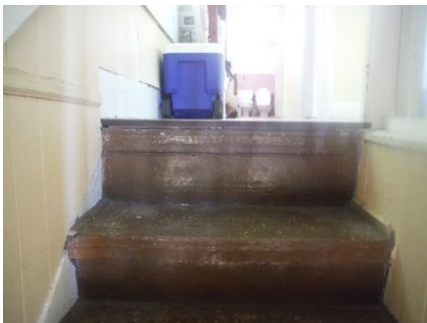
The stair treads were not consistent or built within typical tolerances. The inconsistent tread construction could result in a trip hazard. A licensed general contractor should be consulted to evaluate the stair tread heights and depths and make necessary corrections to ensure safe passage and egress.

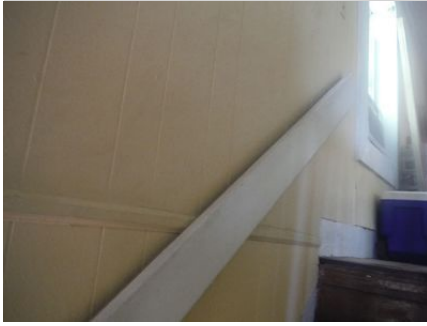
The handrailing for the stairway should be within a size and thickness so that it can be easily gripped to prevent a fall. A licensed general contractor should be consulted for a complete evaluation of the handrail and to make necessary repairs to ensure safe and functional use.

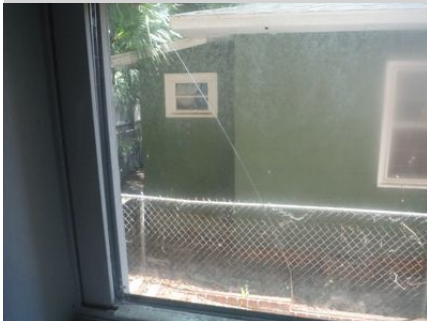
**(H2-1.2) Kitchen Apt. 1**

The kitchen window has a broken/cracked pane. The broken glass should be repaired to prevent accidental injury and weather intrusion. A licensed general contractor should be consulted to make necessary repairs.

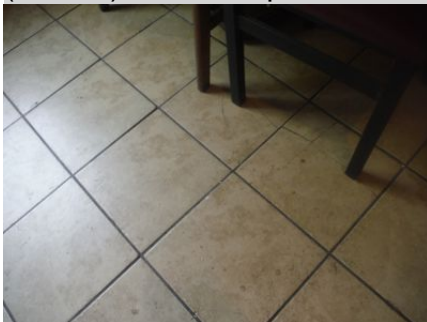
#### (H2-2.2) Kitchen Apt. 2

The tile system for the kitchen floor needs evaluation and repair related to open cracks. A tile installation/repair company should be consulted to evaluate the tile system to determine the significance of the concern and make necessary repairs.

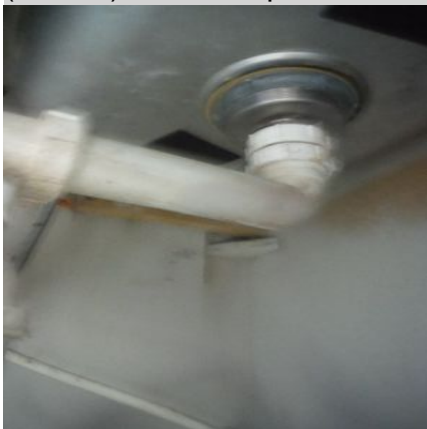
An active plumbing leak was noted on the left side sink. Plumbing leaks should be repaired as soon as possible to ensure sanitary conditions and prevent damage to adjacent building components. A licensed plumbing contractor should be consulted to make necessary repairs to ensure the safe and sanitary condition.

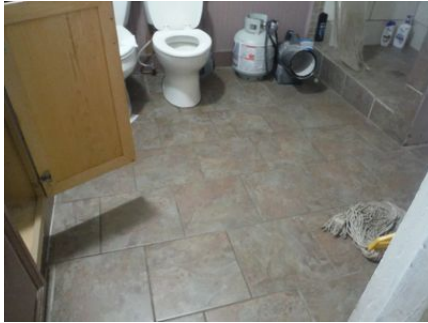
Interior floors were noted to slope toward adjacent walls/rooms. The slope was more than would be typically expected. An engineer should be consulted to evaluate the structure of the home to determine the significance of this concern and if repairs are necessary.

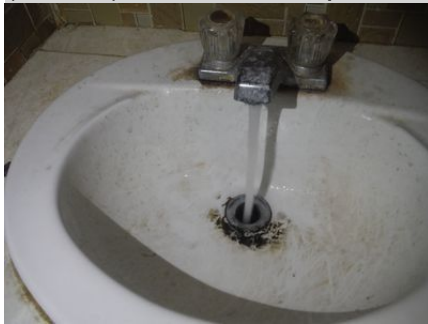
The drain closure assembly was not functional to be able to fill the sink. A general repair person should be consulted for repair/replacement.

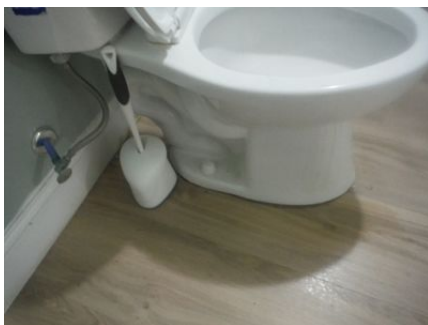
The toilet rocks and is not secure to the floor. Movement of the toilet can result in leaks and damage. A licensed plumbing and general contractor should be consulted for evaluation and repair.

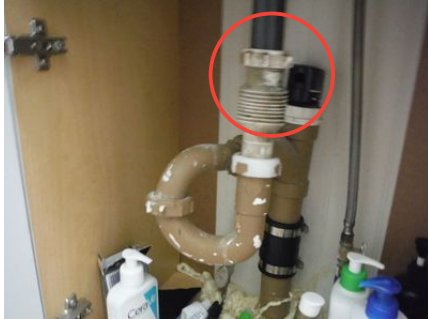
The accordion style drain extension is not an approved material for a drain ( must have a smooth interior to be considered self cleaning), the crevices will collect debris and cause clogs and unsanitary conditions.

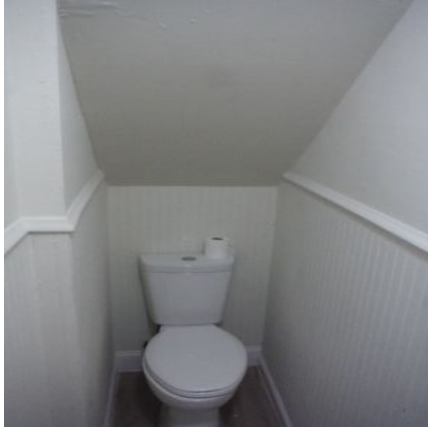
The sloped ceiling is lower than typical, modern requirements = at least 50% of the required floor area must have a minimum ceiling height of 7', no required floor area can be lower than 5'.

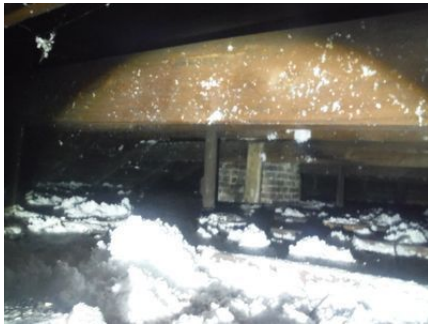
The attic has an upper ventilation exhaust path but no clear lower intake. Improper ventilation could result in condensation, over heating of the building components, over heating of the building components, and inadequate conditioning of the living areas. A licensed general contractor should be consulted for repair/replacement.

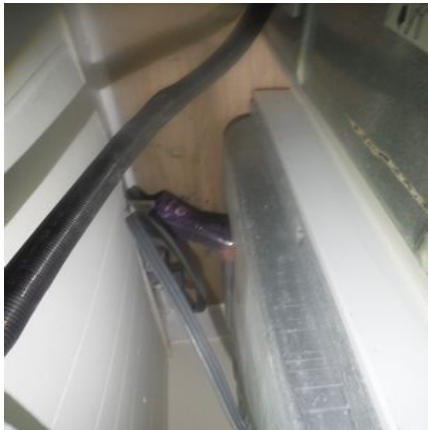
The dryer vent is not an approved material. A metal duct should be installed. A general repair person should be consulted for repair.
