Worldwide ERC® Relocation Property Assessment

Transferee Property Address: 605 Ravenswood Road

City/State/Postal Code: Hampstead, NC 28443

Date: 07/09/2025 Time: 10:00 AM Weather: Cloudy Temp: 80 Estimated Age of Main Dwelling (yrs.): 38

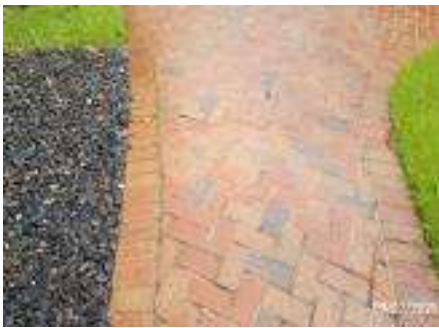
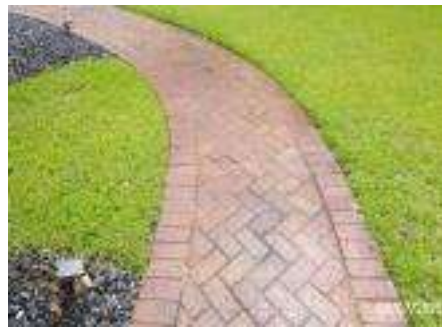
Cracked/Sunken Walkways

(LG) 1 Walks: The walkway is cracked at the front of the house and sunken at the left front side of the house.

Corrective Action: Contractor to repair the cracked walkway at the front of the house and repair the sunken walkway at the left front side of the house.

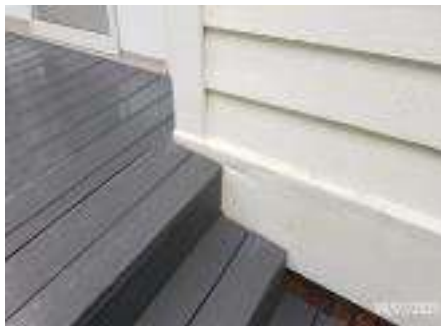
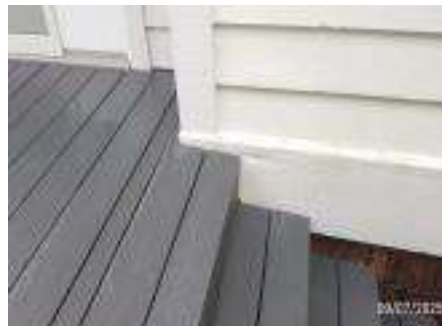
Deteriorated Trim at Rear Left

(ES) 4 Trim: The trim is deteriorated at the rear left exterior, the front left trim is damaged/split, and the front center left window trim is cracked.

Corrective Action: Contractor to replace the deteriorated trim at the rear left exterior, the split trim at the front left exterior, and the cracked front center left window trim.

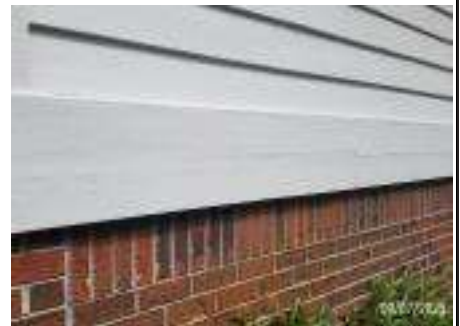
Split Trim at Front Left

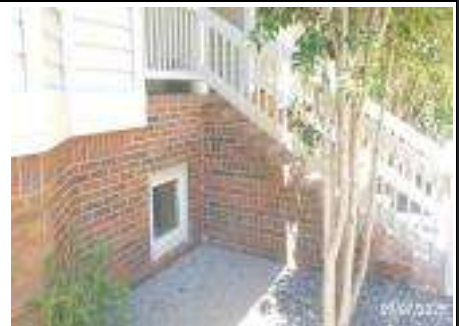
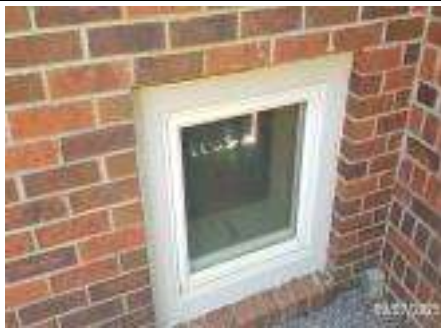
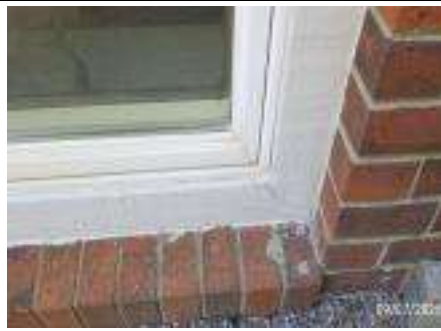
Cracked Trim at Front Center Left Window

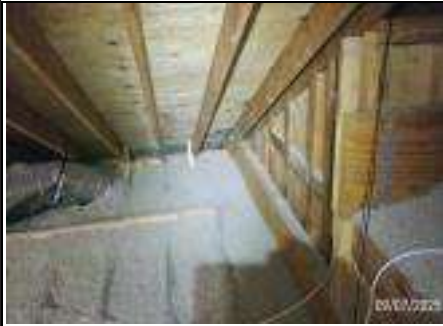
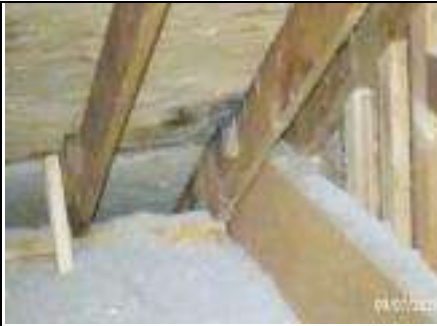
Moisture Stains at Front Right Sheathing

(A) 7 Evidence of Water Penetration: Moisture and/or damage has been observed in the following visually observable areas of the home: moisture stains were observed at the front right attic sheathing.

Corrective Action: Elimination/correction of the source of moisture is required. Repair/replacement of any associated damage is also necessary, if present. All work should be performed by a qualified contractor.

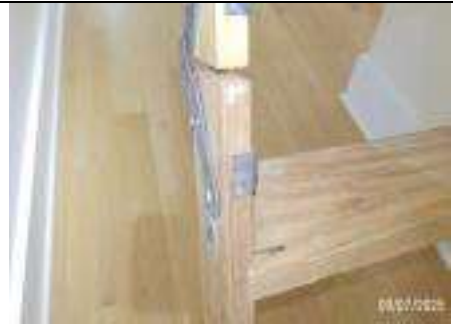
Right Pull Down Stairs Hardware Damaged

(A) 2 Roof Framing: The right attic access pull down stairs hardware is damaged.

Corrective Action: Contractor to replace the damaged attic access pull down stairs hardware.

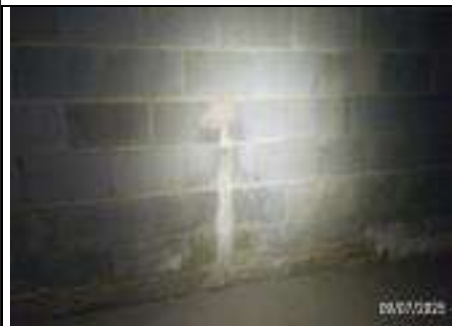
Efflorescence at Rear Left Foundation

(B) 4 Evidence of Water Penetration: Moisture and/or damage has been observed in the following visually observable areas of the home: Efflorescence was observed at the rear left and right basement foundation walls.

Corrective Action: Elimination/correction of the source of moisture is required. Repair/replacement of any associated damage is also necessary, if present. All work should be performed by a qualified contractor.

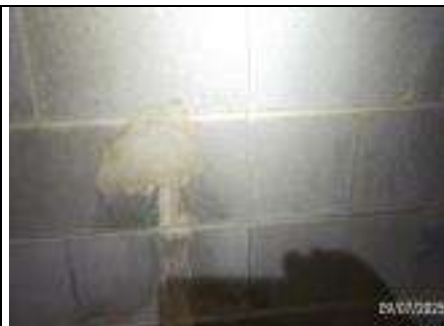
Efflorescence at Rear Right Foundation

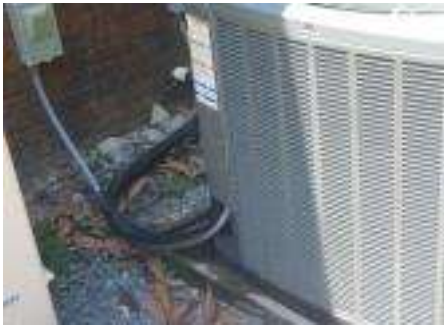
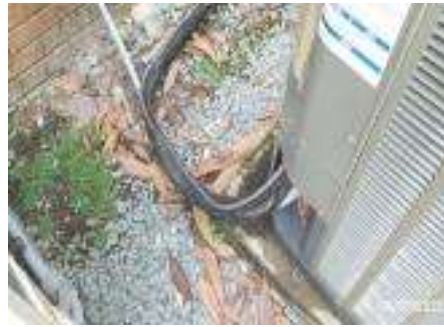
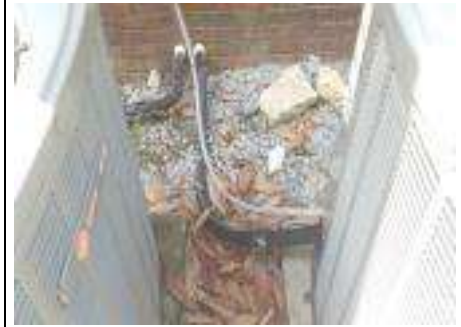
Deteriorated Refrigerant Line Insulation

(AC) 3 System: The exterior refrigerant line insulation is deteriorated.

Corrective Action: Cooling contractor to replace the deteriorated refrigerant line insulation.

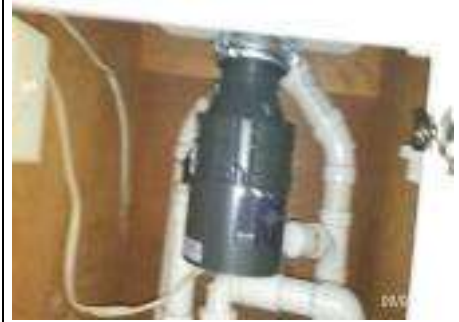
Lower Disposal is Inoperable

Corrective Action: Plumber to replace the lower kitchenette disposal.

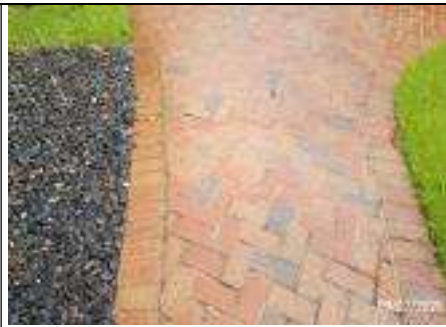
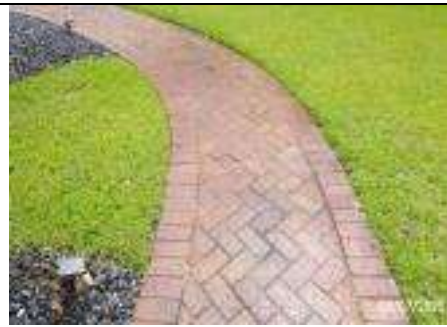
Cracked/Sunken Walkways

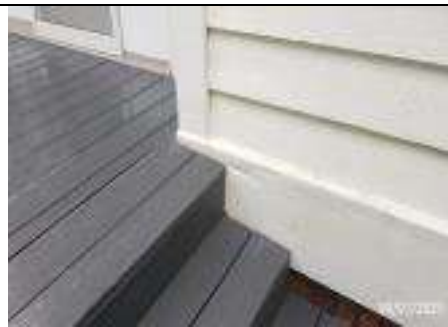
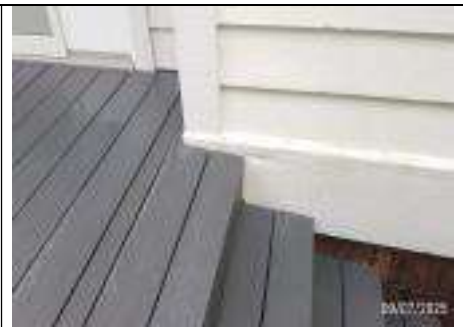
Deteriorated Trim at Rear Left

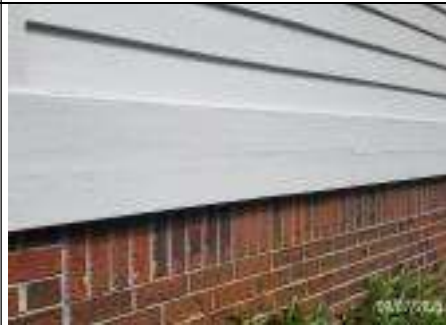
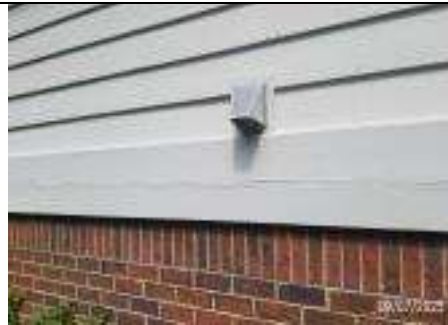
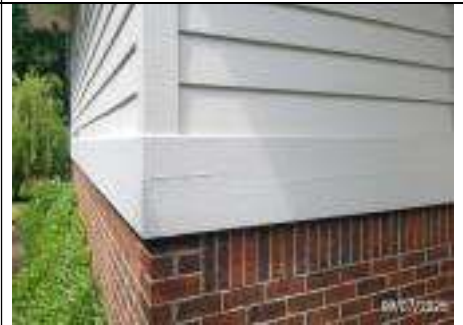
Split Trim at Front Left

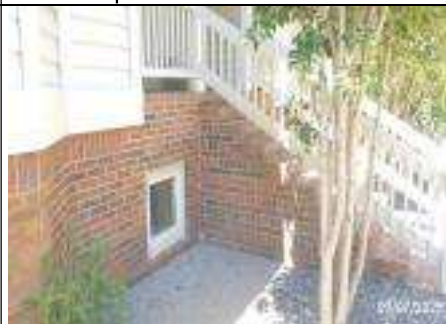
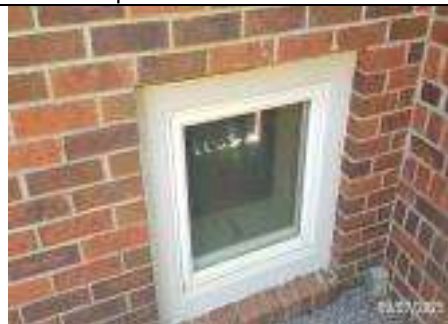
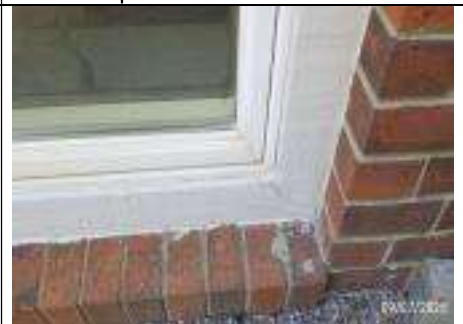
Cracked Trim at Front Center Left Window

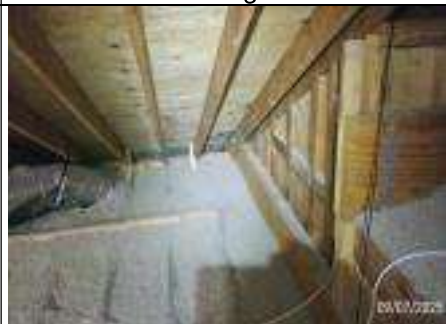
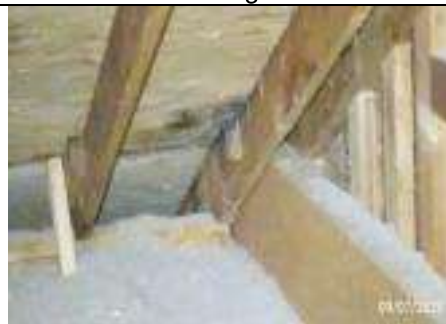
Moisture Stains at Front Right Sheathing

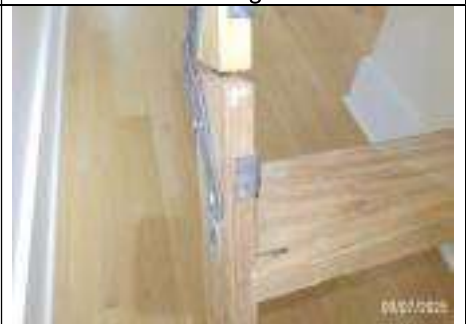
Right Pull Down Stairs Hardware Damaged

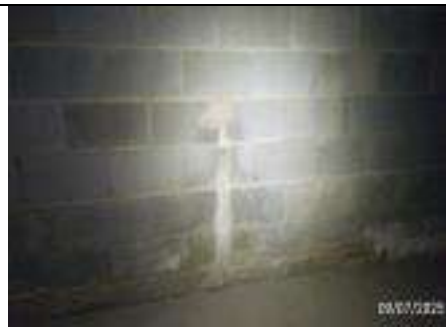
Efflorescence at Rear Left Foundation

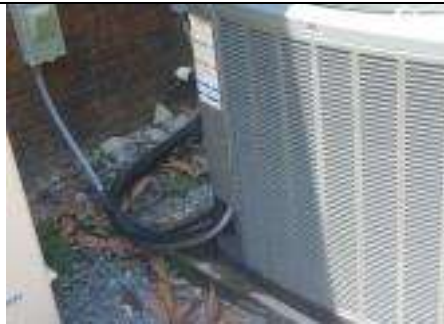
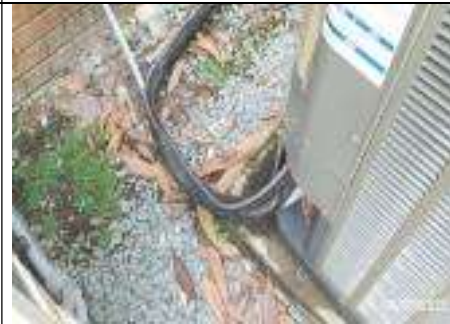
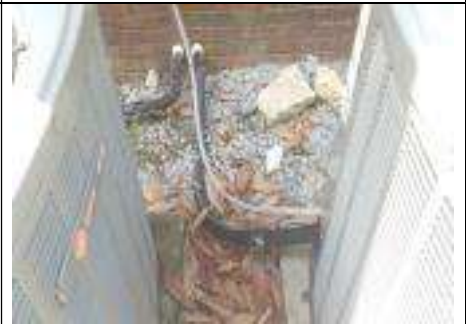
Deteriorated Refrigerant Line Insulation

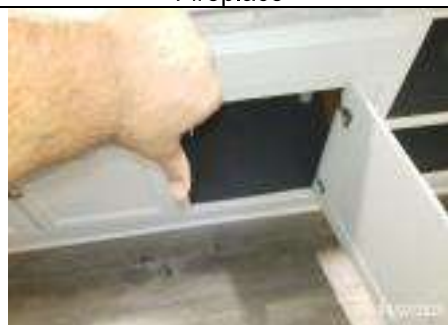
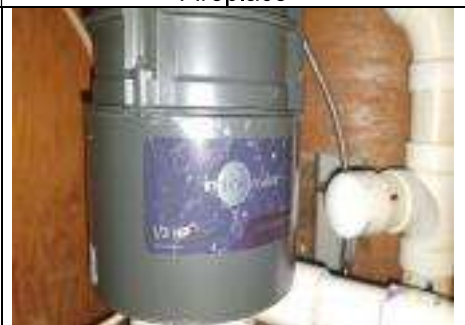
Lower Disposal is Inoperable

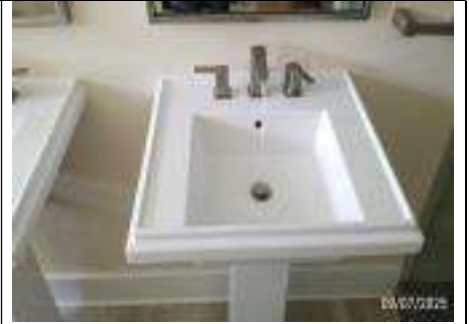
Inoperable Drain Stopper at Master Right Sink

Corrective Action: Plumber to replace the master bathroom right sink stopper.
