Property Inspection Report

February 08, 2024 (9:00 AM)

100288JS
221 W Main St Wallace, NC

Prepared By:
Jon Strout (#3338)
True North Inspection Services

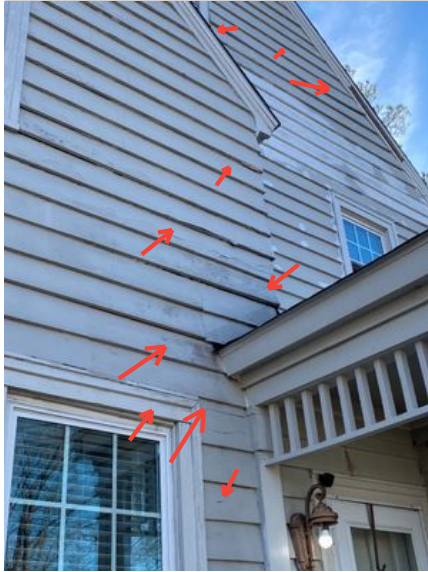
A1-1 Main House

The exterior trim, siding, and boxing of the home need repairs and painting, multiple peeling areas to include an area on right that appeared incomplete) to prevent further damage and water penetration. The following items were noted during the inspection, all areas should be evaluated as a repair plan is prepared: Siding was found to have areas of decay, loose boards, missing, peeling paint; Boxing and trim areas were found to have damage related to age/decay, and roof drainage over window. The wood trim pieces for the siding system are also decayed in areas, including some dormer and window areas. The corner trim provides a finished edge for siding and protects the underlying sheathing. Decay of the corner trim can allow water to enter behind the siding and result in damage to the framing. A licensed general contractor should be consulted for an invasive inspection to determine the extent of the damage to underlying components and make necessary repairs to ensure the weathertightness of the cladding system.

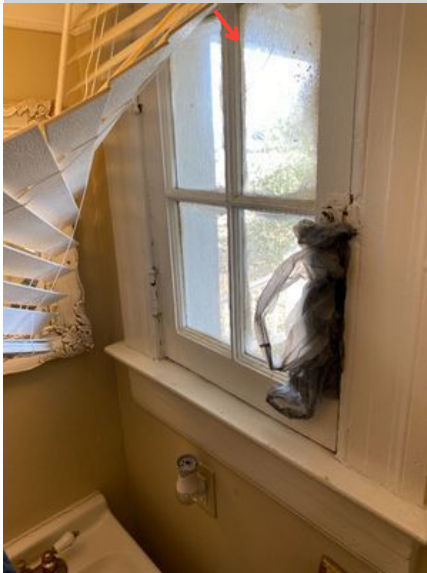
(A2-2.4) All Windows (Location:)

The 1/2 bath window has a broken/cracked pane. The broken glass should be repaired to prevent accidental injury and weather intrusion. Framing/seal concerns present as well. A licensed general contractor should be consulted to make necessary repairs.

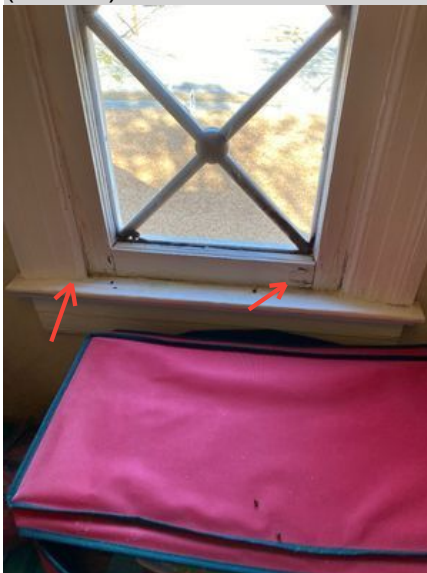
(A2-2.5) All Windows (Location:)

Moisture staining observed at more than one rear and front closet 2nd floor window on the cladding material. This could indicate water penetration in the wall cavity or behind the window claddings. A licensed general contractor should be consulted to determine the source of the stains, the extent of any possible damage, and repair as needed to ensure proper function of the window and protection the building envelope.

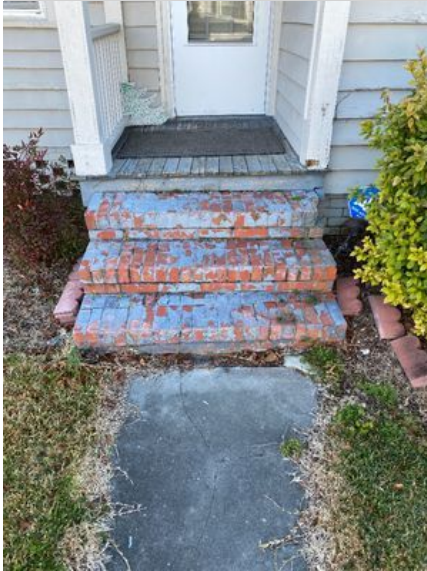
(A3-1.2) Porch/Decks/Stoops/Balconies *(Location: All entries)*

The handrails to the deck and/or other entry areas are loose, too low, or missing with 4 or more steps, and or present a safety/fall hazard. A licensed general contractor should be consulted for evaluation of the deck handrail system and to make necessary repairs. (NOTE: trim damage and weathered surface present as well)

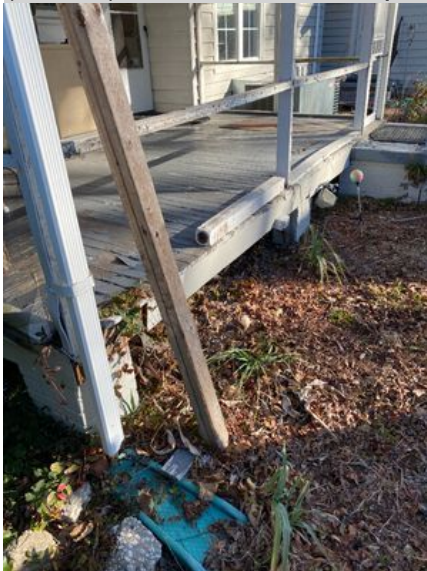
(A3-1.3) Porch/Decks/Stoops/Balconies *(Location: All entries)*

The wood decks were found to be weathered, damaged, with partial repair areas. Decking boards were splintering and cupped. The deck should be considered a safety risk. A licensed general contractor should be consulted for a complete evaluation of the deck and to make necessary repairs to ensure the stability and durability of the deck.

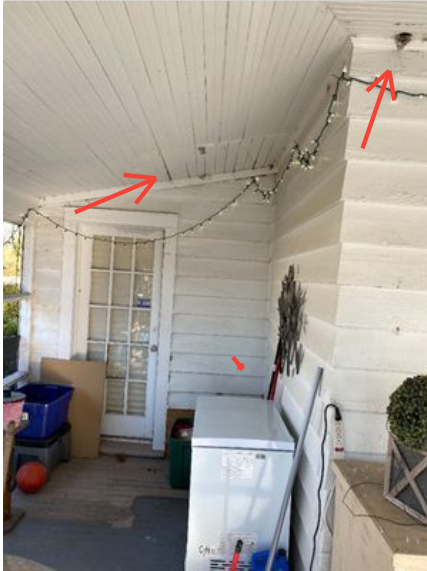
(A3-1.4) Porch/Decks/Stoops/Balconies *(Location: All entries)*

A few areas of ceiling boards appeared buckling, damaged, or holes. The above area was not accessible therefore the specific cause could not be determined. A licensed general contractor should be consulted for further evaluation, to determine the extent of the damage, and to make necessary repairs.

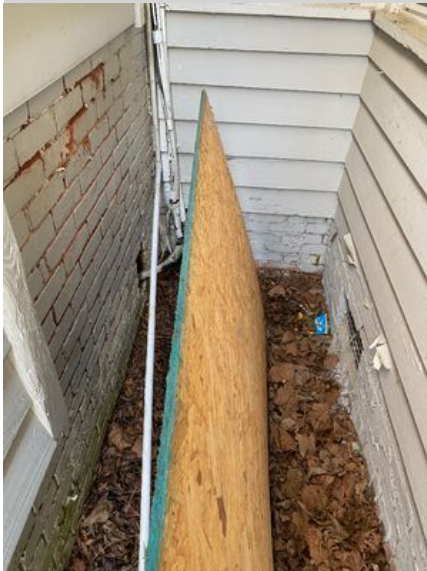
B1. Structural: Foundation**B1-1 Main House**

Deteriorated bricks and mortar lines inside and outside of the foundation have resulted in weak and damaged sections. Spalling of the brick is usually caused by years of water exposure. Layers of the brick are separated by the pressure of salts and freeze-thaw cycles of moisture trapped under the surface. Interior foundation bricks appeared to have a number of areas filled with foam spray at time of inspection. A masonry contractor should be consulted for further evaluation of the foundation and to repair all loose, soft, missing mortar/bricks. Repairs are also needed to prevent water penetration. A licensed general contractor with experience in foundation drainage and water proofing that should be consulted for a complete evaluation to determine the source of the moisture and to make necessary repairs. not limited to picture.

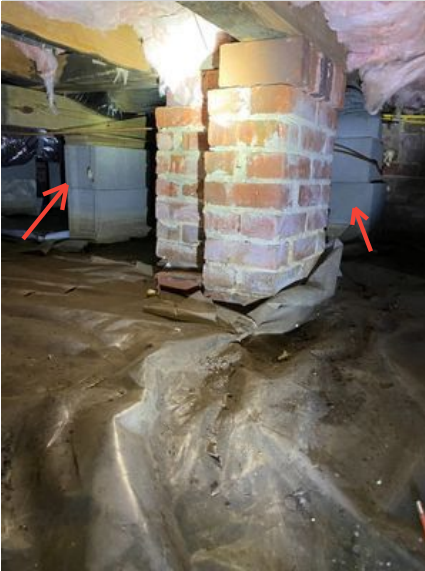
(B1-1.2) Main House

Additional girder support appeared as temporary installation in a few areas of the crawlspace. These are used to stabilize and or raise foundations that have been subjected to differential movement. The owner should be asked for disclosure related to the scope of the repair, service and maintenance requirements, and any warranty that may be transferrable. Main entry support is also not in direct contact with joists. Verification of the adequacy of the repair is beyond the scope of the home inspection, an engineer should be consulted for a complete evaluation of the foundation and the related repair areas to determine if additional repairs or modifications or monitoring is recommended. not limited to picture. see also column/pier details.

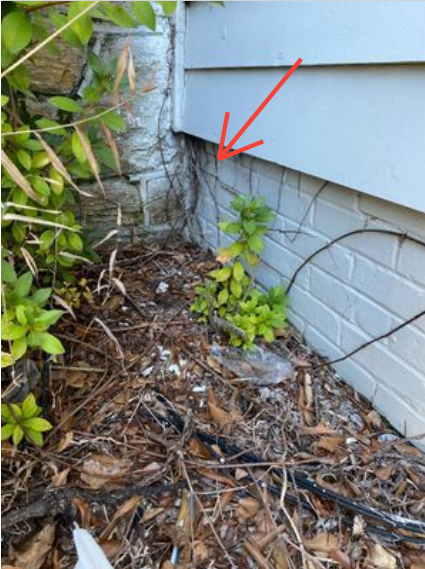
(B1-1.3) Main House

Closed/Open cracks and/or loose bricks were noted in the foundation of the home. Cracks in the foundation indicate a deficiency in the foundation, footing, or supporting soil that can change and worsen if it progresses over the life of the home. One or more areas also appeared to be offset or deflected. An engineer should be consulted to determine the significance/cause of the cracks and outline any necessary repairs.

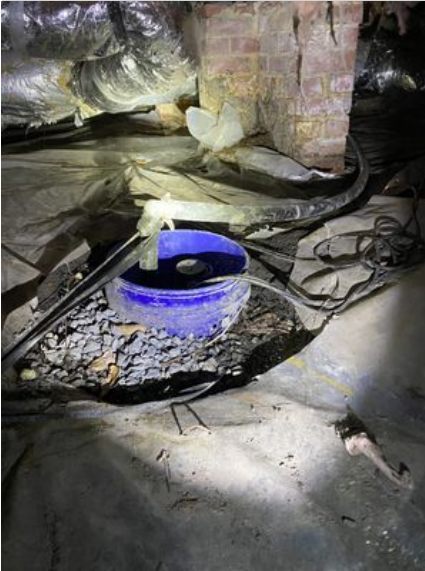
(B1-1.4) Main House

A sump pump have been installed in the crawl space to control direct water penetration. The drainage systems appears to have been recently installed. At the time of the inspection, there was no standing water however the unit is not below grade and installed inside a bucket that is not typically designed for such service. The effectiveness of the system could not be determined. The homeowner should be asked for more information concerning past drainage issues, the reason the drainage system was installed, and possible warranties related to the sump pump and drain. If no information is available, licensed general contractor with experience in crawl space drainage should be consulted for a complete evaluation.

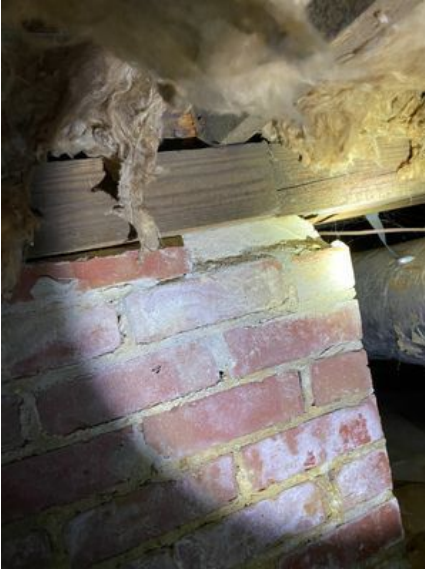
B2. Structural: Columns and Piers**B2-1 Main House**

The cap for more than one pier is damaged or loose. The pier should be capped or filled in the first 4 inches to provide the required bearing area for the wood framing. Degraded or damaged brick supporting joists was also observed near center. A licensed general contractor should be consulted for further evaluation and to make necessary repairs.

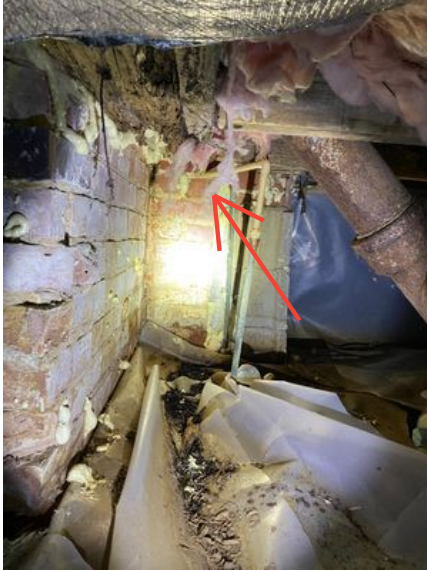
B3-1 Main House

The subflooring under the 1/2 bath toilet and left side structure joists/girder support was noted to be soft and decayed. Evidence suggests direct water penetration. Some areas on center and right also suggest evidence of unwanted pest concerns. A licensed general contractor should be consulted for an invasive investigation to determine the source of the water penetration or noted damaged areas and the extent of the decay to prevent further damage and undesirable conditions.

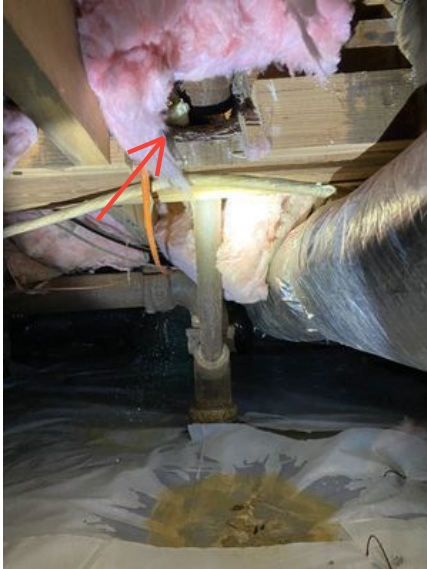
(B3-1.2) Main House

The girder located near center crawl has been notched in 2 areas for plumbing locations. The notch is beyond what would be typically expected and could result in cracking or failure of the beam. The girder is a main structural component that provides support of the framing structure and transfers loads to the foundation. A licensed general contractor should be consulted for further evaluation and to make necessary repairs.

NOTE: evidence of prior leak concerns.

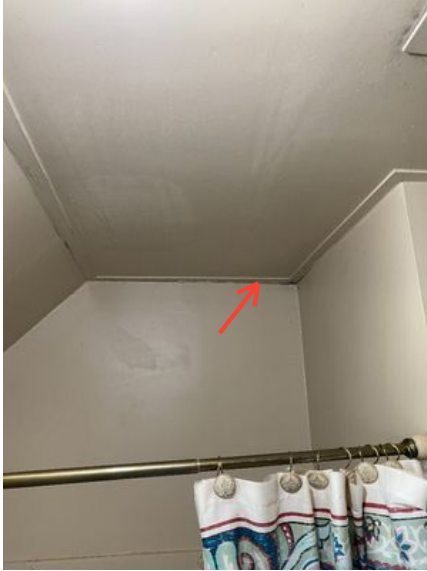
B4-1 All Interior Areas

A noticeable gap/opening was noted along the top of the wall at the intersection with ceiling in the bathroom. The gap was more than what would be expected from typical seasonal movement commonly known as truss lift. This could indicate an underlying problem with the framing, roof truss design, installation, and or attic conditions. An engineer should be consulted for further evaluation to determine the significance of the concern and outline necessary repairs to ensure the stability of the structure.

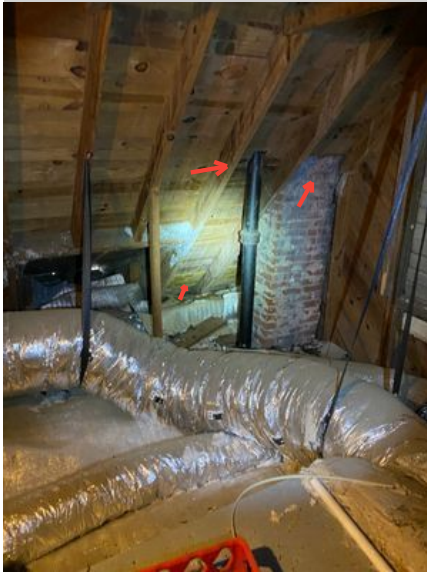
B6-1 Main House

From the attic, the wood framing components located near vents/chimney and rear are discolored, decayed, cracked, and select areas of replaced. The level of decay indicates a history of a long term leak that could involve hidden areas of damage, the flashing, and the roof covering systems. A licensed general contractor should be consulted for further evaluation and repair to determine the source of the leak and extent of the damage to ensure the stability of the home and prevent additional damage.

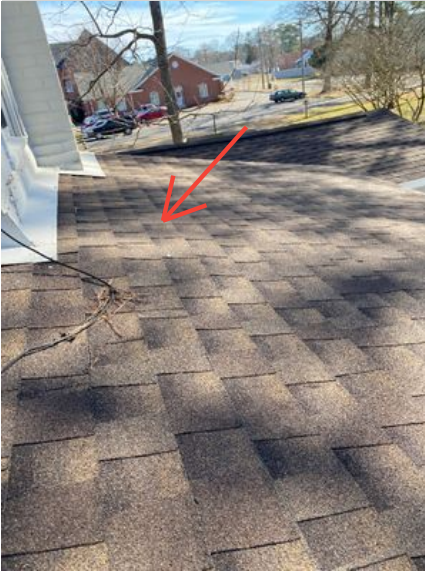
(B6-1.2) Main House

From the exterior of the home, the roof surface has visible low and high spots that correspond to the roof transitions between levels. The raised/low areas have displaced the roof covering materials and this condition could increase the probability of leaking. A licensed general contractor should be consulted for further evaluation and repair to ensure the weathertightness and stability of the structure.

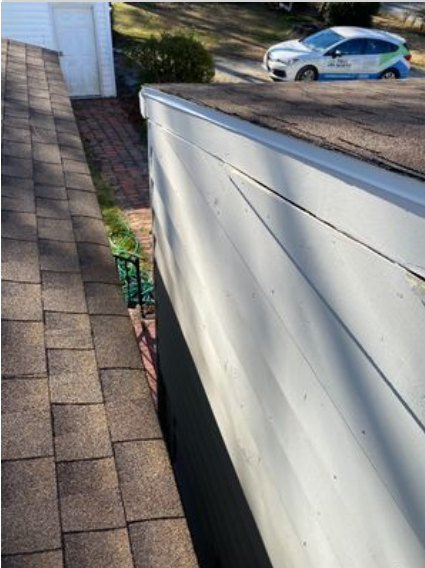
C1. Roofing: Coverings**C1-1 Main House**

The shingles were not properly trimmed along the roof eave. The shingles were cut too short leaving the edge of the roof sheathing exposed. Improper edge termination along eaves can result in water penetration in the building envelope. A licensed roofing contractor should be consulted for a complete evaluation and repair to ensure the weathertightness of the roof covering system.

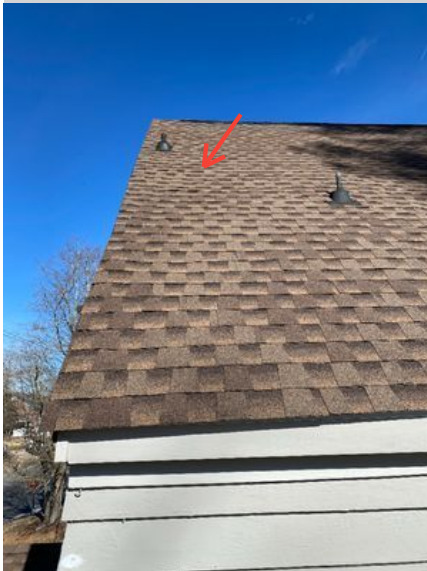
(C1-1.2) Main House

A raised shingle on the rear area of the roof surface is in need of repair/replacement. Displaced shingles could indicate an underlying problem with the shingle installation, roof sheathing, or attic conditions. A licensed roofing contractor should be consulted for a complete evaluation and repair to ensure the weathertightness of the roof covering system.

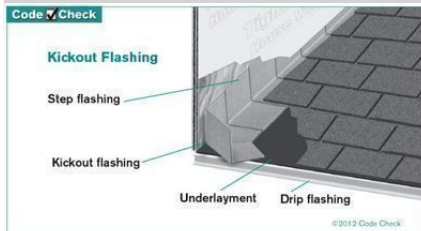
C3. Roofing: Flashings, Skylights, Penetrations**C3-1**

The inspector recommends that the rain boots and/or caulking around the roof vents and flashing material be inspected on an annual basis and touched up when needed to include exposed nail heads. Rainwater leaking into the attic from the roof is a common and avoidable condition of deteriorated flashing and caulking. Some raised flashing is in need of repair. Kick out flashing is also needed to prevent deterioration along the exterior siding or related deterioration. Contact a qualified professional for further evaluation and repairs.

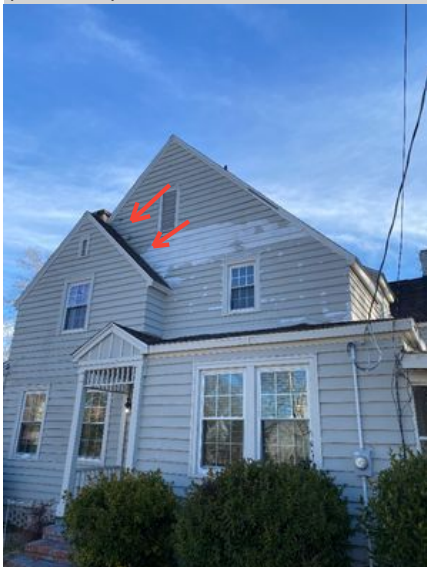
(C3-1.2)

The seam between the right side transition is heavily caulked and no flashing was visible. Heavy caulking is a temporary repair and an indication of a history of leaking. A licensed roofing contractor should be consulted for evaluation and repair to ensure the weathertightness of the roof covering system.

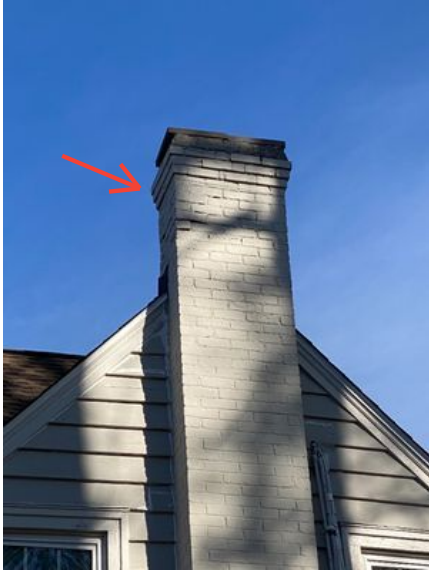
C4-1 Main House

Chimneys built of masonry will eventually need tuckpointing. A chimney top that has cracked is susceptible to water and carbonic acid accessing behind the surface of the brick/stone and could accelerate deterioration. This one appeared to also have deflected brick. Missing, rusted, or damaged caps and screens should also be installed or repaired over time to prevent rain, pests, and stray sparks. Contact a qualified specialist for review and repair.

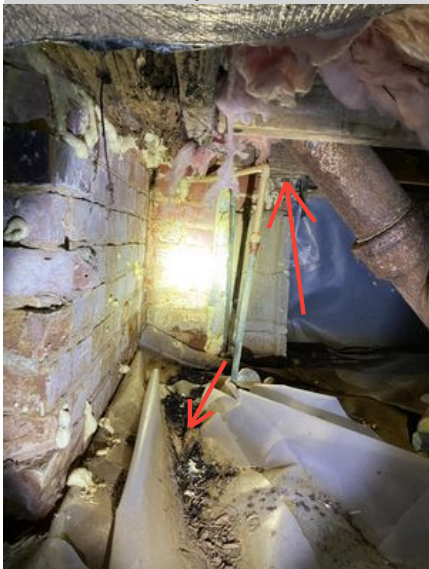
D3-1 Crawl Space

The left side waste line is corroded and leaking under left bath area. The waste line needs to be repaired to ensure sanitary conditions. A licensed plumbing contractor should be consulted for complete evaluation and of the waste line systems to determine the general condition of the system and to make necessary repairs.

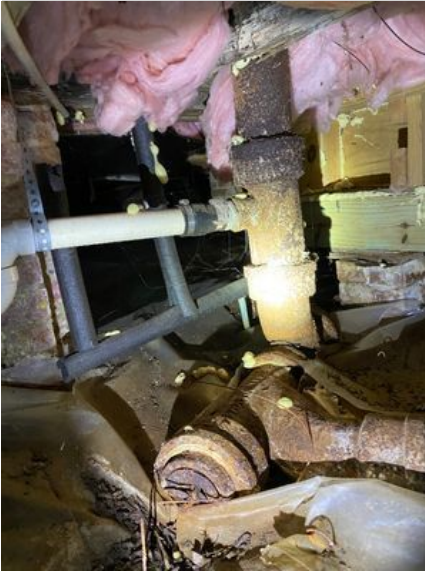
(D3-1.2) Crawl Space

The main waste line is corroded where it has been touching or in close contact with the earth. The waste line is weak and susceptible to leaking. A licensed plumbing contractor should be consulted for complete evaluation of the waste line systems to determine the general condition of the system and to make necessary repairs.

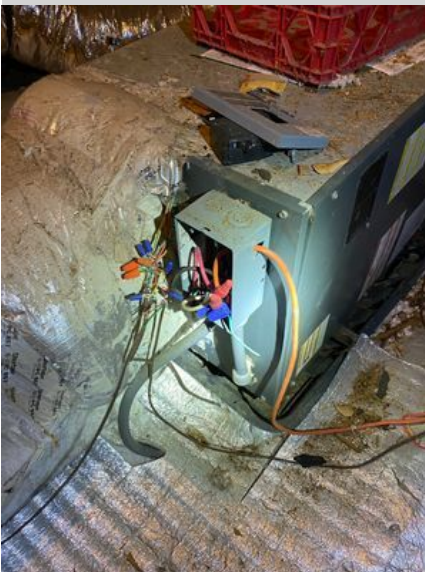
E4. Electrical: Branch Circuits, Wiring**E4-1 Interior and Main Panel**

Electrical connections have been made in the attic area without being properly protected in a covered junction box. The open junction (and service disconnect) leaves electrical conductors exposed and in a hazardous condition. Electrical concerns should be considered fire and safety issues and repaired as soon as possible. The electrical systems and components in the attic are in need of a complete evaluation and repair by a licensed electrical contractor.

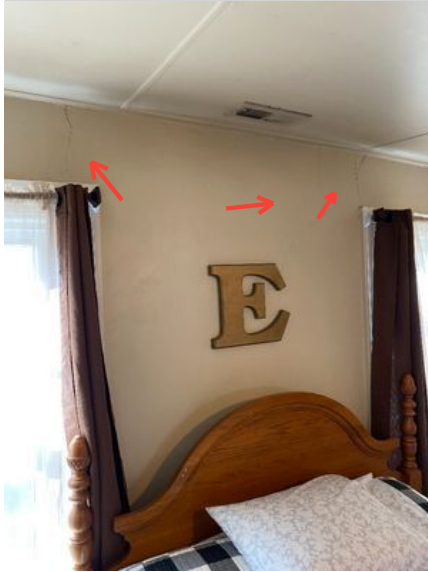
H1. Interiors: General Rooms**H1-1 Bedrooms**

The historical ceiling/walls have crack lines that indicate that plaster is loose from the lath. Repair is needed to prevent system failure. A plaster repair specialist should be consulted to evaluate the ceiling and determine necessary repairs.

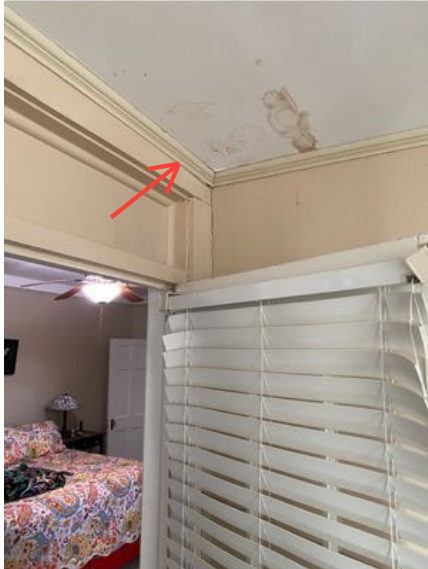
(H1-1.2) Bedrooms

Stains, cracking, damage on the ceilings in bedrooms indicate a history of a leak. At the time of the inspection it was not possible to determine if the condition was due to an active or past occurrence. Further investigation by a repair specialist and owner disclosure is recommended. Refer to the Attic section of the report.

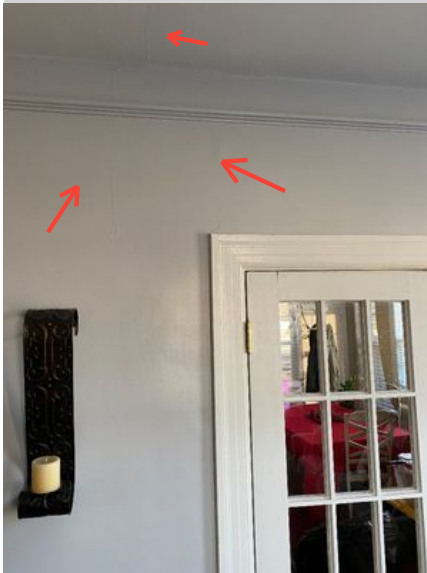
(H1-1.3) Bedrooms

Some of the cracks are present in a way the size and length were more than would be typically expected other than plasterboard cracks. Multiple areas of the flooring were found uneven. An engineer should be consulted to evaluate the structure of the home to determine the significance of this concern and if repairs are necessary.

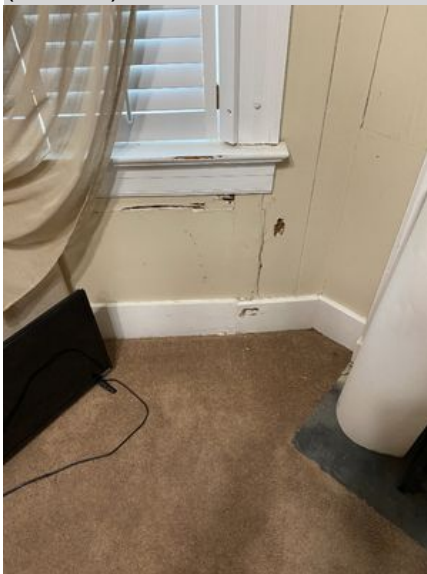
(H1-1.5) Bedrooms

The wall in left front bed room has signs of damage or decay. We recommend consulting with pest specialist for further review and contact a qualified contractor for an invasive inspection to determine the extent of repair..

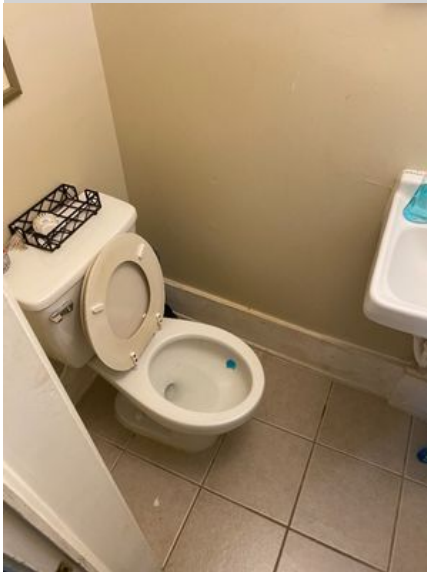
(H3-1.5) Bathrooms (Combined)

The floor is decayed at the 1/2 bath toilet area. Refer to the structural section of the report.

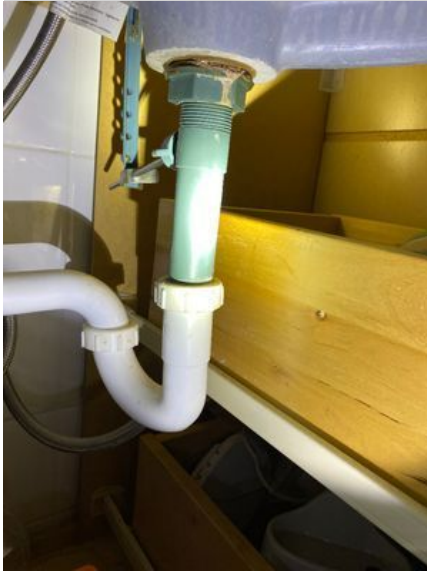
(H3-1.6) Bathrooms (Combined)

The pipe connection located under the sink is corroded. There are also other sinks with cloth on trap which could indicate prior leak concerns. The corroded or compromised seals need to be repaired/replaced to prevent leaks and ensure sanitary conditions. A licensed plumbing contractor should be consulted for evaluation and repair.

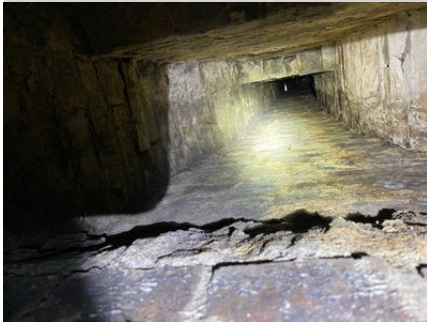
H6-1 Fireplace: Masonry *(Location: Family Room/BR)*

From the fireplace opening, it was noted that the chimney does not have a liner. The chimney needs a complete evaluation and invasive inspection prior to use. A chimney sweep and general contractors should be consulted for a complete evaluation of the chimney and to make necessary repairs to ensure that the chimney is safe and functional.

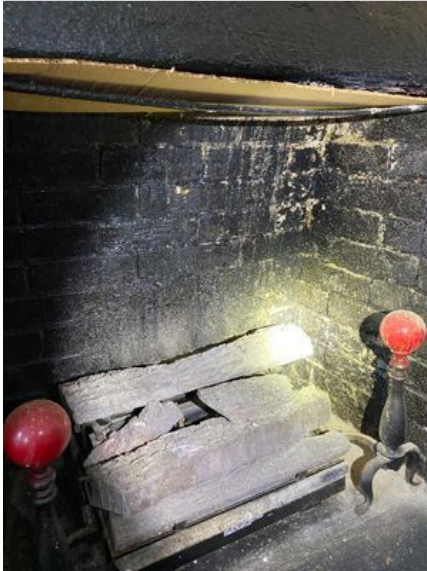
(H6-1.2) Fireplace: Masonry *(Location: Family Room/BR)*

The firebrick liner of the fireplace has areas of loose mortar and/or deflected painted brick. The firebrick liner protects the chimney firebox and adjacent framing components from heat and embers. A masonry contractor should be consulted to repair/replace the damaged firebrick to ensure safe and reliable operation of the fireplace.

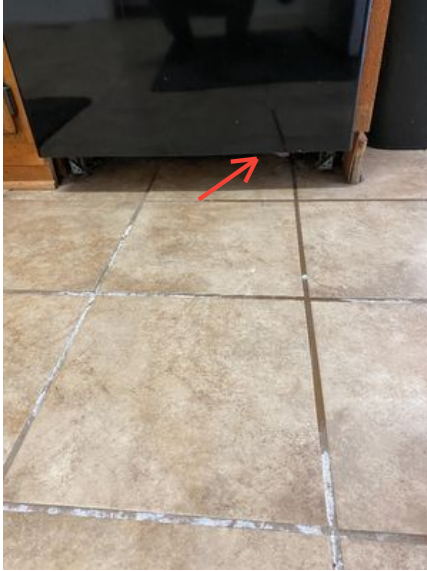
J1-1 Dishwasher (Location: Kitchen)

The inspection of the dishwasher was not completed because the unit leaked during the operation. An appliance repair specialist should be consulted for further evaluation and repair to ensure the proper operation of the appliance. At the time of the repair adjacent areas should be checked for evidence of water damage, any evidence of water damage should be investigated by a licensed general contractor.

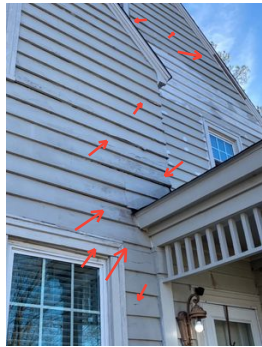
(A1-1.1) Main House

The exterior trim, siding, and boxing of the home need repairs and painting, multiple peeling areas to include an area on right that appeared incomplete) to prevent further damage and water penetration. The following items were noted during the inspection, all areas should be evaluated as a repair plan is prepared: Siding was found to have areas of decay, loose boards, missing, peeling paint; Boxing and trim areas were found to have damage related to age/decay, and roof drainage over window. The wood trim pieces for the siding system are also decayed in areas, including some dormer and window areas. The corner trim provides a finished edge for siding and protects the underlying sheathing. Decay of the corner trim can allow water to enter behind the siding and result in damage to the framing. A licensed general contractor should be consulted for an invasive inspection to determine the extent of the damage to underlying components and make necessary repairs to ensure the weathertightness of the cladding system.

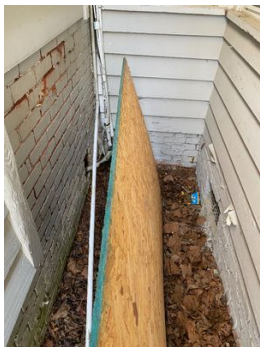
(B1-1.1) Main House

Deteriorated bricks and mortar lines inside and outside of the foundation have resulted in weak and damaged sections. Spalling of the brick is usually caused by years of water exposure. Layers of the brick are separated by the pressure of salts and freeze-thaw cycles of moisture trapped under the surface. Interior foundation bricks appeared to have a number of areas filled with foam spray at time of inspection. A masonry contractor should be consulted for further evaluation of the foundation and to repair all loose, soft, missing mortar/bricks. Repairs are also needed to prevent water penetration. A licensed general contractor with experience in foundation drainage and water proofing that should be consulted for a complete evaluation to determine the source of the moisture and to make necessary repairs. not limited to picture.

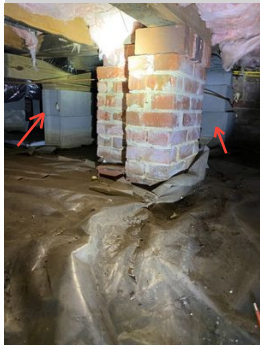
(B1-1.2) Main House

Additional girder support appeared as temporary installation in a few areas of the crawlspace. These are used to stabilize and or raise foundations that have been subjected to differential movement. The owner should be asked for disclosure related to the scope of the repair, service and maintenance requirements, and any warranty that may be transferrable. Main entry support is also not in direct contact with joists. Verification of the adequacy of the repair is beyond the scope of the home inspection, an engineer should be consulted for a complete evaluation of the foundation and the related repair areas to determine if additional repairs or modifications or monitoring is recommended. not limited to picture. see also column/pier details.

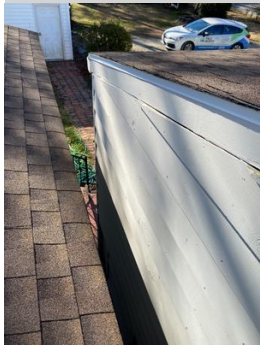
The shingles were not properly trimmed along the roof eave. The shingles were cut too short leaving the edge of the roof sheathing exposed. Improper edge termination along eaves can result in water penetration in the building envelope. A licensed roofing contractor should be consulted for a complete evaluation and repair to ensure the weathertightness of the roof covering system.

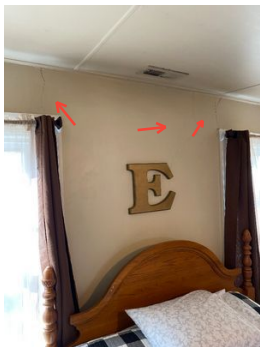
The historical ceiling/walls have crack lines that indicate that plaster is loose from the lathe. Repair is needed to prevent system failure. A plaster repair specialist should be consulted to evaluate the ceiling and determine necessary repairs.

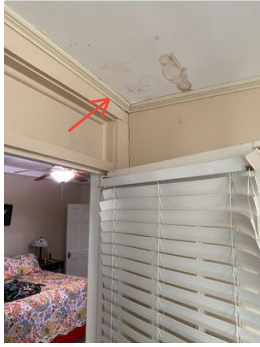
Stains, cracking, damage on the ceilings in bedrooms indicate a history of a leak. At the time of the inspection it was not possible to determine if the condition was due to an active or past occurrence. Further investigation by a repair specialist and owner disclosure is recommended. Refer to the Attic section of the report.

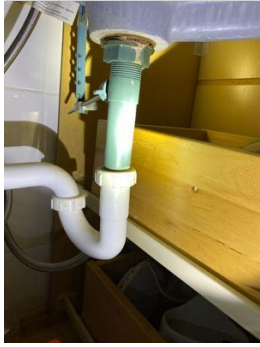
The pipe connection located under the sink is corroded. There are also other sinks with cloth on trap which could indicate prior leak concerns. The corroded or compromised seals need to be repaired/replaced to prevent leaks and ensure sanitary conditions. A licensed plumbing contractor should be consulted for evaluation and repair.

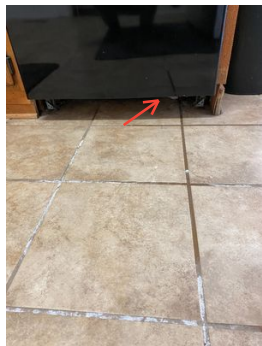
The inspection of the dishwasher was not completed because the unit leaked during the operation. An appliance repair specialist should be consulted for further evaluation and repair to ensure the proper operation of the appliance. At the time of the repair adjacent areas should be checked for evidence of water damage, any evidence of water damage should be investigated by a licensed general contractor.
