Inspection Report

Property Address:
101 Grant St.
Sneads Ferry NC

Seaside Home Inspections, Inc.

Date: 5/14/2026	Time: 09:00 AM	Report ID: 052614
Property: 101 Grant St. Sneads Ferry NC	Customer: Danielle Rivenbark	Real Estate Professional:

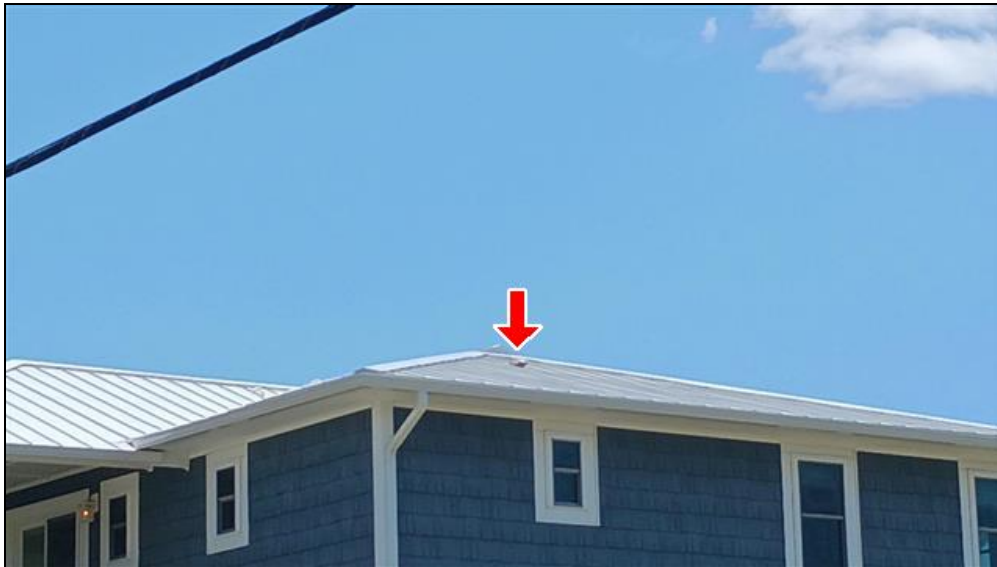
1.2 Picture 1

(1) The metal exhaust fan discharge on the roof over the right side of the second floor is heavily corroded in places. This may lead to water intrusion at this roof penetration. Recommend further evaluation and repair or replacement by qualified tradesmen.

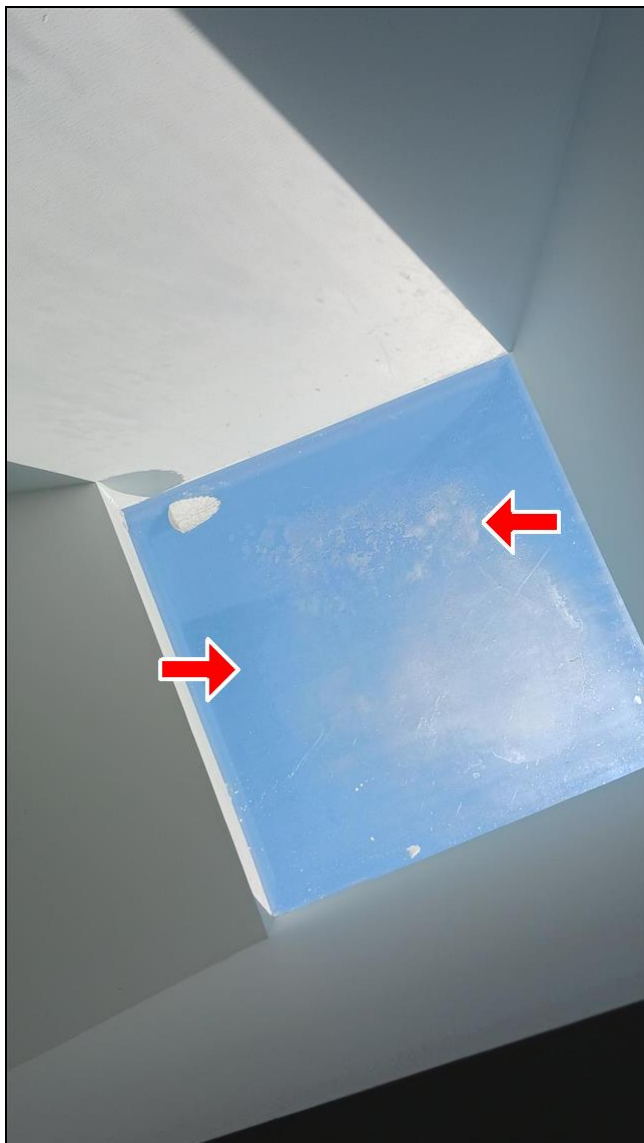
1.2 Picture 2

(2) The glass in the skylight over the laundry room appears to be cloudy between the glass panes. This is typically a result of a bad seal that will require repair or replacement to remove. Recommend further evaluation and repair by a qualified tradesman.

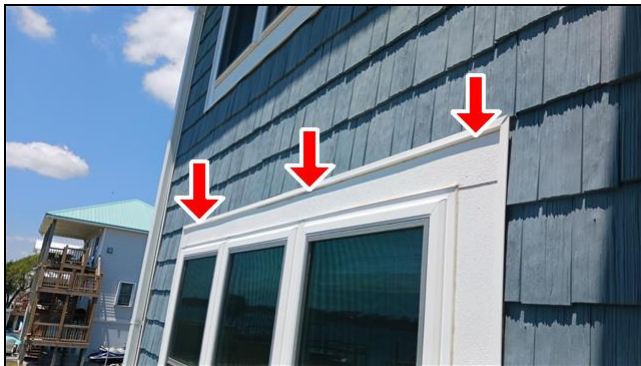
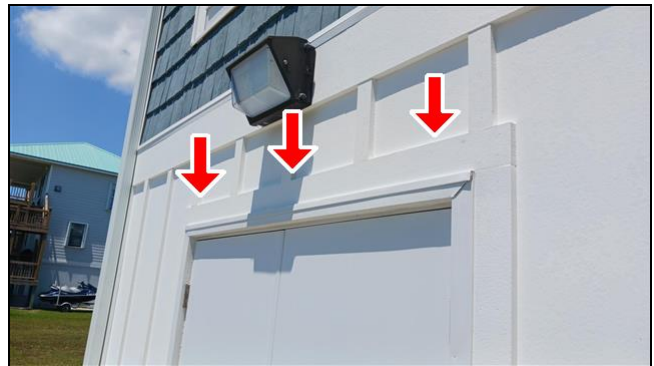
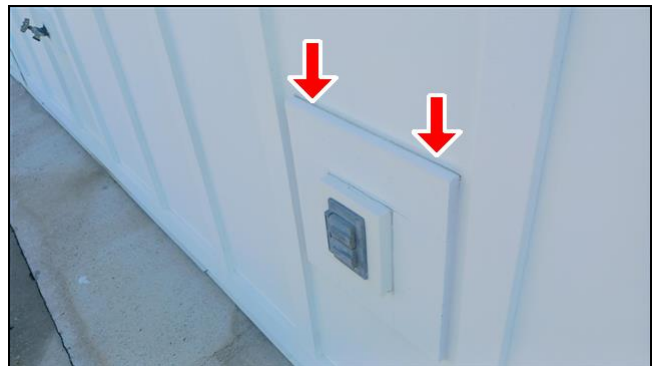
(1) There is no 'drip cap' flashing over the horizontal trim above the windows and doors on the exterior of the home. 'Drip cap' flashing is typically required over horizontal trim above windows and doors to prevent potential water intrusion. Recommend further evaluation and repair by a qualified tradesman.

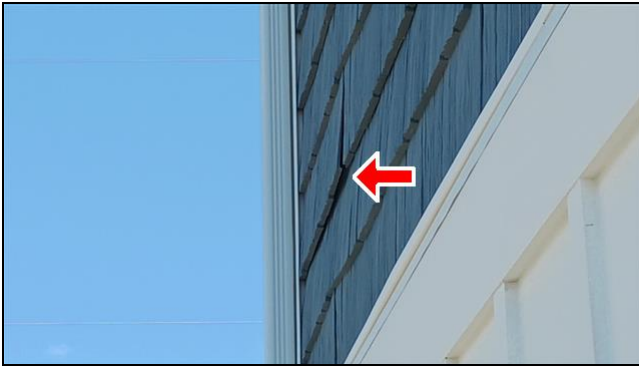
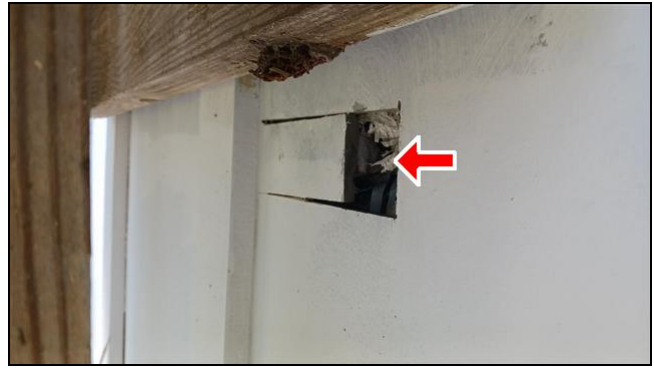
(2) There is a loose piece of vinyl siding at the bottom of the wall on the right side of the first floor. There is an unsealed void in the cement fiber siding on the left side of the ground floor. Recommend further evaluation and repair by a qualified tradesman to prevent potential water intrusion in these areas.

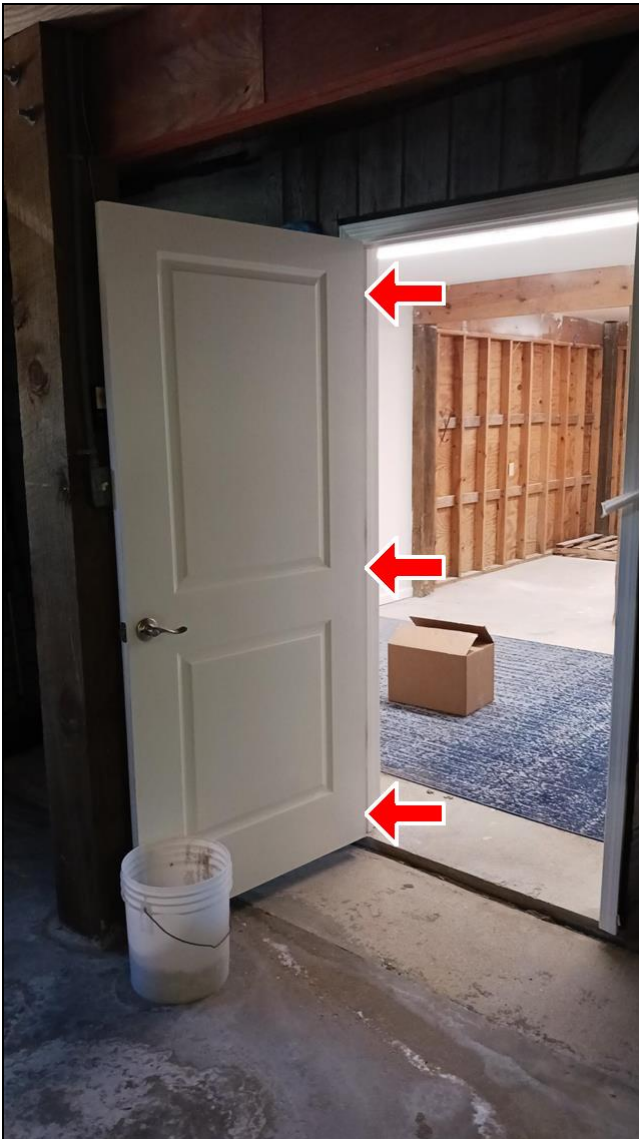
2.3 Picture 1

The garage separation door is a hollow core interior door. Garage separation door should be solid core steel fire rated doors for proper separation between the garage and the living areas inside of the home. Recommend further evaluation and replacement by a qualified tradesman to prevent potential safety hazards.

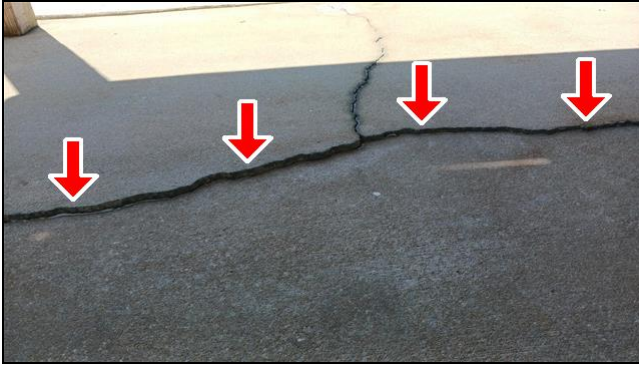
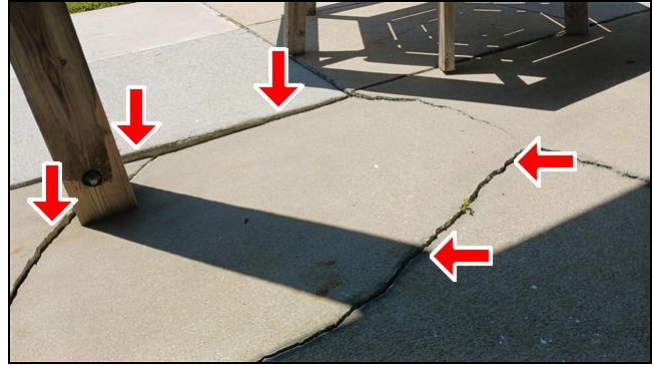
There are cracks in the concrete in places on the back patio on the back of the ground floor. The concrete is raised at some of these breaks in the concrete. These may pose as potential trip hazards. Recommend further evaluation and repair by a qualified tradesman to prevent potential safety hazards.

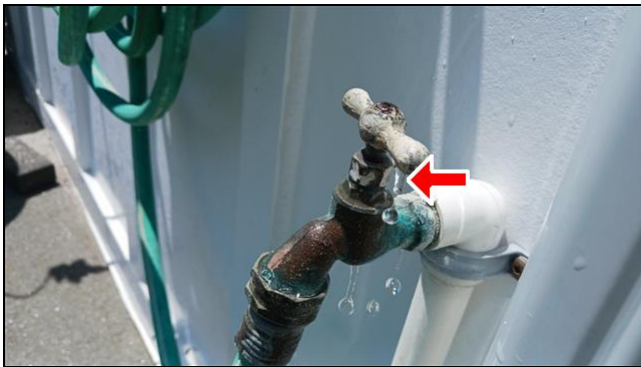
2.10 Picture 1

(1) The handle for the spigot on the front left corner of the ground floor leaks when the spigot is running. The handle for the spigot on the back of the first floor also leaks when this spigot is running. The handle for the spigot on the back of the second floor leaks when the spigot is running. Recommend further evaluation and repair by a licensed plumbing contractor.

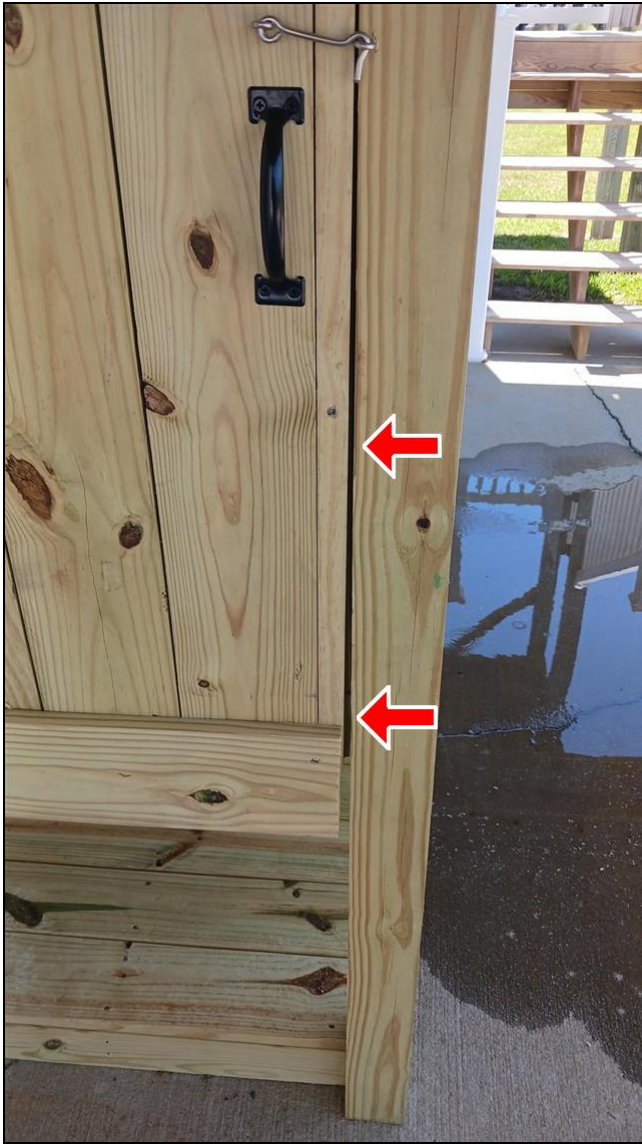
2.10 Picture 2

(2) The door to the outdoor shower rubs the post on the handle side of this door when opening and closing. Recommend further evaluation and repair by a qualified tradesman.

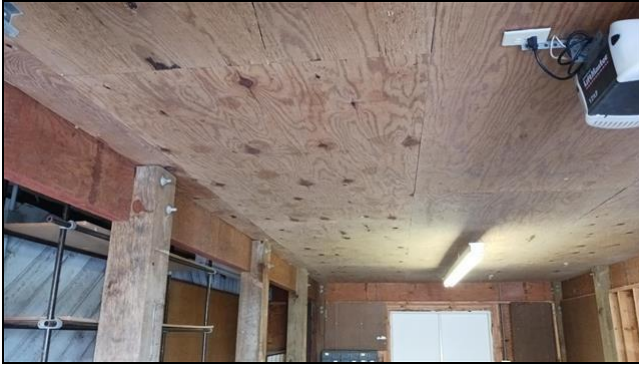
3.2 Picture 1

The garage ceiling is covered with plywood. The garage ceiling should be covered with sheetrock with no unsealed penetrations for proper separation between the garage and the living areas inside of the home. Recommend further evaluation and repair by qualified tradesmen to prevent potential safety hazards.

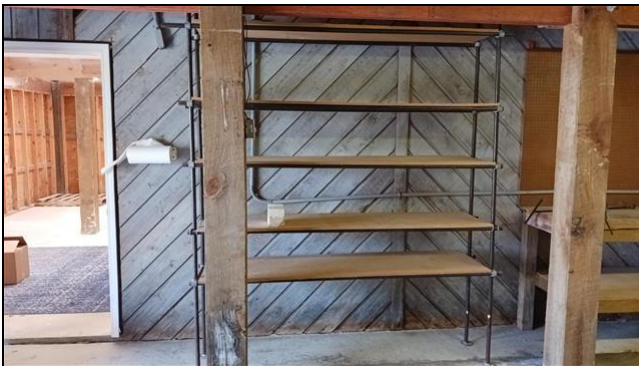
3.3 Picture 1

The garage separation wall is covered with wood. The garage separation wall should be covered with sheetrock with no penetrations to ensure proper separation between the garage and the living areas inside the home. Recommend further evaluation and repair by a qualified tradesman to prevent potential safety hazards.

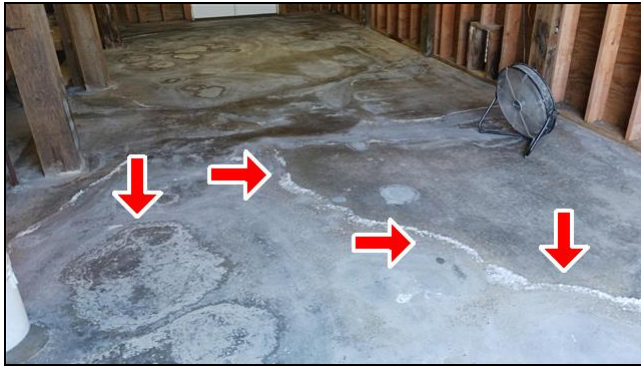
3.4 Picture 1

There are water stains and efflorescence on the concrete floor in the garage. This may indicate previous water intrusion in the garage. Recommend further evaluation by qualified tradesmen and repair as necessary.

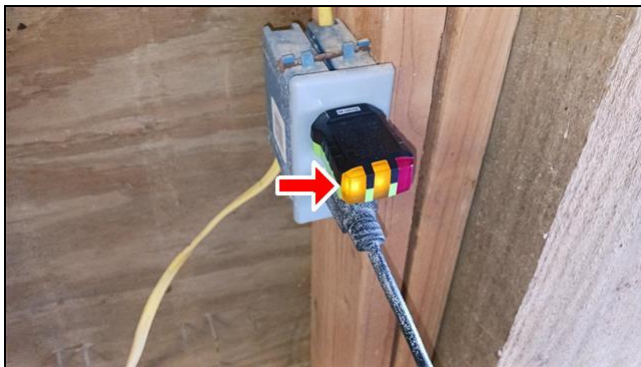
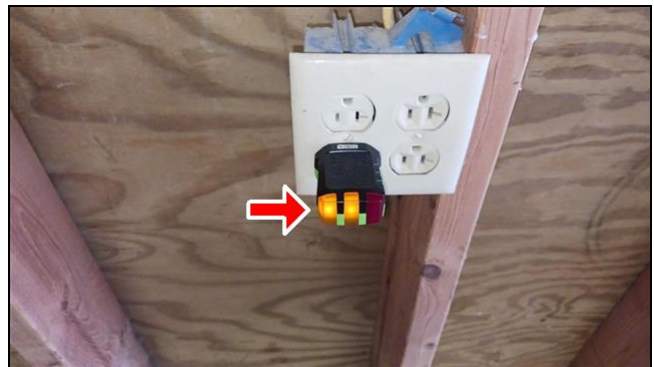
The receptacles in the garage are not GFCI protected. All receptacles in the garage should be GFCI protected to prevent potential safety hazards. Recommend further evaluation and repair by a licensed electrical contractor.

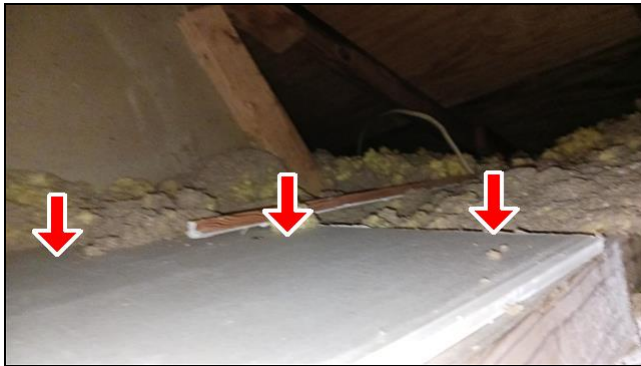
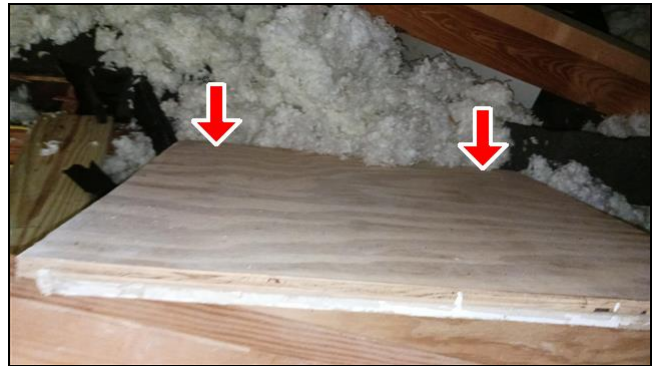
(1) Attic accesses are located in the laundry room and the master closet. Access panels are currently not insulated. Recommend insulating access to ensure that proper R-values are maintained and air conditioning systems work effectively.

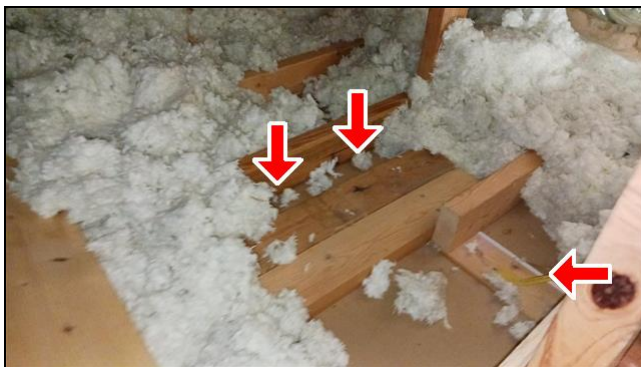
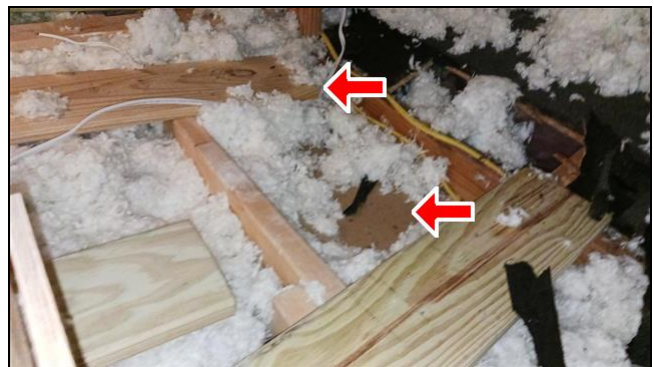
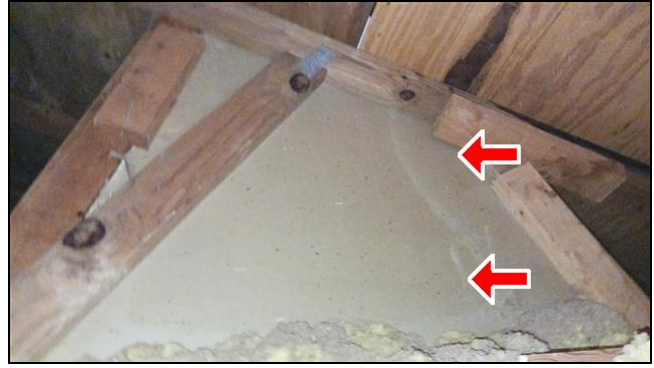
Blown insulation is missing in places in the ceilings near the attic access in the master bedroom closet. The walls beneath both of the skylights have not been insulated in the attic. Insulation has been installed upside down over the back right corner of the second floor. The vapor barrier should be turned down towards the conditioned side of the home. Recommend further evaluation and repair by an insulation contractor to ensure that proper R values are maintained in these areas and air conditioning systems work effectively.

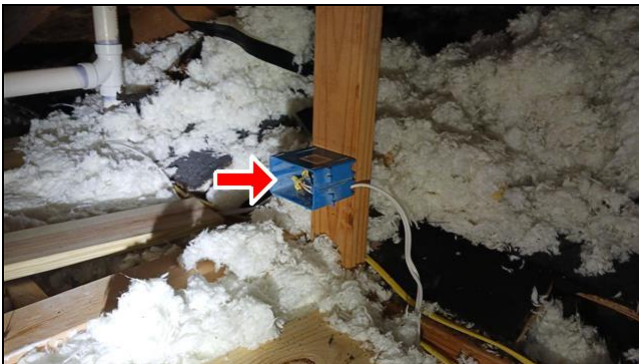
4.5 Picture 1

There is an open junction box in the attic near the attic access over the master bedroom closet. This junction box should have a cover to conceal the wiring inside of the box. Recommend further evaluation and repair by a licensed electrical contractor to prevent potential safety hazards.

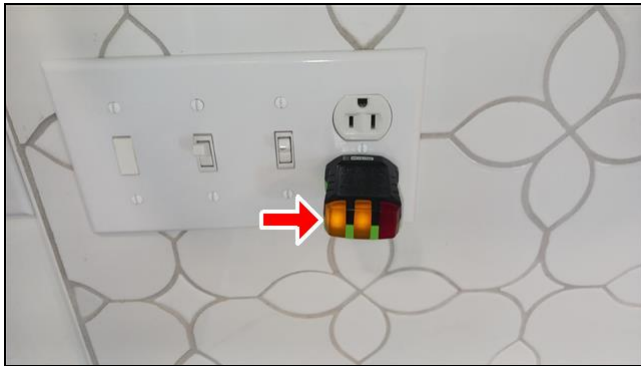
5.7 Picture 1

GFCI receptacles are not present in the kitchen of this home, this is a potential safety hazard. Homes built prior to 1987 were not required to have GFCI receptacles in kitchen areas. Recommend further evaluation and repair by a licensed electrician to prevent potential safety hazards.

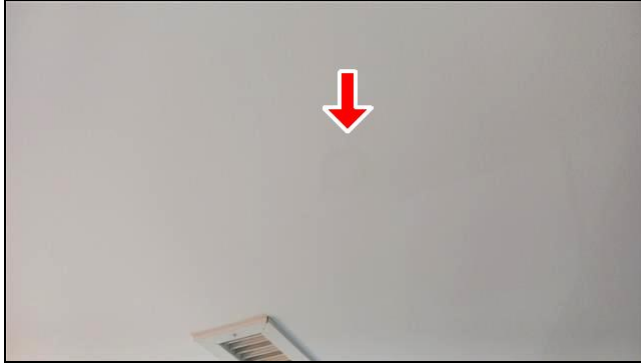
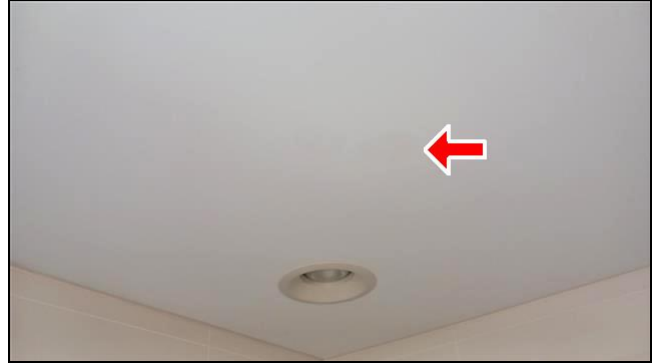
There are water stains on the ceiling in the guest bathroom on the first floor. This may indicate previous leaks in the master bathroom above this area of the home. These areas of the ceiling were dry at the time of inspection. Recommend further evaluation by qualified tradesman and repair as necessary.

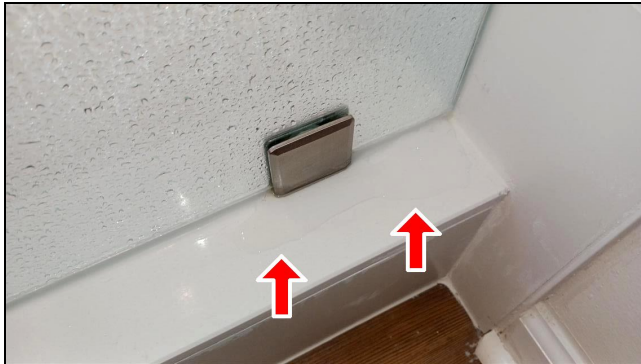
6.1 Picture 1

The glass shower walls are leaking in places in the guest bathroom on the first floor. Recommend further evaluation and repair by qualified tradesmen.

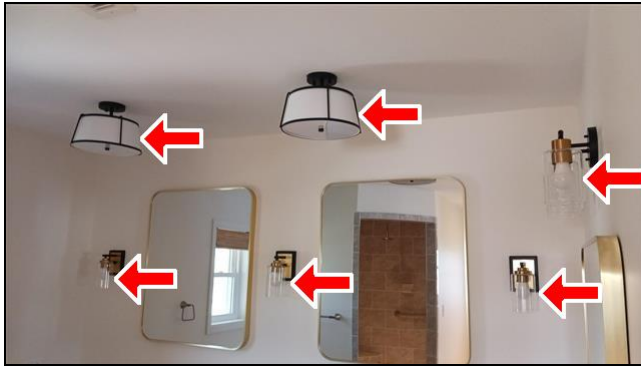
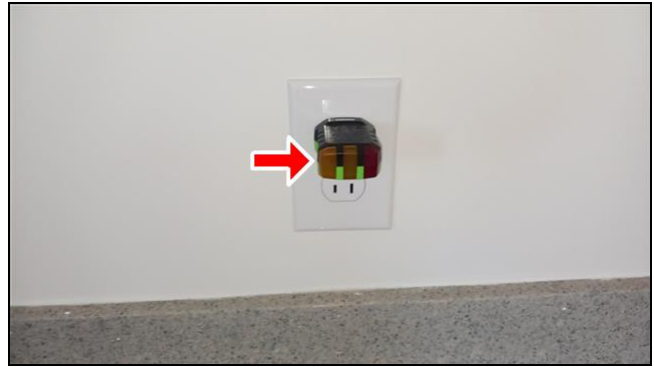
The lights in the master bathroom cut off when the GFCI receptacles in this bathroom are tripped. The lights in the bathrooms are typically isolated from the GFCI receptacles in the bathrooms. Recommend further evaluation and repair by a licensed electrical contractor.

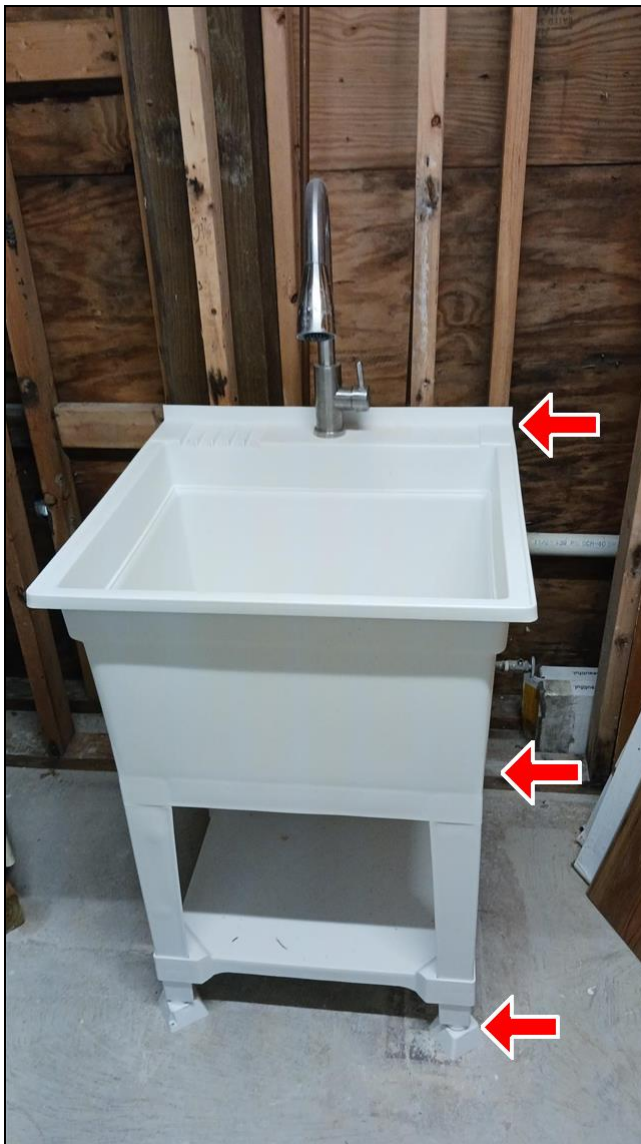
6.7 Picture 1

The sink in the half bathroom on the ground floor is not secured in place. This may lead to leaks at this sink. Recommend further evaluation and repair by a licensed plumbing contractor.

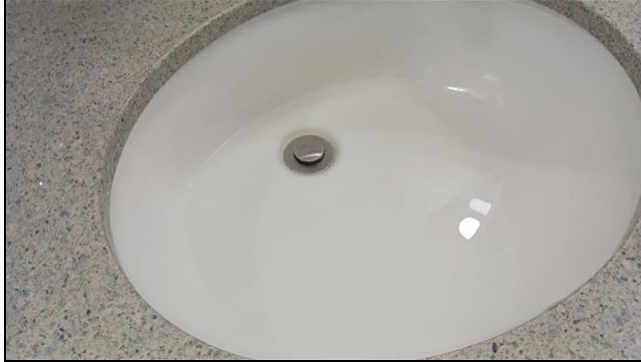
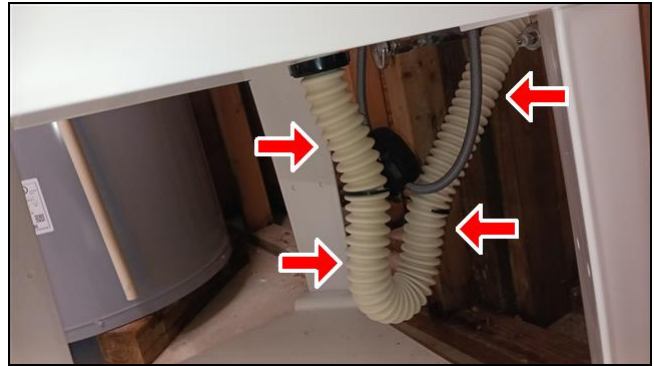
The right sink in the master bathroom is slow to drain. The sink drains beneath both sinks in the back guest bathroom are not equipped with a p-trap. Flexible pipe is being used for a portion of the sink drain in the half bathroom on the ground floor. Flexible pipe should not be used for plumbing drains. Recommend further evaluation and repair by a licensed plumbing contractor.

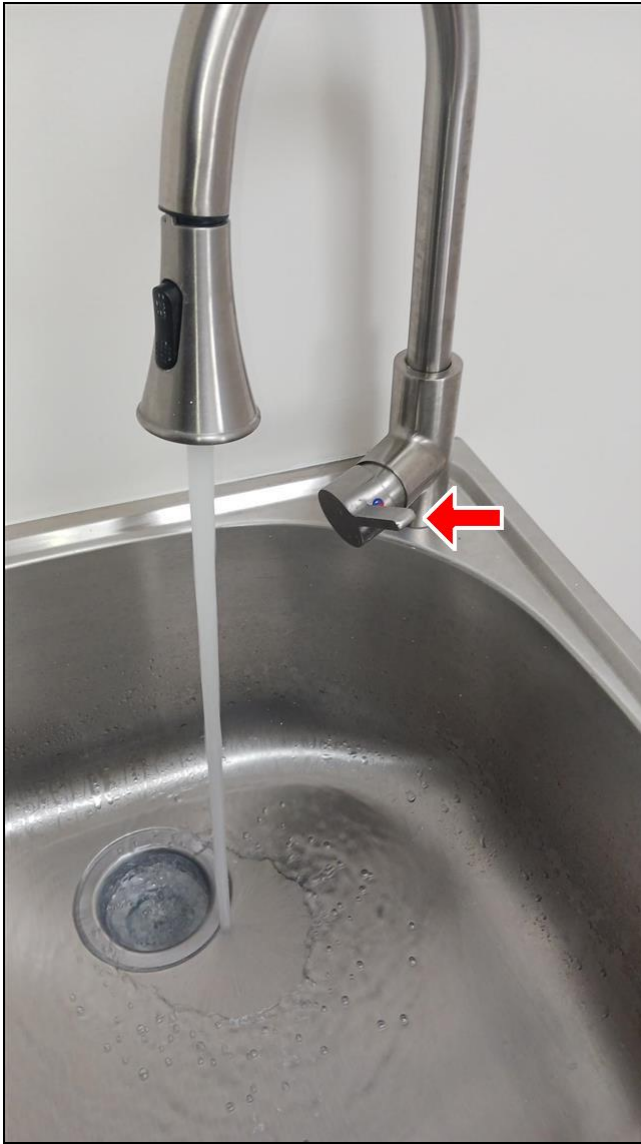
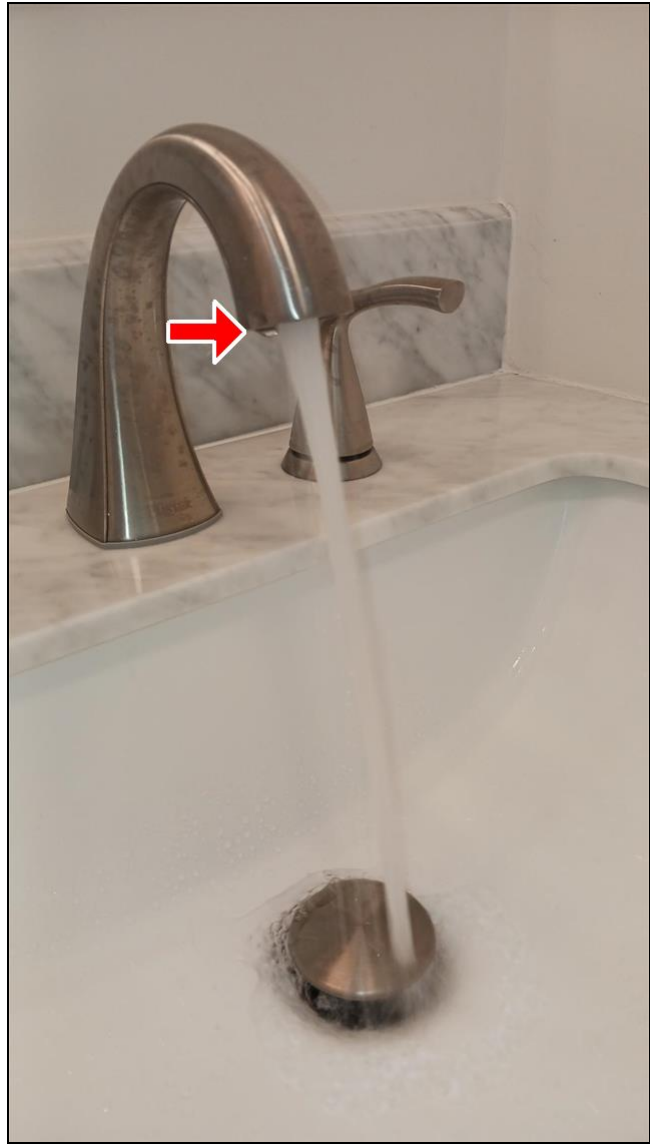
Hot and cold are reversed at the utility sink in the laundry room on the second floor. The aerator is partially clogged for the right sink in the back guest bathroom on the second floor. Recommend further evaluation and repair by a licensed plumbing contractor.

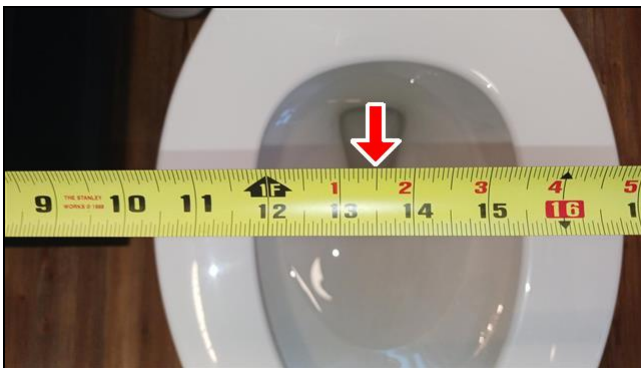
6.11 Picture 1

There is less than 15" clearance from the side of the vanity to the center of the toilet bowl in the guest bathroom on the first floor. There should be a minimum of 15" clearance from the side of the vanity to the center of the toilet bowl. Recommend further evaluation and repair by a licensed plumbing contractor.

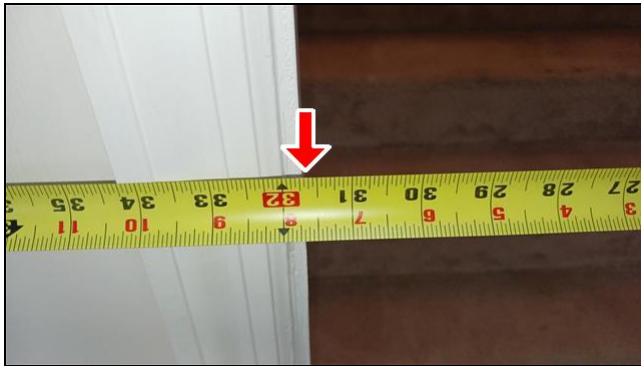
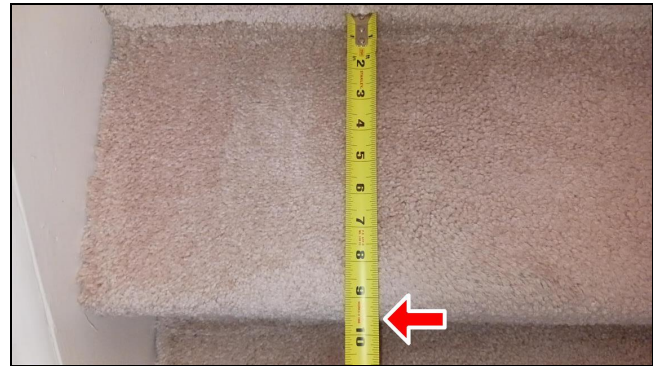
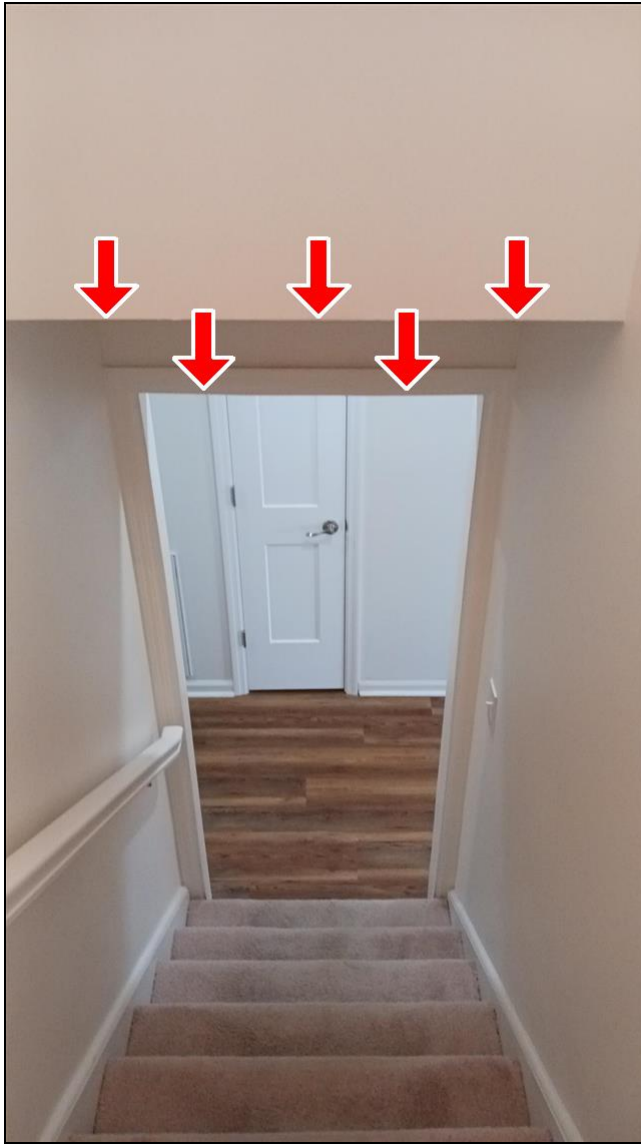
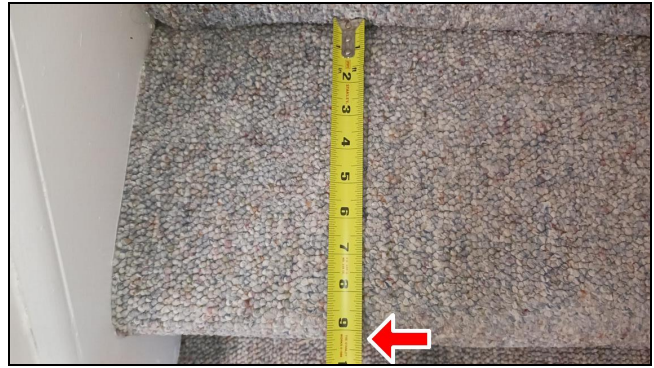
The cased opening at the bottom of the stairs on the first floor is less than 36" wide. The stair treads for the stairs from the first to the second floor are less than 10" deep. There is less than 6' 8" headroom near the bottom of the stairs on the first floor. The stair treads for the stairs from the ground floor to the first floor are less than 10" deep. The door opening at the top of the stairs from the ground floor to the first floor is less than 36" wide. Recommend further evaluation and repair by licensed general contractor to prevent potential safety hazards.

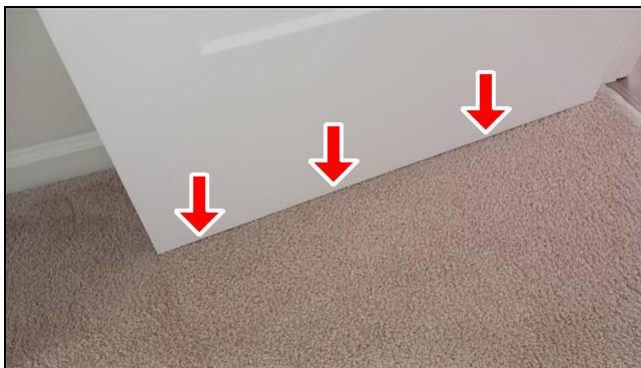
7.4 Picture 1

Interior doors rub the carpet at the bottom of the doors in the bedrooms when opening/closing. There should be an air gap at the bottom of these doors for the HVAC systems to work properly. Recommend further evaluation and repair by a qualified tradesman.

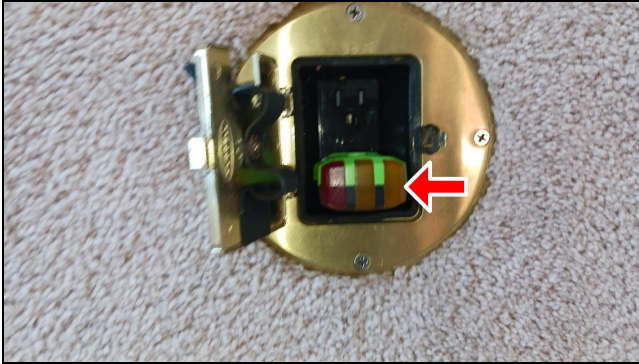
7.6 Picture 1

(1) There is no power at the floor receptacle in the living room on the right side of the first floor. Recommend further evaluation and repair by a licensed electrical contractor.

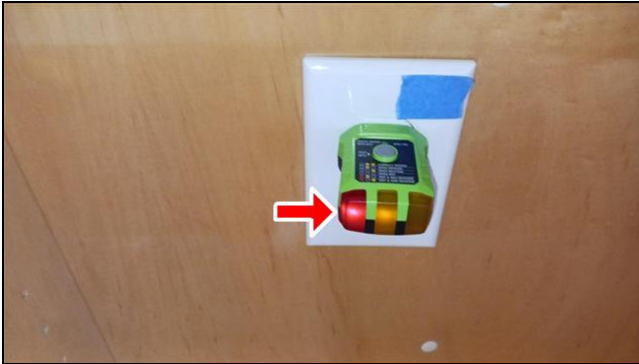
7.6 Picture 2

(2) There is a receptacle on the left side of the living room on the first floor that has reversed polarity. Recommend further evaluation and repair by a licensed electrical contractor to prevent potential safety hazards.

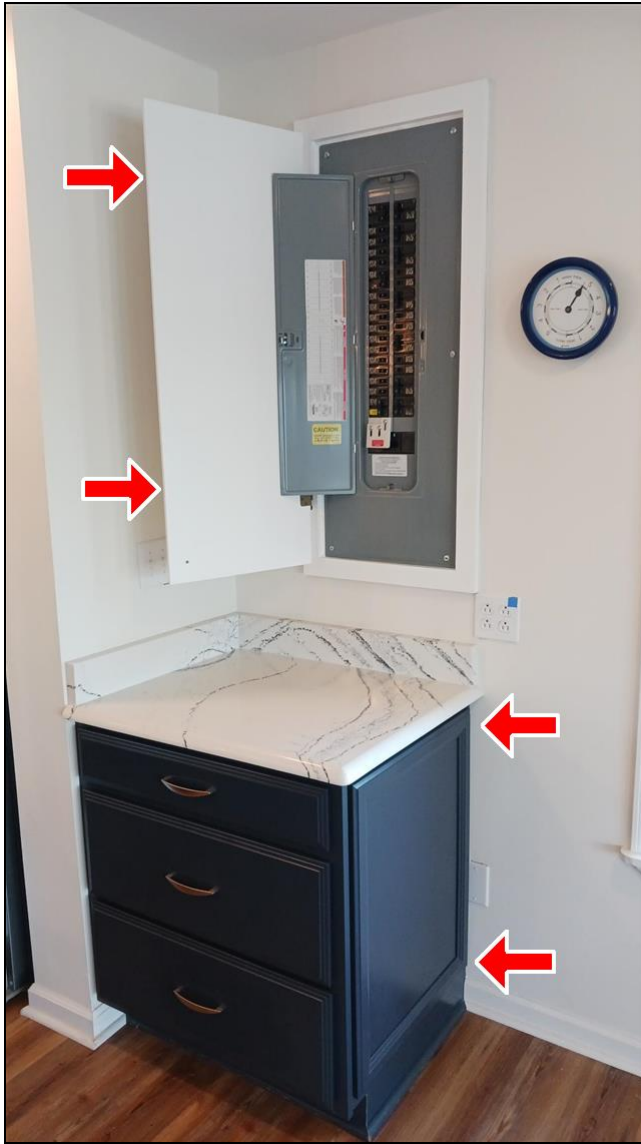
8.1 Picture 1

(1) There is a cabinet directly in front of the main electrical panel on the left side of the kitchen. A cabinet door has been installed over the electrical panel. There should be unobstructed space in front of and around all electrical panels for safe access. Recommend further evaluation and repair by a licensed electrical contractor to prevent potential safety hazards.

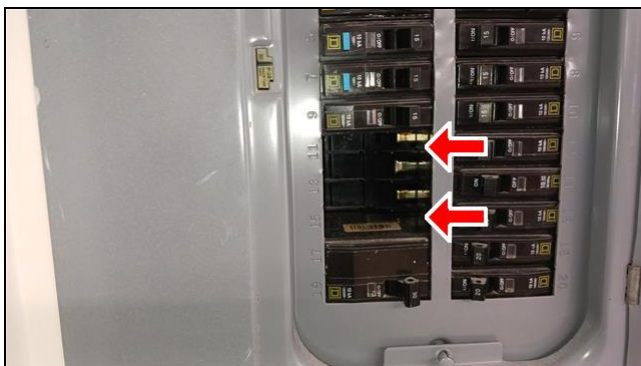
8.1 Picture 2

(2) There are missing knockouts in the sub panel near the bottom of the stairs on the ground floor. This is a potential safety hazard. Recommend further evaluation and repair by a licensed electrical contractor.

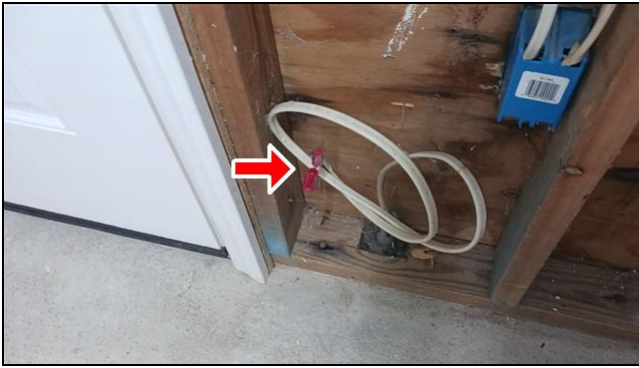
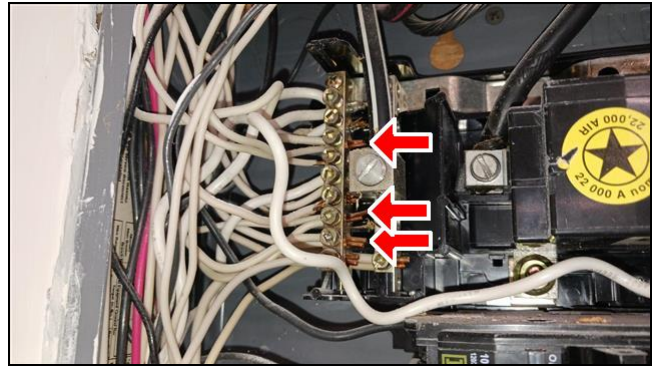
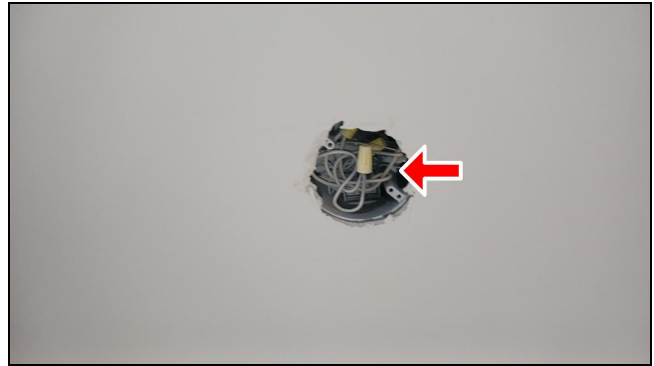
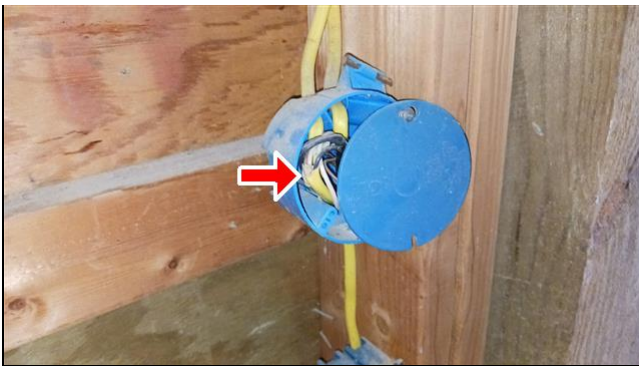
There is a live wire beside the back door at the back of the ground floor that is not concealed in a junction box with a cover. This wire should be concealed in a junction box with a cover. There are double tapped neutrals in the sub panel on the ground floor. There is a missing romex connector where some of the wires penetrate the top of the sub panel on the ground floor. There is an open junction box in the ceiling over the back of the ground floor. The cover is loose for the junction box on the right side of the garage. Recommend further evaluation and repair by a licensed electrical contractor to prevent potential safety hazards.

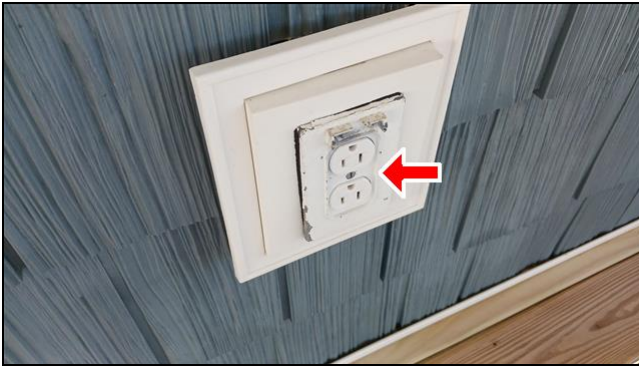
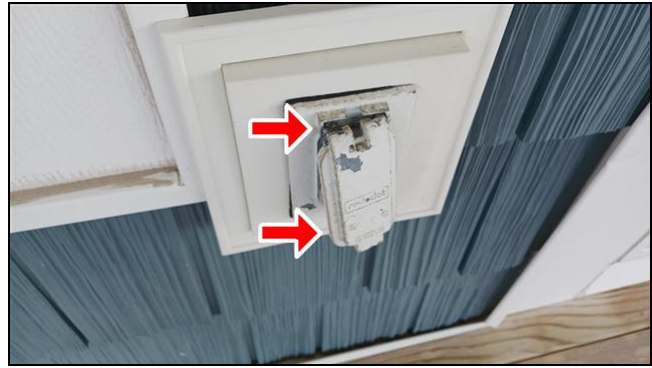
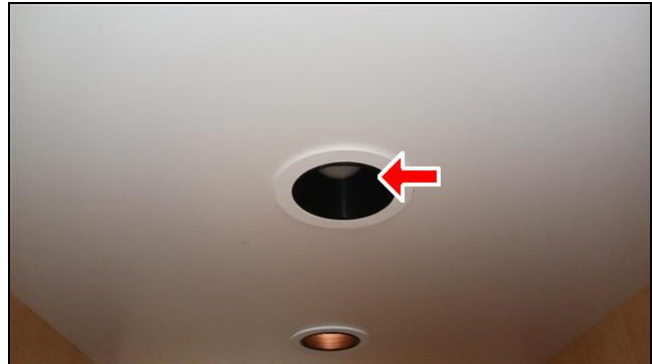
The weatherproof cover is broken for the receptacle on the front deck on the second floor. This may lead to water intrusion at this receptacle. The weatherproof cover is loose for the receptacle on the back deck on the second floor. One of the lights is not illuminating over the vanity in the front guest bathroom. One of the lights in the elevator is not working. The ceiling fan in the master bedroom is not properly balanced. The ceiling fan in the living room on the right side of the first floor did not work when tested. Recommend further evaluation and repair by a licensed electrical contractor.

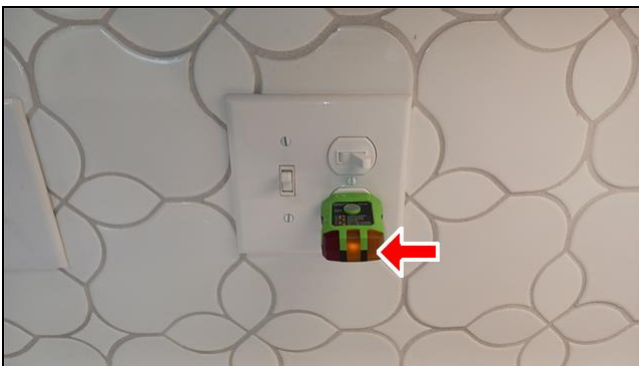
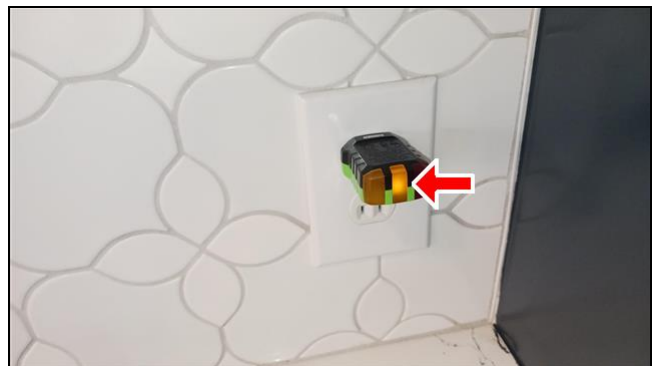
There are receptacles near the sink in the kitchen that read open ground when tested. (marked with blue tape for identification) This is a potential safety hazard. Recommend further evaluation and repair by a licensed electrical contractor.

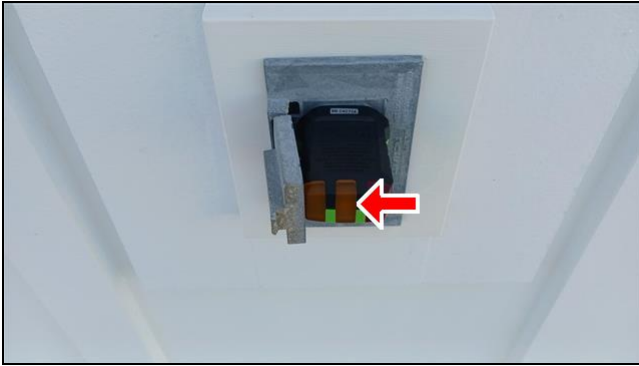
8.6 Picture 1

The receptacle on the right side of the garage is not GFCI protected. All receptacles on the exterior of the home should be GFCI protected to prevent potential safety hazards. Recommend further evaluation and repair by a licensed electrical contractor.

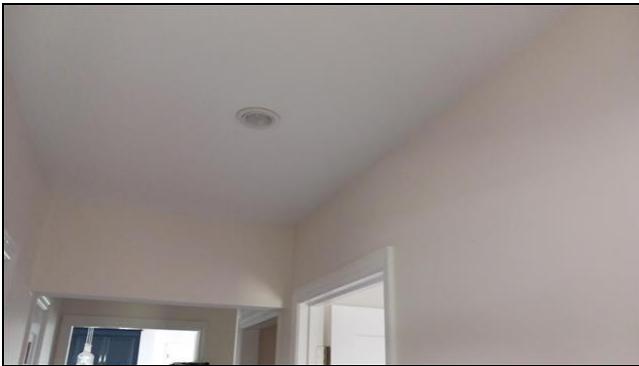
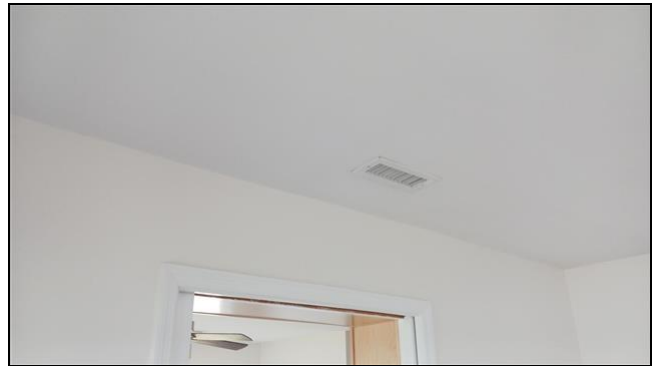
(1) There is no smoke detector present in the hallway outside of the guest bedroom on the first floor. There is no smoke detector present outside of the master bedroom on the second floor. There should be smoke detectors located directly outside of the bedrooms. Recommend further evaluation and repair by a licensed electrical contractor.

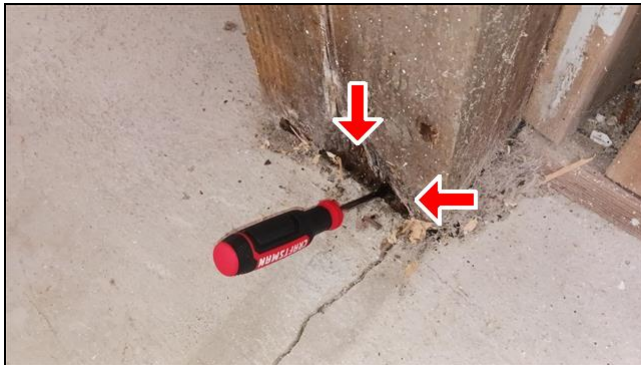
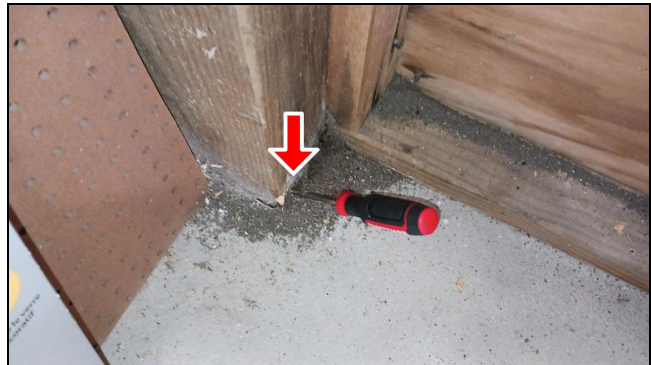
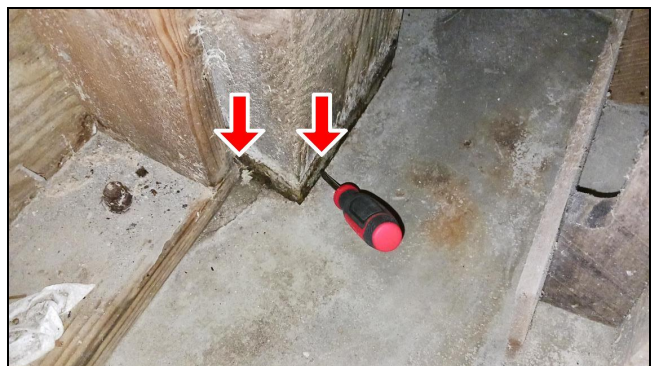
The wood pilings are deteriorated where the penetrates the concrete at the back of the ground floor. Wood pilings are also deteriorated in places at the bottom of the pilings on the right side and front of the garage. Recommend further evaluation by a licensed structural engineer and repair or replace as necessary.

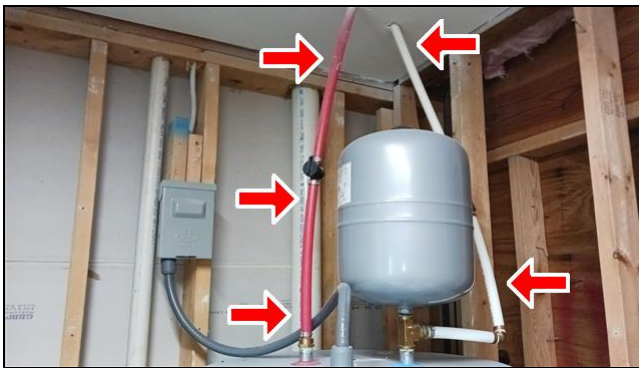
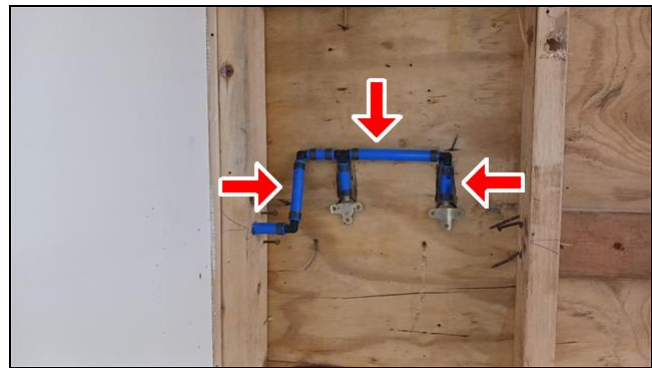
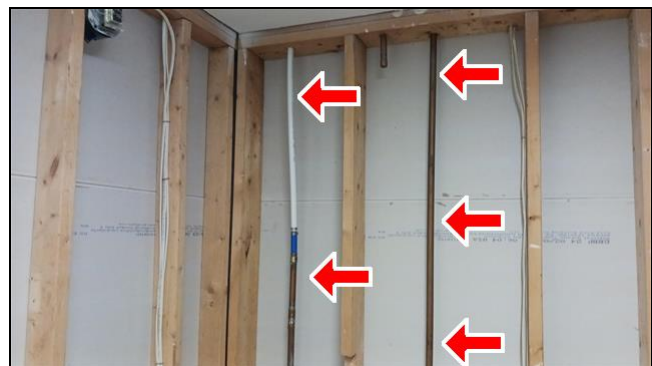
Plumbing supply lines that are exposed on the ground floor and on the exterior of the home should be insulated to prevent them from freezing. Recommend further evaluation and repair by a licensed plumbing contractor.

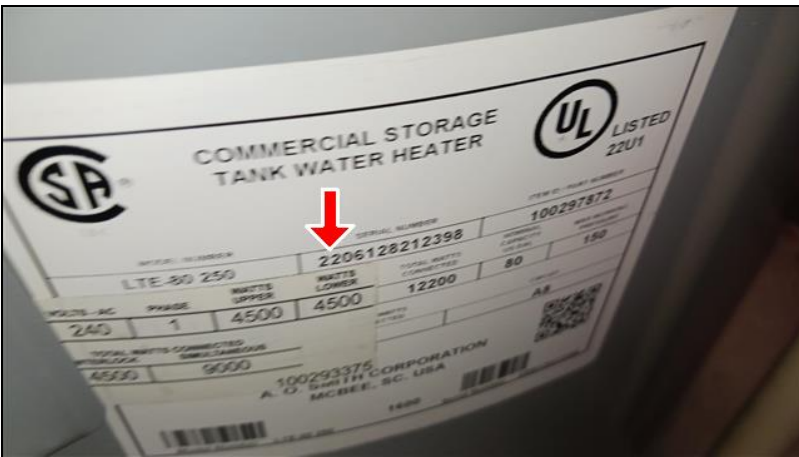
10.4 Picture 1

(1) The 80 gallon AO Smith electric hot water heater was manufactured in 2022. The typical life cycle for these hot water heaters is 12-15 years. Unable to determine if this hot water heater will meet hot water demand for this home.

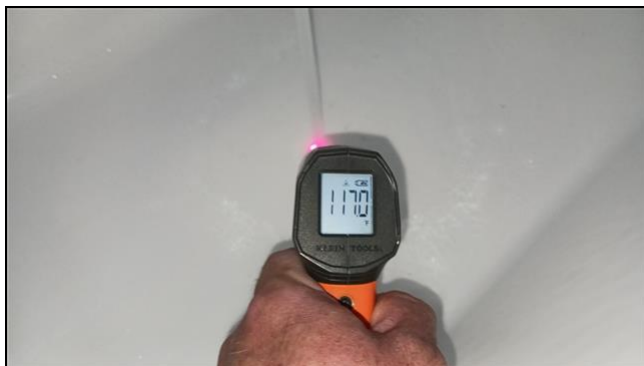
10.4 Picture 2

(2) Water is currently being dispersed at 117 degrees. Water temperatures over 120 degrees are potential scalding hazards. Noted for your information only.
