Inspection Report

Property Address:
101 Grant St.
Sneads Ferry NC

Seaside Home Inspections, Inc.

Date: 5/14/2026	Time: 09:00 AM	Report ID: 052614
Property: 101 Grant St. Sneads Ferry NC	Customer: Danielle Rivenbark	Real Estate Professional:

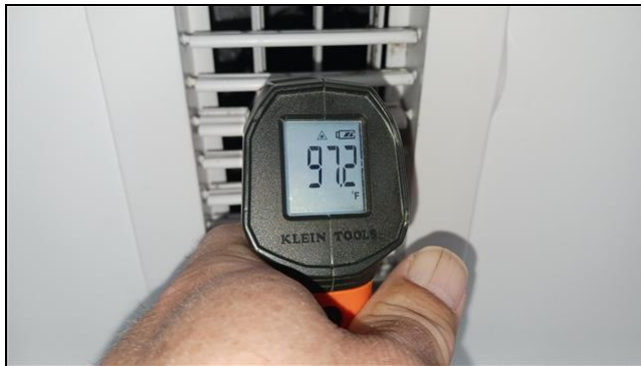
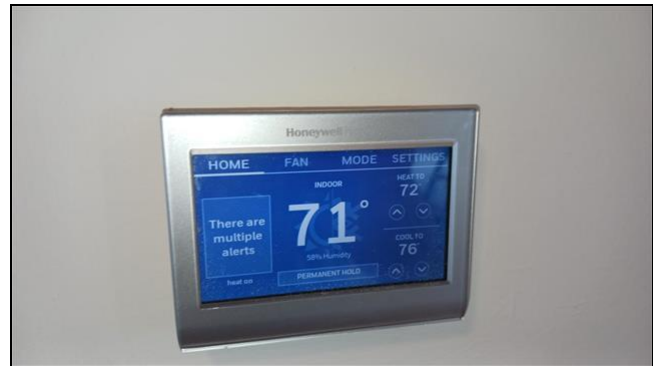
(2) Heat at the register read 97 degrees when tested. Heat at the thermostat read 71 degrees when tested. This is within the normal range and is noted for your information only. (second floor)

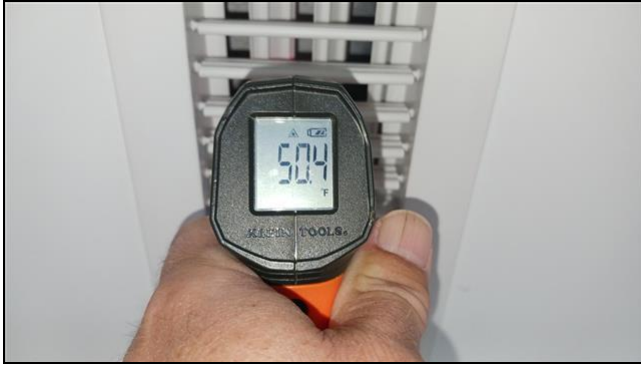
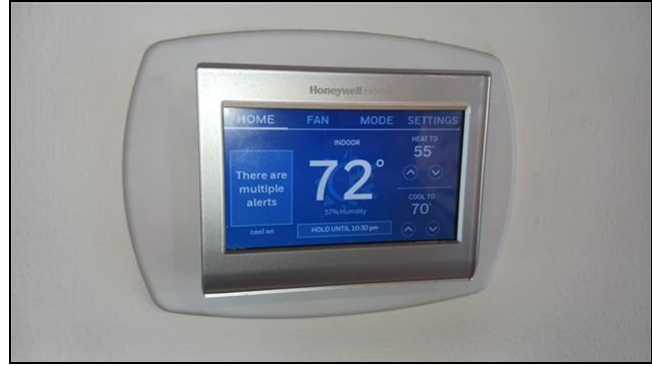
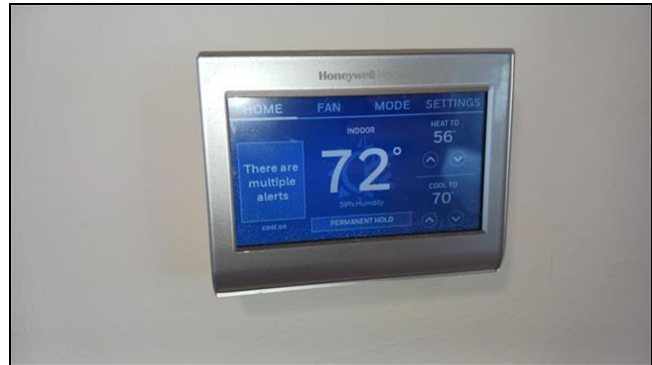
(1) The 3.5 ton ICP heat pump conditioning the first floor of this home this home was manufactured in 2017. The 2 ton Tempstar heat pump conditioning the second floor was manufactured in 2020. The typical life cycle for these heat pumps is 10-15 years.
