Property Inspection Report

Report Number: 9-30-312

312 Juniper Creek Blvd
Pinehurst, North Carolina 28374

Date of Inspection: Tuesday, September 30, 2025

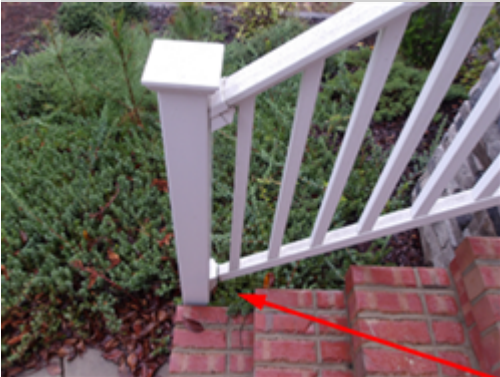
(B3 - 1.1) Porch

The bottom stringer for the porch handrailing is not securely fastened to the bottom post. Recommend repairs by a licensed repair specialist.

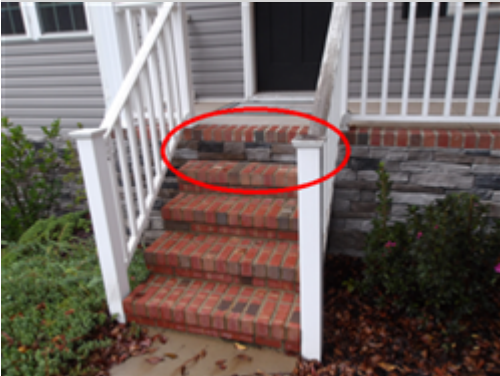
(B3 - 1.2) Porch

The steps at the entrance of the home have a noticeable variance in the height of the first step. This configuration could result in the trip or fall hazard as someone enters or leaves the home. A licensed general contractor should be consulted to review the steps and repair as needed to ensure safe access and egress.

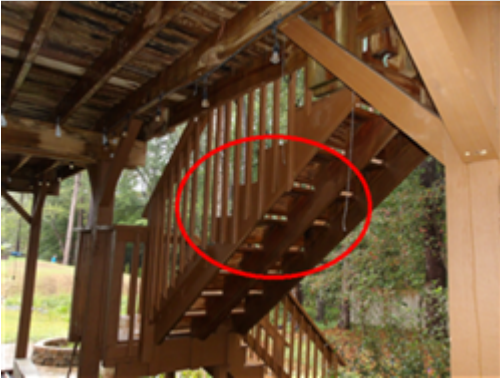
(B3 - 2.1) Deck

Pickets on the handrailing was noted to not be securely fastened to the stair stringer along the bottom. Recommend further evaluation of this concern by a licensed repair specialist and repaired as needed.

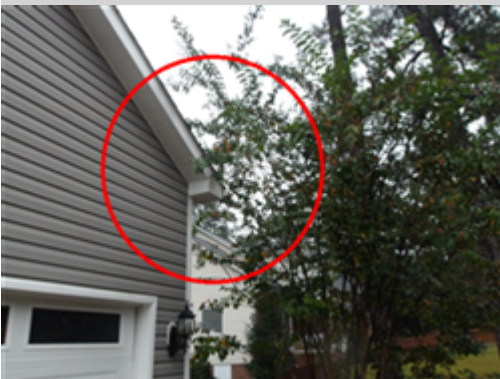
(B5 - 1.1) Vegetation

The vegetation in some areas around the perimeter of the home is over grown and making contact with the home. This also blocks the air circulation and limited the inspection of some areas. Recommend consulting a qualified person to evaluate and trim vegetation as needed.

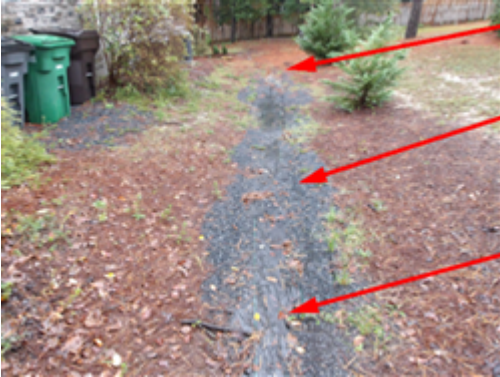
(B5 - 2.1) Grading

Efforts to control soil erosion on the right side of the home need further evaluation and repairs. Erosion was noted to the gravel bed and soil that will worsen over time if not repaired. Recommend consulting a licensed general contractor for further evaluation and repairs.

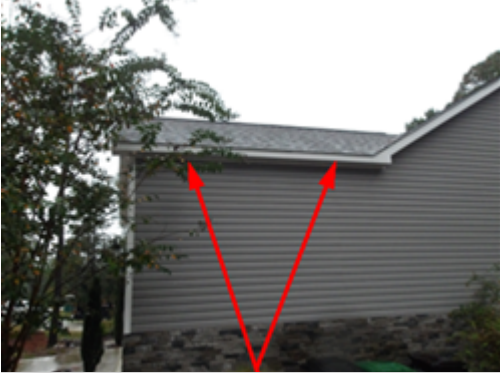
(C2 - 1.1) Main House

This home does not have a system such as gutters to control roof drainage at all eave locations. Direct drainage to the foundation and cladding from the roof system can result in water penetration into the foundation area and foundation deterioration. It is recommended that a gutter system with extended downspouts be installed to protect the wall cladding and foundation areas of the home. A licensed general contractor should be consulted for evaluation and installation.

This home does not have a system such as gutters to control roof drainage at all eve locations. Direct drainage to the foundation and cladding from the roof system can result in water penetration into the foundation area and foundation deterioration. It is recommended that a gutter system with extended downspouts be installed to protect the wall cladding and foundation areas of the home. A licensed general contractor should be consulted for evaluation and installation.

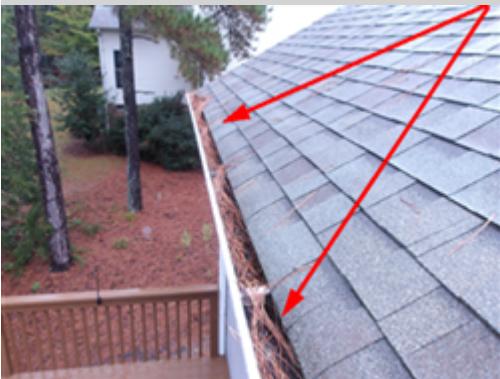
(C2 - 1.2) Main House

During the inspection, the gutters were found to contain debris. This debris prevents the gutters from properly removing water that is shed from the roof areas by clogging gutter trays and down spouts. Water build up in the gutter trays can lead to water penetration of the roofing materials. Water can also overflow onto the foundation areas and cause moisture issues and/or soil erosion to the foundation and crawlspace areas. Recommend cleaning and regularly scheduled maintenance to ensure proper operation of the gutter system.

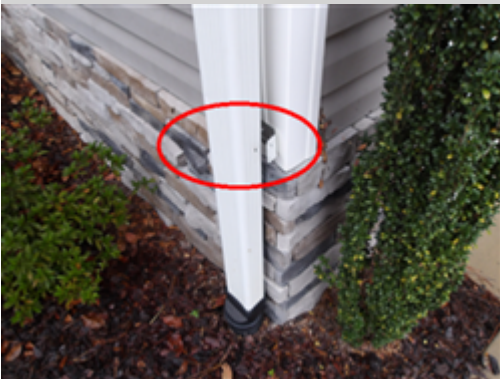
(C2 - 1.3) Main House

The downspout on the left front garage corner is not securely fastened to the home. Recommend repairs by a qualified contractor.

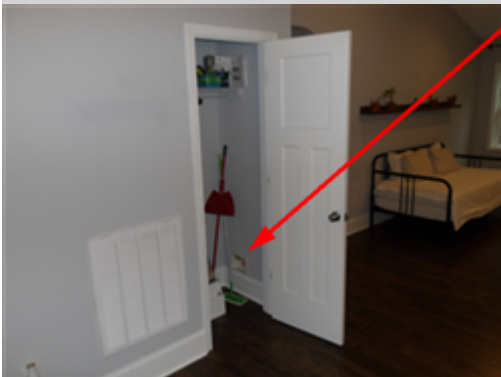
(D1 - 1.1) All Accessible Areas

Photo showing emergency water shut off valve located in the living room closet. The home has a second emergency water shut off located in the basements utility room. This is for your information only.

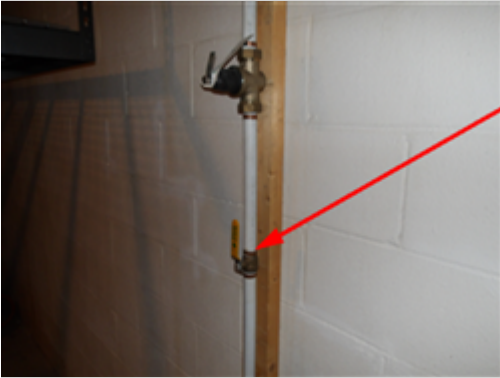
(D1 - 1.2) All Accessible Areas

Photo showing emergency water shut off located in basement utility room area.

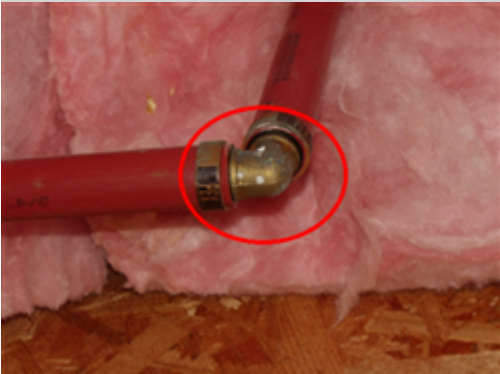
(D1 - 1.3) All Accessible Areas

The visible plumbing lines in this home are cross-linked polyethylene (PEX) with brass fittings. Evidence of discolored/corroded fittings was noted during the basement inspection. This could be the result of dezincification of the brass alloy. Dezincification occurs when zinc leaches from the brass leaving the fittings in a weakened state. As the zinc leaches, it can also form a build-up inside the fitting restricting water flow and ultimately leaving the plumbing system prone to failure. A licensed plumbing contractor should be consulted for a complete evaluation of the plumbing system to determine the significance of this concern and to make necessary repairs.

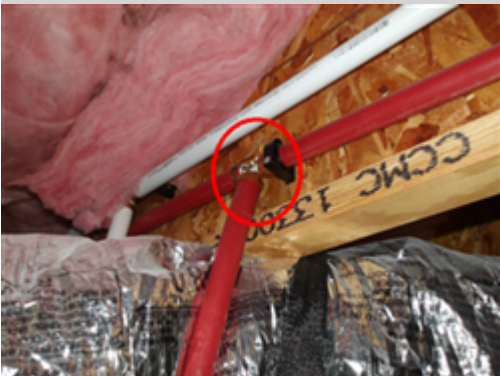
(D1 - 1.4) All Accessible Areas

Additional photo showing corrosion on brass PEX fitting above the water heater.

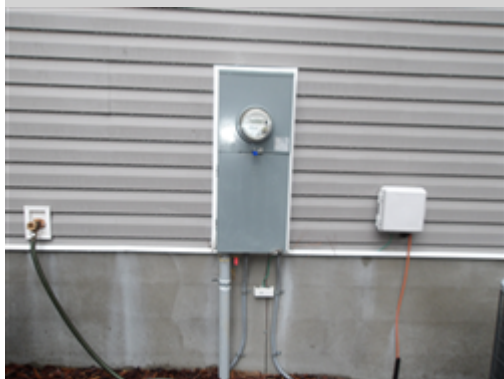
(E1 - 1.1) Underground

Photo of main electrical service. This is for your information only.

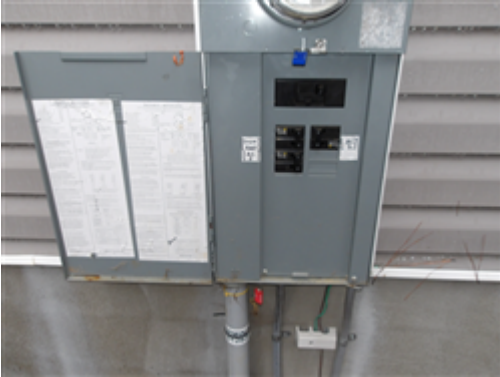
(E2 - 1.1) Main Panel #1

Photo of main electrical panel located on exterior of home. This is for your information only.

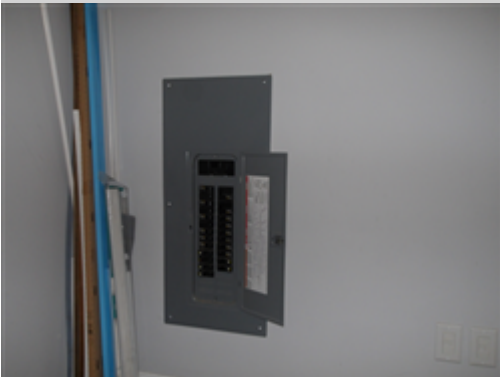
(E2 - 2.1) Main Panel #2

Photo of main electrical panel located in the garage area. This is for your information only.

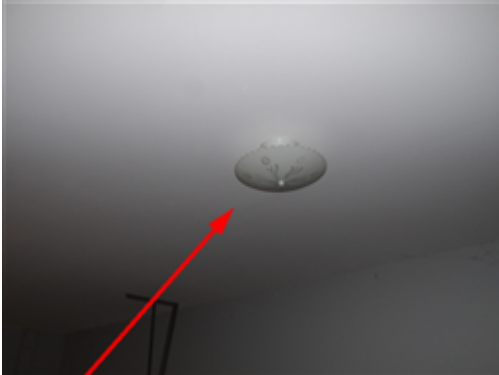
(E5 - 2.1) Interior

Some of the light fixtures for the home were not operational/tested at the time of inspection. This could be due to burned out bulbs. Recommend replacement of the bulbs and contact a licensed electrical contractor for further evaluation and repair if issue is not corrected by bulb replacement.

Some of the light fixtures for the home were not operational/tested at the time of inspection. This could be due to burned out bulbs. Recommend replacement of the bulbs and contact a licensed electrical contractor for further evaluation and repair is issue is not corrected by bulb replacement.

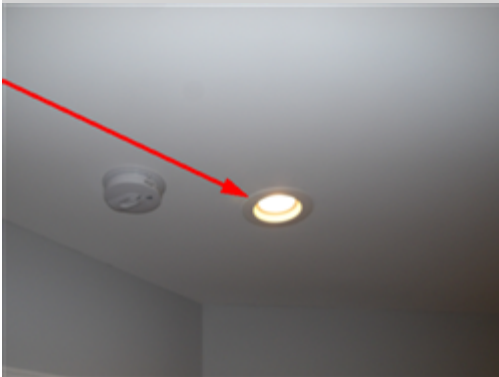
(E5 - 2.2) Interior

Some of the light fixtures on the interior of the home were noted to dim and brighten indicating an issue with the light and/or fixture. Recommend replacement of the bulbs and consult with a licensed electrical contractor if issues persist.

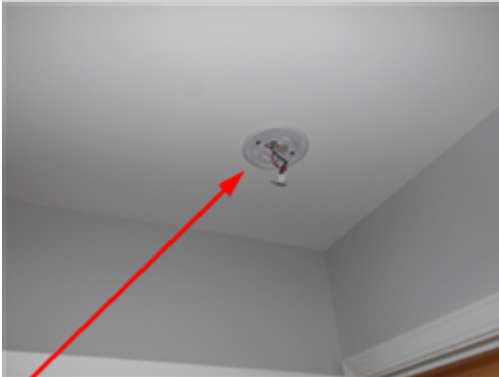
(E5 - 2.3) Interior

A properly functioning smoke detector is vital to the safety of a home. Smoke detector should be replaced where missing by a qualified person and updated every 5 to 7 years and batteries changed annually.

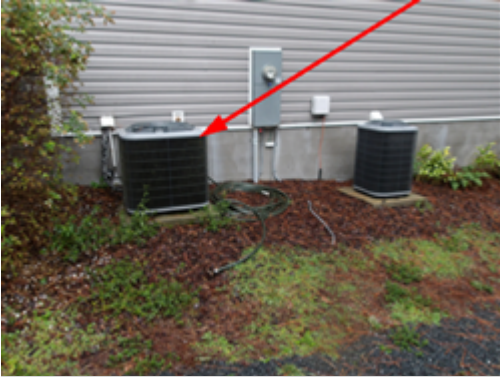
(G1 - 1.1) Cooling Unit #1

Photo of exterior HVAC unit 1. This is for your information only.

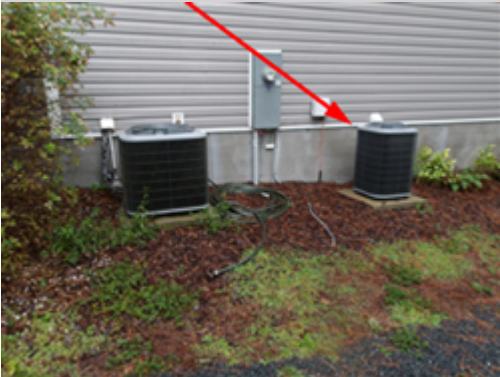
(G1 - 2.1) Cooling Unit #2

Photo of exterior HVAC unit 2. This is for your information only.

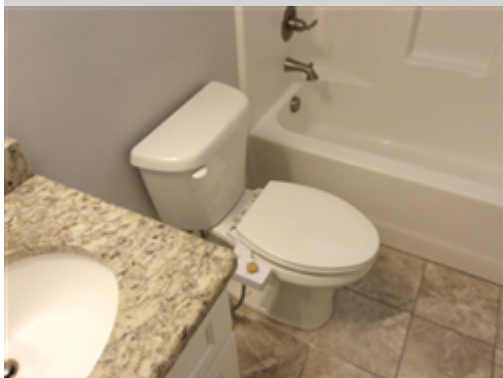
(H3 - 1.1) Bathroom: Main Level

The main level bathroom toilet was noted to be missing the toilet seat screw covers, have damage to the seat bumper, and have the supply line for the bidet disconnected. Recommend a licensed plumbing contractor for repairs as needed.

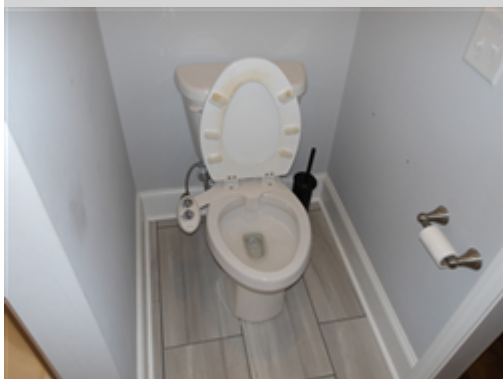
(H3 - 2.1) Bathroom: Master

The master bathroom toilet rocks and is not secure to the floor. Movement of the toilet can result in leaks and damage. The toilet was also noted to have damage to the seat bumper. A licensed plumbing and general contractor should be consulted for evaluation and repair.

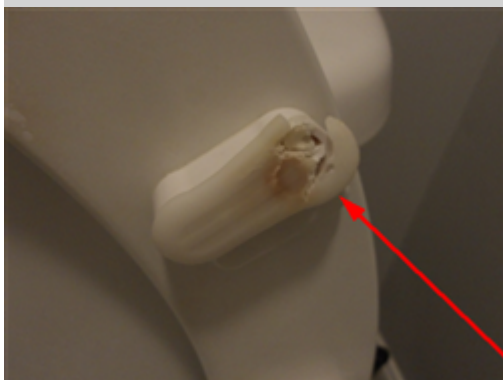
(H3 - 2.2) Bathroom: Master

Photo showing damage to the seat bumper.

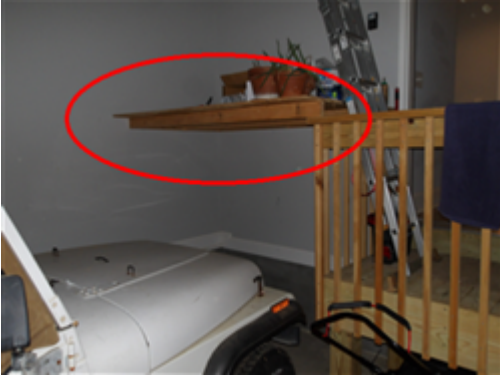
(H4 - 1.1) Garage

The lumber used to support the garage shelf appears to be undersized and installed with what appears to be standard non-structural screws. The fastener installation is crucial to the function of the support, when nails are replaced by screws, only screws determined to be structurally rated should be used. In general, standard screws are not approved for load bearing installations. A licensed general contractor should be consulted for complete evaluation of the shelf to determine the severity of this concern and to make repairs as needed to ensure the structural integrity of the shelf.
