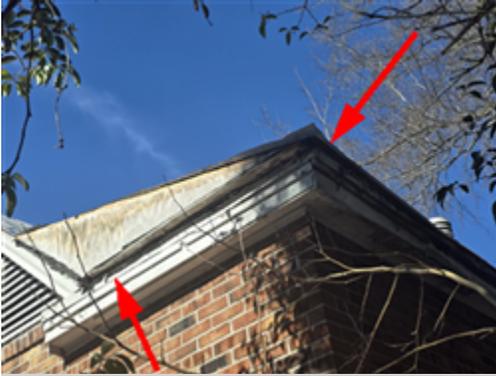
(B1 - 1.8) All Accessible Areas

Additional Photograph: This is a photograph of above noted item 1-1

-Comment # 6 Far view

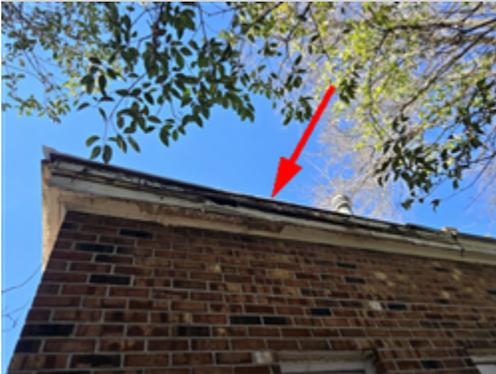
(B1 - 1.9) All Accessible Areas

Additional Photograph: This is a photograph of above noted item 1-1

-Comment # 6 Close view

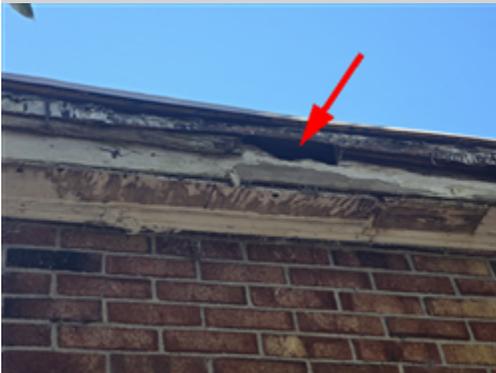
(B1 - 1.10) All Accessible Areas

Additional Photograph: This is a photograph of above noted item 1-1

-Comment # 6 Close view

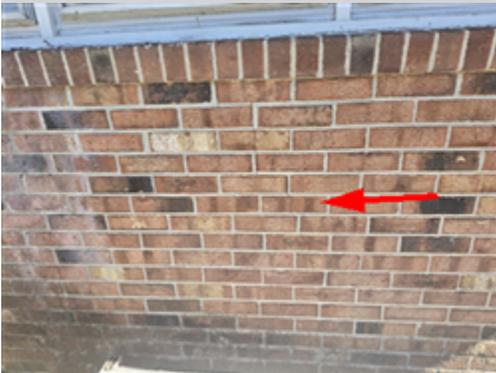
(B1 - 1.11) All Accessible Areas

Cracks were noted below the right rear side fireplace windows and over the left side kitchen windows in the brick veneer. Cracks in brick veneer indicate a deficiency that can change or progress over the life of the home. The cracks on this home were closed at the time of the inspection and presented no visible evidence of progression to the foundation areas, however, the cracks could open or change seasonally. The owners should be asked for disclosure related to the progression, history of repairs, or seasonal changes of the cracks. Even closed or minor cracks can cause consumer or buyer concerns at the time of resell. The buyers should observe the cracks and assess their concerns related to the presence of the cracks, the number of cracks, and possibility of the condition worsening over the life of the home. The cracks should be noted, repaired by a general contractor, and monitored to establish a history of stability. If additional information is needed an engineer should be consulted.

-Under the right rear side fireplace room windows, Close view.

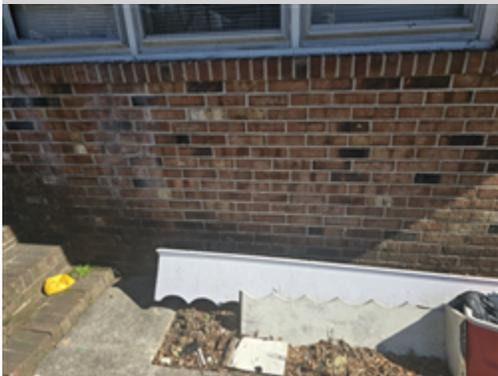
(B1 - 1.12) All Accessible Areas

Additional Photograph: This is a photograph of above noted item 1-11
-Under the right rear side fireplace room windows, Far view.

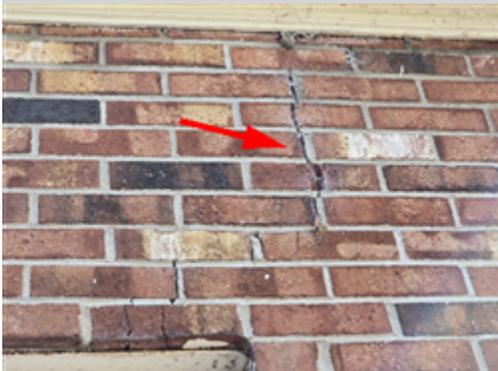
(B1 - 1.13) All Accessible Areas

Additional Photograph: This is a photograph of above noted item 1-11
-Over the left rear side kitchen windows, Close view.

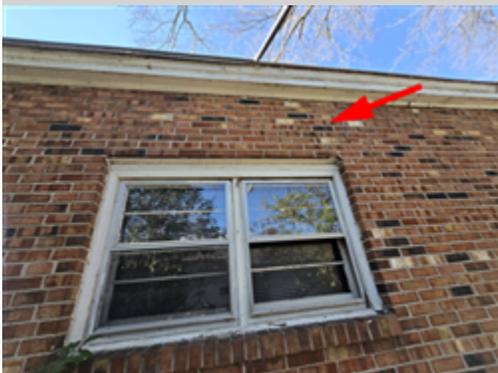
(B1 - 1.14) All Accessible Areas

Additional Photograph: This is a photograph of above noted item 1-11
-Over the left rear side kitchen windows, far view.

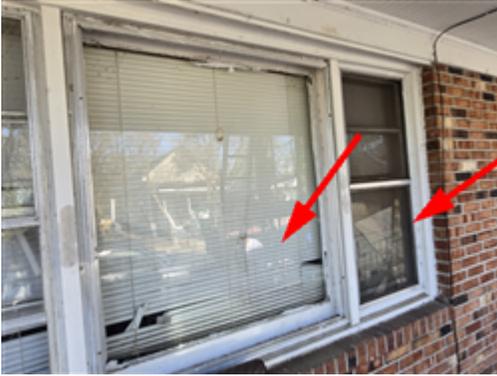
(B2 - 1.1) All Windows

The windows are in need of further evaluation and repair, as they were noted to be of great age and in poor condition. Replacing of all windows is recommended. the following items were noted at the time of the inspection. A complete evaluation is needed as a repair plan is developed to determine the extent of the damage. Repair/replacement is needed to ensure that the home is secure and protected from air/water penetration. A general repair specialist or licensed general contractor should be consulted for evaluation and repair.

1. Several broken large and small window panes were noted on the front and left side windows. The broken glass should be repaired to prevent accidental injury and weather intrusion.
2. Several broken or missing glass panes were noted on several storm windows.
3. Several windows have soft and decayed wood in the sill, trim, sash area; more on windows that have portable a/c units. Decay in the windows can result in leaking and water penetration and should be repaired as soon as possible.

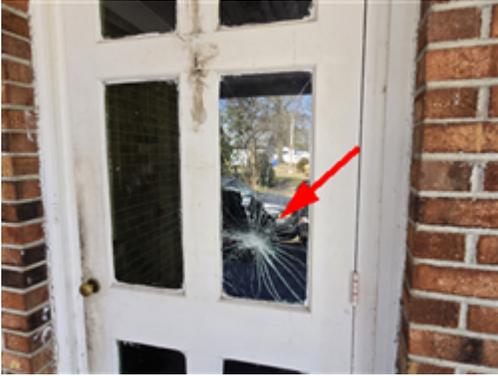
(B2 - 2.1) All Doors

The doors are in need of further evaluation and repair, the following items were noted at the time of the inspection. A complete evaluation is needed as a repair plan is developed to determine the extent of the damage. Repair/replacement is needed to ensure that the home is secure and protected from air/water penetration. A general repair specialist or licensed general contractor should be consulted for evaluation and repair.

1. Broken glass on front storm door.
2. The rear exterior door has soft and decayed wood in the lower frame area. Decay in the door frames can result in leaking and water penetration and should be repaired as soon as possible. Rear storm door has been taken down.
3. The left rear furnace room door slab has soft and decayed wood in the door panel and trim areas. Decay in the door panel can result in leaking and water penetration and should be repaired as soon as possible.

-Comment # 1

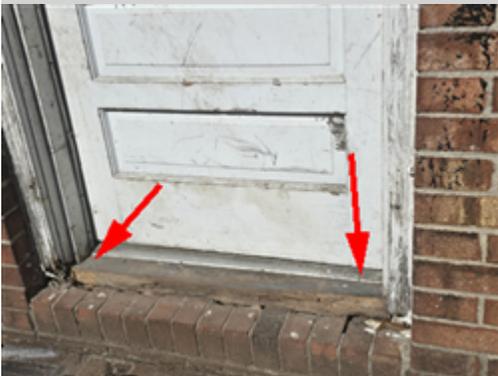
(B2 - 2.2) All Doors

Additional Photograph: This is a photograph of above noted item 2-1

-Comment # 2

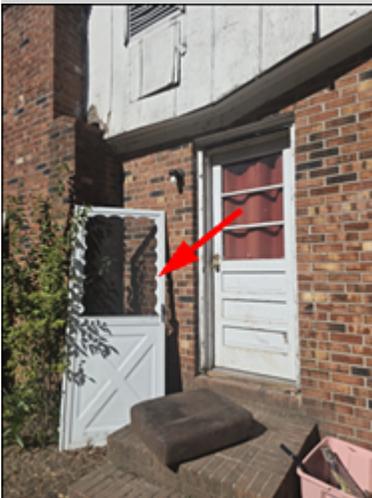
(B2 - 2.3) All Doors

Additional Photograph: This is a photograph of above noted item 2-1

-Comment # 2

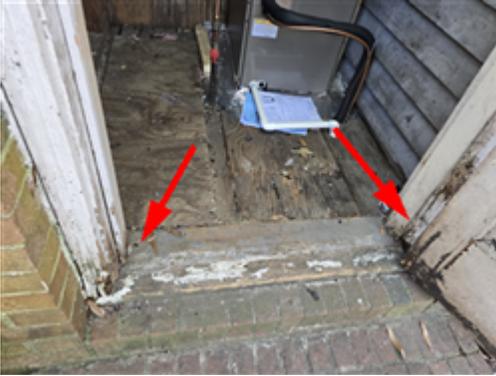
(B2 - 2.4) All Doors

Additional Photograph: This is a photograph of above noted item 2-1

-Comment # 3

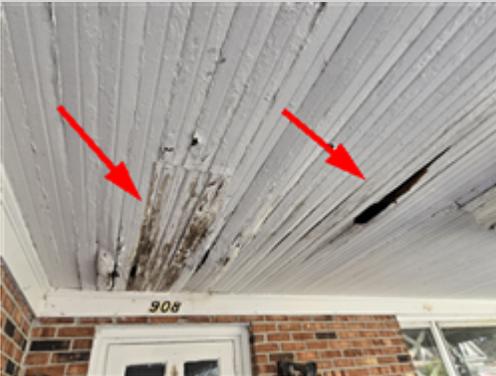
(B3 - 1.1) Porch

The front porch is in need of further evaluation and repair, the following items were noted at the time of the inspection. A complete evaluation is needed as a repair plan is developed to determine the extent of the damage. A licensed general contractor should be consulted for further evaluation, to determine the extent of the damage, and to make necessary repairs.

1. Great damaged noted on the front porch ceiling, adjacent to the front entrance door likely indicates history of a roof leak. At the time of the inspection it was not possible to determine if the condition was due to an active or past occurrence. Further investigation by a repair specialist and owner disclosure is recommended.
2. The right front corner of porch floor pad is cracked and has moved to a point no longer level with the brick perimeter. This condition could indicate a problem with the pad support. The movement of the pad has resulted in an uneven walking surface and created an opening where water could enter the foundation area.
3. The front porch hand railings are loose, damaged, and decayed and in need of repair or replacement to ensure safe and functional use of the deck/porch.

-Comment # 1

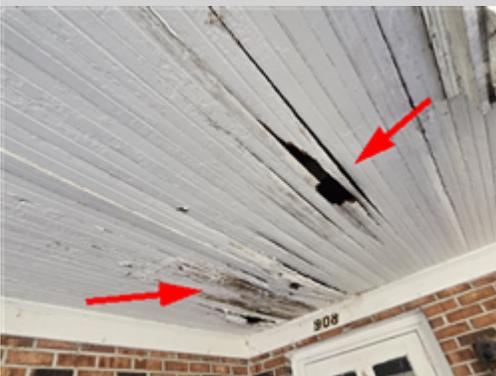
(B3 - 1.2) Porch

Additional Photograph: This is a photograph of above noted item 1-1

-Comment # 1

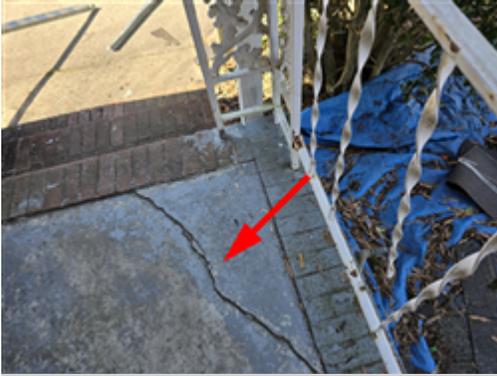
(B3 - 1.3) Porch

Additional Photograph: This is a photograph of above noted item 1-1

-Comment # 2

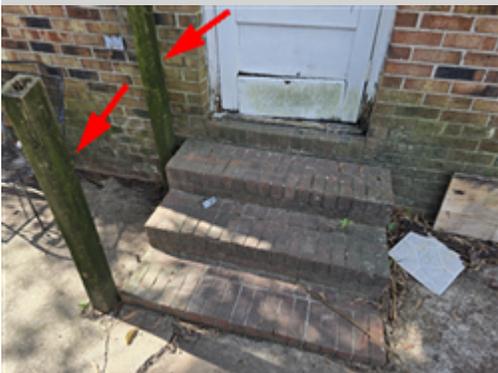
(B3 - 1.9) Porch

Also repair: damaged and loose handrails on left rear storage room/furnace room entry.

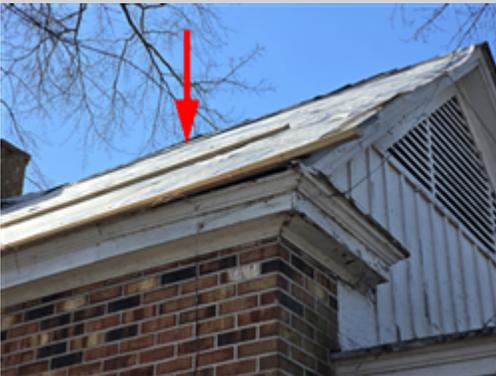
(C1 - 1.1) All Accessible Areas

Note: The home was under a roof shingle replacement at the time of inspection. A licensed roofing contractor should be consulted for a complete evaluation of the roofing systems to verify that shingles are installed correctly and to make necessary repairs to ensure the weathertightness of the roof covering system.

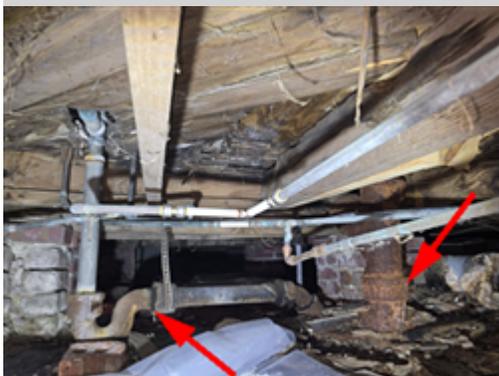
(D2 - 1.1) All Accessible Areas

Most plumbing waste lines for the home are likely the original steel galvanized and cast iron drain pipes. As galvanized and cast iron pipes age they tend to corrode along the inside diameter and become clogged. Evidence such as slow drainage of the sinks and tubs, and visible areas of corrosion indicate that the pipes for this home are nearing the end of their service line. Several areas of corrosion and small dripping leaks were noted in the foundation area of the home. A plumbing contractor should be consulted for a full evaluation of the system and to make necessary repairs.

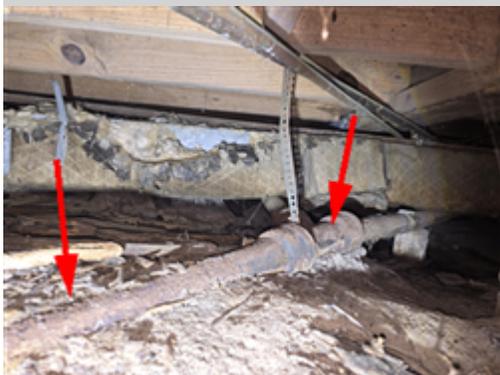
(D2 - 1.2) All Accessible Areas

Additional Photograph: This is a photograph of above noted item 1-1

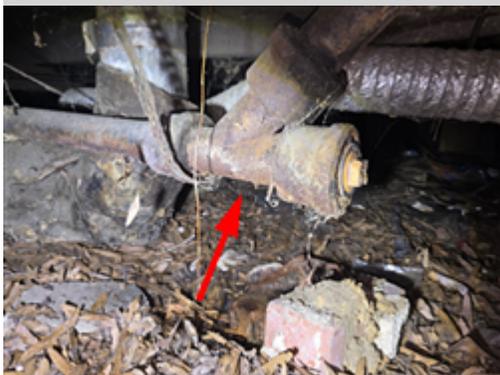
(D2 - 1.3) All Accessible Areas

The waste line for the kitchen sink is damaged and leaking. The waste line needs to be repaired to ensure sanitary conditions. A licensed plumbing contractor should be consulted for a complete evaluation of the waste line systems to determine the general condition of the system and to make necessary repairs.

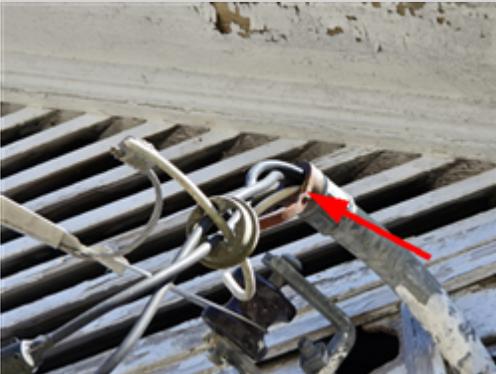
(E1 - 1.1) Overhead

The electrical mast weather-head cover is missing/damaged. The cover protects the service cable and electrical system from water penetration. Water penetration in the electrical system can result in extremely dangerous conditions. The Power Company and or a licensed electrical contractor should be consulted to determine the significance of this concern and if repairs are needed.

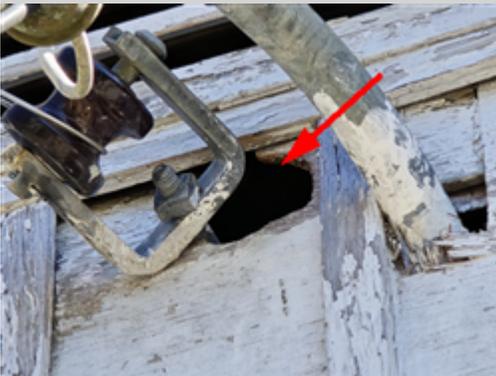
(E1 - 1.2) Overhead

Large hole on siding next to the electrical service head mast should be repaired to prevent entry of rain and/or rodents.

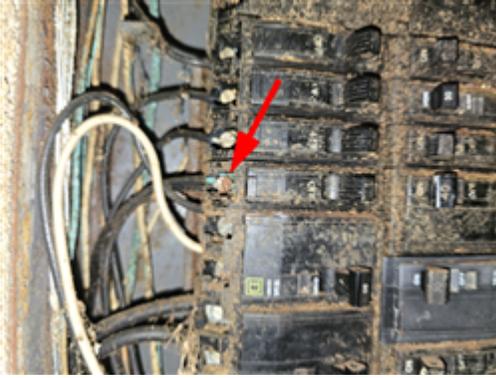
(E2 - 1.4) Main Panel #1

The single pole circuit breaker located on the left side of the electrical panel has two conductors attached to the power screw. Unless the breaker is rated for double taps loose connections and circuit overloads are possible. This condition presents a safety hazard that could result in interrupted service, property damage, and serious personal injury. A licensed electrical contractor should be consulted for further evaluation to verify the breaker rating and to make necessary repairs.

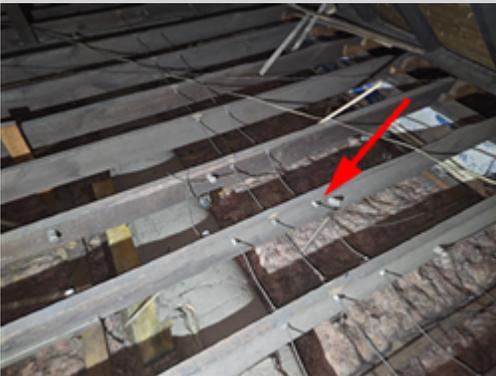
(E4- 1.1)

Disconnected knob and tube type wires were noted throughout the attic. Disconnected wires should be removed or properly terminated. The disconnected wires leave electrical conductors exposed and in a hazardous condition. Electrical concerns should be considered fire and safety issues and repaired as soon as possible. The electrical systems and components in the attic are in need of a complete evaluation and repair by a licensed electrical contractor.

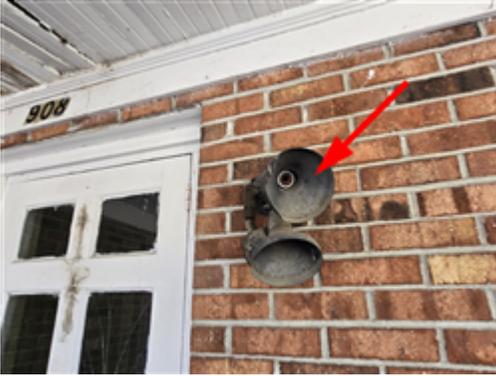
(E5 - 1.1) Interior and Exterior

The interior and exterior electrical fixtures and receptacles of the home are in need of further evaluation and repair. The following concerns were noted at the time of the inspection: The fixtures need repair to ensure proper and safe operation. A licensed electrical contractor should be consulted for repair and a complete evaluation of the electrical system.

1. Missing and damaged light bulbs were noted next to the front entrance door.
2. Multiple receptacles tested as open ground. An equipment ground provides an extra safety feature to prevent electrical shock hazards and property damage. The exterior electrical receptacle left of furnace room door had no power or tested as not hot. This could indicate a damaged receptacle or branch wiring circuit. No GCFI receptacles noted the on exterior of home.

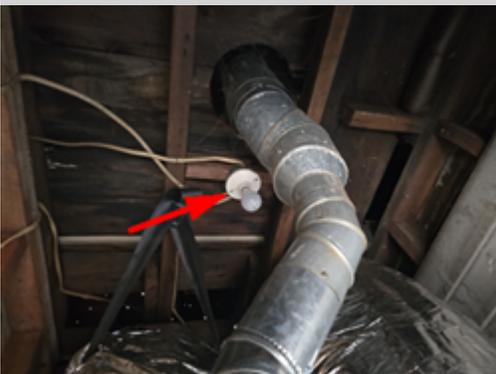
(E5 - 1.3) Interior and Exterior

3. The left rear storage room/furnace room ceiling light fixture was not functional when tested. This could indicate a defective bulb or other more serious problem such as faulty wiring or a defective fixture.

-Comment # 3

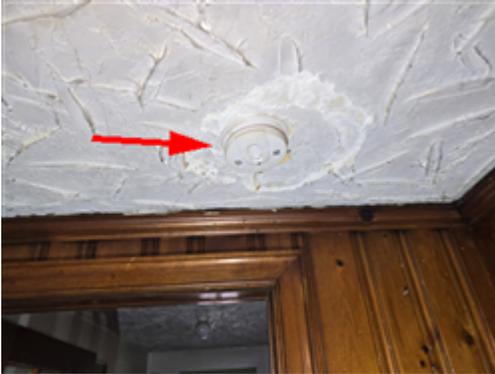
(E5 - 1.4) Interior and Exterior

4. This home has a limited number of smoke detectors as compared to current standards. Currently is it recommended that a smoke detector be installed at each floor level in the home and in each sleeping room. Foyer ceiling smoke detector not operational. Correction is recommended. Installation is recommended.

-Comment # 4

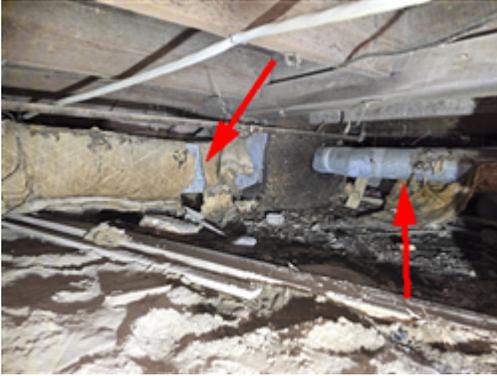
(F2 - 1.1) Heating Unit #1

The duct system is in need of repair to ensure proper air flow and conditioning of the interior areas. The duct work was noted to be in poor condition. The following concerns were noted at the time of the inspection: A HVAC contractor should be consulted for a complete evaluation and to make necessary repairs to ensure safe, reliable, and proper operation of the HVAC system.

1. Heavy debris was noted at several hvac duct lines at the hvac register vents throughout the interior of home. All hvac duct lines should be free of any debris for proper and clean air flow.

2. The duct system is in direct contact with the crawl space floor. Duct systems are required to have clearance from the ground surface to prevent water entry, to prevent decay, and to prevent contamination of the air supply.

3. The insulation cover for the duct branches throughout the crawl space is loose, torn, and/or deteriorated. The cover protects the duct structure and holds the insulation in place.

4. A duct located at right rear of crawl space, next to the hallway bathroom is disconnected and in need of repair/replacement. A HVAC contractor should be consulted for a complete evaluation and repair of the duct system to ensure reliable and proper operation of the HVAC system.

5. Missing filters and filter grill noted at foyer area.
8. Note: Hvac duct work blocks adequate access to many areas of the crawl space.

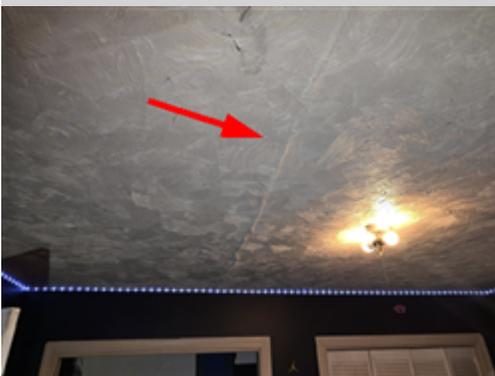
(H1 - 1.1) All Rooms

Random cracks were noted on ceiling of most bedrooms and in the kitchen area. The ceiling is cracked. No related concerns were noted throughout the adjacent inspection areas. The buyer should review the area of concern. If additional concerns or questions are present, invasive inspection and repair will be needed. A general repair specialist should be consulted for evaluation and repair to ensure that the ceiling is secure.

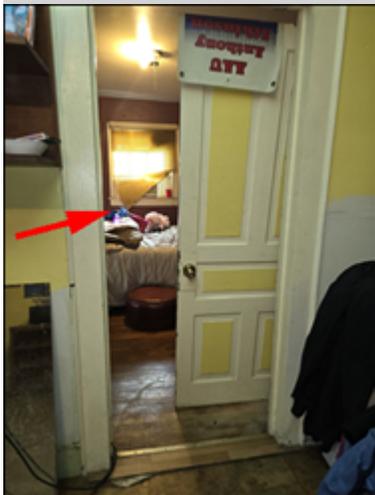
(H1 - 1.6) All Rooms

Missing door at entryway between kitchen and left rear bedroom.

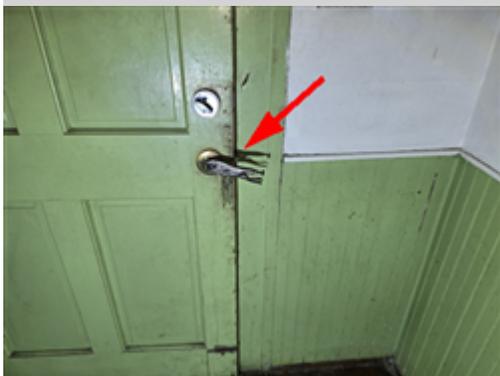
(H1 - 1.7) All Rooms

Damaged door handle noted on main front entrance door.

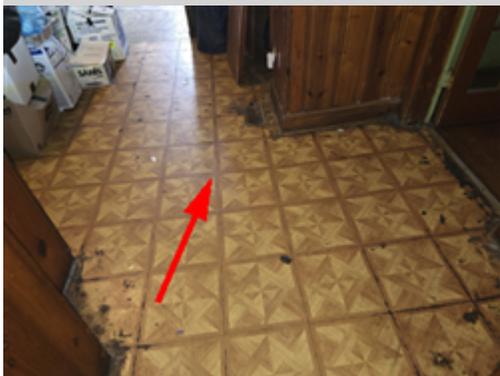
(H1 - 1.8) All Rooms

Sloped area of interior floors noted at along wall shared by the right front bedroom and rear fireplace room. The cause for this unlevel area was not determined as this area of crawl space was not accessible.

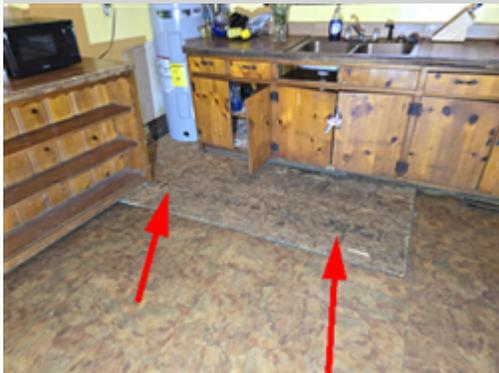
(H2 - 1.1) Kitchen

Unlevel and unstable interior floor noted in kitchen. This is the cause of severe moisture damaged floor system as noted in the structural floor comments: A licensed general contractor should be consulted for evaluation and repair.

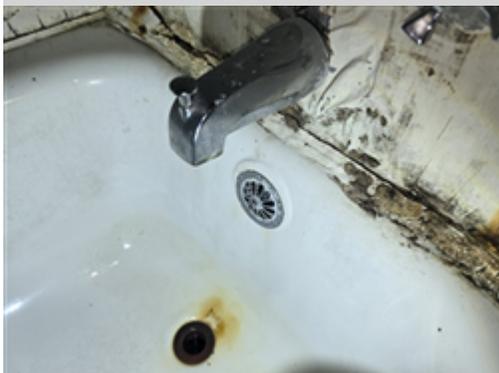
(H3 - 1.1) Main hallway bathroom

Damaged wall noted around the hallway bathroom tub.

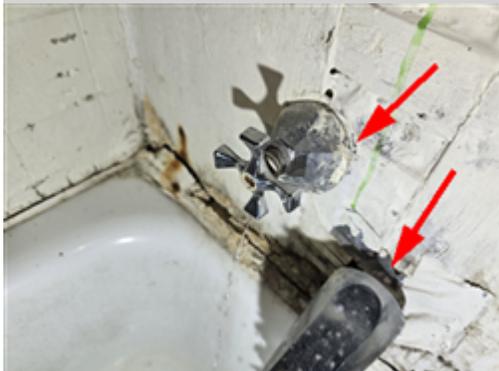
(H3 - 1.2) Main hallway bathroom

Downspout and water control knobs are loose and leaking at the hallway bathroom. A licensed plumbing contractor should be consulted for a complete evaluation to determine the significance of this concern and make necessary repairs to prevent leaks and ensure sanitary conditions.

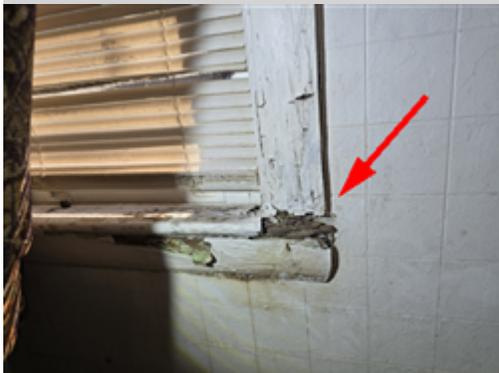
(H3 - 1.3) Main hallway bathroom

Moisture damage window casing noted around the interior of the hallway bathroom.

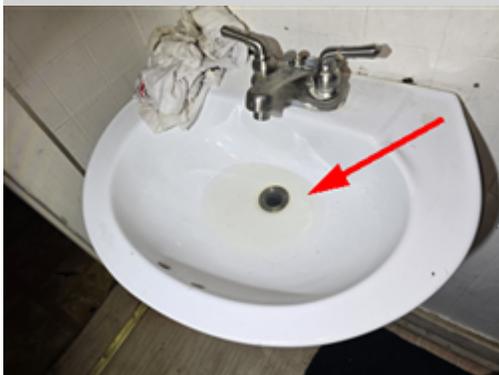
(H3 - 1.4) Main hallway bathroom

The hallway bathroom sink vanity is loose and has very poor drain flow. A licensed plumbing contractor should be consulted for a complete evaluation to determine the significance of this concern and make necessary repairs to prevent leaks and ensure sanitary conditions.

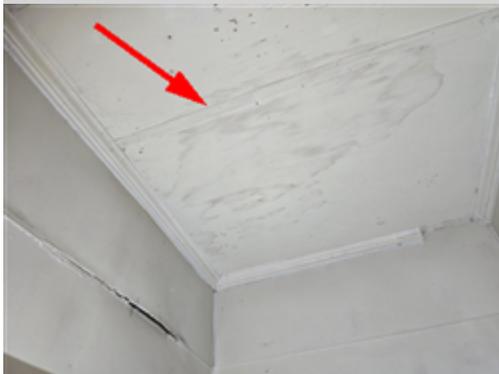
(H3 - 2.1) Master bathroom

Evidence suggests that the master bathroom ceiling has been repaired/painted. The owner should be asked for disclosure related to the extent of any related repairs, leaks or problems and the reason the ceiling was painted. New paint can limit the inspection as all history of defects or concerns are not visible.

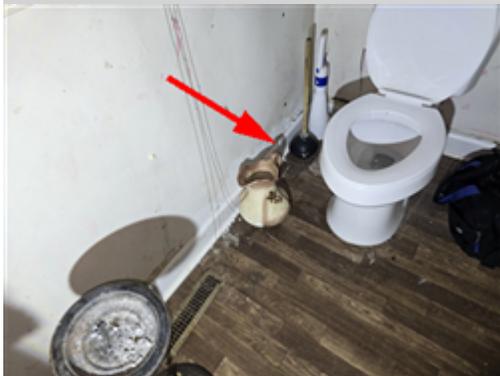
(H3 - 2.2) Master bathroom

Wall damage was also noted around the master bathroom toilet area. A general repair specialist or licensed general contractor should be consulted for evaluation and repair.

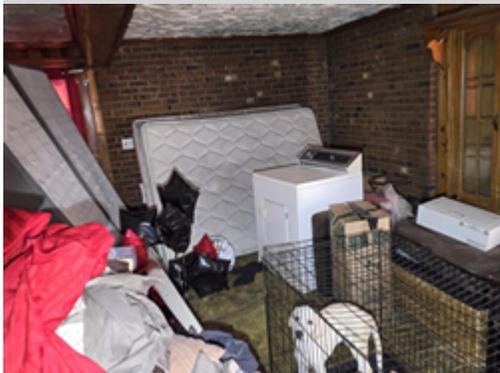
(H6 - 1.1) Fireplaces: Masonry

Fireplaces were not in currently use. All were blocked by large stored items. A HVAC contractor or a fireplace installation specialist should be consulted to evaluate the fireplace systems and make necessary repairs to ensure proper and safe operation of the units.
