Coastal Property Inspections

Property Inspection Report

April 23, 2025 (8:00 AM)

042301
4513 Country Club Road G 101
Morehead City, NC

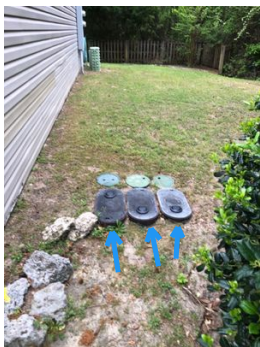
(D1-1.1) Main

For Your Records this is a photograph of the 3 main water turn offs located at the opposite end of the building. The water meter boxes are unmarked so it could not be determined which one belongs to G101.

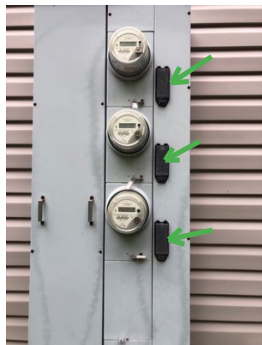
(E2-1.1) Main Panel

For Your Records this is a photograph of the 3 main electric turn offs located at the opposite end of the building. The electric meter boxes are unmarked so it could not be determined which one belongs to G101. The townhomes main breakers are highlighted.

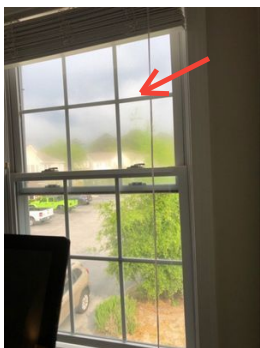
(H1-1.1) Bedroom Top Left

The window has a double pane glass filled with spacers between the two glass panes that are sealed by a metal track and or gasket. The gasket has failed and or is damaged. This could indicate that the seal has been jeopardized which will allow moisture between the panes, cause a cloudy appearance, and/or reduce the energy efficiency of the window. A general contractor or window specialist should be consulted to evaluate all windows, determine the significance of this concern and make necessary repairs.
