Property Inspection Report

Report Number: 1540

105 Bryan Pl.
Washington, North Carolina 27889

Date of Inspection: Monday, September 15, 2025

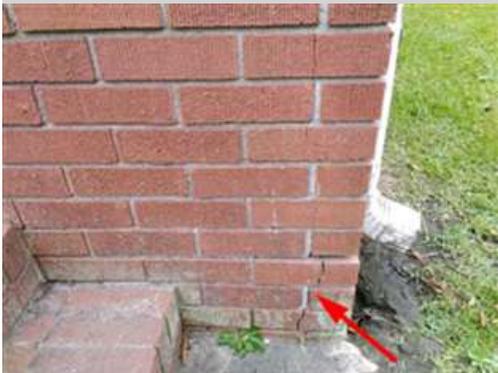
(A1 - 1.1) Main House

Cracks were noted in the foundation of the home. Cracks in the foundation indicate a deficiency in the foundation, footing, or supporting soil that can change and worsen if it progresses over the life of the home. An engineer should be consulted to determine the significance/cause of the cracks and outline any necessary repairs.

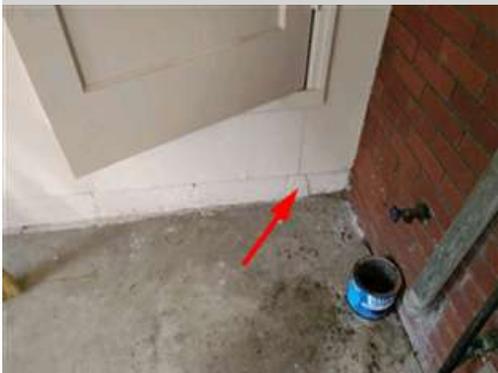
(A1 - 1.3) Main House

Additional photo in laundry room

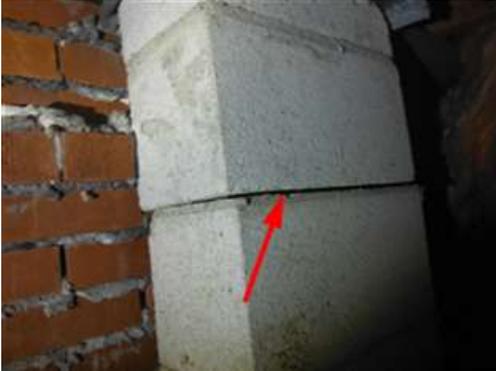
(A2 - 1.1) Main House

A foundation pier on front and rear side of crawl space have rotated or moved. A licensed general contractor should be consulted to evaluate and repair. If further evaluation is needed an engineer should be consulted to evaluate.

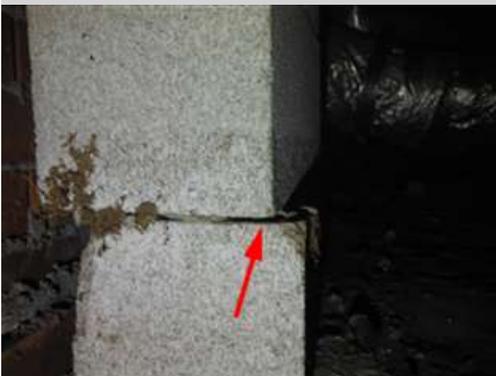
(A2 - 1.2) Main House

Additional photo

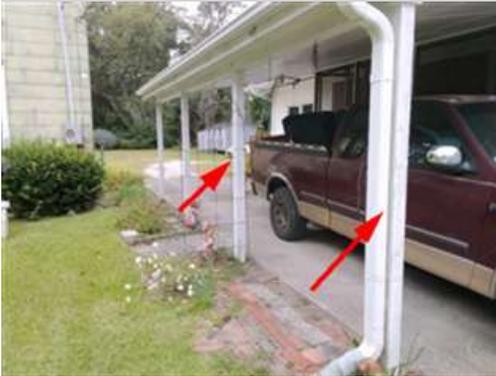
(A2 - 2.1) Carport

Structures over four feet tall require lateral bracing to prevent sway in heavy winds. A general contractor should be consulted to evaluate and determine the significance of the defect.

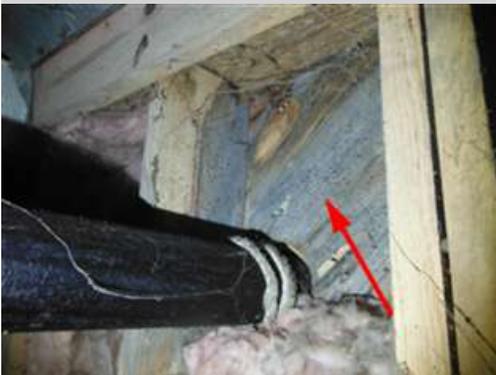
(A3 - 1.1) Main House

The floor sheathing under the hall bathroom is water stained and indicates a history of a leak. There was no visible leak at the time of inspection but the home is vacant. A licensed general contractor should be consulted to evaluate the area and determine if repairs are needed.

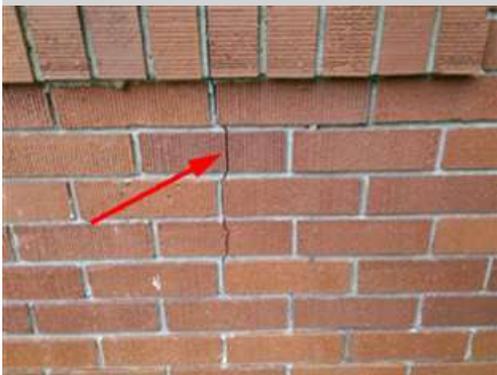
A cracks were noted on right side of home in the brick veneer. Cracks in brick veneer indicate a deficiency in the brick installation and or support of the veneer or underlying structure. Cracks can create openings for direct water penetration into the building envelope which will result hidden damage and poor environmental conditions. A licensed general contractor should be consulted to evaluate and repair. If further evaluation is needed an engineer should be consulted to evaluate.

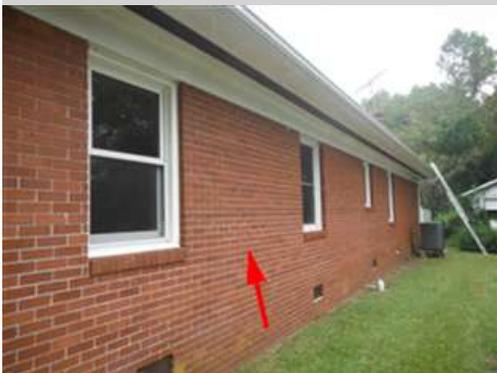
The brick veneer for this home has no visible weep system. The weep system prevents water and condensation buildup behind the brick veneer. Weep openings for homes of this era are typically installed at the foundation vent locations. A licensed general contractor should be consulted for complete evaluation to determine the significance of this concern and repair as necessary.

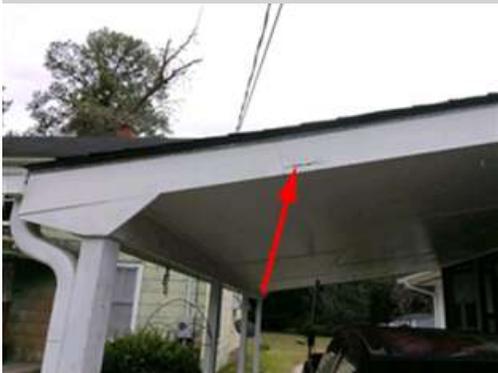
The fascia for the carport area has areas of decay. A licensed general contractor should be consulted to evaluate and repair.

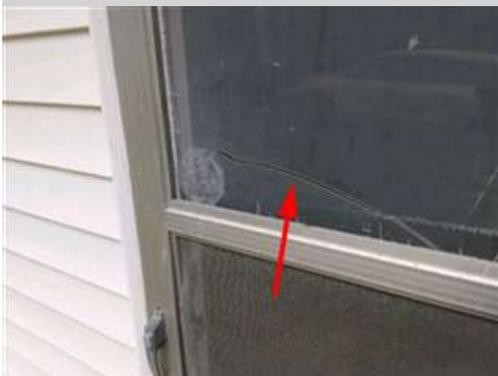
The storm door on rear side of home has a cracked glass. A handyman or general contractor should be consulted to evaluate and repair.

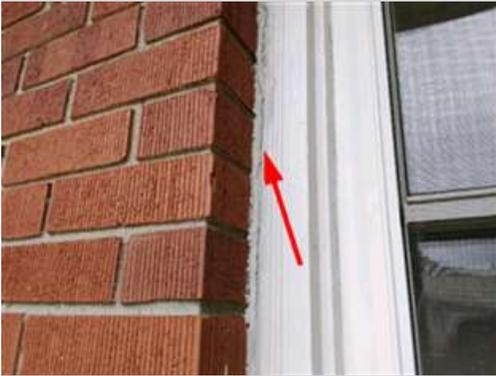
Gaps were noted at the window to brick veneer transitions around the home. This should be repaired to prevent water penetration. A handyman or general contractor should be consulted to evaluate and repair.

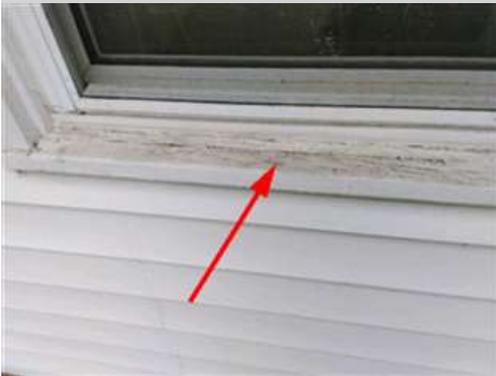
The windows were noted to have areas of missing paint. This should be repaired to help prevent decay. A handyman or general contractor should be consulted to evaluate and repair.

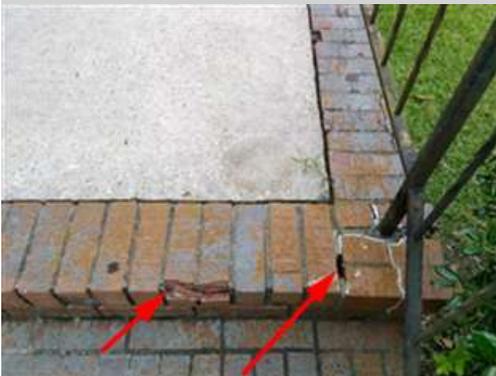
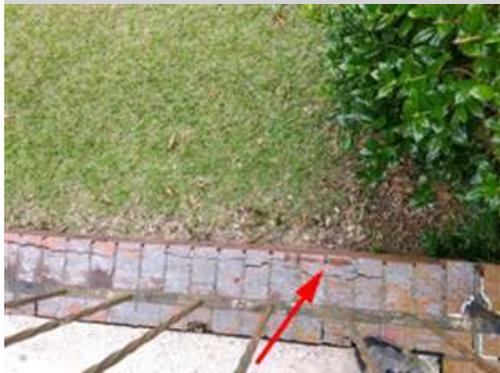
The front stoop has cracked bricks and missing mortar. This should be repaired to ensure the bricks are secure and to help prevent trip/fall hazards. A licensed general contractor or brick mason should be consulted to evaluate and repair.

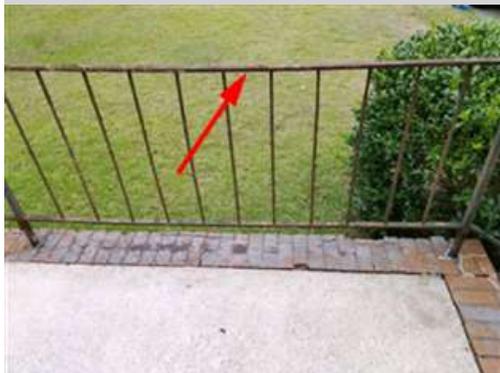
The guard rail and hand rails are loose and should be repaired to help prevent fall hazards. A licensed general contractor should be consulted to evaluate and repair.

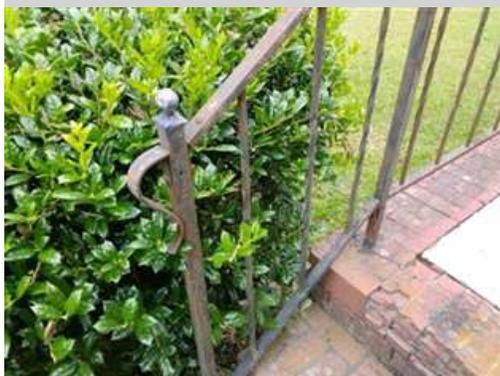
The hand rail and guard rails were noted to be rusted. This should be repaired to prevent further deterioration. A licensed general contractor should be consulted to evaluate and repair.

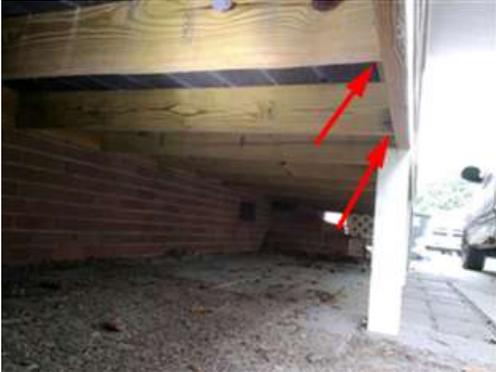
The floor joists for the screened porch on left side of home are nailed only without a ledger boards or joist hangers. This increases the chance of movement. A licensed general contractor should be consulted to evaluate and repair.

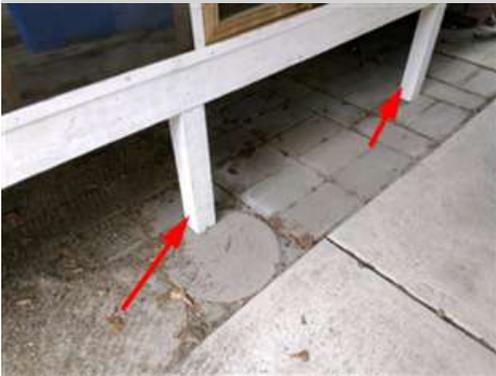
Some of the posts for the screened porch are not attached to the ground. This increases the chance of structural movement. A licensed general contractor should be consulted to evaluate and repair.

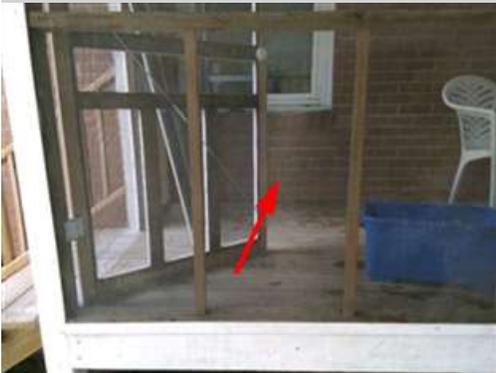
The balusters for the screened porch guard rails are spaced wide and this elevates the chance of a fall hazards. A licensed general contractor should be consulted to evaluate and repair.

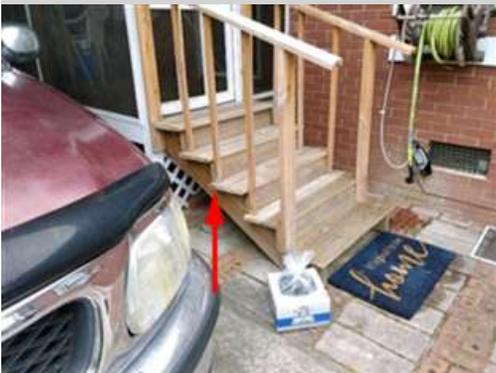
The stairs for front side of screened porch appear to have shifted and are not level. A licensed general contractor should be consulted to evaluate and repair.

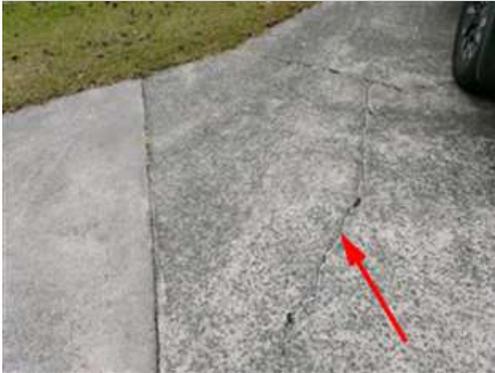
The driveway is cracked and displaced. The raised section of the driveway has created a path for water penetration under the slab and a trip or fall hazard. A licensed general contractor should be consulted for further evaluation and repair.

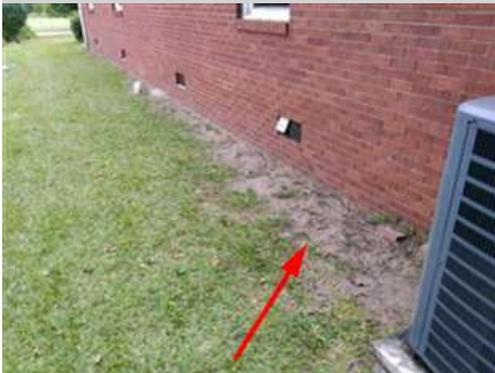
The grading around the foundation of the home is lower than the adjacent yard sections which will not allow storm water to drain away from the foundation. A licensed general contractor should be consulted to evaluate and correct the grading as needed to protect the foundation.

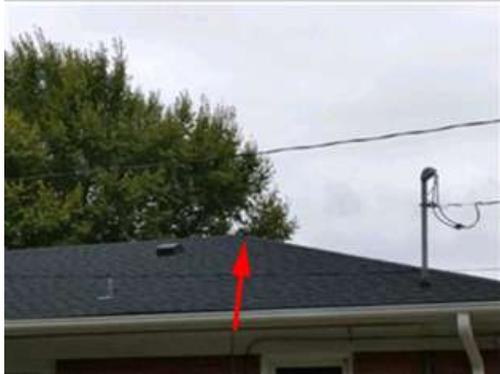
A raised shingle on the front left area of the roof surface is in need of repair/replacement. Displaced shingles could indicate an underlying problem with the shingle installation, roof sheathing, or attic conditions. A licensed roofing contractor should be consulted for a complete evaluation and repair to ensure the weathertightness of the roof covering system.

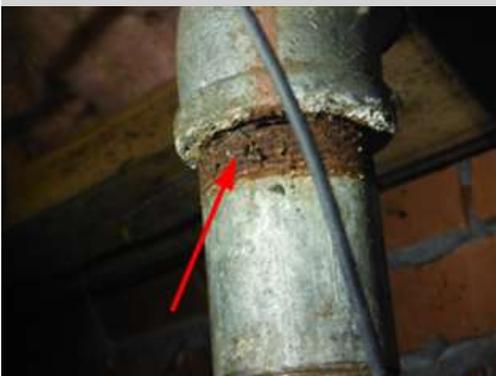
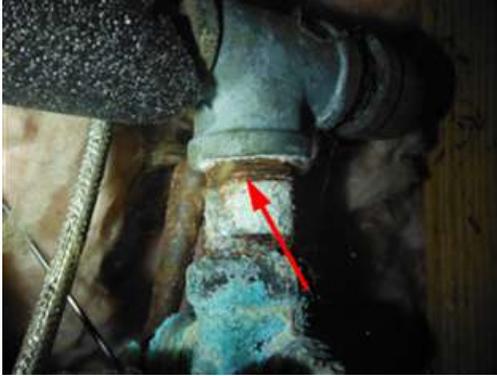
Some of the plumbing supply lines for the home are the original steel galvanized pipes. As galvanized pipes age they tend to corrode along the inside diameter and become clogged. Evidence such as visible area of corrosion can indicate that the pipes for this home are nearing the end of their service line. A plumbing contractor should be consulted for a full evaluation of the system and to make necessary repairs.

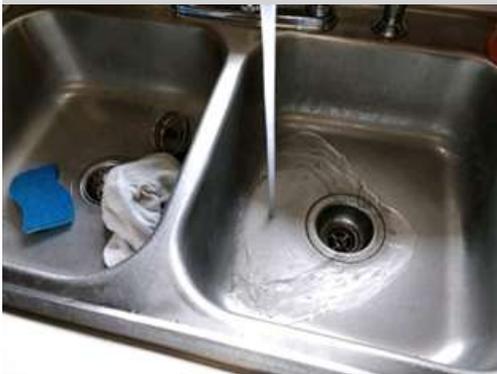
The hot water temperature in the home is lower than typically recommended for proper service and to prevent viral and bacterial development in the storage tank of the system. The low temperature could be the result of the actual thermostat setting or could indicate improper operation of the water heating unit. A plumbing contractor should be consulted for a complete evaluation.

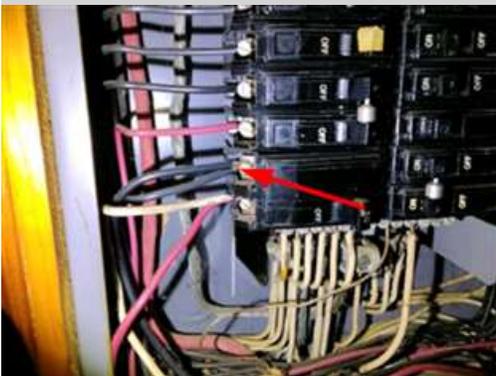
The 30 amp breaker located on the left side of the electrical panel has two conductors attached to the power screw. Unless the breaker is rated for double taps loose connections and circuit overloads are possible. This condition presents a safety hazard that could result in interrupted service, property damage, and serious personal injury. A licensed electrical contractor should be consulted for further evaluation to verify the breaker rating and to make necessary repairs.

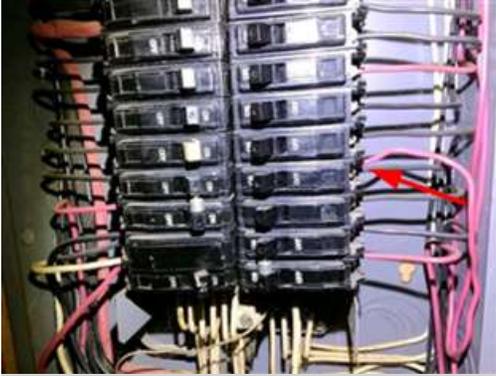
The breaker located on the right side of the electrical panel has two conductors attached to the power screw. Unless the breaker is rated for double taps loose connections and circuit overloads are possible. This condition presents a safety hazard that could result in interrupted service, property damage, and serious personal injury. A licensed electrical contractor should be consulted for further evaluation to verify the breaker rating and to make necessary repairs.

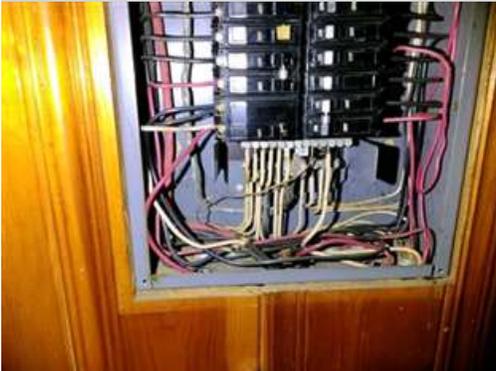
The ground bus bar located on the left / right side of the panel is not bonded or connected to the grounding system. This condition presents a safety hazard that could result in interrupted service, property damage, and serious personal injury. A licensed electrical contractor should be consulted for repair and a complete evaluation of the electrical system.

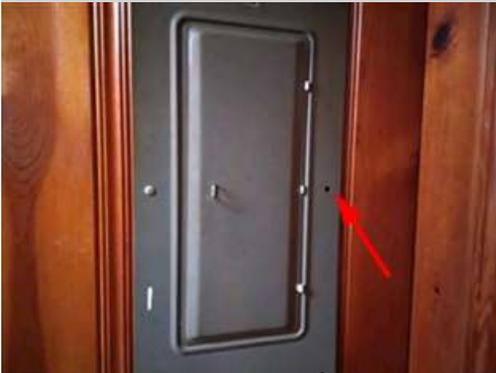
The electrical service panel cover is missing a fastener that secures the cover to the enclosure. The door/cover prevents direct contact with hot electrical circuits and contains the electrical energy of the electrical system in the event of a short or electrical explosion; therefore the cover must be secured with the correct type, size, and number of fasteners. This condition presents a safety hazard that could result in serious personal injury or death. A licensed electrical contractor should be consulted for a complete inspection of the electrical system and for repair/replacement of the panel to ensure that it is safe and functioning properly.

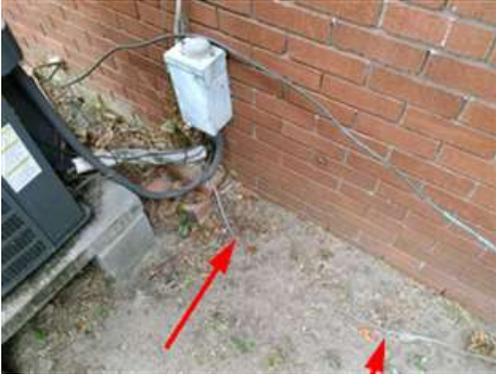
There is an unprotected wire on right side of home. The wire can be damaged and this elevates the chance of fire/shock hazards. A licensed electrician should be consulted to evaluate and repair.

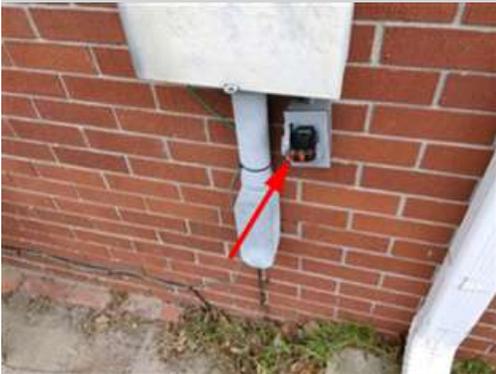
The home was built before GFCI circuits were required to protect all electrical receptacles located outside or within six feet of water. GFCI circuits add an important safety feature to electrical systems. The buyer should consider upgrading the electrical system to include GFCI protection.

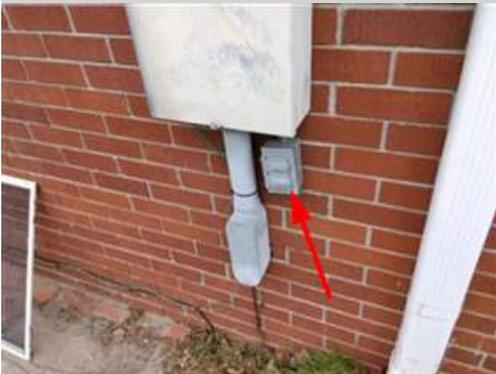
The receptacle is loose. Loose receptacles could result in electrical shock hazard or property damage. A licensed electrical contractor should be consulted for a complete evaluation to determine the significance of this concern and make necessary repairs to correct defects and prevent safety hazards.

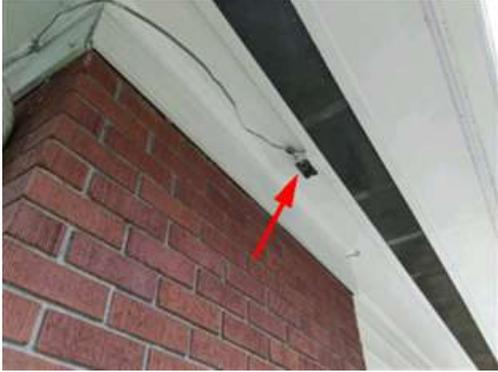
The junction box on rear side of home is missing the cover. This elevates the chance of fire/shock hazards. A licensed electrician should be consulted to evaluate and repair.

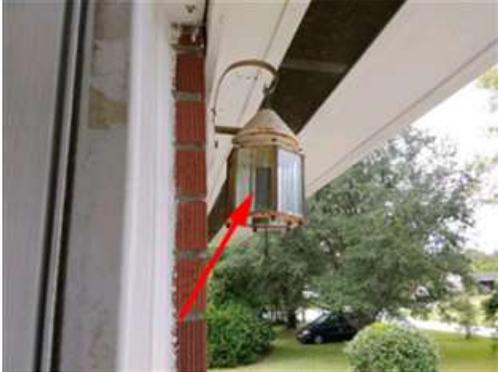
The light fixture was not functional when tested. This could indicate a defective bulb or other more serious problem such as faulty wiring or a defective fixture. A licensed electrical contractor should be consulted for further evaluation and repair.

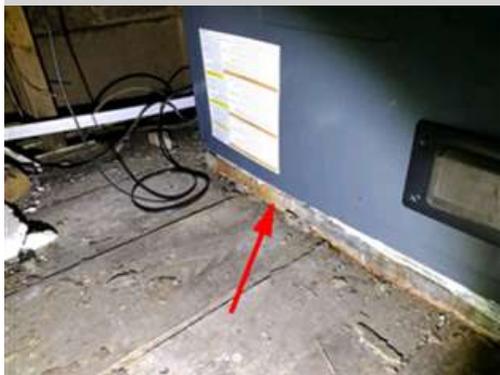
Rust was noted at the base of the air handler for the HVAC system in the utility room. This can indicate improper drainage of condensate. A licensed HVAC contractor should be consulted to evaluate.

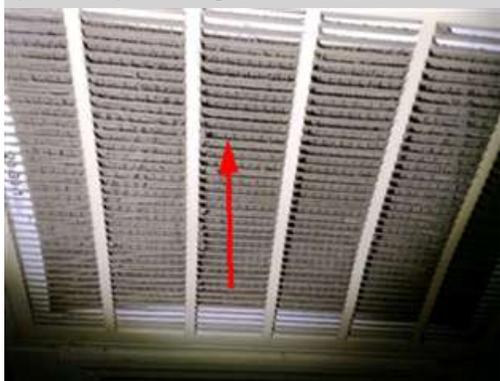
The return air filter in the home was found to be clogged. A clogged filter reduces add load to the system that can result in premature failures. A HVAC contractor should be consulted for a complete evaluation and service of the system to ensure reliable and proper operation.

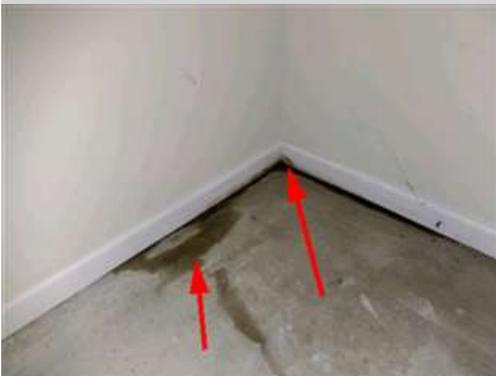
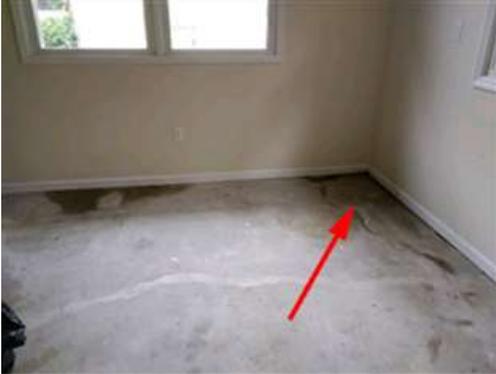
The base boards were noted to be decayed on rear left corner of the laundry room. Water stains were noted in the same area and indicates a history of water penetration. A licensed general contractor should be consulted to determine the source of water penetration and make repairs to the decayed areas and ensure the area is water tight.

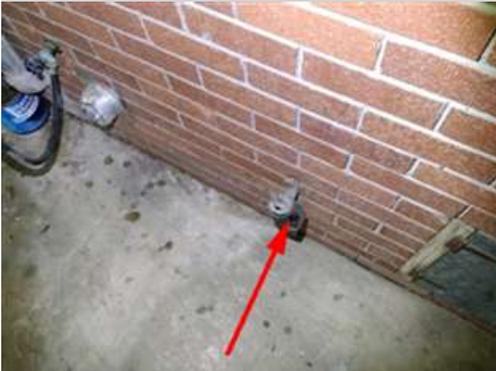
The receptacle is loose. Loose receptacles could result in electrical shock hazard or property damage. A licensed electrical contractor should be consulted for a complete evaluation to determine the significance of this concern and make necessary repairs to correct defects and prevent safety hazards.

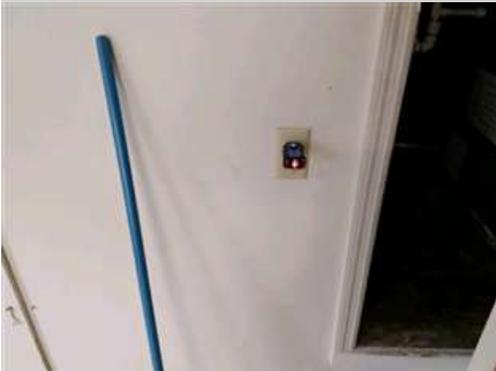
The receptacles tested as open ground. An equipment ground provides an extra safety feature to prevent electrical shock hazards and property damage. A licensed electrical contractor should be consulted for further evaluation and repair.

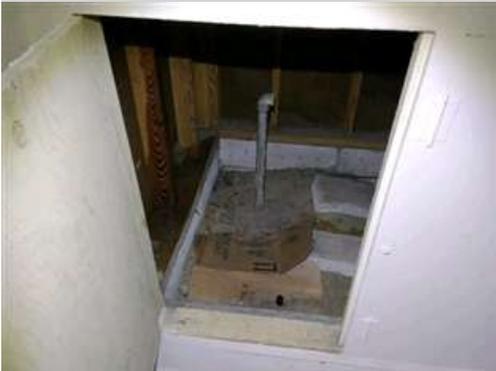
The cabinets in laundry room open up to an unfinished area of the home. This will allow heat loss/gain. A licensed general contractor should be consulted to evaluate and repair.

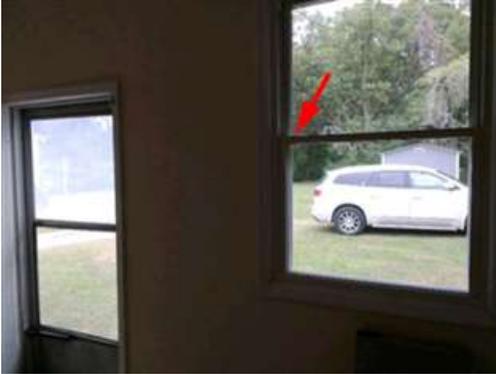
The tilt lock for the window is stuck on left side and should be repaired to ensure the window can tilt during cleaning. A handyman or general contractor should be consulted to evaluate and repair.

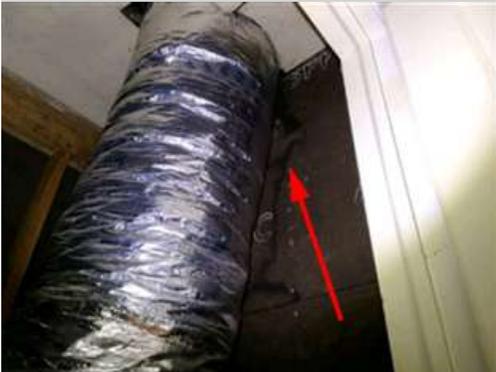
The walls in the utility room are water stained. Some of the stains were near the HVAC supply duct and can indicate a history of condensation. A licensed general contractor should be consulted to evaluate.

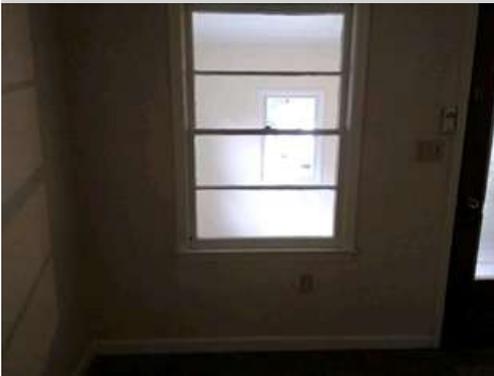
The window needs repair to ensure proper operation. The window could not be opened. A licensed general contractor should be consulted for evaluation and repair.

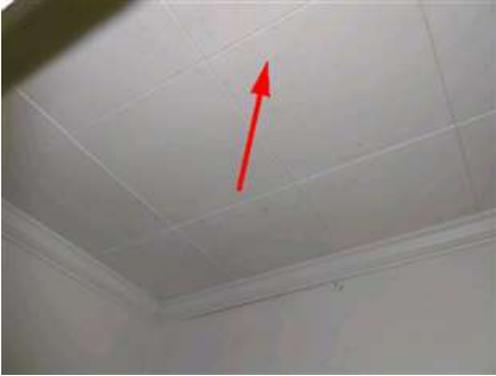
Mildew was noted on the closet ceiling. A licensed general contractor should be consulted to evaluate.

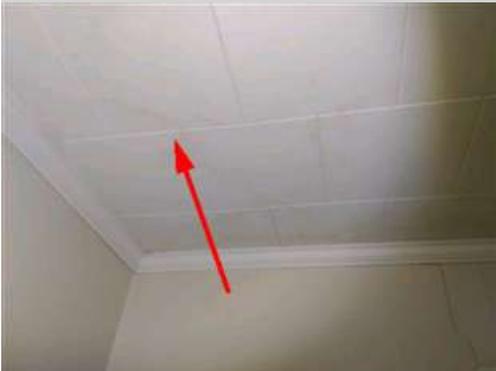
Stains on the ceilings indicate a history of a leak. At the time of the inspection it was not possible to determine if the condition was due to an active or past occurrence. Further investigation by a general contractor is recommended.

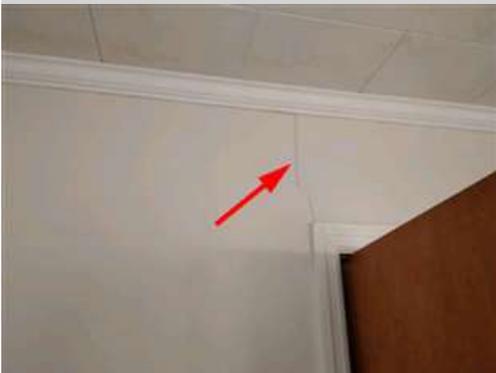
The wall is cracked. No related concerns were noted in the throughout the other inspection areas. The buyer should review the area of concern. If additional concerns or questions are present, invasive inspection and repair will be needed.

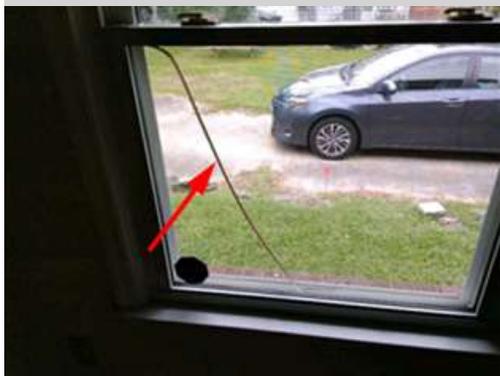
The weather-stripping for the window is damaged. The weather-stripping needs repair/replacement to ensure that the window is weather tight. A licensed general contractor should be consulted for evaluation and repair.

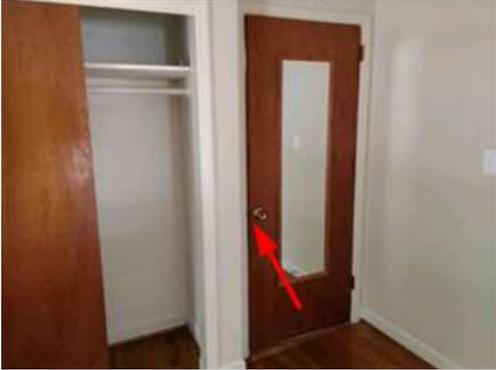
The door drags and is difficult to open or close. This condition could indicate improper installation or framing movement. The door needs repair/replacement to ensure that the door closes securely and operates properly. A handyman or licensed general contractor should be consulted for evaluation and repair.

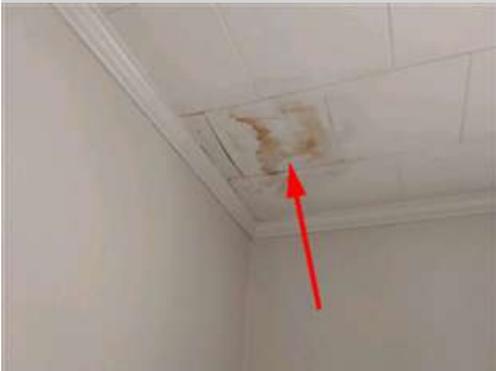
Stains on the ceilings indicate a history of a leak. At the time of the inspection it was not possible to determine if the condition was due to an active or past occurrence. Further investigation by a general contractor is recommended.

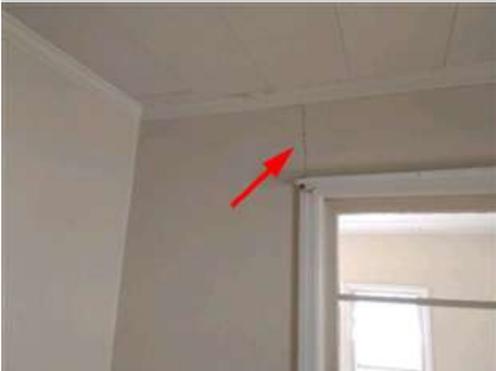
The wall is cracked. No related concerns were noted in the throughout the other inspection areas. The buyer should review the area of concern. If additional concerns or questions are present, invasive inspection and repair will be needed.

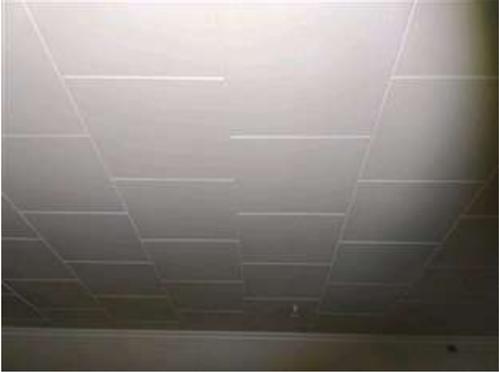
Ceiling tiles installed before 1990 could contain asbestos. Asbestos was banned in ceiling treatments by the Clean Air Act of 1978 in the United States. However, in order to minimize economic hardship to existing inventories of asbestos ceiling materials were exempt from the ban, so it is possible to find asbestos in ceilings that were installed through the 1980s. The tiles in this home may have been installed before the ban on asbestos; its removal/repair should only be done by a licensed professional or after testing of a sample by a qualified laboratory has ruled out asbestos contamination. For more information consult <http://www.epa.gov/asbestos/protect-your-family.html>.

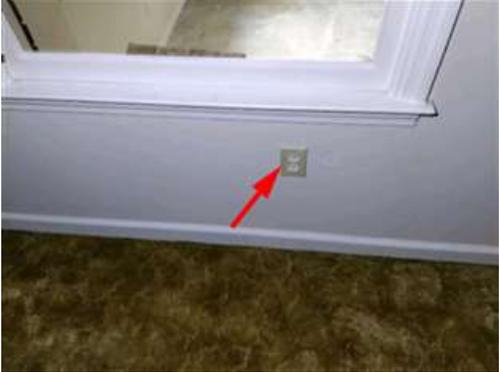
For the era of this home most of the receptacles are not equipped with equipment ground paths. In most situations for daily use this does not present a safety issue because most devices only have 2 prong cords. For washing machines, dryer timers, refrigerators, and surge protectors, an equipment ground path is needed to operate safely. A licensed electrical contractor should be consulted to review the appliance circuits and repair as needed to ensure safe and reliable service.

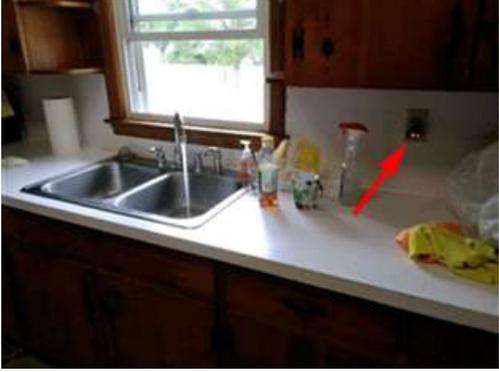
The home was built before GFCI circuits were required to protect all electrical receptacles located outside or within six feet of water. GFCI circuits add an important safety feature to electrical systems. The buyer should consider upgrading the electrical system to include GFCI protection.

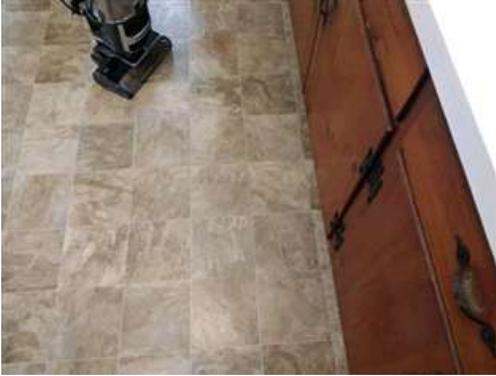
Some floor movement was noted in the kitchen floor. There were not visible defects from the crawl space, however, insulation limits the inspection. A licensed general contractor should be consulted to evaluate.

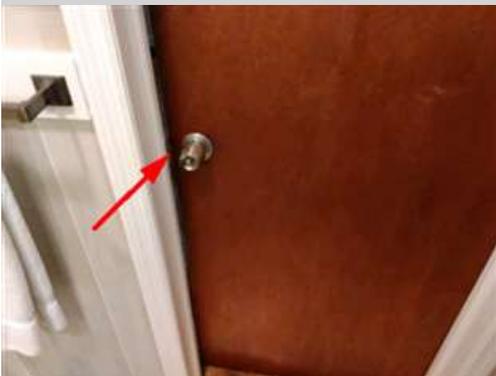
The door lock assembly is not aligned with the striker in the jamb area. The lock could not be engaged to secure the door. The door/lock needs repair/replacement to ensure that the door closes securely and operates properly. A handyman or licensed general contractor should be consulted for evaluation and repair.

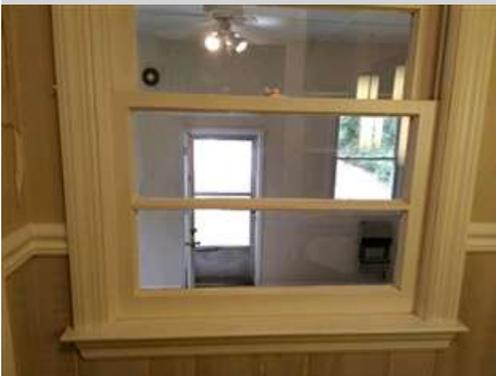
The window needs repair to ensure proper operation. The window could not be opened. A licensed general contractor should be consulted for evaluation and repair.
