# Property Inspection Report

**Report Number: 8629**

778 Alum Springs Rd.  
Mount Olive, North Carolina 28365

Date of Inspection: Monday, July 21, 2025

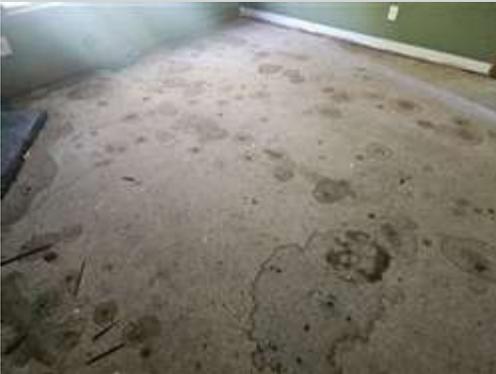
##### (A3 - 1.2) Main House

The floors were noted to be stained throughout the home. It is assumed this is from animals. A general repair specialist or licensed general contractor should be consulted to determine the significance of the concern.

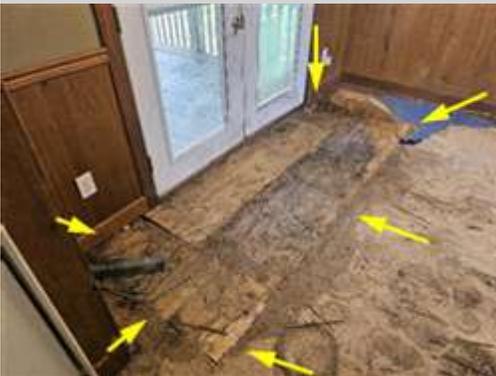
The subfloor in front of the French doors has been replaced. This can indicate a history of water penetration. The sellers can be asked for disclosure. If concerned further, a general repair specialist or licensed general contractor should be consulted for review.

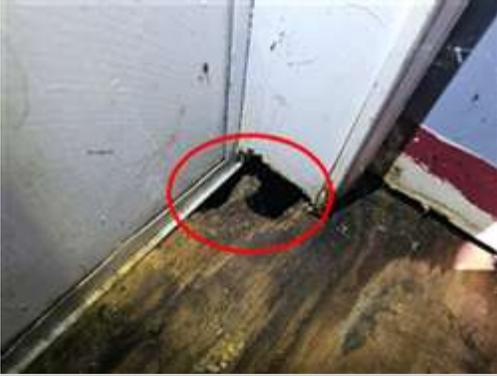
The floor was noted to be decayed to the right of the rear door out of the laundry ton. This only happens if moisture has been able to penetrate to this point for an extended period of time. The sellers should be asked for disclosure. A licensed general contractor should be consulted for review.

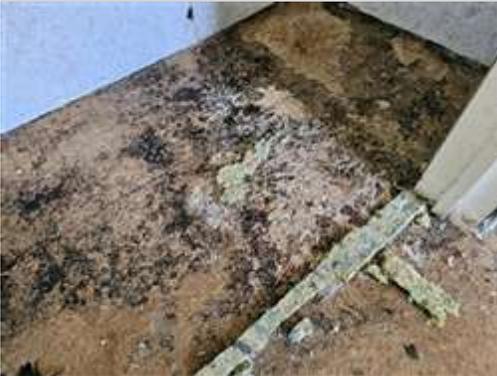
The subfloor in the front left bedroom closet is discolored and decayed and show evidence of wood destroying fungus. High moisture levels are required for wood destroying fungus to be active. A licensed general contractor should be consulted for an invasive inspection of the wood framing components and to reduce the moisture levels.

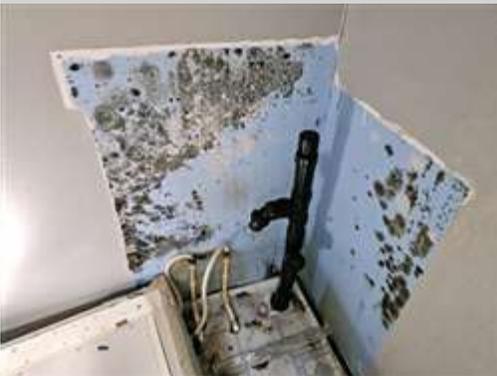
There is a growth consistent with mold on the wall in the master bathroom. Mold requires a constant moisture content to survive. A licensed general contractor should be consulted for an inspection to determine the source of the moisture and to make any corrections needed.

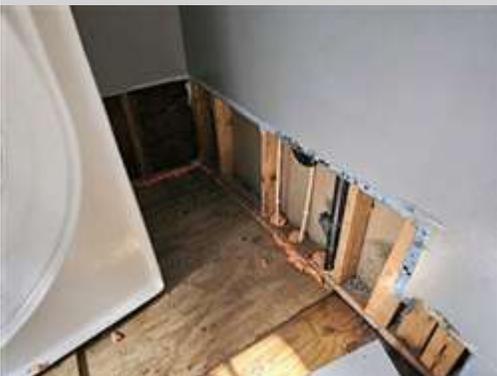
The wall behind where the garden tub was removed in the master bathroom is damaged. A general repair specialist or licensed general contractor should be consulted for review.

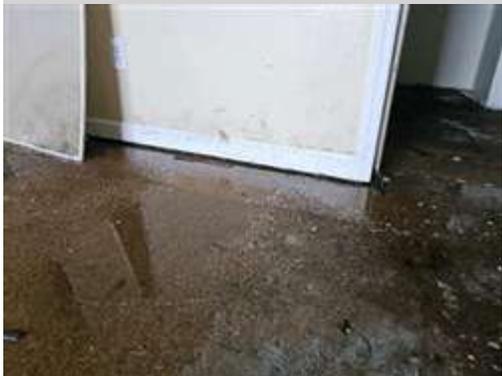
The bottom of the walls in the master bathroom, master bedroom, master bedroom closet, living room, and laundry room have been subjected to moisture from the leak in the master bathroom. This can negatively effect the walls and potentially produce fungal growth. A general repair specialist or licensed general contractor should be consulted for review.

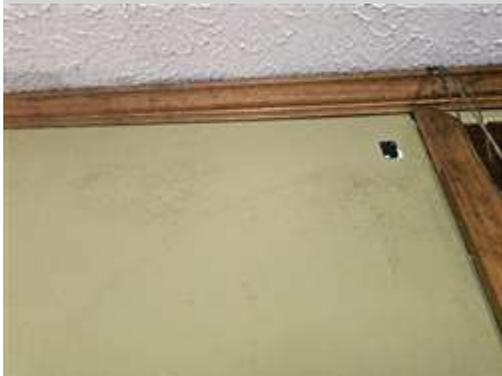
There is a growth consistent with mold in multiple areas on the walls around the home. Mold requires a constant moisture content to survive. A licensed general contractor should be consulted for an inspection to determine the source of the moisture and to make any corrections needed.

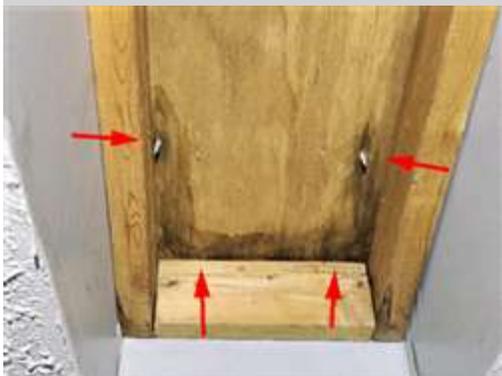
Stains were noted on the wood that covered up the skylight in the master bathroom. It could not be determined if this is an active or historical issue. A roofing contractor can be consulted for review.

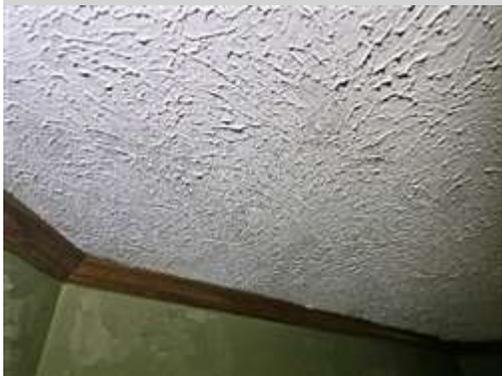
Active mold was noted on the ceilings in isolated areas around the home. Active mold requires a constant source of moisture. The health ramifications of mold are beyond the scope of a home inspection. A licensed general contractor should be consulted to determine the source of the mold and to make any necessary repairs to the ceiling.

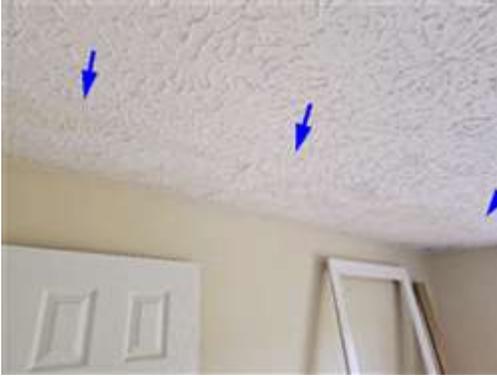
There is a stain on the ceiling on the right side of the front right bedroom. It could not be determined if this is an active or historical issue. A general repair specialist or licensed general contractor should be consulted for review.

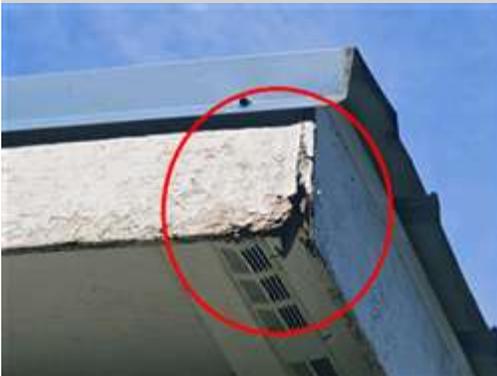
The gable board is decayed in the following locations: front left corner of the home, rear left corner of the home. Decayed boards are usually the result of long term exposure to water. This can allow water to enter the attic space. A licensed general contractor should be consulted to review the area and make necessary changes to ensure the weathertightness of the system.

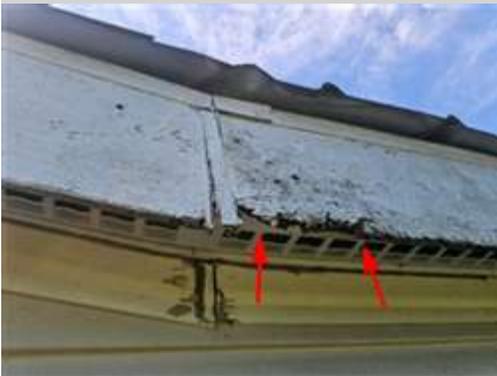
The fascia is decayed as seen in multiple areas on the front of the home. Water has been able to penetrate to the roof structure. A licensed general contractor should be consulted to perform an invasive inspection of the area to determine the extent of the damage and to make any necessary repairs.

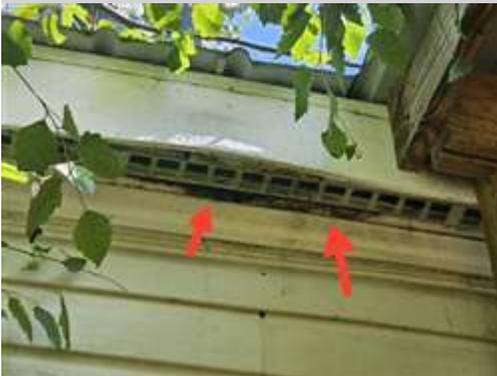
The soffit to the left of the rear porch is decayed. No other surrounding areas showed any evidence of damage. A licensed roofing contractor and/or licensed general contractor should be consulted to perform an invasive inspection to determine the source of the water that has caused the decay and of the surrounding areas and to make any necessary repairs.

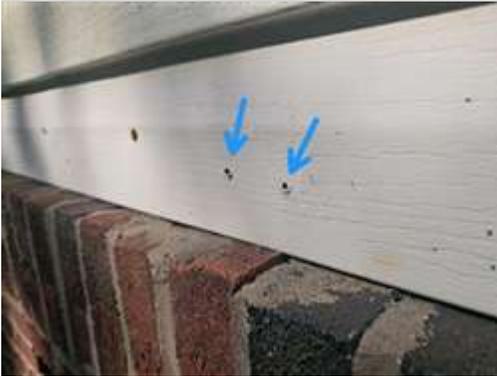
There are small holes in the siding system as noted on the bottom around the entire home. This can allow water to penetrate to the framing of the home. A general repair specialist or licensed general contractor should be consulted for review.

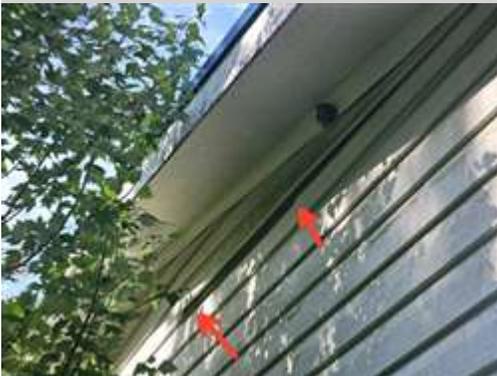
The vinyl siding was noted to be loose in the following locations: near the peak on the left side of the home, above the windows to the left of the front deck. This can allow wind to pull the siding away from the home further and allow water to access the framing behind the siding system. A licensed general contractor should be consulted to evaluate the siding system and make necessary repairs to ensure the weathertightness of the system.

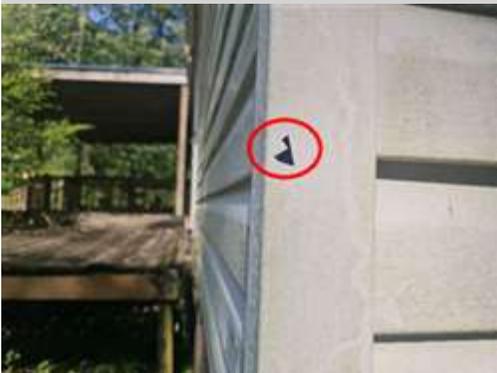
The vinyl siding trim is damaged on the rear left corner of the home. Damaged trim can allow water to penetrate to the framing. A general repair specialist or licensed general contractor should be consulted to evaluate the entire siding system to ensure the weathertightness of the system.

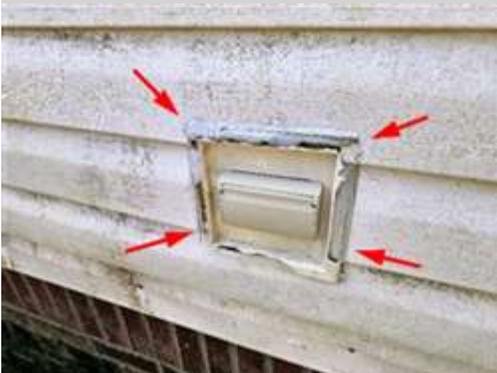
There is some trim missing from the following areas: around the exterior receptacles on the front and rear of the home, around the hood vent exit on the rear of the home. This can allow water to penetrate to the framing of the home. A general repair specialist or licensed general contractor can be consulted for repair.

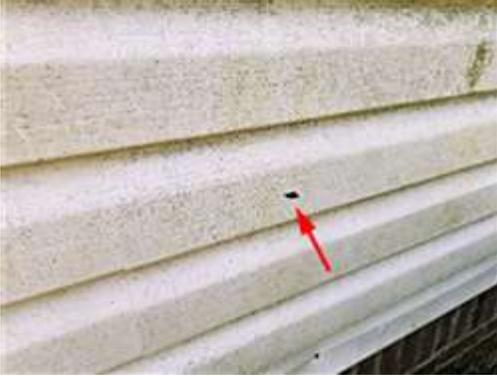
The siding was noted to be damaged in the following areas: under the right window on the front of the home, two areas near the bottom on the right side of the home, three areas on the left side of the rear of the home, to the right of the window under the rear porch. Damaged siding can allow water to penetrate to the framing. A licensed general contractor should be consulted to evaluate the entire siding system to ensure the weathertightness of the system.

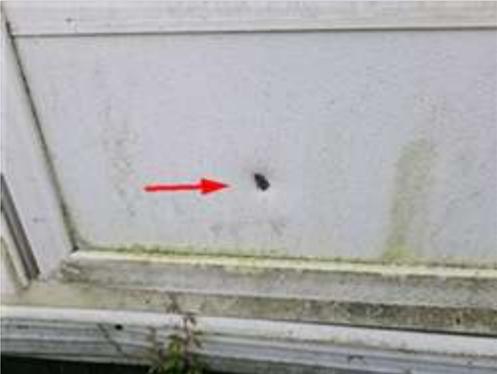
There is a hole in the storm door for the front door. This can allow moisture and creatures access to the home. A general repair specialist should be consulted for review.

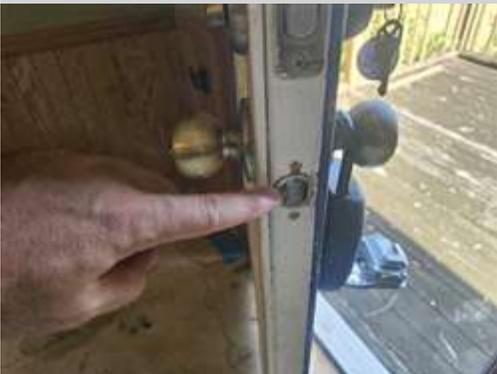
The door knob for the front door does not function. The door cannot be closed and secured. A general repair specialist should be consulted for repair.

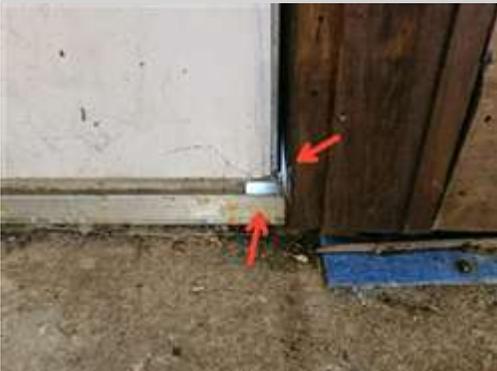
The weather-stripping for the front door is damaged or poor. There is visible light coming in around the panel. The weather-stripping needs repair/replacement to ensure that the door closes securely and is weather tight. A general repair specialist or licensed general contractor should be consulted for evaluation and repair.

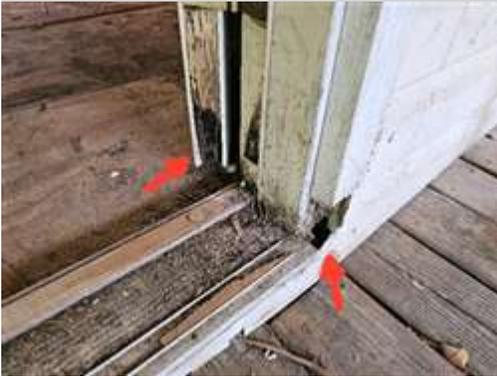
There is wood rot on the French door frame and panel. Wood rot is a result of water exposure to these areas over an extended period of time. This can allow water to penetrate the home. A general repair specialist or licensed general contractor should be consulted to review the entire framing system and make any necessary repairs.

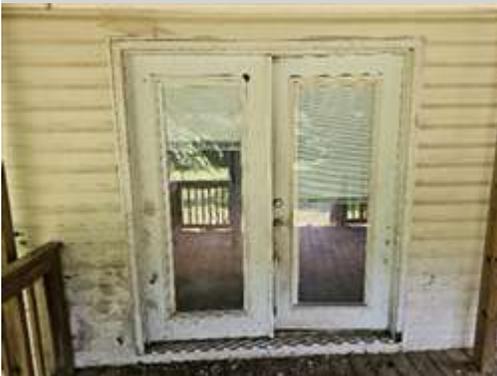
The exterior side of the French door is not painted. The manufacturer requires that all six sides of a door be painted for the warranty to be valid. More importantly, the paint provides an extra level of protection to avoid decay and damage to the door. A general repair specialist should be consulted for review.

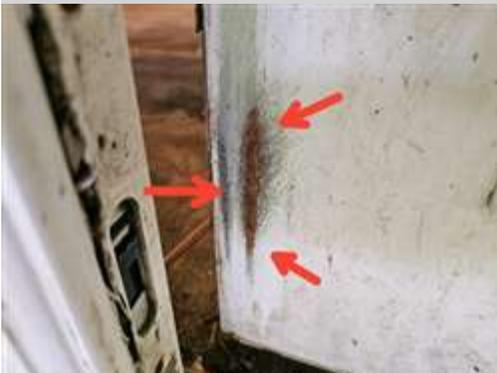
There is rust on the metal faced French door. Rust causes the metal to weaken. A general repair specialist or licensed general contractor should be consulted to review all of the doors on the home and make any necessary repairs to ensure proper operation of the doors and ensure the weathertightness of the system.

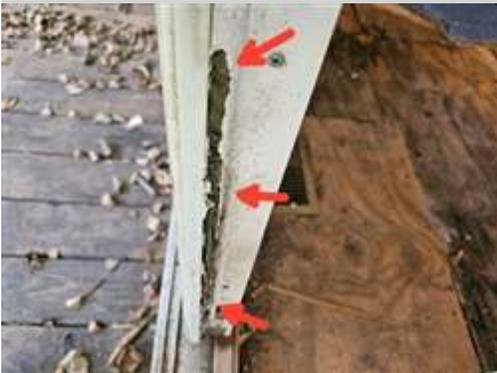
The weather-stripping for the French door is damaged. The weather-stripping needs repair/replacement to ensure that the door closes securely and is weather tight. A general repair specialist or licensed general contractor should be consulted for evaluation and repair.

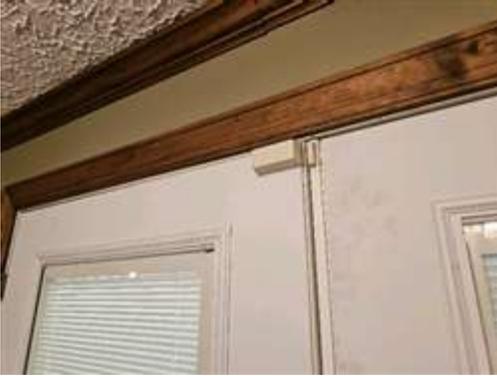
The French door rubs. This could mean that the door is not properly installed, that there has been some slight movement in that area of the house, or the frame is not properly supported from below. A licensed general contractor should be consulted to review the door and make any necessary repairs.

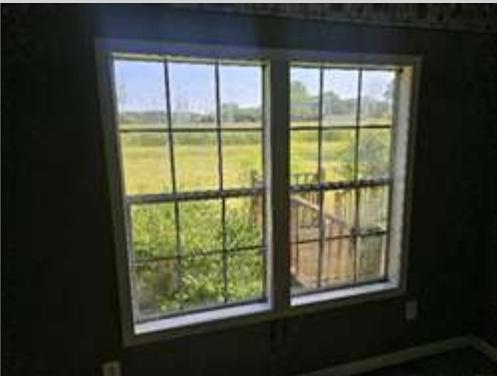
The majority of the windows in the home were difficult to operate. It was hard to lift and close the bottom sash. This can be due to the sash cords/springs that help hold the bottom sash in place. Difficult operation can be frustrating but can also be a safety hazard in the event that someone needs to open the window during an emergency. A general repair specialist, window contractor, or licensed general contractor can be consulted for review.

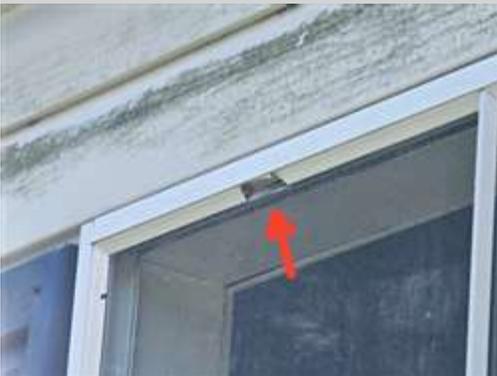
The trim around the far left window on the front of the home is damaged. This can allow water to penetrate behind the trim and decay the framing elements of the window and/or wall. A licensed general contractor should be consulted to review the windows on the home and make necessary repairs.

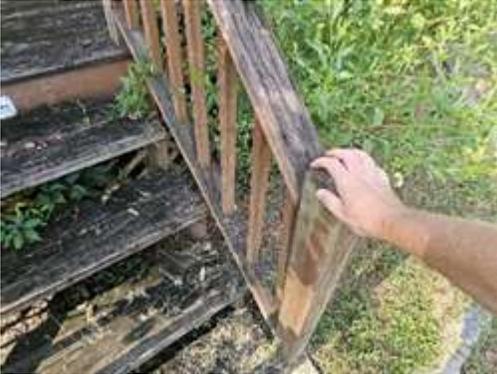
The handrail of the steps to the front deck is loose and presents a safety / fall hazard. A general repair specialist or licensed general contractor should be consulted for evaluation of the deck system and to make necessary repairs.

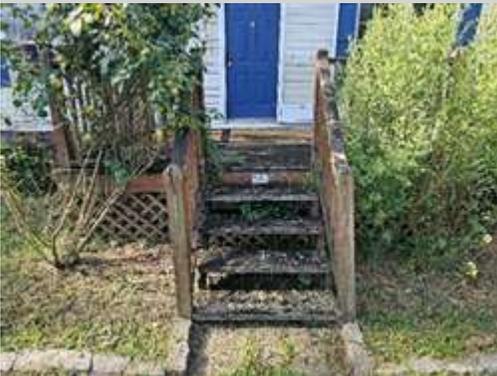
The steps to the front deck are loose. This freedom of movement can cause stress on the system. A general repair specialist or licensed general contractor can be consulted for review.

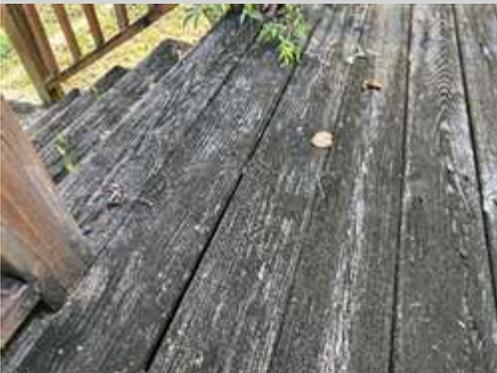
The front deck has several boards that are loose. This is a safety/trip hazard. A general repair specialist or licensed general contractor should be consulted for review and repair.

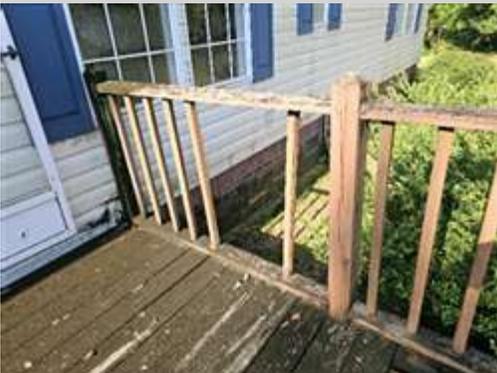
Several balusters (vertical units between the deck surface and top of the railing) are missing from the handrailing on the front deck. This is a trip and fall hazard and could allow small children to fall from the deck surface. A general repair specialist should be consulted for repair.

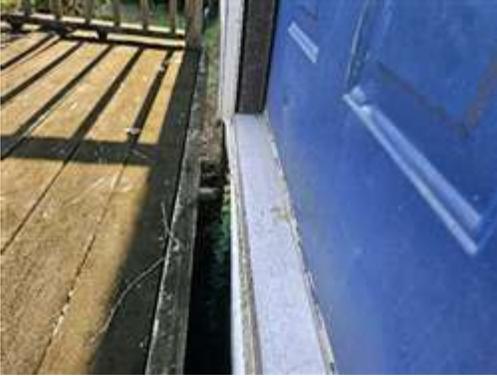
There is a gap between the deck and the home, which is a safety hazard. A general repair specialist or licensed general contractor should be consulted for review.

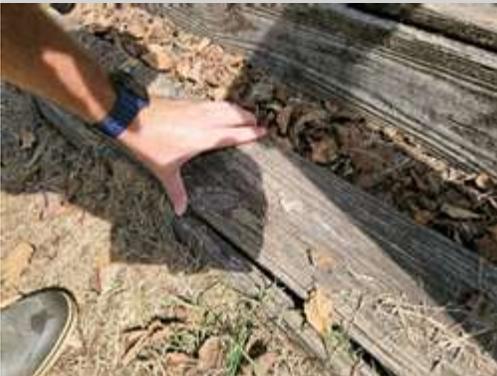
There is a loose board on the stairs to the rear porch. This is a trip/fall hazard. A general repair specialist or licensed general contractor should be consulted for review.

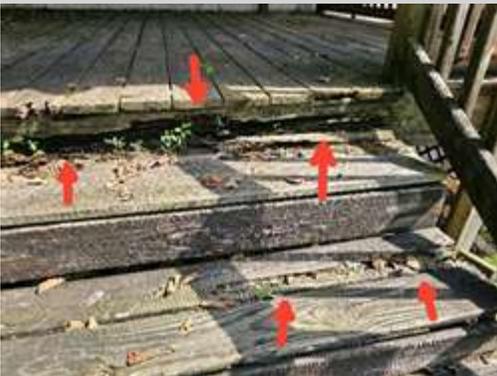
Some of the boards on the steps for the rear porch were noted to be decayed. This can effect the stability of the decking floor system. A general repair specialist or licensed general contractor can be consulted to review the entire decking system and make any necessary repairs.

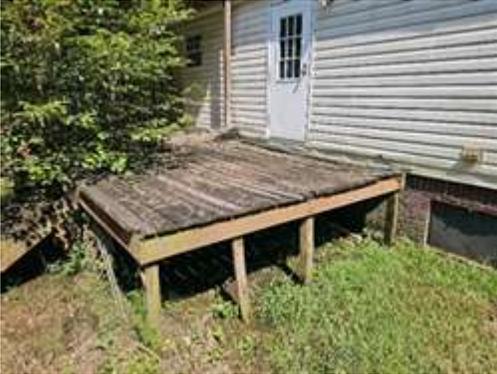
The rear deck has multiple issues and appears unsafe to use. A licensed general contractor should be consulted for a complete evaluation and to make any necessary repairs.

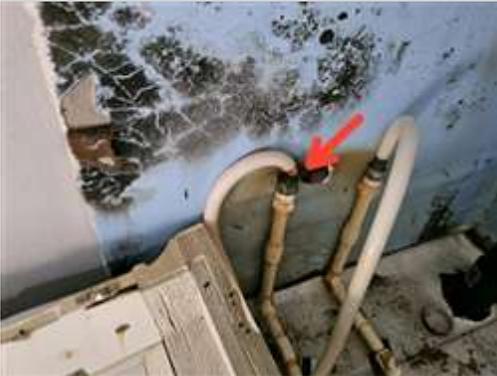
The distribution line for the right vanity in the master bathroom is actively leaking. It has flooded the master bathroom, master bedroom, master bedroom closet, living room, and laundry room. Leaks in the water supply lines should be addressed to prevent property damage and flooding. A plumber should be consulted for a complete evaluation of the distribution systems to determine the general condition of the system and make necessary repairs.

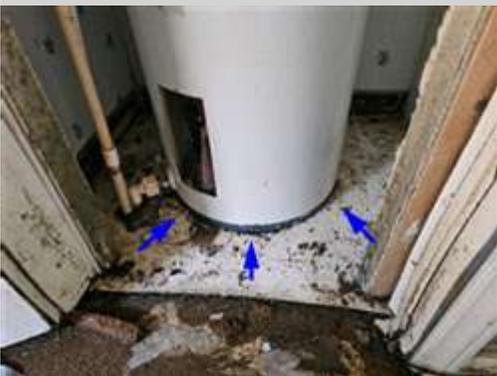
There is not a pan underneath the water heater. The pan is designed to catch any water that may come out of the drain valve and/or Temperature Pressure Relief Valve (TPRV). If there are any leaks or the TPRV releases, the water will flow out into the surrounding area and could cause damage to the floor framing in the area. If desired, a plumber can be consulted for review.

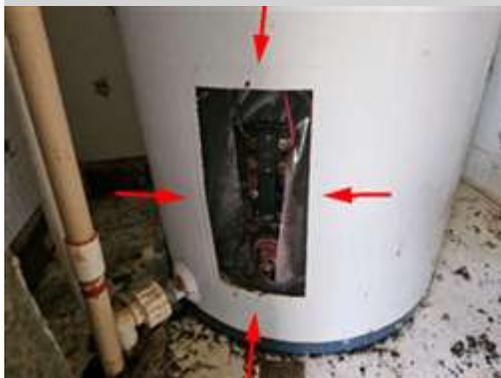
There is not a cover for the electrical element on the water heater. This is a safety hazard. A general repair specialist or plumber should be consulted for review.

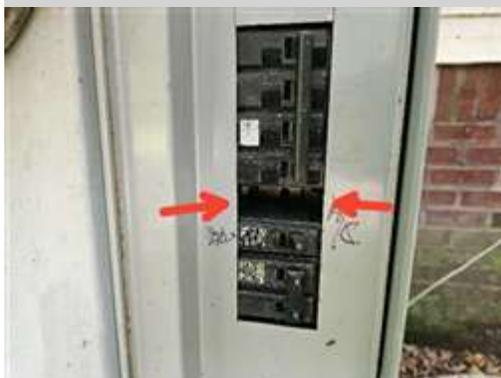
The main electrical service panel cover is missing a knock out opening plug. The cover or plug prevents direct contact with hot electrical circuits. This condition presents a safety hazard that could result in interrupted service and serious personal injury /death from electrocution. A general repair specialist or electrician should be consulted for review.

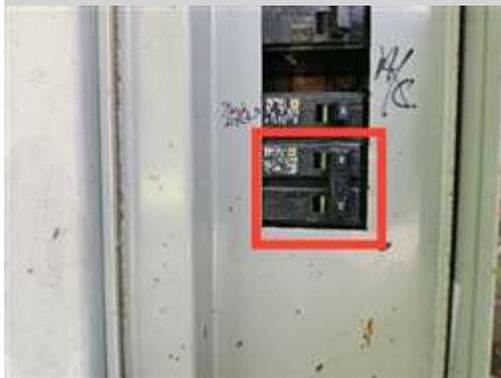
The bottom breaker in the main electrical service panel is not labeled. Correctly labeled breakers are vital to the safety of any person who operates or works on the electrical system. An electrician should be consulted to correctly label the breaker.

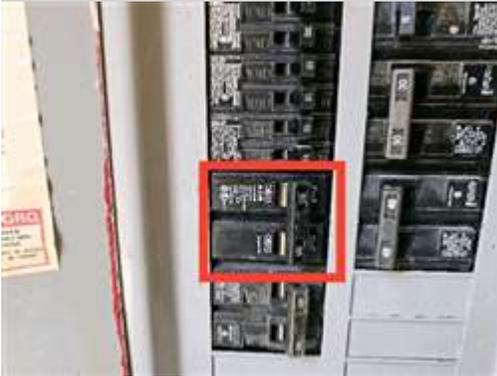
The 50 amp breaker in the distribution panel has been added or replaced. The new breaker is of a different brand from the panel enclosure and is not listed on the label of the panel. Breakers must be UL listed and certified for each panel to ensure proper operation. The compatibility of the breakers to the panel needs further evaluation by an electrician to ensure safe and proper operation of the overcurrent protection systems.

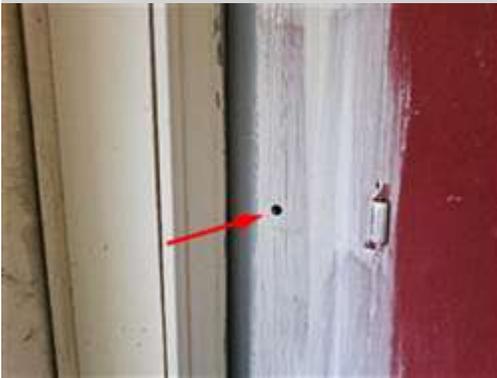
The distribution electrical service panel is missing a fastener that secures the cover to the enclosure. The door/cover prevents direct contact with hot electrical circuits and contains the electrical energy of the electrical system in the event of a short or electrical explosion; therefore the cover must be secured with the correct type, size and number of fasteners. This condition presents a safety hazard. A general repair specialist or electrician should be consulted for placement.

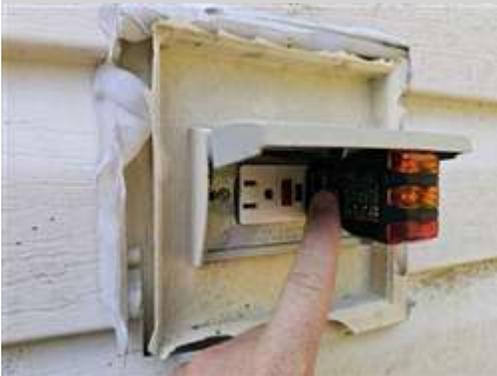
The Ground Fault Circuit Interrupter (GFCI) receptacle on the front of the home did not operate properly when tested. The GFCI is an important safety feature that should be kept functional to reduce shock hazards. An electrician should be consulted for review of the electrical system and to make any necessary repairs.

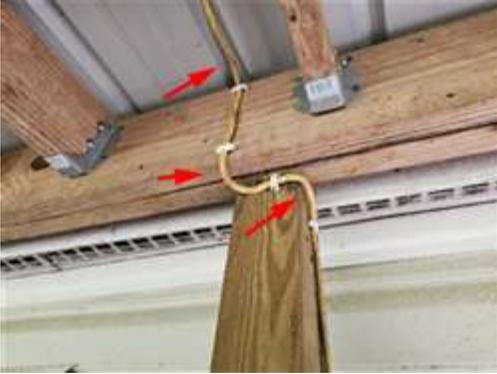
The electrical cable on the rear porch does not have a conduit to protect it. This can lead to accidental damage and be a safety hazard. A general repair specialist or electrician should be consulted for review.

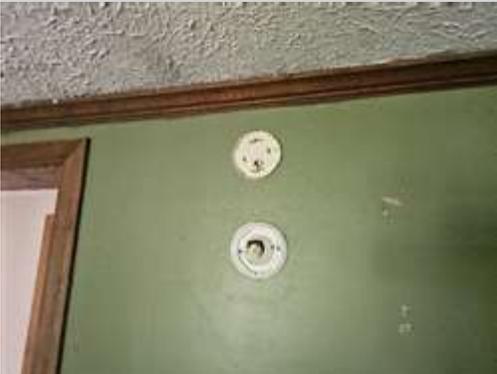
Some of the smoke detectors in the home are missing. Smoke detectors are vital to the safety of the occupants of the home. A general repair specialist should be consulted for review and installation.

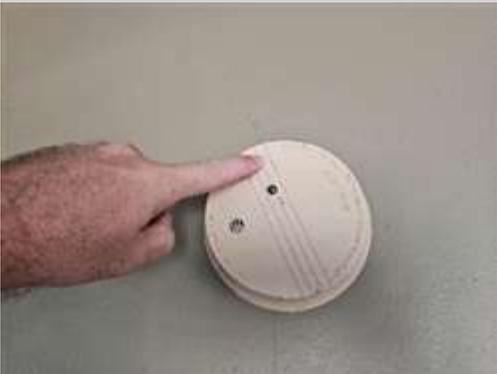
The smoke detector in the living room did not respond to the test button. A properly functioning smoke detector is vital to the safety of a home. Smoke detectors should be replaced or updated every 5 to 7 years and batteries changed annually. The unit should be repaired or replaced to ensure a safe environment.

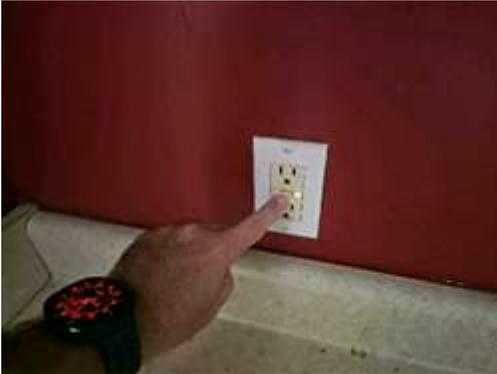
The button to the following Ground Fault Circuit Interrupter (GFCI) receptacles would not reset: left receptacle on the rear wall in the kitchen, on the rear of the home. The reset allows for power to be restored to the receptacle after the GFCI protection has been used. An electrician should be consulted for review.

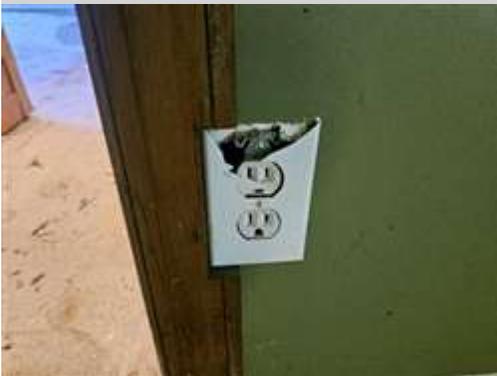
There is a damaged cover plate to a receptacle in the following locations: on the left wall of the family room, right wall of the living room. A missing or damaged cover plate leaves the wires exposed to damage and possible bodily harm. A general repair specialist should be consulted for repair.

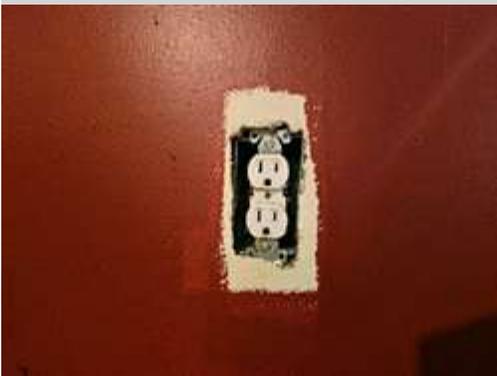
There are cover plates missing in the following areas: behind the refrigerator, on the rear porch, laundry room, front wall of the front right bedroom. A missing cover plate leaves the wires exposed to damage and possible bodily harm. A general repair specialist should be consulted for repair.

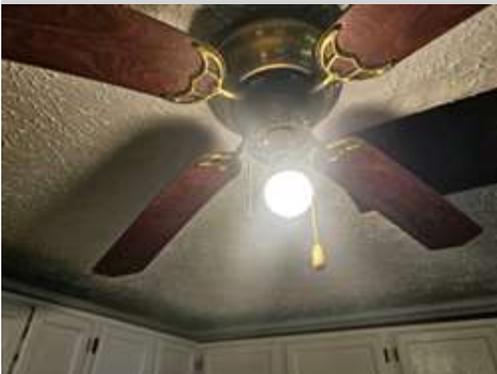
The light fixture in the kitchen is missing its cover. This can be a safety hazard. A general repair specialist or licensed general contractor can be consulted for placement.

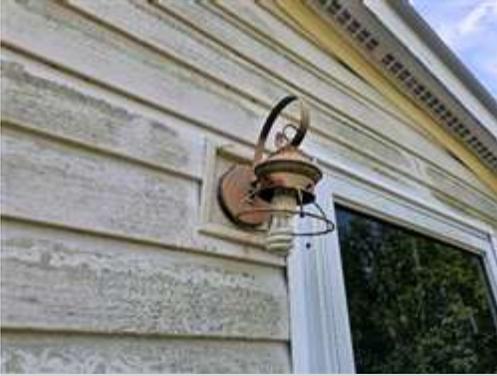
The cover to the light fixture outside the front door is missing. All exterior light fixtures should have a cover on them to prevent damage to the bulb and ensure water doesn't cause undesired electrical activity. A general repair specialist should be consulted to repair the fixture.

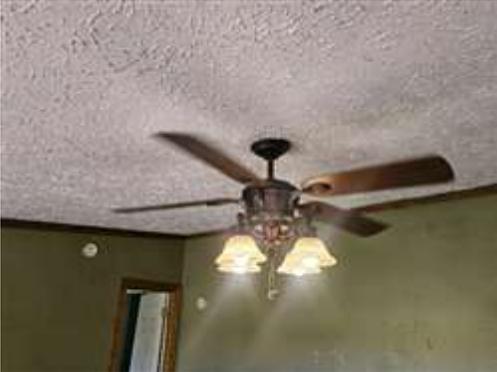
The ceiling fans in the following locations are off balance: living room, kitchen. A general repair specialist should be consulted for review.

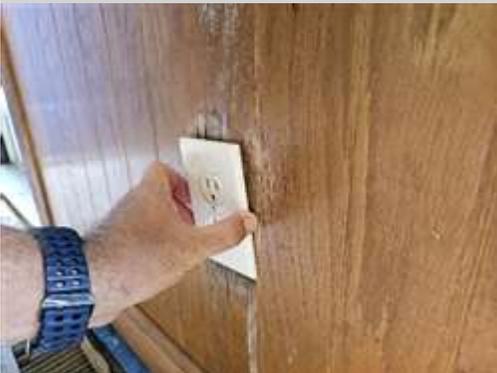
Multiple receptacles around the home are loose. Loose receptacles could result in electrical shock or property damage. An electrician should be consulted for a complete evaluation to determine the significance of this concern and make necessary repairs to correct defects and prevent safety hazards.

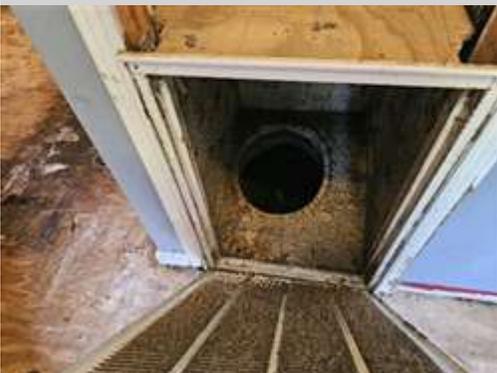
There is not a filter in the return. A filter should be added to prevent airborne contaminants from entering the HVAC system.

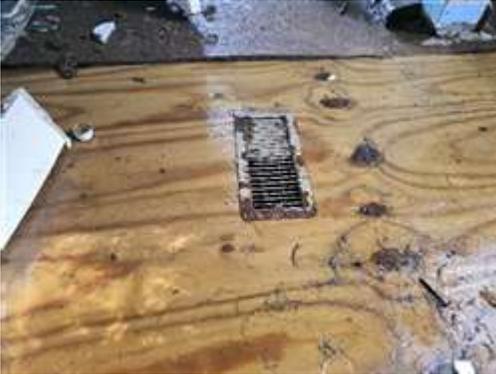
Water from the leak in the master bathroom has entered the duct work system via the registers in the master bathroom and living room. Moisture in the ducts can cause fungal growth. Moisture in the ducts can also damage them. An HVAC contractor can be consulted for review.

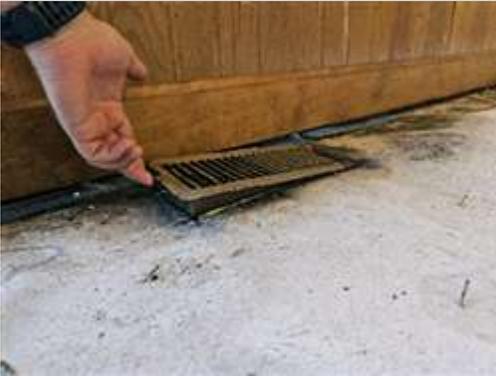
Multiple registers are loose in the floor. This can be a safety / trip hazard. A general repair specialist or HVAC contractor should be consulted for review.

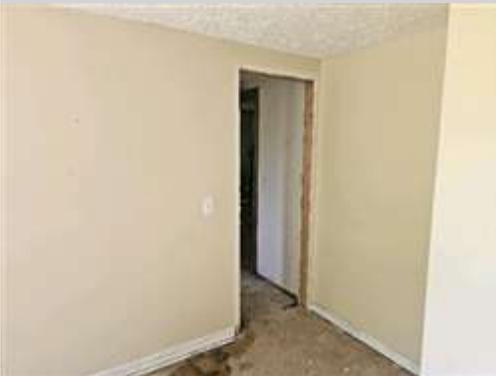
The front right bedroom door is not installed. It is not known why the door is not in service. A general repair specialist or licensed general contractor can be consulted for placement.

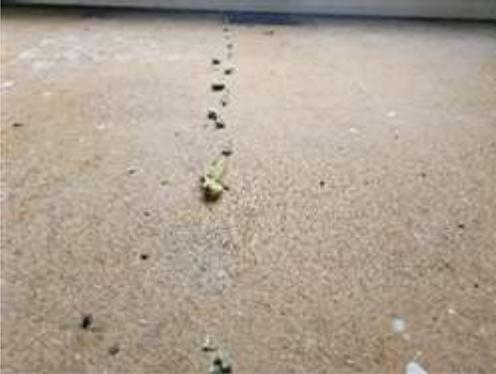
The flooring has been removed throughout the home. The staples and nails haven't been removed. These can be a trip and / or safety hazard. A general repair specialist or flooring contractor should be consulted for review.

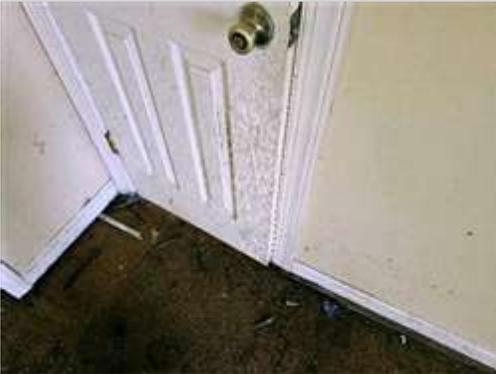
The following doors rubbed when closed: master bedroom door, rear right bedroom door, rear right bedroom closet door, hall bathroom closet door, hall bathroom door, front left bedroom door, front left bedroom closet door. Slight movement in the floor system, placement of the door frame without direct support on both sides from below, or improperly installed or positioned hinges can all cause this issue. A general repair specialist or licensed general contractor should be consulted to review the door systems and make any necessary repairs.

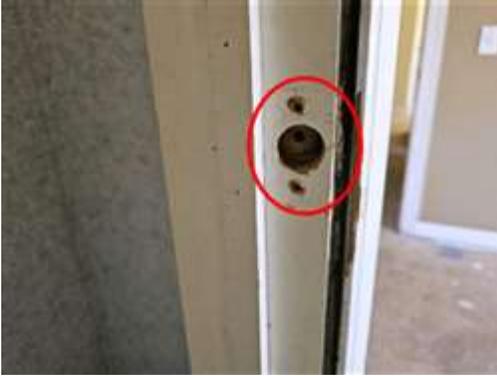
The catch plate is missing for the front left bedroom closet door. The door does not latch. A general repair specialist should be consulted to repair to provide privacy to the room's occupants.

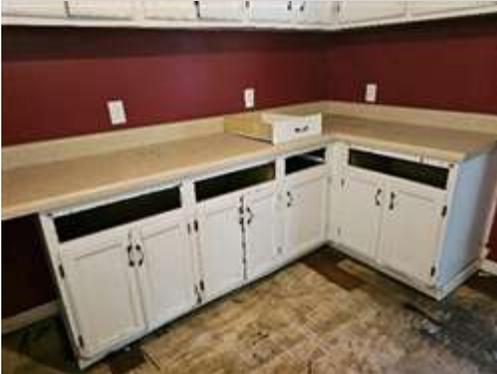
There are missing drawers in the kitchen cabinet system. A cabinetry contractor or general repair specialist can be consulted for replacement.

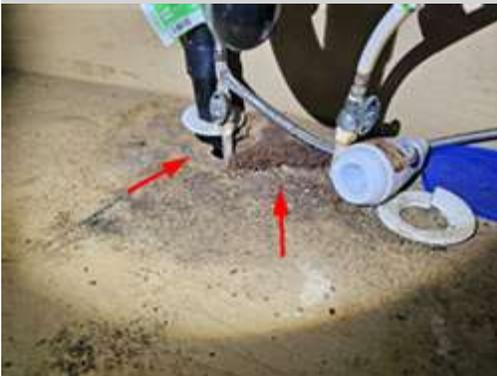
The bottom of the cabinet under the kitchen sink is damaged. This makes it difficult to store items. A general repair specialist or cabinetry contractor can be consulted for repair.

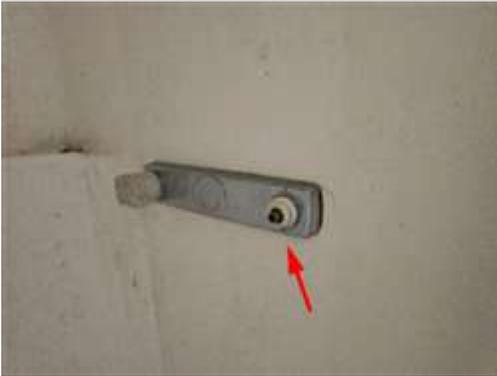
The right shower handle in the master bathroom is missing. It is difficult to operate the shower. A general repair specialist or plumber can be consulted for placement.

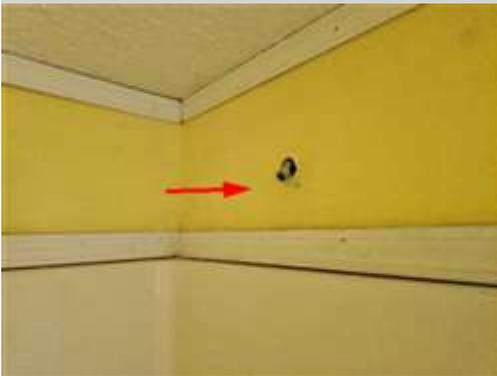
The shower head in the hall bathroom is missing. This prevented an inspection of the plumbing. A general repair specialist should be consulted to place a shower head. If any issues arise after placement, a plumber should be consulted for repairs.

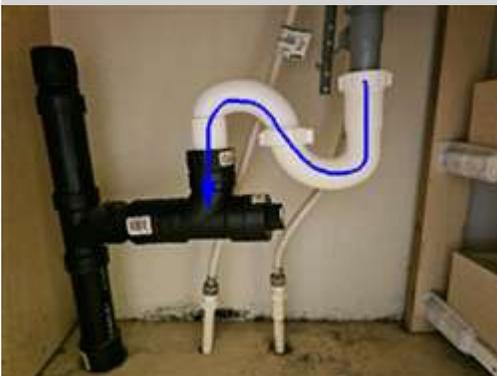
The plumbing trap for the hall bathroom sink is an S type trap. This trap has a tendency to siphon and become dry, allowing sewer gases to enter the home. The trap plumbing needs to be corrected or replaced to prevent sewer gases from entering the home and to ensure sanitary conditions. A plumber should be consulted for evaluation and repair.

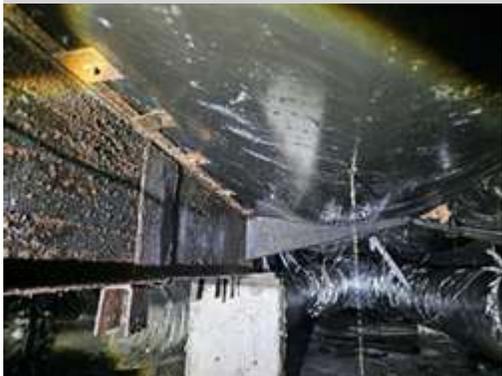
Water was noted in the elevated vapor barrier. Moisture compromises the insulation and can create fungal growth. A licensed general contractor should be consulted for review.

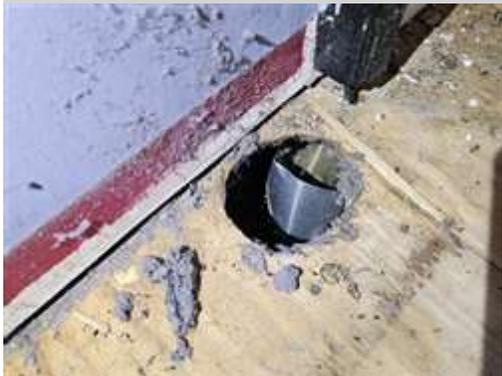
The dryer duct at the exit in the laundry room is not connected. The duct should be connected on both ends to ensure that the warm air is being distributed outside and not to the crawl space area. A general repair specialist should be consulted to repair.

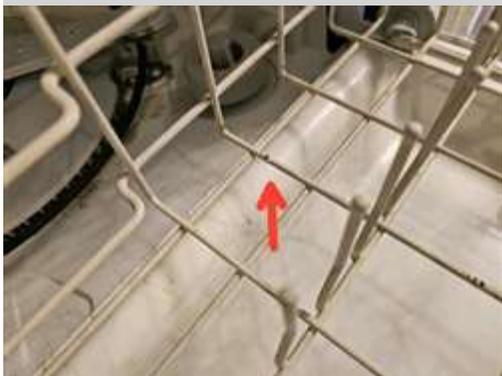
There are areas on the dishwasher trays where the protective coating has eroded away and rust is visible on the underlying metal. This rust can be transferred to the dishes when the dishwasher is operated. An appliance repair person should be consulted for review and to make any necessary repairs.
