Property Inspection Report

Report Number: 1860 - 9/9

1860 Oak Harbor Drive
Ocean Isle Beach, North Carolina 28469

Date of Inspection: Tuesday, September 9, 2025

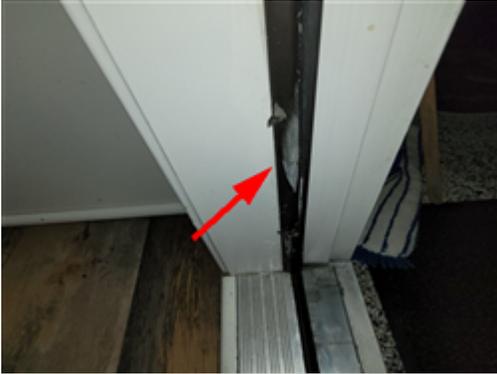
(B2 - 1.1) Doors

The garage entrance door weather-stripping is damaged. The weather-stripping needs repair/replacement to ensure that the door closes securely and is weather tight. A general repair specialist or licensed general contractor should be consulted for evaluation and repair.

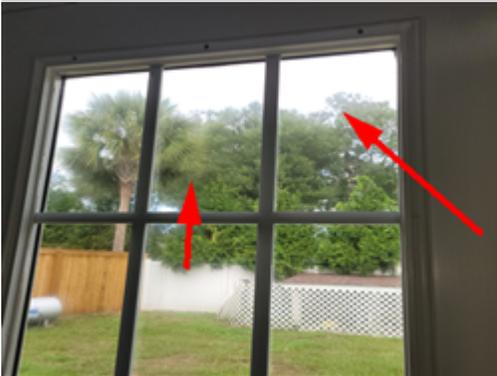
(B2 - 1.2) Doors

The rear pool room (far left side) door has a cloudy or hazed appearance. The cloudy appearance indicates that the gas seal between the double glass panes has been jeopardized reducing the visibility through the glass and the energy rating of the door. The severity of the visual obstruction in the glass can vary from intense white minerals that result in the door appearing cloudy to light hazing which varies with season and time of the day; therefore, all damaged windows and door glass may not have been visible at the time of the inspection. All windows and doors should be evaluated as repairs are made. A licensed general contractor should be consulted to evaluate the extent of the concern and make necessary repairs.

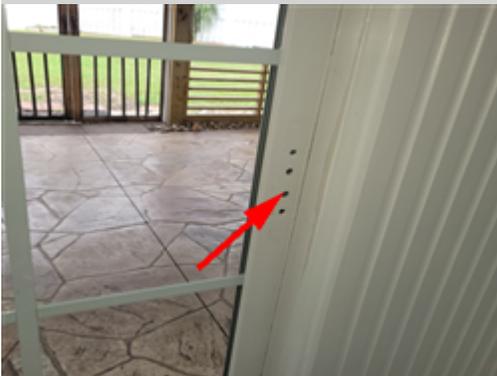
(B2 - 2.1) Doors

One of the slider doors is missing the handles. The parts are there but need to be installed. The door needs repair to ensure that the door closes securely and is weather tight. A general repair specialist or licensed general contractor should be consulted for evaluation and repair.

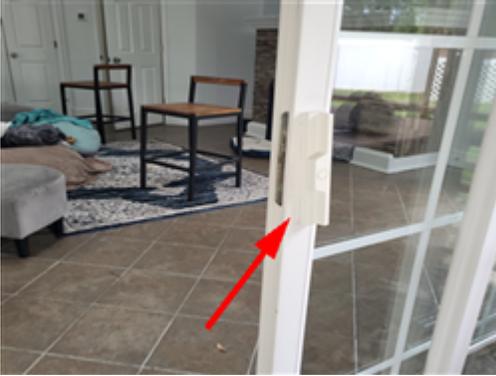
(B2 - 2.2) Doors

The handles are loose on the next door down. Repairs should be made when the other door is repaired.

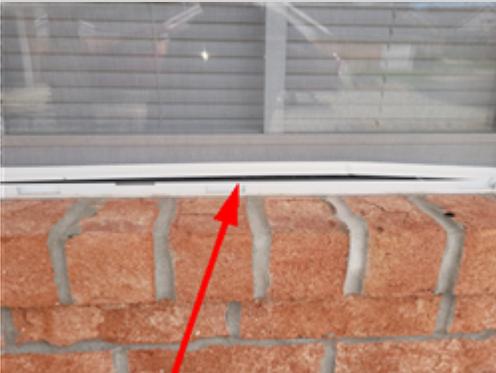
(B2 - 4.1) Windows

Many of the window screens were noted to be bent at the bottom. Replacement can be expected. A general repair specialist or licensed general contractor should be consulted for evaluation and repair.

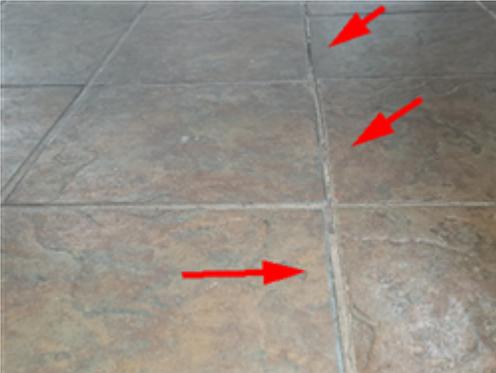
(B3 - 3.1) Pool Room / Sunroom

The tile system for the pool room floor needs evaluation and repair related to a loose tile pieces and loose grout. A tile installation/repair company should be consulted to evaluate the tile system to determine the significance of the concern and make necessary repairs.

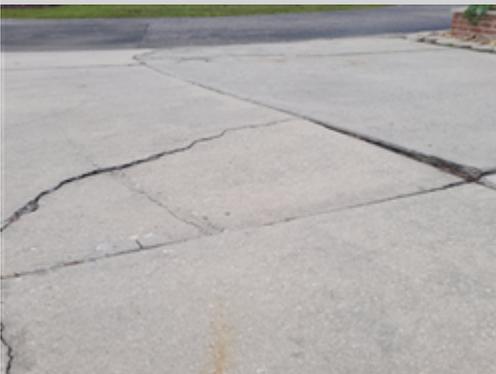
(B4 - 1.1) Driveway

The driveway is cracked and displaced. The raised section of the driveway has created a path for water penetration under the slab and a trip or fall hazard. A licensed general contractor should be consulted for further evaluation and repair.

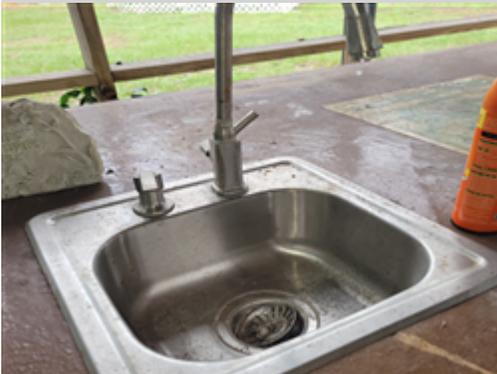
(D1 - 2.1) Exterior: Screened Porch

The porch sink did not function when tested. It is likely winterized but that was not confirmed. A general repair specialist or licensed plumbing contractor should be consulted for evaluation and repair.

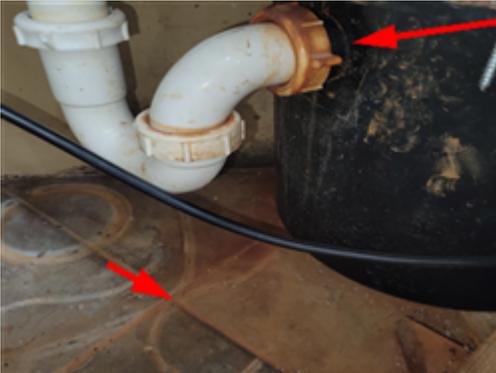
(D2 - 2.1) Pool Room Bar

The sump pump under the pool room bar shows evidence of a past leak (it did not leak during this inspection). Evaluation and monitoring is recommended.

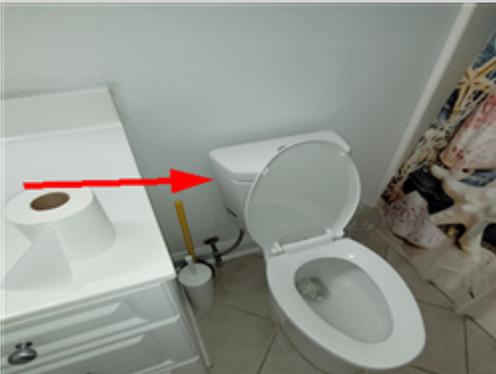
(D2 - 3.1) First Floor Guest Bathroom
--

The downstairs guest bath toilet tank is loose. Movement of the toilet tank can result in leaks and flooding. A licensed plumbing contractor should be consulted for evaluation and repair.

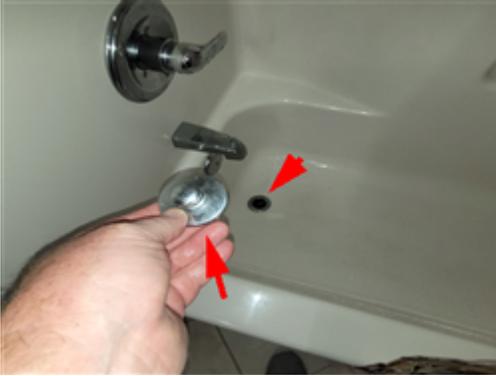
(D2 - 3.2) First Floor Guest Bathroom

The guest bath tub stopper is not installed.

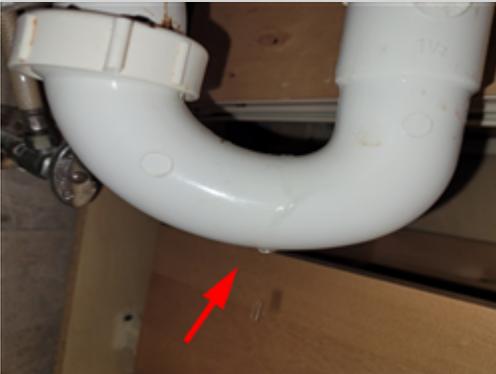
(D2 - 4.1) Second Floor (Owner's Bedroom) Bathroom

The upstairs bath (right side) sink drain leaks during use. Plumbing leaks should be repaired as soon as possible to ensure sanitary conditions and prevent damage to adjacent building components. A licensed plumbing contractor should be consulted for a complete evaluation to determine the significance of this concern and make necessary repairs to prevent leaks and ensure sanitary conditions.

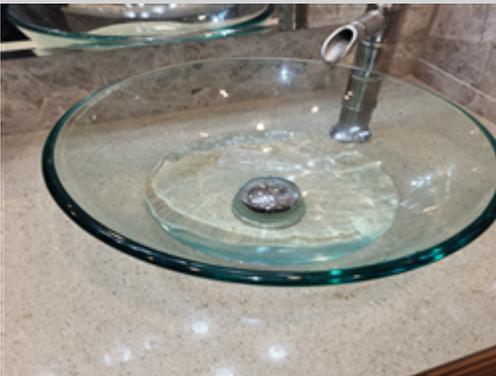
(D2 - 4.2) Second Floor (Owner's Bedroom) Bathroom

The sink was also noted to drain slow (likely from an obstruction at the leaky "p" trap).

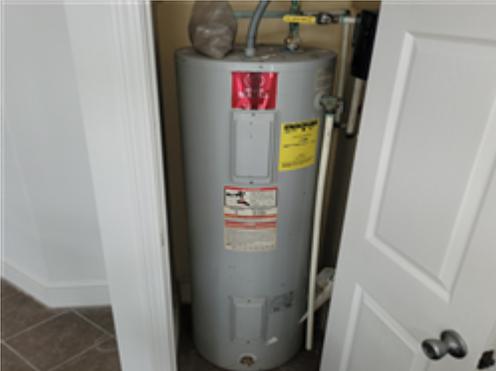
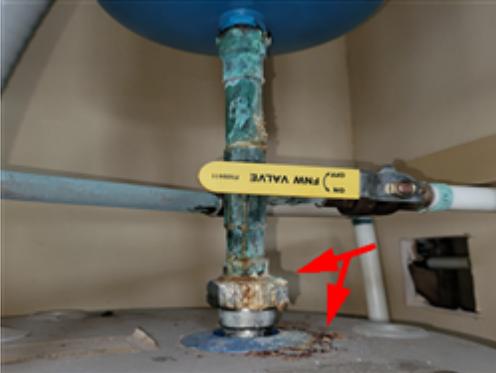
(D3 - 2.1) Unit #2 (Pool Room Unit) (Man. Year 2008)

The pool area water heating unit is over ten years old. A water heating unit has a life expectancy of 10 to 12 years. The unit was noted to be operational but was found to be in poor condition. The casing was noted to be corroded, and water lines indicate a history of leaks. A licensed plumbing contractor should be consulted to evaluate the system and repair/replace as needed to ensure safe, reliable and proper operation of the water heating system.

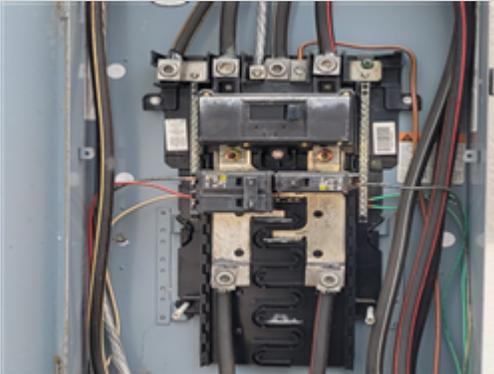
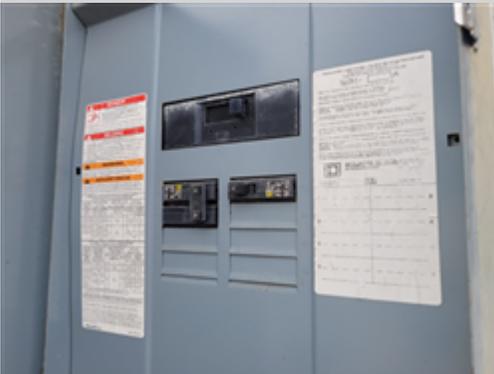
(E2 - 1.1) Meter Panel

The service breakers in the outside panel are not properly identified or labeled. Proper labeling ensures adequate service for appliances and sub-panels and the overall safety of system when emergencies occur or repairs are needed. Without proper labels the inspector's ability to evaluate and inspect system is greatly reduced. A licensed electrical contractor should be consulted for a complete evaluation to label all electrical panels, subpanels, and service breakers and verify the compatibility of the configuration, and the main service disconnect.

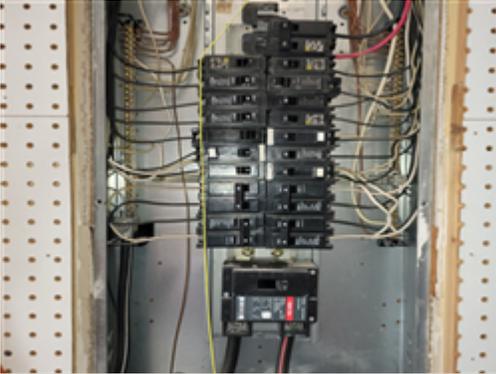
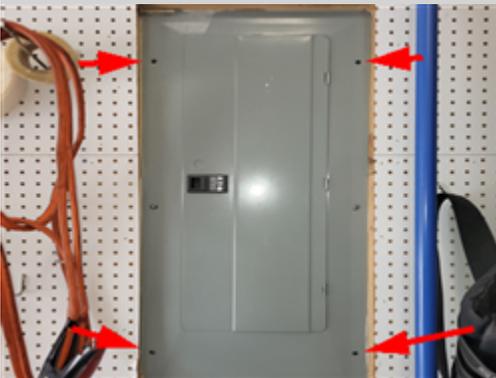
(E2 - 2.1) Main Panel #2

The left garage electrical service panel cover is missing fasteners that secure the cover to the enclosure. The door/cover prevents direct contact with hot electrical circuits and contains the electrical energy of the electrical system in the event of a short or electrical explosion; therefore the cover must be secured with the correct type, size and number of fasteners. This condition presents a safety hazard that could result in serious personal injury or death. A licensed electrical contractor should be consulted for a complete inspection of the electrical system and for repair/replacement of the panel to ensure that it is safe and functioning properly.

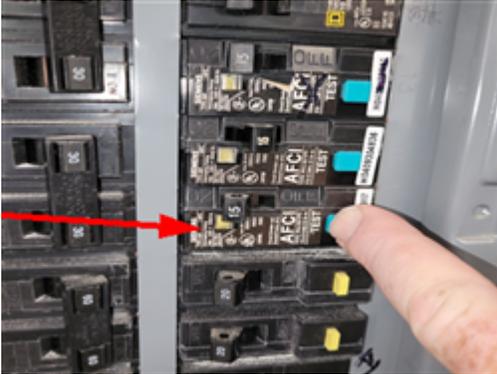
(E4- 1.1) Area: Right Main Panel

The lower Arc Fault breaker in the right garage panel did not trip when tested. The AFCI is an important safety feature that should be kept functional to reduce shock hazards. A licensed electrical contractor should be consulted for repair.

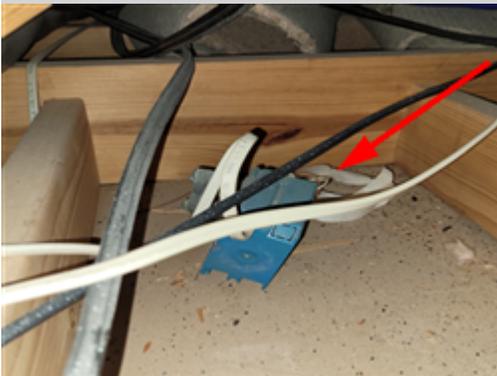
(E4- 2.1) Attic

Electrical connections have been made in the attic area without being properly protected in a covered junction box. The open junction leaves electrical conductors exposed and in a hazardous condition. Electrical concerns should be considered fire and safety issues and repaired as soon as possible. The electrical systems and components in the attic are in need of a complete evaluation and repair by a licensed electrical contractor.

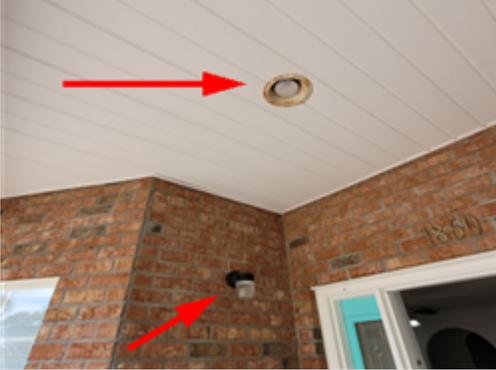
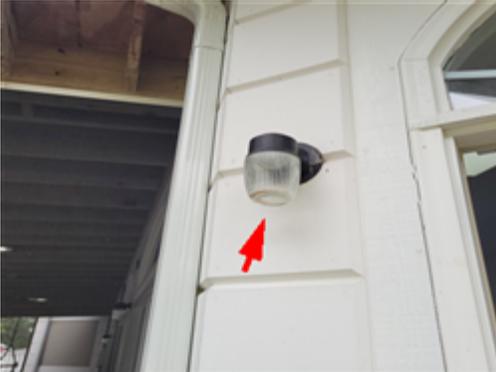
(E5 - 1.1) Exterior: Front Porch / Left Rear

The front porch light fixtures (and left rear pool room door) were not functional when tested. This could indicate that the correct switch was not located, a defective bulb or other more serious problem such as faulty wiring or a defective fixture. A licensed electrical contractor should be consulted for further evaluation and repair.

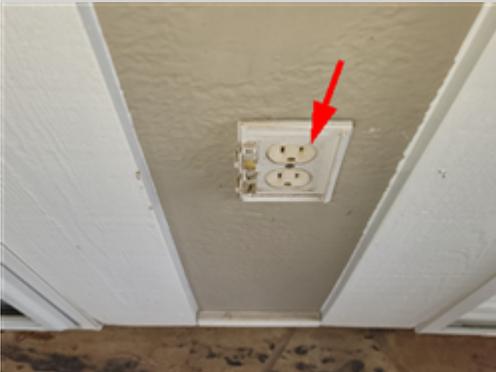
(E5 - 2.1) Exterior: Screened Porch

The exterior receptacles of this home were covered or protected to prevent electrical shock hazards if used in the rain or in damp conditions. The screened porch covers are broken/damaged/missing. The requirement for receptacles to have a protective cover to keep the receptacle and the cord connection of a device dry and protected and are an important safety feature. A licensed electrical contractor should be consulted to repair as needed to ensure safe and reliable service.

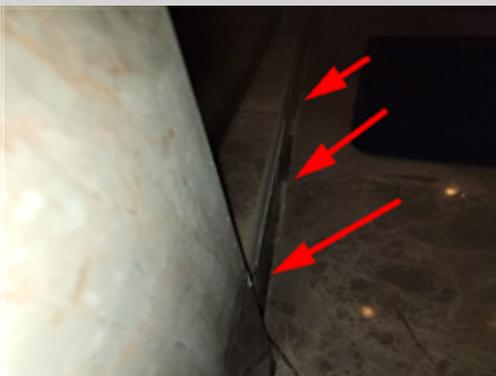
(H1 - 1.1) Owner's Bathroom

The tile system for the shower curbing needs evaluation and repair related to low/soft grout. The purpose of the grout is to fill the space between the tiles and protect the bond between the tile and the mortar base. A tile installation/repair company should be consulted to evaluate the tile system to determine the significance of the concern and make necessary repairs.

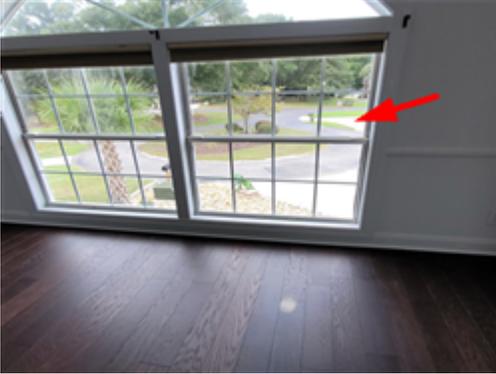
(H1 - 2.1) Owner's Bedroom (and Kitchen)

The sash springs were noted to be disconnected on the owner's bedroom (right side) window and the kitchen window during the inspection. The sash springs assist in lifting and holding the window in place when it is opened. When the springs are disconnected or broken the window will not remain in the open position and can drop suddenly resulting in personal injury. Repair is needed to ensure proper function of the window. A general repair specialist or licensed general contractor should be consulted for evaluation and repair.

During the inspection I was not able to identify a fall prevention mechanism for the second floor windows. Typically second floor windows in new homes were required to have a safety feature in place to prevent falls from the upper levels of the home when windows are installed below 24 inches from the floor. The window installations in the second floor sections of this home need further evaluation by a general contractor to verify that a required fall protection mechanism is in place and if it was required in this jurisdiction when this home was built.

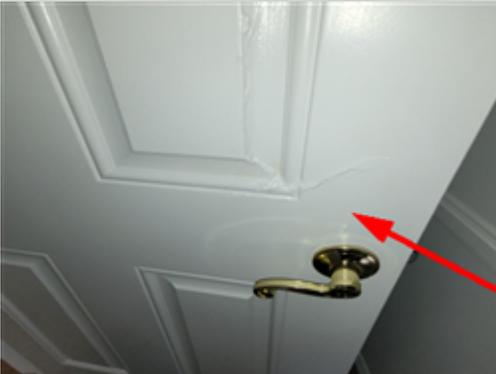
(H1 - 3.1) Right Side Rear Bedroom

The right rear bedroom door is damaged/busted in the panel area. The door needs repair/replacement to ensure that the door closes securely and operates properly. A general repair specialist or licensed general contractor should be consulted for evaluation and repair.

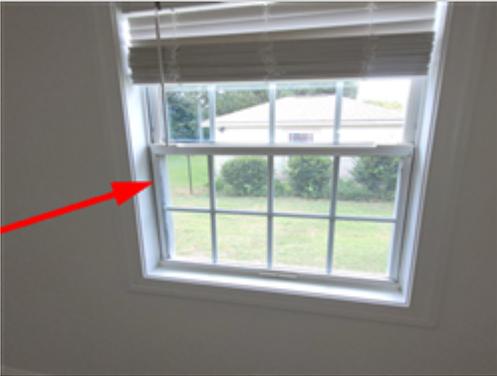
(H1 - 4.1) Right Side Center Bedroom

The center bedroom window needs repair to ensure proper operation. The window could not be opened. This window is the means of emergency egress for the bedroom. It is very important to have a proper method of egress from every sleeping area in case of an emergency such as a fire. A licensed general contractor should be consulted for evaluation and repair.

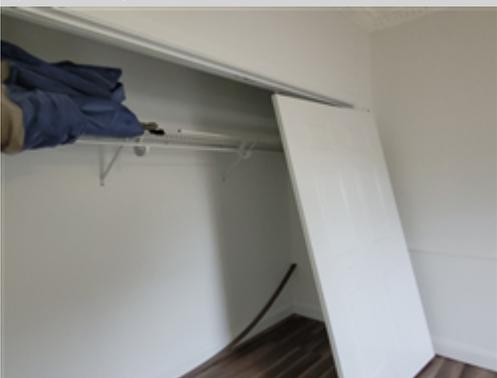
(H1 - 5.1) Bedrooms: General

Several closet doors were not installed at the time of the inspection.

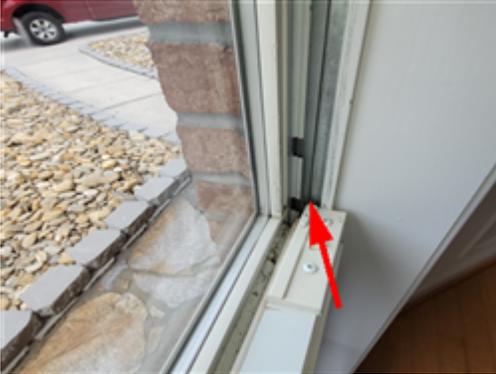
(H1 - 6.1) Right Front Room

The right front room (right front) window needs repair to ensure proper operation. The window could not be opened. A licensed general contractor should be consulted for evaluation and repair.

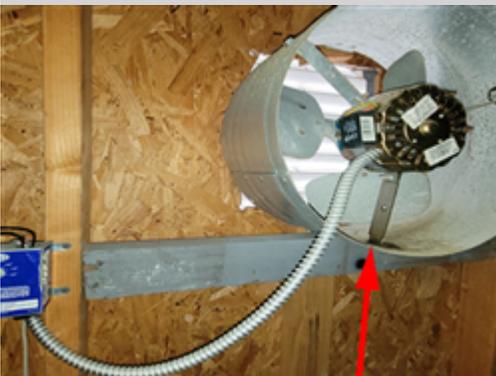
(I1 - 1.1) Attic: All Accessible

The attic fan did not function when tested. Damaged fan units can cause ventilation problems and present fire hazards. A licensed general contractor should be consulted for repair/replacement.

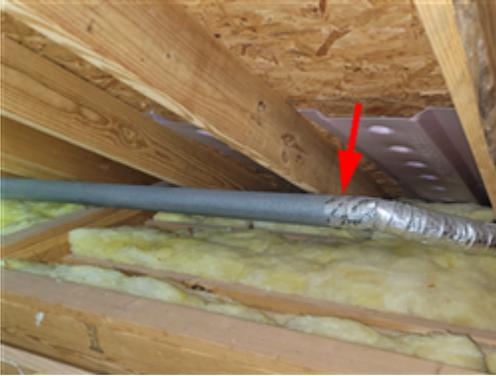
(I1 - 1.2) Attic: All Accessible

The clothes dryer exhaust duct is vertical then exits at the upper wall level. The installation of a dryer duct in the vertical position is an approved method for most appliances, however, this installation requires annual inspection and cleaning to prevent clogging. It is recommended that a duct cleaning contractor be consulted to inspect and clean the duct prior to purchasing the home if the homeowners have not had the duct cleaned recently.

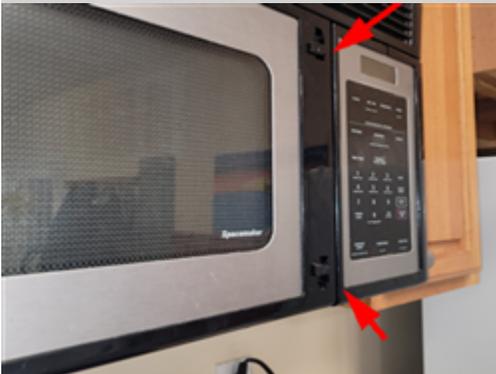
(J1 - 10.1) Microwave: Over Range

The door handle of the microwave was found to be damaged. An appliance repair specialist should be consulted for further evaluation and repair to ensure proper operation of the appliance.

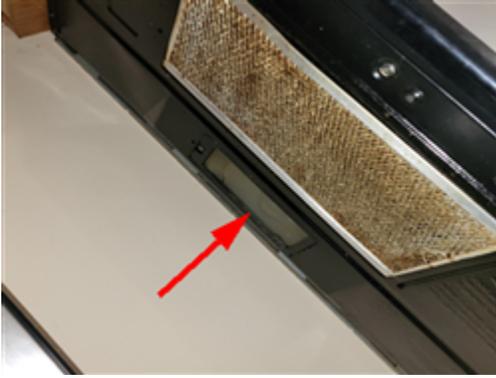
(J1 - 10.2) Microwave: Over Range

The surface light for the microwave did not function. An appliance repair specialist should be consulted for further evaluation and repair to ensure proper operation of the appliance.

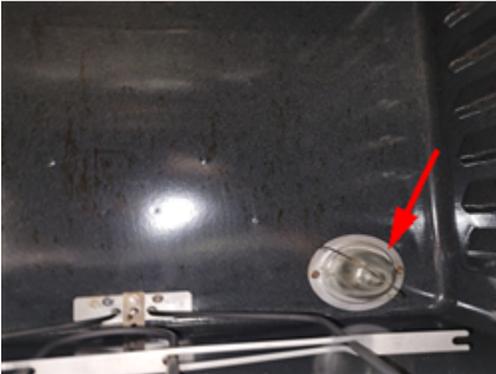
(J1 - 12.1) Oven: Electric

The garage oven interior light did not function when tested. An appliance repair specialist should be consulted for further evaluation and repair to ensure safe and proper operation of the appliance.

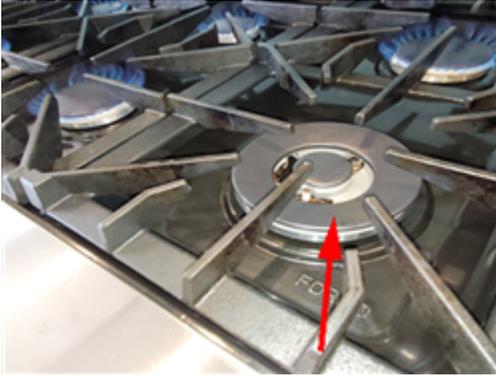
(J1 - 13.1) Range Top: Gas

The right front burner for the range top did not operate to produce heat or respond to the control panel when it was requested to heat. An appliance repair specialist should be consulted for further evaluation and repair to ensure proper operation of the appliance.
