# Structural Building Conditions Assessment Report

## Ocean Point Resort Condominiums

January 12, 2022  
Ardurra #2021-1159-00

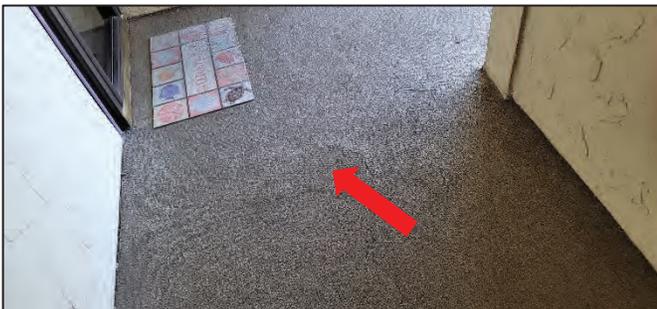
Photo 1 Typical Possible Shallow Surface Spall to Concrete Slab Under Carpet

Some possible spalling of the concrete slab was observed throughout; however, direct observation could not be performed (see Photo 1).

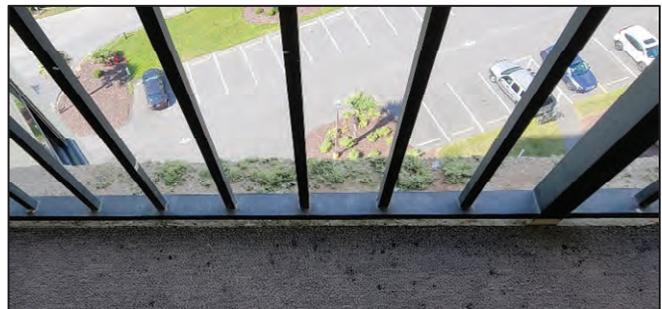
Photo 2 Organic Growth on Edge of Breezeway Concrete Slab

Some organic growth was observed on the top and outside edges of the slabs at various floor levels - 13<sup>th</sup>, 11<sup>th</sup>, 9<sup>th</sup>, etc. (see Photo 2).

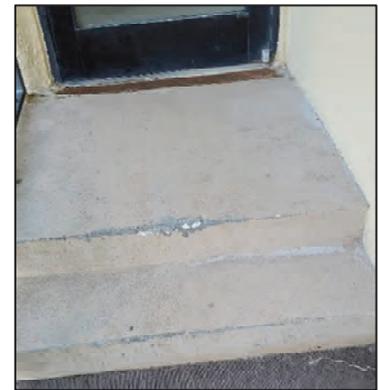
- Edge of top step to Owner's Center observed to have some delamination (see Photo 3).
- Edge coating was observed to be delaminated on the overhead slab edge at the eastern exterior walkway.

**Photo 3 Spall/Delamination of 2<sup>nd</sup> Level Concrete Step to Owner's Center**

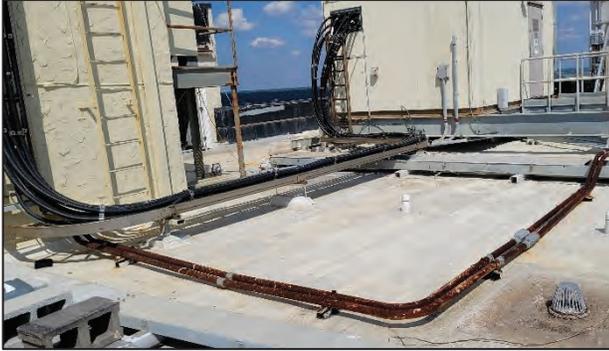
Photo 4 Main Roofing with Utility Piping and Electrical Trays

The main roof appears to be in fair to good condition with some apparent, small, isolated “soft” areas observed throughout (see Photo 4). Utility piping and electrical cable trays were observed throughout the roof. A galvanized steel cellular platform supporting a pre-manufactured building system were observed to have been installed at some time in the past.

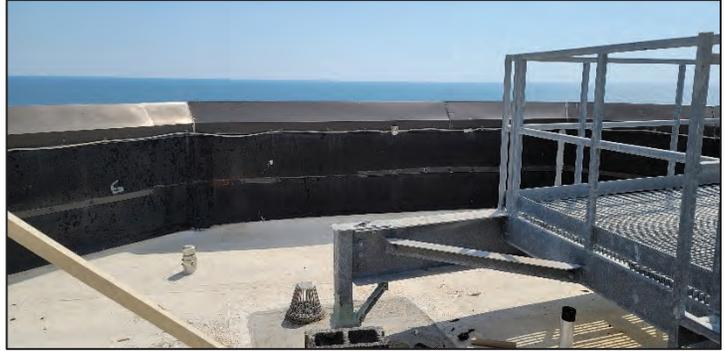
Photo 5 Main Roof Parapet and Cell Platform

The main roof parapets are flashed with a membrane up the sides and continuous aluminum caps across the top of the parapet walls, which are in good condition (see Photo 5).

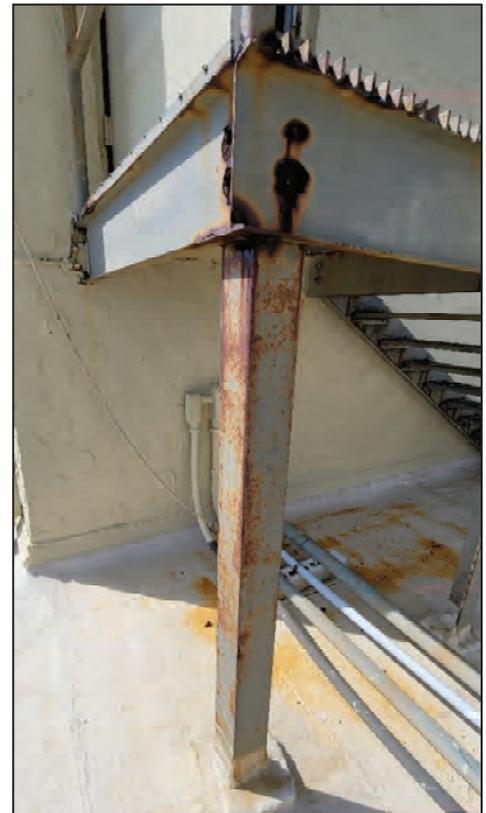
- Some localized corrosion was observed to the stair framing and base of guardrail posts to the elevator penthouse (see Photo 6).
- Unless noted below, the pedestrian traffic coating on the accessible roof deck slabs appears to be in average to good condition. The age of the traffic coating is unknown but is estimated to have been applied circa 2012.

Photo 6 Corroded Steel of Penthouse Stair Framing

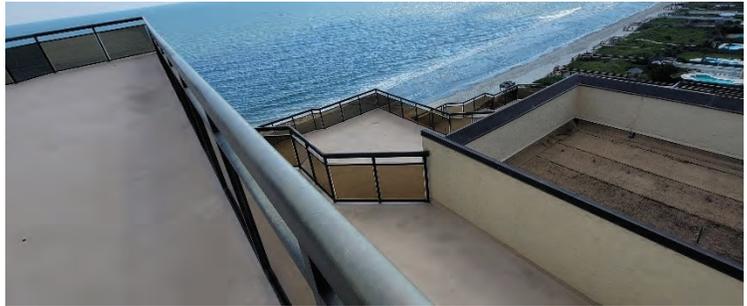
**Photo 7 Traffic Coating on Habitable Roof Decks and Modified Bitumen Roofing on Unhabitable Roof Deck**

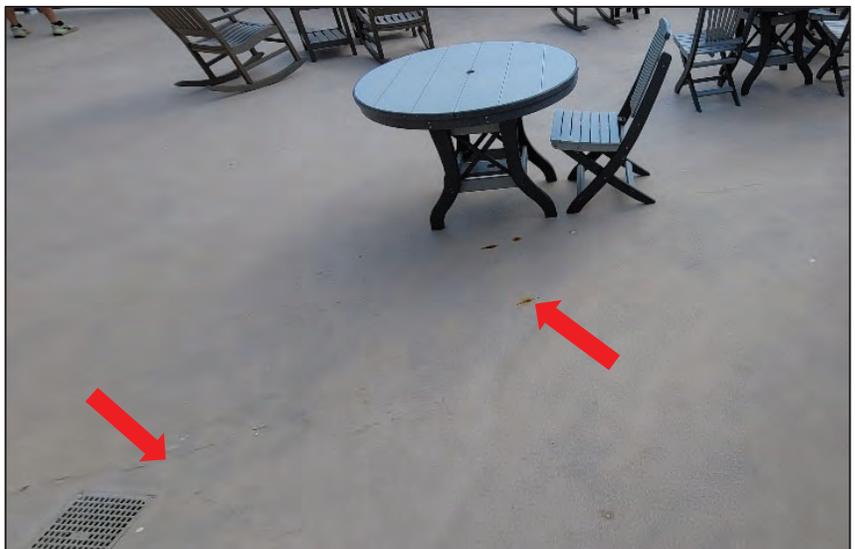
- Several rust spots and hairline cracking was observed protruding through the pedestrian traffic coating system near the southern deck drain (See Photo 8).
- Some localized delamination of the traffic coating system was observed throughout this roof deck.

**Photo 8 Rusting Through Urethan Deck Coating and Cracks in Slab at Roof Drain**

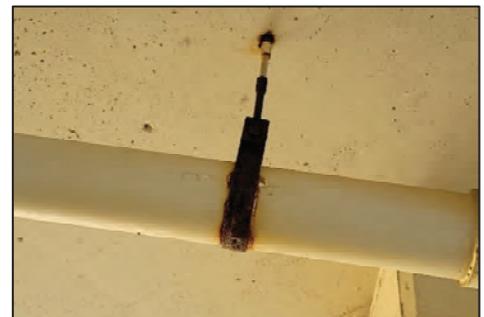
- The bottom of the elevated slab was observed to provide support for overhead water, sewer, and drainage pipes throughout, which are supported by pipe hangers. The pipe hangers were observed to vary in condition from fair to poor condition throughout (see Photo 9).
- Several of the steel utility pipes under the overhead slab were observed to have various degrees of miscellaneous corrosion from mild to pitted. (see Photo 10).
- An old concrete repair patch material was observed to be letting go at the top south face of the concrete column at grid 3B.

Photo 9 Typical Deteriorated Pipe Hanger

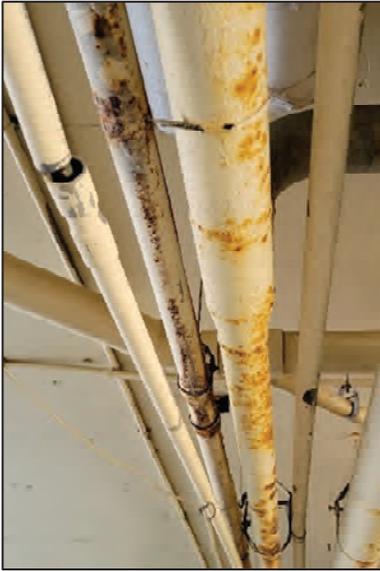
Photo 10 Pitted Steel Utility Pipe

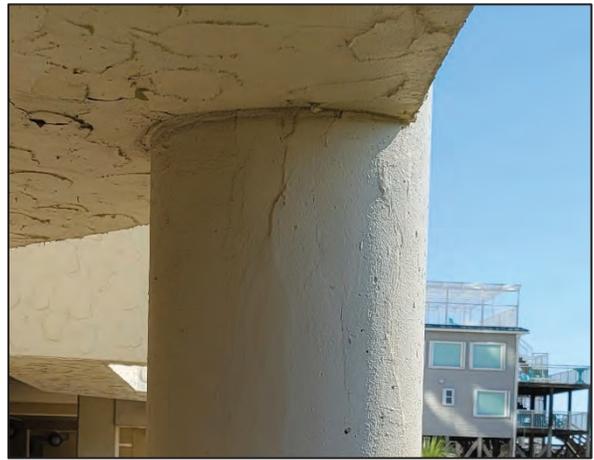
Photo 11 Concrete Column Spall at Grid 7X

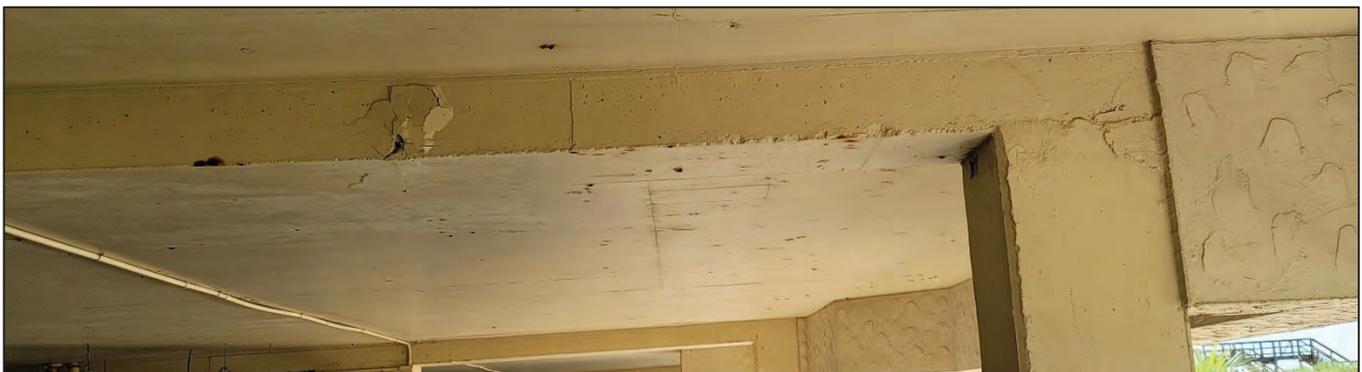
Photo 12 Concrete Beam and Column Spalls/Cracks

- A spall was observed on the western side and bottom face of the reinforced concrete beam along with miscellaneous rust spots, spanning between columns at grids Q to V, along grid line 10 (see Photo 12).

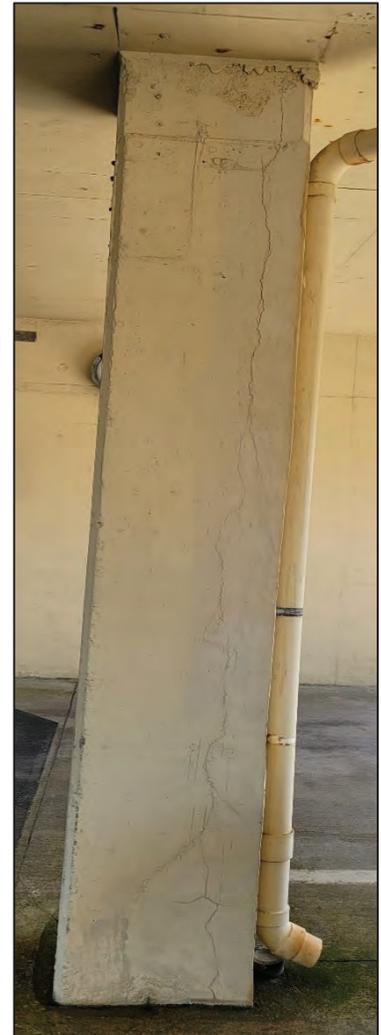
- A 6"x6" x 5'-0"± corner crack/spall was observed at the top of the southwest corner (assumed to have corroded corner vertical reinforcing as well but no rust stains showing), along with a 4"x4" x 6'-0"± corner crack/spall at the top of the southeast corner, a 3'± crack/spall at the bottom of the northeast corner & a 2" x 4" x 12"± spall at the top and northeast corner (old spall repair) was observed at the column, located at column grid 7R (see Photo 13).

Photo 13 Column With Corner Spalls

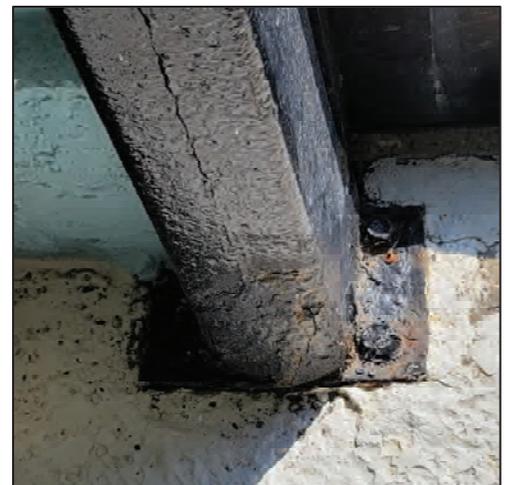
- Some mild to moderate localized corrosion was observed on the horizontal wind girt steel tubes and connections as well as at the base of the vertical tube columns.
- The column base plates were observed to have moderate to severe corrosion (See Photo 14).
- Several of the anchor rods connecting the base plates of the columns to their respective foundations were observed to have deteriorated nuts, with many of them nuts observed to be completely or nearly completely deteriorated away(See Photo 14).

Photo 14 Deteriorated Base Plate and Anchor Rods of Steel Curtainwall Column At Owner's Center Interior Pool
