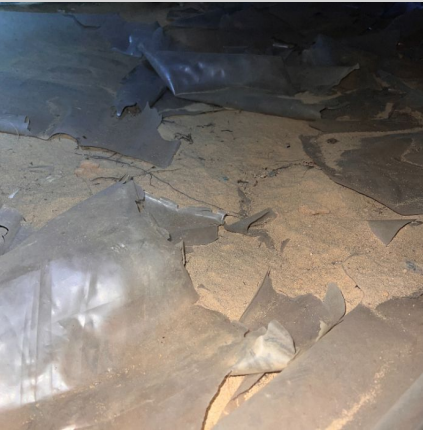
**(B1-1.2) Main House**

The crawlspace ground was not fully covered with a plastic vapor barrier. This can allow ground evaporation to condense on various components, resulting in damage.

It was noted that some HVAC ducts were moisture damaged/cracked and microbial growths were present on wooden and other surfaces, indications of reoccurring periods of elevated moisture. Continued and/or repeated exposure to excessive moisture may result in floor system decay or further defects. A crawlspace remediation specialist or licensed general contractor should be consulted for comprehensive evaluation of the crawlspace to determine the cause(s) and extent of moisture related concerns, and to make recommendations of repair as needed.

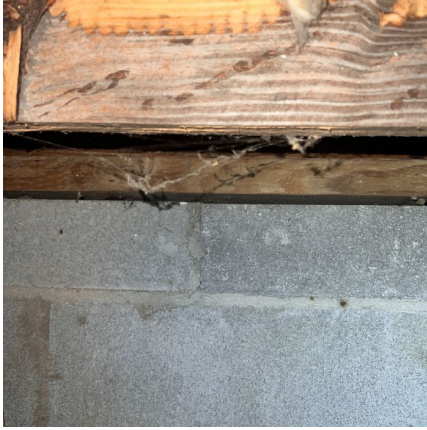
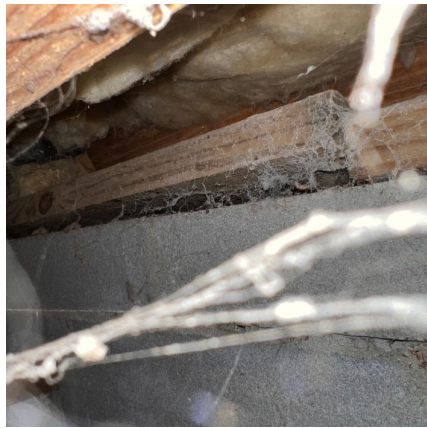
(B3-1.1) Main House

The sill plates were noted to have movement and were not flat on the foundation in most locations, particularly on the right and rear of the home. Movement of the sill plates can indicate improper fastening of the floor structure to the foundation and related movement of the floor and/or wall structures. Further movement could potentially result in damages to finished surfaces. A licensed general contractor should be consulted to evaluate the sill plate throughout the home to determine the extent of defects and to make repairs as needed.

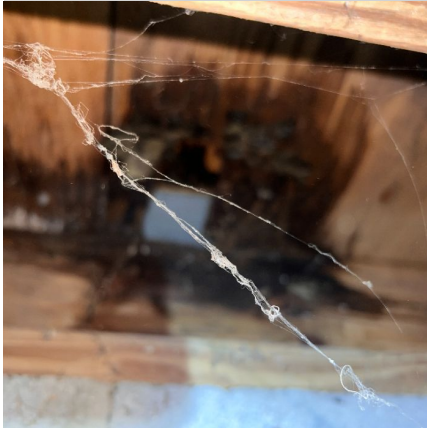
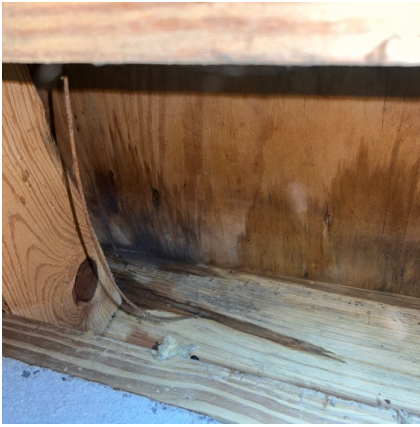
**(B3-1.2) Main House**

Varying degrees of wood decay were noted in all floor structure components at the left door/kitchen door, conditions which could result support capabilities of the floor, potentially resulting in movement and related damages. A licensed general contractor should be consulted to determine the cause and extent of defects and to make repairs as needed.

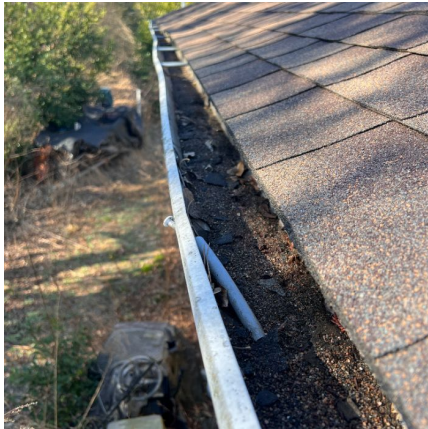
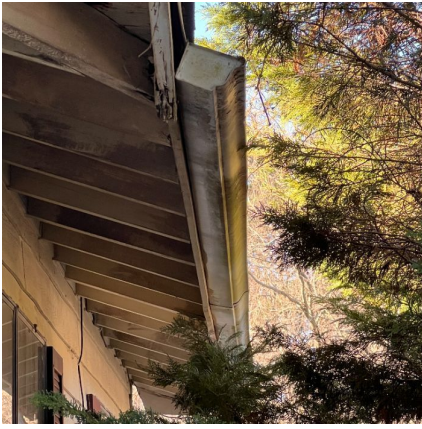
(C2-1.1) Gutters

Gutter systems were in poor overall condition, were with damaged or improperly installed fasteners, damaged trays and noted to be full of shingle granules of other debris, conditions which can impair proper roof drainage. Improper roof drainage can result in damages to fascia, sheathing and other underlying components. A licensed general contractor should be consulted for full evaluation of the roof drainage systems and to make repairs as needed.

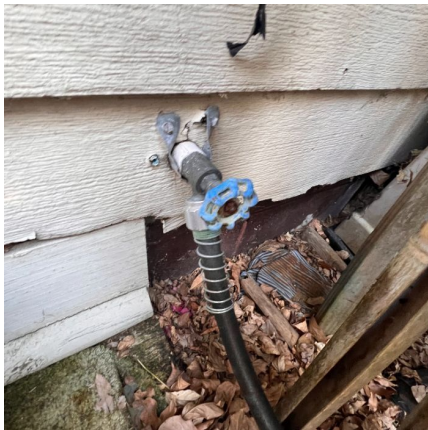
The hose bib at the rear of the home was not secured, a condition which allows potentially damaging movement of the plumbing supply components. A qualified general repair specialist should be consulted to make repairs as needed.

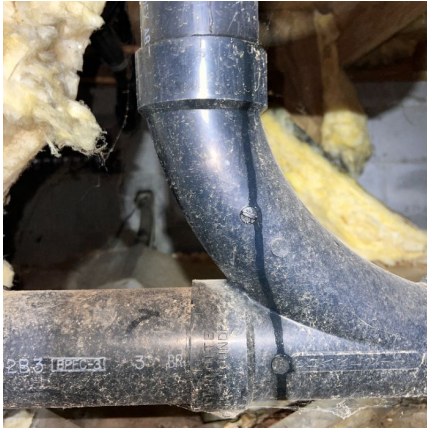
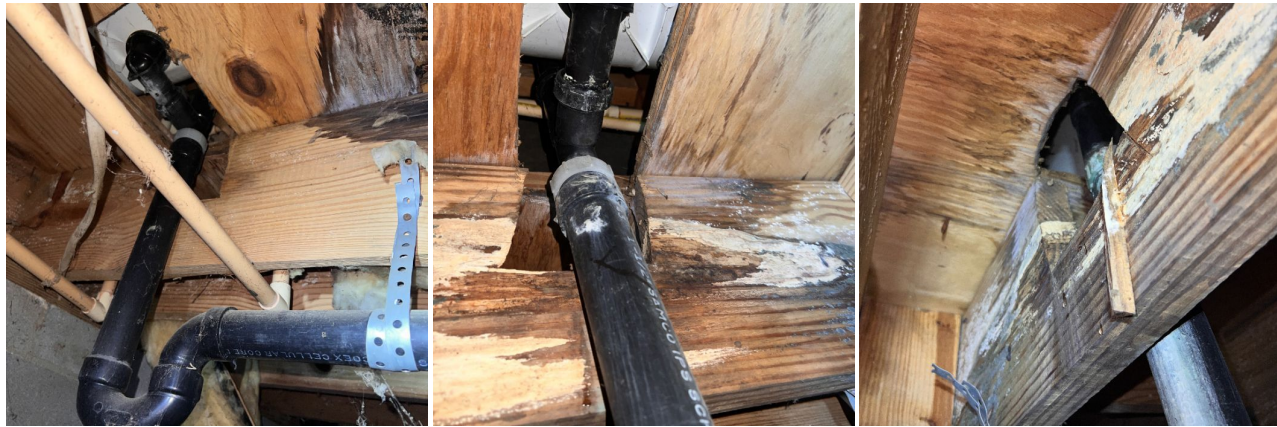
(D3-1.1) Crawl Space

There were leaks from the hall bathroom shower assembly and evidence of prior leaks from the hall and master bathroom toilets. Further leaks may result in damages to underlying and adjacent components. A licensed plumbing contractor should be consulted to evaluate all hall and master bathroom drain systems and to make repairs where needed.

Wood decay, water damages and wood destroying fungus were noted on a few structural components in the hall and master bathroom areas related to prior leaks. Repairs have been made, however, some damages are still present. Damaged wooden structure can result in improper support, related movement, and further damages. A licensed general contractor should be consulted to fully evaluate the floor structure components at the bathrooms' location, and to make repairs as needed.

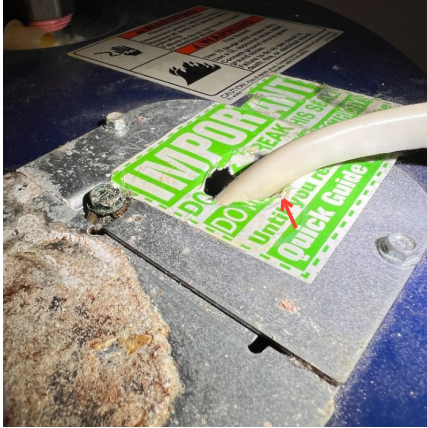
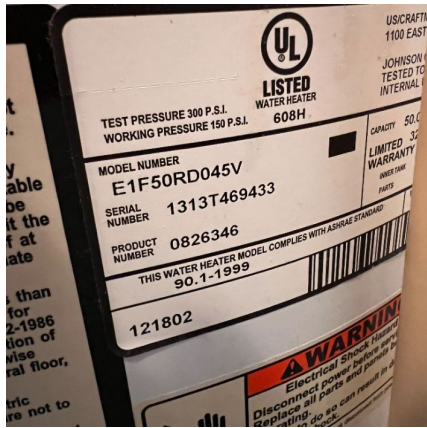
(D4-1.1) Unit 1

It was noted that the electrical service conductor entered the onboard junction without proper strain relief connection. This allows the electrical conductor to contractor the sharp metal edge of the junction lid, a condition which can result in damages. This can also allow damaging movement of the conductor and loss of service. A licensed electrician or licensed plumbing contractor should be consulted to make repairs as needed.

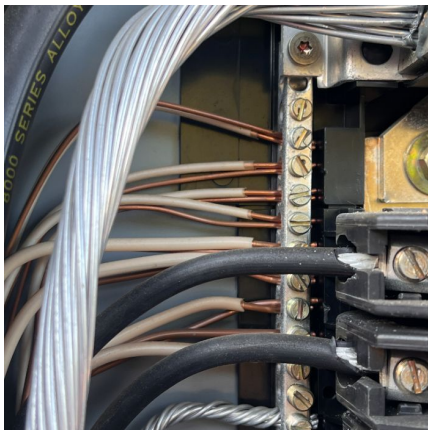
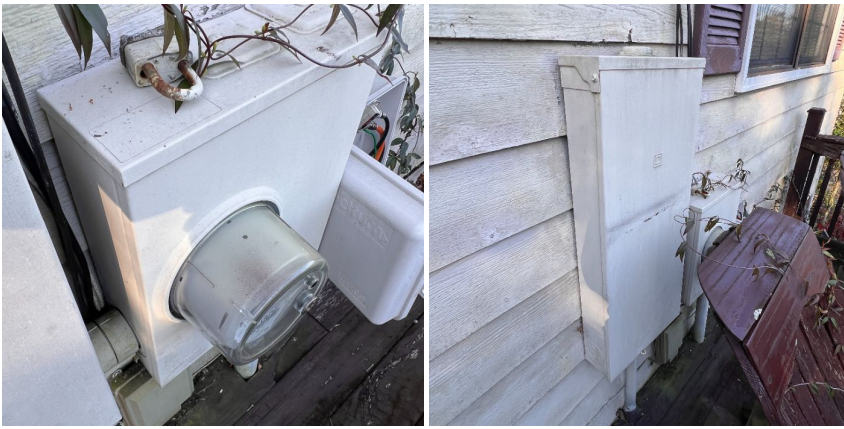
(E2-1.1) Main Panel

The following concerns were noted with the main electrical panel and meter base, located on the exterior left of the home -

1. The ground/neutral bus bar located has connections where two neutral conductors or neutral/grounds are connected together under one lug (double-tapped). This condition presents a safety hazard that could result in improper overcurrent protection, improper grounding, and/or circuit overheating.

2. Both the meter base and the main panel were not secured to the exterior of the home, a condition which can allow for potentially damaging movement of electrical components. (This is likely the result of failed cladding/siding)

A licensed electrical contractor should be consulted to make repairs.

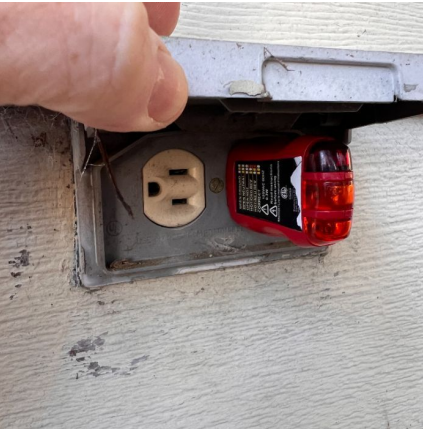
Exterior receptacles were not functioning at the time of the home inspection. This may indicate damages to the circuit, the corresponding GFCI device, or other components. A licensed electrician should be consulted to make repairs as needed to restore service to the exterior receptacles.

*Note - this may be linked to a GFCI not located during the inspection.

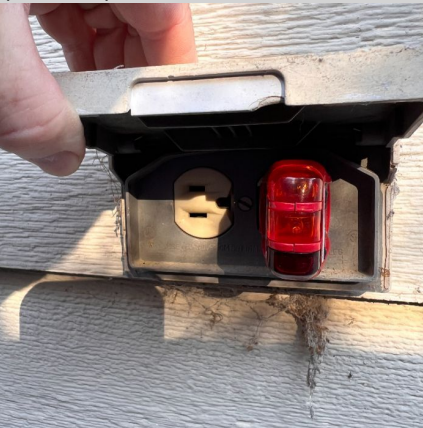
(E5-1.2) Exterior

Exterior electrical receptacles were loose within wall mounts at the rear of the home, a condition which can result in damages and/or shock hazards. A licensed electrician or qualified general repair specialist should be consulted to evaluate all interior receptacles and to make repairs as needed.

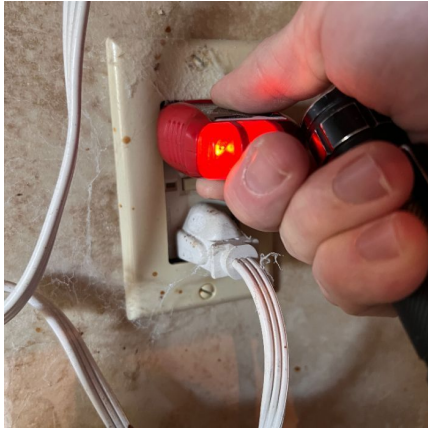
(E5-2.1) Interior

The GFCI receptacle to the right of the of kitchen sink did not respond the handheld tester, possibly indicating component damages. The receptacle did respond to onboard test buttons, however. Improperly functioning GFCI devices may present shock hazards. A licensed electrician should be consulted to make repairs as needed.

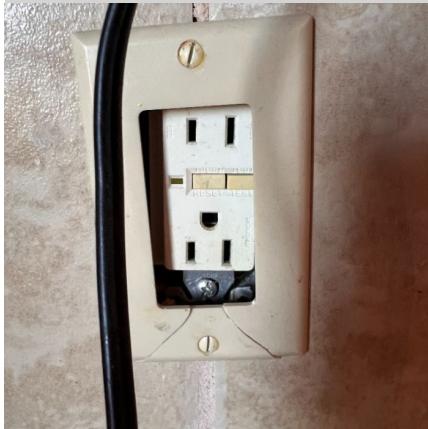
(E5-2.2) Interior

The receptacle left of the kitchen sink was noted to be loose and/or to have a damaged to the mount, a condition which may result in damaging movement of the receptacle or the attached conductors. A licensed electrician should be consulted to make repairs.

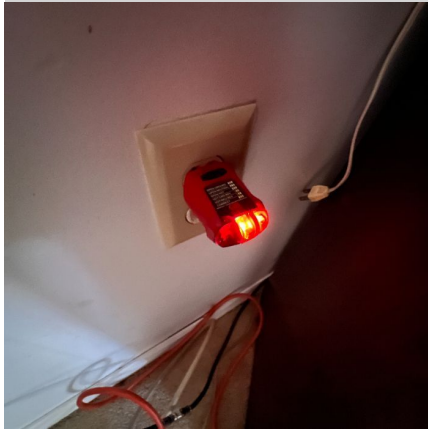
(E5-2.3) Interior

Interior electrical receptacles were loose within wall mounts in various locations of the home, a condition which can result in damages and/or shock hazards. A licensed electrician or qualified general repair specialist should be consulted to evaluate all interior receptacles and to make repairs as needed.

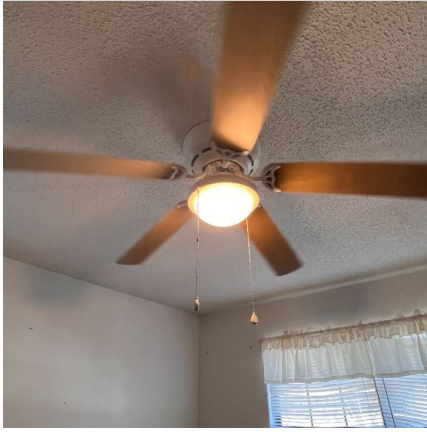
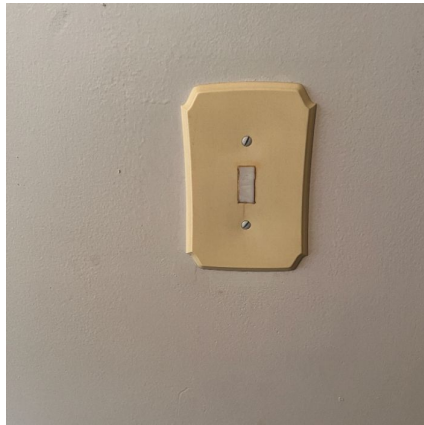
(E5-2.4) Interior

The front right bedroom fan and fan light are direct wired and not controlled by the wall switch. This not technically a defect, however, is not typical of modern installations.

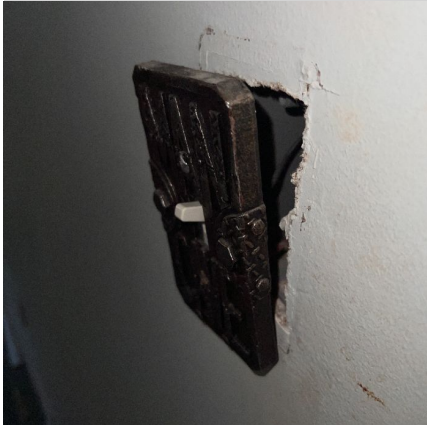
(E5-2.5) Interior

The wall switch in the master bedroom was loose and detaching from the wall, a potential shock hazard. A licensed electrician should be consulted to make repairs.

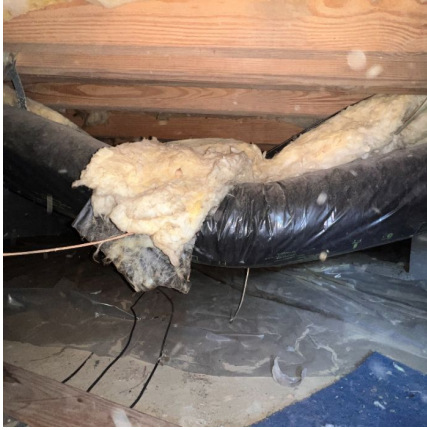
(F2-1.1) Heating Unit 1

A duct near the air handler was excessively sagged and appeared to be holding water at the time of inspection, a condition which can impair or negate function of the duct, and potentially result in further damages. A licensed HVAC contractor should be consulted to fully evaluate the HVAC ducts to determine the extent defects and to make repairs as needed.

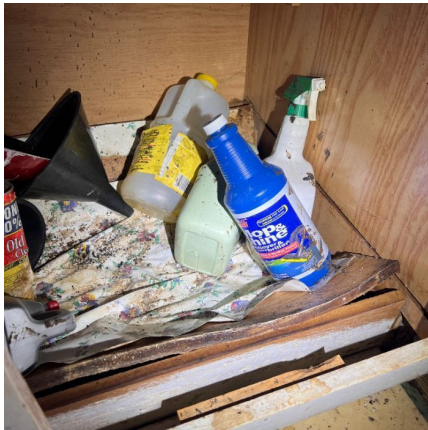
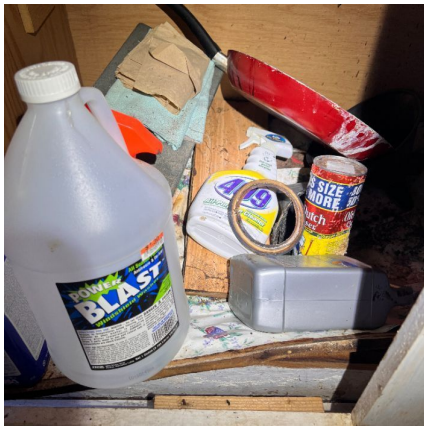
(H2-1.1) Kitchen

The kitchen sink base was water damaged from prior leaks, negating intended storage function. Have repaired by a cabinet repair specialist or licensed general contractor.

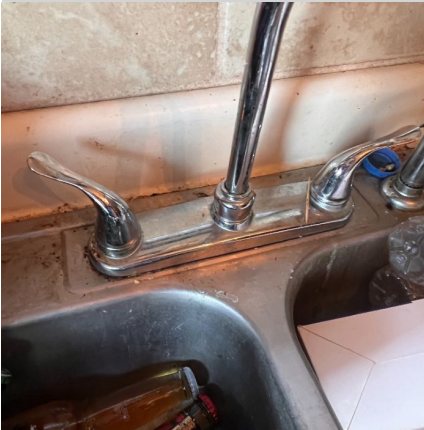
(H2-1.2) Kitchen

The kitchen sink faucet, while functional, was installed reversed of intended orientation.

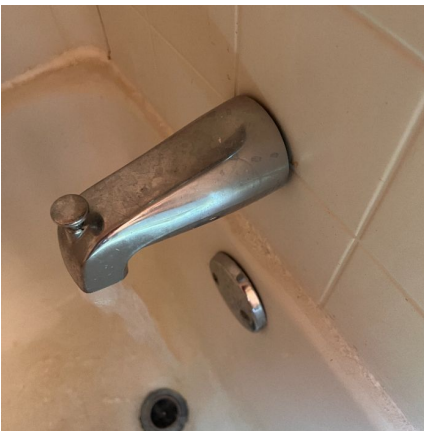
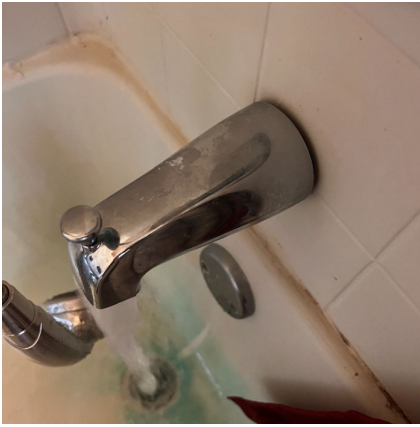
(H3-1.1) Both Bathrooms

The tub spouts were loose and not sealed to the surrounds, a condition which may result in damages to the attached supply line. A plumbing contractor should be consulted to make repairs.

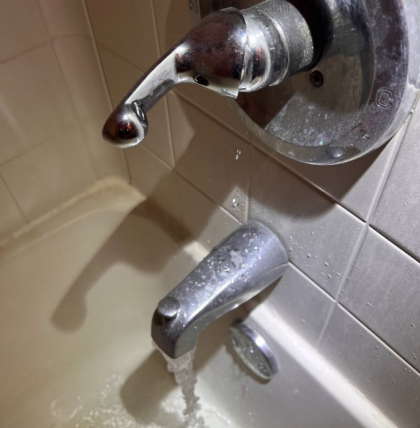
**(H3-1.2) Both Bathrooms**

The hall bathroom shower control valve leaks, indicative of component damages. This may result in improper operation of the diverter valve. A plumber should be consulted for repair.

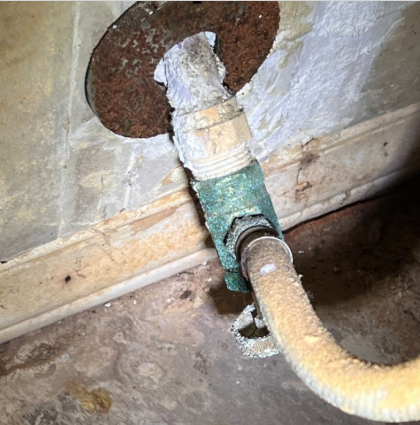
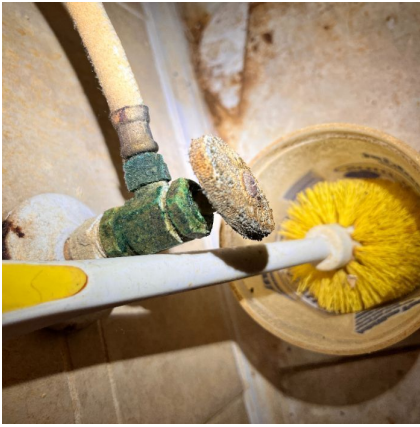
(H3-1.3) Both Bathrooms

Toilet supply valves were heavily corroded and not secured, conditions prone to leaks and/or component failure. The master bathroom valve had evidence of reoccurring leakage, a condition which could damage underlying components. A licensed plumbing contractor should be consulted for further evaluation and to make repairs as needed.

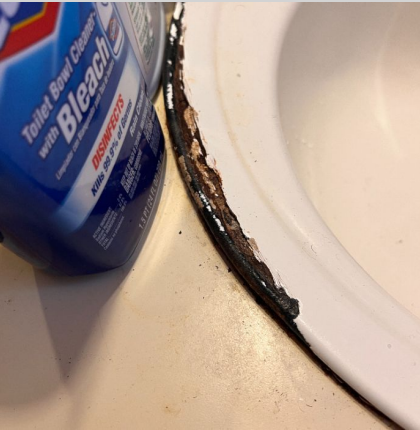
(H3-1.4) Both Bathrooms

The master bathroom sink porcelain has failed and underlying metal is rusted, conditions which can be considered personal injury concerns. A licensed plumbing contractor should be consulted to make repairs or replacements as needed.

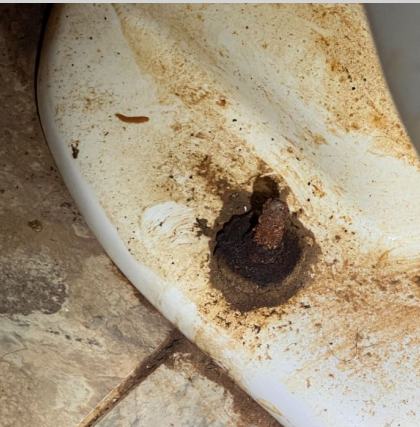
(H3-1.5) Both Bathrooms

The master bathroom toilet floor flange bolts were heavily rusted, a condition prone to improper bolt function and related toilet movement and damage. A plumbing contractor should be consulted to make repairs as needed.

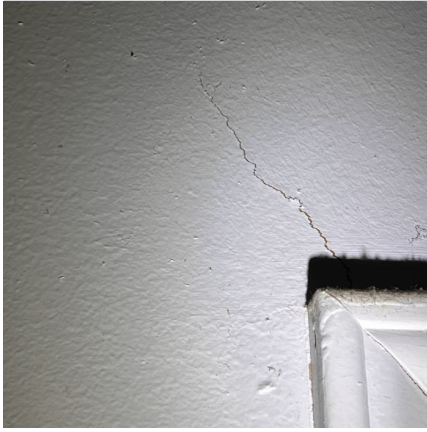
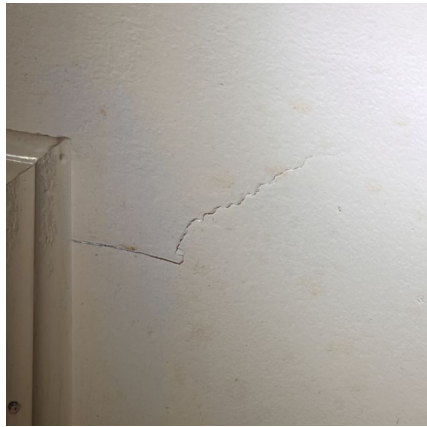
(H3-1.6) Both Bathrooms

Cracks were noted in the drywall above the master bathroom door, a possible indication of prior movement in this location of floor and/or wall structure components. This could be the result of one or the combination of multiple factors, ranging from damages to underlying floor structure or structural support, excessive moisture or expansion due to moisture, foundation concerns, improper framing installations and more. A licensed general contractor should be consulted to determine the cause and extent of defects, and to make repairs as needed.

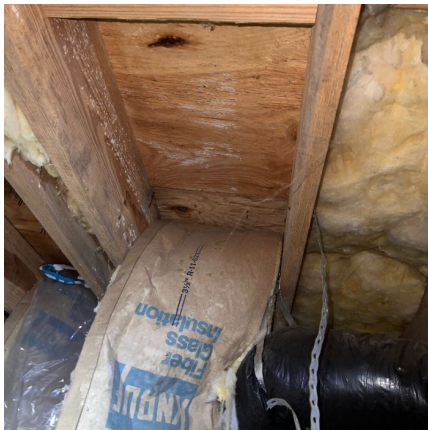
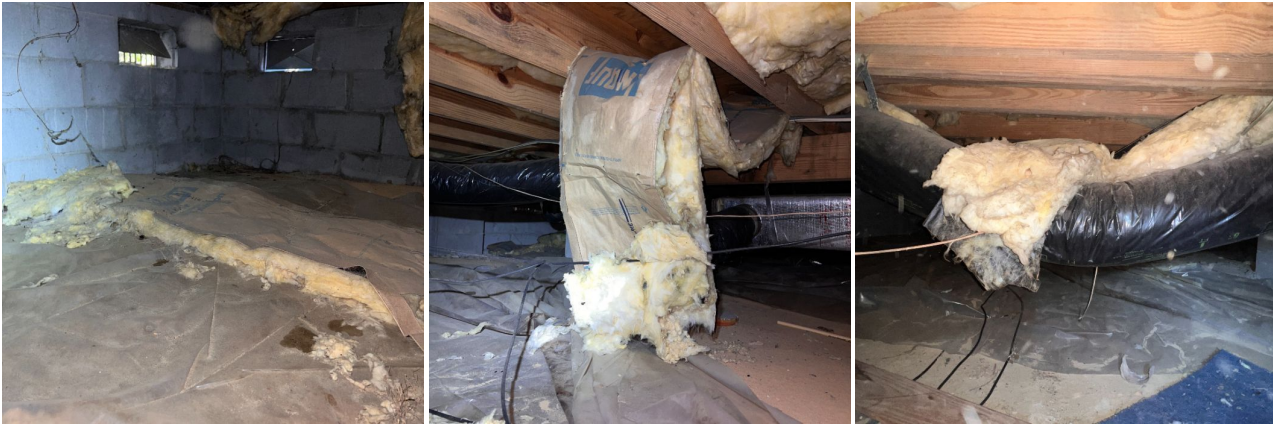
(I1-2.1) Crawl Space

Fiberglass batt floor system insulation was damaged and downed in various locations of the crawlspace, impairing intended function. A crawlspace remediation specialist or licensed general contractor should be consulted for further evaluation of the floor system insulation and to make repairs as needed.

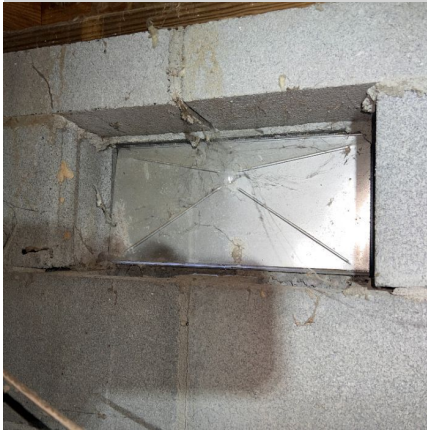
**(I1-2.2) Crawl Space**

Foundation vents were closed or partially opened in most locations, conditions which prevent proper crawlspace ventilation. This can result in elevated moisture within the crawlspace and related damages. A crawlspace remediation specialist or qualified general repair specialist should be consulted to make repairs as needed.

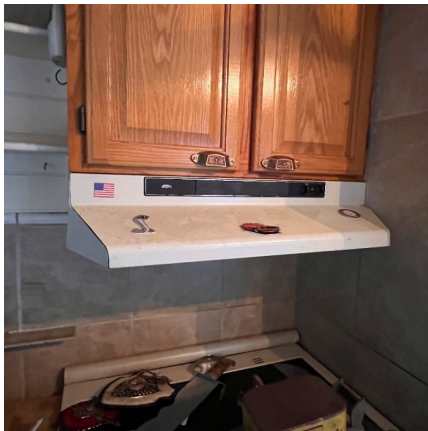
(J1-2.1) Range Hood

The range hood installation was improper. The range hood was not equipped with recirculating fan or exterior exhaust, resulting in the fan exhausting into the base of the cabinet. This negates the intended purpose of the fan. A licensed general contractor should be consulted to make repairs as needed.
