## Property Inspection Report

March 12, 2025 (9:30 AM)

031225-1  
8212 Main Street West End , NC

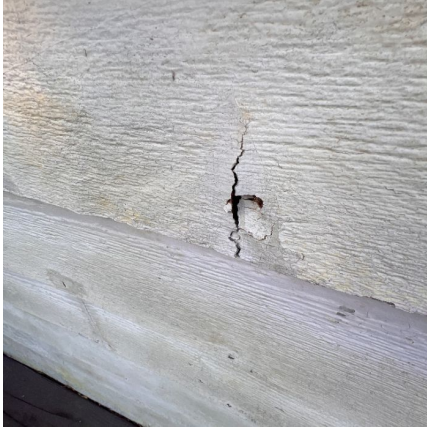
#### A1-1 Main House

The exterior cladding was decayed and was failing in multiple locations, most notably on the left and rear of the home, a condition which can allow water to enter behind the cladding and into the wall cavity, resulting in further component decay and damages. A licensed general contractor is needed for comprehensive review of the exterior cladding of the home to determine the extent of defects, and to make repairs as needed.

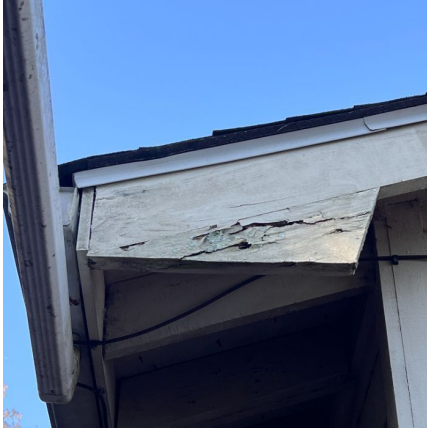
#### (A1-1.2) Main House

All wooden fascia, soffit, and trims, and the left awning, were noted to have varying degrees of weather/age related decay. Progression of these damages may result in water penetration into underlying areas, further decay or component failure. A licensed general contractor should be consulted for further evaluation of all exterior components to determine the extent of defects, and to make repairs as needed.

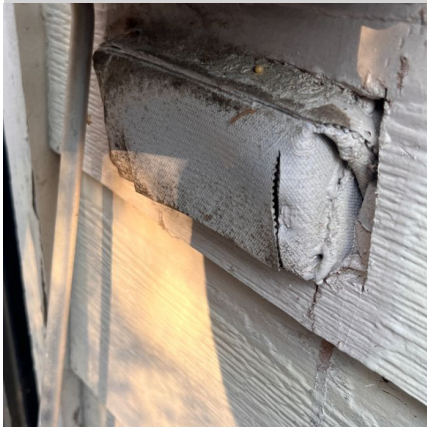
#### (A1-1.3) Main House

The open wall penetration was not fully sealed at the rear left of the home. This can result in inefficiency and potential moisture/insect entry. A qualified general repair specialist should be consulted to make repairs.

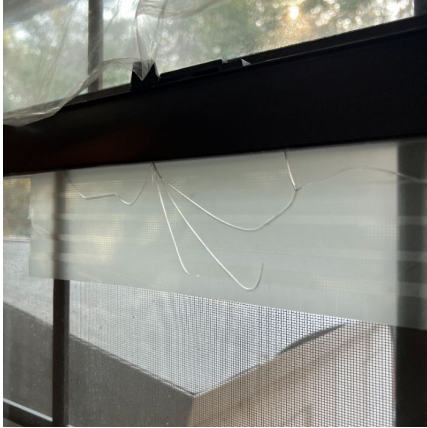
### A2-1 Windows/Doors (Location: All)

A window in the dining room was noted to have broken glass, a personal injury hazard. A glass repair specialist or licensed general contractor should be consulted to make repairs.

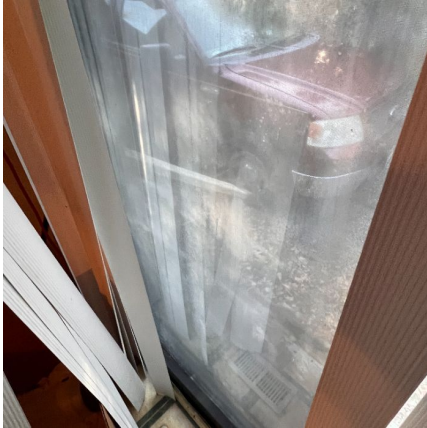
### (A2-1.2) Windows/Doors (Location: All)

Multiple windows of the home had interior hazing, a condition often indicative of gas seal damage and related moisture entry. Gas seal damage can impair overall insulation capabilities of the window and continued moisture entry may result in further damages to glass and/or frame components. A glass or window repair specialist should be consulted to evaluate all windows of the home to determine the extent of defects, and to make repairs as needed.

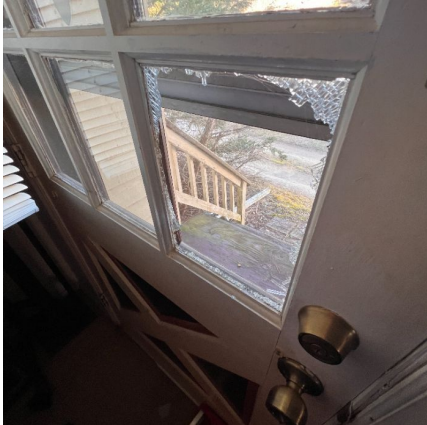
### (A2-1.3) Windows/Doors (Location: All)

The front door was noted to have broken glass, a condition which may present personal injury concerns and impairs security features of the door. A window repair specialist or licensed general contractor should be consulted to make repairs needed.

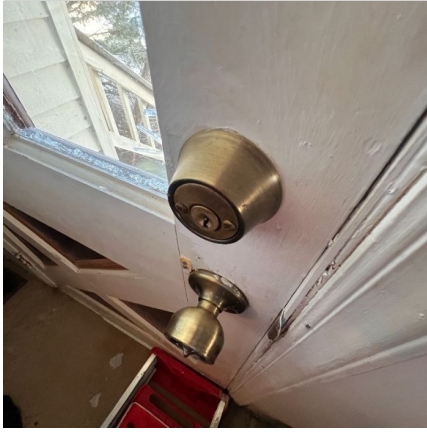
**(A2-1.4) Windows/Doors** *(Location: All)*

Some exterior doors of the home have a double key deadbolt lock. This type of lock cannot be unlocked from the interior of the home without the key and is not recommended. In the event of an emergency, the key may not be available resulting in a person not being able to exit the home, presenting a personal injury concern. If this is of further concern to the buyer, a locksmith or qualified repair specialist should be consulted.

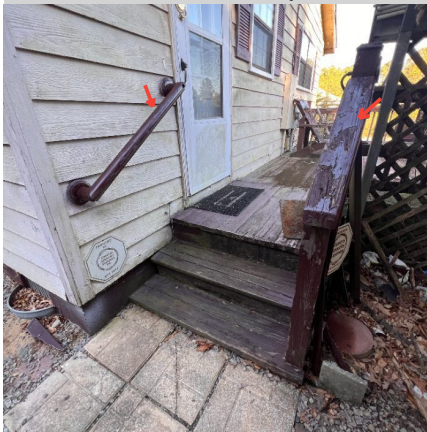
**A3. Exterior: Decks, Porches, Stoops, and Balconies****A3-1 Deck/Rear Steps** *(Location: Main House Left)*

The following concerns were noted with the deck and the rear steps by the sliding glass door -

1. Moderate to severe wood decay was noted throughout exposed wood components, stair treads and rail systems, conditions which may impair support, potentially presenting personal injury or trip hazards. Also, hand rails at the stairs were loose, a fall hazard.
2. Joists and other support or deck structure framing were inaccessible due to lattice, however, were partially viewable from the exterior front of the deck. From that position, a few joists close to the front were noted to be split. This can be the result of improper installations/improper support and related movement, or, decay. Damaged joists may result in structural movement.
3. Broken and decayed balusters may present fall hazards.
4. Stair stringers at the rear steps were noted to have areas of rot where in contact with the ground, a condition prone to movement and unsafe conditions.

A licensed general contractor should be consulted for comprehensive evaluation of the deck to determine all defects, and to make repairs as needed.

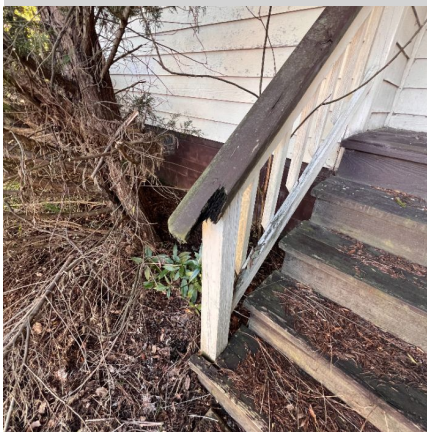
**A3. Exterior: Decks, Porches, Stoops, and Balconies****A3-2 Porch** *(Location: Main House Front)*

The front porch installations were noted to have multiple defects which presented potential fall and/or personal injury concerns, such as but not limited to -

1. Loose, damaged and improperly constructed handrails.
2. Decayed stair treads.
3. Stairs are at varying heights and/or at are greater gaits than typical. Also, stairs appeared to be too shallow.
4. The wooden porch was noted to have decay and was not flat.

A licensed general contractor should be consulted for full evaluation of all front porch components to determine the extent of defects and to make repairs as needed.

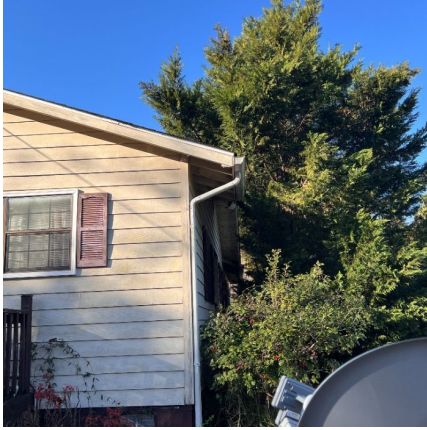
### A5-1 Vegetation *(Location: All)*

Trees were in contact with exterior components, a condition prone to cladding, trim and/or roofing damage. An arborist should be consulted to remove limbs/trees safely away from the home to avoid damages.

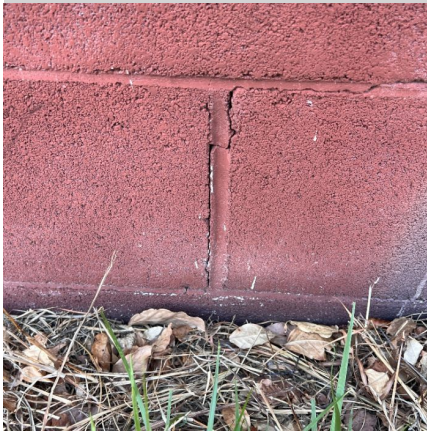
### B1-1 Main House

Hairline stepping cracks were noted in the foundation mortar at the front right and right of the home. These cracks appeared to be consistent with expansive drying and did not transfer to the interior of the foundation wall. Damages such as these are generally considered superficial, however, may sometimes be attributed to other underlying causes, such as improper foundation support or support damages.

These damages did appear minor/superficial, however, it is beyond the scope of a home inspection to fully determine the cause and extent of structural concerns or related defect implications. A licensed general contractor should be consulted for further evaluation of the foundation to determine the significance of these concerns, and to make repairs/recommendations of repair as needed. IF the contractor determines structural repairs beyond scope of license, an engineer should be consulted.

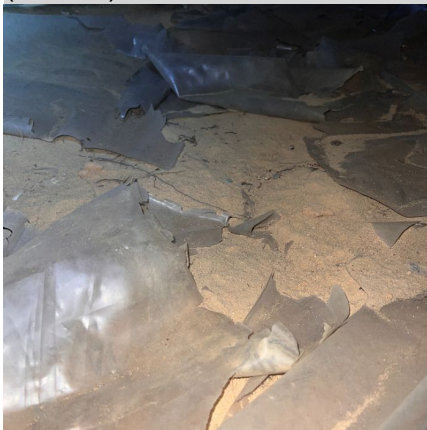
### (B1-1.2) Main House

The crawlspace ground was not fully covered with a plastic vapor barrier. This can allow ground evaporation to condense on various components, resulting in damage.

It was noted that some HVAC ducts were moisture damaged/cracked and microbial growths were present on wooden and other surfaces, indications of reoccurring periods of elevated moisture. Continued and/or repeated exposure to excessive moisture may result in floor system decay or further defects. A crawlspace remediation specialist or licensed general contractor should be consulted for comprehensive evaluation of the crawlspace to determine the cause(s) and extent of moisture related concerns, and to make recommendations of repair as needed.

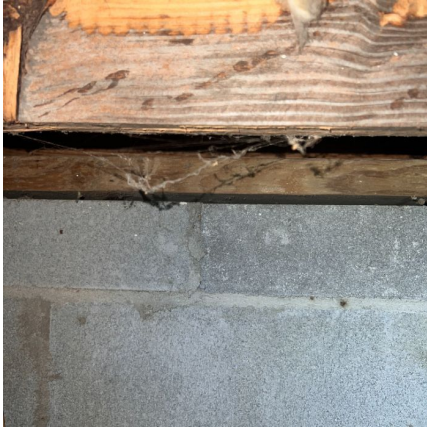
### B3-1 Main House

The sill plates were noted to have movement and were not flat on the foundation in most locations, particularly on the right and rear of the home. Movement of the sill plates can indicate improper fastening of the floor structure to the foundation and related movement of the floor and/or wall structures. Further movement could potentially result in damages to finished surfaces. A licensed general contractor should be consulted to evaluate the sill plate throughout the home to determine the extent of defects and to make repairs as needed.

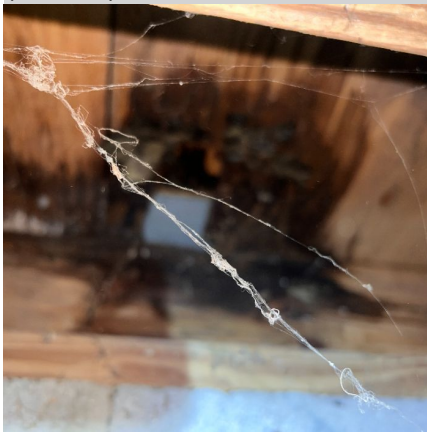
### (B3-1.2) Main House

Varying degrees of wood decay were noted in all floor structure components at the left door/kitchen door, conditions which could result support capabilities of the floor, potentially resulting in movement and related damages. A licensed general contractor should be consulted to determine the cause and extent of defects and to make repairs as needed.

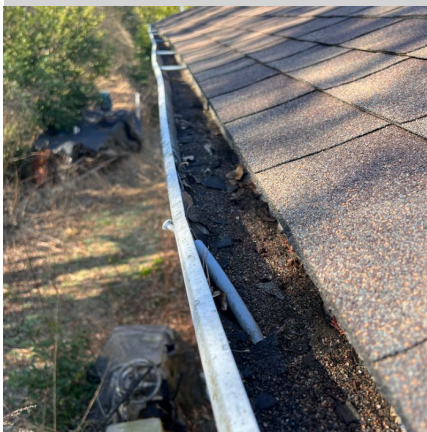
### C2-1 Gutters

Gutter systems were in poor overall condition, were with damaged or improperly installed fasteners, damaged trays and noted to be full of shingle granules of other debris, conditions which can impair proper roof drainage. Improper roof drainage can result in damages to fascia, sheathing and other underlying components. A licensed general contractor should be consulted for full evaluation of the roof drainage systems and to make repairs as needed.

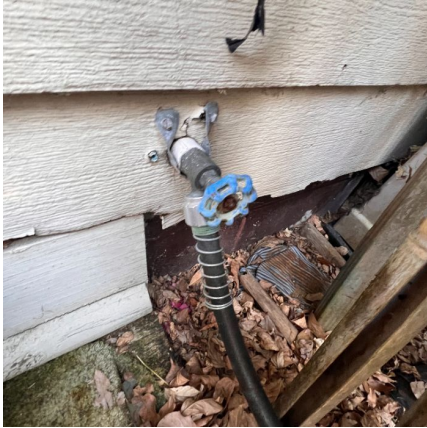
### D2-1 All

The hose bib at the rear of the home was not secured, a condition which allows potentially damaging movement of the plumbing supply components. A qualified general repair specialist should be consulted to make repairs as needed.

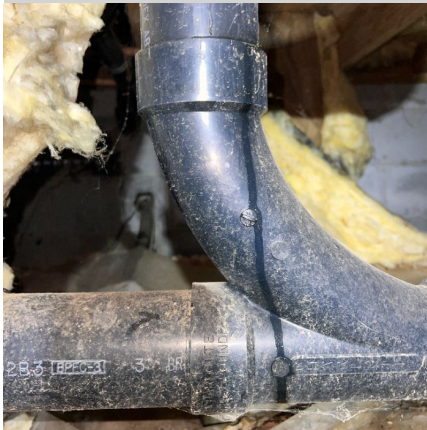
### D3-1 Crawl Space

There were leaks from the hall bathroom shower assembly and evidence of prior leaks from the hall and master bathroom toilets. Further leaks may result in damages to underlying and adjacent components. A licensed plumbing contractor should be consulted to evaluate all hall and master bathroom drain systems and to make repairs where needed.

Wood decay, water damages and wood destroying fungus were noted on a few structural components in the hall and master bathroom areas related to prior leaks. Repairs have been made, however, some damages are still present. Damaged wooden structure can result in improper support, related movement, and further damages. A licensed general contractor should be consulted to fully evaluate the floor structure components at the bathrooms' location, and to make repairs as needed.

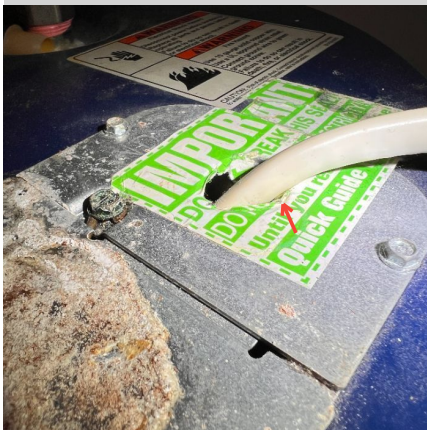
### D4-1 Unit 1 (Location: Laundry)

The 2013 US Craftmaster 50 gallon electric water heater was operated and functioned as intended.

It was noted that the electrical service conductor entered the onboard junction without proper strain relief connection. This allows the electrical conductor to contact the sharp metal edge of the junction lid, a condition which can result in damages. This can also allow damaging movement of the conductor and loss of service. A licensed electrician or licensed plumbing contractor should be consulted to make repairs as needed.

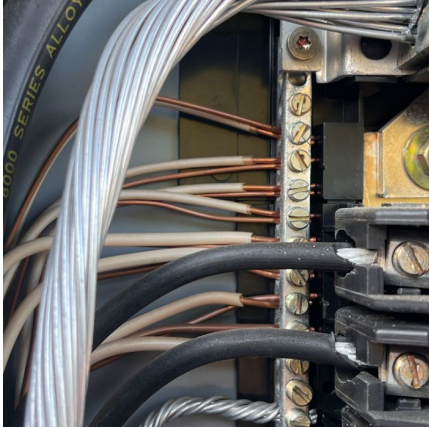
### E2-1 Main Panel (Location: Exterior Left)

The following concerns were noted with the main electrical panel and meter base, located on the exterior left of the home -

1. The ground/neutral bus bar located has connections where two neutral conductors or neutral/grounds are connected together under one lug (double-tapped). This condition presents a safety hazard that could result in improper overcurrent protection, improper grounding, and/or circuit overheating.
2. Both the meter base and the main panel were not secured to the exterior of the home, a condition which can allow for potentially damaging movement of electrical components. (This is likely the result of failed cladding/siding)

A licensed electrical contractor should be consulted to make repairs.

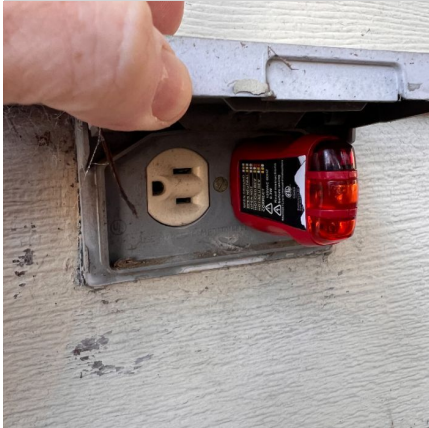
### E5-1 Exterior

Exterior receptacles were not functioning at the time of the home inspection. This may indicate damages to the circuit, the corresponding GFCI device, or other components. A licensed electrician should be consulted to make repairs as needed to restore service to the exterior receptacles.

\*Note - this may be linked to a GFCI not located during the inspection.

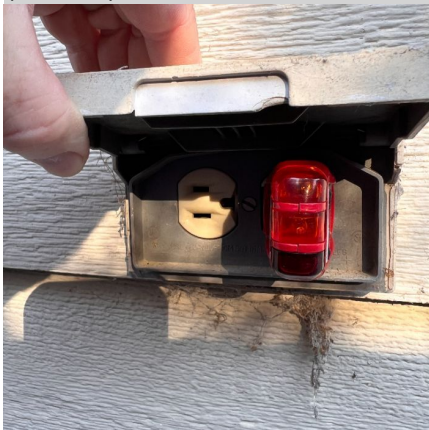
### (E5-1.2) Exterior

Exterior electrical receptacles were loose within wall mounts at the rear of the home, a condition which can result in damages and/or shock hazards. A licensed electrician or qualified general repair specialist should be consulted to evaluate all interior receptacles and to make repairs as needed.

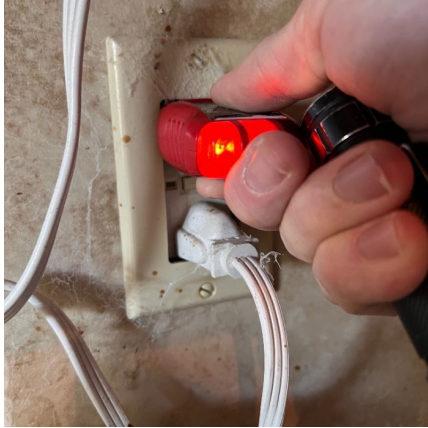
### E5-2 Interior

The GFCI receptacle to the right of the of kitchen sink did not respond the handheld tester, possibly indicating component damages. The receptacle did respond to onboard test buttons, however. Improperly functioning GFCI devices may present shock hazards. A licensed electrician should be consulted to make repairs as needed.

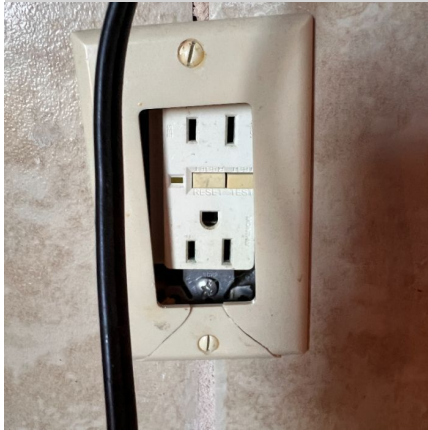
### (E5-2.2) Interior

The receptacle left of the kitchen sink was noted to be loose and/or to have a damaged to the mount, a condition which may result in damaging movement of the receptacle or the attached conductors. A licensed electrician should be consulted to make repairs.

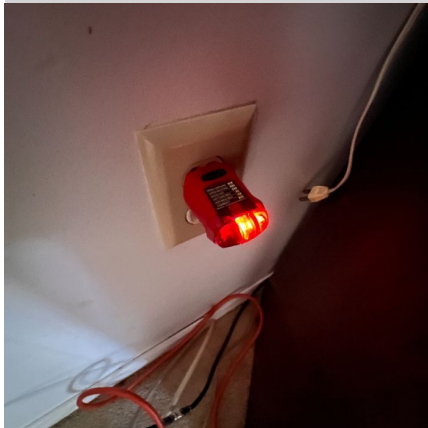
### (E5-2.3) Interior

Interior electrical receptacles were loose within wall mounts in various locations of the home, a condition which can result in damages and/or shock hazards. A licensed electrician or qualified general repair specialist should be consulted to evaluate all interior receptacles and to make repairs as needed.

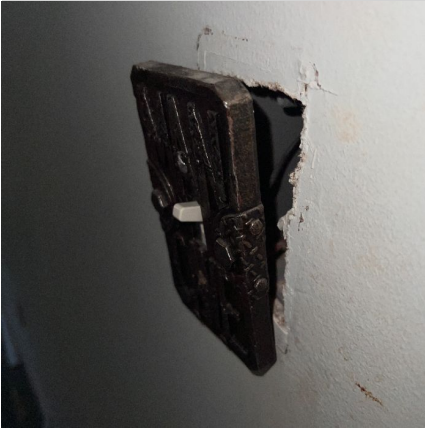
### (E5-2.4) Interior

The wall switch in the master bedroom was loose and detaching from the wall, a potential shock hazard. A licensed electrician should be consulted to make repairs.

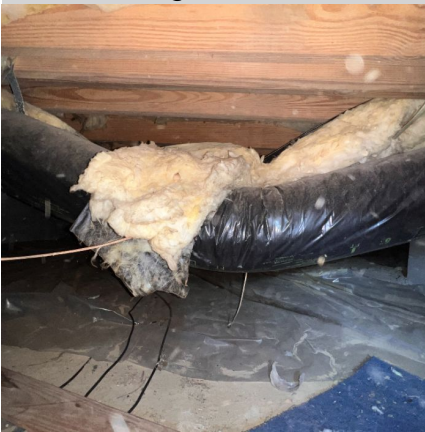
### F2-1 Heating Unit 1

A duct near the air handler was excessively sagged and appeared to be holding water at the time of inspection, a condition which can impair or negate function of the duct, and potentially result in further damages. A licensed HVAC contractor should be consulted to fully evaluate the HVAC ducts to determine the extent defects and to make repairs as needed.

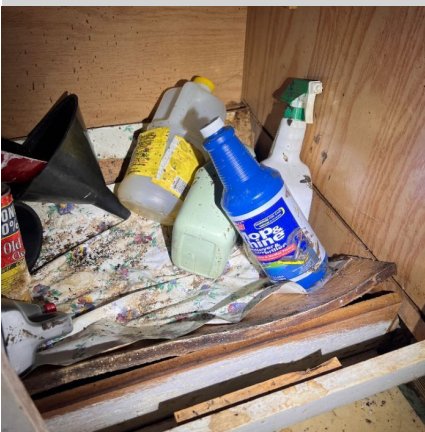
### H2-1 Kitchen

The kitchen sink base was water damaged from prior leaks, negating intended storage function. Have repaired by a cabinet repair specialist or licensed general contractor.

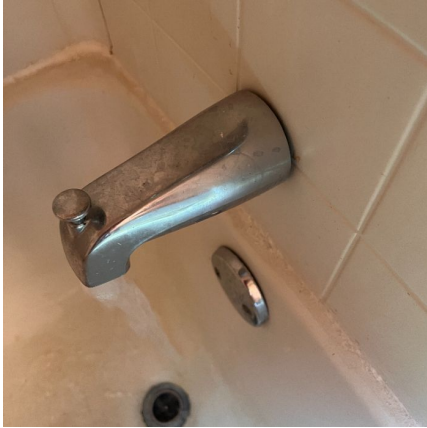
#### H3-1 Both Bathrooms

The tub spouts were loose and not sealed to the surrounds, a condition which may result in damages to the attached supply line. A plumbing contractor should be consulted to make repairs.

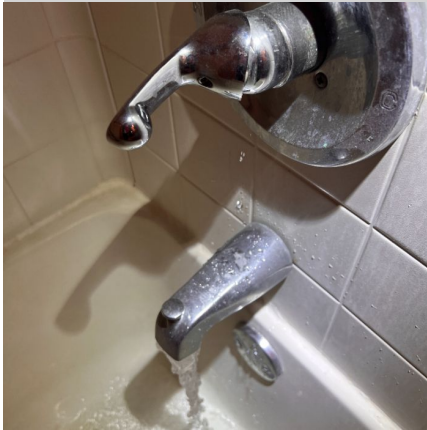
#### (H3-1.2) Both Bathrooms

The hall bathroom shower control valve leaks, indicative of component damages. This may result in improper operation of the diverter valve. A plumber should be consulted for repair.

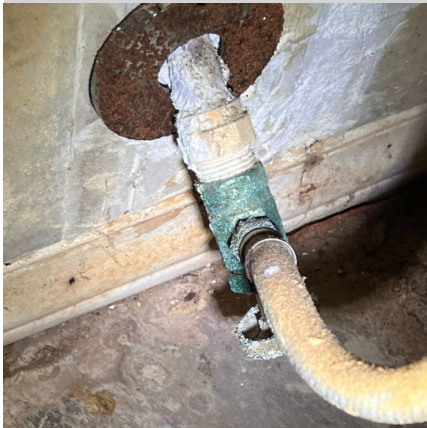
#### (H3-1.3) Both Bathrooms

Toilet supply valves were heavily corroded and not secured, conditions prone to leaks and/or component failure. The master bathroom valve had evidence of reoccurring leakage, a condition which could damage underlying components. A licensed plumbing contractor should be consulted for further evaluation and to make repairs as needed.

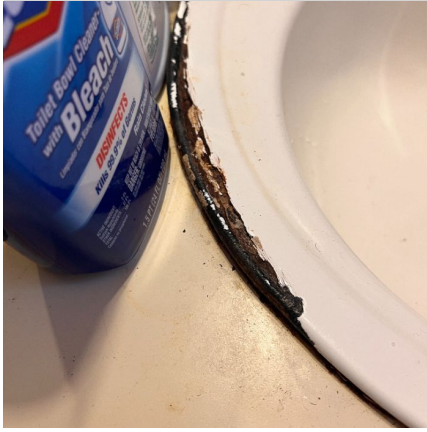
**(H3-1.4) Both Bathrooms**

The master bathroom sink porcelain has failed and underlying metal is rusted, conditions which can be considered personal injury concerns. A licensed plumbing contractor should be consulted to make repairs or replacements as needed.

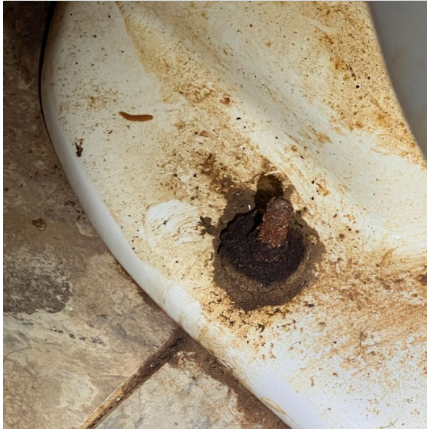
**(H3-1.5) Both Bathrooms**

The master bathroom toilet floor flange bolts were heavily rusted, a condition prone to improper bolt function and related toilet movement and damage. A plumbing contractor should be consulted to make repairs as needed.

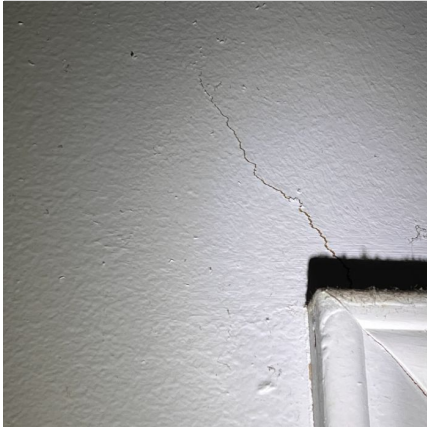
**(H3-1.6) Both Bathrooms**

Cracks were noted in the drywall above the master bathroom door, a possible indication of prior movement in this location of floor and/or wall structure components. This could be the result of one or the combination of multiple factors, ranging from damages to underlying floor structure or structural support, excessive moisture or expansion due to moisture, foundation concerns, improper framing installations and more. A licensed general contractor should be consulted to determine the cause and extent of defects, and to make repairs as needed.

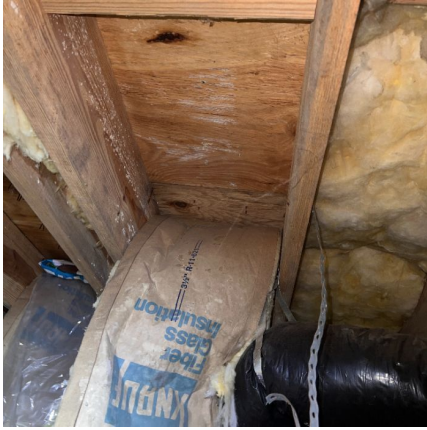
### I1-2 Crawl Space

Fiberglass batt floor system insulation was damaged and downed in various locations of the crawlspace, impairing intended function. A crawlspace remediation specialist or licensed general contractor should be consulted for further evaluation of the floor system insulation and to make repairs as needed.

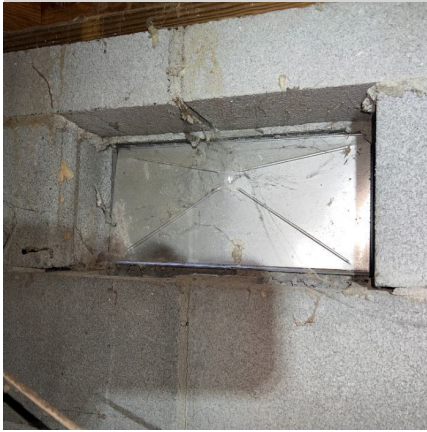
### (I1-2.2) Crawl Space

Foundation vents were closed or partially opened in most locations, conditions which prevent proper crawlspace ventilation. This can result in elevated moisture within the crawlspace and related damages. A crawlspace remediation specialist or qualified general repair specialist should be consulted to make repairs as needed.

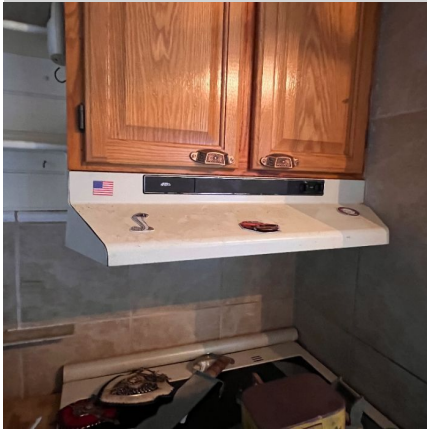
### J1-2 Range Hood (Location: Kitchen)

The range hood installation was improper. The range hood was not equipped with recirculating fan or exterior exhaust, resulting in the fan exhausting into the base of the cabinet. This negates the intended purpose of the fan. A licensed general contractor should be consulted to make repairs as needed.

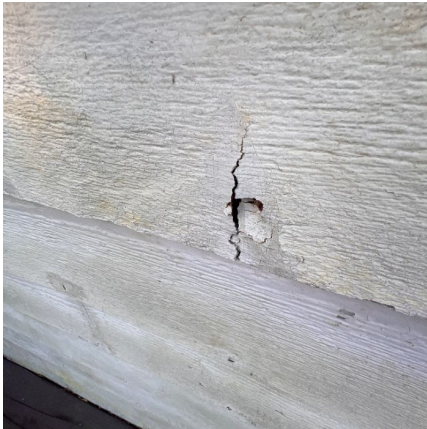
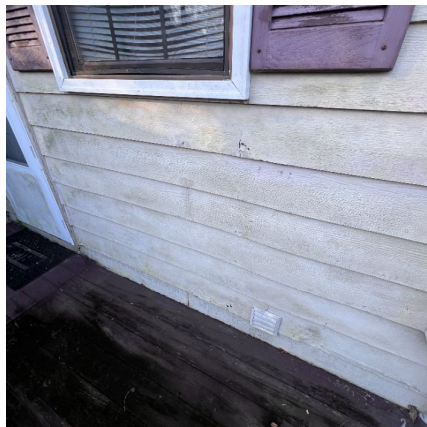
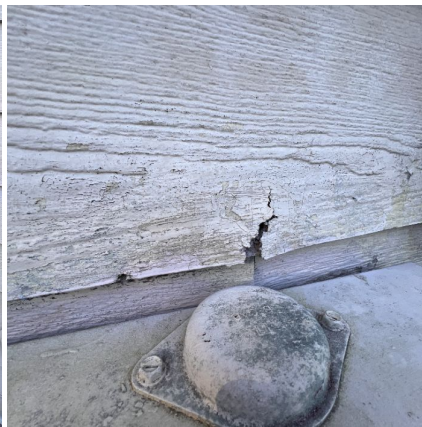
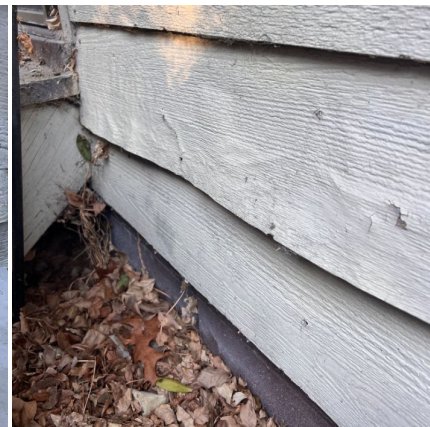
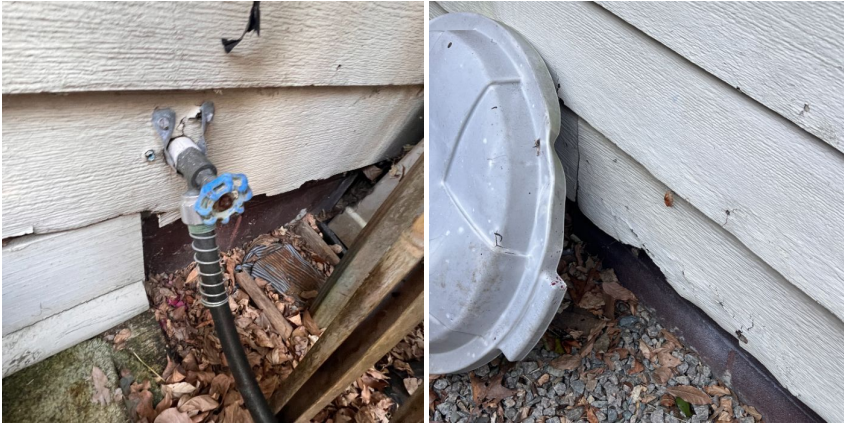
(A1-1.1) Main House

The exterior cladding was decayed and was failing in multiple locations, most notably on the left and rear of the home, a condition which can allow water to enter behind the cladding and into the wall cavity, resulting in further component decay and damages. A licensed general contractor is needed for comprehensive review of the exterior cladding of the home to determine the extent of defects, and to make repairs as needed.

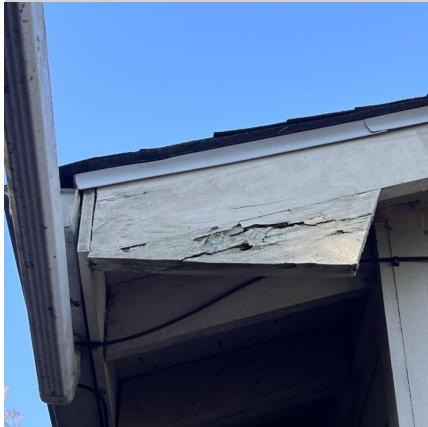
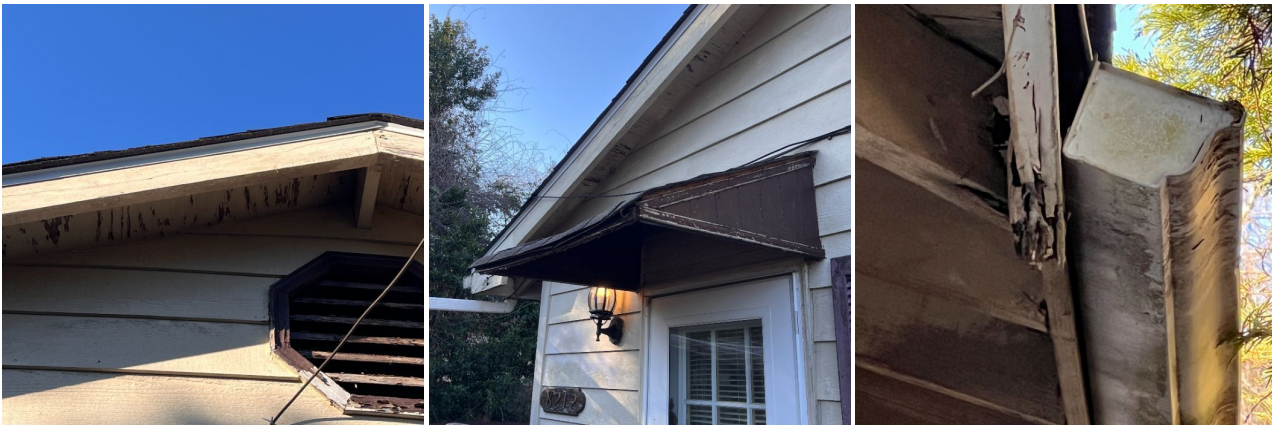
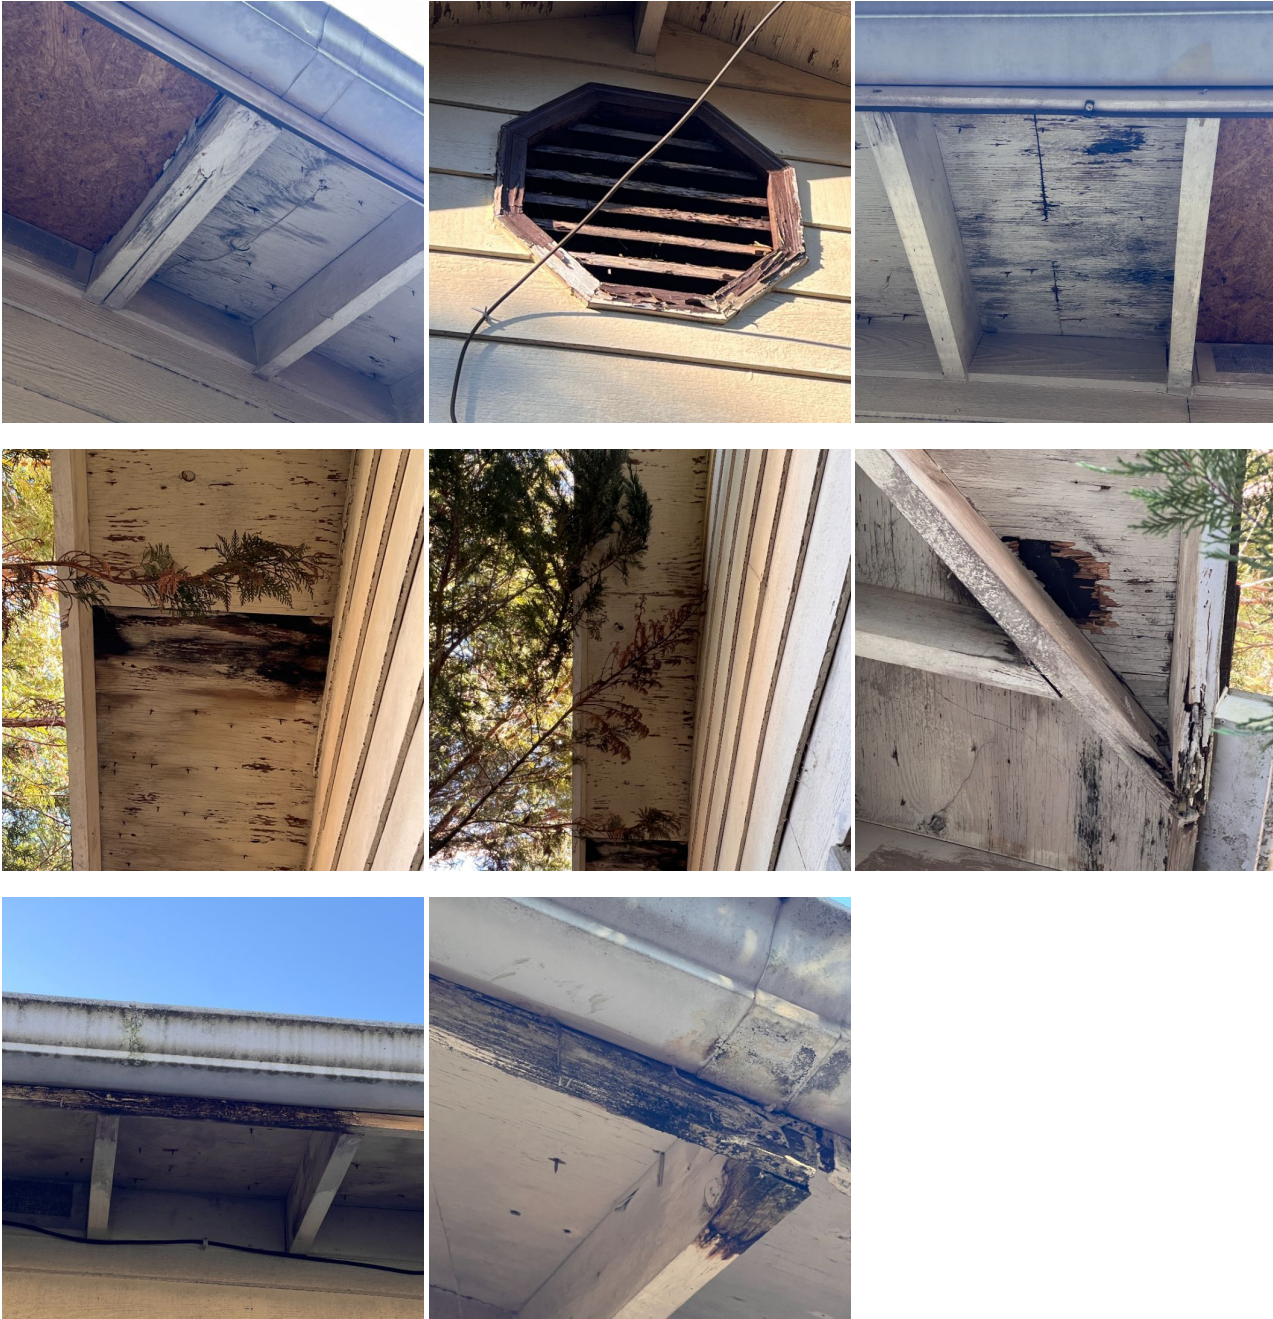
(A1-1.2) Main House

All wooden fascia, soffit, and trims, and the left awning, were noted to have varying degrees of weather/age related decay. Progression of these damages may result in water penetration into underlying areas, further decay or component failure. A licensed general contractor should be consulted for further evaluation of all exterior components to determine the extent of defects, and to make repairs as needed.

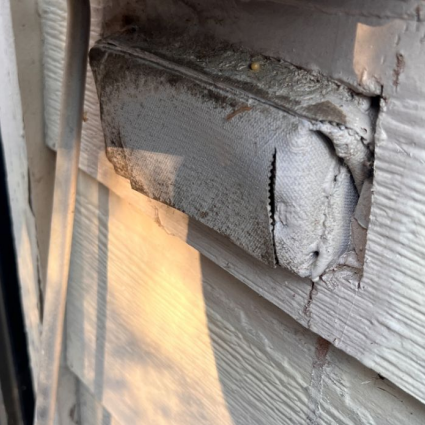
**(A1-1.3) Main House**

The open wall penetration was not fully sealed at the rear left of the home. This can result in inefficiency and potential moisture/insect entry. A qualified general repair specialist should be consulted to make repairs.

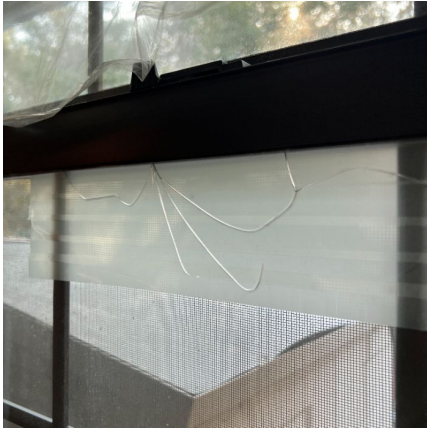
#### (A2-1.1) Windows/Doors

A window in the dining room was noted to have broken glass, a personal injury hazard. A glass repair specialist or licensed general contractor should be consulted to make repairs.

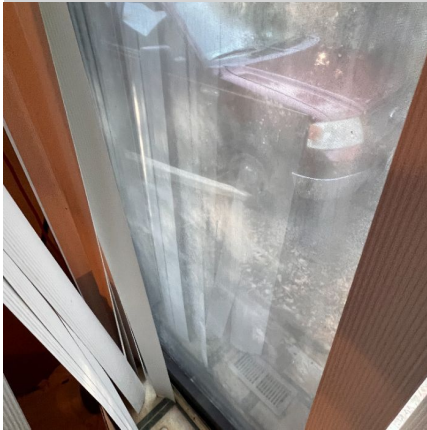
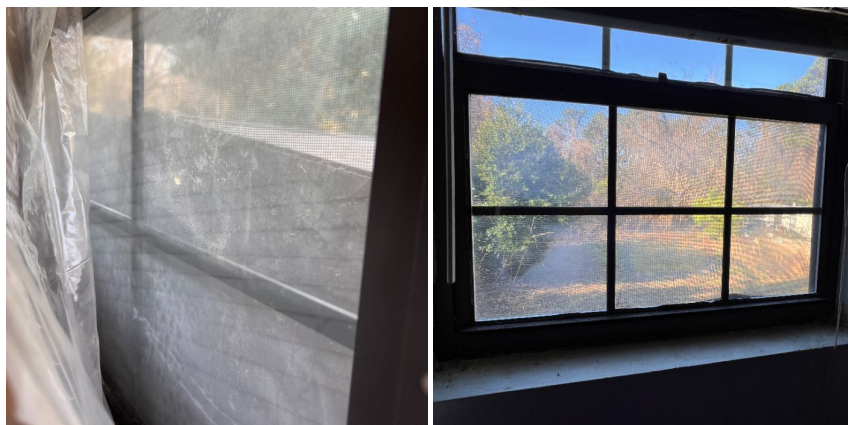
#### (A2-1.2) Windows/Doors

Multiple windows of the home had interior hazing, a condition often indicative of gas seal damage and related moisture entry. Gas seal damage can impair overall insulation capabilities of the window and continued moisture entry may result in further damages to glass and/or frame components. A glass or window repair specialist should be consulted to evaluate all windows of the home to determine the extent of defects, and to make repairs as needed.

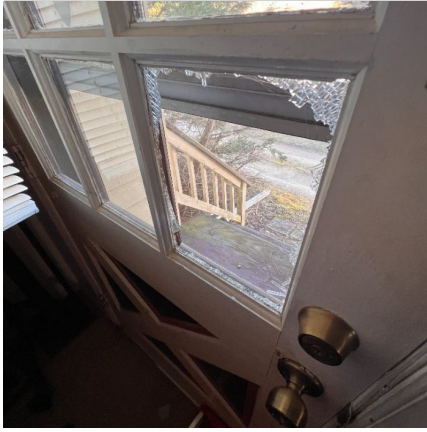
**(A2-1.3) Windows/Doors**

The front door was noted to have broken glass, a condition which may present personal injury concerns and impairs security features of the door. A window repair specialist or licensed general contractor should be consulted to make repairs needed.

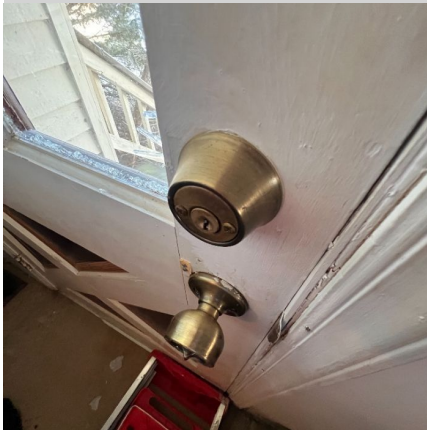
**(A2-1.4) Windows/Doors**

Some exterior doors of the home have a double key deadbolt lock. This type of lock cannot be unlocked from the interior of the home without the key and is not recommended. In the event of an emergency, the key may not be available resulting in a person not being able to exit the home, presenting a personal injury concern. If this is of further concern to the buyer, a locksmith or qualified repair specialist should be consulted.

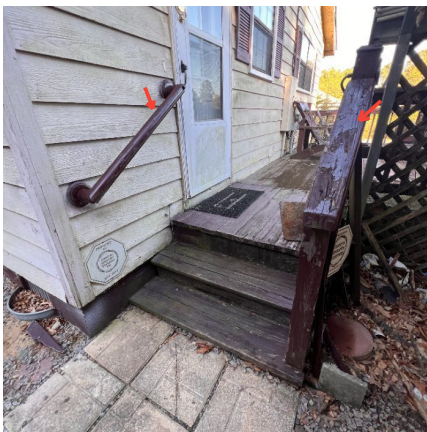
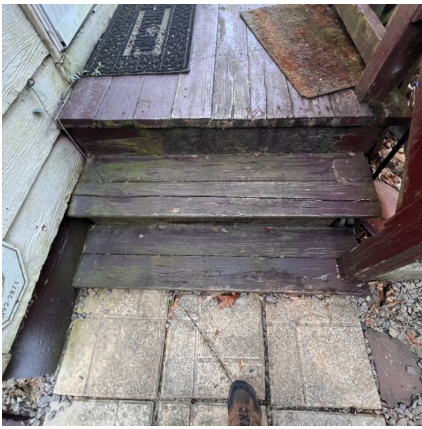
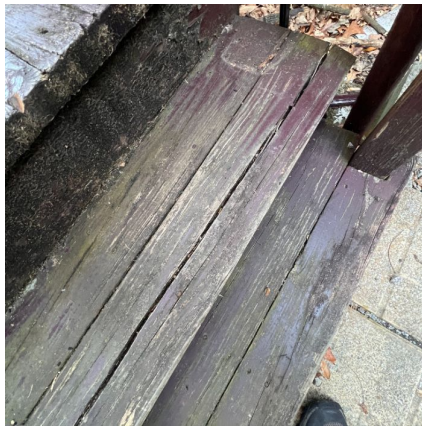
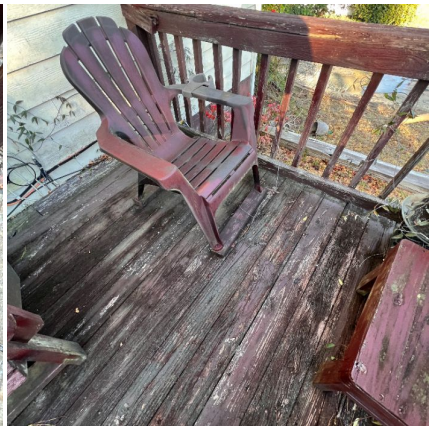
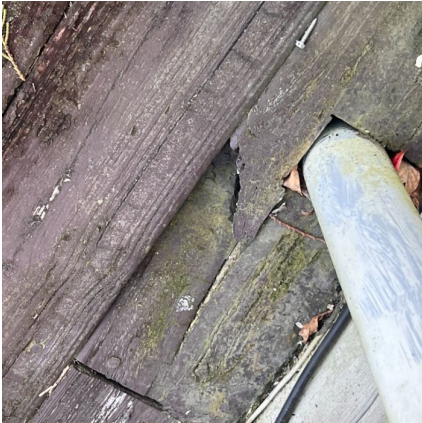
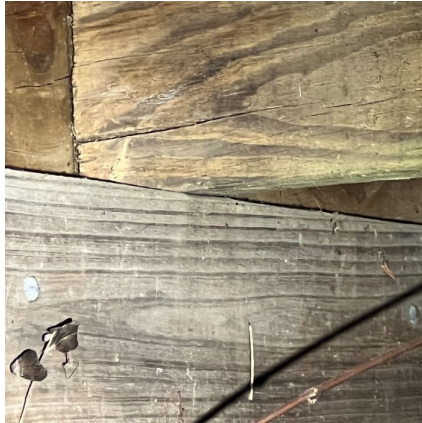
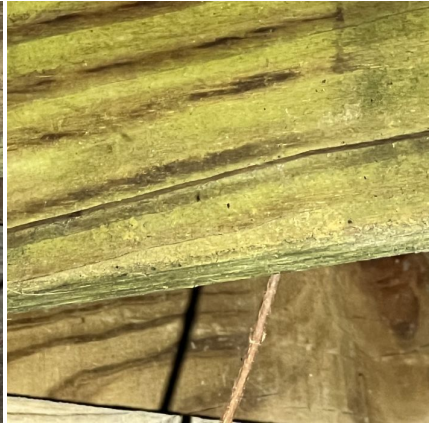
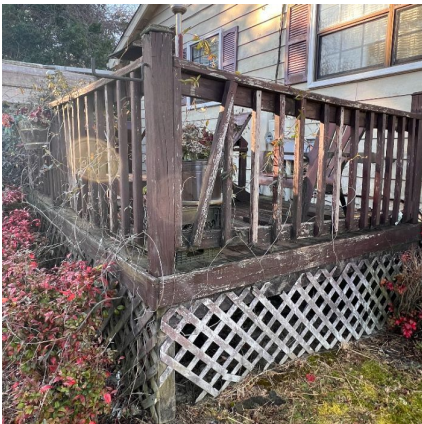
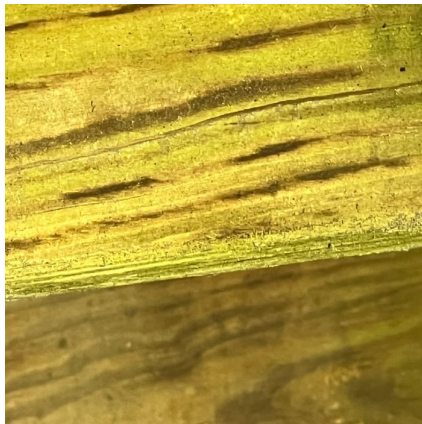
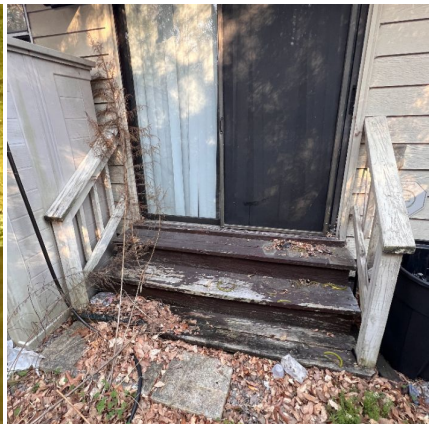
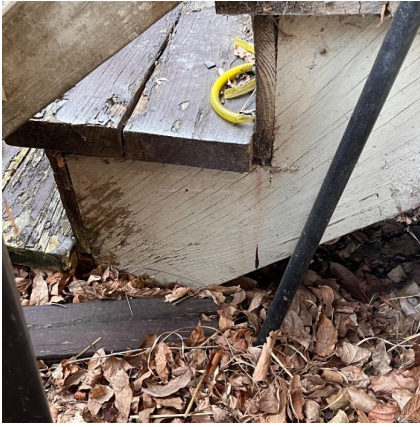
**(A3-1.1) Deck/Rear Steps**

The following concerns were noted with the deck and the rear steps by the sliding glass door -

1. Moderate to severe wood decay was noted throughout exposed wood components, stair treads and rail systems, conditions which may impair support, potentially presenting personal injury or trip hazards. Also, hand rails at the stairs were loose, a fall hazard.
2. Joists and other support or deck structure framing were inaccessible due to lattice, however, were partially viewable from the exterior front of the deck. From that position, a few joists close to the front were noted to be split. This can be the result of improper installations/improper support and related movement, or, decay. Damaged joists may result in structural movement.
3. Broken and decayed balusters may present fall hazards.
4. Stair stringers at the rear steps were noted to have areas of rot where in contact with the ground, a condition prone to movement and unsafe conditions.

A licensed general contractor should be consulted for comprehensive evaluation of the deck to determine all defects, and to make repairs as needed.

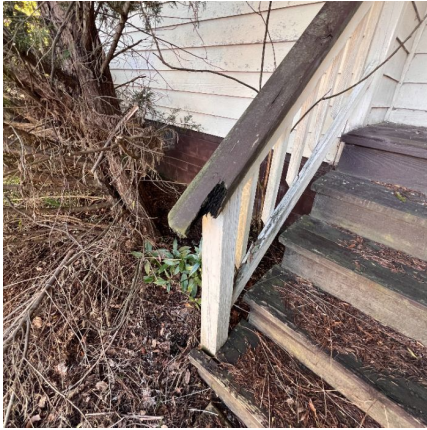
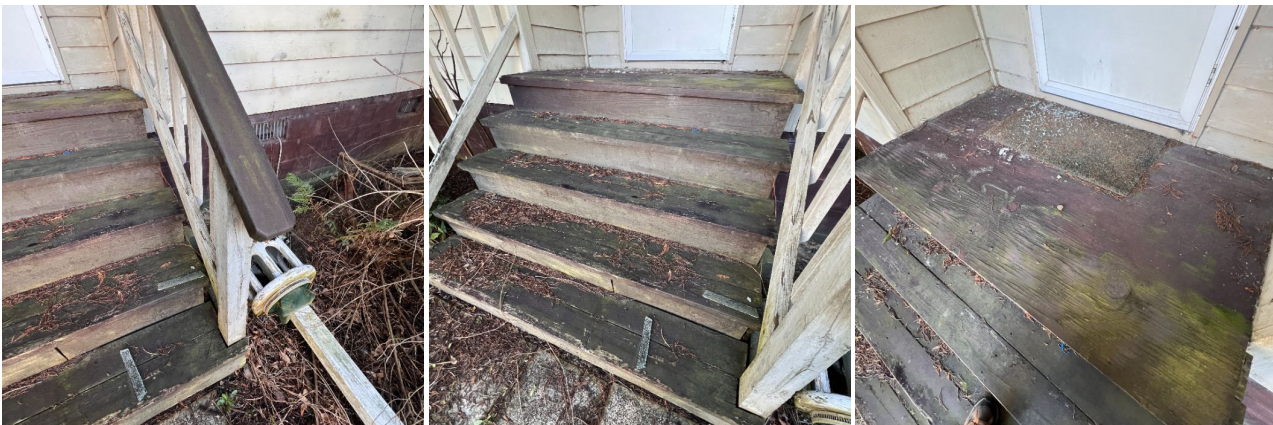
(A3-2.1) Porch

The front porch installations were noted to have multiple defects which presented potential fall and/or personal injury concerns, such as but not limited to -

1. Loose, damaged and improperly constructed handrails.
2. Decayed stair treads.
3. Stairs are at varying heights and/or at are greater gaits than typical. Also, stairs appeared to be too shallow.
4. The wooden porch was noted to have decay and was not flat.

A licensed general contractor should be consulted for full evaluation of all front porch components to determine the extent of defects and to make repairs as needed.

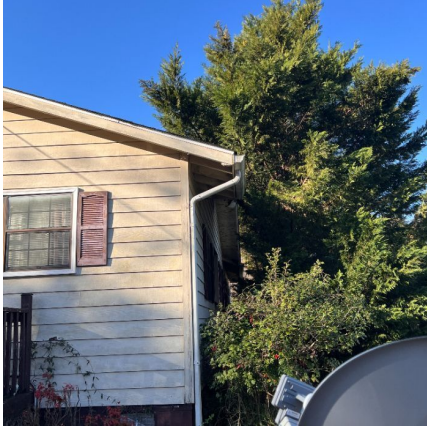
(A5-1.1) Vegetation

Trees were in contact with exterior components, a condition prone to cladding, trim and/or roofing damage. An arborist should be consulted to remove limbs/trees safely away from the home to avoid damages.

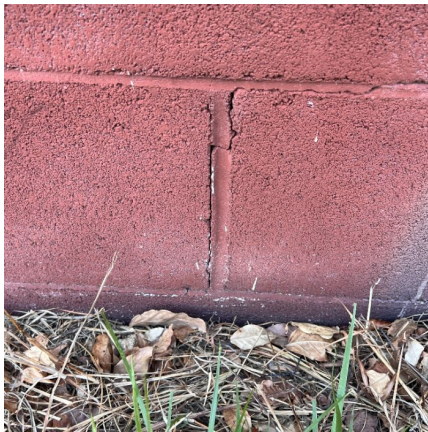
(B1-1.1) Main House

Hairline stepping cracks were noted in the foundation mortar at the front right and right of the home. These cracks appeared to be consistent with expansive drying and did not transfer to the interior of the foundation wall. Damages such as these are generally considered superficial, however, may sometimes be attributed to other underlying causes, such as improper foundation support or support damages.

These damages did appear minor/superficial, however, it is beyond the scope of a home inspection to fully determine the cause and extent of structural concerns or related defect implications. A licensed general contractor should be consulted for further evaluation of the foundation to determine the significance of these concerns, and to make repairs/recommendations of repair as needed. IF the contractor determines structural repairs beyond scope of license, an engineer should be consulted.
