SEAHAWK INSPECTION SERVICES

RESIDENTIAL REPORT

305 N 21st St
Wilmington, NC 28405

09/18/2025

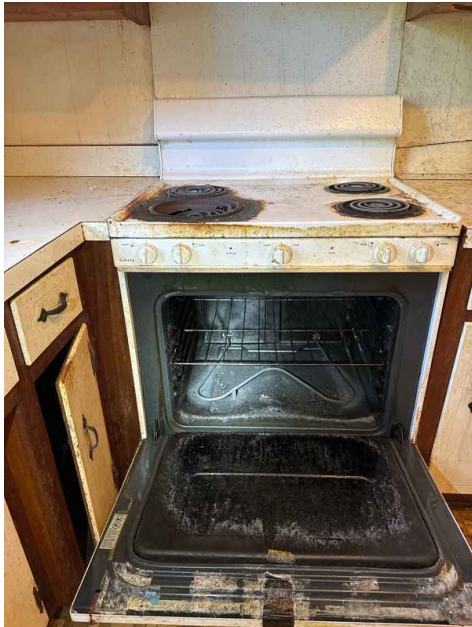
KITCHEN

Range should be replaced. Poor condition, not fit for use. Inspector did not operate.

Range old and very dirty. Replacement is recommended.

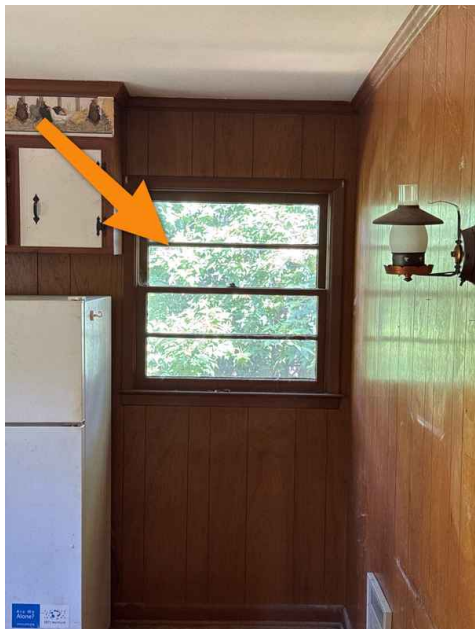
Kitchen

Window(s) were difficult to open or did not open at the time of the inspection. Windows should open without excess force and are required to open easily as a means of emergency escape in certain parts of the home. Service by a qualified professional for repair to ensure proper function is recommended.

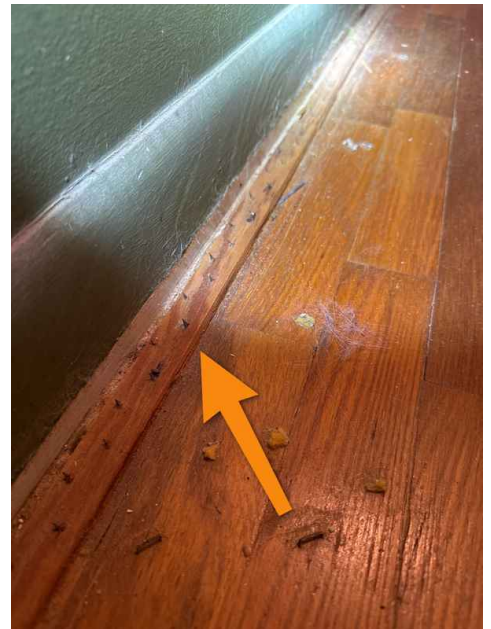
BEDROOMS, LIVING ROOM, HALLWAY

Tack strips present and visible due to carpet having been removed. Tack strips hold carpet in place but when exposed pose a safety hazard as they can be stepped on causing injury. Service to remove is recommended.

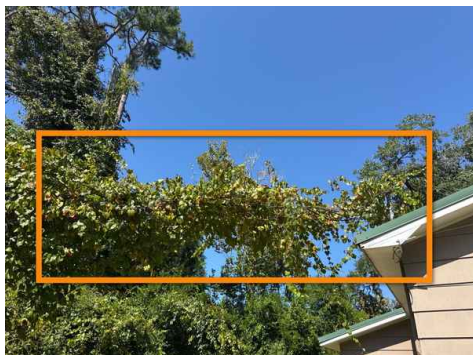
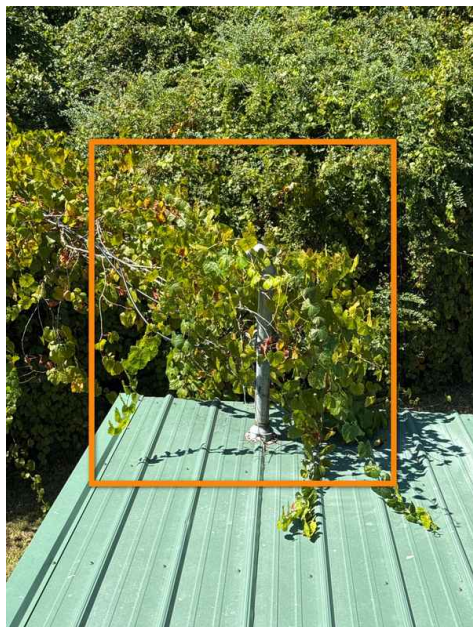
Vines growing on Service Entrance Cables. Vines conceal cables from inspection and could possibly grow into the mast or contact high voltage wire. Service by a qualified professional to carefully remove vines from cables is recommended at this time. Client is advised to contact electrical utility company prior to removal.

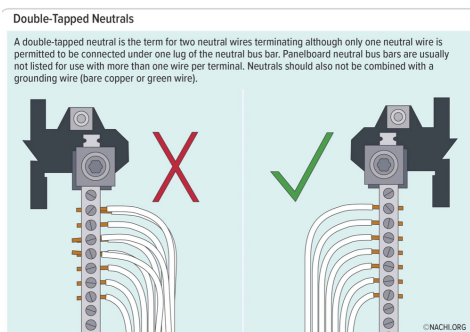
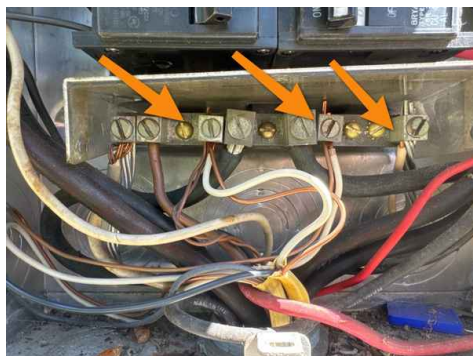
LEFT REAR EXTERIOR

Neutral (white wire) and equipment grounding conductors (bare or green wire) terminate under the same lug. An individual terminal should be provided for the connection of each branch-circuit neutral conductor. When the neutral is disconnected, the objective is to still have the equipment ground connected. If both the neutral and grounded conductor is under the same terminal, this may not be accomplished. Service by a qualified electrical contractor to properly repair is recommended at this time.

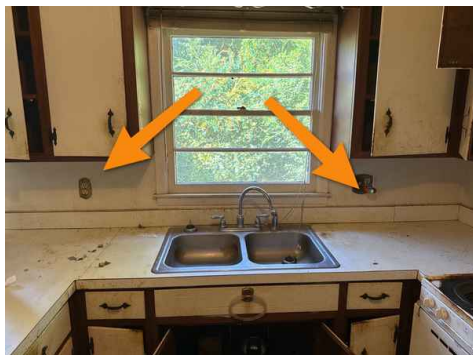
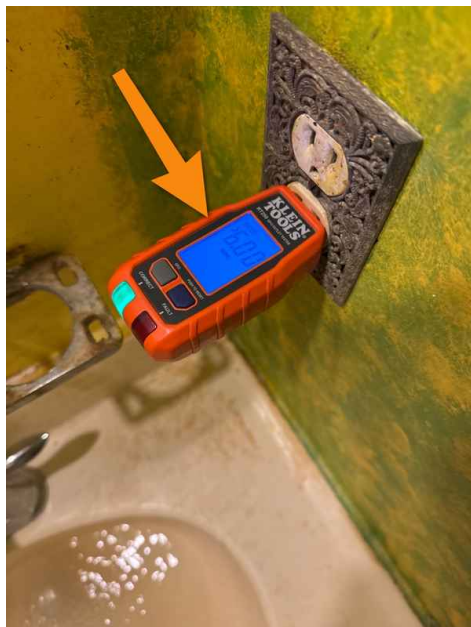
GFCI protection was not present in one or more required locations at the time of the inspection. GFCI is for enhanced shock protection mainly in potentially wet locations. Due to age of home/code requirements when constructed. Service by a qualified electrical contractor to properly install ground fault receptacles in all necessary locations is recommended at this time.

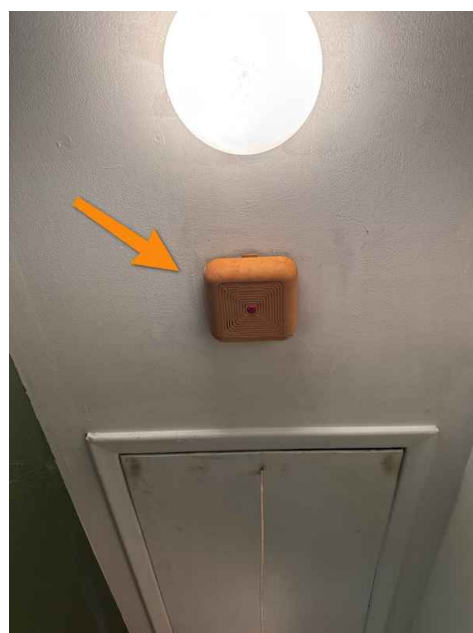
HALLWAY

Smoke detectors/alarms were present, but observed to be out of date. Smoke and Carbon Monoxide detectors should be replaced every 10 years or sooner regardless of function. Service by a qualified professional to replace is recommended prior to occupancy.

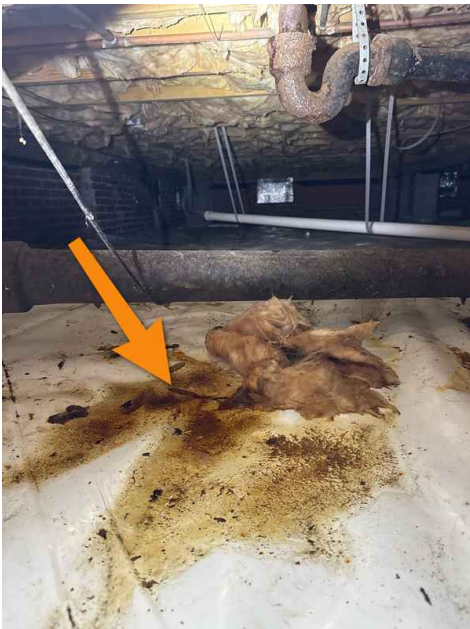
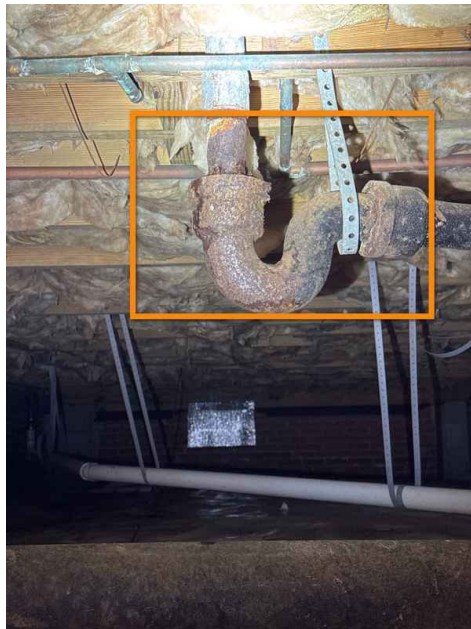
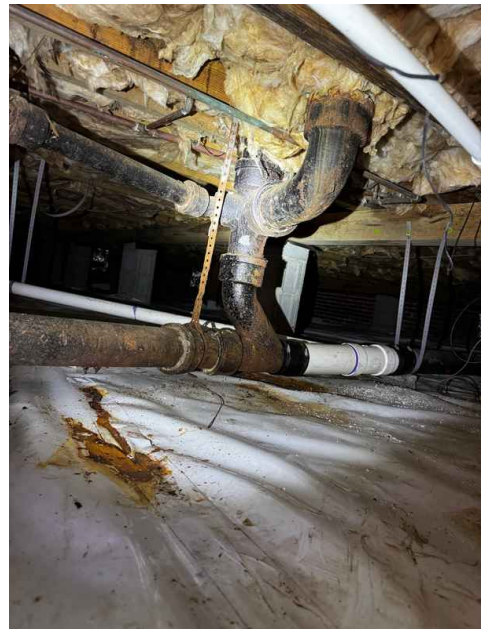
Area of corroded/deteriorated pipe and/or pipe connections observed. Leak observed at drain pipe in crawlspace. Cast Iron is at the end of its service life. Service by a qualified plumbing contractor for repair/replacement is recommended.

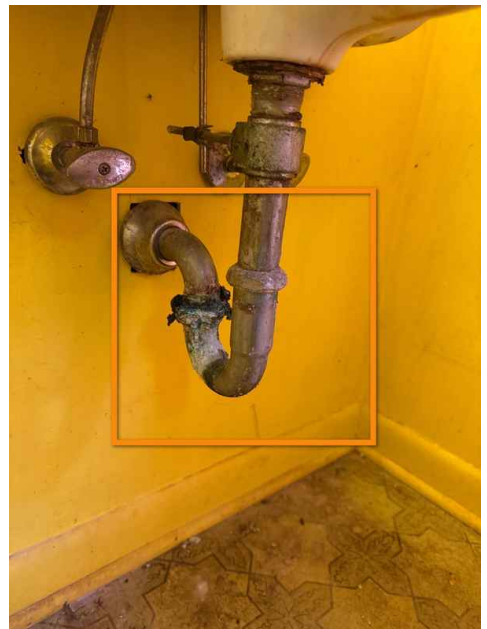
REAR HALF BATHROOM

Area of corroded/deteriorated pipe connections observed. Deferred maintenance. No leaks were observed when inspected but will likely worsen. Service by a qualified plumbing contractor for repair/replacement is recommended.

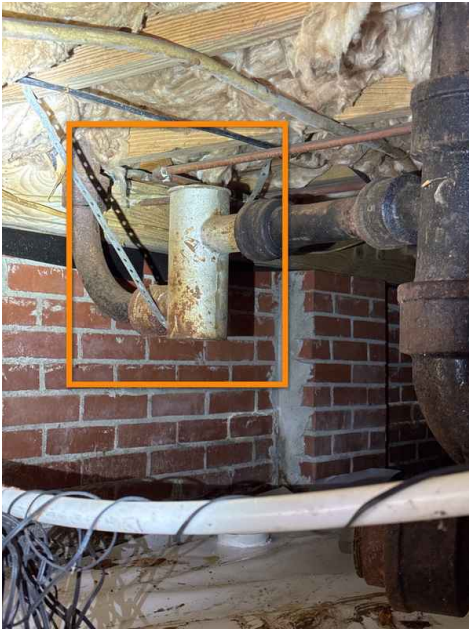
CRAWLSPACE

A drum trap was present and in use. Drum traps are antiquated systems that are no longer in use or permitted for install, but may be functioning as intended. Client is advised these traps are more prone to clogging than modern trap assemblies and can be difficult to unclog if lid is rusted on. Consider service by a qualified professional to replace/upgrade to a modern pvc plastic p-trap.

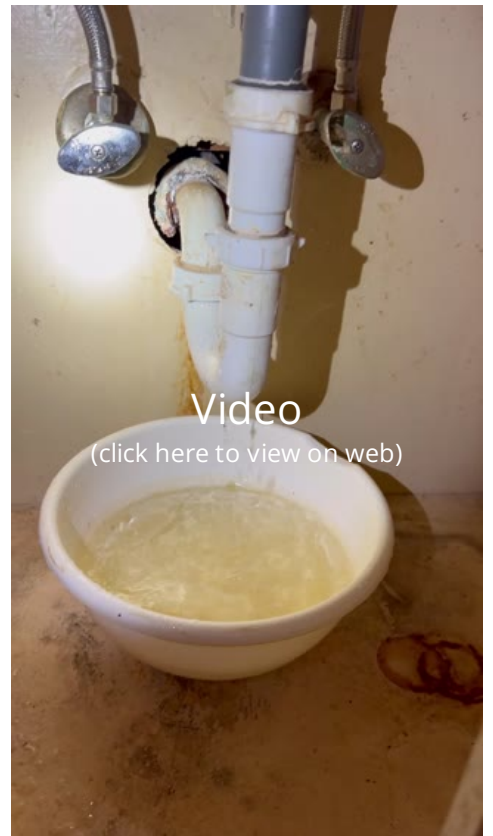
Sink(s) observed leaking at the time of the inspection. Leaks damage cabinets, waste water and raise water bills. Service by a qualified plumbing contractor for repair is recommended at this time.

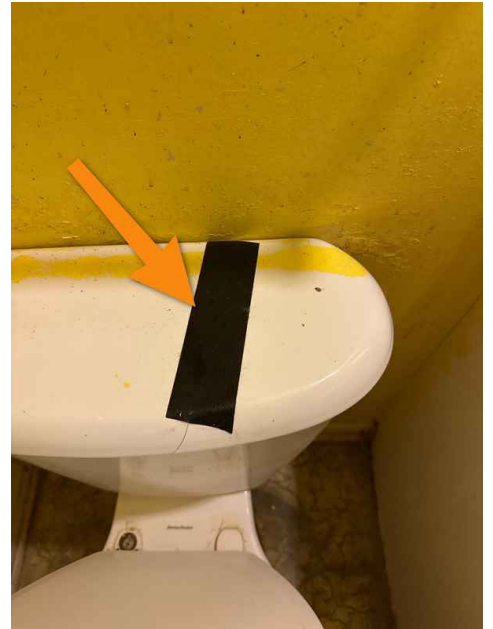
Tank Cover cracked. Minor but may worsen. Recommend replacing toilet tank cover.

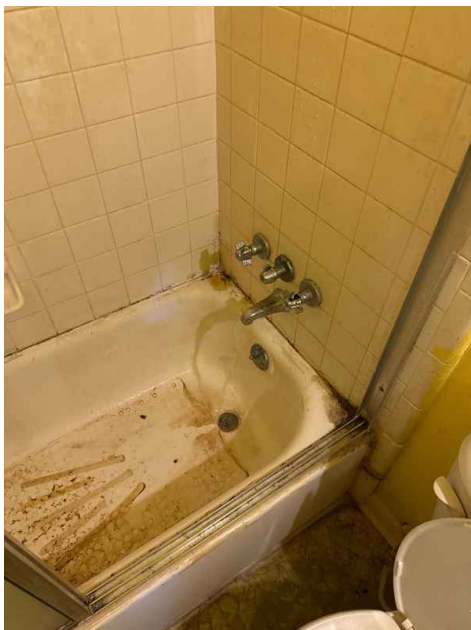
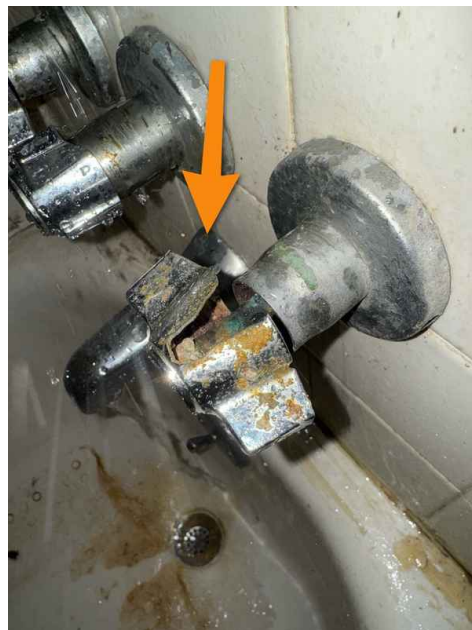
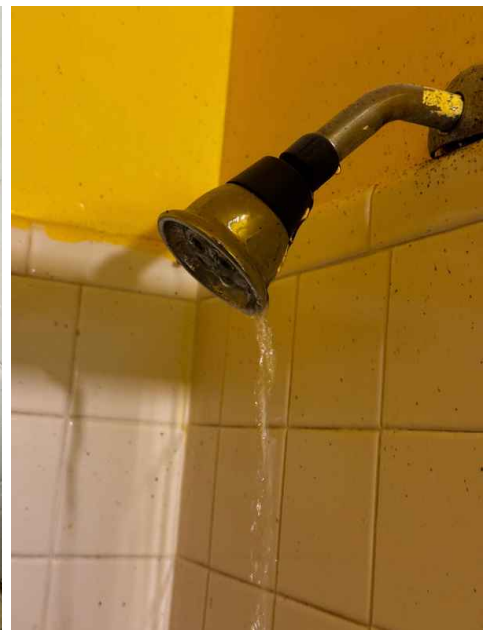
Tub/Shower observed in poor condition. Old, dirty, poorly maintained. Tub spout and shower head performed poorly; low flow and leaks. Valve handles are broken - safety risk due to jagged metal edges. Evaluation by a qualified professional for replacement is recommended.

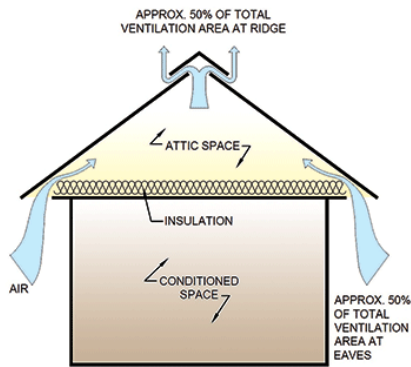
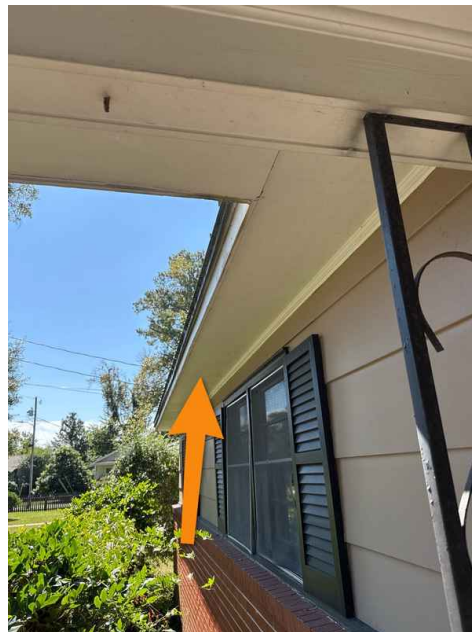
Attic is ventilated with only gable and/or ridge vent(s). No soffit vents installed. Gable and ridge vents near roof peak function better with soffit vents installed on underside of eave to allow cooler 'wind wash' into to lower level of attic to help circulate and force out hotter air. Service by a qualified professional to install soffits vents is recommended.

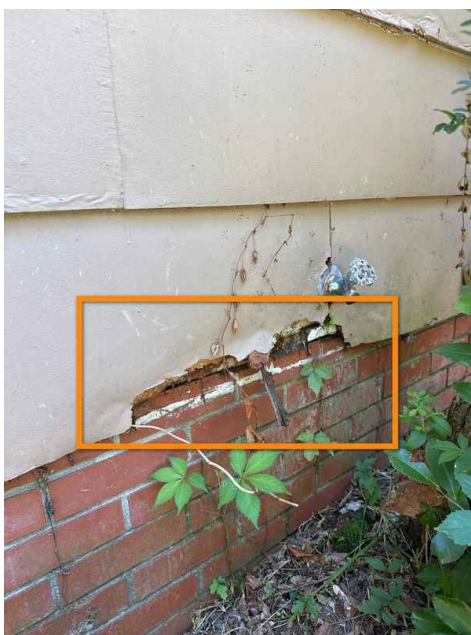
Right Rear

Area(s) of moisture damaged siding observed. Indicates moisture intrusion which may worsen. Additional latent damage not visible during non-invasive inspection may be present. Some siding boards were loose or have fallen. Evaluation for replacement by a qualified siding contractor is recommended.

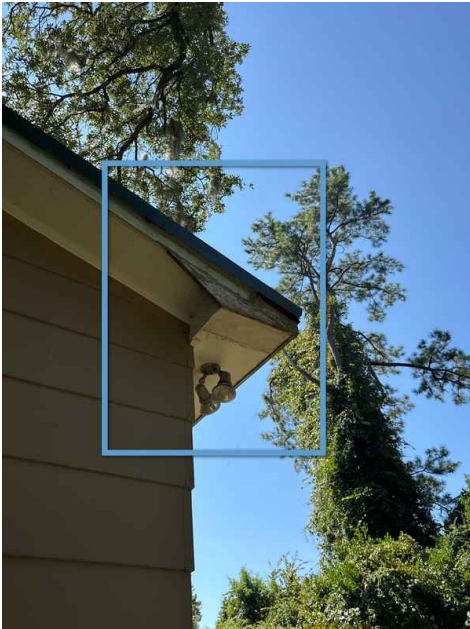
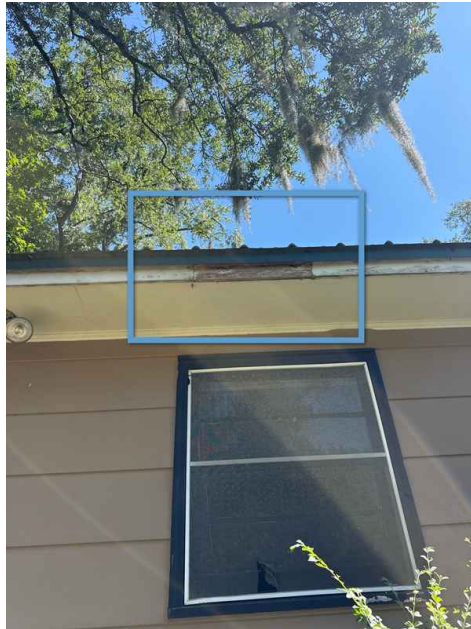
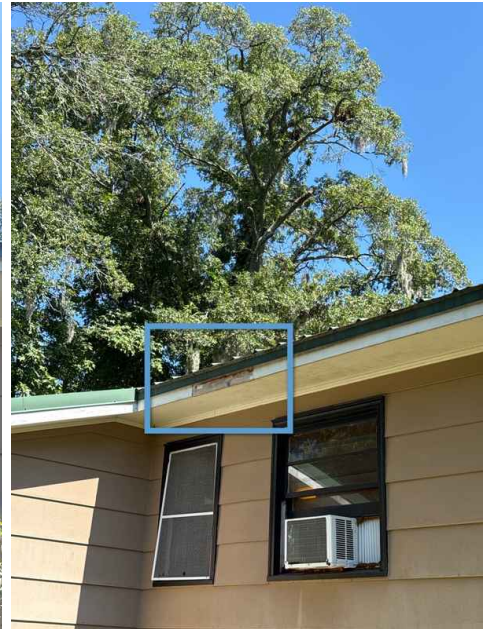
Rear Exterior

Failing or missing paint was observed in one or more areas of the eaves/soffit/fascia. Deferred maintenance. Service by a qualified painter to repaint these areas is recommended.

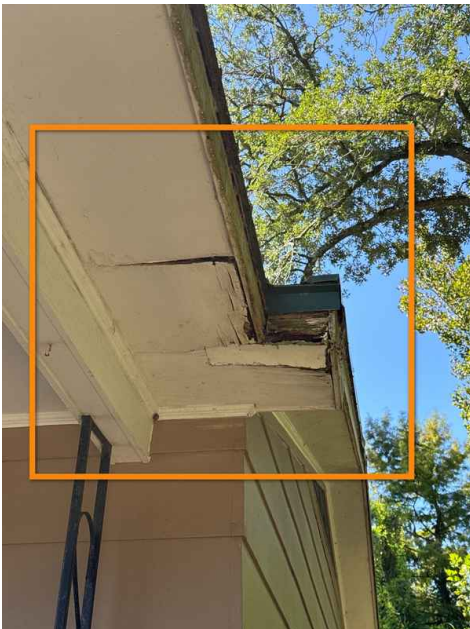
Front Right

Areas at the eaves observed damaged. This may allow water intrusion and access to insects and animals. Service by a qualified contractor to evaluate & repair is recommended.

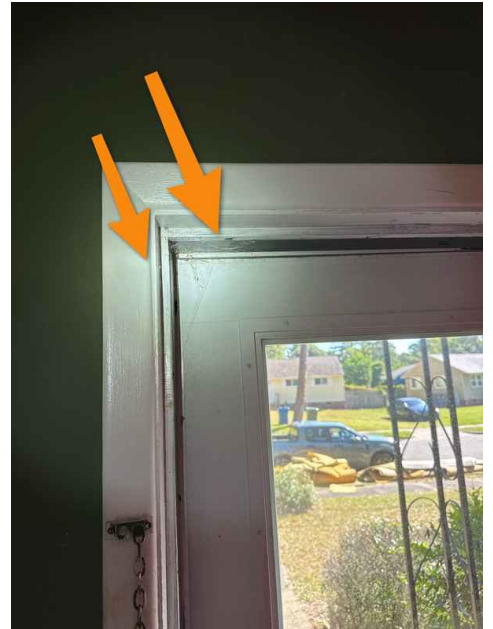
Door observed missing some or weatherstripping. This increases energy loss and may allow moisture intrusion. Recommend installation of weatherstrip at all sides of door.

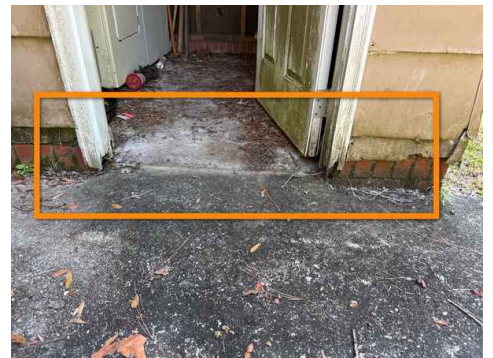
REAR EXTERIOR

Door, door frame and/or trim was observed deteriorated at the time of the inspection. Very common due to moisture intrusion over time. Deferred maintenance. Service by a qualified contractor for repair or replacement is recommended.

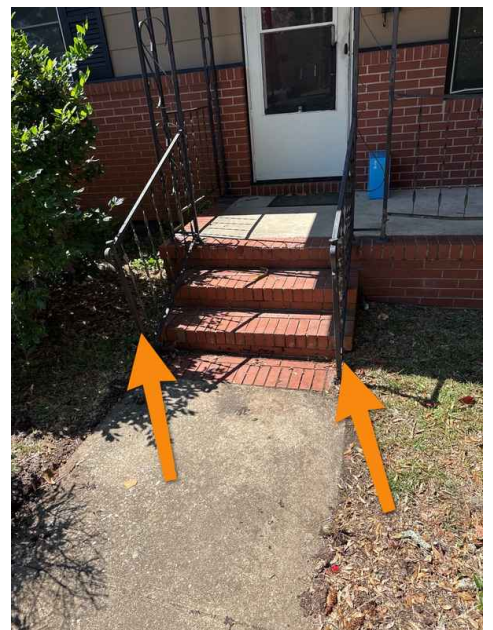
Handrails observed loose. Corroded at base. Safety concern as they may move when weight put against them. Service by a qualified professional for repair is recommended.

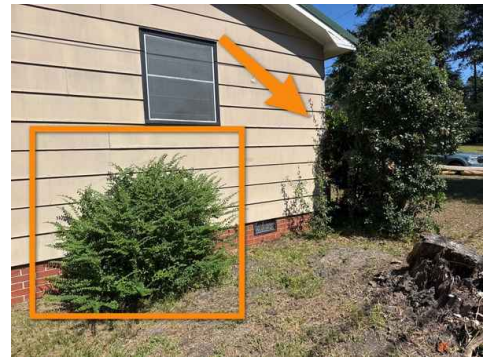
LEFT EXTERIOR, FRONT EXTERIOR

One or more areas of vegetation in contact with exterior at time of the inspection. This may cause accelerated deterioration of siding over time as vegetation holds moisture against the exterior or damage from limbs/branches esp. during periods of high wind. This can also attract and conceal insects/pests. Recommend trimming or removing vegetation.

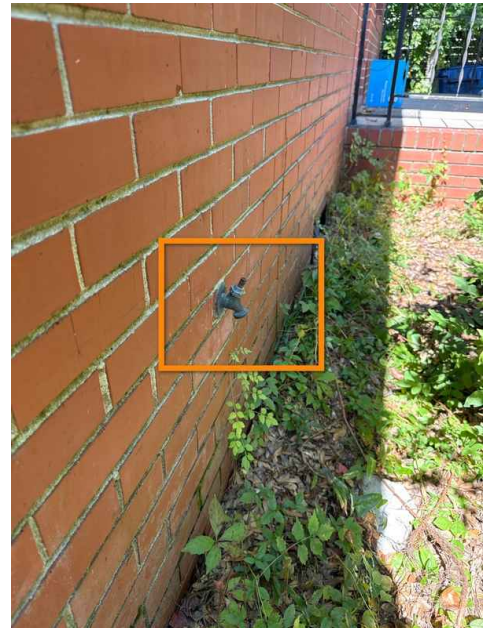
FRONT EXTERIOR

Exterior hose bibs valve handle missing. Not functioning as intended. Service by a qualified professional for repair is recommended.
