## Pre-listing Home Inspection Report

242 Black Bear Way, Ellsworth , ME 04605

Friday July 10, 2026

071026

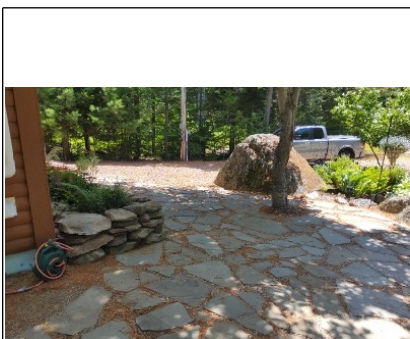
Monitor walkway flagstone walkways periodically. Uneven surface can be a tripping hazard.

Walkway

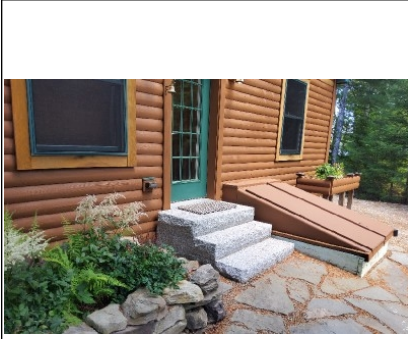
Step risers are uneven, may present a trip hazard. Recommend repair and/or replacement  
 Recommend railing for steps - SAFETY CONCERN.

It is recommended that steps with three or more risers be served by a handrail. Recommend installing a handrail along the main entrance steps

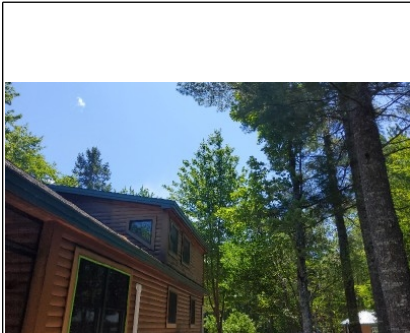
**Comments** Recommend maintaining a positive drainage slope away from the foundation.  
 Watering flowering beds next to house may cause moisture intrusion into home. Recommend removing  
 Recommend trimming and/or removal of vegetation away from home

Trim and maintain tree limbs  
 away from the home as needed

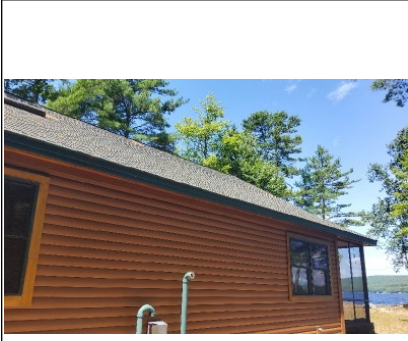
**Comments** Installing gutters, downspouts, and downspout extensions may prevent water seepage into the basement.  
 At a minimum, install gutters above entrance doors and decks to prevent ice build-up and protect deck connections from deterioration.

Installing gutters along roof eaves may direct rainwater away from the home, protect siding and windows from damage

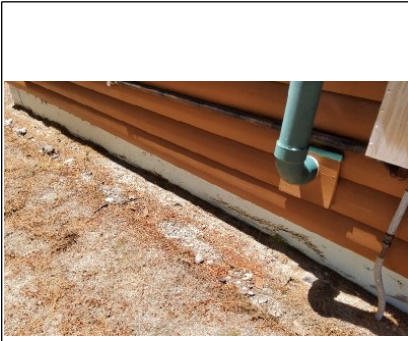
**Comments** Vegetation covering foundation (stem) wall, not visible, not evaluated.

Concrete stem walls are covered with insulation

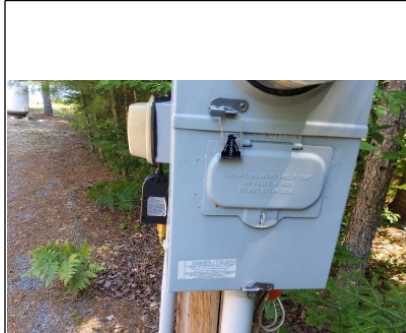
Install a lock on exterior meter disconnect panel door

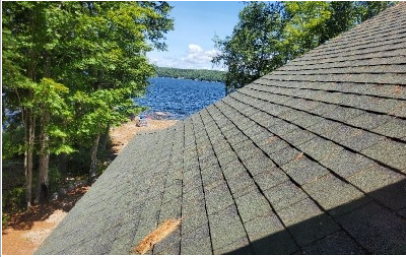
Asphalt shingles serving the home appears to be in satisfactory condition. There were no signs of active or past roof leaks observed in the home at the time of this inspection

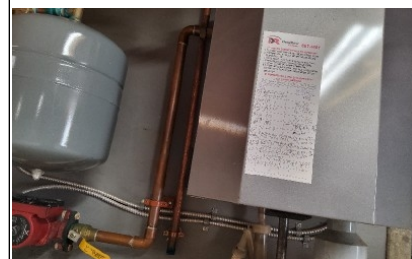
Recommend on demand hot water boiler be cleaned and serviced

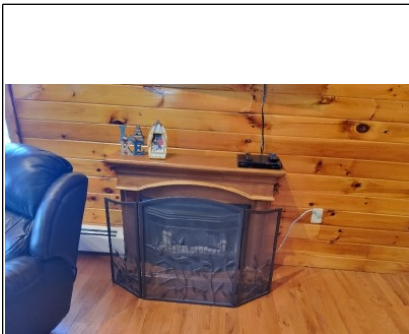
Demonstrate propane fireplace is operational at the time of all showing

Propane fireplace in a non-venting heat stove. Non-venting heat stove are considered a safety concern. Do not leave stove unattended when in use.

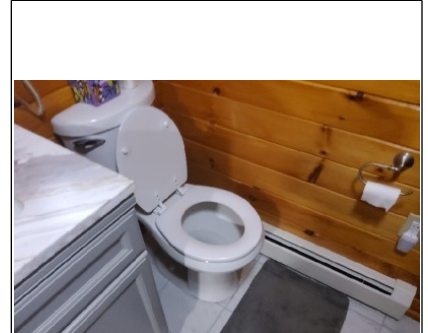
Toilet bowl is slightly loose

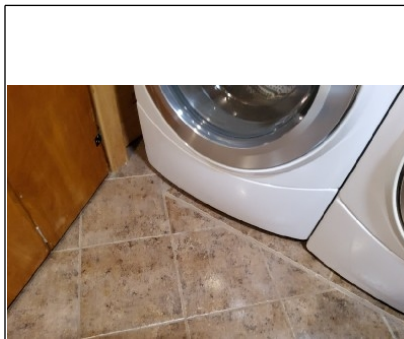
Recommend installing a drip pan beneath washing machine

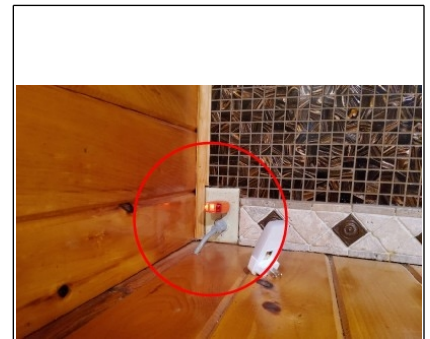
Outlet is GFCI protected, trips along south wall of the bathroom

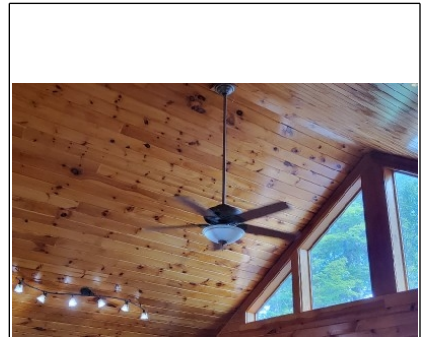
Living Room ceiling light did not function, change bulbs?

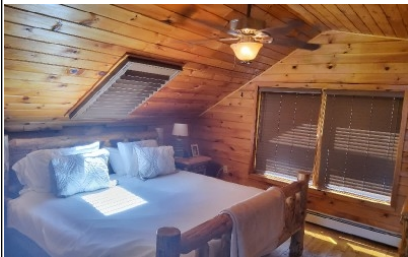
**Comments** Ceiling fan is wobbling, recommend repair.

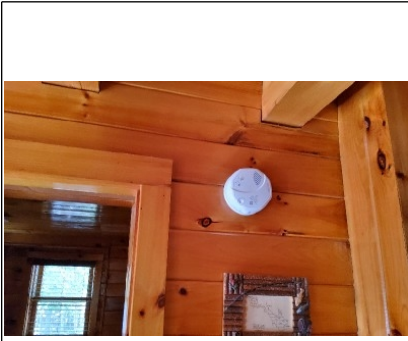
Smoke and carbon monoxide detectors are connected in series. Smoke detectors are installed in all bedrooms
