## **Green Bridge Home Services, LLC Inspection Report**

Prepared for: Katie Hitch & Lee Roe  
Location: 57 Ellsworth Rd, Blue Hill, ME  
Date of Inspection: 6/12/2026

## Inspection Report

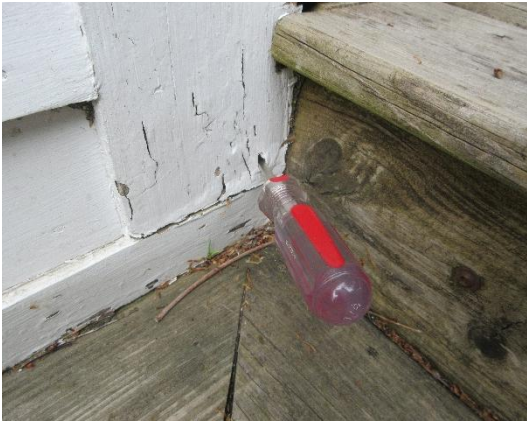
rot at lower trim board

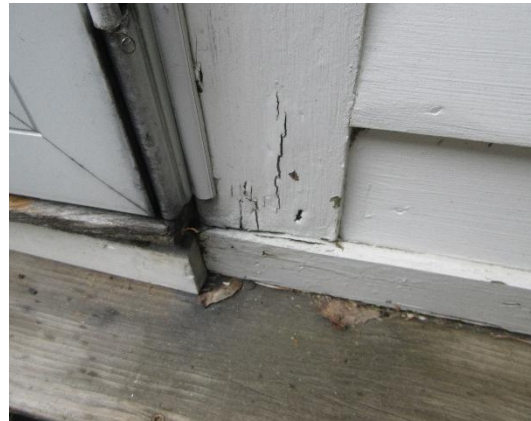
rot at lower door trim

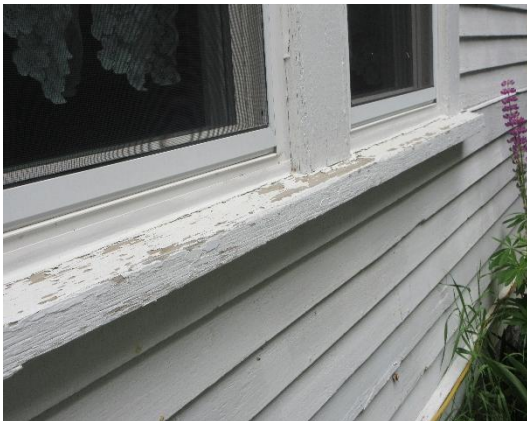
peeling paint at window sill, trim

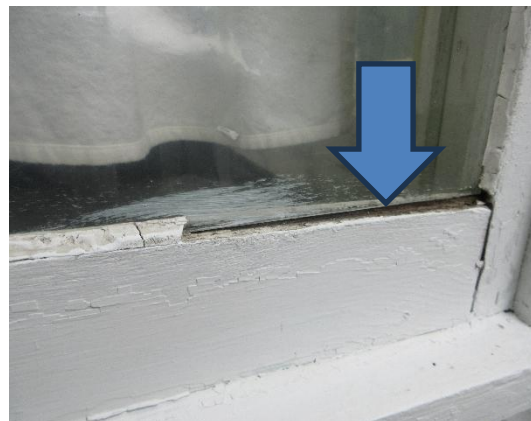
re-glaze single pane windows

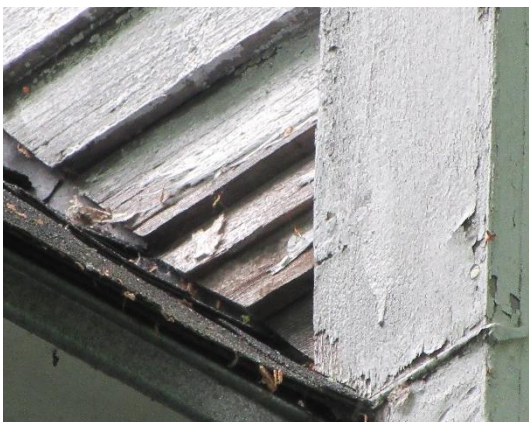
peeling siding paint

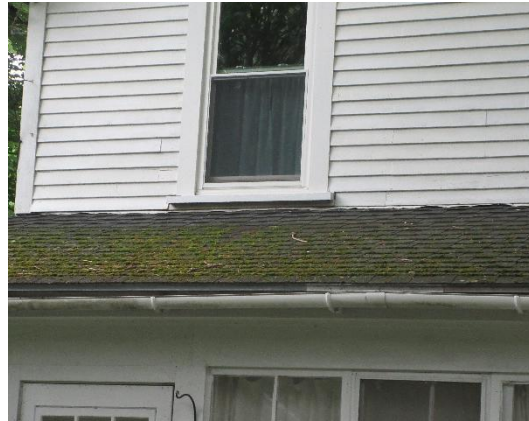
**remove moss from roof**

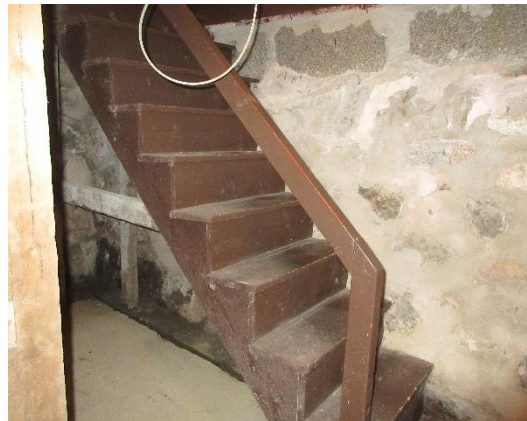
- Basement:
  - The basement stairs lack adequate railings. Current standards recommend a railing height of 36 inches, balusters spaced no larger than 4 and ½ inches, with a graspable handrail from top to bottom.

**stairs lack adequate railings**

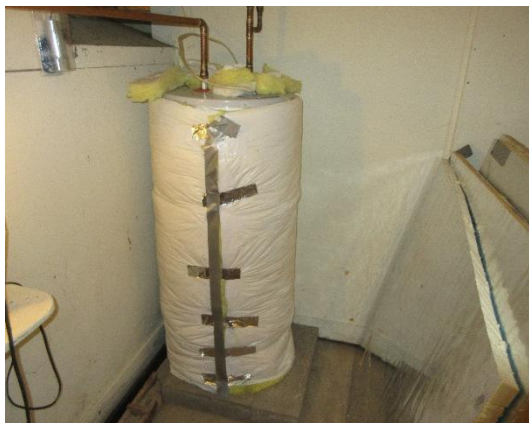
- The hot water heater is operating acceptably. However, it appears to be over 15 years old and may be nearing the end of its useful life. Consider budgeting for future repairs or replacement.

water heater

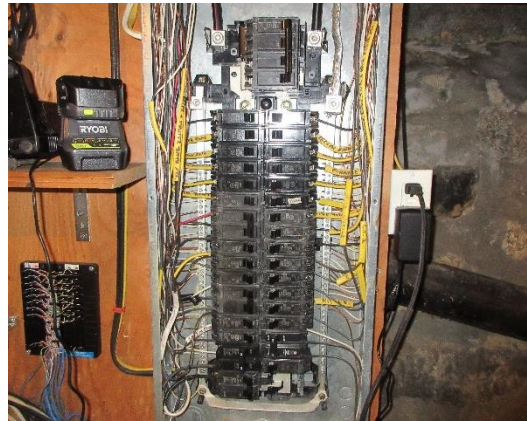
panel with faceplate removed

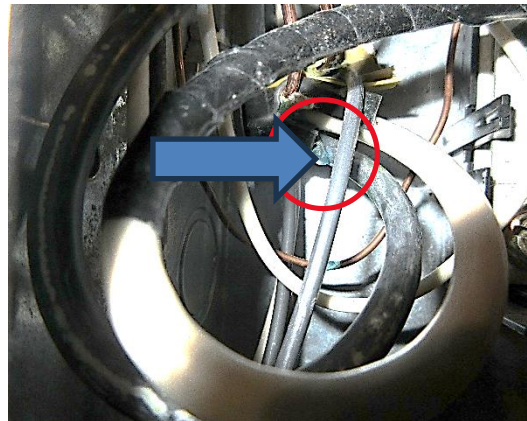
- Electrical:
  - There is a puddle of water in the main electrical panel. This appears to be coming out of the heat pump wire. We recommend contacting the heat pump contractor who installed the system and having a new line installed. The water is entering the panel through the protective sleeve from the heat pump electrical wire. The whole line should be replaced, as there is water inside the protective sleeve, dripping into the panel. The breakers for the heat pump should also be replaced as they are rusty.

water dripping out of heat pump electrical line sleeve

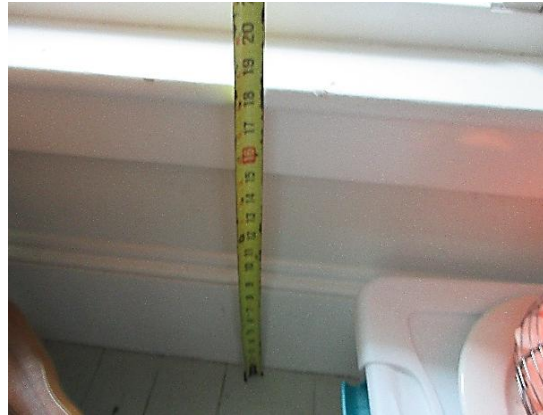
- The some of the windows on the second floor are too low to the floor. This creates a fall hazard. Current building standards recommend windows be at least 24 inches off the floor.
- The west set of stairs lacks adequate railings. Current standards recommend a railing height of 36 inches.
- Attic:
  - The attic stairs lack adequate railings. Current standards recommend a handrail from top to bottom and fall protection around the opening at the top of the stairs. The railing around the top of the stairs should be 36 inches tall with balusters spaced no large than 4 and ½ inches.

**window low to floor**

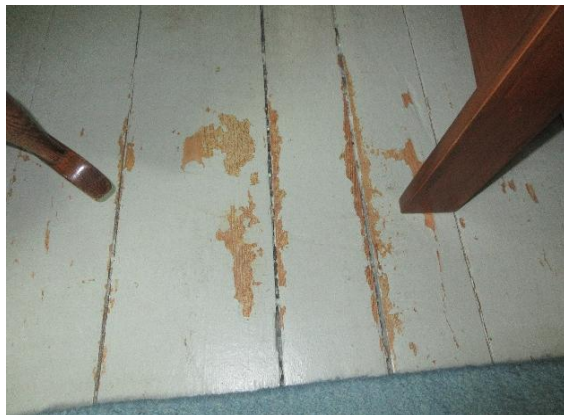
**wear on flooring**

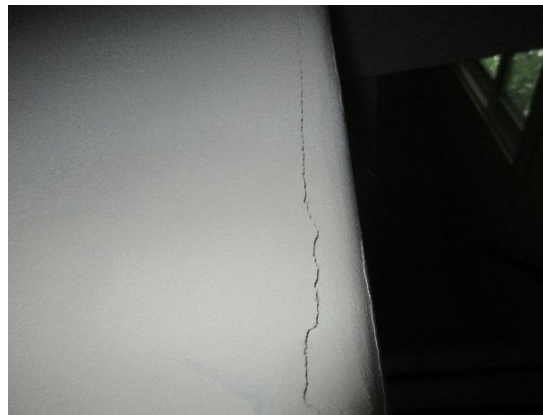
**crack in plaster**

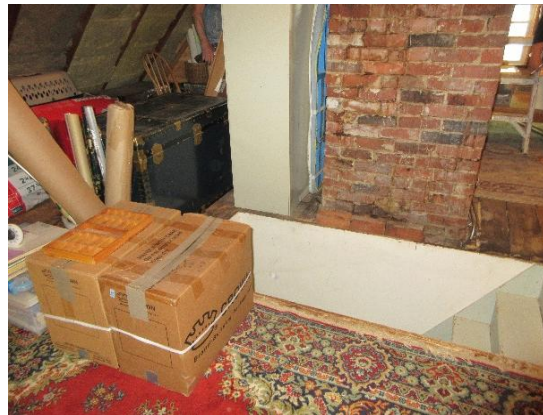
**opening around top of stairs lack fall protection**
