Monday, October 12, 2026  
Bonnie Boisvert  
70 Freeman Ridge Rd  
Southwest Harbor, Maine 04679

We have enclosed the report for the property inspection we conducted for you on Monday, October 12, 2026 at:

Inspector, Michael Chaisson  
MRCHAI, Inc.

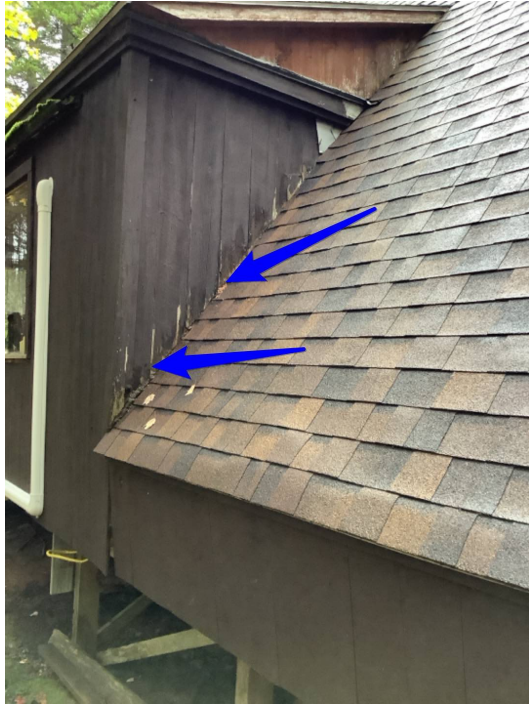
There is some deterioration starting on the bottom of the siding on the dormers where the wood meets the roof shingles, especially on the left side. There is proper flashing under the siding to prevent water intrusion. See photo.

Deterioration starting

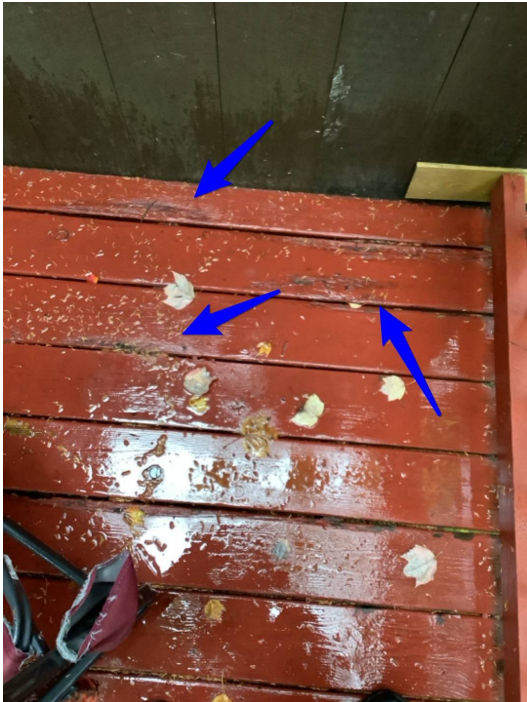
There is some deterioration starting on the front deck left front floorboards. See photo.

Areas of deterioration

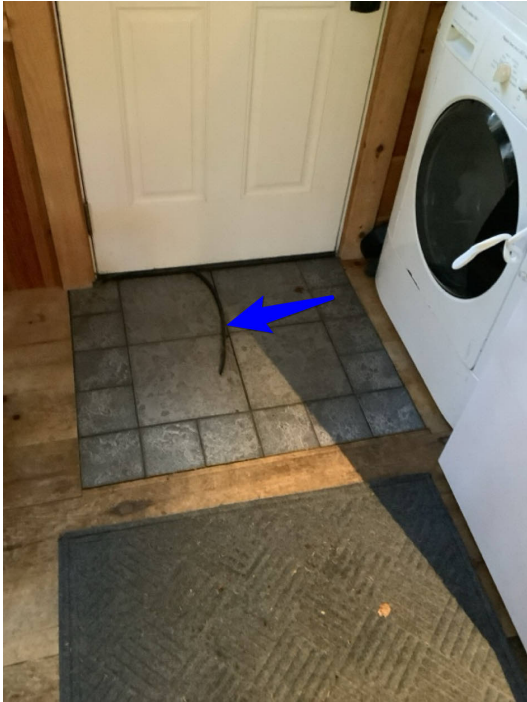
The front entry door bottom weatherstripping has come loose.
