## **J. Peabody & Son Septic Inspections Septic System Inspection Report**

Prepared for: Duncan Leach  
Location: 1023 Pleasant St. Blue Hill ME  
Date of Inspection: 10/8/26

**J. Peabody & Son Septic Inspections****Septic Inspection Report**

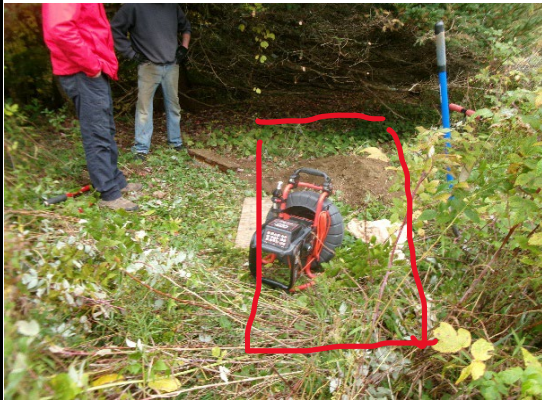
**Septic Tank Location**

| Septic | Rating | Description | Comments |
|---|---|---|---|
| location | | west | |

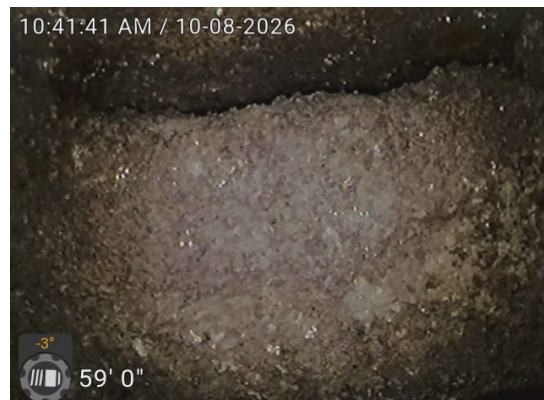
| Septic | Rating | Description | Comments |
|---|---|---|---|
| baffle | | acceptable | viewed with pipe camera |

**Inlet Cover and Baffle**

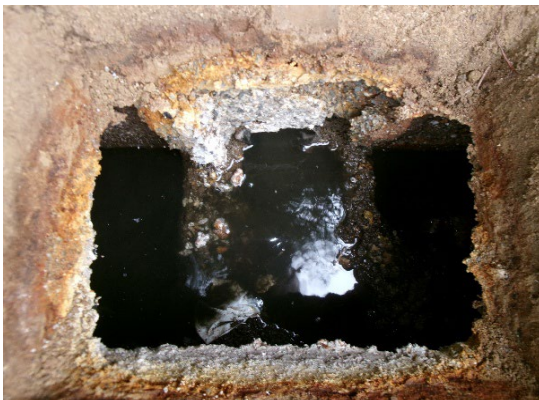
| Septic | Rating | Description | Comments |
|---|---|---|---|
| outlet cover removed | MI | broken or damaged | |
| baffle | MI | poor condition;<br>repairs<br>recommended | |

**Outlet Cover and bad Baffle**

1. The outlet baffle inside of the septic tank has deteriorated beyond its useful life. A new outlet baffle is recommended to be installed, and the outlet cover should be replaced at the same time.
2. The septic tank is recommended to be pumped out.

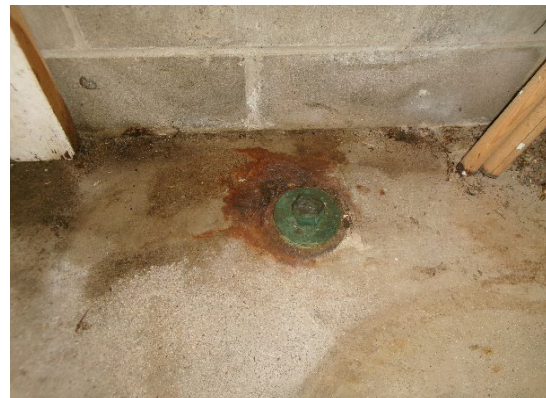
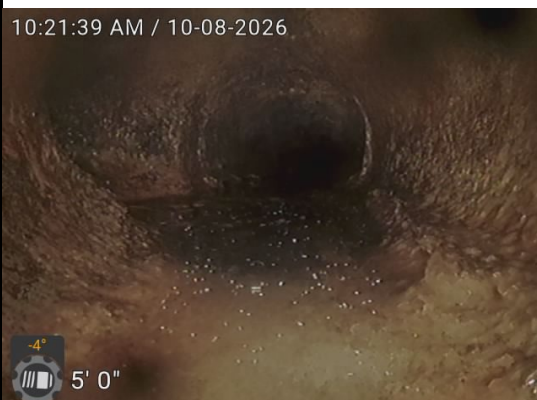
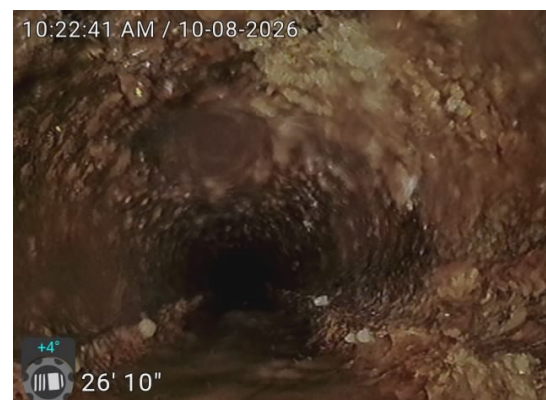
| Septic | Rating | Description | Comments |
|---|---|---|---|
| plumbing/piping to tank | | satisfactory | older, cast iron pipe has diminished inside dimensions due to rust and debris. |

**Piping From House to Tank**

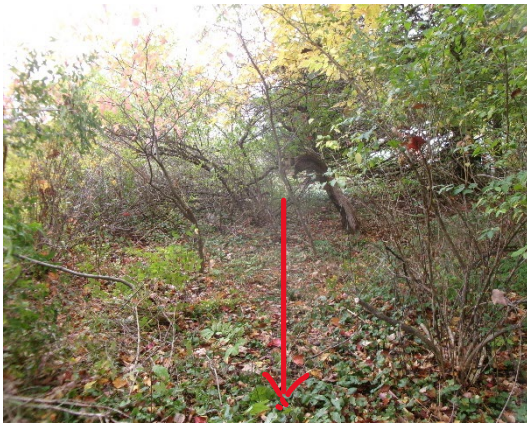
3. The leach field appears to be one perforated pipe into the side yard. This doesn't appear to be a leach field that is up to today's codes and standards. The current leach field is still functioning, and no effluent was observed at grade during the hydraulic load test.

| Septic | Rating | Description | Comments |
|---|---|---|---|
| vegetation growth? | | poor condition | bushes, brush, etc should be kept trimmed at leach field |

**view of leach field area**

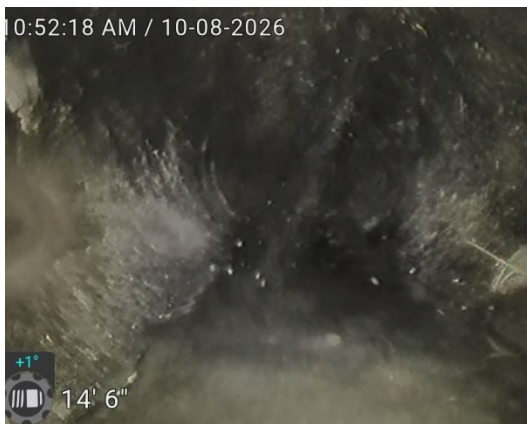
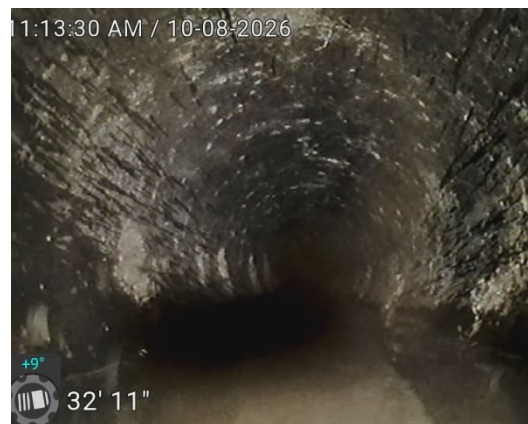
| Septic | Rating | Description | Comments |
|---|---|---|---|
| piping accessed? | | yes | perforated pvc pipe system |

**perforated pipe**
