## **J. Peabody & Son Septic Inspections Septic System Inspection Report**

Prepared for: Greg Bush  
Location: 515 Falls Bridge Rd. Blue Hill Me  
Date of Inspection: 9/11/25

## Septic Inspection Report

**Client:** Greg Bush  
**Phone number:**  
**Email Address:** [publicbush@gmail.com](mailto:publicbush@gmail.com)  
**Address of Inspection:** 515 Falls Bridge Rd. Blue Hill Me.  
**Inspection Date/Time:** 9/11/25 8:30am

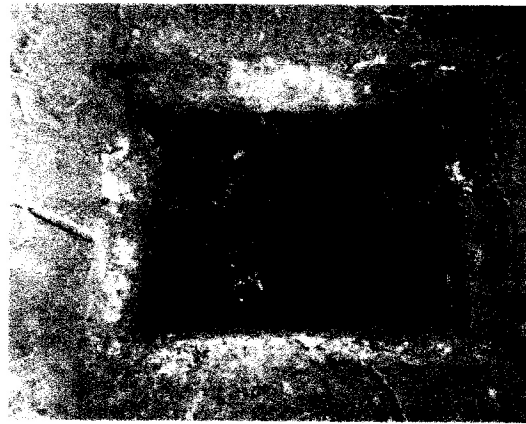
| <b>Septic</b> | <b>Rating</b> | <b>Description</b> | <b>Comments</b> |
|---|---|---|--|
| inlet cover removed | | yes | |
| baffle | | acceptable | |

**inlet cover and baffle**

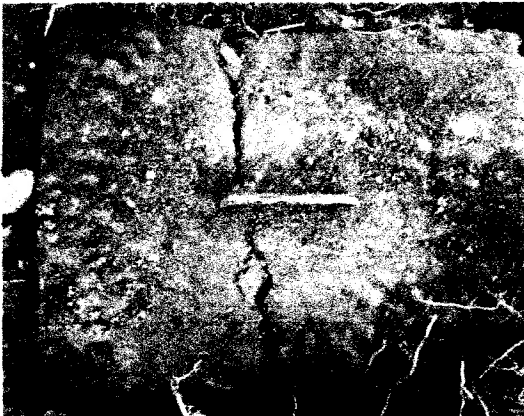
| <b>Septic</b> | <b>Rating</b> | <b>Description</b> | <b>Comments</b> |
|---|---|---|--|
| outlet cover removed | MI | broken or damaged | |

**cracked outlet cover**

1. The outlet cover on the septic tank is broken and should be replaced.
2. The bushes on and around the leach field should be trimmed periodically as to keep them from growing in the leach field.
3. The septic tank appears to be undersized for the number of bedrooms and kitchens this house is stated to have; therefore, the leach field may be undersized as well. Overworking an undersized septic system can cause it to fail prematurely.
