**CERTIFIED INSPECTION
SERVICES Inc.**

Home Inspection Report

17 Main Street, Albion, AK 04910

Friday November 8, 2024

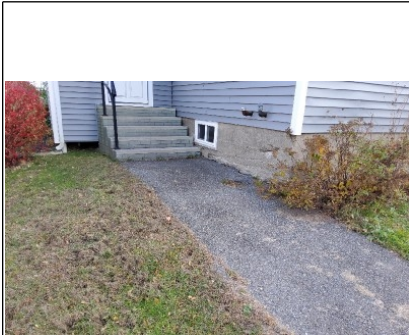
Comments Walkway had some cracking and settlement but usable

Walk way, some settlement observed

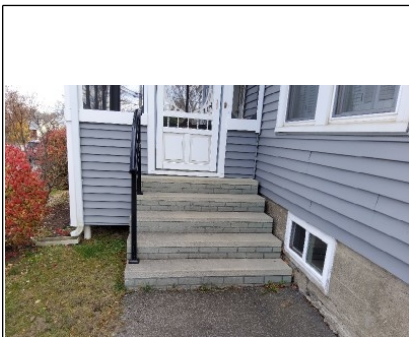
North entrance steps

Comments Step risers are uneven, may present a trip hazard. Recommend repair and/or replacement

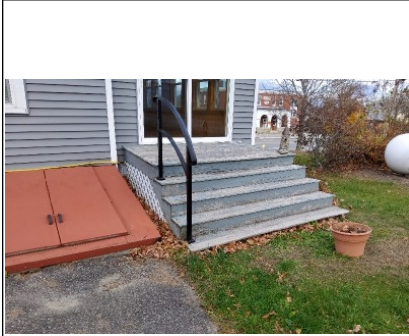
Comments Deck appeared to be in satisfactory condition, applying a sealant on the wood will help prolong the life of the deck.
Recommend painting or treating wood.

Southeast deck
Stain or paint southeast entrance deck to prolong the life of the wood

1. Stain or paint southeast entrance deck to prolong the life of the wood.
2. Maintain ground surface away from the basement windows. Caulk around basement windows.

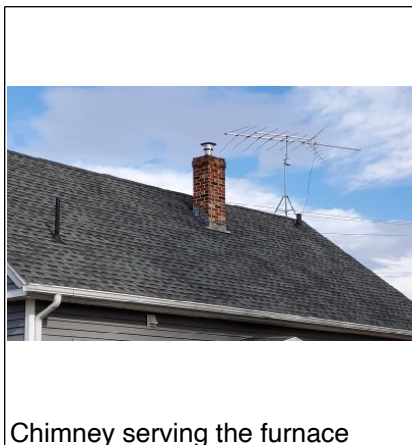
Comments Chimney flue was not evaluated.
Chimney flue was not accessible so not evaluated

Chimney serving the furnace

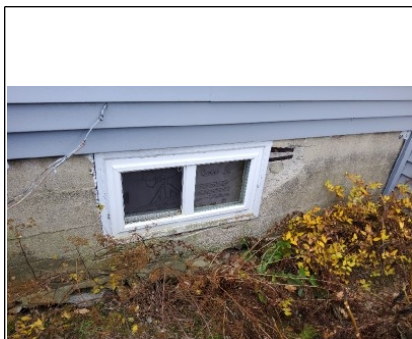
Comments Typical hairline cracks in slab.
Foundation (stem) wall shows signs of deterioration recommend repair

Repair damaged north concrete stem walls, concrete has chipped away

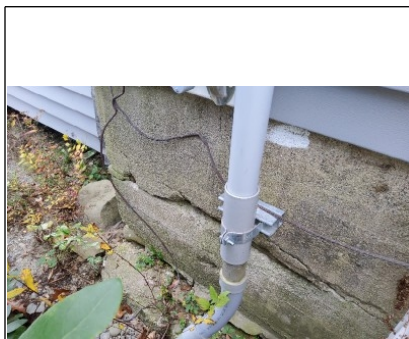
Fill cracks in along concrete stem walls to prevent further damage

3. Fill cracks along concrete stem walls to prevent further damage, located on the north exterior foundation wall.
4. Recommend installing a galvanized zinc coating on metal roof covering serving the north porch.

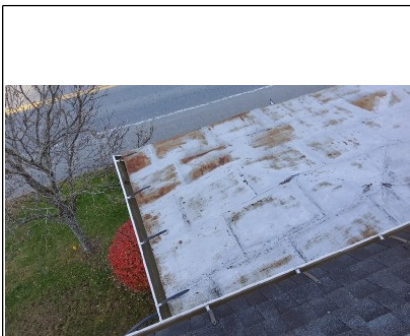
Recommend installing a galvanized zinc coating on metal roof covering serving the porch

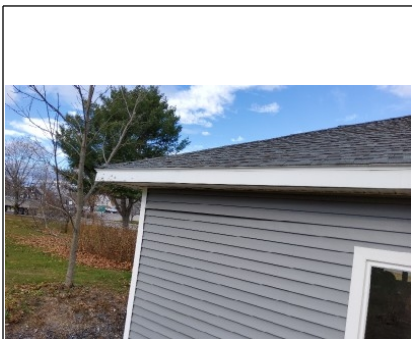
Secure loose siding located along the South side of the garage

5. Install gutters above entrance doors to prevent water seepage into the garage.
6. Secure loose siding located along the South side of the garage.
7. Divert rainwater away from the garage south wall.

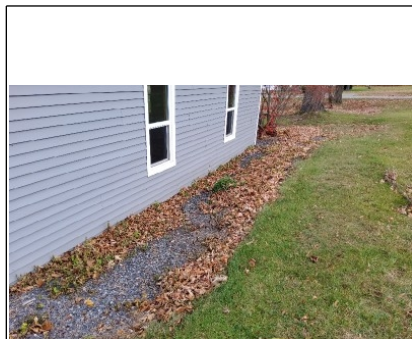
Divert rainwater away from the garage

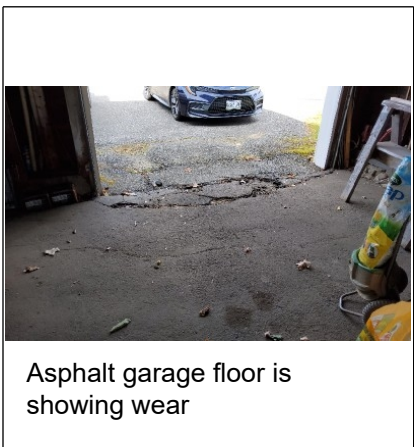
Asphalt garage floor is showing wear

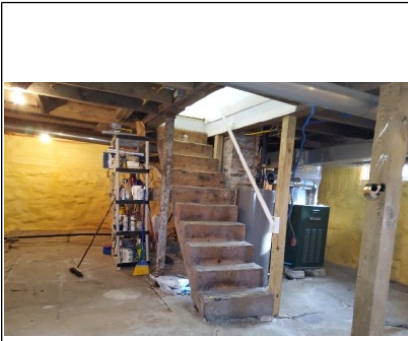
Comments Uneven steps, potential safety/trip hazard. Recommend repair
 Carpet torn/wrinkled on steps, possible safety hazard. Recommend repair
 Handrail missing, potential safety issue. Recommend Installing handrail

Recommend installing a handrail along both sides of the basement stairs

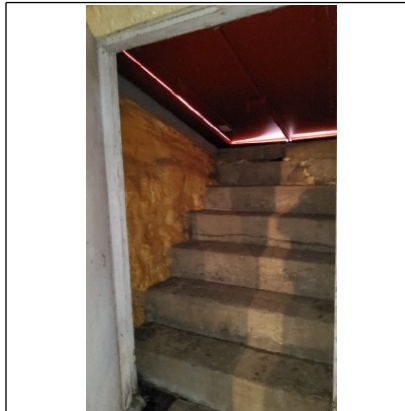
Maintain rainwater away from bulkhead doors.
 Seal and close doors

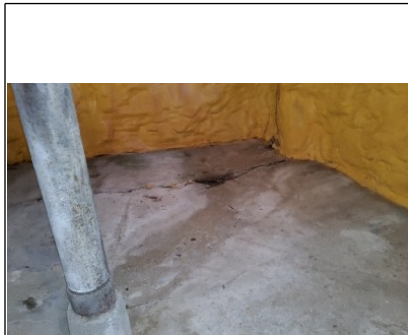
Filling cracks with a water plug cement may reduce water seepage into the basement

8. Filling cracks with a water plug cement along base of southwest and concrete slab of the basement may reduce water seepage. Lowering sump pump may reduce groundwater conditions beneath the concrete slab and reduce water seepage observed in the basement. Install a cover on sump pit.

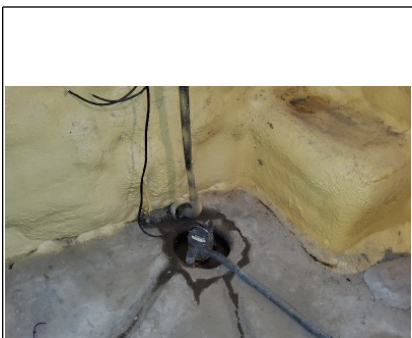
Comments Some old moisture stains are present, recommend maintaining proper slope away from the house and make sure the gutters drain properly..
Some signs of past flooding is evident. Recommend asking seller about possible past flooding.
Recommend sealing sump pump crock. Potential safety concern for children.

Sump pump.
Lowering sump pump may reduce groundwater conditions beneath the concrete slab and reduce water seepage observed in the basement. Install a cover on sump pit

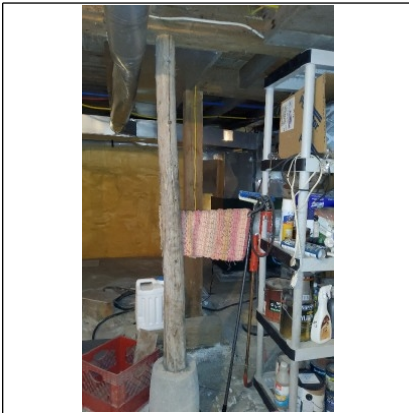
Recommend installing an additional steel column adjacent to east basement wood columns

9. Recommend installing an additional steel column adjacent to east basement wood column.
10. Last date the furnace was serviced is not labeled. Recommend furnace be cleaned and serviced if not conducted within the last twelve months. Furnace dehumidifier control has been discontinued.

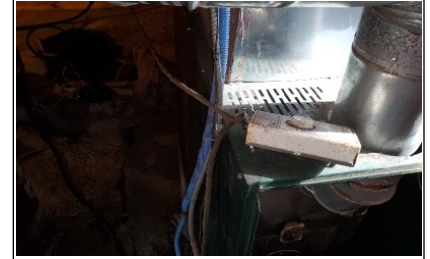
Comments Recommend furnace be cleaned and serviced if not conducted within the last twelve months.
Last date the furnace was serviced is not labeled. Recommend furnace be cleaned and serviced if not conducted within the last twelve months

Furnace dehumidifier control has been discontinued

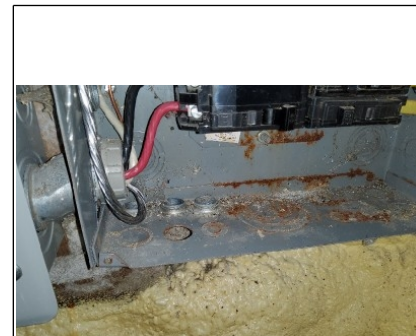
Comments Panel size appeared to be compatible to service size.
Evidence of rust in panel.
No signs of overheating were evident at the time of the inspection.
Outlets were randomly tested and had correct polarity, except as noted.

Rust in the main panel

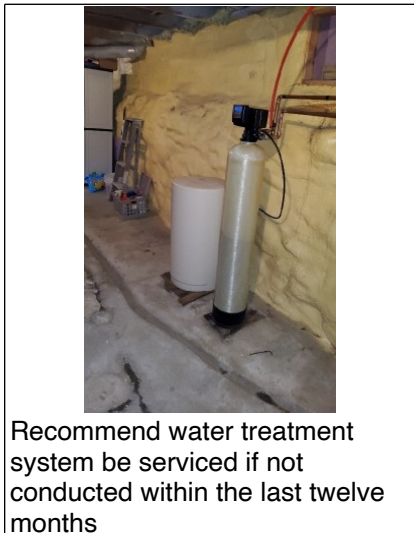
Recommend water treatment system be serviced if not conducted within the last twelve months

11. Recommend generator be serviced if not conducted within the last twelve months.
12. Recommend water treatment system be serviced if not conducted within the last twelve months.

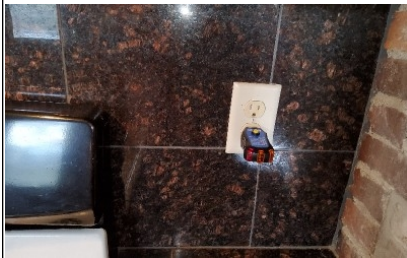
Outlet is slightly loose, right of the right

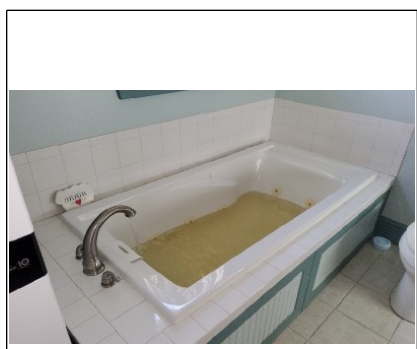
Jet tub Water is discolored. Hot water tank has not been used for awhile.
Assure jet tub is on a GFCI protected outlet or breaker.

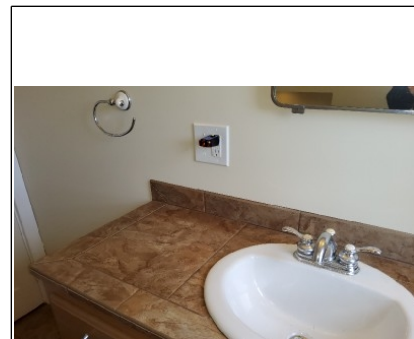
Outlet serving Bathroom is not GFCI protected

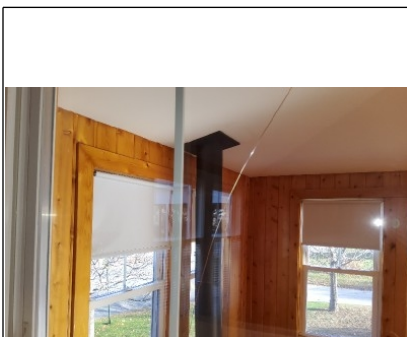
Repair broken window pane located along the east side of the room

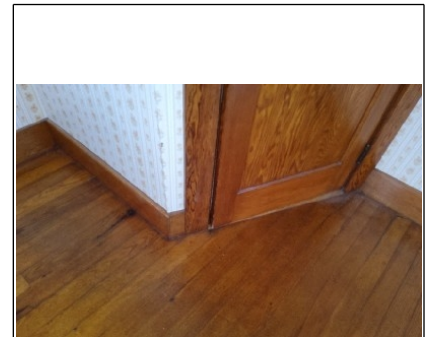
Door did not close

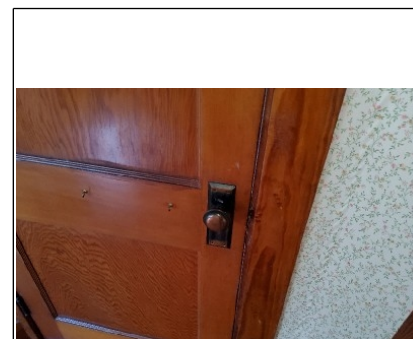
Door did not latch

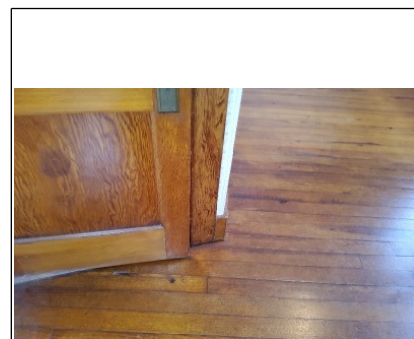
Door was difficult to close
