**Jerald C Smith & Son**  
669 Troy Road, Burnham, Maine 04922  
*Septic System Inspections*  
*System Evaluations / Trouble Shooting / Repairs*

**PROPERTY INFORMATION**

Address:	15 Salem Towne Road	Lot Size:	UNKN
Municipality:	Southwest Harbor, Maine 04679	Tax Map No:	UNKN
County:	Hancock	Lot No:	UNKN
Buyer:	Last Name: Vekasi First Name: Jim

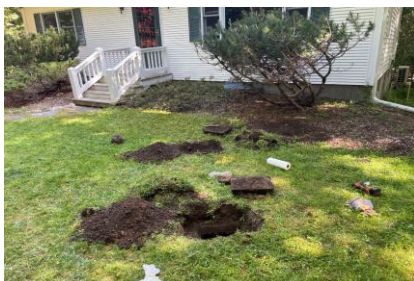
1,000-gallon concrete septic tank location

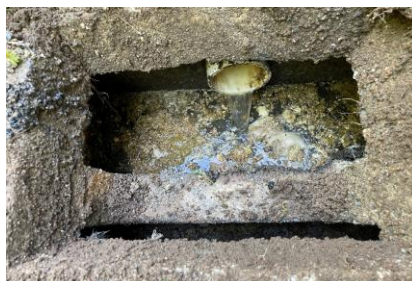
**3. Septic Tank Narrative:** A 1,000-gallon concrete septic tank was located to the front-right of the dwelling, 6-8 in. below the surface. The inlet and outlet access covers were exposed and removed for the inspection. Observed portions of the tank and solid levels were satisfactory. The original concrete outlet baffle had been replaced by a 90° baffle. The baffle extended to the tank bottom. A hole was bored into the top of the coupling so a camera could be introduced. Typically a tee is used. The inlet pipe was scoped and found to have a sag present for 10' back towards the dwelling. The outlet pipe was scoped and found in satisfactory condition and had proper pitch. In my opinion, the septic tank will be in satisfactory condition once the sag in the inlet pipe is repaired and the outlet baffle is replaced by a PVC tee baffle.

schedule 40 PVC inlet pipe & concrete splash-plate baffle

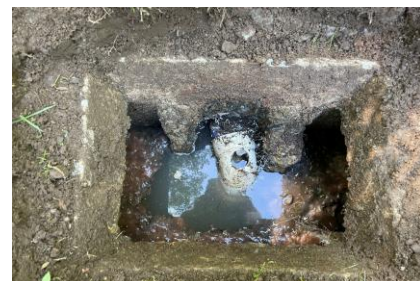
90° outlet baffle extends to tank bottom

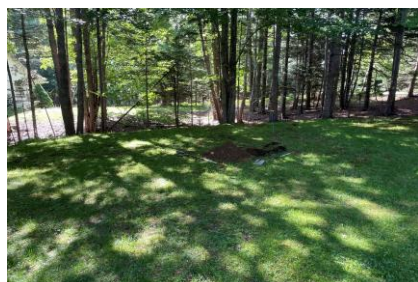
disposal area location

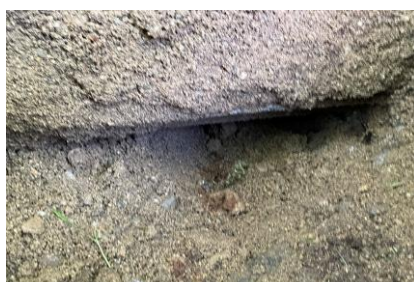
**5. Disposal Area Narratives:** A proprietary device type disposal area was present, consisting of a level 16'x28' cluster of concrete chambers with a foot width of crushed stone placed around the perimeter. An inspection site was dug exposing the side of a chamber and stone. The stone was dirty however, it was dry with no past nor present signs of biomat nor a malfunction. A camera was introduced into the chamber from a vent along its side. The chamber was found to have a clear void with no signs of roots. Ground and grass cover were satisfactory. In my opinion, this disposal area appeared to be in satisfactory operable condition on the day of the inspection.

concrete chamber
