# Inspection Report

**Property Address:**  
109 Little Ponderosa Road  
Macon NC 27551

**Cornerstone Residential Inspections, LLC.**

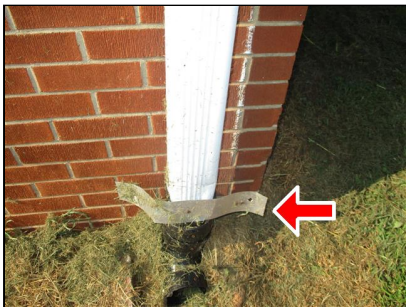
1.3 Item 1(Picture)

- 1.0 ROOF COVERINGS
- Comments: Inspected
- 1.1 FLASHINGS
- Comments: Inspected
- 1.2 SKYLIGHTS, CHIMNEYS AND ROOF PENETRATIONS
- Comments: Inspected
- 1.3 ROOF DRAINAGE SYSTEMS
- Comments: Inspected
- The downspout is loose at the right corner (facing rear). Erosion can continue or become worse if not corrected. A qualified person should repair or replace as needed.

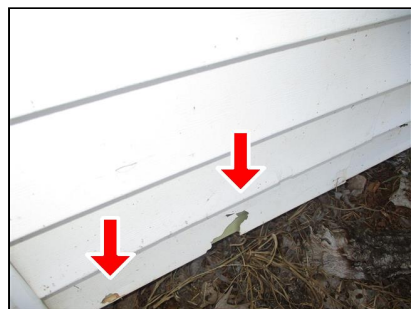
2.0 Item 1(Picture)

(1) There is numerous areas of damage to the vinyl siding and trim. Have a qualified person inspect all the siding and trim and repair or replace as needed to eliminate possible moisture intrusion.

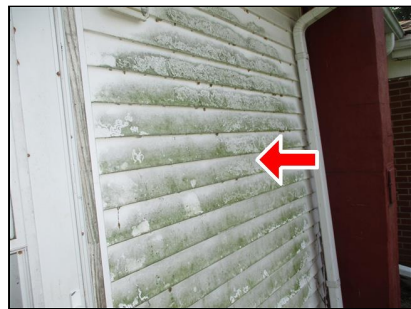
2.0 Item 8(Picture)

(2) The siding is dirty and mildewed. Have the siding power washed to remove the dirt and mildew. Have a qualified person perform the work.

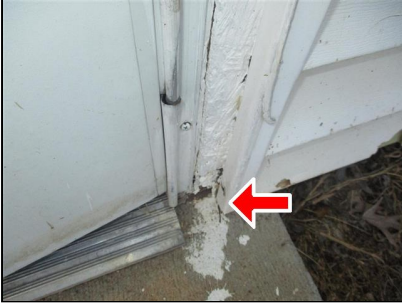
2.1 Item 1(Picture)

(1) There is moisture penetration and damage at the door frame and trim at the exterior entry door at the rear of the house. Further deterioration will occur if not corrected. Have a qualified person inspect and repair or replace as needed.

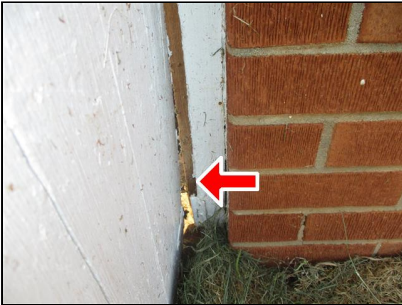
2.1 Item 2(Picture)

(2) The access door to the crawlspace is loose at door hardware,. I recommend repair as needed.

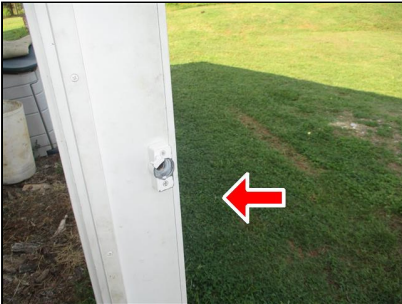
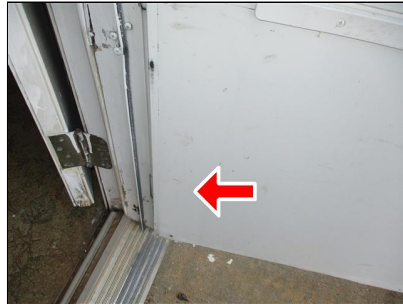
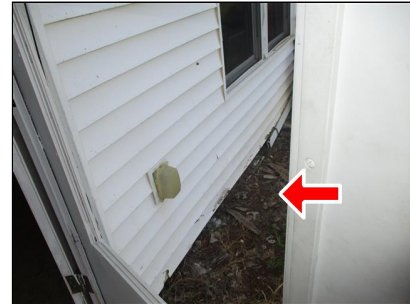
(3) The storm door at the rear of home is missing a closure, does not shut properly and has a broke glass. This is a maintenance issue and is for your information. A qualified person should repair or replace as needed.

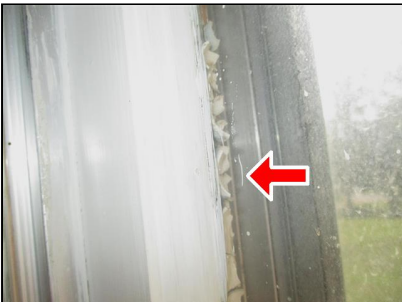
2.2 Item 1(Picture)

The glazing between glass panes are failing at some windows. The glazing is used to hold the window in place as well as reduce energy loss. Have a qualified contractor fully evaluate all the windows and repair or replace as needed to correct.

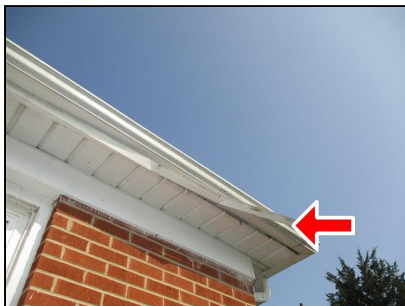
2.5 Item 1(Picture)

There is damage to the soffit and eaves at the right front side of the house. Further deterioration may occur if not corrected. Have a qualified contractor evaluate and repair or replace as needed.

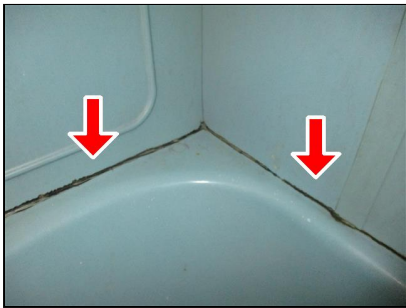
3.1 Item 1(Picture)

Caulking is needed at the tub/wall area of the hall tub. Further damage may occur if not corrected. Have a qualified person caulk and seal at the tub.

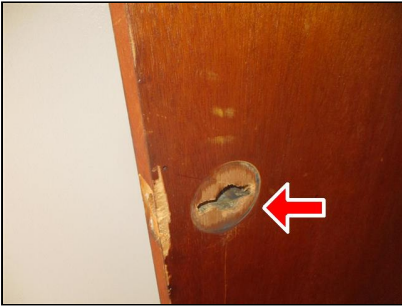
3.5 Item 2(Picture)

(2) The door hardware is missing on the bedroom door. Have a qualified person install the door for proper operation.

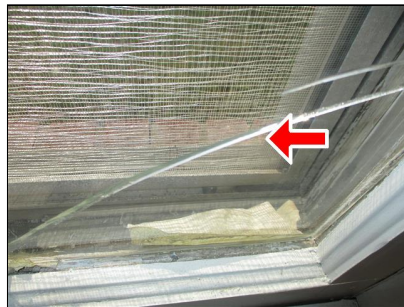
3.6 Item 2(Picture)

(1) There are cracked glass in some windows throughout home. This is a safety issue that needs to be corrected. Have a qualified contractor replace the broken glass..

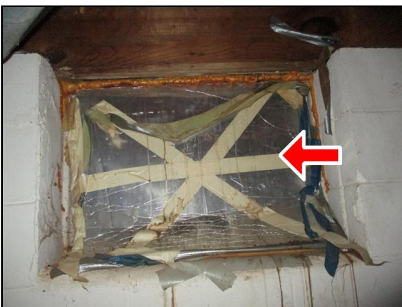
3.6 Item 4(Picture)

(2) The window at the basement is damaged and attempts have been made to seal the window. Further deterioration or moisture intrusion may occur. Have a qualified contractor repair or replace as needed to correct.

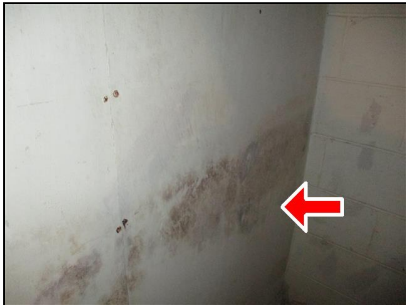
4.0 Item 1(Picture)

(1) White efflorescence (powder substance) on block wall indicates moisture is in contact with the masonry. This does not necessarily indicate that intrusion will occur. I recommend checking the gutters and the downspout drain lines for proper operation. Also, a water proofing paint could be applied to the interior side of the block if necessary. Efflorescence is found on many homes without water intrusion occurring inside the home. But, it should alert you to the possibility that future steps may be needed.

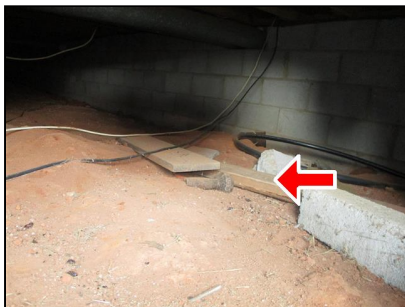
4.0 Item 2(Picture)

(2) The construction debris needs removing from the crawlspace under home. Such debris can be conducive to attract wood destroying insects which can damage the home. Have a qualified person remove the debris.

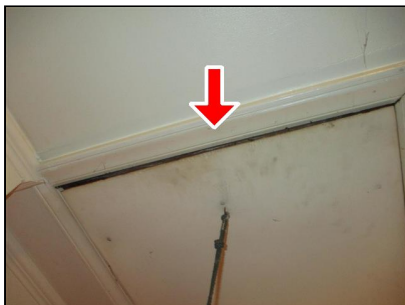
4.5 Item 1(Picture)

(1) The pull down stairs no longer shuts tight when closed. This can cause some heat loss in winter and loss of cool air in summer if not corrected Springs could be weak and needs repair or replace. A qualified person should repair or replace as needed.

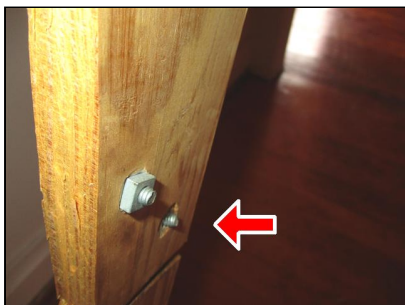
4.5 Item 2(Picture)

(2) The pull down stairs has loose hardware and is considered dangerous. Injury could result if not repaired. A qualified person should repair or replace as needed.

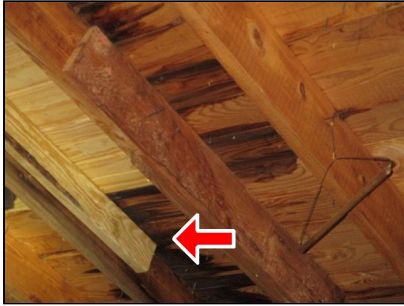
4.5 Item 3(Picture)

(3) Water signs are on plywood resulting from a roof leak found around the chimney. The leak appears to be corrected. It is recommend to monitor after a heavy rain and repair if needed.

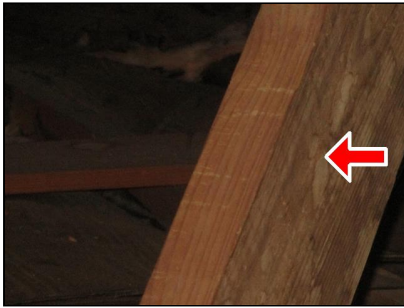
4.5 Item 4(Picture)

(4) Signs of fungi growth is present on the rafters/trusses in several areas of the attic. We did not inspect, test or determine if this growth is or is not a health hazard. The underlying cause is moisture. I recommend you contact a mold inspector or expert for investigation or correction if needed.

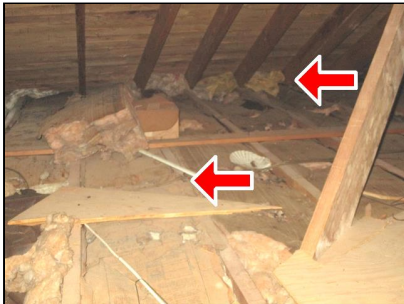
4.5 Item 6(Picture)

(5) There is homeowners personal items and debris in the attic. There is clothing shoved into the eaves area. Have a qualified person remove the items.

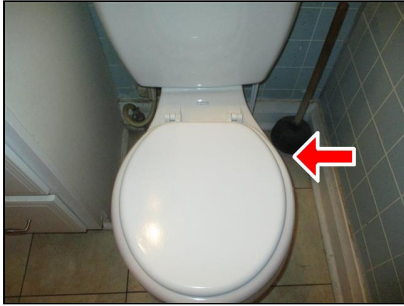
5.0 Item 2(Picture)

(2) The toilet is loose at floor at the bath. Repairs may involve re-setting the toilet on a new wax seal. I recommend a qualified licensed plumber repair or correct as needed.

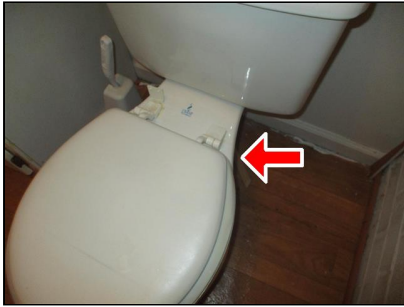
5.0 Item 3(Picture)

(3) The toilet is loose at floor at the rear bath. Repairs may involve re-setting the toilet on a new wax seal. I recommend a qualified licensed plumber repair or correct as needed.

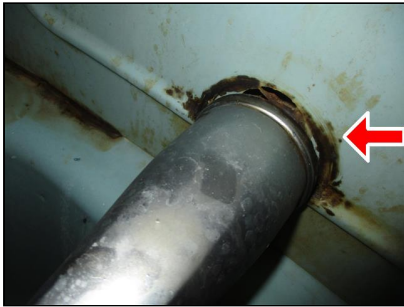
5.1 Item 1(Picture)

(1) There is exposed area around the tub spout where it meets the shower wall. Have the exposed area caulked and sealed to eliminate water intrusion.

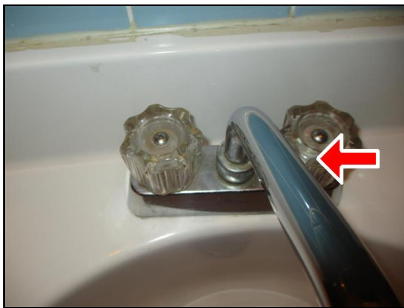
5.1 Item 2(Picture)

(2) The sink faucets is loose at the half bath. Repairs are needed. A qualified licensed plumber should repair or correct as needed.

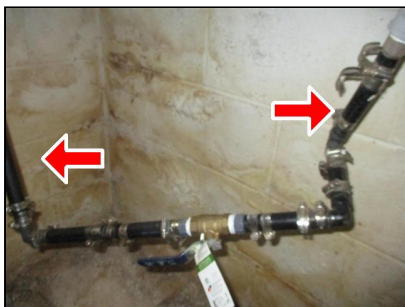
5.1 Item 4(Picture)

(4) Numerous plumbing supply lines are sagging and not properly secured to the floor joist. This may cause straining to the connections and fittings on the supply lines. Have a licensed plumber inspect and properly secure the lines as needed.

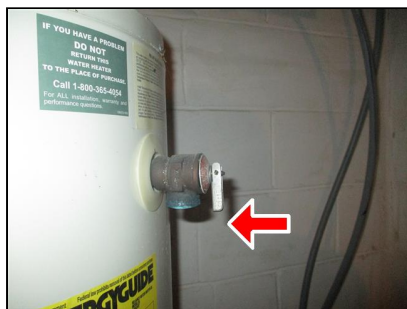
5.2 Item 1(Picture)

(1) The T&P (Test and Pressure) valve on water heater needs a 3/4 threaded pipe to extend within 6 inches of floor for safety. (PVC is not approved for hot water use). I recommend repair by a qualified person.

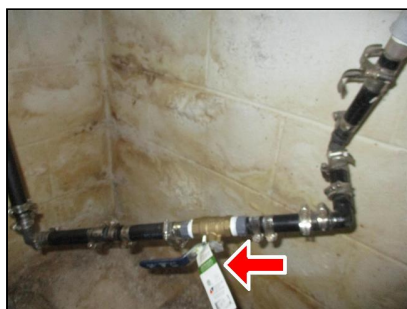
5.3 Item 1(Picture)

The main shut off is the black lever located in the basement. This is for your information.

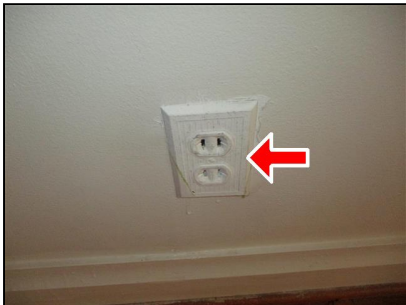
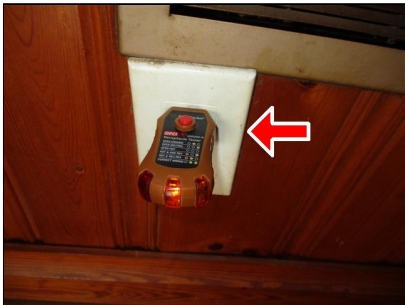
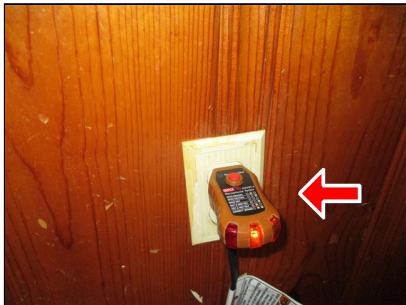
(1) There are 2 prong outlets in the house. This usually indicates that the house is not grounded. There are numerous 3 prong outlets that are not properly grounded. This is a safety issue that needs to be corrected. Have a licensed electrician inspect and repair or replace as needed.

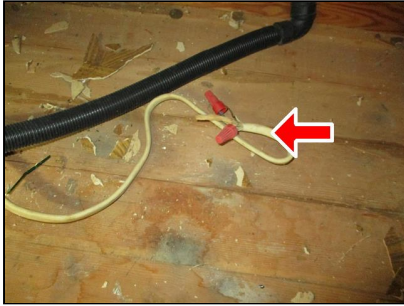
6.3 Item 4(Picture)

(2) There is an exposed wire that is improperly terminated in the kitchen where the dishwasher was removed. This is a safety issue that needs to be corrected. Have a licensed electrician cap the wires and install a junction box and cover.

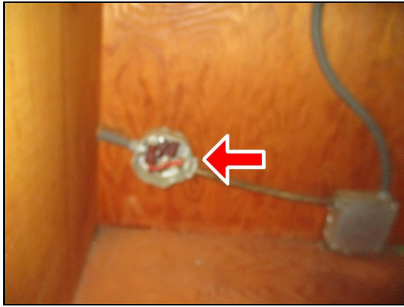
6.3 Item 5(Picture)

(3) There is an open junction box under the kitchen cabinet. This is a safety issue that needs to be corrected. Have a qualified person install a proper cover.

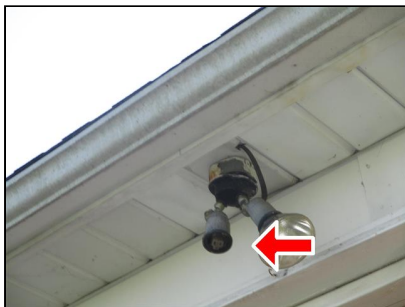
6.3 Item 9(Picture)

(6) The light fixture at the left front corner of the eaves did not function. Have a qualified person replace the bulb and assure the proper operation of the fixture.

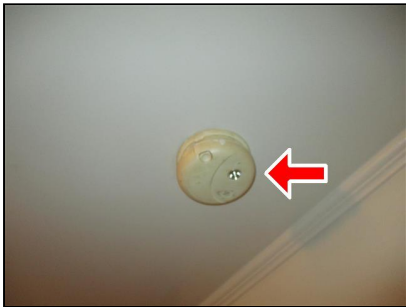
6.6 Item 1(Picture)

Smoke detectors are checked for operation by using the test button. This does not evaluate the proper operation of the detector unless tested by means of gas or smoke. This company does not test with gas or smoke but can only assure that the batteries in the detectors are functional.. Recommend changing the batteries every 6 months. Manufacturers recommend changing detectors after 10 year. This is for your information.

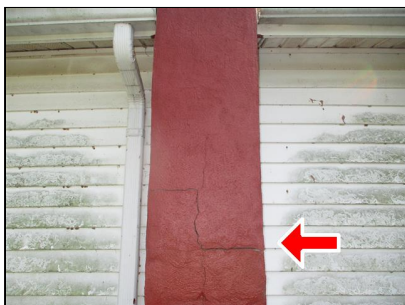
7.5 Item 1(Picture)

There is evidence of settlement and separation to the masonry blocks for the chimney at the addition. This may indicate damage to the flue liner as well. This can be a safety issue that needs to be corrected. Have the chimney further evaluated by a licensed structural contractor or engineer. Further evaluation may be needed by a chimney sweep.

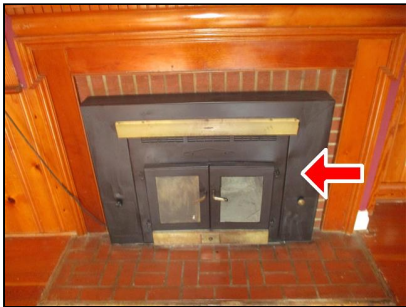
7.6 Item 1(Picture)

(1) There is a woodstove installed in the home. The woodstove was not inspected by this company. Recommend further inspection and evaluation by a qualified chimney sweep.

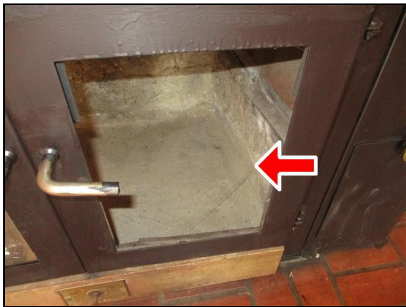
7.6 Item 3(Picture)

(2) The glass door at the right side of the wood stove in the living room. Have a qualified person install the glass for safety.

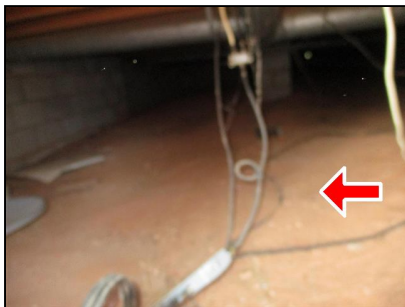
8.2 Item 1(Picture)

Missing vapor barrier in the crawlspace. Recommend installing 6 mil plastic barrier to cover the exposed ground area. Have the vapor barrier installed by a qualified contractor.

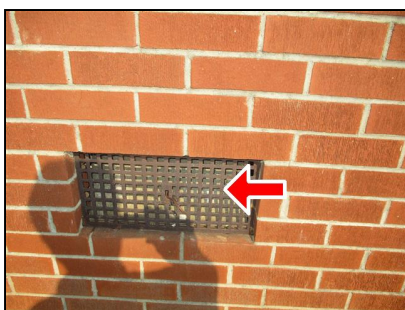
8.3 Item 1(Picture)

The screening material is missing from numerous foundation vents. Recommend installing new screening material or replace the vents to eliminate insect intrusion. Have the work done by a qualified person.

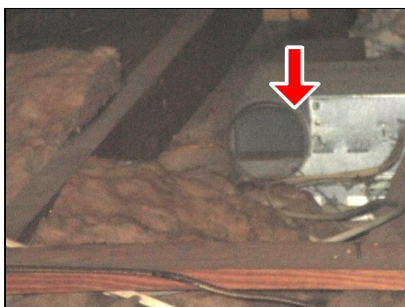
8.4 Item 1(Picture)

The Exhaust fan does not vent to outside at the hall bath. Vent pipes should terminate outside and not in the attic. Many homes have their vent pipe poised at the roof vent such as yours. It is up to you to determine whether or not this is a concern or needs further consideration from a general contractor. A qualified person should repair or replace as needed.

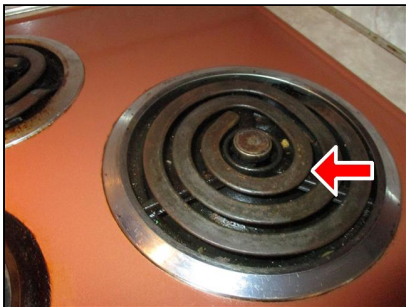
9.0 Item 1(Picture)

(1) The front right coil element for the stove did not work when tested. I recommend repair as needed.

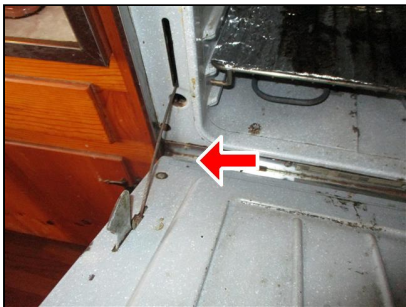
9.0 Item 2(Picture)

(2) The oven door for oven is damaged, the door springs do not function as designed and the door will drop. I recommend repair as needed.

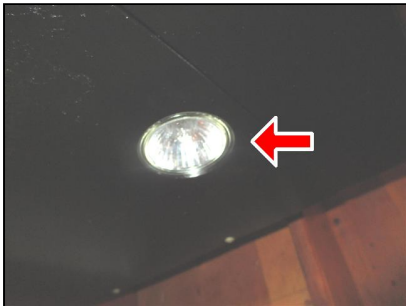
9.1 Item 1(Picture)

(1) The light bulb for fan did not work when tested. I recommend repair or replace as needed.

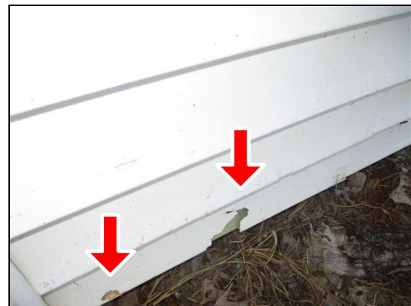
Item 1 - Item 1(Picture)

- 1
- (1) There is numerous areas of damage to the vinyl siding and trim. Have a qualified person inspect all the siding and trim and repair or replace as needed to eliminate possible moisture intrusion.

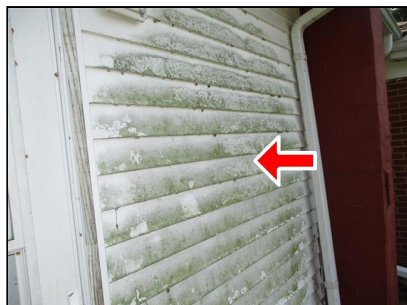
Item 2 - Item 1(Picture)

- 2 (2) The siding is dirty and mildewed. Have the siding power washed to remove the dirt and mildew. Have a qualified person perform the work.

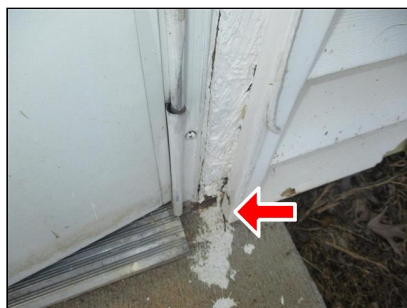
Item 3 - Item 1(Picture)

- 3 (1) There is moisture penetration and damage at the door frame and trim at the exterior entry door at the rear of the house. Further deterioration will occur if not corrected. Have a qualified person inspect and repair or replace as needed.

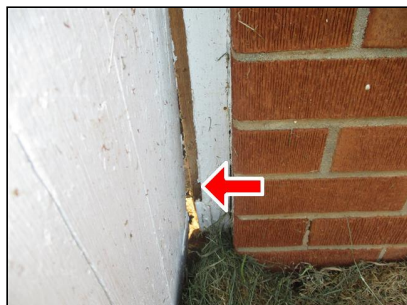
Item 4 - Item 1(Picture)

- 4 (2) The access door to the crawlspace is loose at door hardware,. I recommend repair as needed.

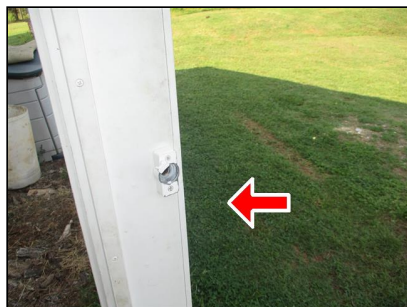
Item 5 - Item 1(Picture)

- 5 (3) The storm door at the rear of home is missing a closure, does not shut properly and has a broke glass. This is a maintenance issue and is for your information. A qualified person should repair or replace as needed.

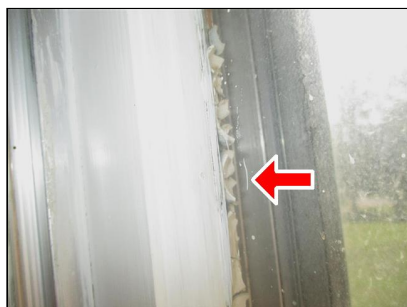
Item 6 - Item 1(Picture)

- 6 The glazing between glass panes are failing at some windows. The glazing is used to hold the window in place as well as reduce energy loss. Have a qualified contractor fully evaluate all the windows and repair or replace as needed to correct.

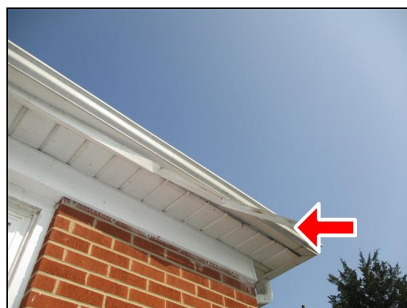
Item 7 - Item 1(Picture)

- 7 There is damage to the soffit and eaves at the right front side of the house. Further deterioration may occur if not corrected. Have a qualified contractor evaluate and repair or replace as needed.

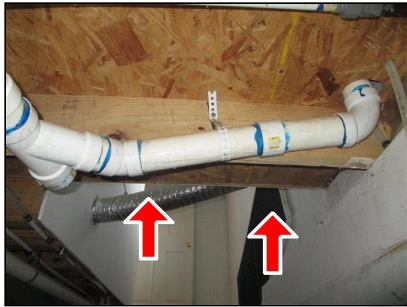
Item 8 - Item 1(Picture)

- 8 The head clearance is inadequate and does not conform to the usual industry standards. Also there is no handrail for the steps. This is a safety issue and further evaluation by a contractor should be done. Repair or replace as needed.

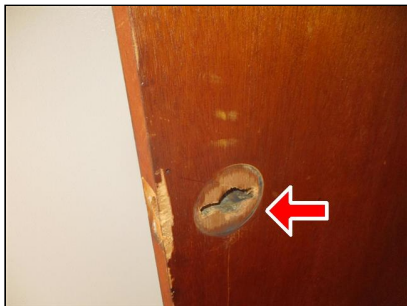
Item 10 - Item 1(Picture)

- 10 (2) The door hardware is missing on the bedroom door. Have a qualified person install the door for proper operation.

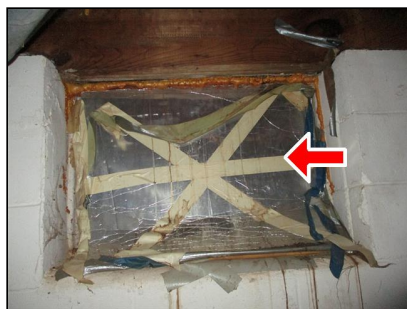
Item 12 - Item 1(Picture)

- 12 (2) The window at the basement is damaged and attempts have been made to seal the window. Further deterioration or moisture intrusion may occur. Have a qualified contractor repair or replace as needed to correct.

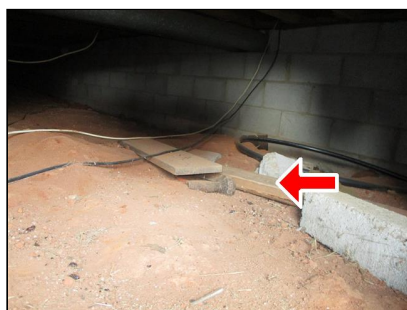
Item 14 - Item 1(Picture)

- 14 (2) The construction debris needs removing from the crawlspace under home. Such debris can be conducive to attract wood destroying insects which can damage the home. Have a qualified person remove the debris.

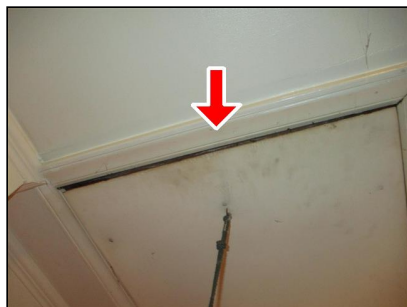
Item 15 - Item 1(Picture)

- 15 (1) The pull down stairs no longer shuts tight when closed. This can cause some heat loss in winter and loss of cool air in summer if not corrected Springs could be weak and needs repair or replace. A qualified person should repair or replace as needed.

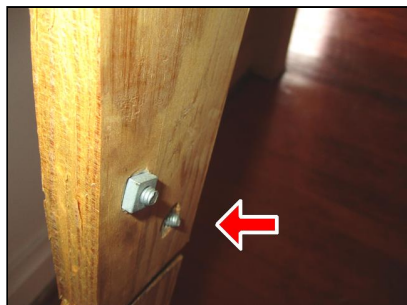
Item 16 - Item 1(Picture)

- 16 (2) The pull down stairs has loose hardware and is considered dangerous. Injury could result if not repaired. A qualified person should repair or replace as needed.

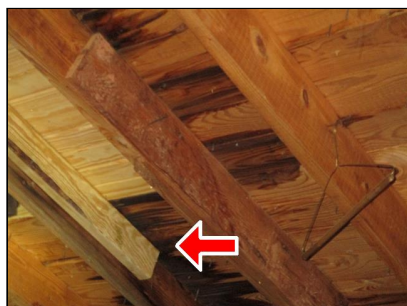
Item 17 - Item 1(Picture)

- 17 (3) Water signs are on plywood resulting from a roof leak found around the chimney. The leak appears to be corrected. It is recommend to monitor after a heavy rain and repair if needed.

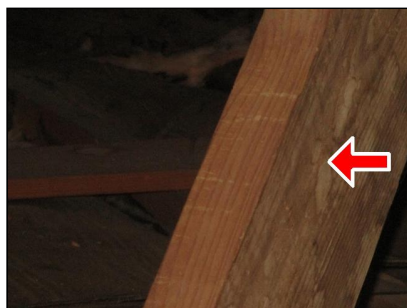
Item 18 - Item 1(Picture)

- 18 (4) Signs of fungi growth is present on the rafters/trusses in several areas of the attic. We did not inspect, test or determine if this growth is or is not a health hazard. The underlying cause is moisture. I recommend you contact a mold inspector or expert for investigation or correction if needed.

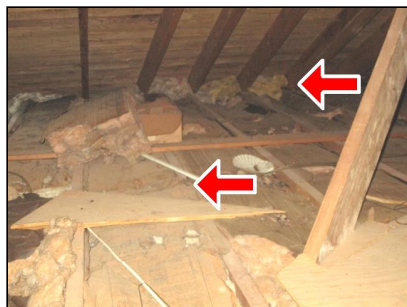
Item 19 - Item 1(Picture)

- 19 (5) There is homeowners personal items and debris in the attic. There is clothing shoved into the eaves area. Have a qualified person remove the items.

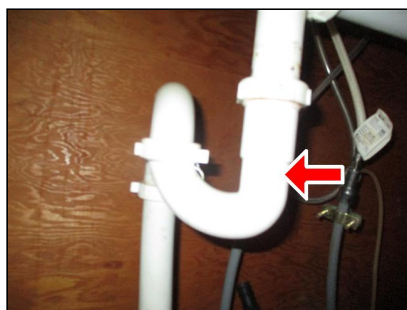
Item 21 - Item 1(Picture)

- 21 (1) The waste line has a S-trap, and should be changed to a P-trap and "Auto-vent" at the Kitchen sink. Repairs are needed. A qualified licensed plumber should repair or correct as needed.

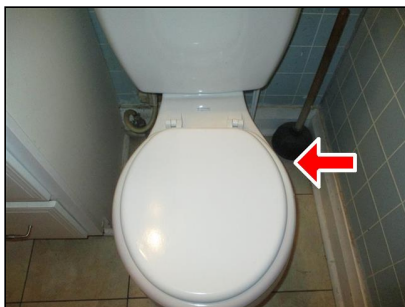
Item 22 - Item 1(Picture)

- 22 (2) The toilet is loose at floor at the bath. Repairs may involve re-setting the toilet on a new wax seal. I recommend a qualified licensed plumber repair or correct as needed.

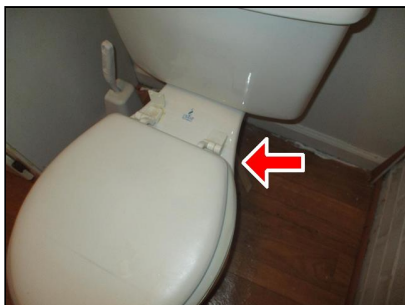
Item 23 - Item 1(Picture)

- 23** (3) The toilet is loose at floor at the rear bath. Repairs may involve re-setting the toilet on a new wax seal. I recommend a qualified licensed plumber repair or correct as needed.

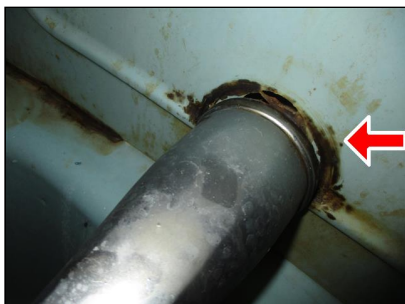
Item 24 - Item 1(Picture)

- 24** (1) There is exposed area around the tub spout where it meets the shower wall. Have the exposed area caulked and sealed to eliminate water intrusion.

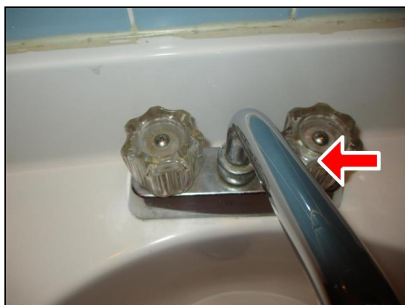
Item 25 - Item 1(Picture)

- 25** (2) The sink faucets is loose at the half bath. Repairs are needed. A qualified licensed plumber should repair or correct as needed.

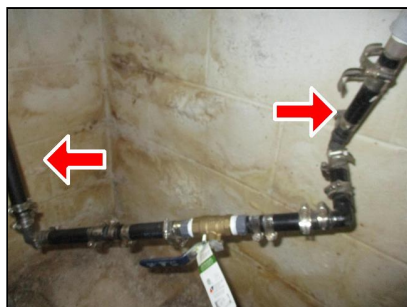
Item 27 - Item 1(Picture)

- 27 (4) Numerous plumbing supply lines are sagging and not properly secured to the floor joist. This may cause straining to the connections and fittings on the supply lines. Have a licensed plumber inspect and properly secure the lines as needed.

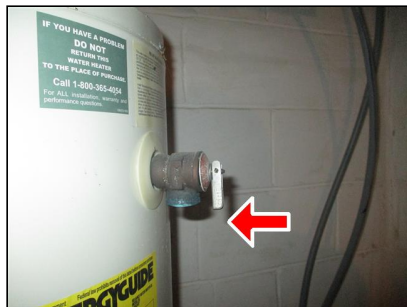
Item 29 - Item 1(Picture)

- 29 (1) The T&P (Test and Pressure) valve on water heater needs a 3/4 threaded pipe to extend within 6 inches of floor for safety. (PVC is not approved for hot water use). I recommend repair by a qualified person.

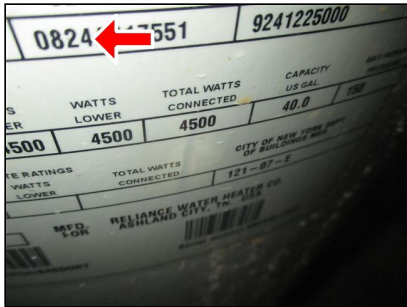
Item 30 - Item 1(Picture)

- 30 (2) Water heater manufacturers label - Reliance - 2008. The unit was functional at the time of the inspection. This is for your information.

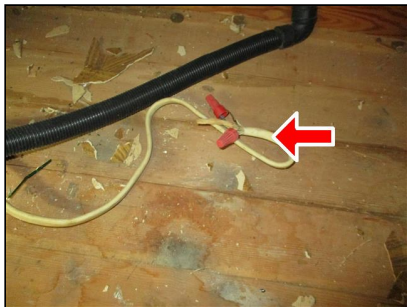
Item 32 - Item 1(Picture)

- 32 (2) There is an exposed wire that is improperly terminated in the kitchen where the dishwasher was removed. This is a safety issue that needs to be corrected. Have a licensed electrician cap the wires and install a junction box and cover.

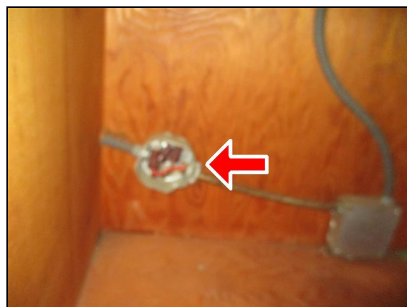
Item 33 - Item 1(Picture)

- 33 (3) There is an open junction box under the kitchen cabinet. This is a safety issue that needs to be corrected. Have a qualified person install a proper cover.

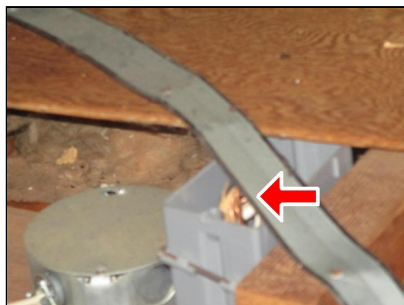
Item 34 - Item 2(Picture)

- 34 (4) There is an open junction box in the attic. This is a safety issue that needs to be corrected. Have a qualified person install a proper cover.

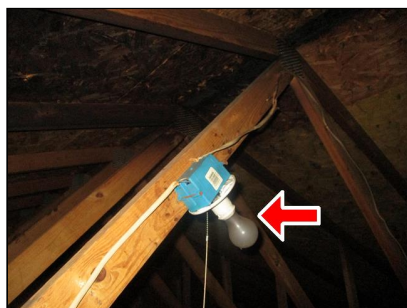
Item 35 - Item 1(Picture)

- 35 (5) The light fixture in the attic is not working. This is a safety issue that needs to be corrected. Have a qualified person install a bulb and assure the operation of the fixture.

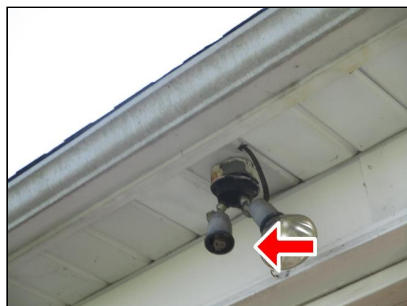
Item 36 - Item 1(Picture)

- 36 (6) The light fixture at the left front corner of the eaves did not function. Have a qualified person replace the bulb and assure the proper operation of the fixture.

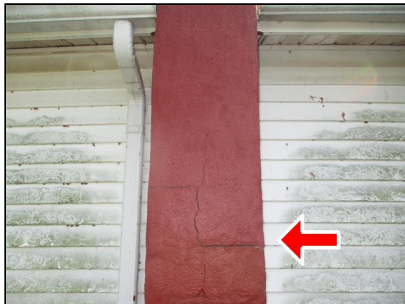
Item 39 - Item 1(Picture)

- 39
- There is evidence of settlement and separation to the masonry blocks for the chimney at the addition. This may indicate damage to the flue liner as well. This can be a safety issue that needs to be corrected. Have the chimney further evaluated by a licensed structural contractor or engineer. Further evaluation may be needed by a chimney sweep.

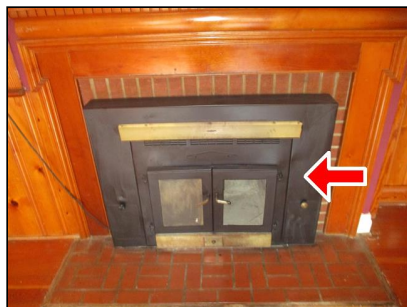
Item 40 - Item 1(Picture)

- 40
- (1) There is a woodstove installed in the home. The woodstove was not inspected by this company. Recommend further inspection and evaluation by a qualified chimney sweep.

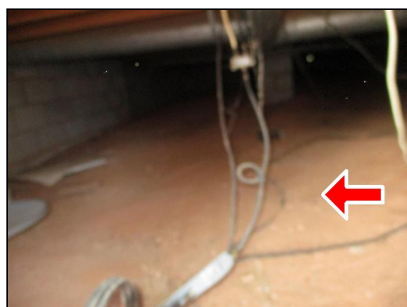
Item 42 - Item 1(Picture)

- 42 Missing vapor barrier in the crawlspace. Recommend installing 6 mil plastic barrier to cover the exposed ground area. Have the vapor barrier installed by a qualified contractor.

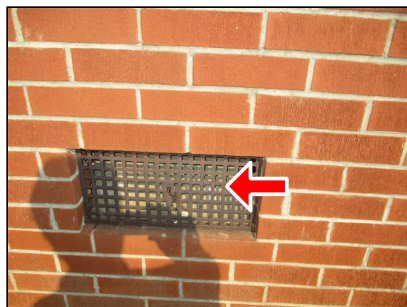
Item 43 - Item 1(Picture)

- 43 The screening material is missing from numerous foundation vents. Recommend installing new screening material or replace the vents to eliminate insect intrusion. Have the work done by a qualified person.

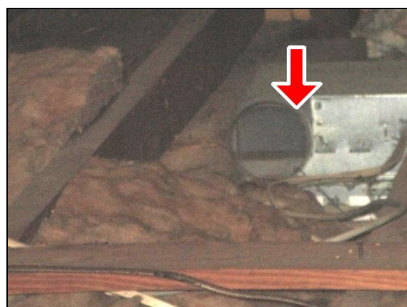
Item 44 - Item 1(Picture)

- 44** The Exhaust fan does not vent to outside at the hall bath. Vent pipes should terminate outside and not in the attic. Many homes have their vent pipe poised at the roof vent such as yours. It is up to you to determine whether or not this is a concern or needs further consideration from a general contractor. A qualified person should repair or replace as needed.

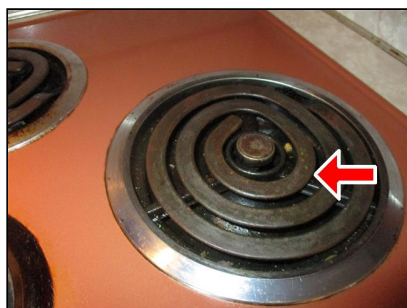
Item 45 - Item 1(Picture)

- 45** (1) The front right coil element for the stove did not work when tested. I recommend repair as needed.

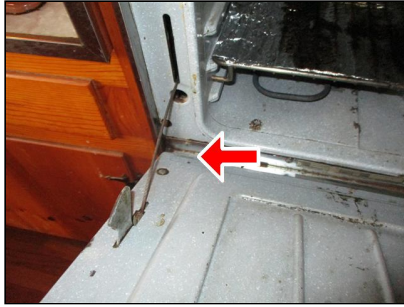
Item 46 - Item 1(Picture)

- 46** (2) The oven door for oven is damaged, the door springs do not function as designed and the door will drop. I recommend repair as needed.

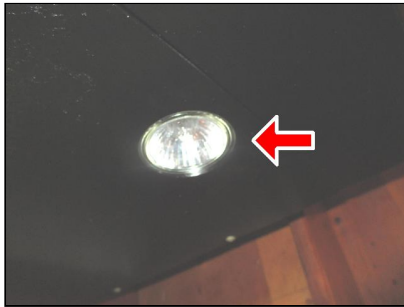
Item 47 - Item 1(Picture)

- 47 (1) The light bulb for fan did not work when tested. I recommend repair or replace as needed.
