NEST EGG HOME SERVICES, LLC

## RESIDENTIAL REPORT

602 Williamsboro St  
Oxford, Nc 27565

Tyler Woodside  
03/17/2026

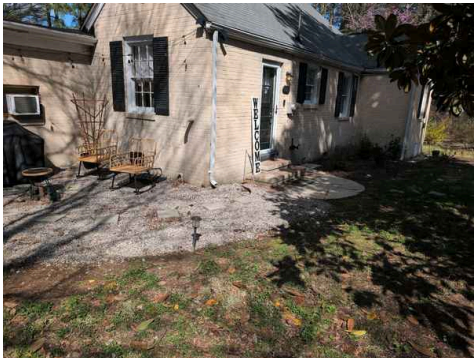
Back

Grading was inspected. Grading is sloping towards the home in some areas. This can lead to water intrusion and foundation issues. Contact a qualified contractor to repair.

Contact a qualified landscaping, grading, tree contractor

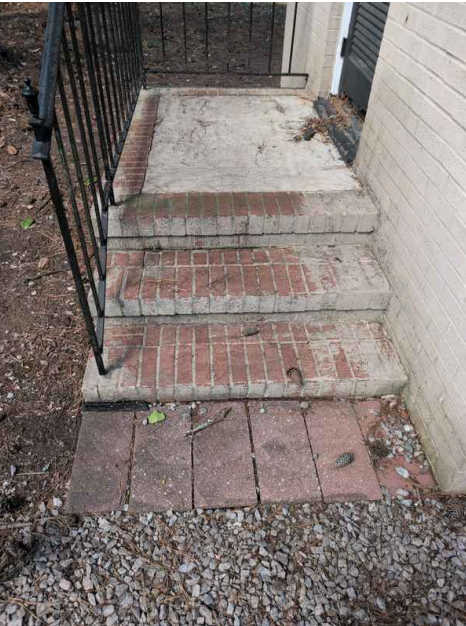
Left

DETERIORATED MORTAR

Inspected steps. There are areas of deteriorated/separated mortar joints at the steps. This can cause brick/stone to break free and allow moisture infiltration. Contact a qualified contractor to repair.

Contact a qualified general contractor.

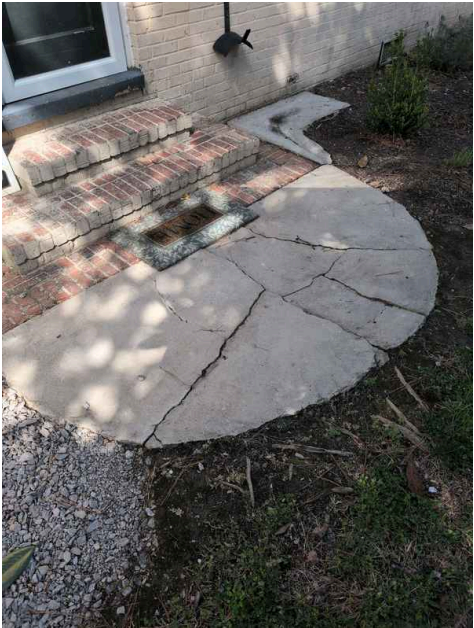
Back

CONCRETE CRACKING

Exterior was inspected. Cracking was observed on concrete. This can get worse over time, creating function issues. Contact a qualified contractor to repair.

Contact a qualified concrete / driveway contractor

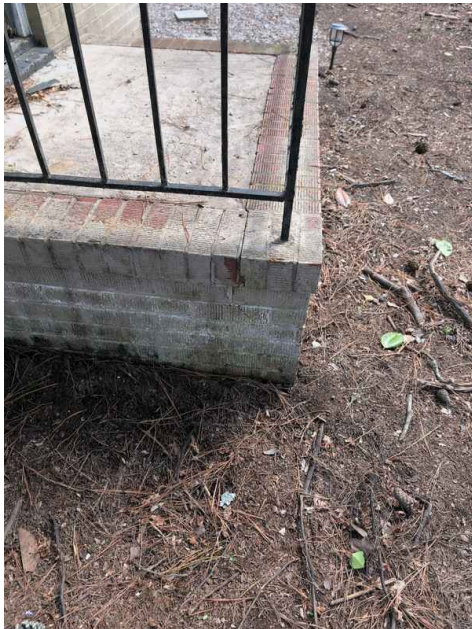
Left

**PORCH FOUNDATION CRACKS**

Inspected front porch. There are cracks in the porch foundation. This can lead to further deterioration. Contact a qualified contractor to repair.

Contact a qualified general contractor.

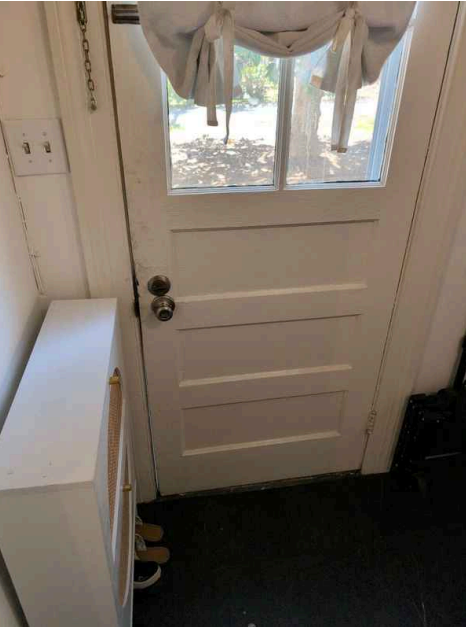
Back

**AIR LEAKAGE AROUND EXTERIOR DOORS**

Exterior doors were inspected. There are one or more entry doors that have gaps around the frame. This can allow air, water and/or wildlife intrusion. Contact a qualified contractor to repair.

Contact a qualified general contractor.

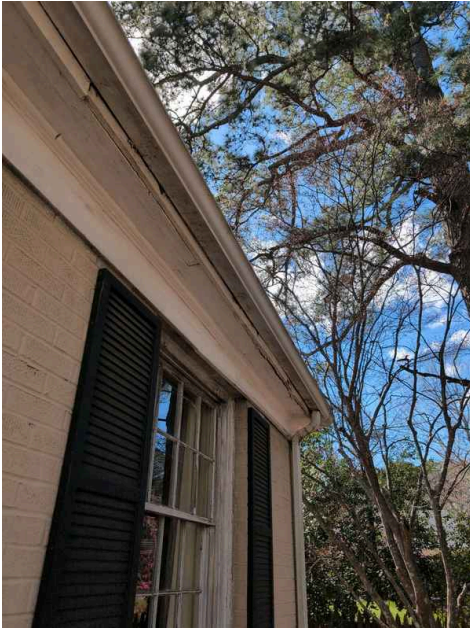
Front

##### **EAVES, FASCIA & SOFFIT- DAMAGED**

Inspected soffit and fascia system. One or more sections of the eaves/fascia system are damaged. This can allow moisture and/or wildlife into the structure area. Contact a qualified contractor to repair.

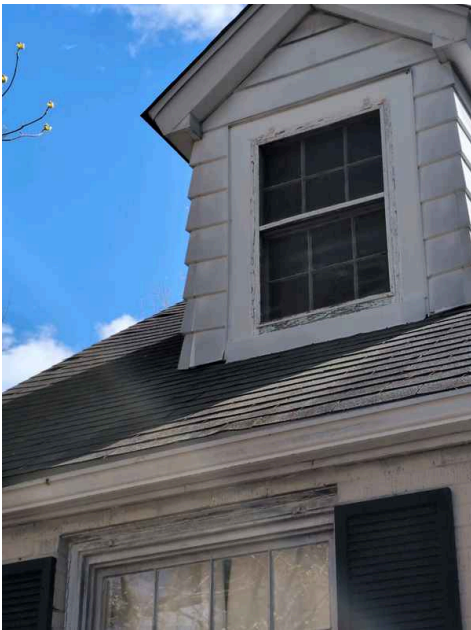
Front

**LOOSE SIDING/TRIM**

Inspected siding and/or trim. There are one or more areas around the home where the siding is not properly secure. This can allow the siding/trim to become detached during high winds and allow moisture penetration in the affected area. Contact a qualified contractor to repair.

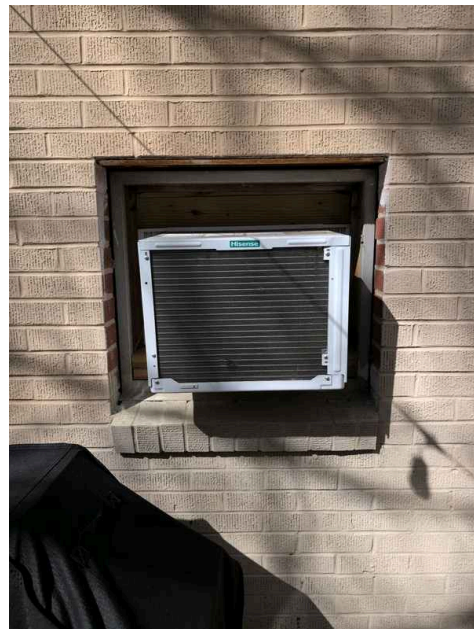
Back

**IMPROPER TRIM/SEALANT**

Inspected exterior of the home. There is improper trim/sealant on one or more sidewall penetrations on the exterior of the home. Improper trim/sealant can allow moisture into the wall structure and cause damage. Contact a qualified contractor to repair.

Contact a qualified general contractor.

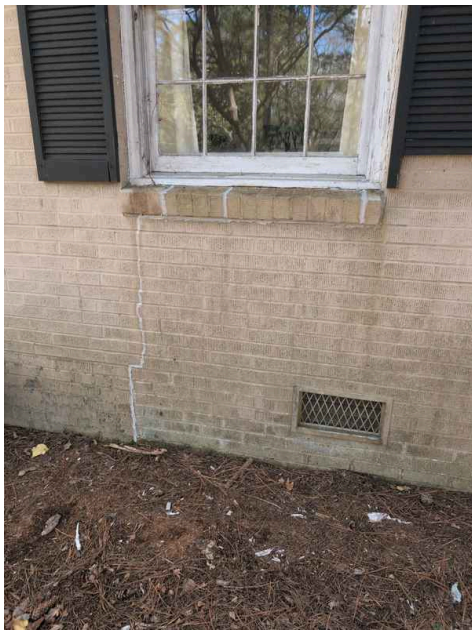
Front

### CRACKS IN BRICK VENEER

Inspected brick veneer. There is cracking at areas of the home. This can allow moisture infiltration and/or be sign of excessive movement. Contact a qualified contractor to repair.

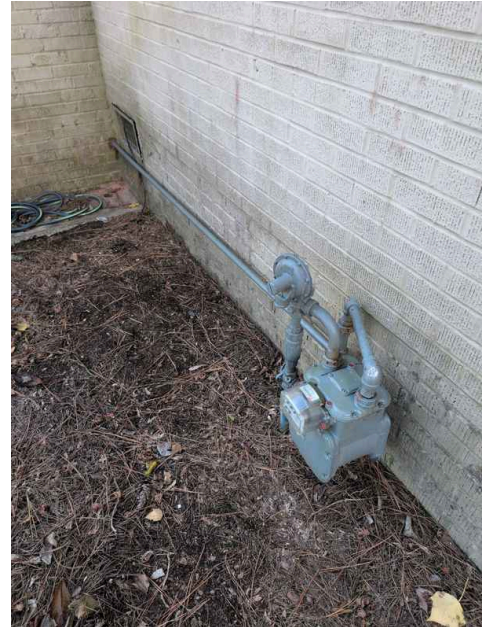
Inspected fuel distribution lines. Gas pipes does not show any signs of being bonded to the home electrical system. Energized gas lines can cause an arcing concern. Contact a qualified contractor to repair.

Contact a qualified electrical contractor.

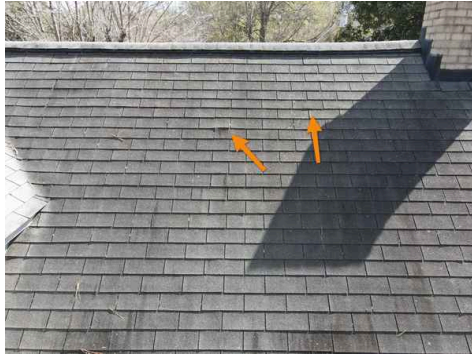
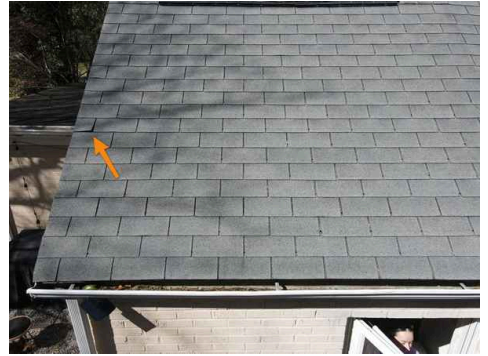
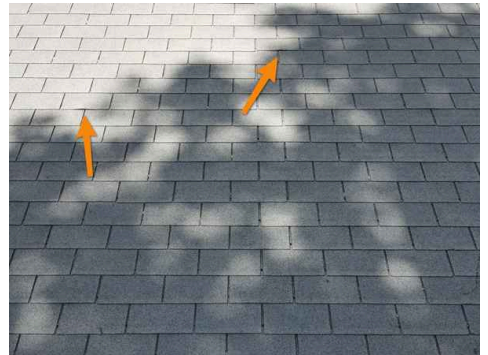
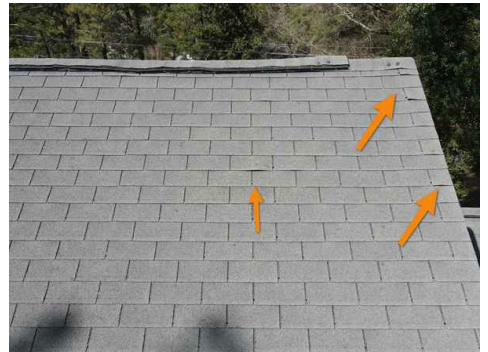
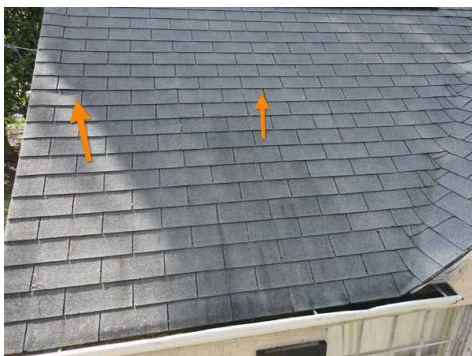
**RAISED SHINGLES**

Inspected roof coverings. There are one or more areas of raised shingles. This can cause damage to the shingles during high winds. Contact a qualified contractor to repair.

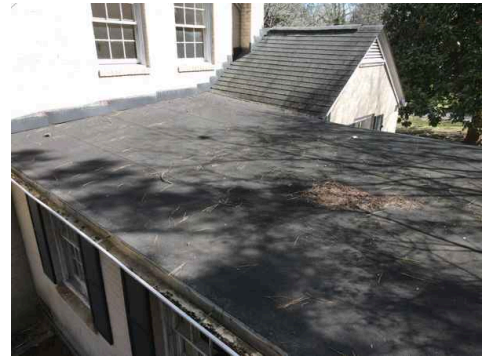
**DEBRIS ON ROOF**

Inspected roof coverings. There is debris on areas of the roof. This can damage roof coverings and prevent proper water shedding, cause leaks, and also limits inspection. Contact a qualified contractor to repair.

Contact a qualified general contractor.

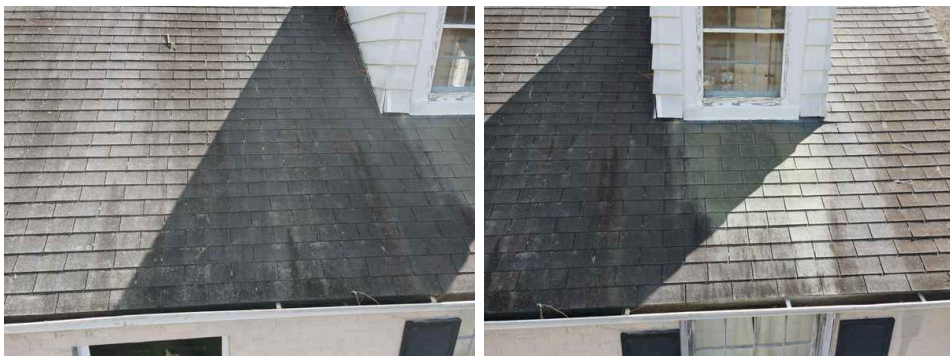
#### **DISCOLORATION**

Inspected roof. Roof shingles were discolored, which can be caused by moisture, rust or soot. This can lead to damage and leaks. Contact a qualified contractor to repair.

Contact a qualified roofing contractor

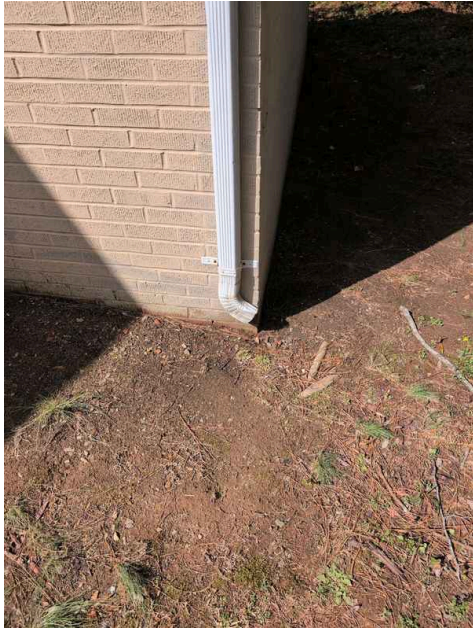
Right

Gutter system was inspected. One or more downspouts drain too close to the home's foundation. This can result in excessive moisture in the soil at the foundation, which can lead to foundation/structural movement. Contact a qualified contractor to repair.

Recommendation  
Contact a qualified general contractor.

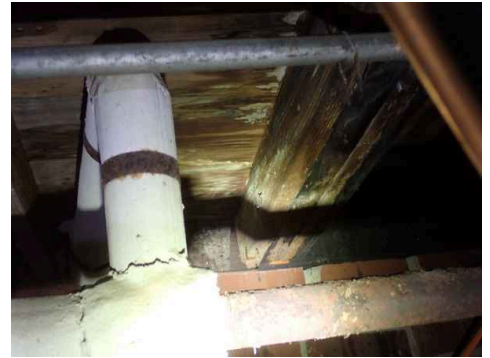
Under 1st Floor Bathroom

Floor structure was inspected. There are signs of fungal growth in one or more areas. Certain types of growth can damage floor structure materials. Contact a qualified contractor to repair.

Contact a qualified environmental contractor

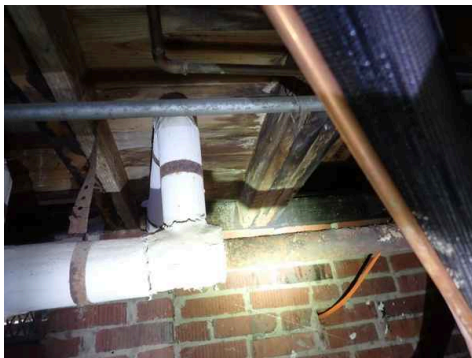
Under 1st Floor Bathroom

**MOISTURE DAMAGED SUB FLOOR**

Inspected floor structure. There is moisture damaged sub floor. This can cause deterioration and movement of flooring structure. Contact a qualified contractor to repair.

Contact a qualified general contractor.

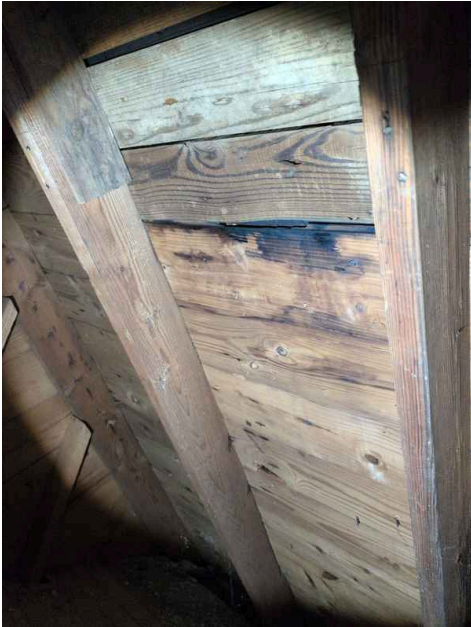
**MOISTURE STAINS ON ROOF STRUCTURE**

Inspected attic structure. There appears to be signs of moisture intrusion on attic structure. This can decrease the integrity of the roof support if cause is not corrected. Contact a qualified contractor to repair.

Contact a qualified roofing contractor

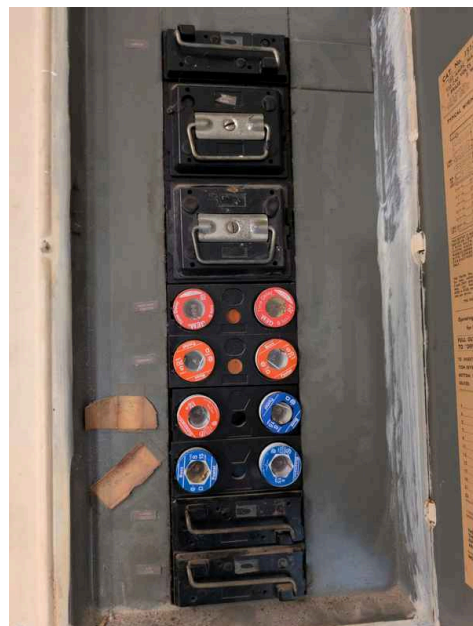
Inspected the electrical panel. There are fuses that are not labeled. This can cause a safety hazard to contractors working with fuses and wiring. Contact a qualified contractor to repair.

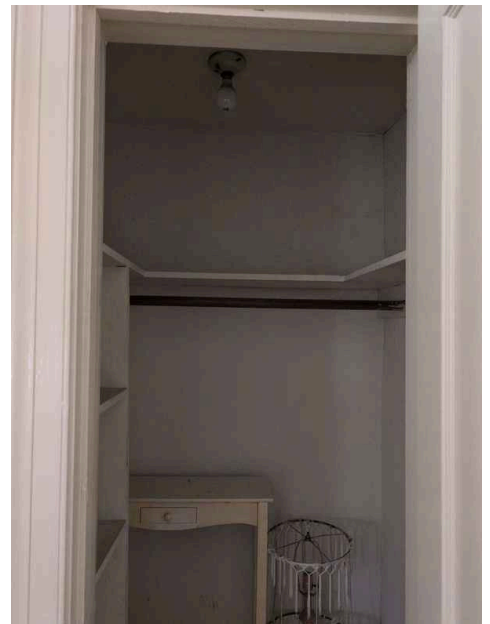
2nd Floor Left Bedroom Closet

Electrical was inspected. A light is not attached to switch. This can make it difficult to operate light. Contact a qualified contractor to repair.

Contact a qualified electrical contractor.

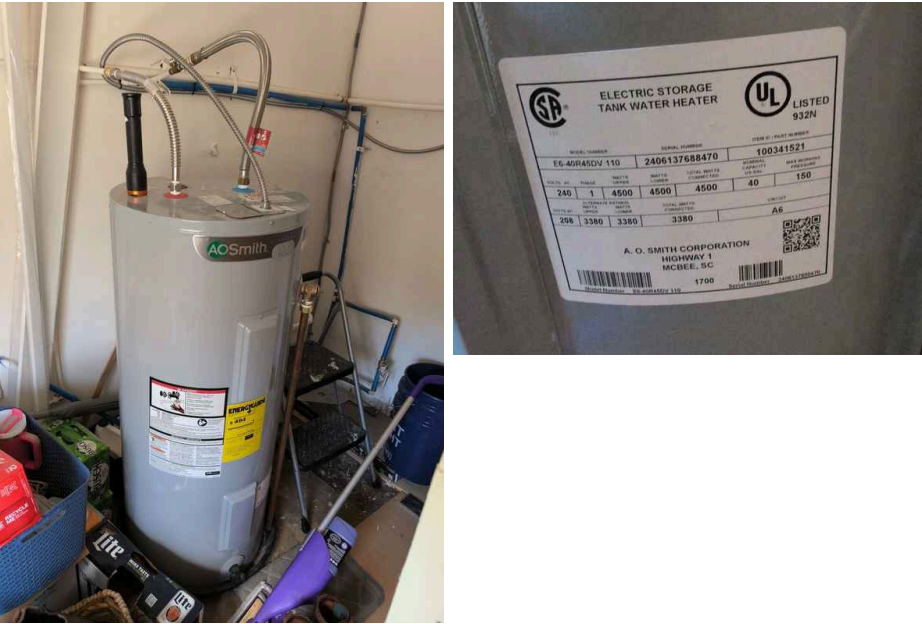
Water Heater: Pictures of water heater

Pictures for informational purposes only.

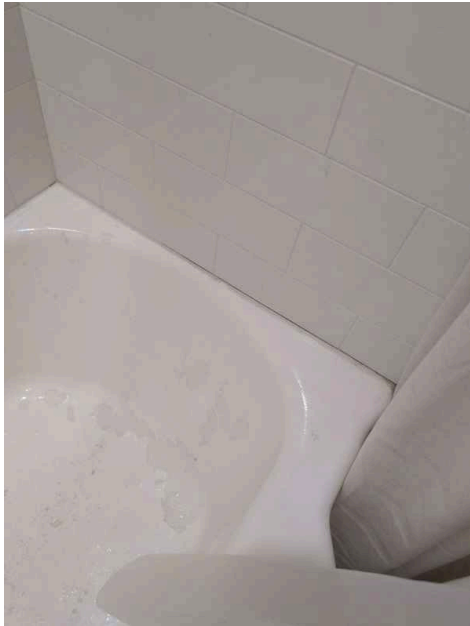
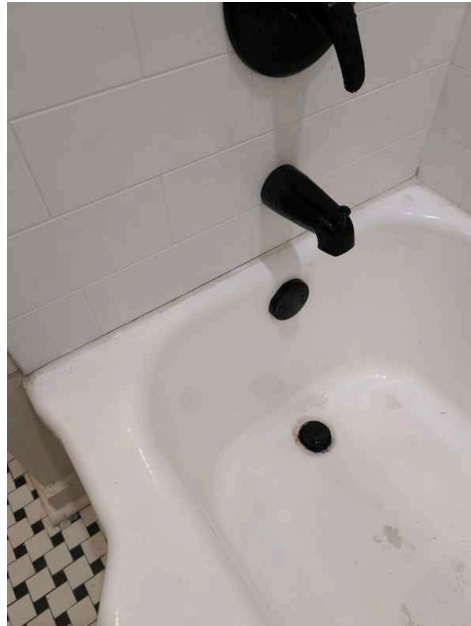
1st Floor Bathroom

Inspected bathrooms. There are one or more areas where there are gaps between materials. This can allow moisture behind the wall and to subfloor below causing damage. Contact a qualified contractor to repair.

Contact a qualified general contractor.

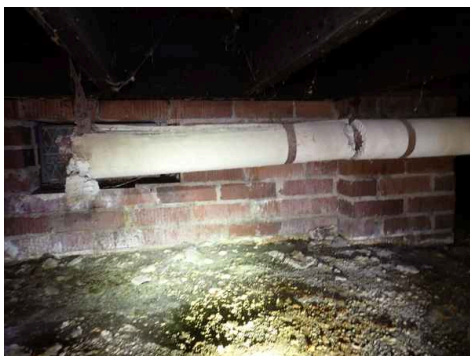
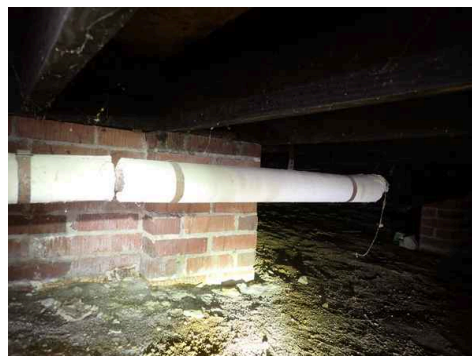
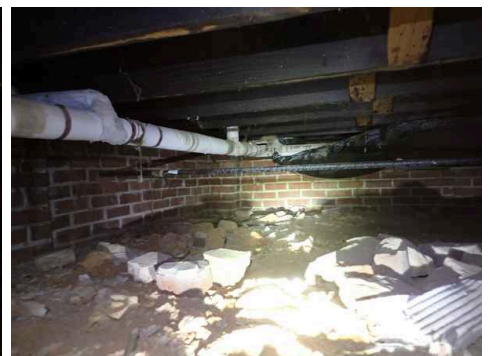
**POSSIBLE HAZARDOUS PIPE INSULATION MATERIAL**

Plumbing was inspected. There is white ridged insulation present on piping. The pipe insulation appears to be asbestos. This insulating material is a known health hazard if disturbed. Contact a qualified contractor to repair.

Contact a qualified environmental contractor

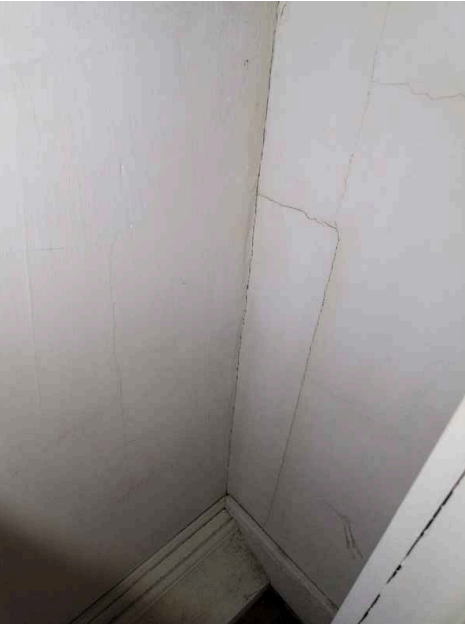
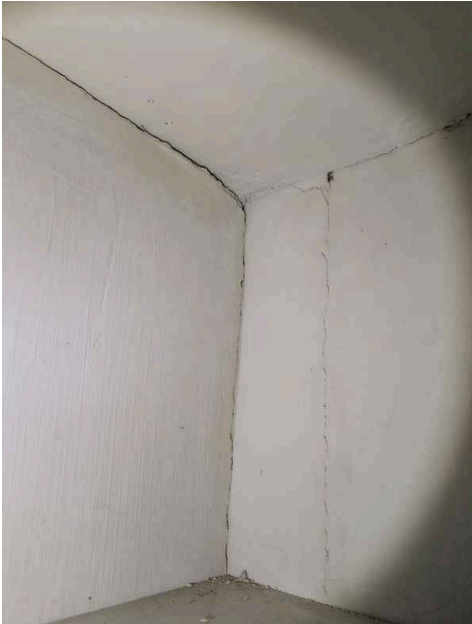
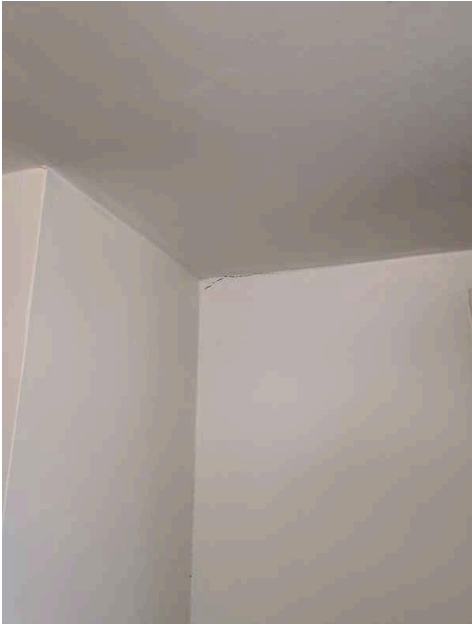
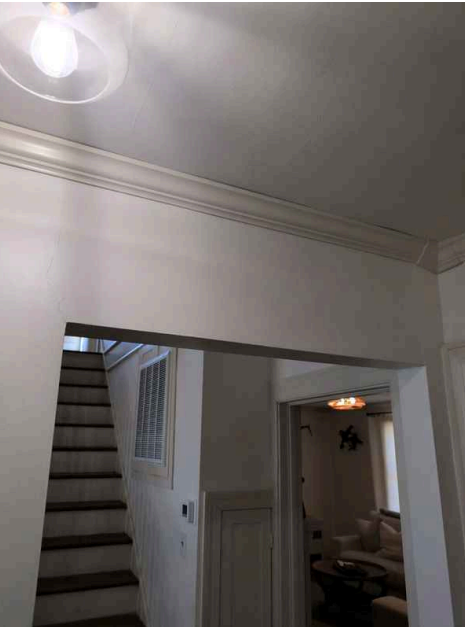
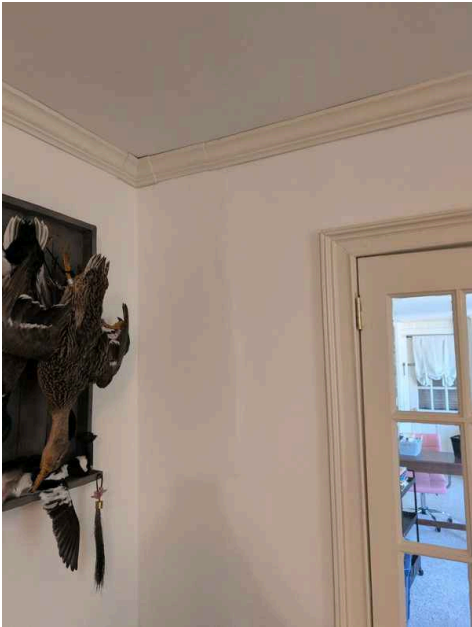
2nd Floor Right Bedroom Closet

WALL CRACKING

Inspected interior walls. There are one or more areas of cracks in the wall. This can get worse over time allowing for issues with support. Contact a qualified contractor to repair.

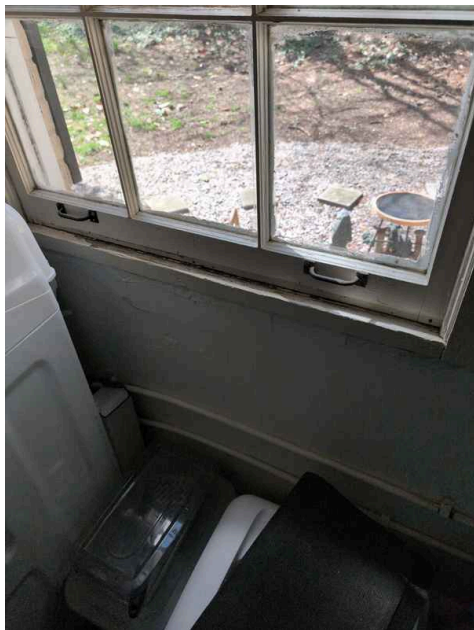
Laundry

WALL DAMAGE

Interior walls were inspected. There are one or more areas of damaged wall material. This can cause support issues and/or allow debris in to wall cavity. Contact a qualified contractor to repair.

Contact a qualified general contractor.

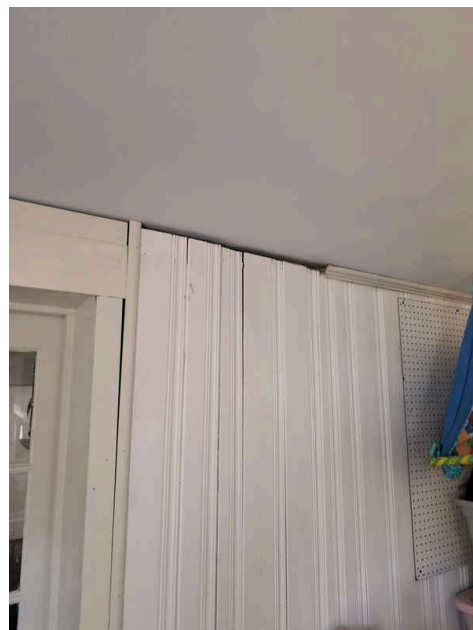
Bonus Room

**LOOSE/MISSING TRIM**

Inspected interior walls/trim. There is loose/missing trim. This can allow debris to get behind wall/flooring. Contact a qualified contractor to repair.

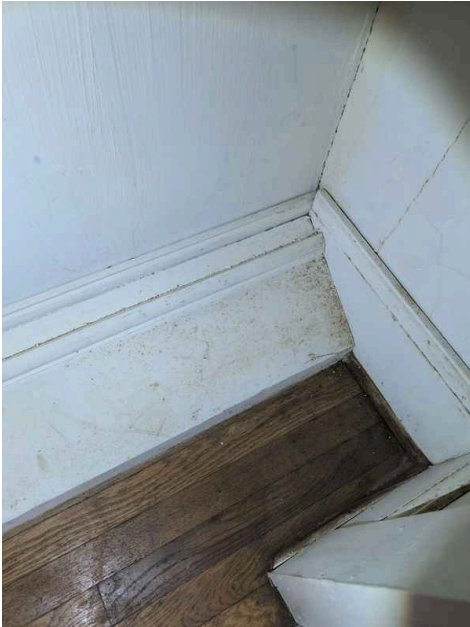
2nd Floor Right Bedroom Closet

Interior walls were inspected. There are signs of organic growth in one or more areas in the wall. Certain types of growth can cause health concerns. Contact a qualified contractor to repair.

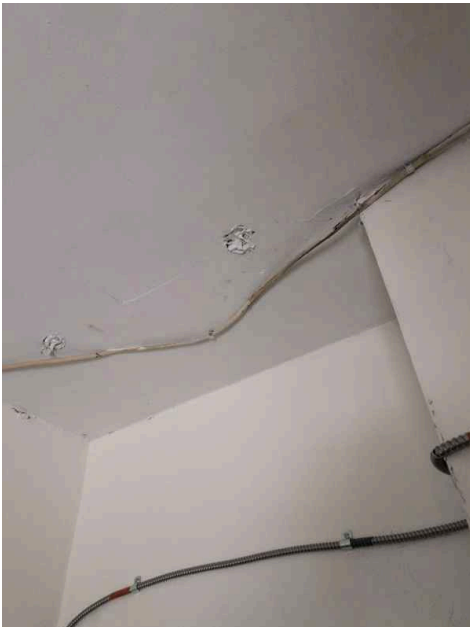
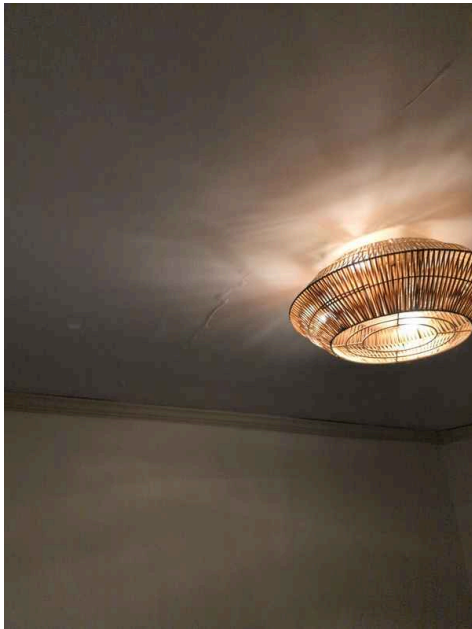
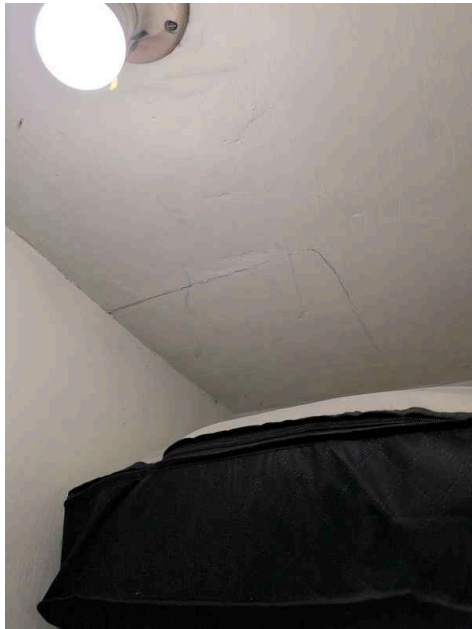
Laundry

#### **CRACKING**

Ceiling was inspected. There are one or more areas of cracking. This can get worse over time. Contact a qualified contractor to repair.

Contact a qualified general contractor.

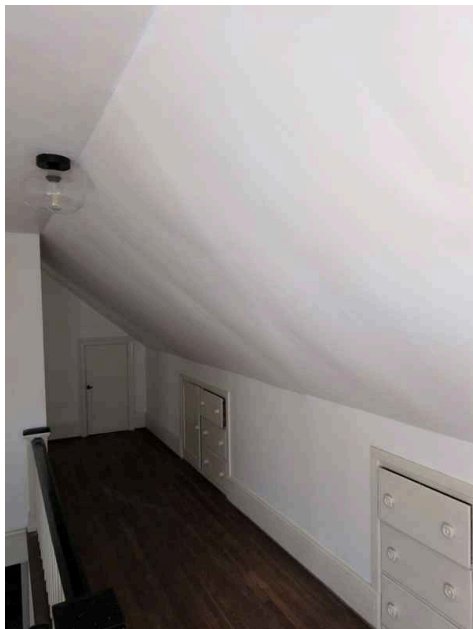
2nd Floor Hallway

Inspected ceilings. The ceiling height is low in areas. This can be a safety hazard. Contact a qualified contractor to repair.

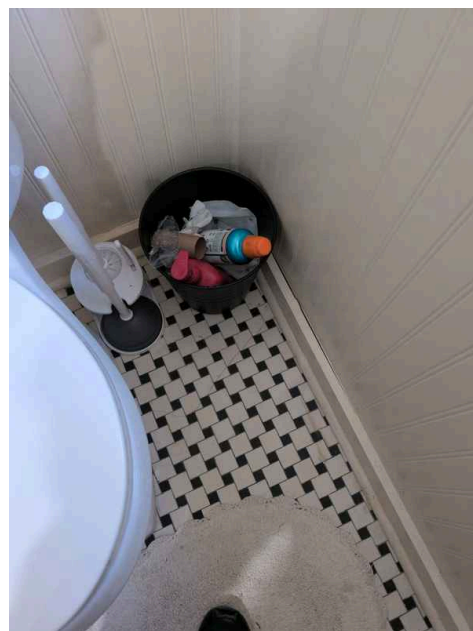
1st Floor Bathroom

**DAMAGED FLOORING MATERIAL**

Inspected floor coverings. There are one or more areas of damaged flooring material. This can be a trip concern and/or allow debris to get to subfloor. Contact a qualified contractor to repair.

Contact a qualified general contractor.

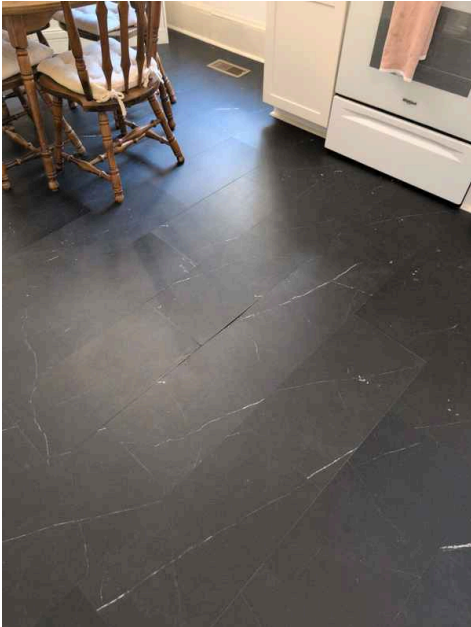
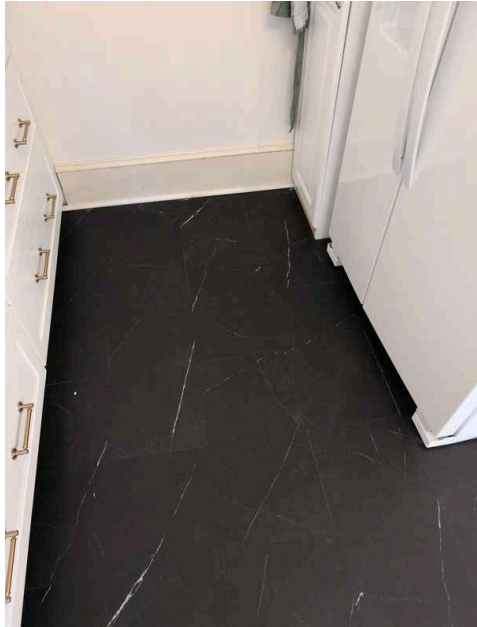
Kitchen

Inspected floor coverings. There are one or more areas of floor deflection (spongy feel). This can get worse over time causing floor squeaks and/or damage to surface material. Contact a qualified contractor to repair.

Contact a qualified general contractor.
