## RESIDENTIAL INSPECTION

1505 Salter Path Rd Unit 325  
Indian Beach, NC 28512

Deborah Pakay  
11/22/2024

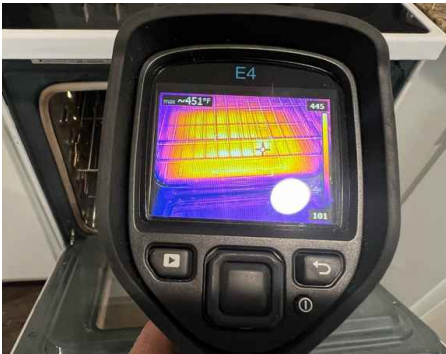
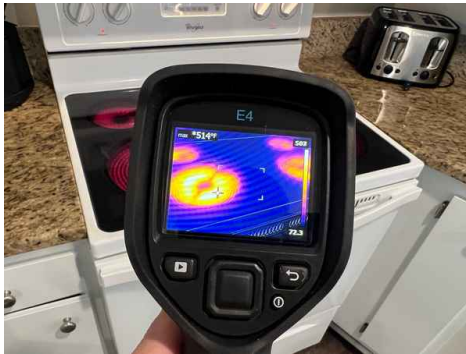
**Ranges/Cooktops and Ovens: Thermal Image(s) of Burners & Oven**

Infrared picture of range/cooktop in operation. This unit appeared to be functional at the time of the inspection.

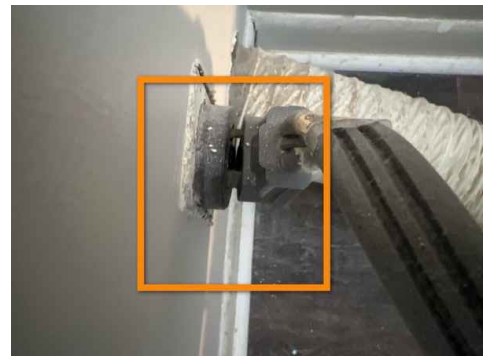
### 3.7.1 Washer/Dryer

#### **DRYER - 3 PRONG 220V LAUNDRY OUTLET**

The laundry room is equipped with a three prong outlet for the dryer. The new standard is a four prong outlet. Recommend evaluation by a qualified professional. For more information click [here](#).

Contact a qualified electrical contractor.

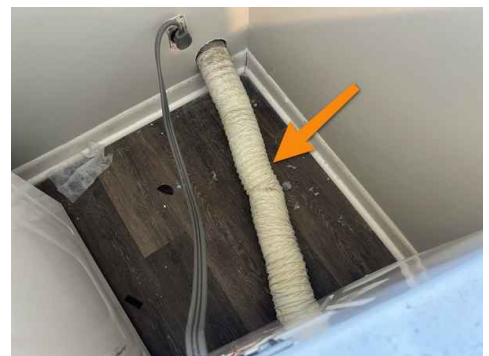
### 3.7.2 Washer/Dryer

#### **DRYER - VENT PVC/PLASTIC**

The dryer ductwork is made of plastic PVC/vinyl materials. This material is no longer recommended. Recommend it be replaced with proper ductwork by a skilled professional.

Noted at Laundry Room/Area

Contact a handyman or DIY project

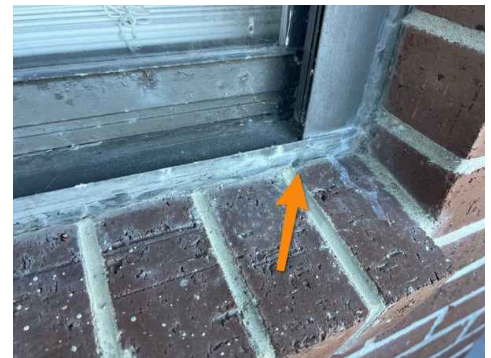
### 4.3.1 Windows

#### **WINDOWS - NEED CAULKED**

The exterior frame of the window should be caulked in where it connects with the siding. This is to prevent moisture from going behind the wall cladding. Recommend caulking skills professional caulk around windows also adding this to a routine maintenance schedule.

Recommended DIY Project

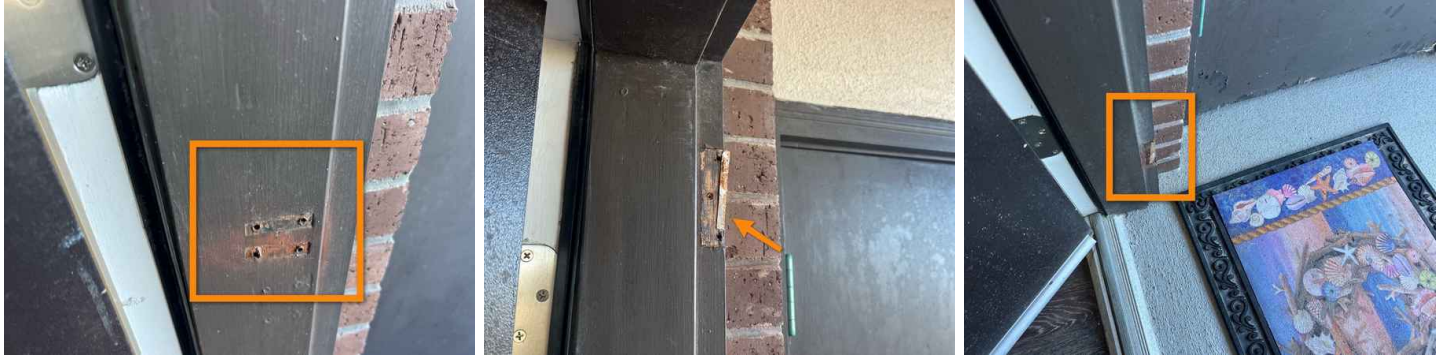
4.4.1 Doors

**EXTERIOR DOOR - WOOD ROT/RUST/PEELING PAINT**

Wood rot, rust, and/or peeling paint was noted at one or more exterior door(s) and/or frame(s). This is indicative of moisture intrusion or damage to the door/frame structure. This condition will worsen overtime if not corrected. I recommend a qualified professional make repairs.

Recommended DIY Project

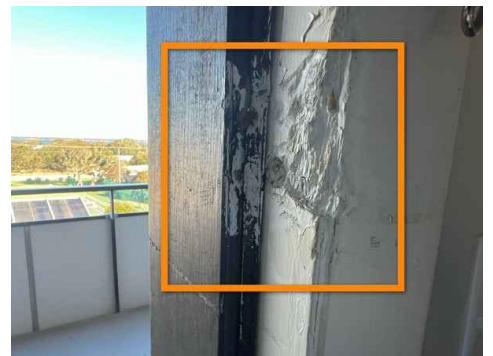
4.4.2 Doors

**EXTERIOR DOOR - DOOR JAM DAMAGE**

Damage was noted on the exterior door jam. This condition can allow water intrusion. Recommend evaluation by qualified professional.

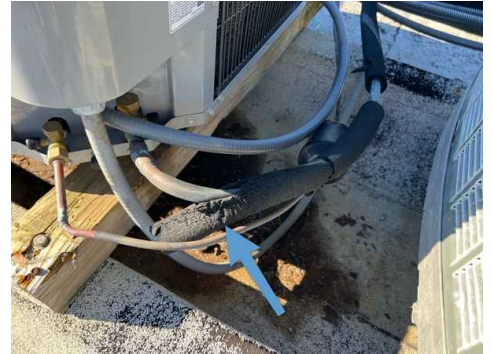
### 5.2.1 HVAC Components

#### **CONDENSER - REFRIGERANT LINE INSULATION WEATHERED, MISSING OR DAMAGED**

Damaged or weathered foam insulation at the cooling system's refrigerant line, which can cause energy loss and excessive condensation.

Contact a qualified HVAC professional.

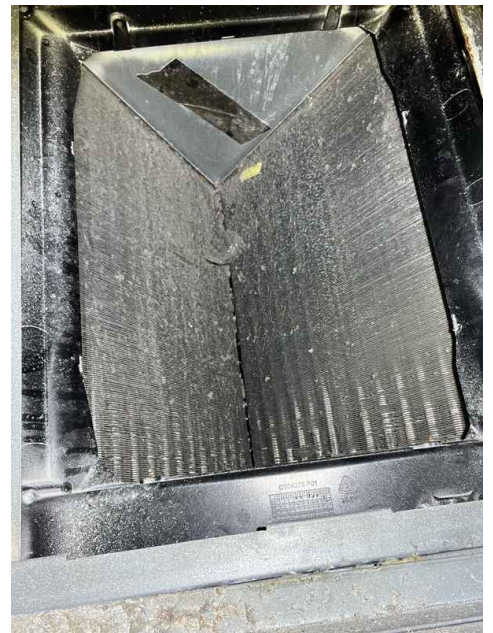
### 5.2.3 HVAC Components

#### **AIR HANDLER - DIRTY**

One or more air handler(s) show signs of dirt, or fungal growth(mold), which can significantly impact the system's efficiency and degrade indoor air quality. If left unaddressed, this condition could lead to increased energy costs, strain on the HVAC system, and potential health risks due to mold spores circulating through the home. The buildup and fungal growth may also cause premature wear on system components, resulting in costly repairs or a shortened lifespan of the unit. I recommend having the air handler cleaned and treated by a qualified HVAC technician to ensure optimal performance and prevent these potential issues.

Recommended DIY Project

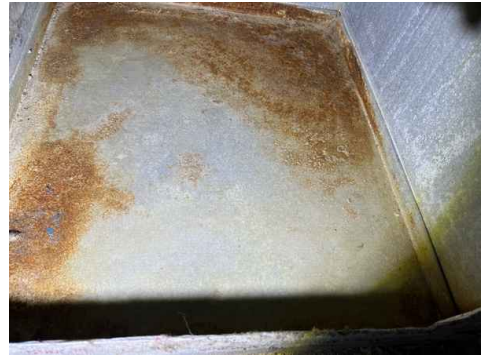
## 5.2.4 HVAC Components

**DRIP PAN - CORROSION & RUST**

Rust was noted in the drip pan. This is a potential air quality hazard.

Contact a qualified HVAC professional.

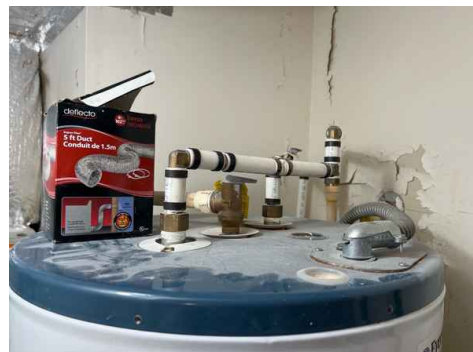
6.2.1 Water Heating Equipment

#### **EXPANSION TANK - MISSING**

There is no expansion tank installed on the water heater. An expansion tank is a newer device that alleviates pressure on the water heater and can extend the service life. We recommend further evaluation by a qualified professional.

Contact a qualified plumbing contractor.

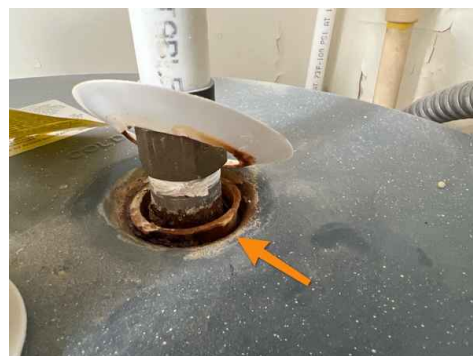
6.2.2 Water Heating Equipment

#### **WATER HEATER - CORROSION**

Corrosion was noted in one or more areas of the water heater. This condition may be indicative of worn or damaged components and can lead to a damaged water heater and/or leaks.

Contact a qualified plumbing contractor.

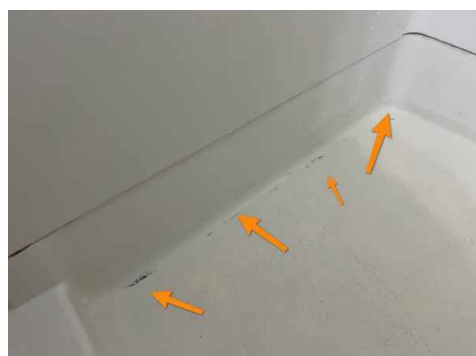
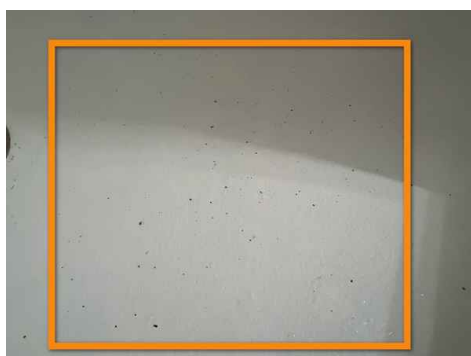
6.5.1 Fixtures and Connected Devices

#### **SHOWER - CHIPPED, CRACKED, OR DAMAGED**

The shower was noted as chipped, cracked, or damaged. This can lead to water intrusion and damage to the surrounding area.

Noted at Hall Bathroom

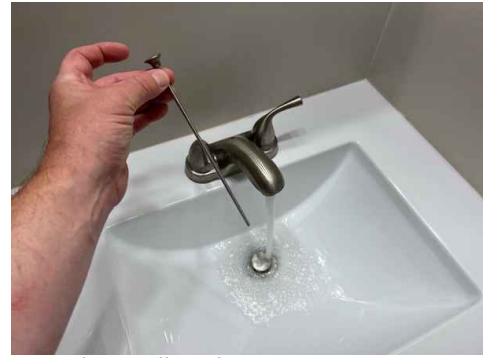
## 6.5.2 Fixtures and Connected Devices

Marginal/Defect**SINK - SINK STOP INOPERABLE, DAMAGED, MISSING**

One or more sink stops were noted as having missing, damaged, or improperly installed components. This does not allow the sink to be stopped. This could also be indicative of obstructions in the drain. Recommend evaluation by a qualified professional

Noted at Hall Bathroom

Recommended DIY Project

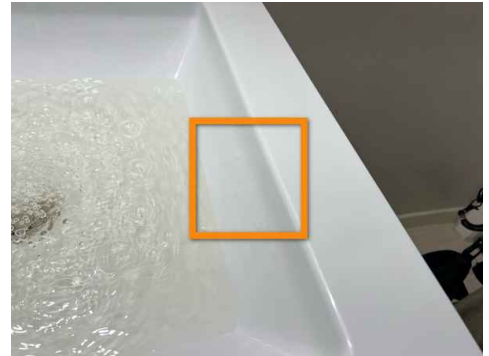
## 6.5.3 Fixtures and Connected Devices

Marginal/Defect**SINK - OVERFLOW MISSING/BLOCKED**

One or more sinks were noted as missing overflows or they were blocked and unable to drain this will not prevent the sink from overflowing if the sink stopper is closed, and water is running. This may lead to damage to the materials and or the structure.

Noted at Main Bedroom

Recommended DIY Project

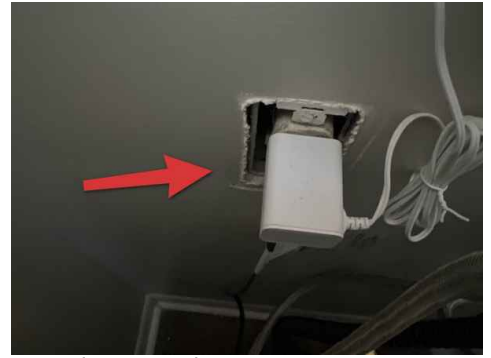
#### 7.4.1 Switches, Lighting Fixtures, and Receptacles

### RECEPTACLE - FACE PLATE MISSING/DAMAGED

The receptacle faceplate is missing or damaged, posing a potential safety hazard. It is recommended to promptly replace the faceplate to ensure the safety and functionality of the electrical outlet.

Noted at Laundry Room/Area

Contact a qualified electrical contractor.

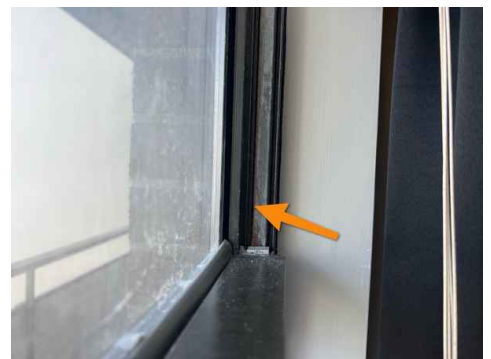
#### WINDOW - DAMAGED HARDWARE

Window hardware is found to be damaged. The windows are not operating as designed, this could lead to a security issue if not corrected, recommend a qualified professional make repairs.

Contact a qualified window repair/installation contractor.

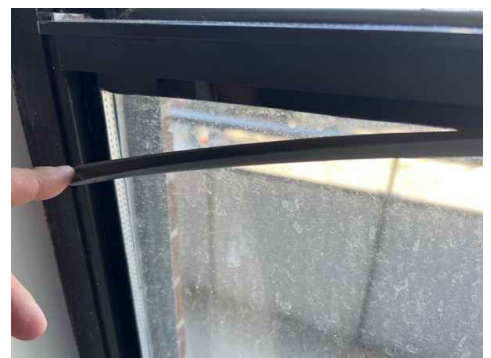
### 8.2.3 Windows

#### WINDOW - DAMAGED/MISSING TRIM

Window trim in one or more areas was observed to be damaged. I recommend repair or replacement by a qualified contractor to maintain structural integrity and prevent moisture intrusion.

Noted at Bedroom #2

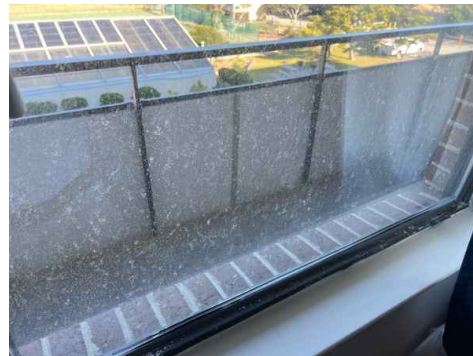
8.2.4 Windows

**WINDOW - SCREEN MISSING/DAMAGED**

I observed a missing or damaged window screen. This condition may allow unwanted pest into your home. Recommend a widow screen be installed by a qualified professional.

Noted at Bedroom #4

Contact a qualified window repair/installation contractor.
