Property Address: 248 Sulidae Court Elizabeth City, NC 27909

Listing agents' disclosure of property condition. A home inspection was performed on 06/21/25, the following items were discovered on the inspection and have not been addressed by the seller.

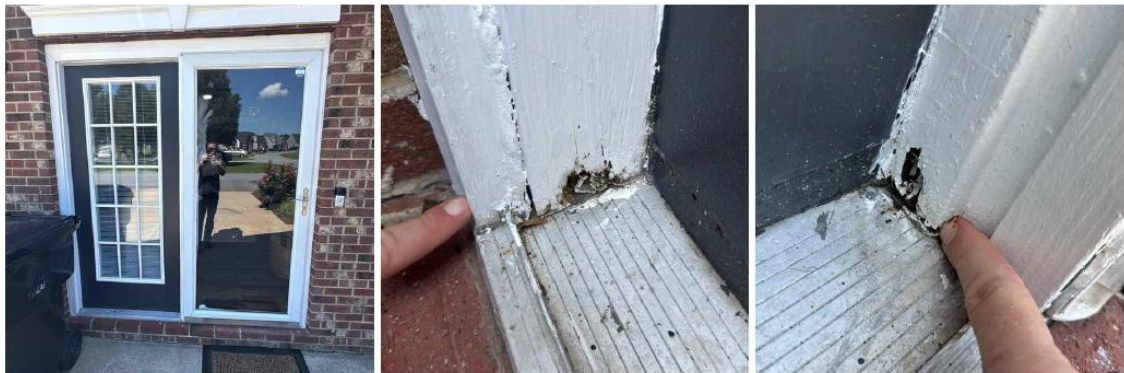
DRIVEWAY/FAMILY ROOM DOOR

DOOR: TRIM/MOLDING DAMAGE

Moisture damage was observed at the weather exposed entry door threshold, trim and/or jamb. Without correction further deterioration can occur and can lead to moisture and/or pest entry into the structure. Repair or replacement of all affected areas, caulk (seal), prime and paint is recommended.

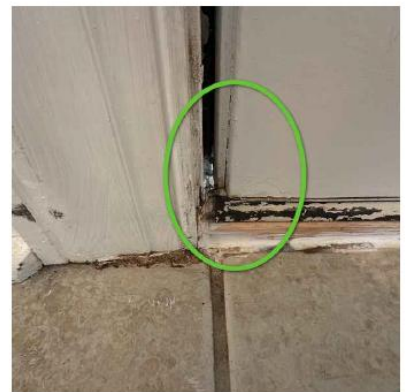
RIGHT SIDE

DOOR: DAMAGED/DOESN'T SEAL

There is one or more exterior entry doors that are damaged in one or more places, does not seal, hardware malfunction or not operating as intended. Repair and/or replace to secure that the door operates, locks and seals. In the case of garage doors to the interior of the home, an improperly sealed door compromised the fire barrier to the home. Without corrections moisture or pest entry is possible and can affect conditioning off the home.

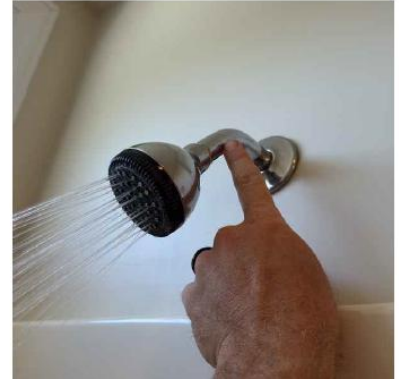
2ND FLOOR BATHROOM SHOWER

FIXTURE: LOOSE AT WALL

The fixture/s attached to the tub/surround are inadequately fastened to the framing/structure behind finished surface. Have a plumber further evaluate and make corrections. Without corrections loose fixture can result in leaks and water damage.

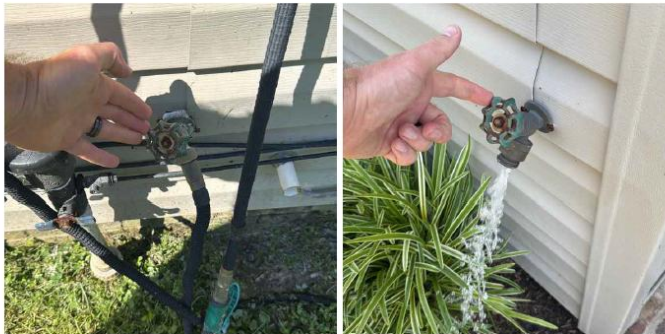
EXTERIOR LEFT AND RIGHT

FIXTURE: LOOSE SPIGOT/HOSE BIB

There is a hose bib that is loose and not adequately secured to the exterior of the home. Have a plumber evaluate this discovery and make corrections. Without corrections loose fixtures can result in damage to the fixture or leaks.

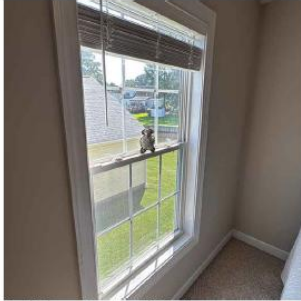
2nd Floor Front Left Bedroom

INTERIOR: WINDOW, FAILED SEAL

There are window(s) that suggest evidence of trapped moisture between the panes of glass. The location of the window(s) are provided. It is recommended that a window installer further evaluate the window/s to determine the scope of the discovery and what corrections are needed and repairs done.

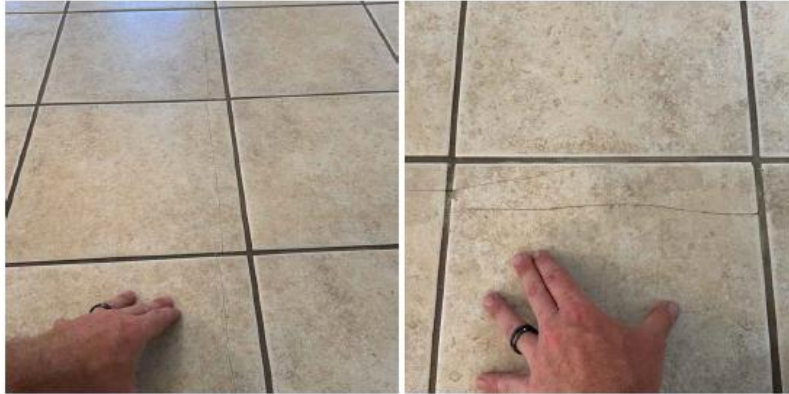
KITCHEN/EIK

INTERIOR: LOOSE/CRACKED TILE

The tile system in the floor is in poor condition, has loose or missing grout, cracked and or loose tile suggestion improper installation or floor movement or both. Loose tile can be a safety hazard, therefore a tile setter should be consulted to determine cause and repair costs and timing
