Property Address: 248 Sulidae Court Elizabeth City, NC 27909

Listing agents' disclosure of property condition. A home inspection was performed on 06/21/25, the following items were discovered on the inspection and have not been addressed by the seller.

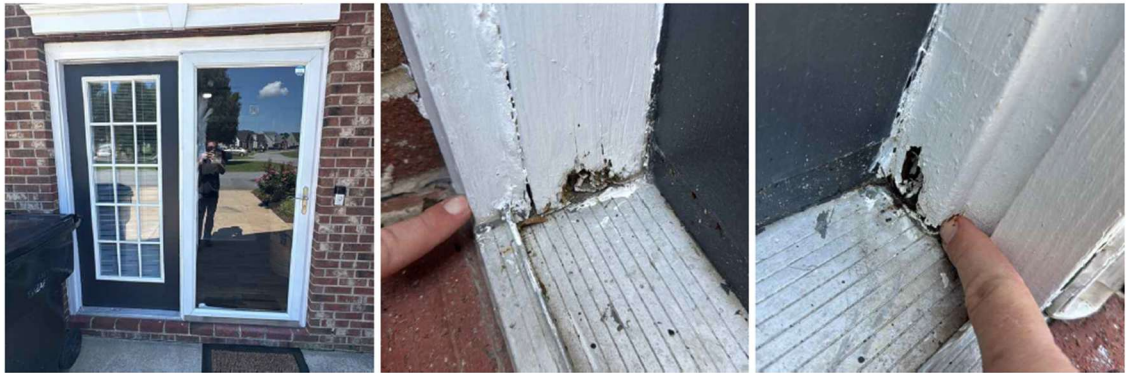
DRIVEWAY/FAMILY ROOM DOOR

**DOOR: TRIM/MOLDING DAMAGE**

Moisture damage was observed at the weather exposed entry door threshold, trim and/or jamb. Without correction further deterioration can occur and can lead to moisture and/or pest entry into the structure. Repair or replacement of all affected areas, caulk (seal), prime and paint is recommended.

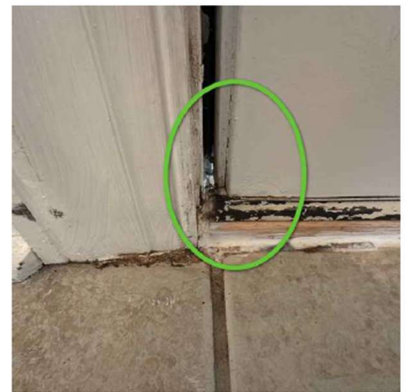
RIGHT SIDE

**DOOR: DAMAGED/DOESN'T SEAL**

There is one or more exterior entry doors that are damaged in one or more places, does not seal, hardware malfunction or not operating as intended. Repair and/or replace to secure that the door operates, locks and seals. In the case of garage doors to the interior of the home, an improperly sealed door compromised the fire barrier to the home. Without corrections moisture or pest entry is possible and can affect conditioning off the home.

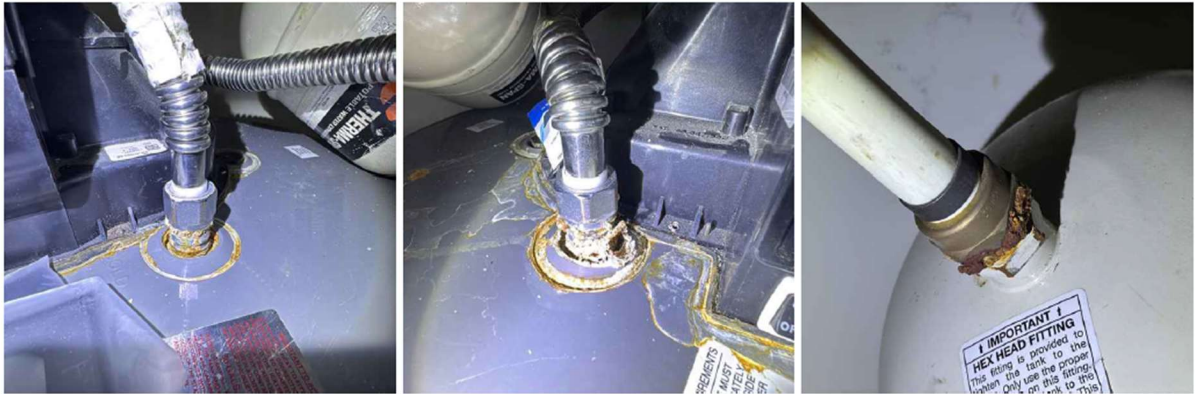
**WATER HEATER: CORROSION/LEAK**

One or more taps, valves or fittings at the water heater supply and/or distribution system are corroded. The rusting and scaling at the components could eventually result in a rupture. Evaluation and replacement all the affected components by a licensed plumber

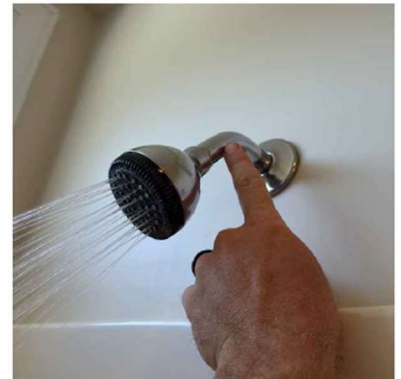
2ND FLOOR BATHROOM SHOWER

**FIXTURE: LOOSE AT WALL**

The fixture/s attached to the tub/surround are inadequately fastened to the framing/structure behind finished surface. Have a plumber further evaluate and make corrections. Without corrections loose fixture can result in leaks and water damage.

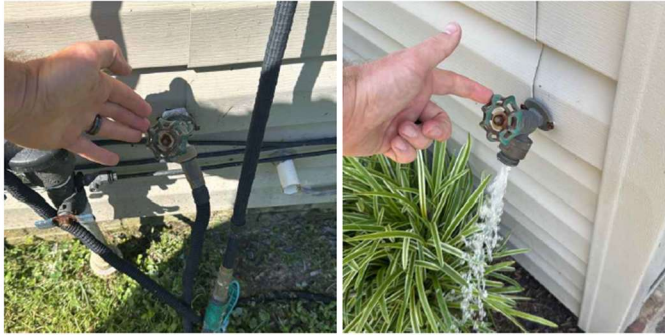
EXTERIOR LEFT AND RIGHT

**FIXTURE: LOOSE SPIGOT/HOSE BIB**

There is a hose bib that is loose and not adequately secured to the exterior of the home. Have a plumber evaluate this discovery and make corrections. Without corrections loose fixtures can result in damage to the fixture or leaks.

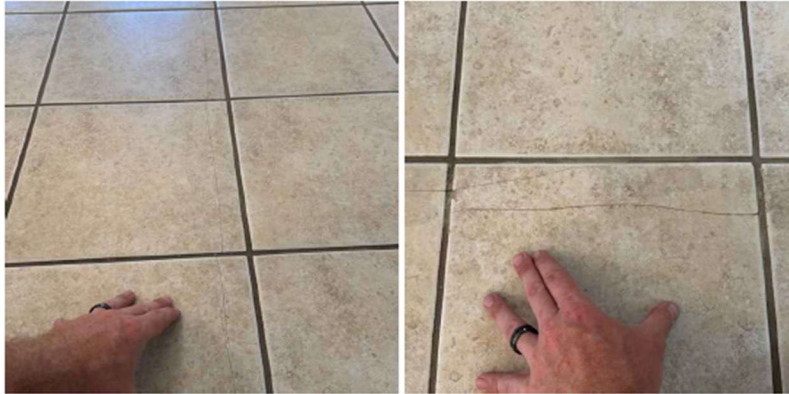
KITCHEN/EIK

**INTERIOR: LOOSE/CRACKED TILE**

The tile system in the floor is in poor condition, has loose or missing grout, cracked and or loose tile suggestion improper installation or floor movement or both. Loose tile can be a safety hazard, therefore a tile setter should be consulted to determine cause and repair costs and timing
