RESIDENTIAL INSPECTION

312 E Highland Ave
Rocky Mount, NC 27801

02/18/2025

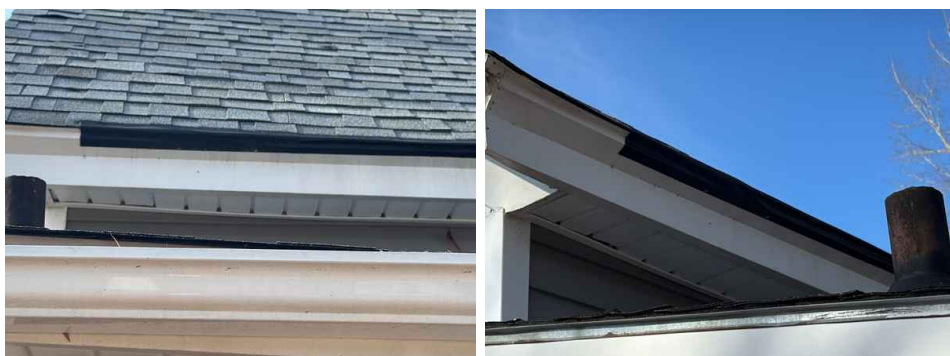
NON-STANDARD ROOF REPAIR

Section of shingles was taped. This is a non-standard repair and may lead to further damage. Recommend repair by qualified roofing contractor.

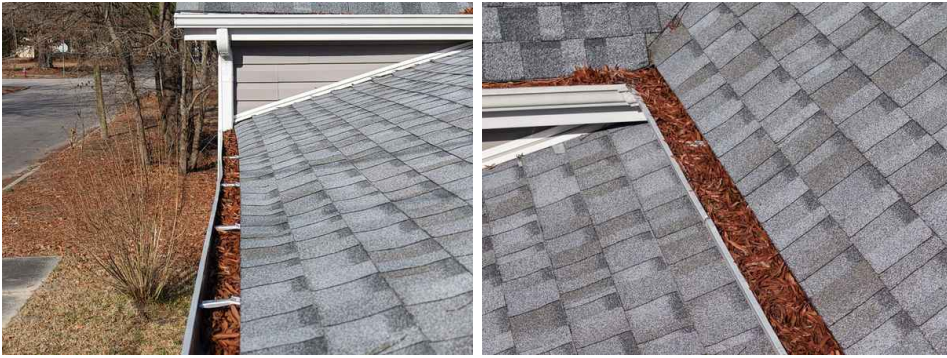
2.2.1 Roof Drainage Systems

LEAF DEBRIS IN GUTTERS

Leaf debris was accumulated in the gutters. Water could be unable to properly divert away from the roof structure leading to moisture damage around the fascia and soffit. Recommend cleaning by a qualified contractor.

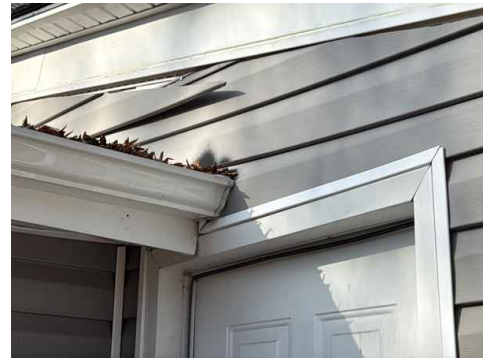
2.4.1 Roof Flashings

MISSING KICKOUT FLASHING

No kickout flashing was present where recommended. Rain runoff may overshoot the gutters onto the door. Recommend installation of a kick out flashing at all sidewall terminations by a qualified gutter contractor.

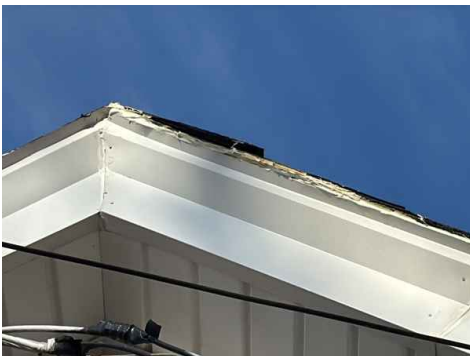
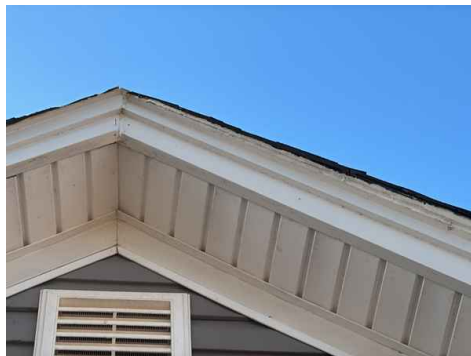
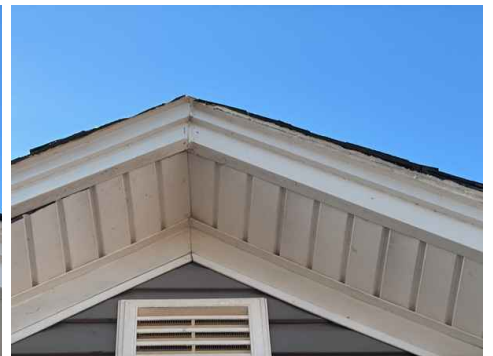
2.4.2 Roof Flashings

DRIP EDGE CAULKED

Various drip edge locations around the roof was caulked. This is a non-standard repair and a result of improper shingle trimming. This may lead to leaks and water damage to the roof decking material. Recommend repair by qualified roofing contractor.

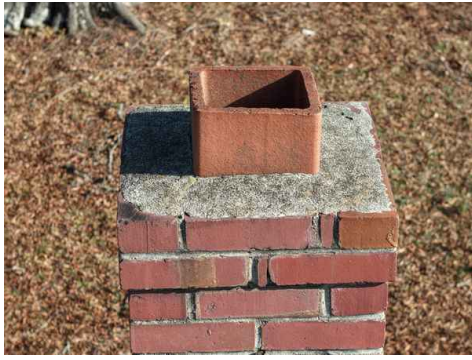
2.5.1 Chimney

ABANDONED CHIMNEY

Abandoned chimney was not capped. This can allow moisture and debris to fall down the chimney. Recommend repair by a qualified chimney contractor.

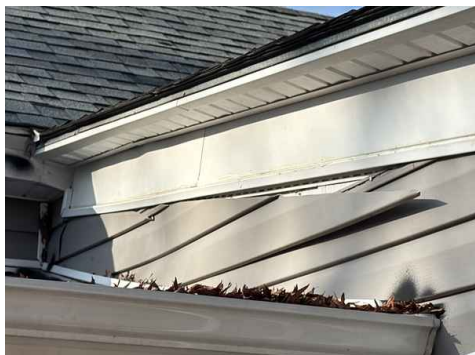
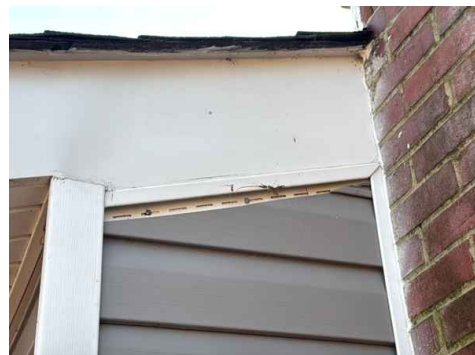
LOOSE SIDING

One or more sections of siding was loose. This can result in the siding falling off the home or allowing moisture intrusion behind the siding. Recommend repair by a qualified siding contractor.

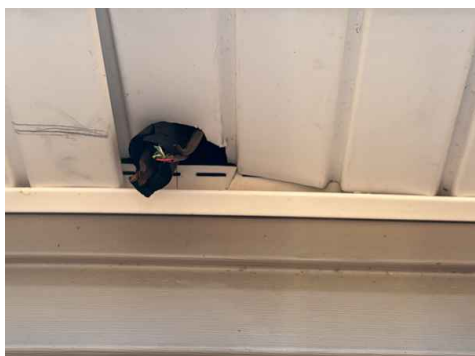
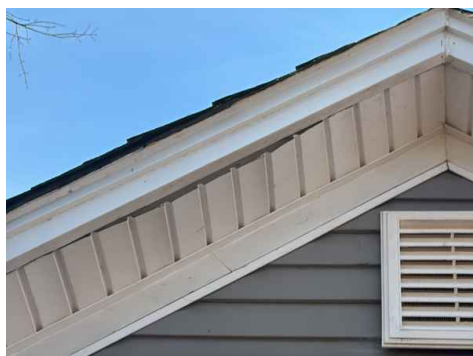
3.3.1 Eaves, Soffits & Fascia

SOFFIT OUT OF TRACK

Soffit was not properly secured into track. This can cause the soffit to fall out. Recommend repair by a qualified contractor.

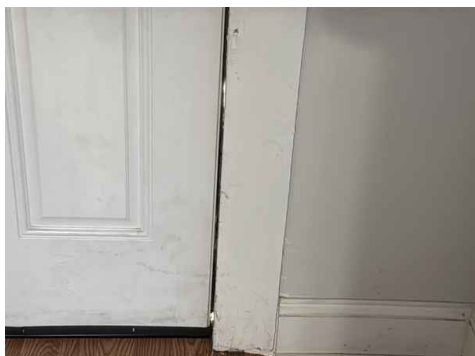
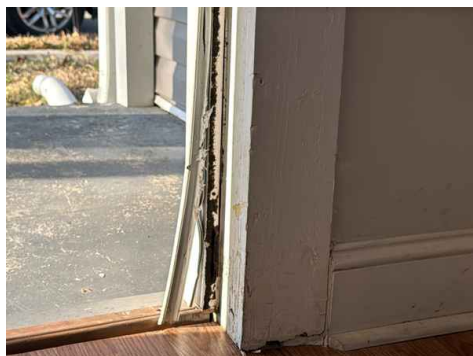
3.4.1 Exterior Doors

WEATHERSTRIPPING INADEQUATE

Door weatherstripping was not adequate. Air gap noted at front door. This can result in significant energy loss and moisture intrusion. Recommend installation of new standard weatherstripping by a qualified contractor.

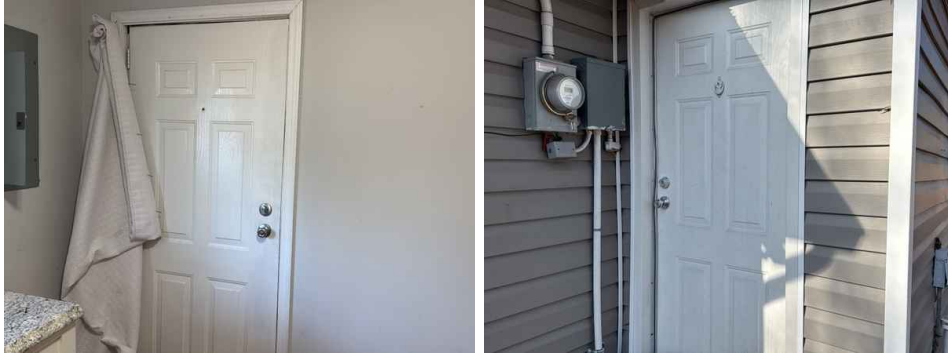
3.4.2 Exterior Doors

Rear entry door did not open. This can prevent it egress in an emergency situation. Recommend repair by qualified carpentry contractor.

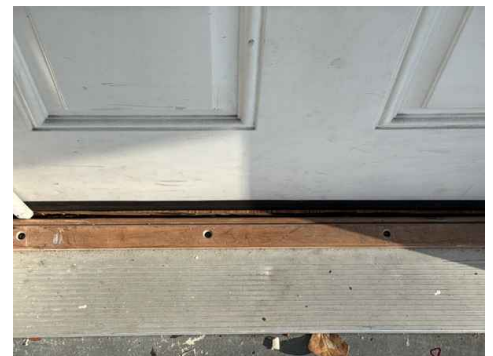
3.4.3 Exterior Doors

Installation of threshold left the interior flooring exposed. This can result in weather related damage to the flooring. Recommend repair by a qualified carpentry contractor.

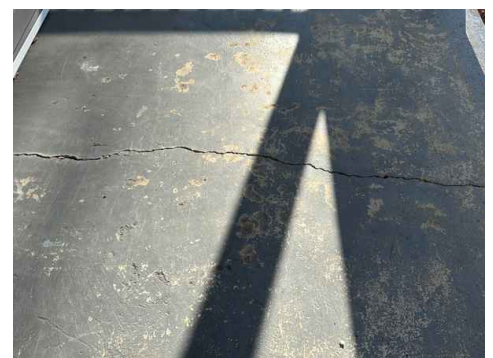
3.5.1 Decks, Balconies, Porches & Steps

**PORCH CRACKED**

Moderate cracking was present on the front porch. This can allow water to penetrate the concrete leading to further accelerated damage. Recommend sealing by a qualified masonry contractor.

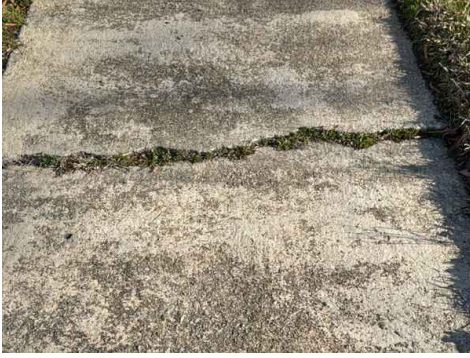
3.6.1 Walkways & Driveways

**WALKWAY CRACKING - MAJOR**

Major cracks observed. This can be a tripping hazard. Recommend repair by a qualified masonry contractor.

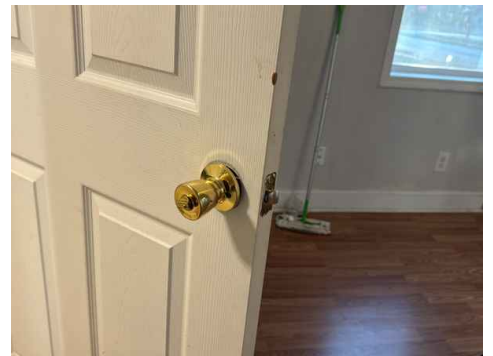
LOOSE DOOR HANDLE

Door handle was loose. This can prevent operation as intended.. Recommend tightening of handles by a qualified contractor.

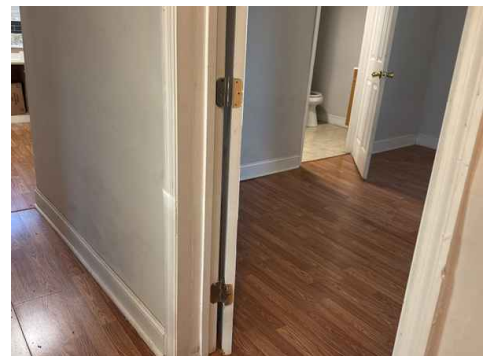
4.2.2 Doors

HINGE LOOSE

Door hinges were loosely mounted or not mounted. This can prevent operating the door as intended. Recommend repair by qualified carpentry contractor.

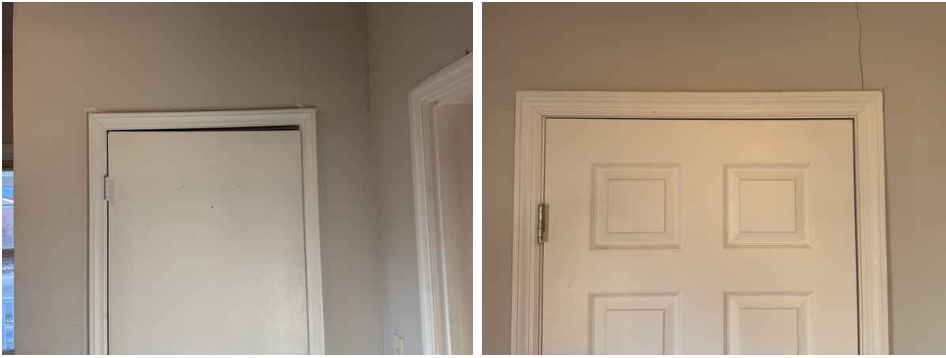
4.2.3 Doors

DOOR FRAME IS NOT SQUARE

Door frame was out of square due to settlement. This can prevent opening and closing of the door as intended. Recommend review of the root cause and repair by a qualified contractor.

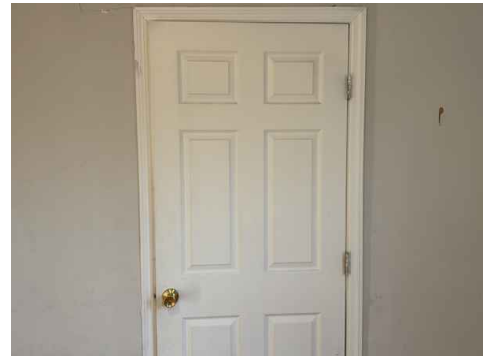
4.2.4 Doors

DOOR DOES NOT CLOSE

Door did not close completely. Recommend repair by a qualified carpentry contractor.

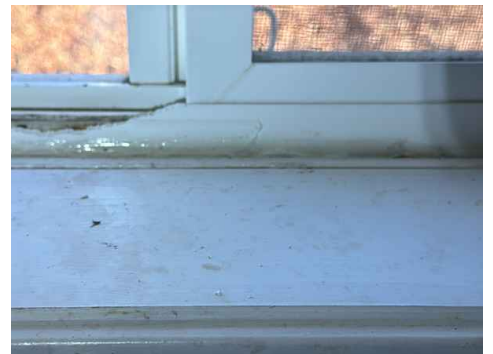
4.3.1 Windows

IMPROPER INSTALLATION

Window installation had heavy silicone applied to the interior side. This can be a sign of previous leaking or improper installation. Recommend repair by qualified window contractor.

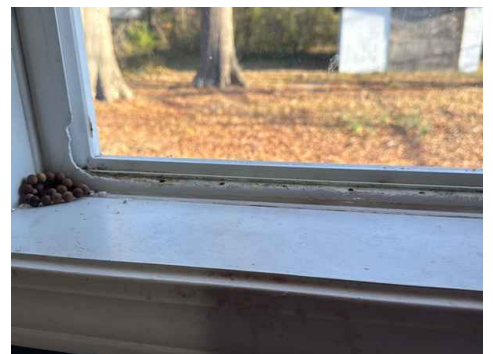
4.3.2 Windows

DAMAGED WINDOW

Window trim, was damaged. This did not affect the operation of the window. Recommend repair by a qualified contractor.

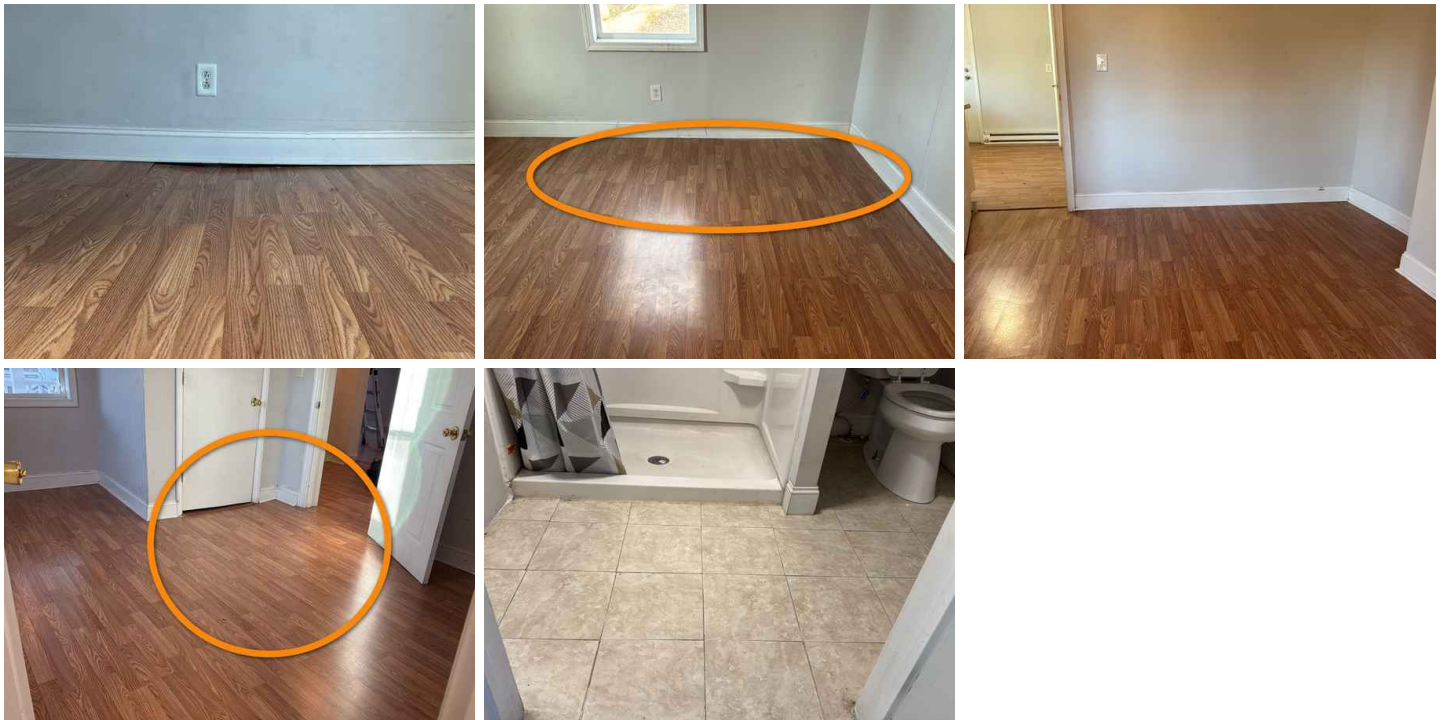
4.4.1 Floors

UNEVEN FLOOR

Floor was noted to be uneven. This could be due to subfloor or foundation related movement. No crawlspace access was available to review. Recommend further review and repair by a qualified general contractor.

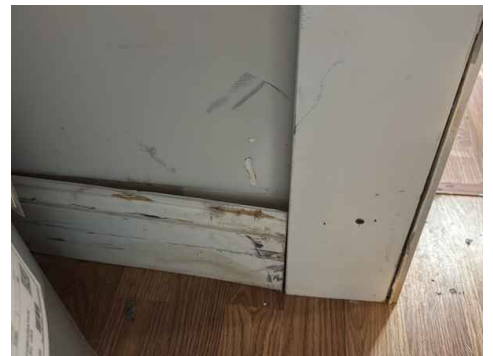
4.4.2 Floors

FLOOR TRIM LOOSE

Floor trim was loosely installed in the utility closet. Recommend installation by a qualified carpentry contractor.

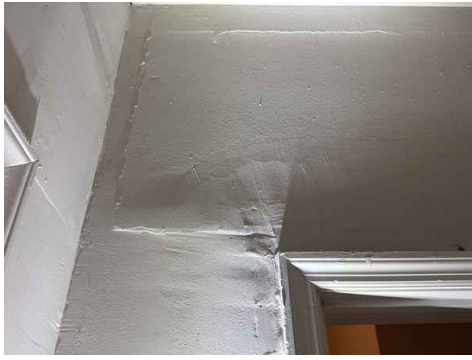
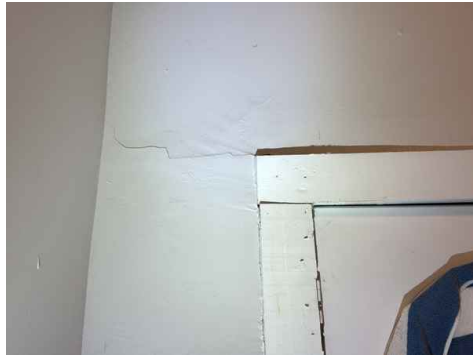
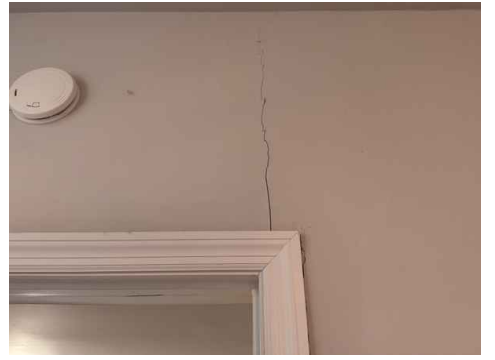
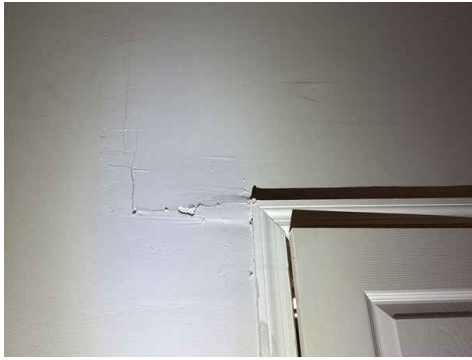
4.5.1 Walls

SETTLEMENT CRACKS

Multiple settlement cracks were present in the drywall. Recommend review of the root causes and repair by a qualified contractor.

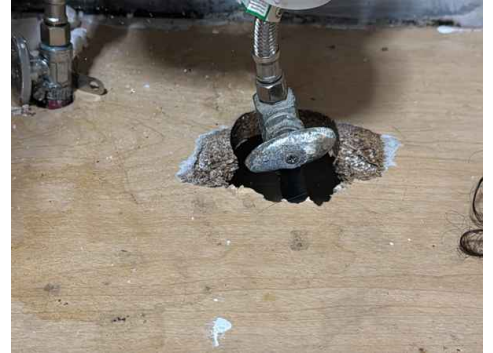
Holes were present in the cabinet base of the bathroom vanity. This can allow pest intrusion. Recommend repair or sealing by a qualified cabinet contractor.

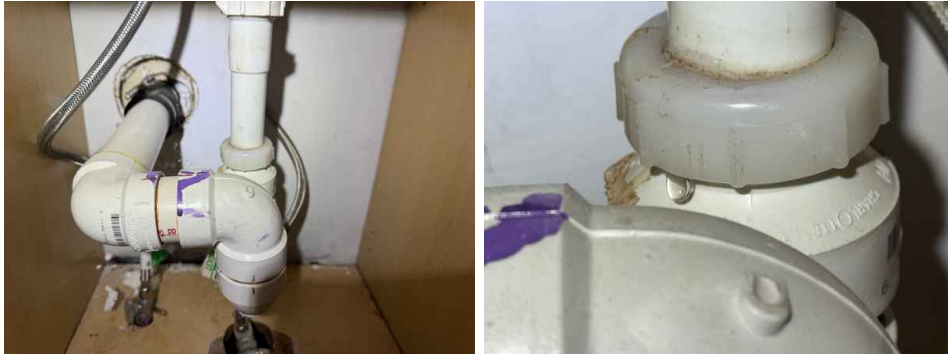
SINK LEAKING

Sink in the bathroom has a leak at the drain connection. This could lead to cabinet and flooring damage if not repaired. Recommend repair by a plumbing contractor.

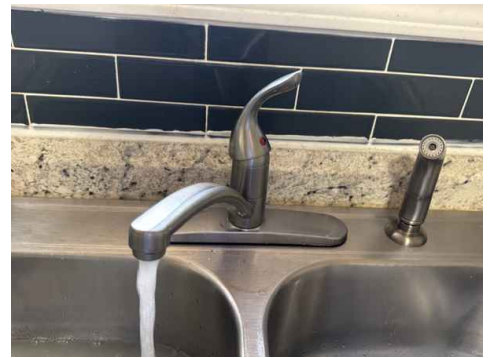
8.4.2 Water Supply, Distribution Systems & Fixtures

Hot and cold valves were reversed. Hot should be on the left. Recommend repair by a qualified contractor.

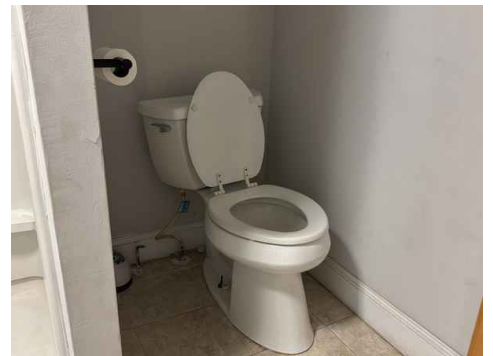
8.4.3 Water Supply, Distribution Systems & Fixtures

TOILET MOUNT LOOSE

Toilet was not tightly mounted and could be moved. This can cause leaking and floor damage. Recommend repair by a qualified plumbing contractor.

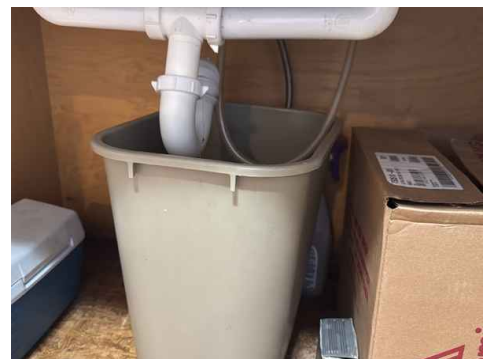
8.4.4 Water Supply, Distribution Systems & Fixtures

KITCHEN SINK LEAKING

Active leak at the kitchen sink. This can allow water to damage the cabinet and floor. Recommend repair by a qualified plumbing contractor.

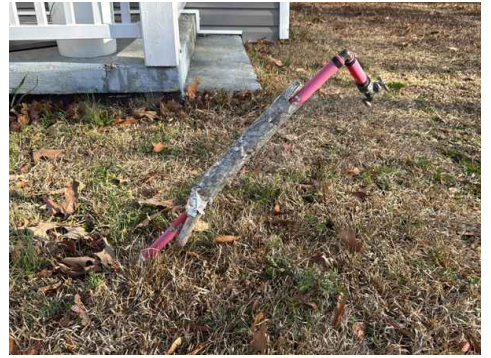
8.4.5 Water Supply, Distribution Systems & Fixtures

Uninsulated plumbing on the exterior of property. This can result in damage to the plumbing lines. Recommend insulating by a qualified contractor or removal.

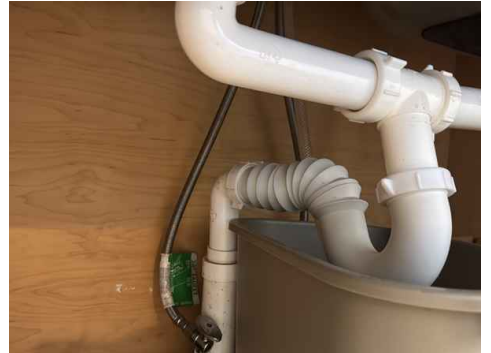
8.5.1 Drain, Waste, & Vent Systems

Flex drain tube was in use under the kitchen sink. This tubing is prone to clogging. Recommend replacement with smooth wall drain pipe by a qualified plumbing contractor.

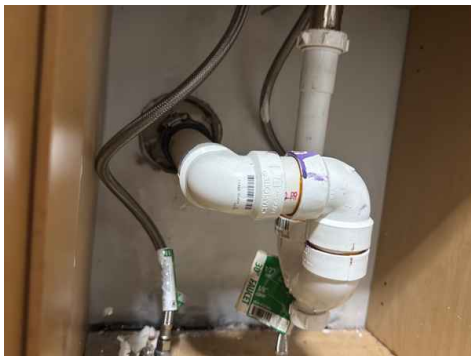
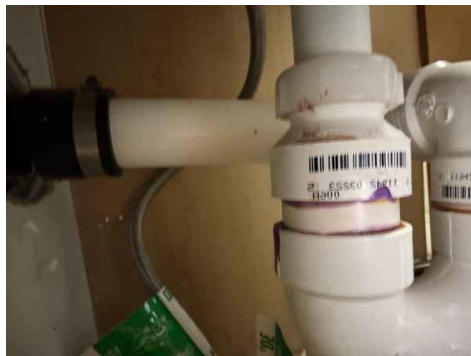
8.5.2 Drain, Waste, & Vent Systems

IMPROPER DRAIN SLOPE

Drain had improper slope. This can prevent the gravity flow of water and require excessive water in the line in order to drain. Recommend repair by a licensed plumbing contractor.

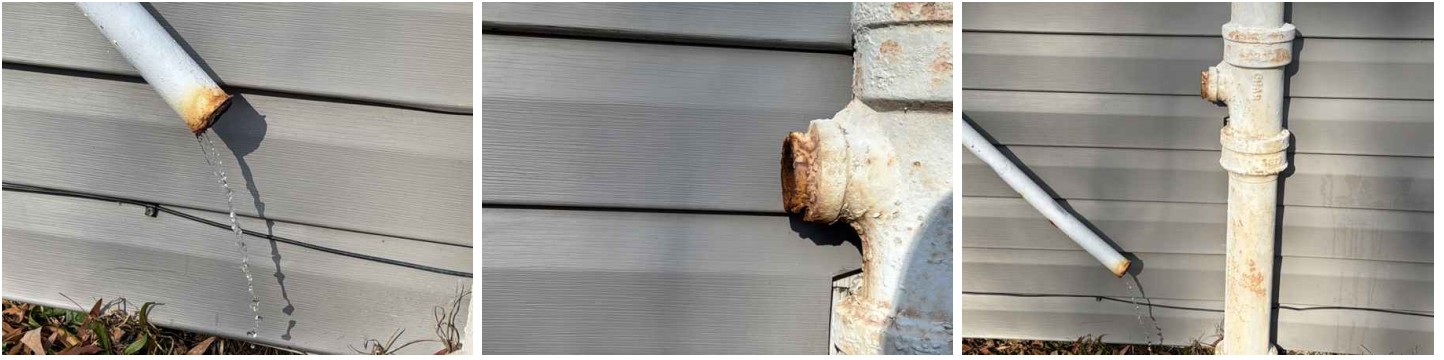
8.5.3 Drain, Waste, & Vent Systems

Bathroom sink drain line was disconnected from the main stack. Recommend repair by a qualified plumbing contractor.

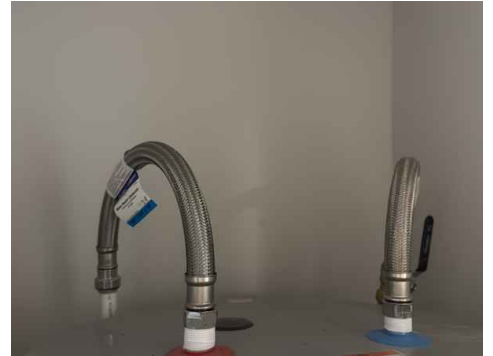
8.6.1 Hot Water Systems, Controls, Flues & Vents

Recommendation
NO EXPANSION TANK

No expansion tank was present at the water heater or located under the home. Expansion tanks allow for the thermal expansion of water in the pipes. Recommend installation by a qualified plumbing contractor.

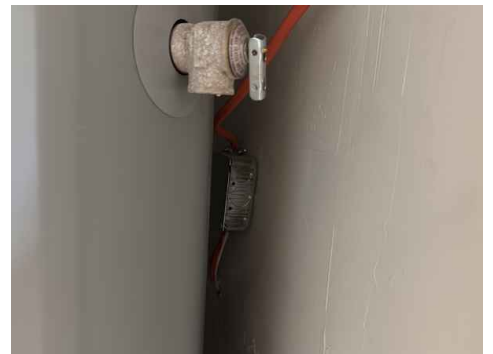
8.6.2 Hot Water Systems, Controls, Flues & Vents

Safety Hazard
TPR VALVE MISSING DISCHARGE TUBE

Water heater tpr valve was missing a discharge tube. This can allow heated water to spray in an uncontrolled manner. Recommend installation of discharge tube by a qualified contractor.

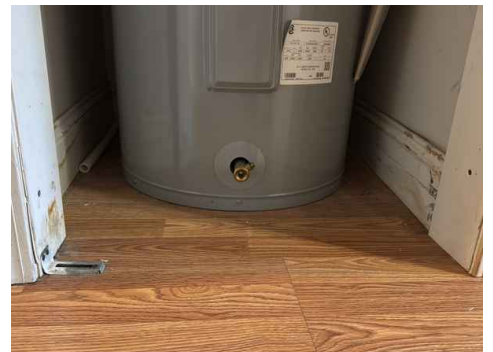
8.6.3 Hot Water Systems, Controls, Flues & Vents

Recommendation
NO DRAIN PAN

No drain pan for exterior drainage was located at the water heater. This could result in significant damage to the property if there were to be a leak. Recommend install installation to an exterior drain by a qualified contractor.

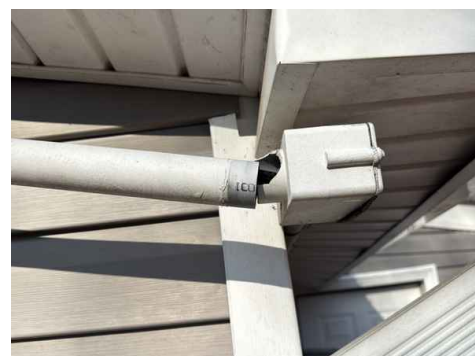
DAMAGED CONDUIT

Electrical conduit was damaged and disconnected. Recommend repair by qualified electrical contractor.

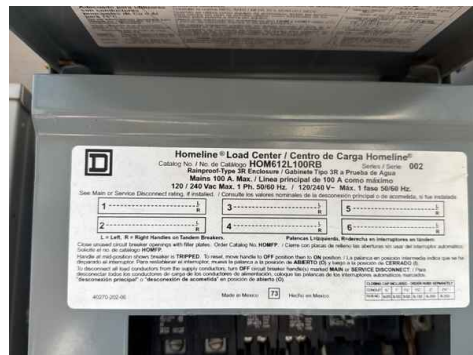
9.3.1 Main Panel and Overcurrent Device

UNLABELED BREAKER

Unlabeled breakers were present in the panel. This can delay the deenergizing of a circuit in an emergency. Recommend labeling of all circuit breakers by a qualified contractor.

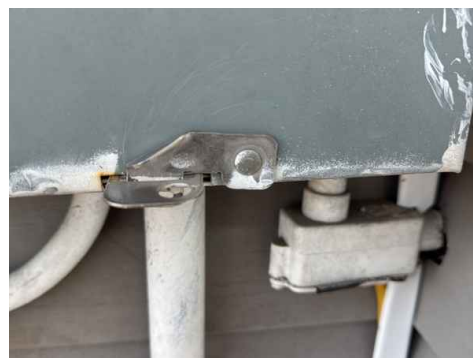
9.3.2 Main Panel and Overcurrent Device

RECOMMEND SECURING

Exterior panel was not secured. Recommend locking to prevent unwanted access.

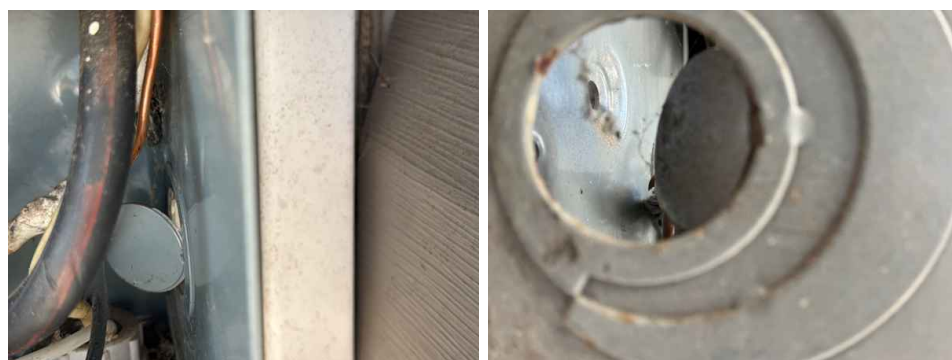
9.3.3 Main Panel and Overcurrent Device

MISSING KNOCKOUTS

Missing knockouts or openings or present in the electrical panel. This can allow entry of insects or Unlabeled breakers were present in the panel. This can delay the deenergizing of a circuit in an emergency. Recommend labeling of all circuit breakers by a qualified contractor. Recommend repair by qualified electrical contractor.

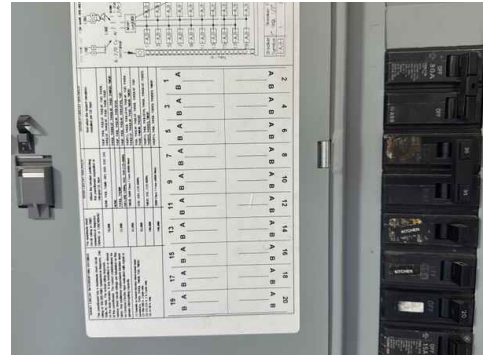
9.4.1 Subpanel

UNLABELED BREAKERS

Unlabeled breakers were present in the panel. This can delay the deenergizing of a circuit in an emergency. Recommend labeling of all circuit breakers by a qualified contractor.

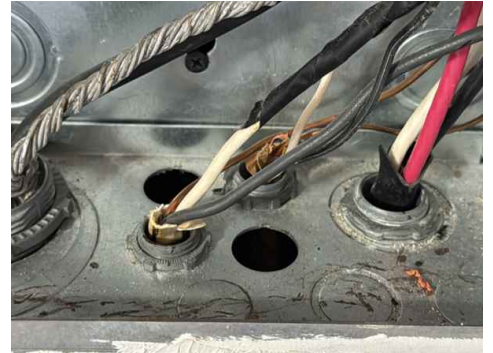
9.4.2 Subpanel

MISSING KNOCKOUTS

Missing knockouts or openings are present in the electrical panel. This can allow entry of insects or unlabeled breakers were present in the panel. This can delay the deenergizing of a circuit in an emergency. Recommend labeling of all circuit breakers by a qualified contractor. Recommend repair by qualified electrical contractor.

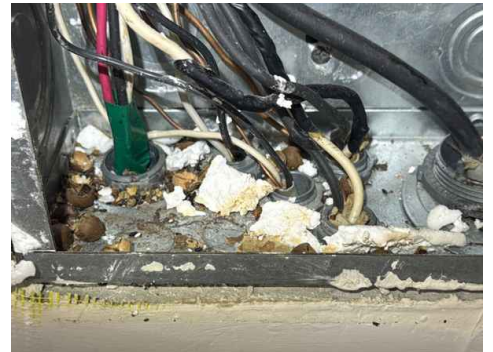
9.4.3 Subpanel

DEBRIS INSIDE PANEL

Debris was present inside the sub panel. This can be a fire hazard. Recommend removal by a qualified electrical contractor.

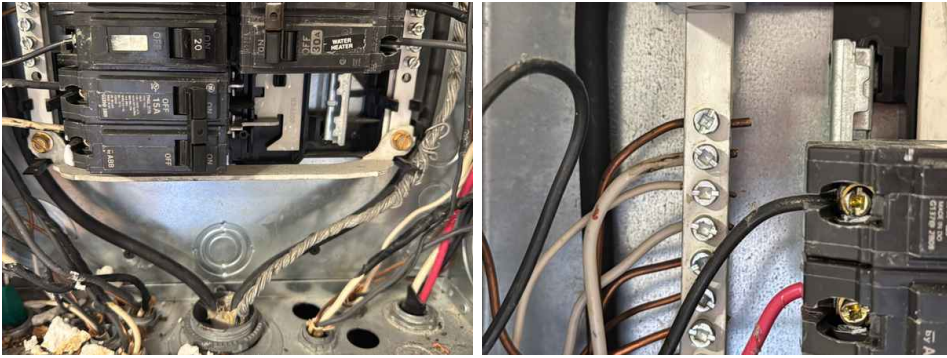
9.4.4 Subpanel

GROUNDS AND NEUTRALS NOT SEPARATED

Grounds and neutrals were not separated at the subpanel as recommended. This can create an unsafe condition in the home. Recommend repair by a licensed electrical contractor.

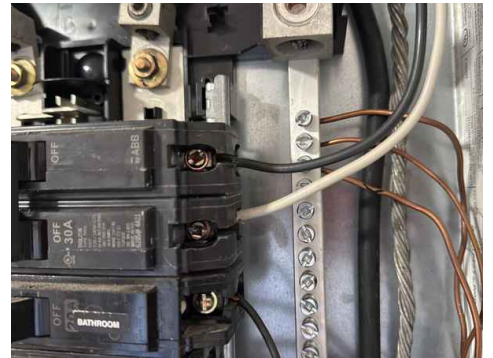
9.4.5 Subpanel

WHITE WIRE HOT

Unlabeled white cables were in use as hot wires in the panel. This is a shock hazard and did not correctly re-identify the cables. Recommend repair by a qualified electrical contractor.

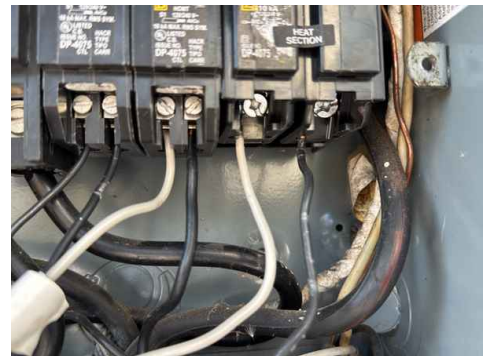
9.5.1 Branch Wiring Circuits, Breakers & Fuses

WHITE CABLES NOT RE-IDENTIFIED AS HOT

Unlabeled white cables were in use as hot wires in the panel. This is a shock hazard and did not correctly re-identify the cables. Recommend repair by a qualified electrical contractor.

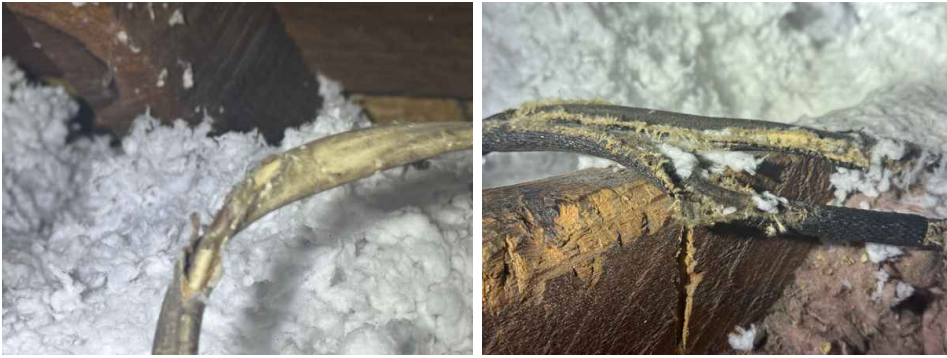
9.5.2 Branch Wiring Circuits, Breakers & Fuses

DAMAGED CABLE

Wires in the attic, appear to have two marks from rodents. This can leave the cable unprotected and potentially dangerous. Recommend repair by a licensed electrical contractor.

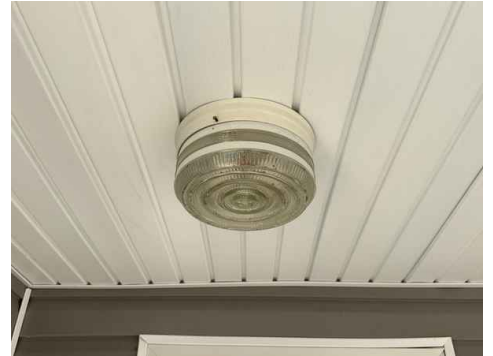
9.6.1 Lighting Fixtures, Switches & Receptacles

LIGHT INOPERABLE

Light was not operating. New light bulb possibly needed or repair of fixtures by a qualified contractor.

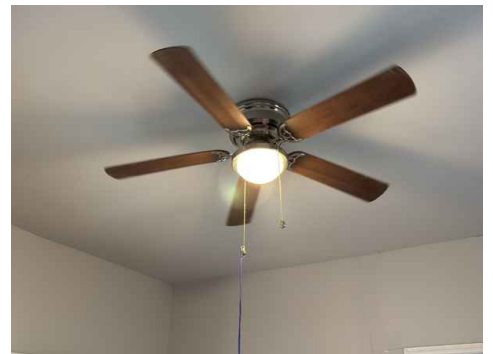
9.6.2 Lighting Fixtures, Switches & Receptacles

CEILING FAN LOOSE

Ceiling fan vibrated excessively during operation. This can loosen the mount if not corrected. Recommend repair by a qualified contractor.

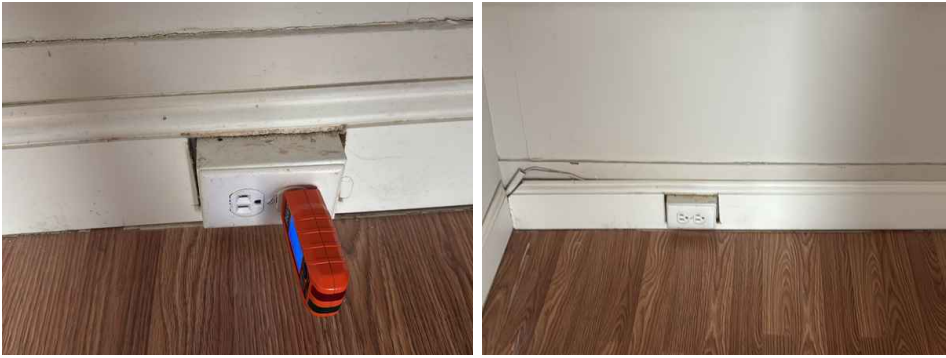
9.6.3 Lighting Fixtures, Switches & Receptacles

OUTLET NO POWER

Outlet failed to produce power. This can render the outlet unusable. Recommend repair by a qualified electrical contractor.

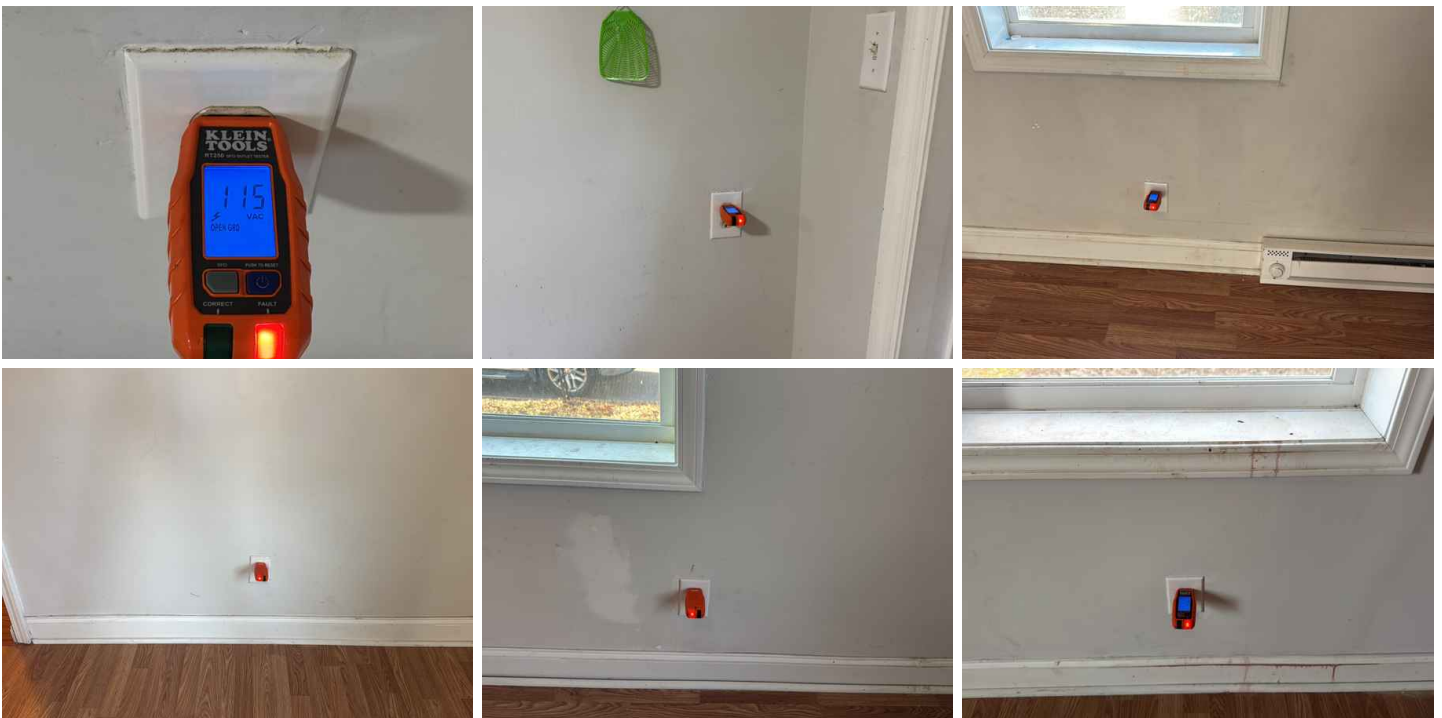
9.6.4 Lighting Fixtures, Switches & Receptacles

Multiple outlets had open ground faults. This is a hazardous condition. Recommend review of the outlets and repair by a licensed electrical contractor.
