Inspection Report

Property Address:
2489 Pocosin Road
Ayden NC

Dependable Inspections, Inc.

Date: 9/15/2025	Time:	Report ID: 25-324
Property: 2489 Pocosin Road Ayden NC	Customer: CNC Home Services LLC	Real Estate Professional: Chris Peele Tyre Realty Group

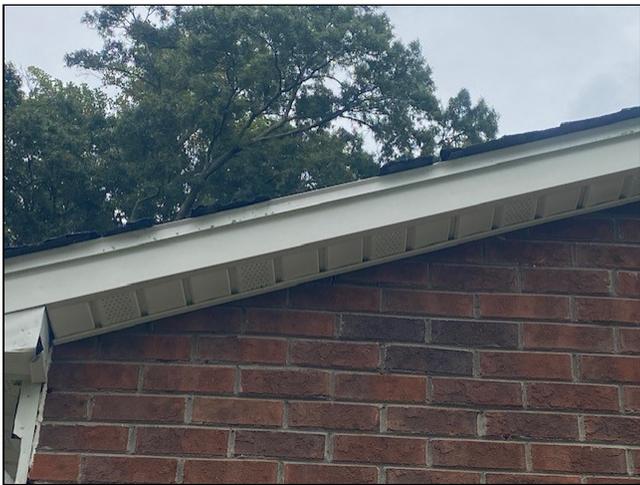
1.0 Item 1 (Picture)

1.0 Repair: There is shingle damage along right front edge of roof

Repair: There is shingle damage along right front edge of roof

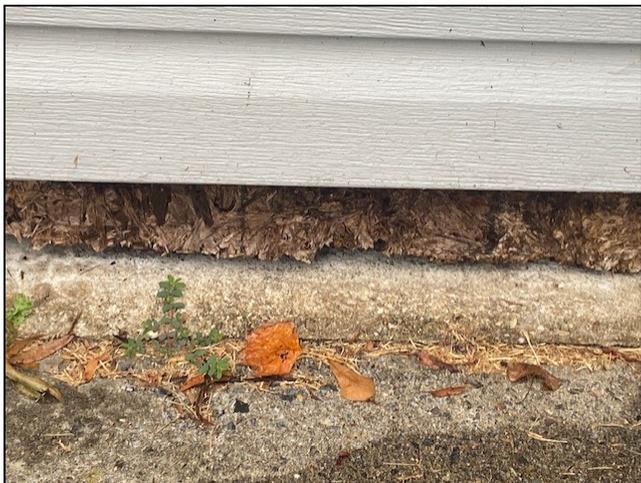
2.1 Item 1 (Picture)

2.1 (1) Repair: There is moisture damage in the bottom of the rear storage room door

(1) Repair: There is moisture damage in the bottom of the rear storage room door

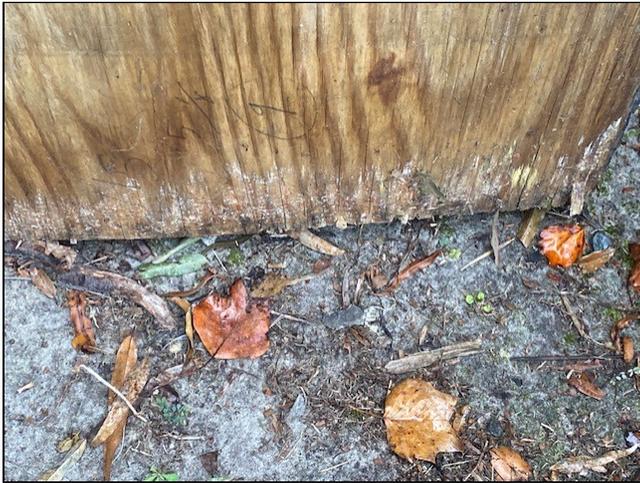
2.1 Item 2 (Picture)

(2) Repair: There is moisture damage in the bottom of the crawl space door

(2) Repair: There is moisture damage in the bottom of the crawl space door

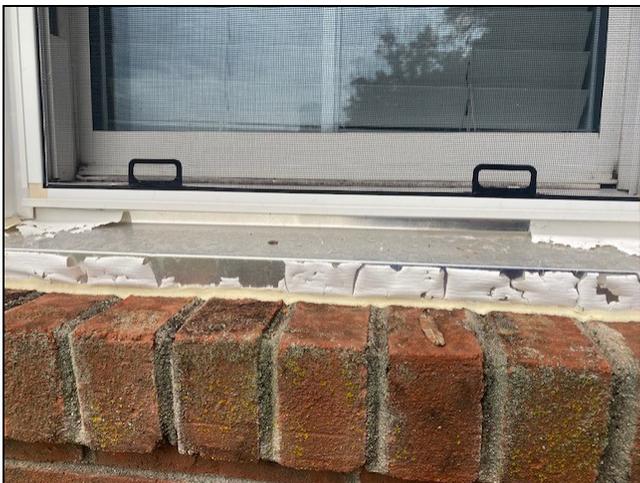
2.2 Item 1 (Picture)

2.2 (1) Note: All the window sills/trim are wrapped in aluminum on the exterior making any possible damage difficult to determine

(2) Repair: Paint is peeling off some of the windows sills throughout exterior

(2) Repair: Paint is peeling off some of the windows sills throughout exterior

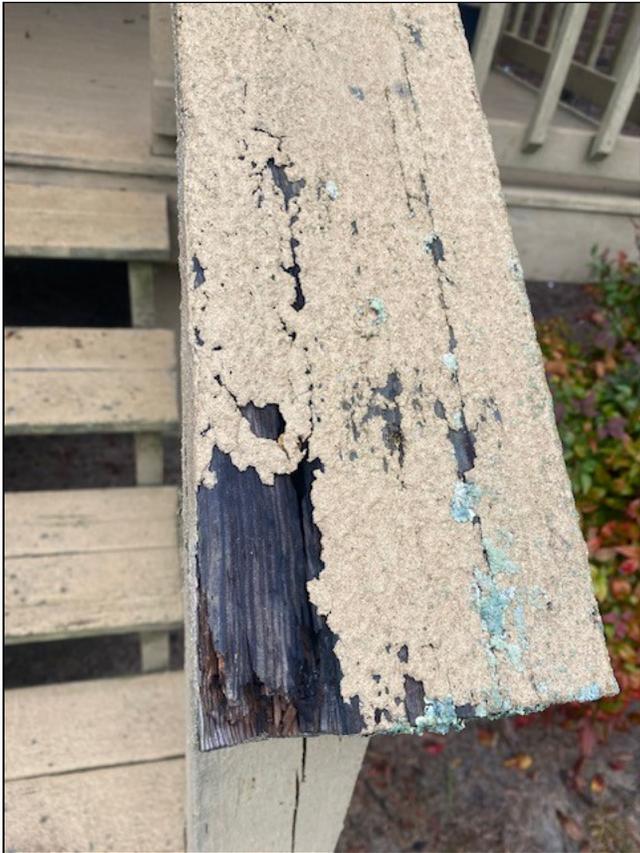
2.3 Item 1 (Picture)

2.3 Repair: There is moisture damage in the top handrail at rear steps

Repair: There is moisture damage in the top handrail at rear steps

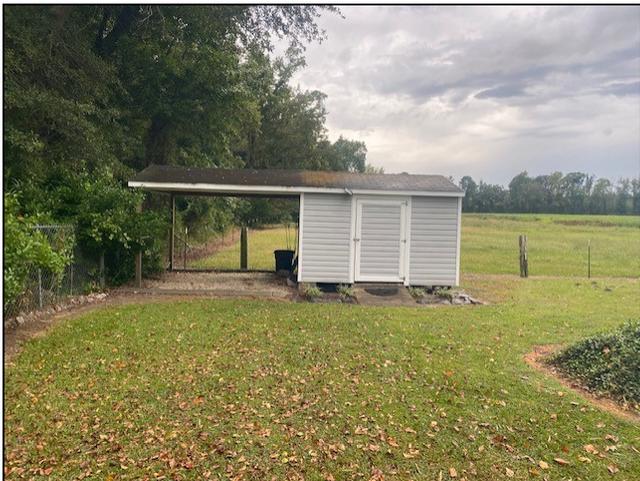
2.6 Item 1 (Picture)

2.6 Note: Home has a detached building. This was not included in the inspection.

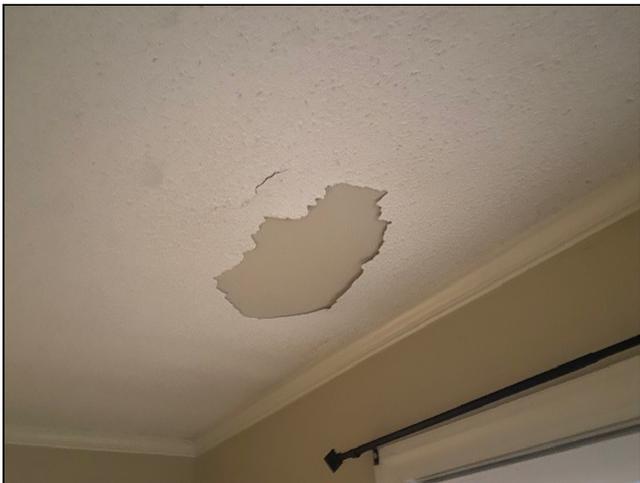
3.0 Item 1 (Picture)

3.0 (1) Repair: Paint is peeling off ceiling inside front living room area

(1) Repair: Paint is peeling off ceiling inside front living room area

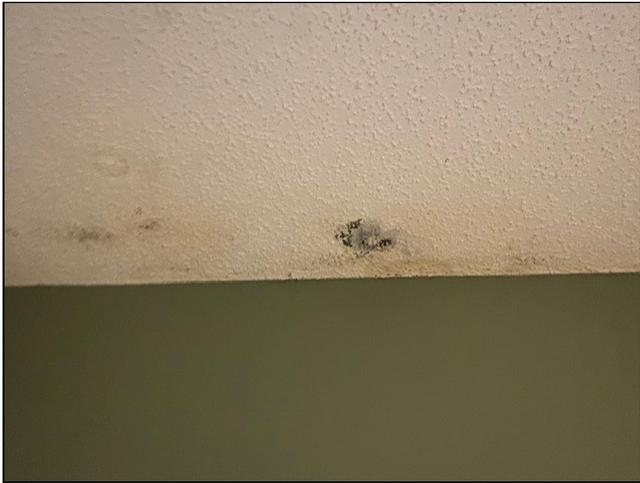
3.0 Item 2 (Picture)

(2) Evaluate/Repair: There are stains and discoloration on the laundry room ceiling above the washer/dryer area

(2) Evaluate/Repair: There are stains and discoloration on the laundry room ceiling above the washer/dryer area

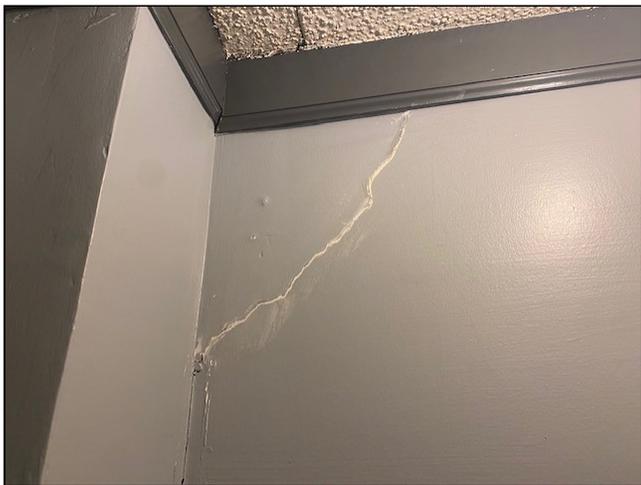
4.1 Item 1 (Picture)

4.1 Evaluate/Repair: There is a large crack in the wall inside the left front bedroom closet. I recommend it be evaluated by a licensed contractor. Refer to structural section of report.

Evaluate/Repair: There is a large crack in the wall inside the left front bedroom closet. I recommend it be evaluated by a licensed contractor. Refer to structural section of report.

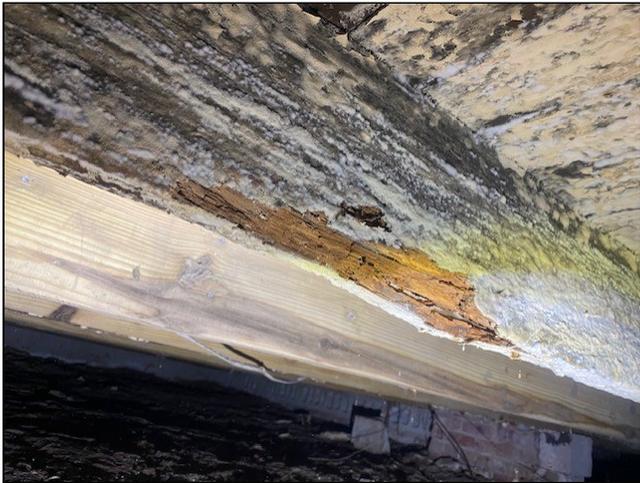
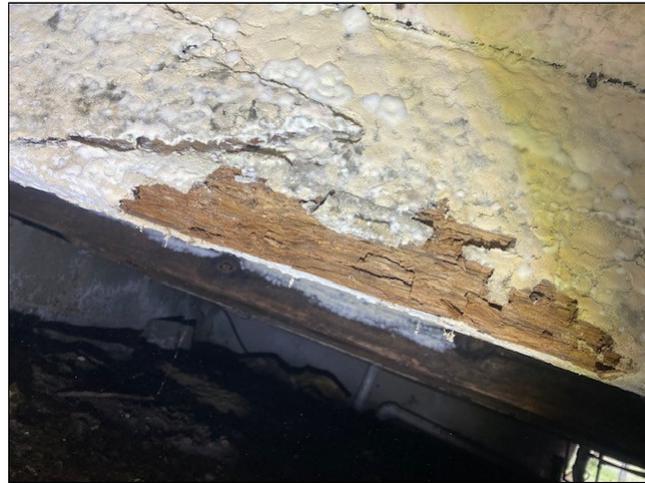
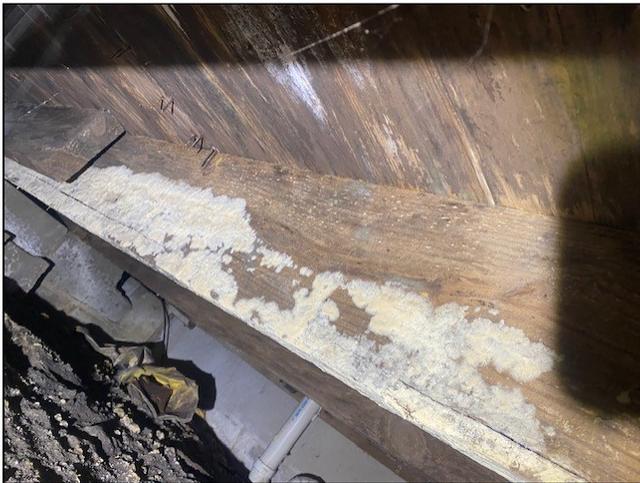
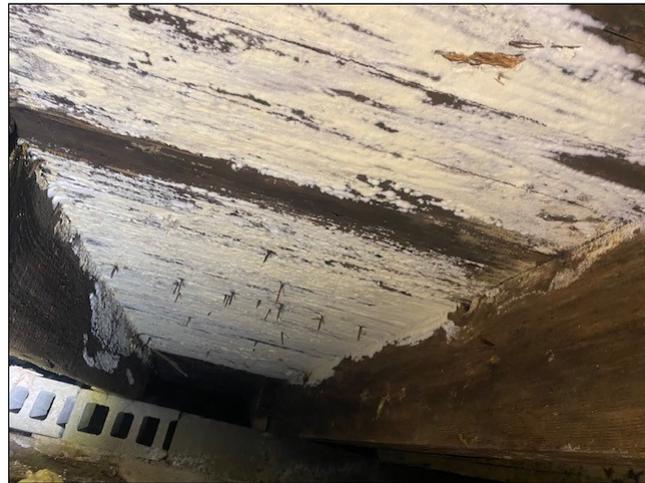
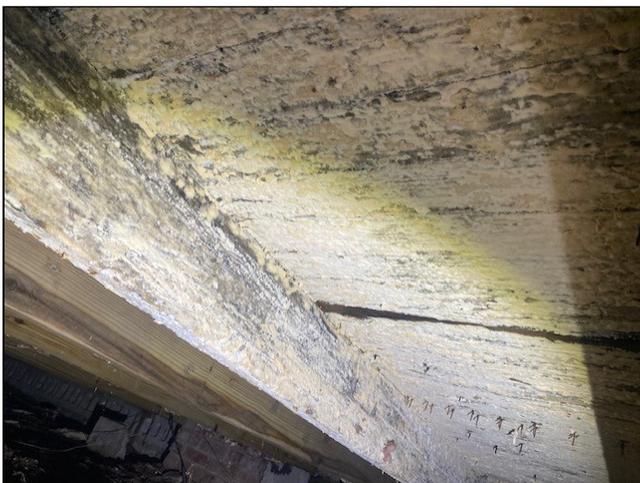
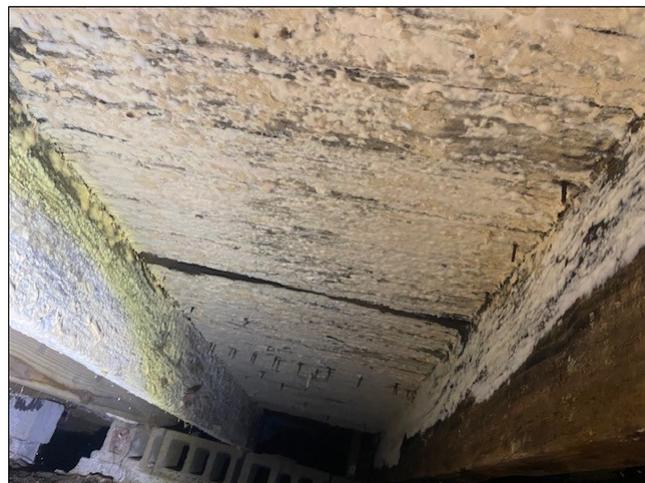
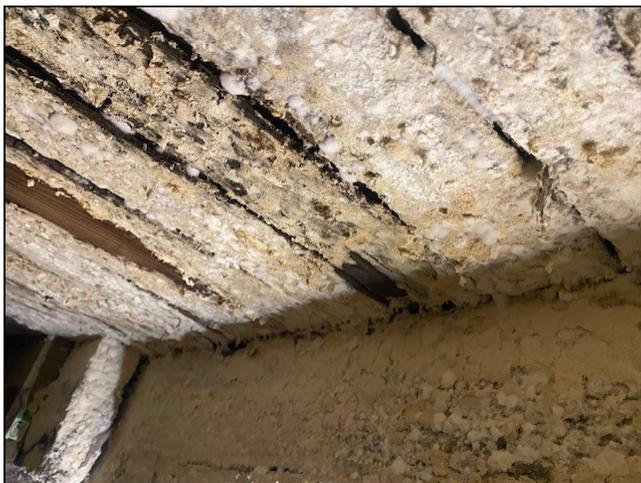
4.3 (1) Evaluate/Repair: From the middle of crawl space all the way toward the left side of crawl space, there is heavy moisture damage in the floor system (floor joists, girders, subfloor and possibly outer sills). I recommend damage be evaluated/repaired by a licensed contractor that specializes in structural repairs.

(1) Evaluate/Repair: From the middle of crawl space all the way toward the left side of crawl space, there is heavy moisture damage in the floor system (floor joists, girders, subfloor and possibly outer sills). I recommend damage be evaluated/repared by a licensed contractor that specializes in structural repairs.

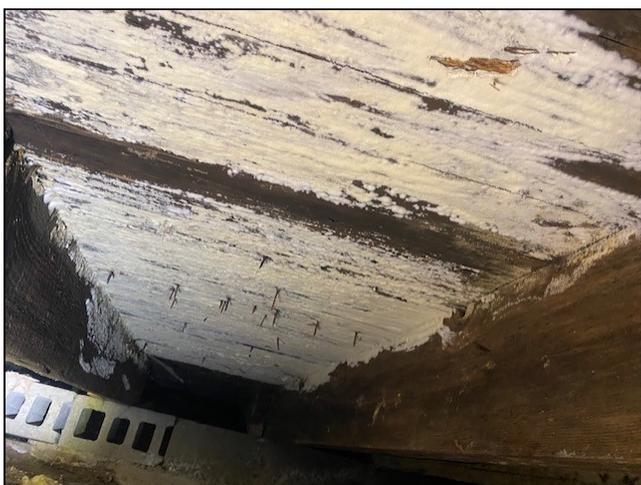
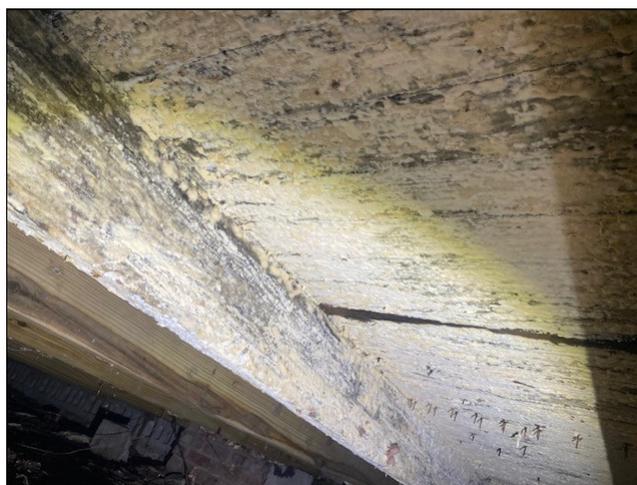
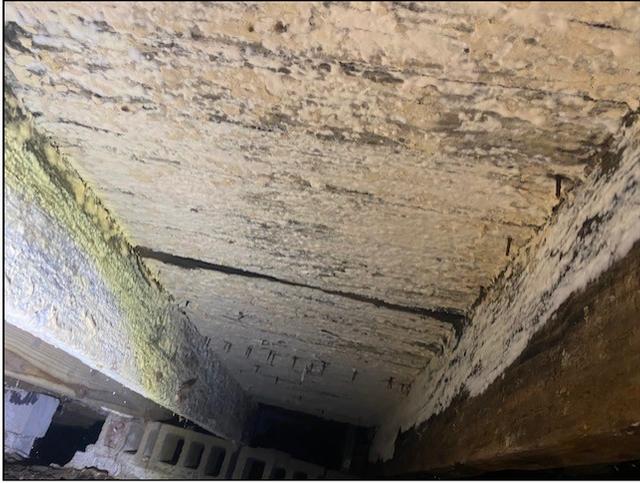
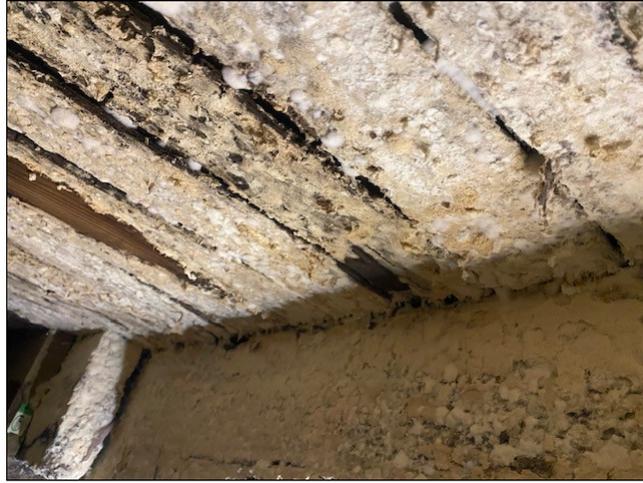
(2) Evaluate/Repair: There are high moisture levels in wooden members throughout crawl space. I recommend crawl space be evaluated by a moisture control specialist.

(3) Evaluate/Repair: There are signs of wood destroying insects on wooden members and foundation walls. I recommend home a wood destroying insect report be completed by a licensed pest control company.

(4) Evaluate/Repair: Signs of fungi growth is present on wooden members from the middle of crawl space all the way toward left side of crawl space. We did not inspect, test or determine if this growth is or is not a health hazard. The underlying cause is moisture. I recommend you contact a mold inspector/industrial hygienist or expert for investigation or correction if needed.

(4) Evaluate/Repair: Signs of fungi growth is present on wooden members from the middle of crawl space all the way toward left side of crawl space. We did not inspect, test or determine if this growth is or is not a health hazard. The underlying cause is moisture. I recommend you contact a mold inspector/industrial hygienist or expert for investigation or correction if needed.

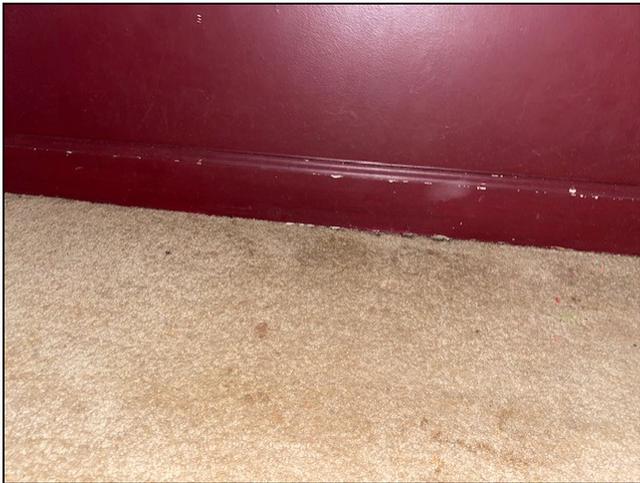
4.3 Item 12 (Picture)

(5) Evaluate/Repair: Daylight is visible inside the left rear bedroom between the floor and wall. I recommend it be evaluated/repared by a licensed contractor that specializes in structural repairs.

(5) Evaluate/Repair: Daylight is visible inside the left rear bedroom between the floor and wall. I recommend it be evaluated/repared by a licensed contractor that specializes in structural repairs.

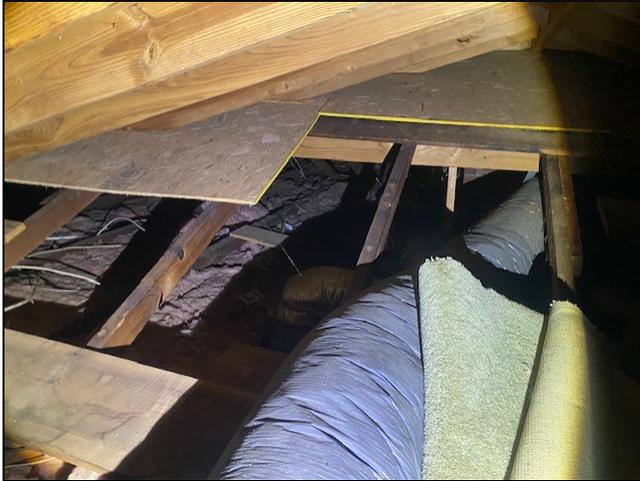
4.5 Item 1 (Picture)

4.5 Note: The middle to the left side of attic was inaccessible/not visible for inspection due to not being floored and low clearance

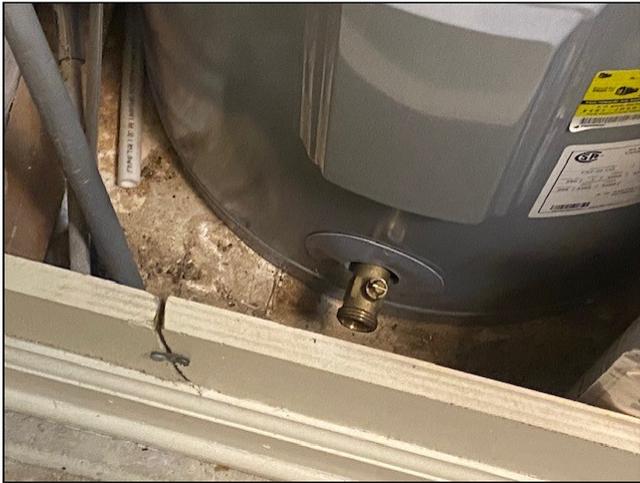
5.2 Item 1 (Picture)

5.2 Evaluate/Repair: There is no drain pan underneath water heater

Evaluate/Repair: There is no drain pan underneath water heater

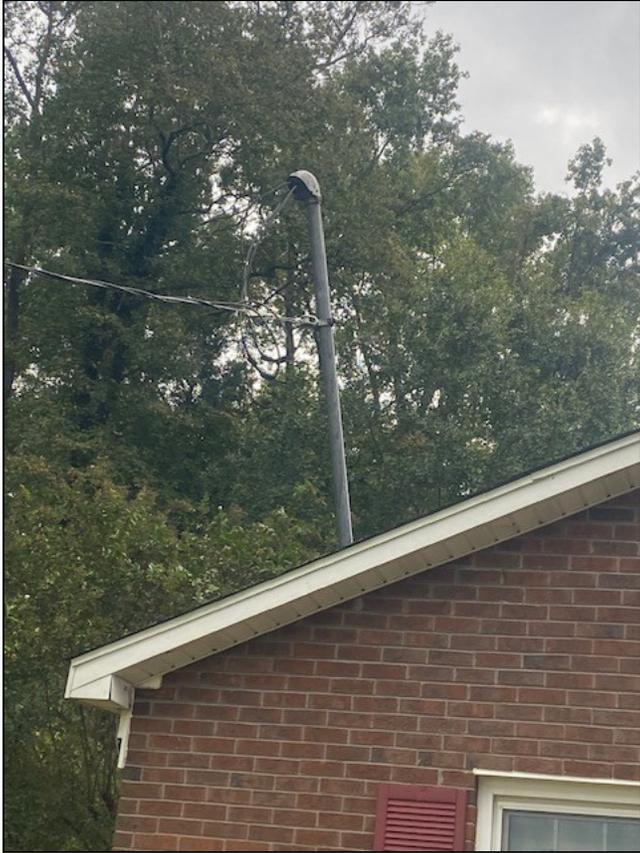
6.0 Item 1 (Picture)

6.0 Repair: The overhead electrical service mast is bent

Repair: The overhead electrical service mast is bent

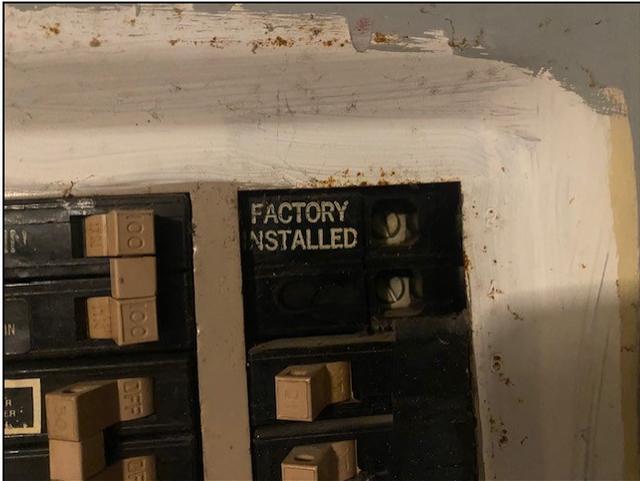
6.1 Item 1 (Picture)

6.1 Repair: Knock out plug is missing inside the top of the electrical panel

Repair: Knock out plug is missing inside the top of the electrical panel

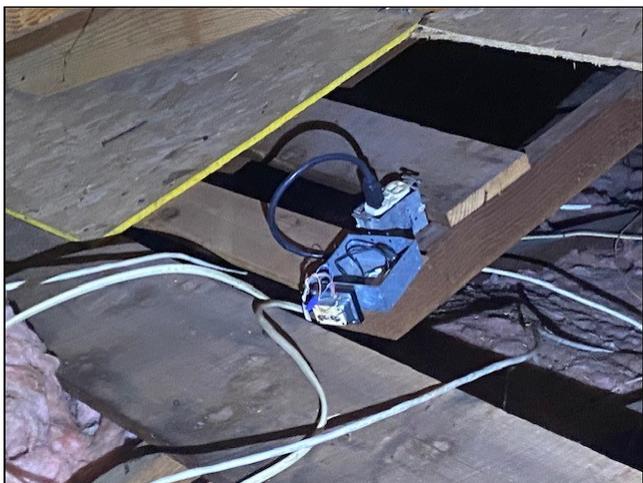
6.3 Item 1 (Picture)

(3) Repair: There is an open electrical box at front center of attic. It needs a cover.

(3) Repair: There is an open electrical box at front center of attic. It needs a cover.

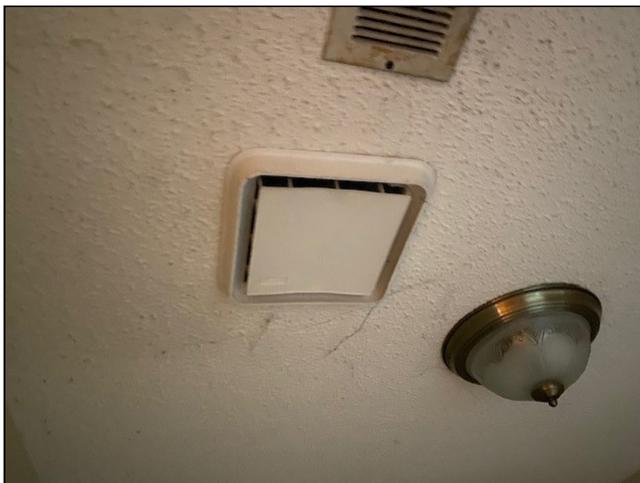
8.4 Item 1 (Picture)

8.4 (1) Repair: Primary bathroom vent fan does not operate. I recommend it be evaluated by a licensed electrical contractor.

(1) Repair: Primary bathroom vent fan does not operate. I recommend it be evaluated by a licensed electrical contractor.

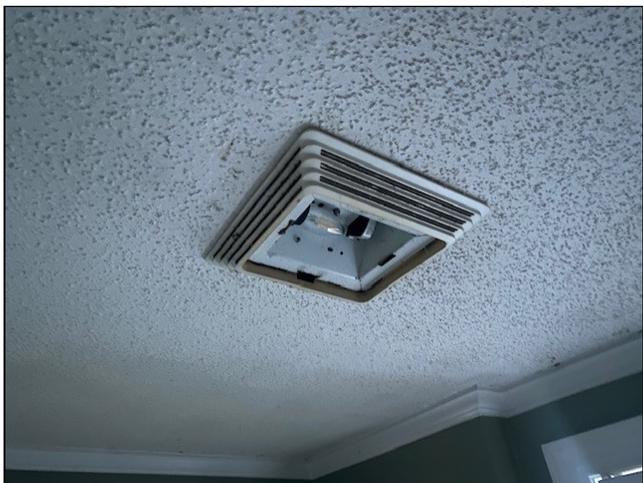
8.4 Item 2 (Picture)

(2) Repair: Left rear bathroom vent fan does not operate. I recommend it be evaluated by a licensed electrical contractor.

(2) Repair: Left rear bathroom vent fan does not operate. I recommend it be evaluated by a licensed electrical contractor.
