## Inspection Report

**Property Address:**  
901 Candlewood Drive  
Kinston NC

<b>Date:</b> 1/13/2025	<b>Time:</b>	<b>Report ID:</b> 25-10
<b>Property:</b> 901 Candlewood Drive Kinston NC	<b>Customer:</b> Samantha Baltazar	<b>Real Estate Professional:</b> Brenda Ochoa United Real Estate

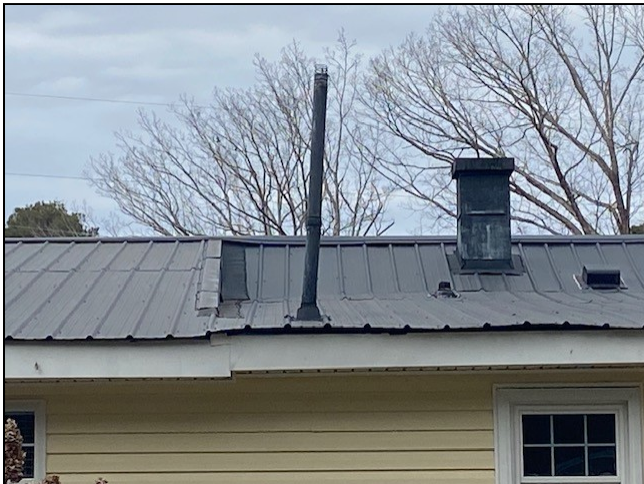
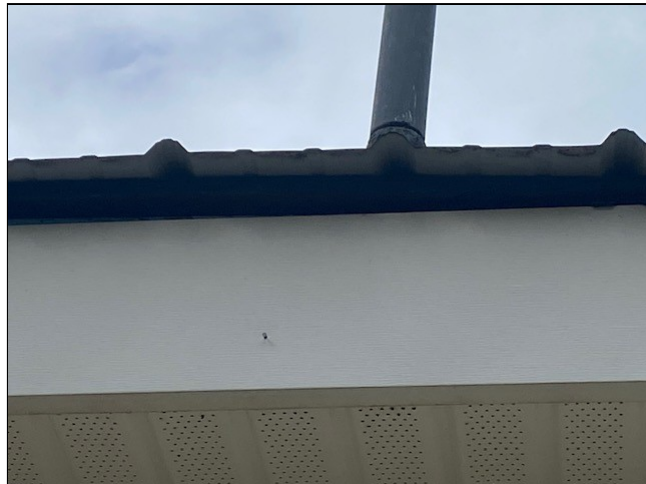
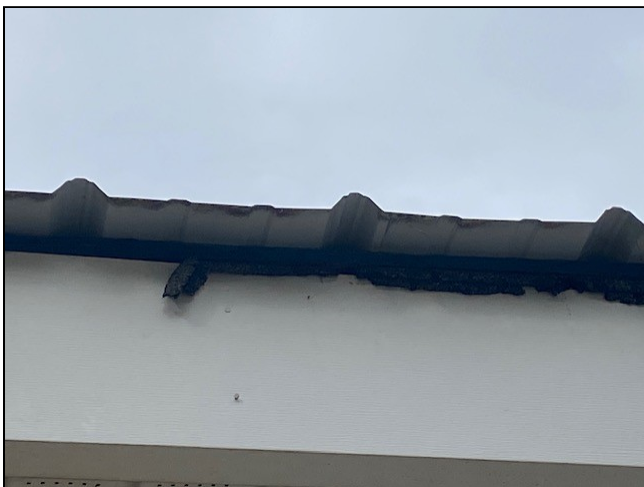
**1.0 Evaluate/Repair:** The entire roof system needs to be evaluated by a roofing contractor due to its condition and leaks found. Roof system is sunk in at rear center. It appears the metal roof was installed over the old shingle roof.

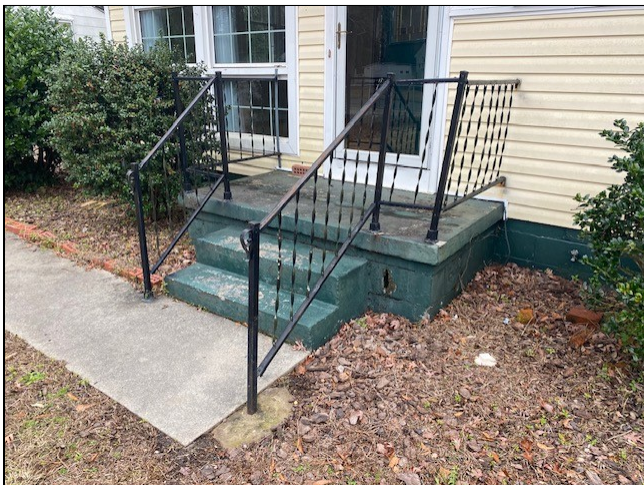
2.3 Item 1 (Picture)

**2.3 (1) Repair:** Handrails and railing around front porch is not properly secured

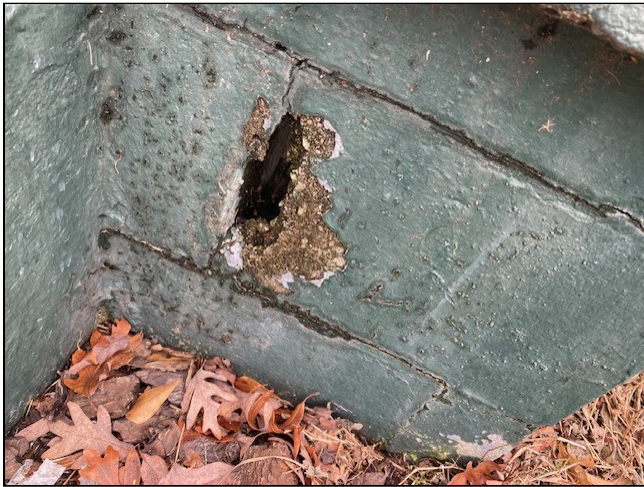
2.3 Item 2 (Picture)

(2) Repair: Some of the concrete blocking around foundation of front porch is deteriorated

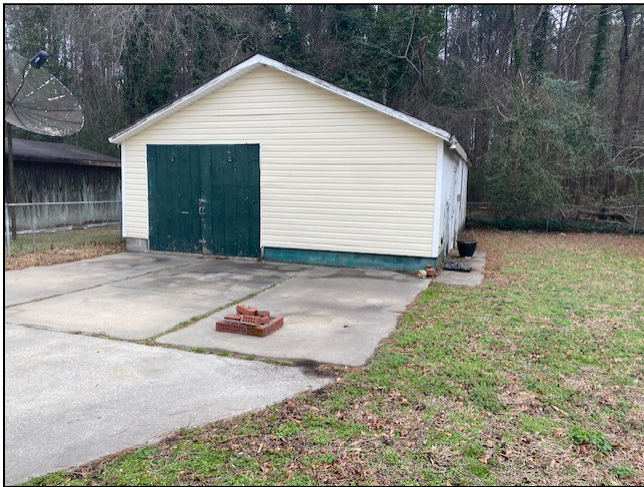
2.6 Item 1 (Picture)

**2.6 Note:** Home has a detached building. This was not included in the inspection.

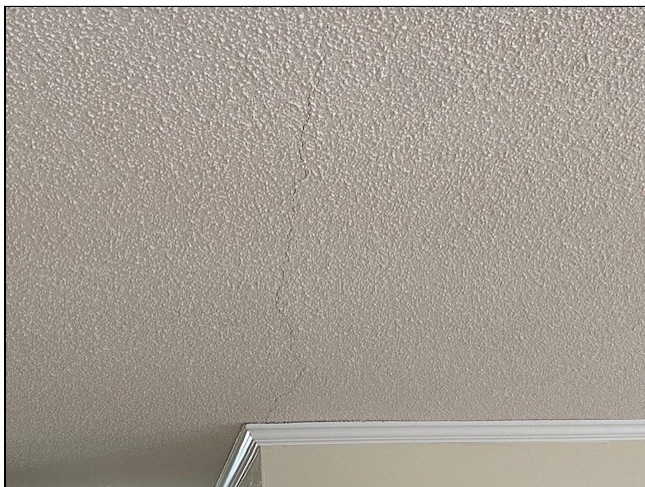
3.0 Item 1 (Picture)

**3.0 Evaluate/Repair:** There is a significant crack in the living room ceiling. I recommend it be evaluated by a licensed contractor.

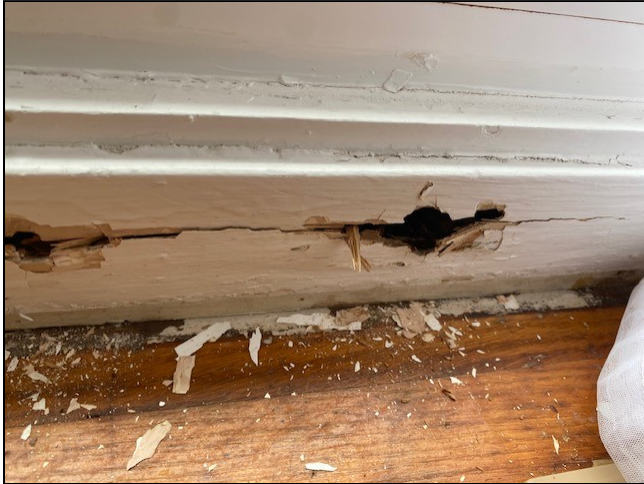
3.1 Item 1 (Picture)

3.1 (1) Repair: There is moisture damage in the baseboard underneath front living room windows. I recommend it be evaluated by a licensed contractor.

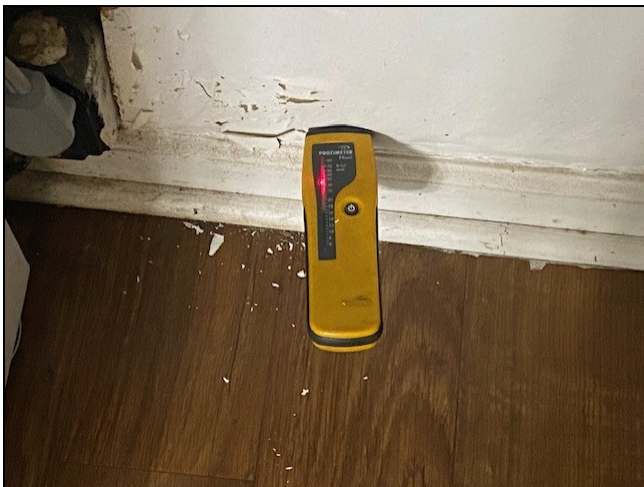
3.1 Item 2 (Picture)

(2) Repair: Wall is damaged behind washer/dryer area. Wall was wet at time. I recommend it be evaluated by a licensed contractor. Refer to plumbing section of report.

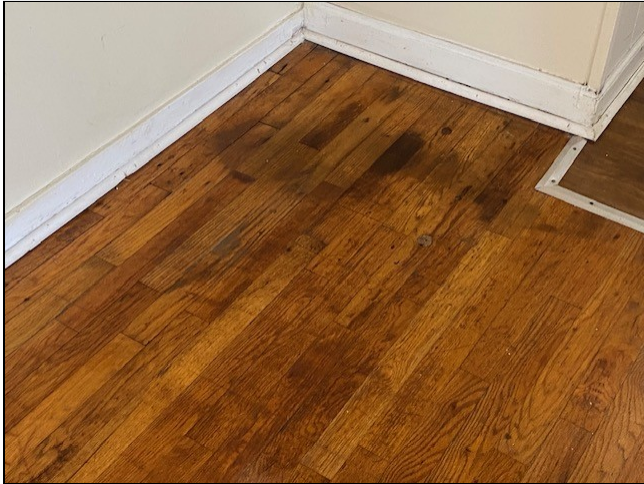
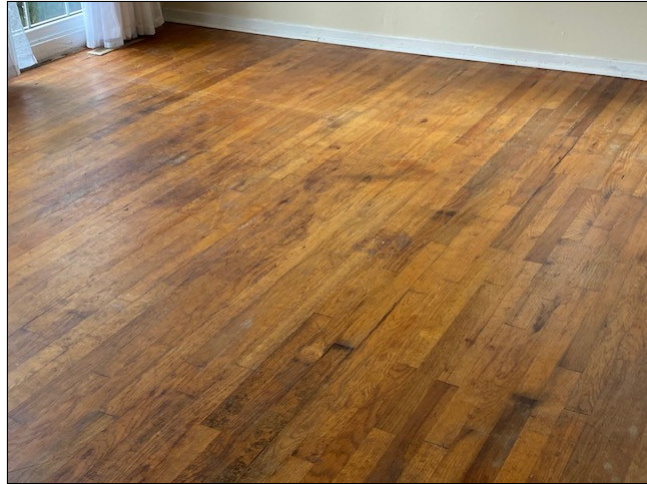
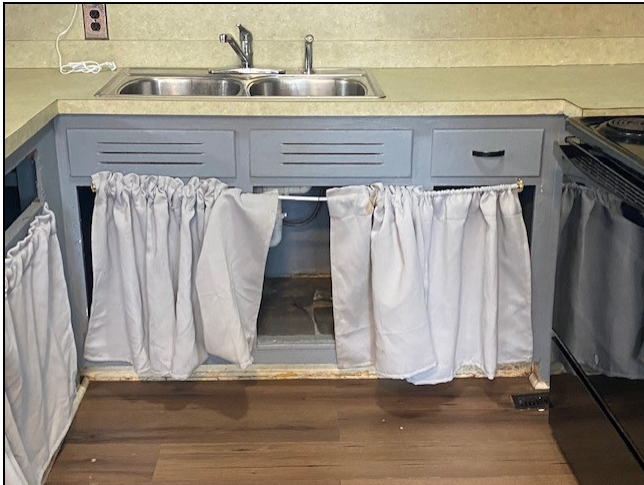
3.2 Evaluate/Repair: There is a lot of bounce in the flooring throughout the house. There is a lot of uneven flooring throughout house. There are a lot of soft areas in the flooring inside the front living room. There is a lot of sagging in the flooring inside kitchen. Countertop inside kitchen is not level due to the flooring. I recommend it be evaluated by a licensed contractor. Refer to structural section of report.

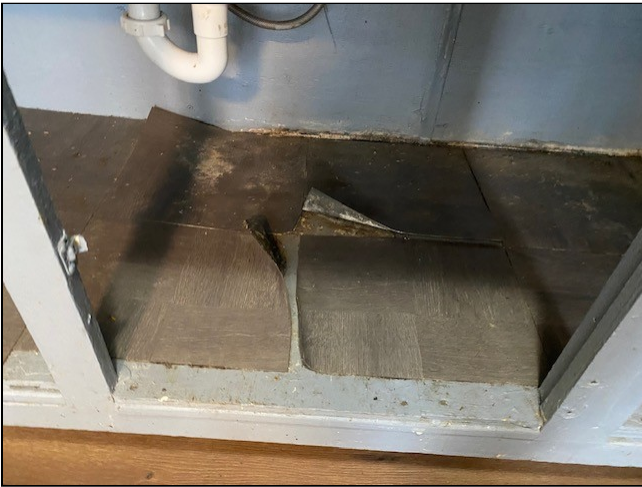
3.3 Item 1 (Picture)

**3.3 Evaluate/Repair:** The inside (bottom) of kitchen sink cabinet is damaged

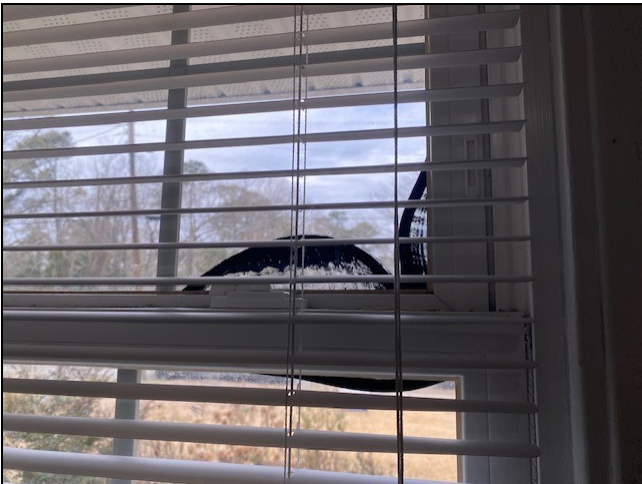
3.5 Item 1 (Picture)

**3.5 (1) Repair:** Rubber seal has come loose between panes of glass on the left front bedroom windows. I recommend it be evaluated by a window specialist.

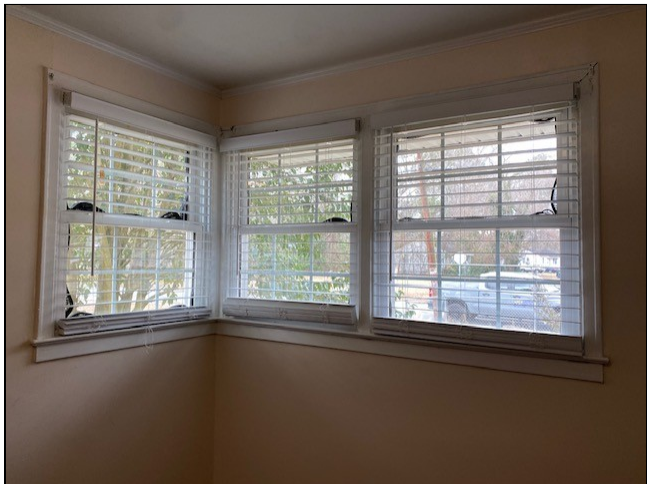
3.5 Item 2 (Picture)

(3) Repair: Rubber seal has come loose between panes of glass on all three windows inside the right front bedroom. I recommend they be evaluated by a window specialist.

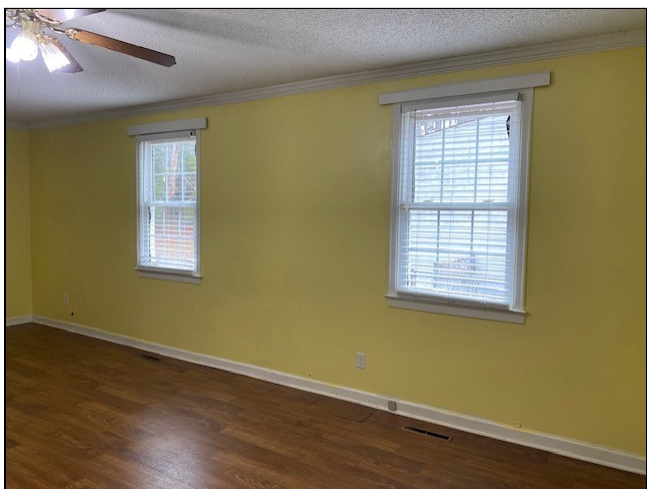
3.5 Item 3 (Picture)

(4) Repair: Rubber seal has come loose between panes of glass on both windows inside the right rear bedroom. I recommend it be evaluated by a window specialist.

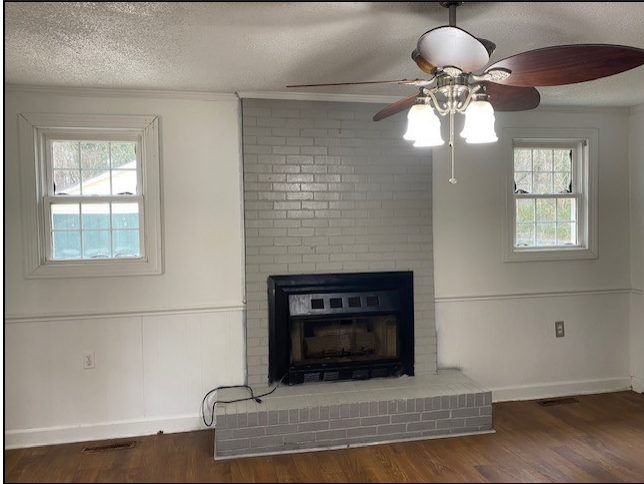
3.5 Item 4 (Picture)

(5) Repair: Rubber seal has come loose between panes of glass on windows to the left and right of fireplace. I recommend they be evaluated by a window specialist.

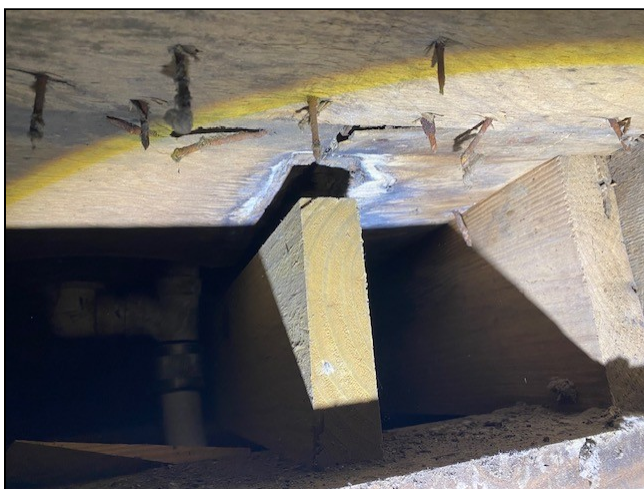
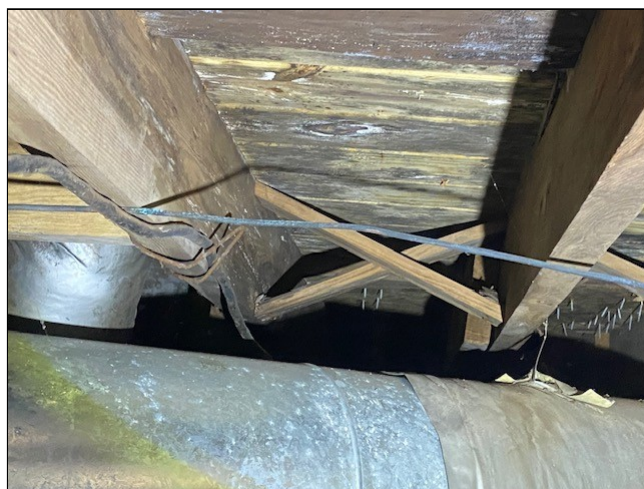
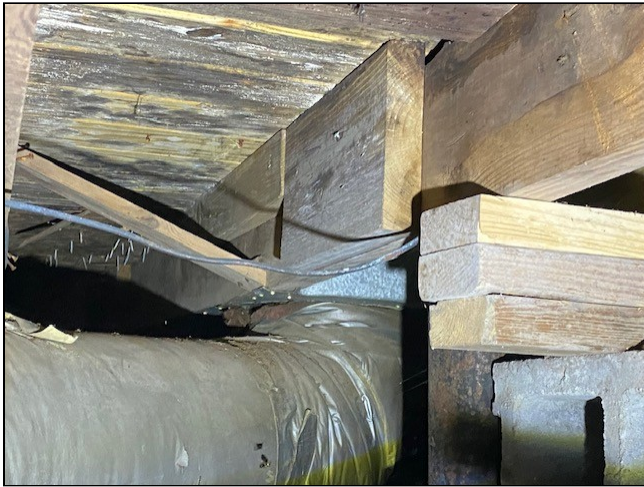
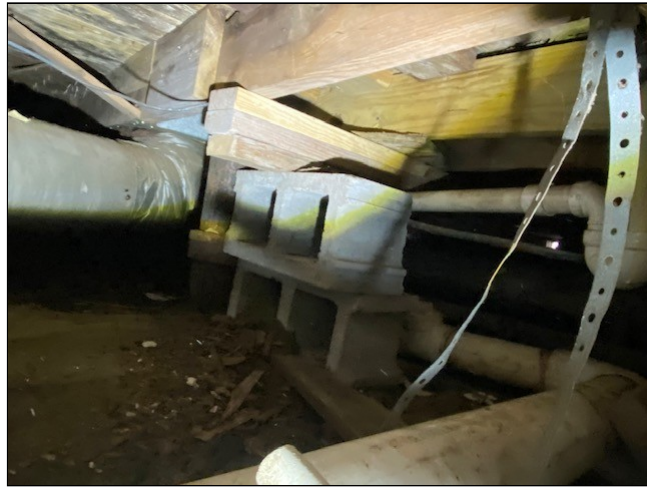
**4.3 Evaluate/Repair:** Viewed from crawl space entry, there is heavy moisture damage in subfloor, floor joists, and outer sills throughout the crawl space. I recommend access to crawl space be made and entire crawl space be evaluated by a licensed contractor that specializes in structural repairs.

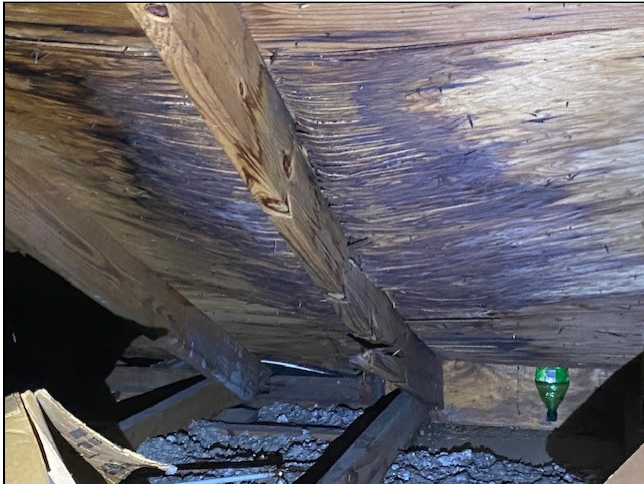
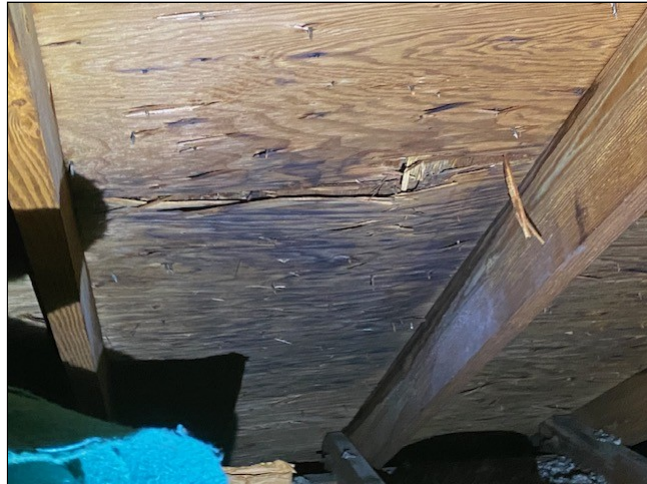
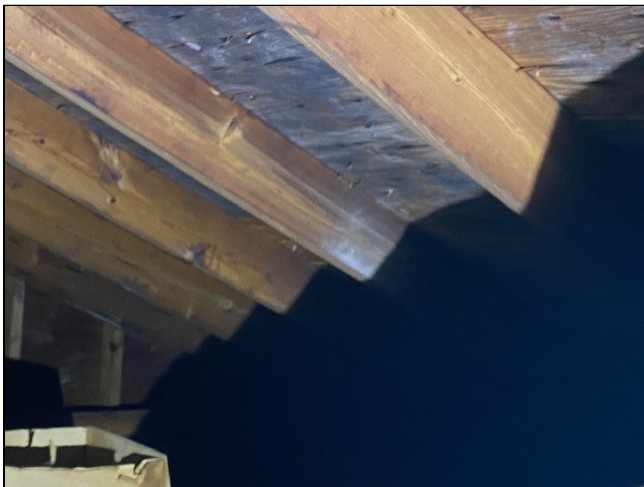
**4.5 Evaluate/Repair:** The roof system is caved in at the rear center of attic. The rafter is broken in the area. There is moisture damage in the roof system throughout this area. Roof appears to be leaking in a lot of areas throughout attic. I recommend it be evaluated/repared by a roofing contractor.

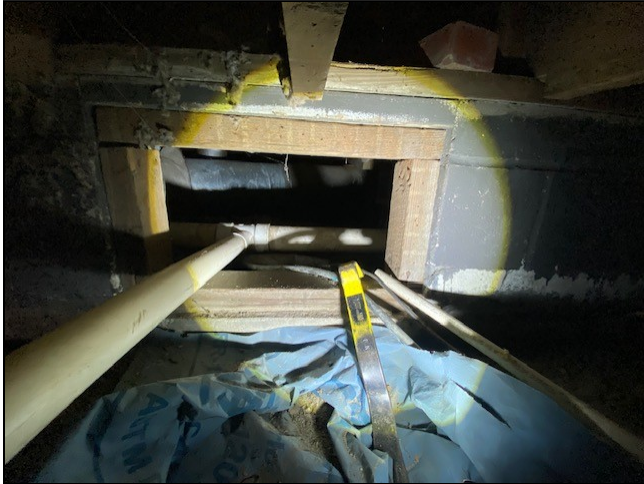
4.6 Item 1 (Picture)

4.6 Note: There was limited access to inspect the crawl space. Crawl space was viewed from crawl space entry of main house.

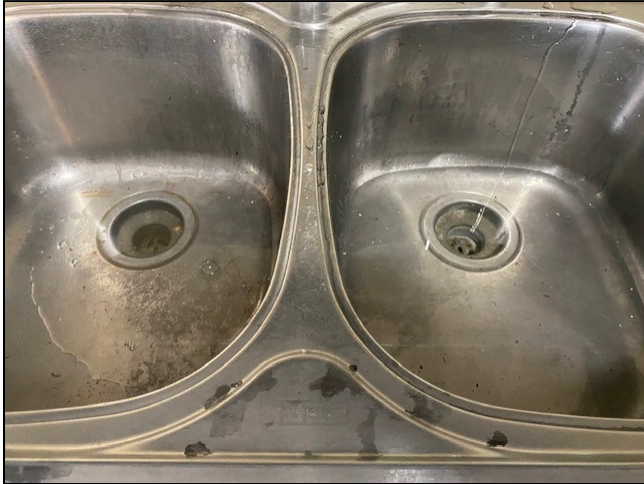
5.0 Item 1 (Picture)

5.0 (1) Evaluate/Repair: Both kitchen sink drains are not draining properly. They drain extremely slowly. I recommend it be evaluated by a licensed plumbing contractor.

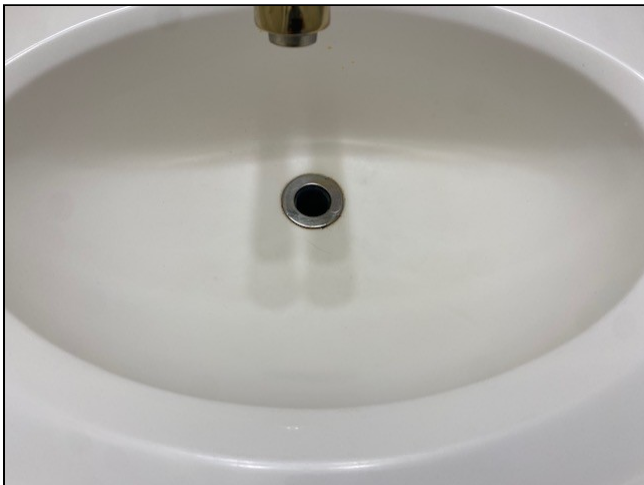
5.1 Item 1 (Picture)

5.1 (1) Repair: Hall bathroom sink drain stop is missing

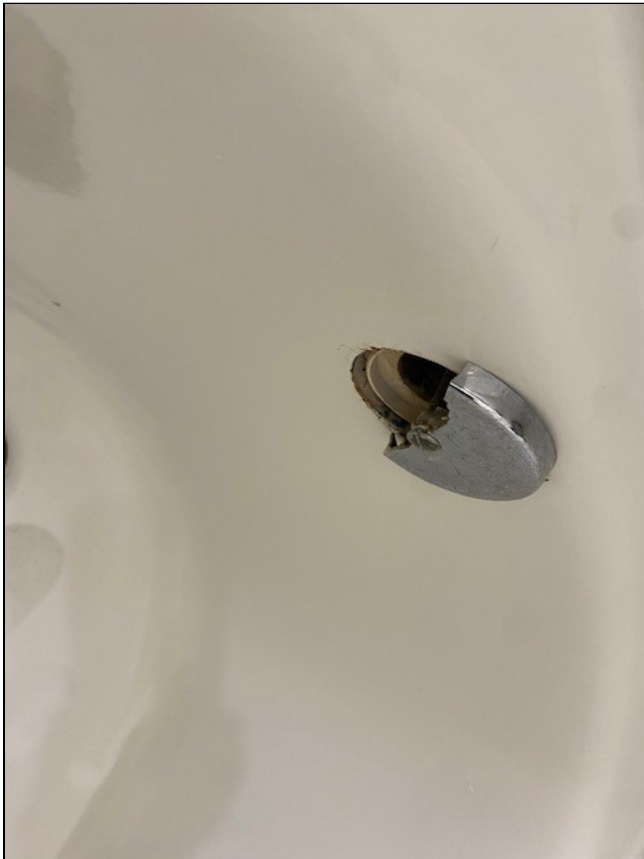
5.1 Item 2 (Picture)

(2) Repair: Hall bathroom tub overflow fixture is broken

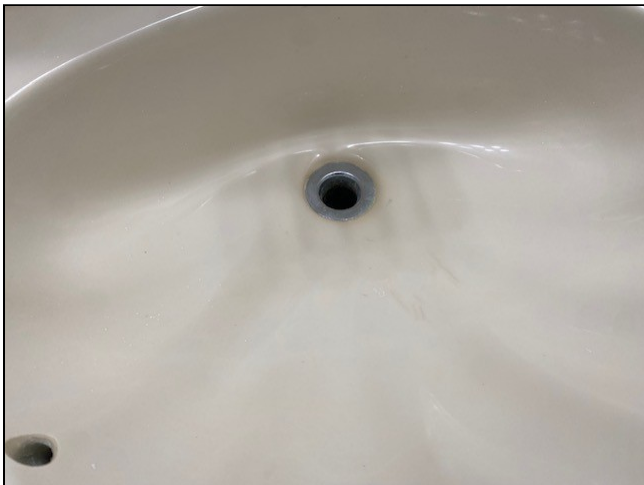
5.1 Item 3 (Picture)

(3) Repair: Primary bathroom sink drain stop is missing

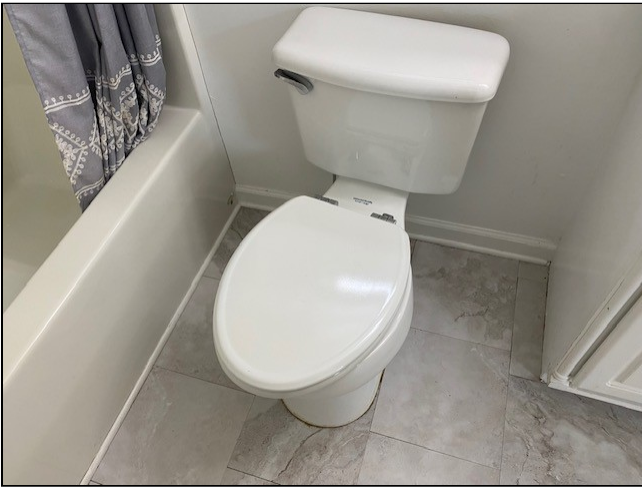
5.1 Item 4 (Picture)

(4) Repair: Primary bathroom toilet is mounted crooked to the floor

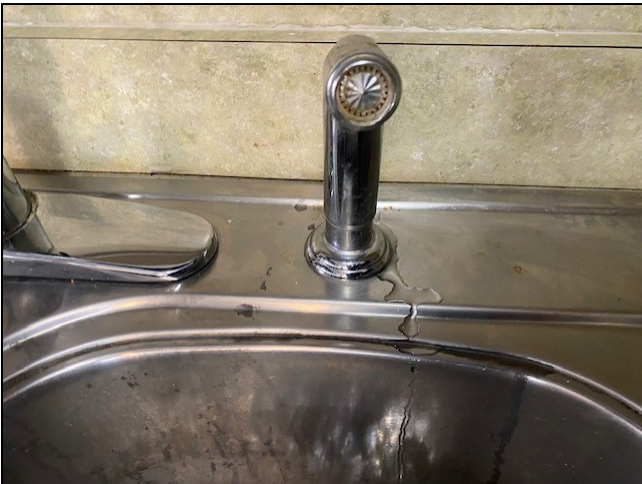
5.1 Item 5 (Picture)

(6) Repair: Kitchen sink sprayer nozzle leaks. I recommend it be evaluated by a licensed plumbing contractor.

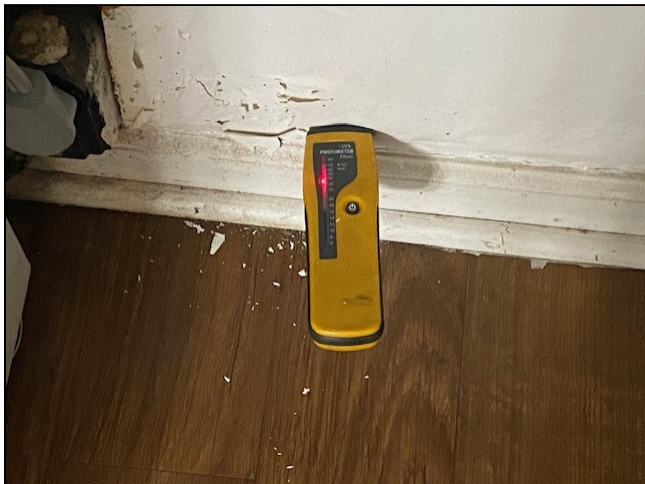
5.1 Item 6 (Picture)

(7) Evaluate/Repair: I recommend a licensed plumbing contractor evaluate to determine source of leak in wall behind washer/dryer area and repair

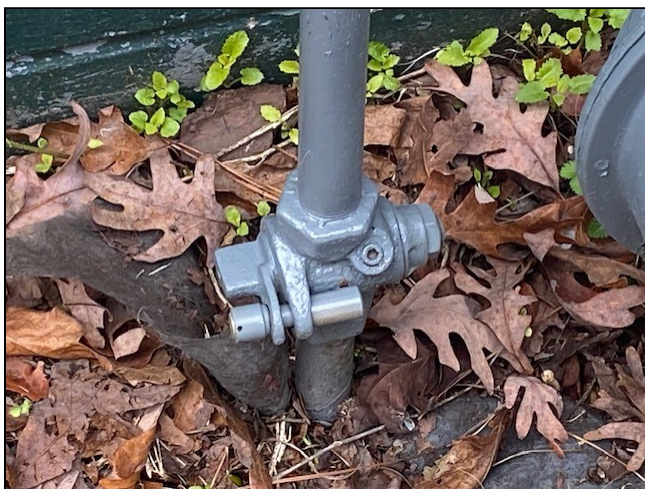
5.4 Item 1 (Picture)

**5.4 Note:** Gas meter was locked out at time of inspection. I was not able to check operation of gas heating system, gas water heater or gas logs.

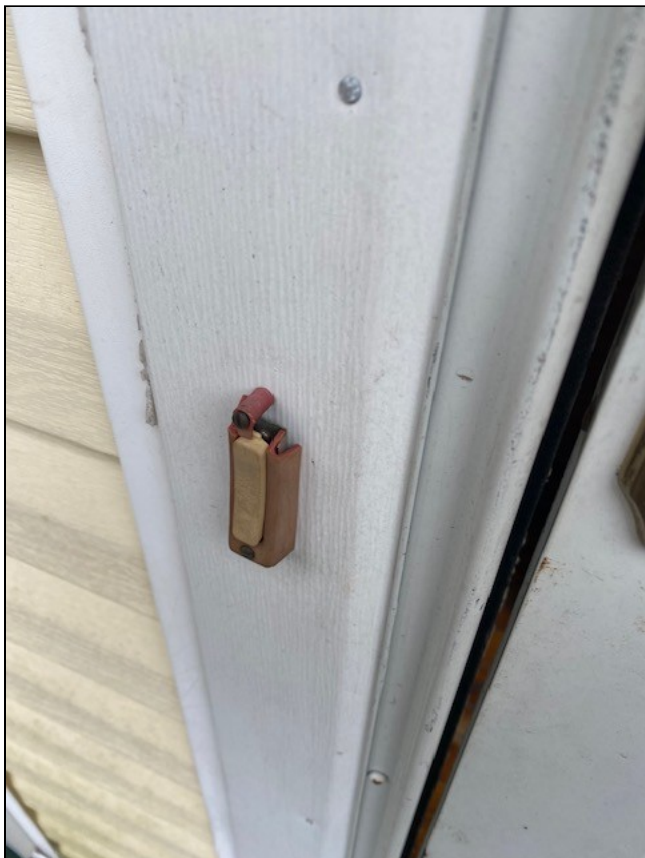
6.3 Item 1 (Picture)

**(3) Repair:** Front doorbell does not operate. Button is also broken.

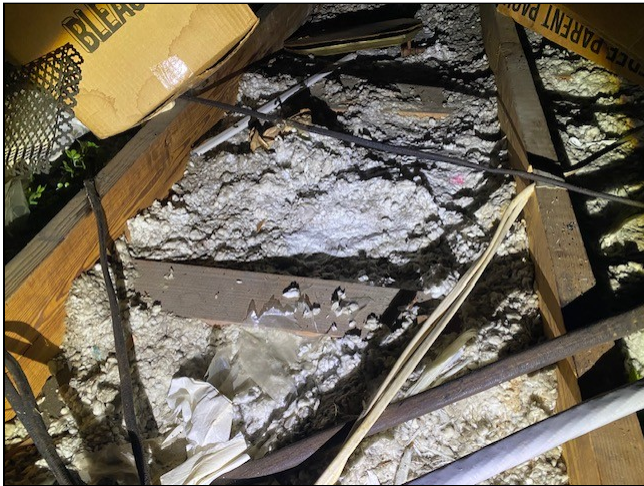
8.0 Item 1 (Picture)

**8.0 Evaluate/Repair:** There is very little insulation inside the attic. I recommend attic be evaluated by an insulation specialist.

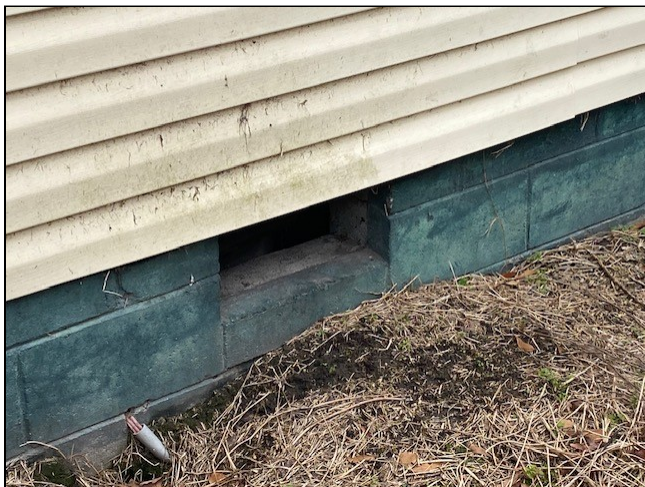
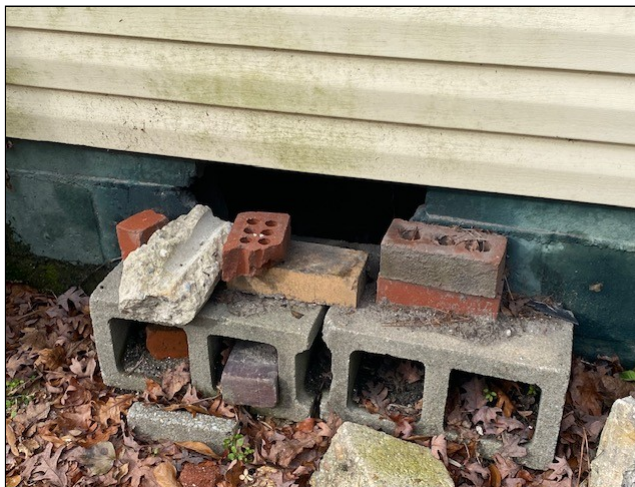
**8.3 Repair:** Crawl space vent is missing at right rear of house and left rear of house
